As-built Stormwater Dike

STORMWATER DIKE BUTTRESS AS-BUILT REPORT

**AGNICO-EAGLE MINES LIMITED
MEADOWBANK GOLD PROJECT**

DECEMBER 11, 2016

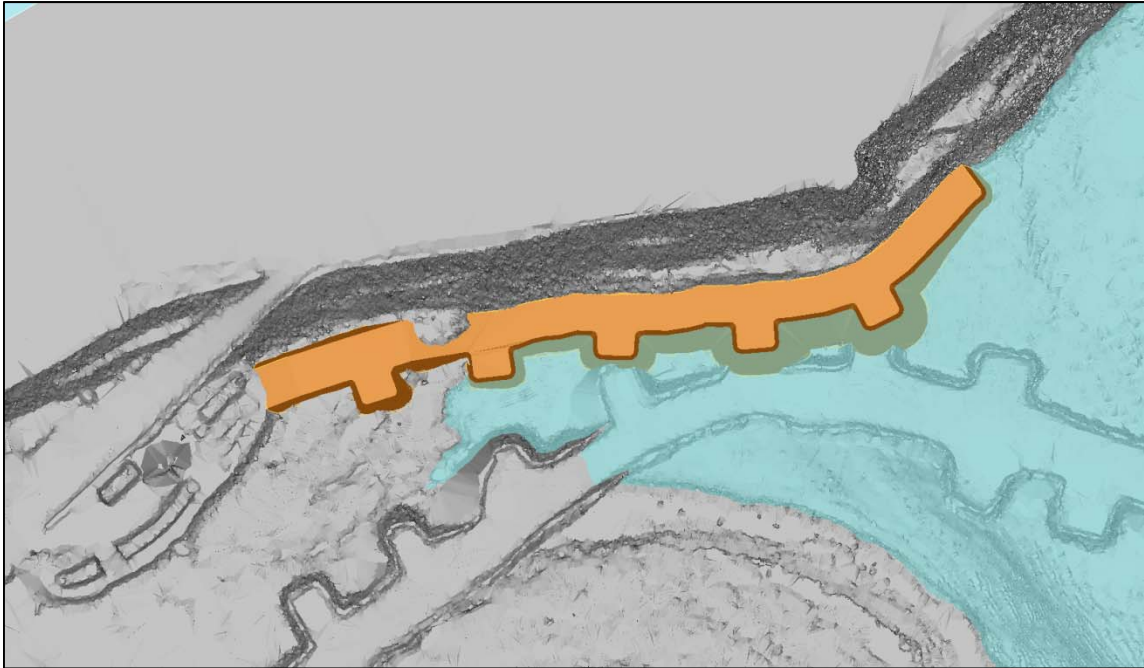
The original buttress design (see Figure 3) was for a buttress 315m long and 15m wide with haul truck turnarounds every 50m. The buttress would be built to elevation 133m. On September 10th

Figure 3: Plan view of the original buttress design.

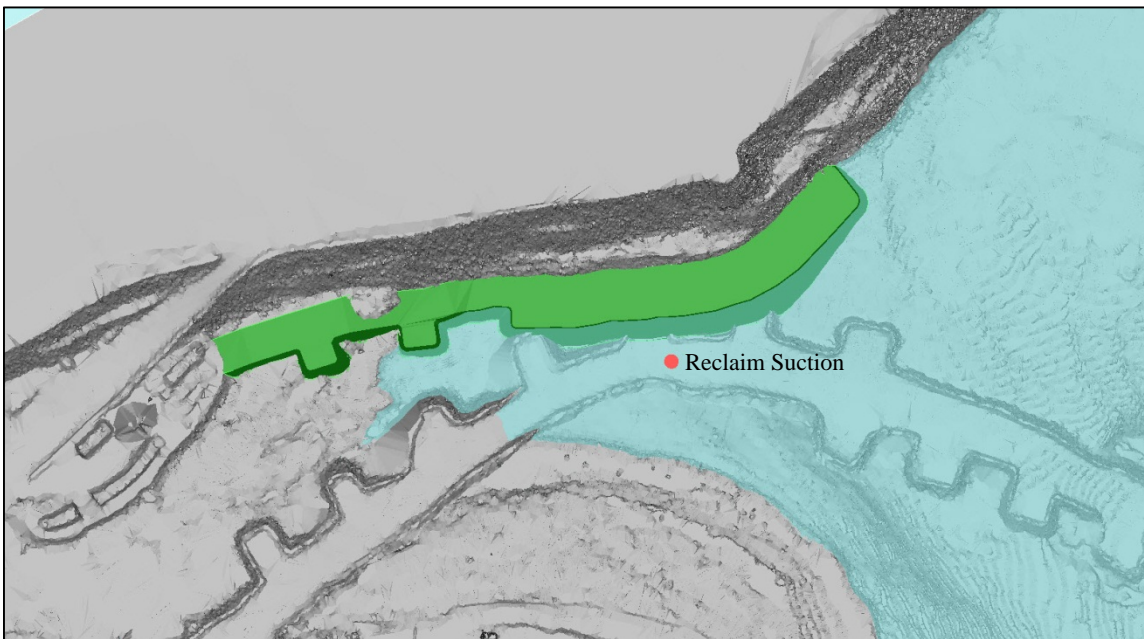
the buttress design was revised to an increased width of 25m starting at the third haul truck turnaround (see Figure 4). With a width of 25m haul truck turnarounds would no longer be required. In addition, the buttress would be constructed in two lifts with the first lift being constructed to 131.1m elevation; 0.5m above the South Cell water level at that time. This revised buttress design results in a more stable buttress, provides more stabilization for Stormwater Dike, and is a safer way to construct a rockfill structure in water.

Figure 4: Plan view of the revised buttress design.

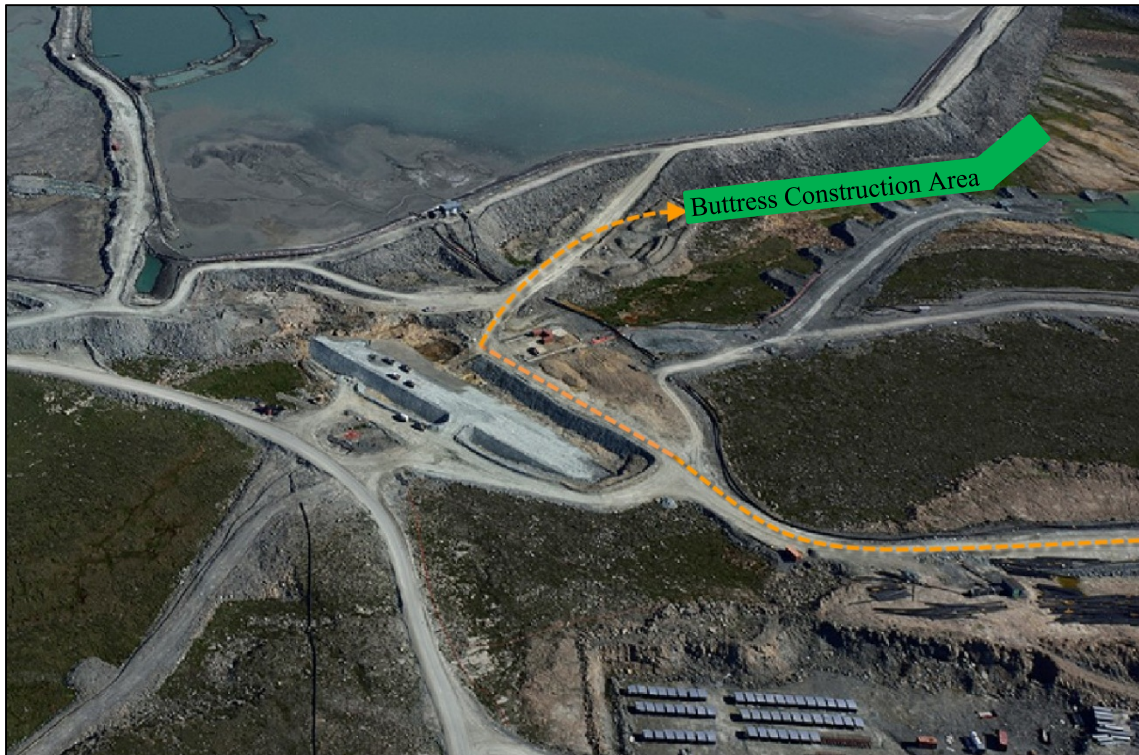
The first step prior to all works in the buttress construction area was to build an access road (see Figure 5). Existing roads near Saddle Dam 3 had to be widened to a minimum of 15m wide to provide enough room for 100T haul trucks to circulate. 0-6" till reject and till was used for widening the roads. Access was then made through the road berms on the ramp up to Stormwater Dike and through the pad beyond into the tundra along the downstream toe of Stormwater Dike. Pickets were placed in the tundra to indicate where the access road needed to go. When on the tundra the access road was built within the pickets using a minimum lift thickness.

Figure 5: View of the plan for the access road for the SWD buttress (aerial photo from summer 2015 with access road plan added).

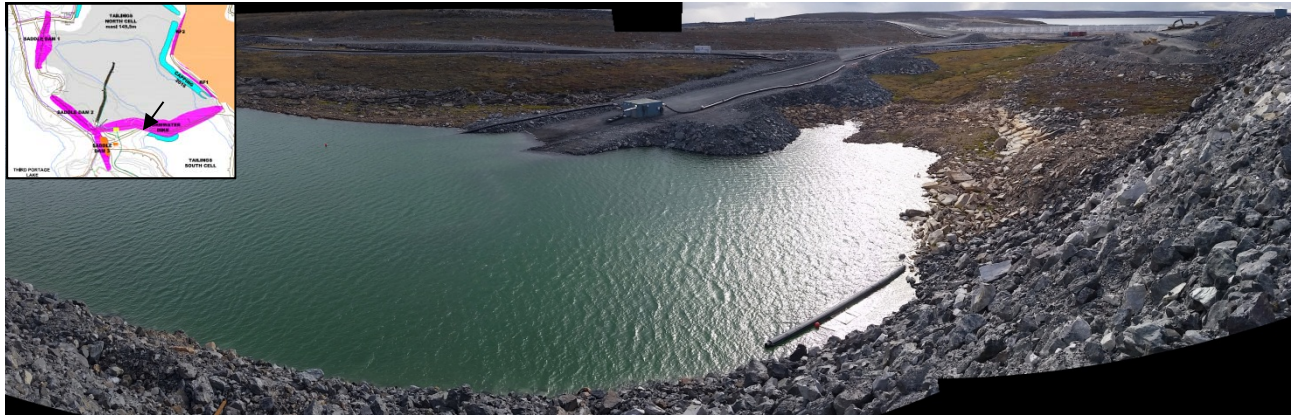
Figure 1: Photo of the Stormwater Dike downstream slope toe area prior to buttress construction looking south (September 1, 2016).

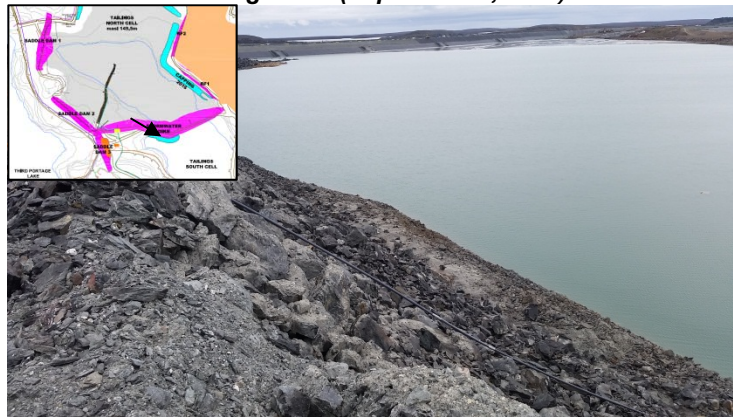
Figure 2: Photo of the Stormwater Dike downstream slope toe area prior to buttress construction looking east towards Central Dike (August 31, 2016).

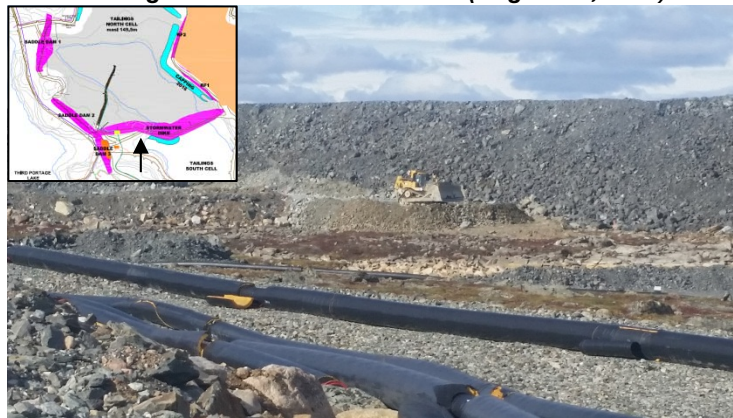
Figure 3: Dozer building the access road to the buttress construction area (September 4, 2016).

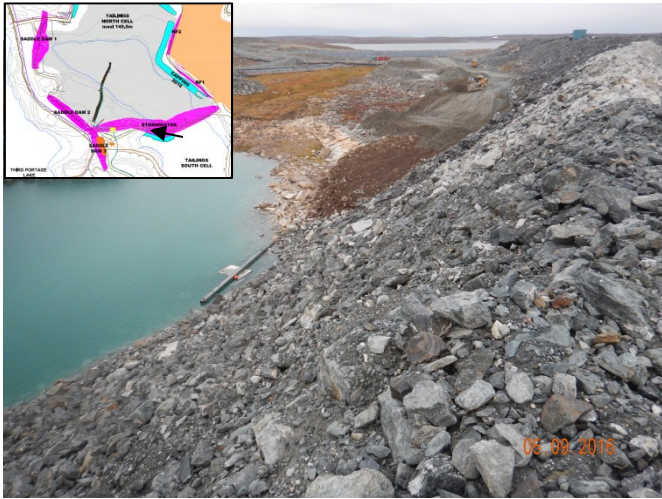
Figure 4: Construction of the access road continues (September 5, 2016).

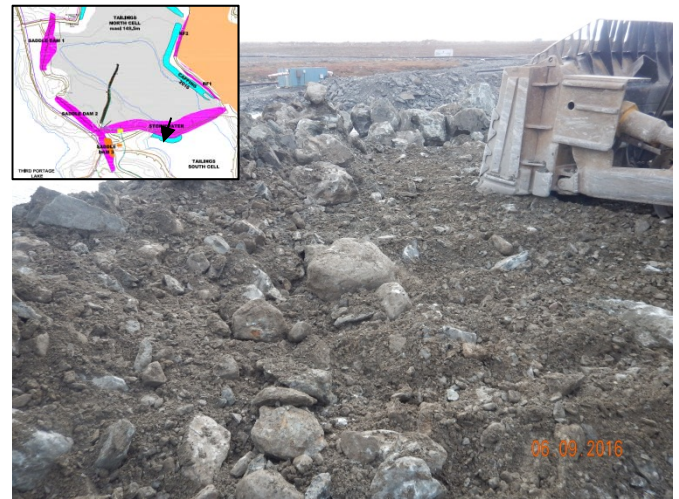
Figure 7: Close up view of the first lift of rockfill for the buttress (September 6, 2016).

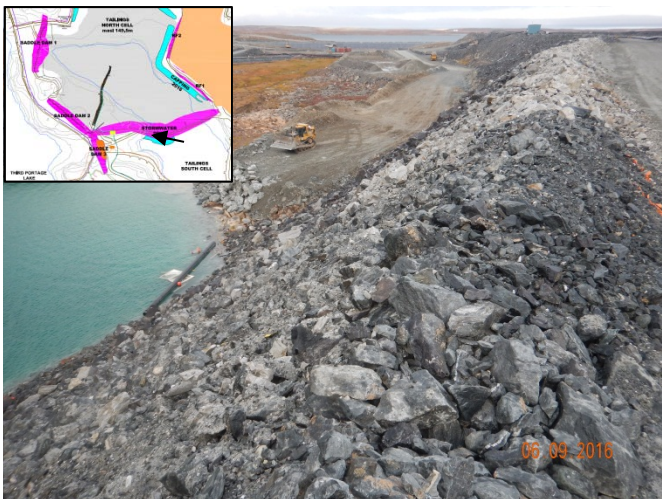
Figure 5: Placement of the first lift of rockfill for the buttress begins (September 6, 2016).

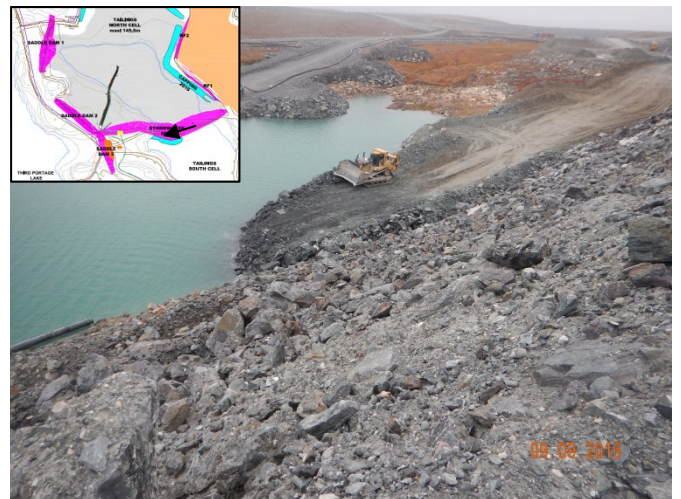
Figure 8: Advancement of the first lift of rockfill for the buttress (September 9, 2016).

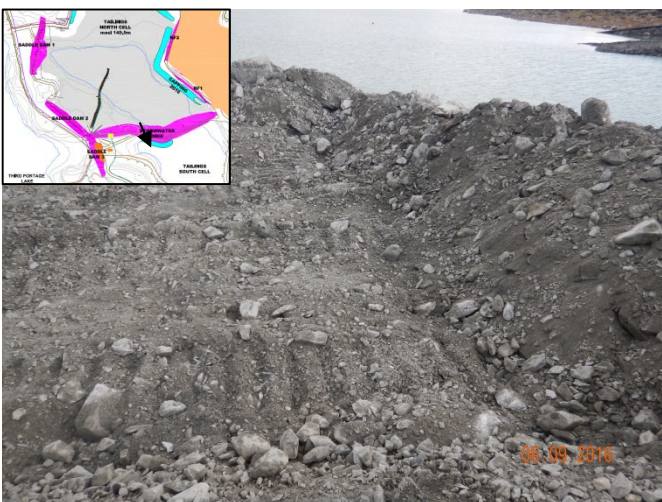
Figure 6: Close up view of the first lift of rockfill for the buttress (September 6, 2016).

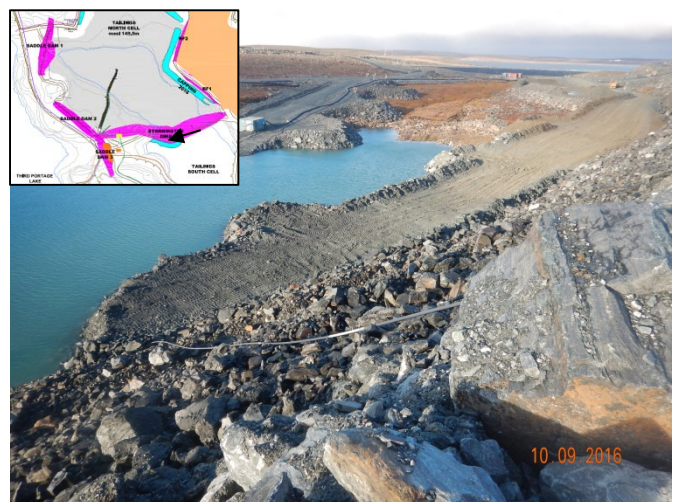
Figure 9: View of the buttress; note the turnaround area for the haul trucks (September 10, 2016).

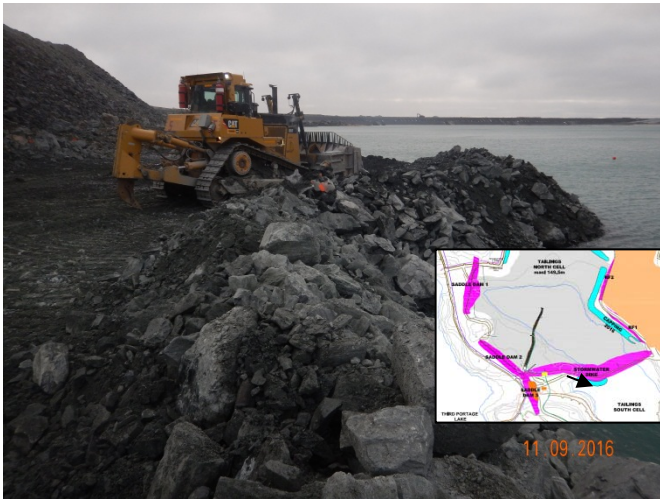
Figure 10: View of the dozer as it pushes rockfill to construct the buttress (September 11, 2016).

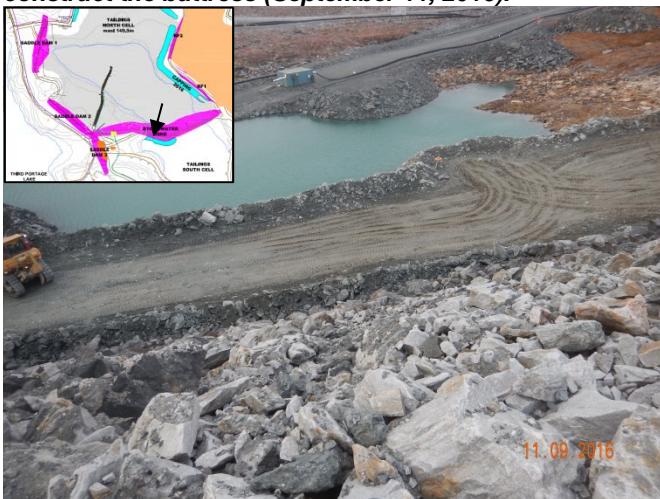
Figure 11: View of the buttress progress (September 11, 2016).

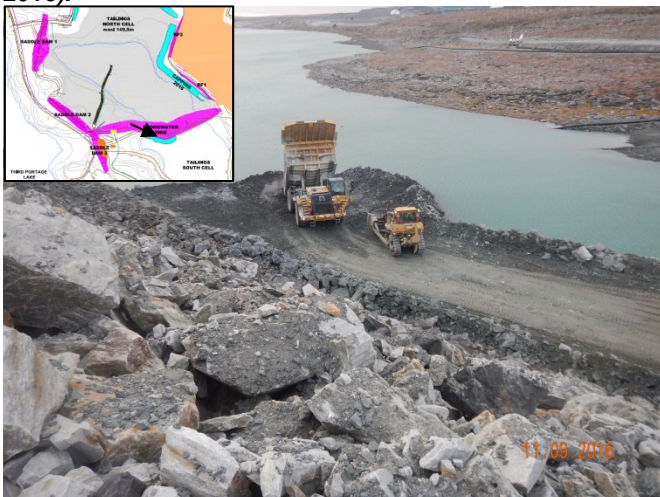
Figure 12: A haul truck dumps rockfill as the dozer stands by; at this point the buttress design has been changed to a width of 25m. Previously, the width was 15m between truck turnarounds. (September 11, 2016).

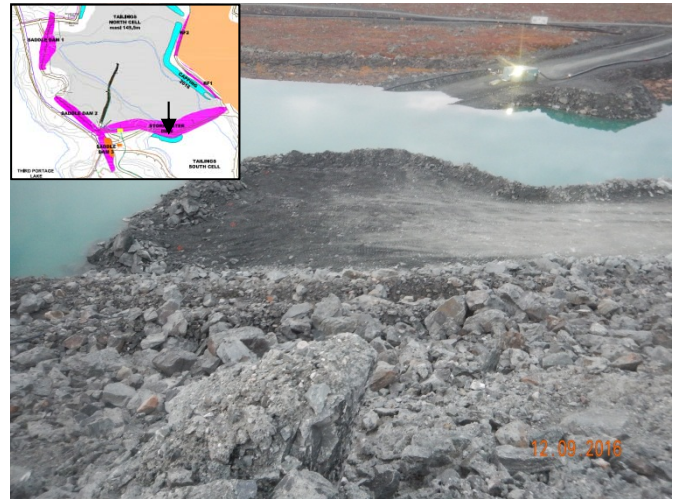
Figure 13: View of the buttress progress (September 12, 2016).

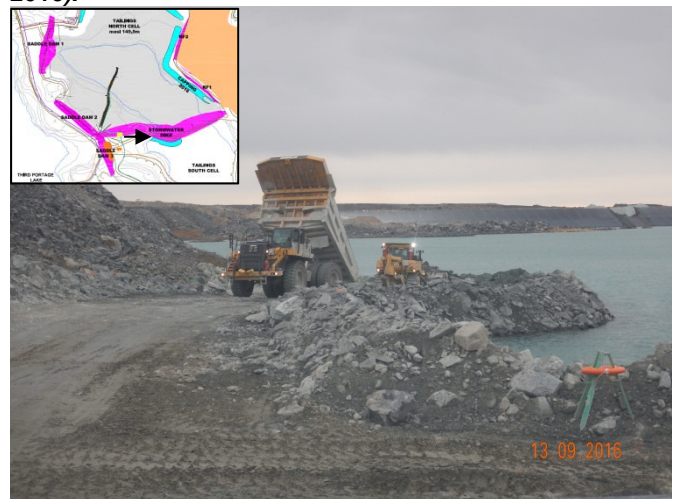
Figure 14: View of the buttress construction (September 13, 2016).

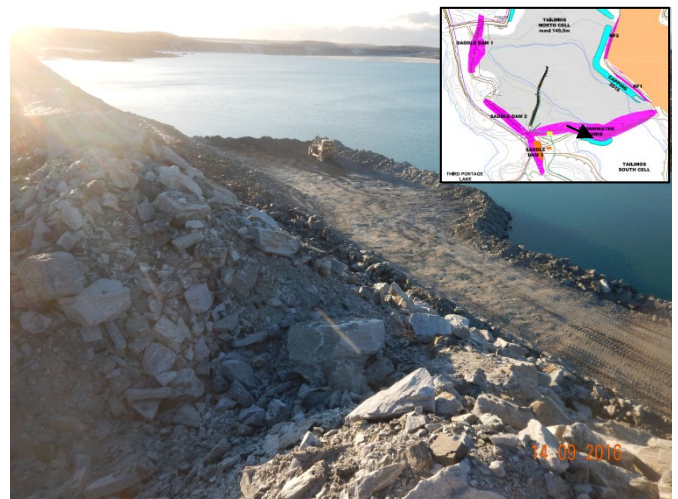
Figure 15: Buttress construction continues (September 14, 2016).

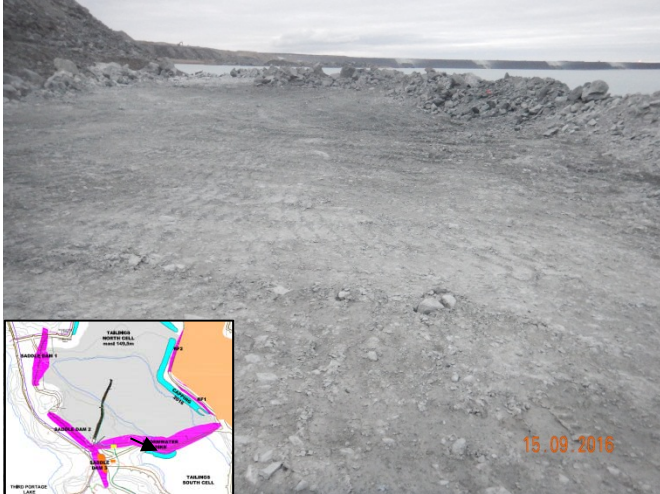
Figure 16: View of the top surface of the buttress; regular grade shots are performed during construction to ensure it is level (September 15, 2016).

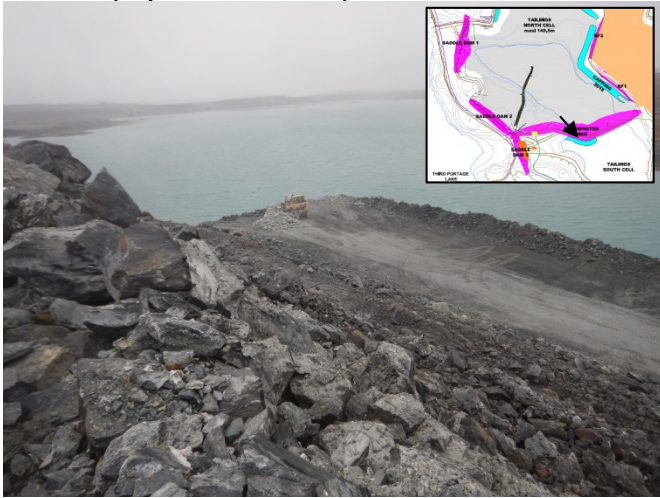
Figure 17: View of the buttress construction (September 17, 2016).
