### **2017 TSF As-built Report**

**SOUTH CELL INTERNAL STRUCTURE AS-BUILT REPORT**

**AGNICO-EAGLE MINES LIMITED  
MEADOWBANK GOLD PROJECT**

**DECEMBER 31, 2017**

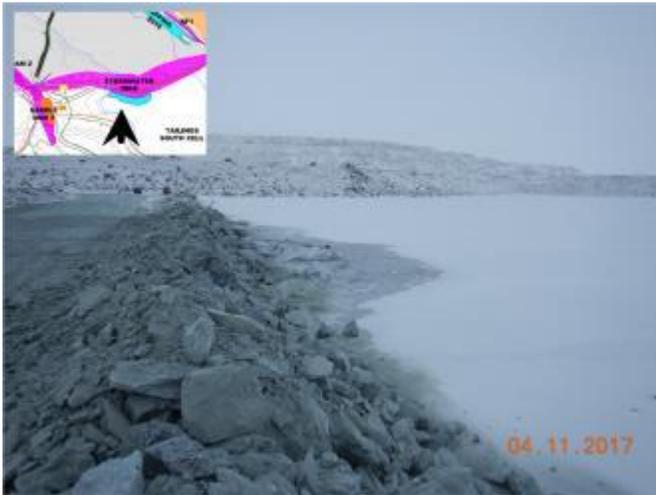
**Photo 7: Close up view of the ice sheet collapsing as material placement occurs (November 4, 2017).**

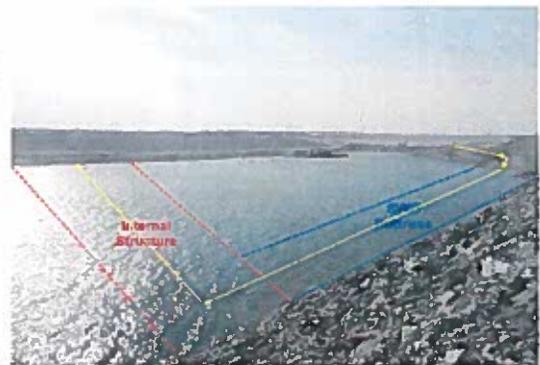
Material gradually sloughing down the edge slope of internal structure. Advised operator to maintain higher beam and dump trucks further away from the edge

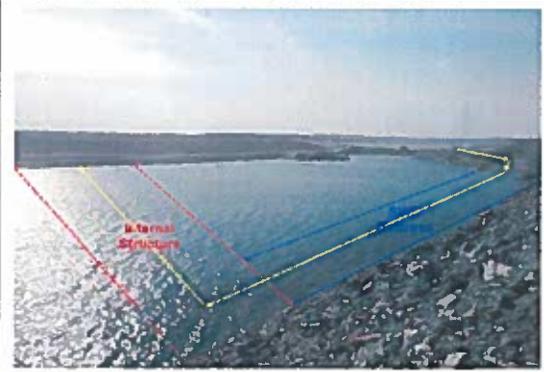
The project was completed  
Water was pouring through the structure toward the end. They put another load on it to cover.
