Appendix F1

GN Spill Report

Please find the following information as a follow up to the Spill report submitted January 2nd, 2016 by Agnico Eagle Meadowbank division. This detailed report is submitted to the Inspector in compliance with the conditions under the Nunavut Water Board License 2AM-MEA1525, Part H, Item 8b.

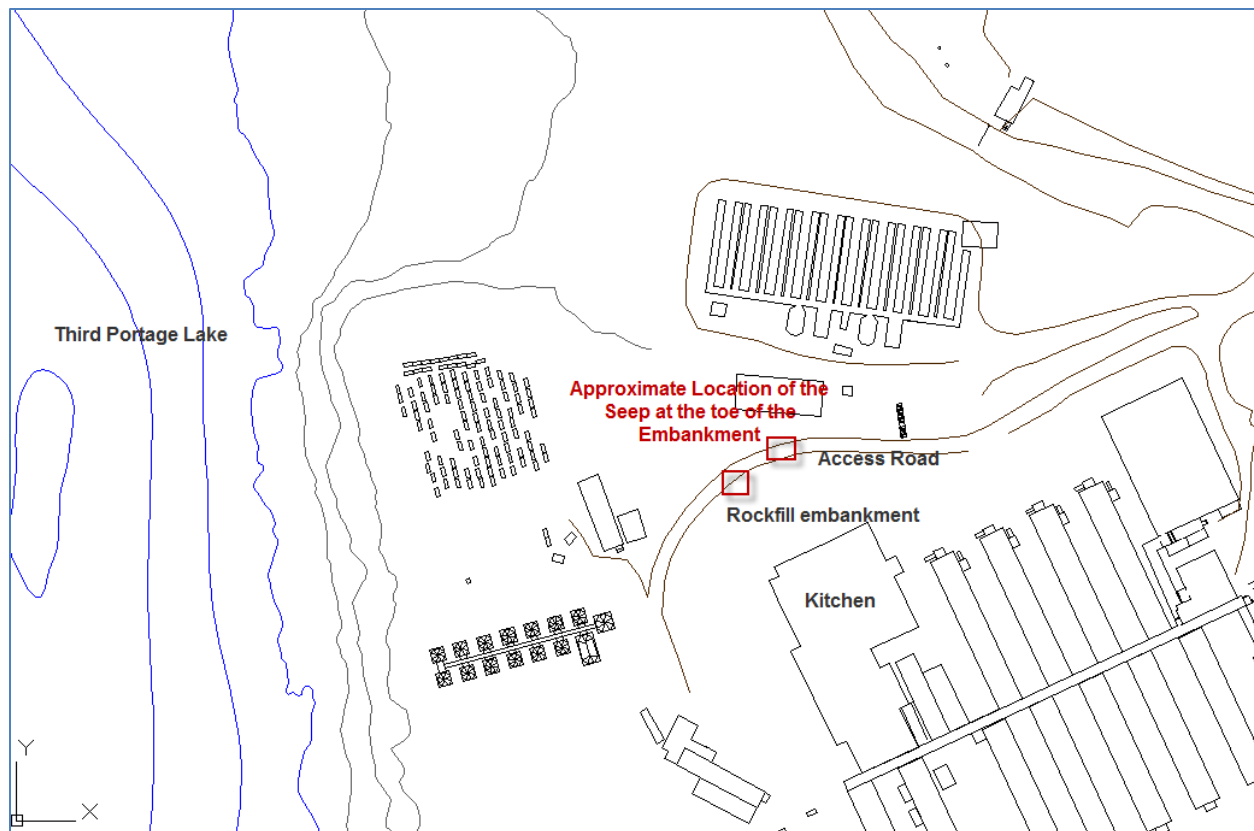
A coupling from one of the kitchen drain pipe underneath the camp kitchen broke, likely due to cold weather, leading the pipe to leak. In addition, it is suspected that there was an accumulation of grease (from the grease trap) in the pipe, which caused the coupling to fail because of the weight. The kitchen water/grease percolated through the rockfill under the kitchen and through the embankment and was then seeping at the toe of the embankment, on the access road.

Figure 1 – Approximate location of the seep (red), kitchen, rockfill embankment and the access road

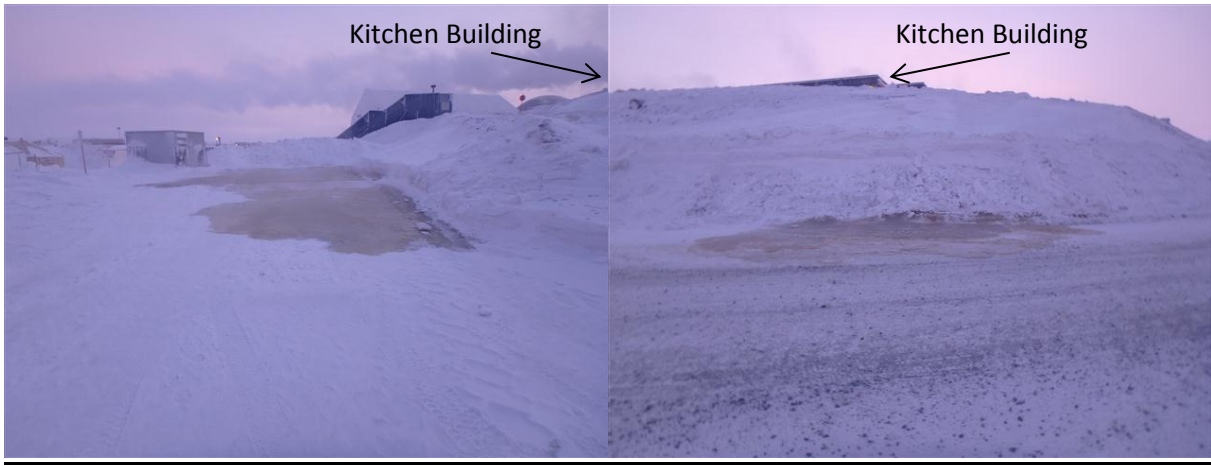
On January 2nd 2016, it was found that a coupling from one of the kitchen drain pipe underneath the camp kitchen was broken. The pipe coupling was fixed shortly after and the water/grease underneath the camp was cleaned with the sucker truck. The next day, on January 3rd 2016, it was found that water from the broken drain had migrated through the rockfill under the kitchen building (unseen) and discharge at the bottom of the embankment slope below the kitchen. Figure 1 shows the approximate location of the seep at the toe of the embankment in red, the access road, the kitchen location, and the rockfill embankment. To avoid the water/grease from migrating further on the access road, 2 berms were constructed. The water/grease/snow was picked up and disposed in the tailings area to avoid attracting wildlife on site. The seepage at the bottom of the embankment stopped on January 5th 2016.

Photos 1-2- Seepage observed at the toe of the rockfill embankment, 2 locations (January 3rd, 2016)

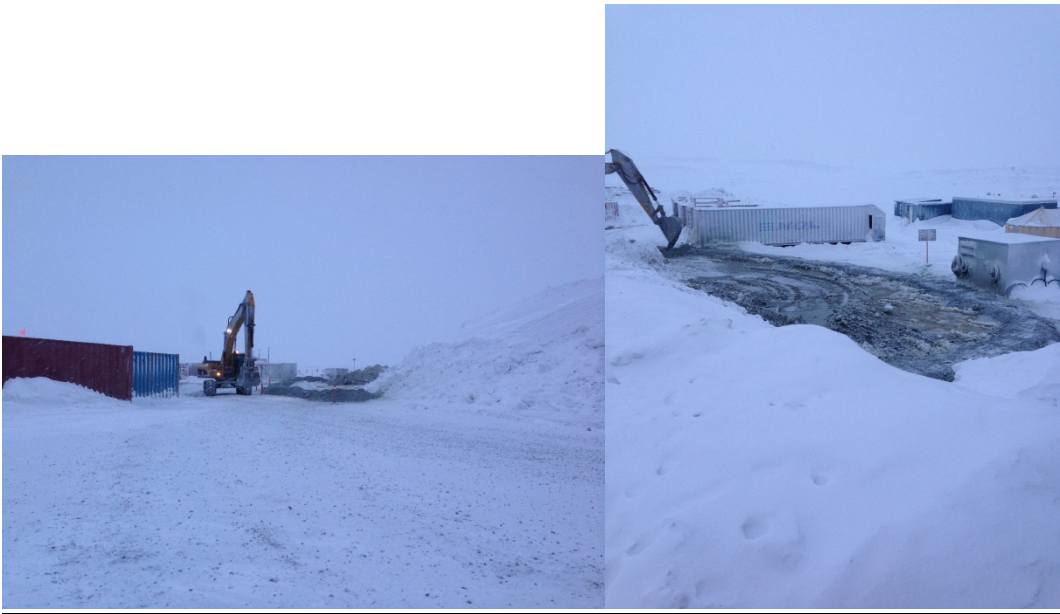
Photos 3-4- Berms constructed to contain the water/grease, 2 locations (January 4th, 2016)

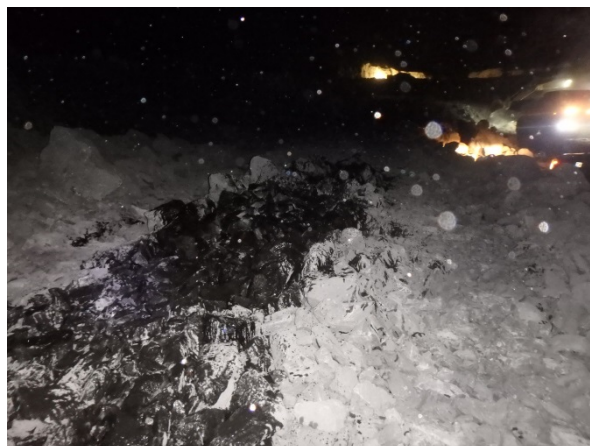
On January 23rd 2016, the main hydraulic hose on backhoe #8, working in Pit E3, failed and caused hydraulic oil to be spilled on the ground. The quantity of hydraulic oil spilled was 300 liters, and the area of contamination was 30 m² after the equipment was moved for clean-up. The spill was contained on location the hose was repaired.

Hydraulic hose on backhoe #08 failed while working in Pit E3 mainly due to cold weather conditions.

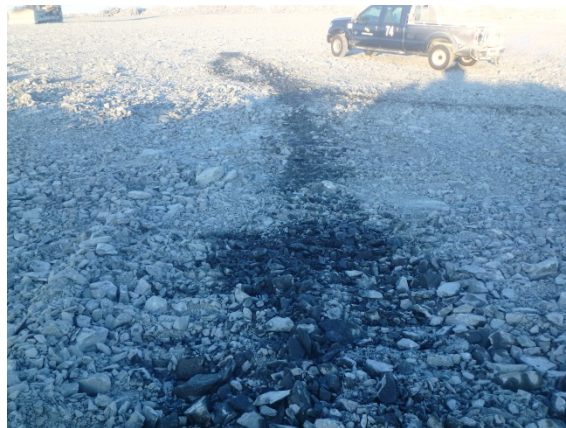
On January 25th 2016, one of the major coolant hoses had a failure and the coolant system flushed on the ground while going uphill on the Vault hauling road. Truck proceeded to empty load and then stopped so repairs could be safely done. The quantity of coolant spilled was 250 liters, and the area of contamination 500 m².

Main coolant hose failure on haul truck related to cold weather conditions.

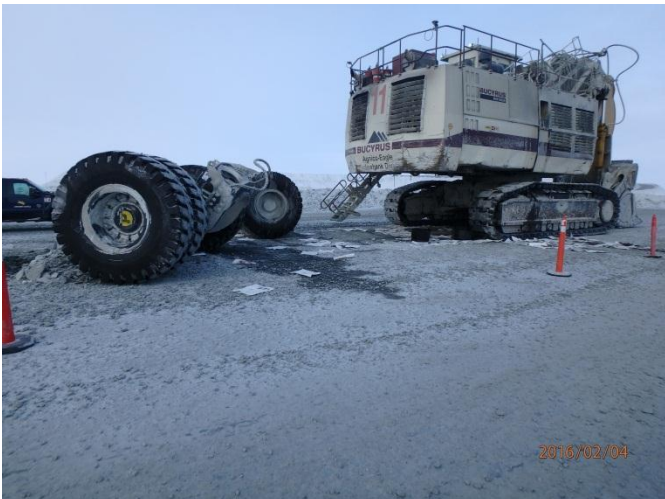
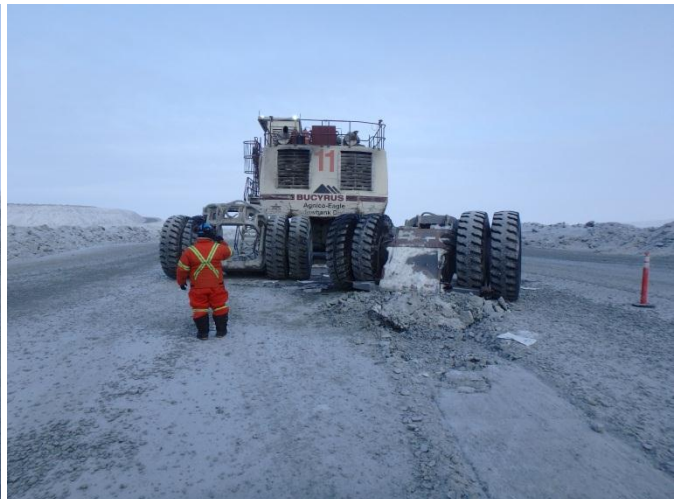
On February 4th, Backhoe 11 was on the Sleipner and being pulled by HTR 31. The Sleipner caught on the road, it flipped over and punctured the fuel tank and at the same time ruptured a hydraulic hose.

The leak from the fuel tank was plugged with wood pieces and secondary containment was also put under the Backhoe. Once the equipment moved out of the way, the area was cleaned using a shovel and contaminated soil was collected and brought to the Meadowbank Landfarm. An estimated volume of 30 m³ of contaminated material was collected.

A formal training program for the use of Sleipner will be developed and all operators will have to receive the training. The procedure for the use of Sleipners will be modified to ensure appropriate operations and communications are being done.

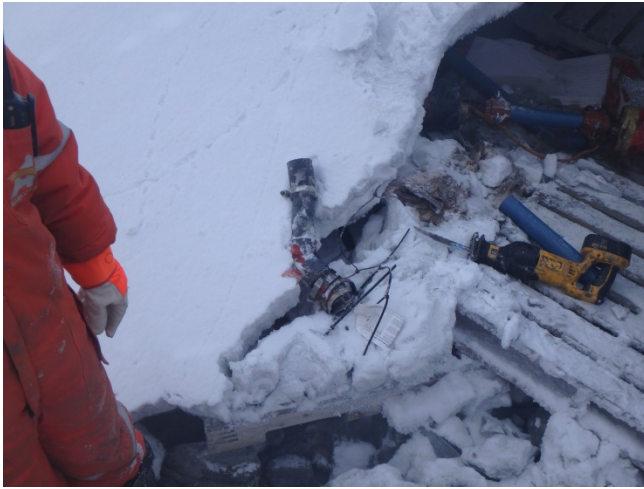
The fitting on the line broke because external pressure was being added to the pipe by snow being pushed over from the iron pad towards the discharge line. The sewage was thus discharge closer to the road. This created a change in the path of the flow, resulting in water being observed on the north side.

Broken fitting and pipe

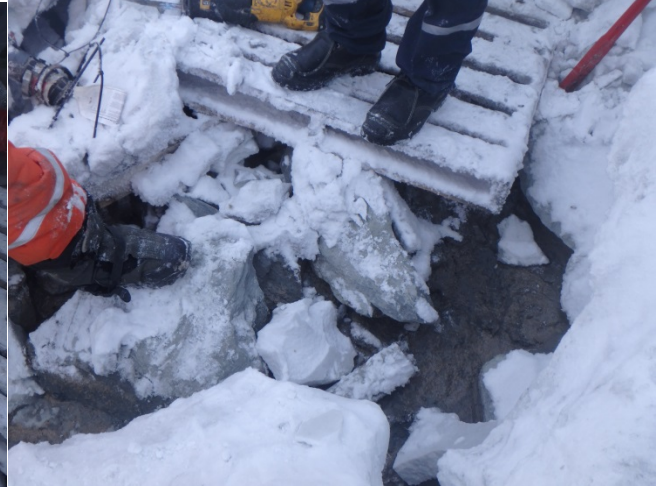
Area of broken line

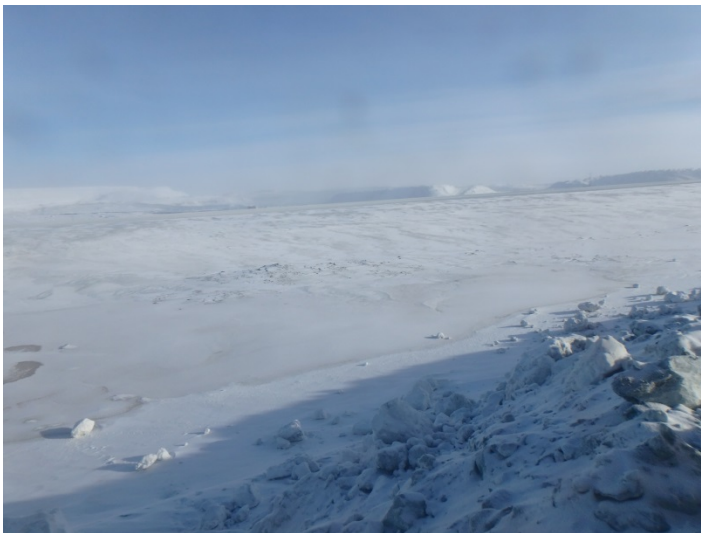
North side

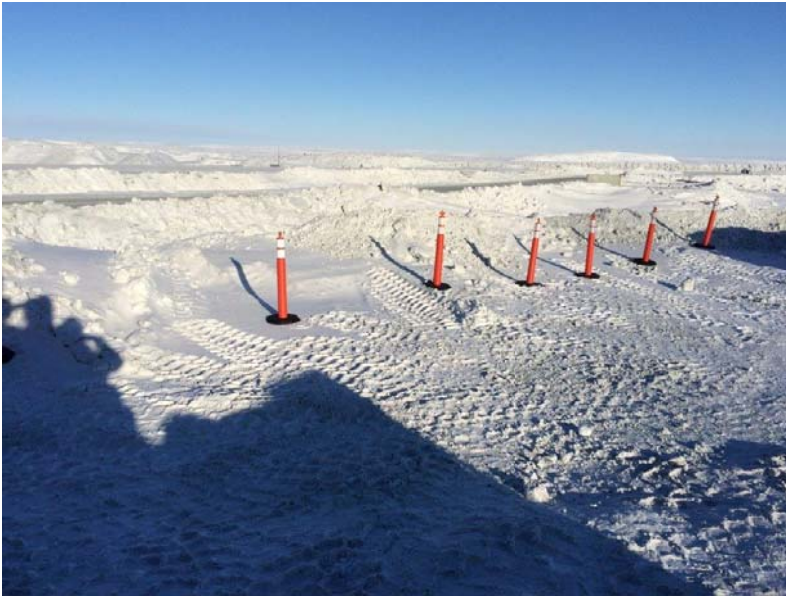
Side blocked for snow

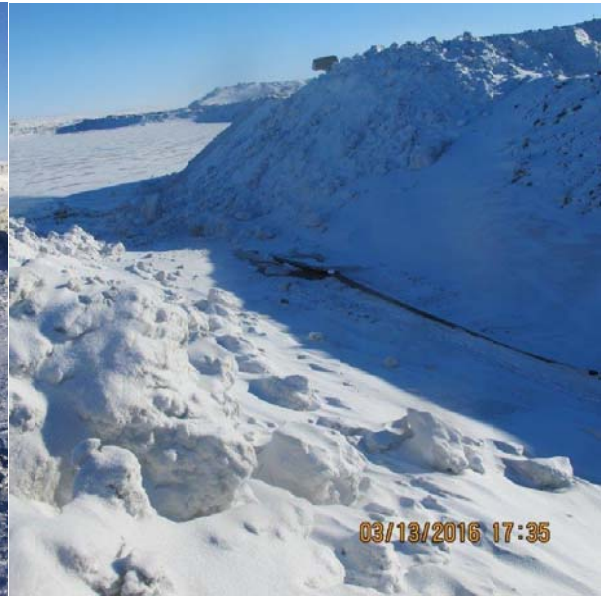
Repaired and extended discharge pipe

The area was inspected after the repair and no evidence of seeping was found on the north side.

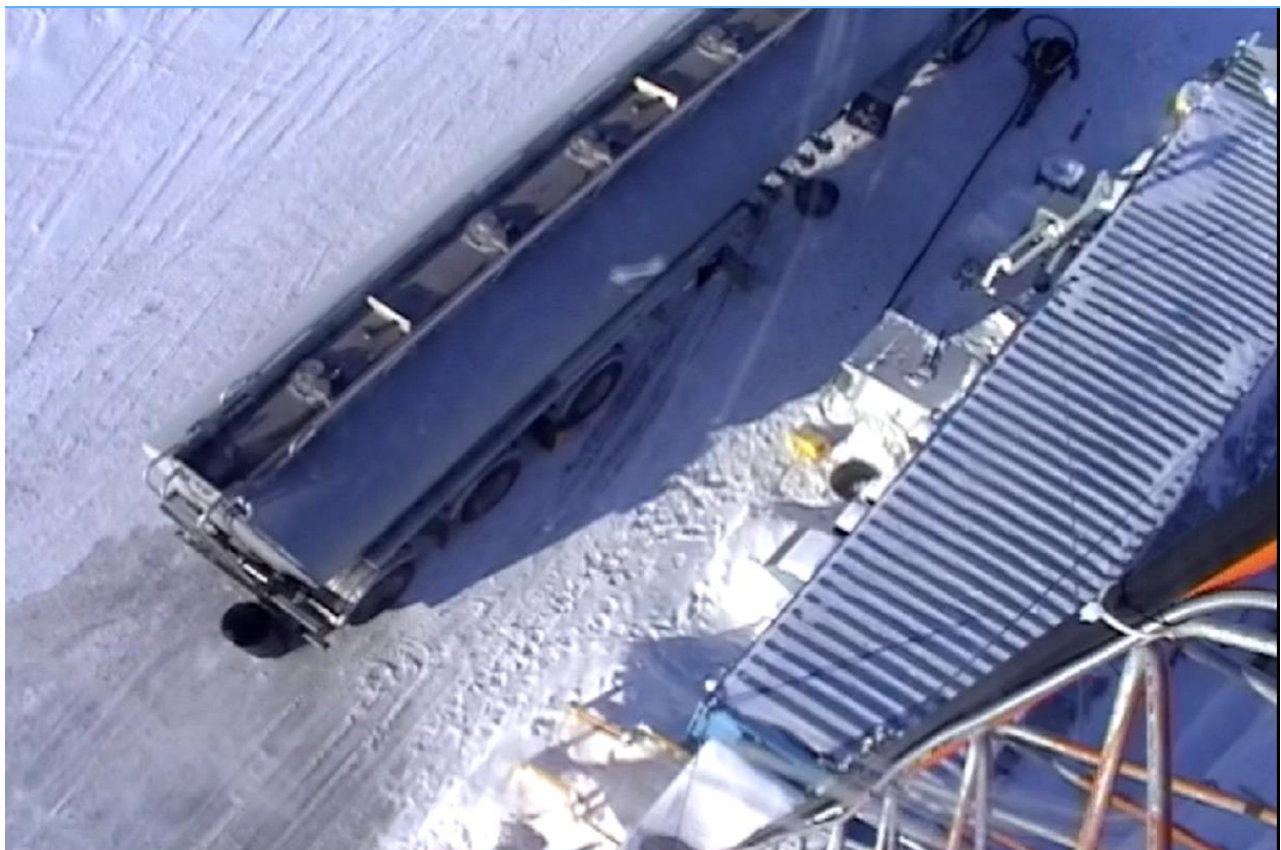
On March 13th, 2016, a truck operator from Arctic Fuel was in process of filling up the tanker truck at the Baker Lake facility and noticed fuel coming out of the overflow pipe. He quickly stopped the fuelling. The driver called the supervisors from Arctic Fuel and AEM immediately. After tabulating all data, spill was calculated at 1100 liters (originally estimated at 700 liters).

A miscalculation was made on the tanker compartment capacity by the driver. After investigation (report included in appendix 1) it was found that the Fuel arm was hooked on compartment #2 (capacity of 5000 liters) instead of #1 (capacity of 15 000 liters).

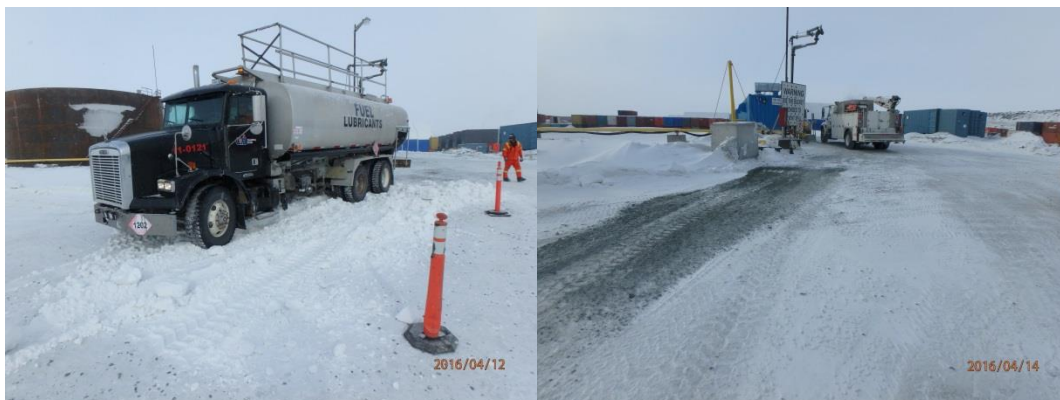
Area with added snow before clean-up

The area was then cleaned with a loader. Contaminated snow and soil was brought to the TSF and absorbent pads were properly disposed of.

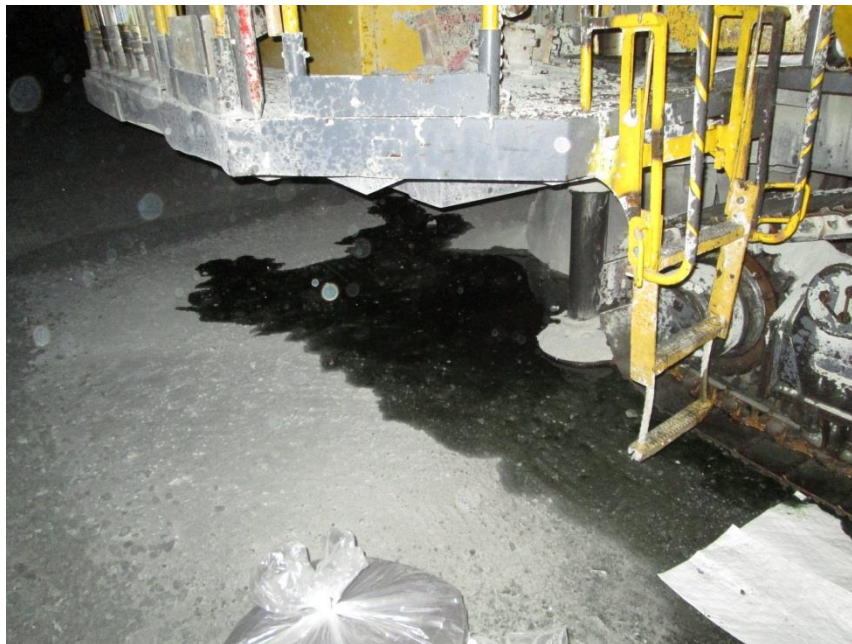
On April 12th, 2016, drill RBD02 was drilling in Vault pit when a control unit on the equipment failed and caused hydraulic oil to be spill on the ground

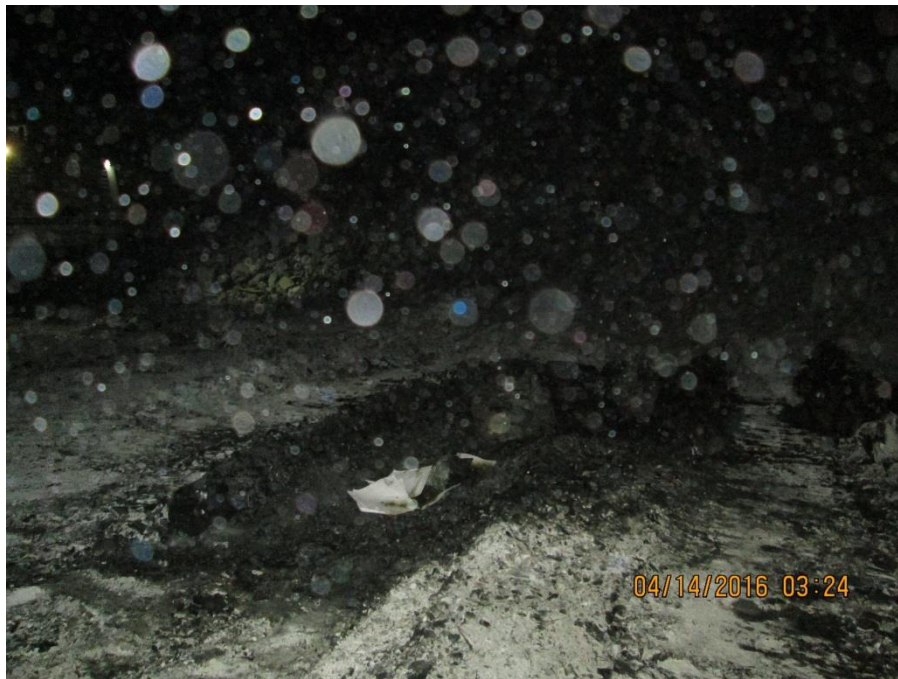
On April 14th, 2016, backhoe 11 was working in Vault pit when an “o-ring” failed on one the hose and caused hydraulic oil to be spill on the ground

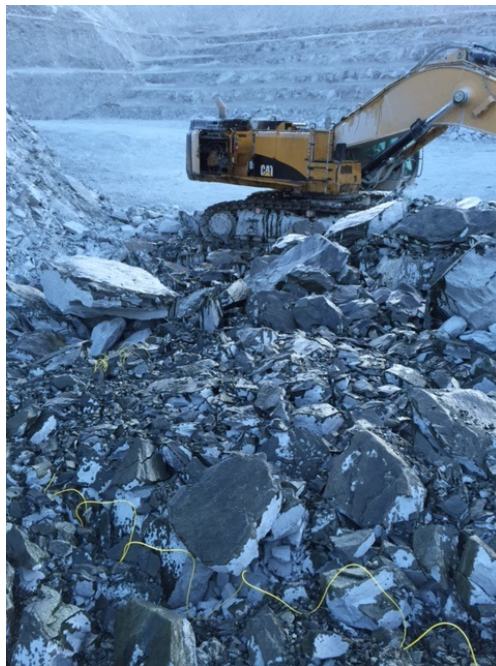
On May 3rd at 21:00, Backhoe #6 was working in Vault pit when a valve from the hydraulic system busted causing the oil to spill onto the ground

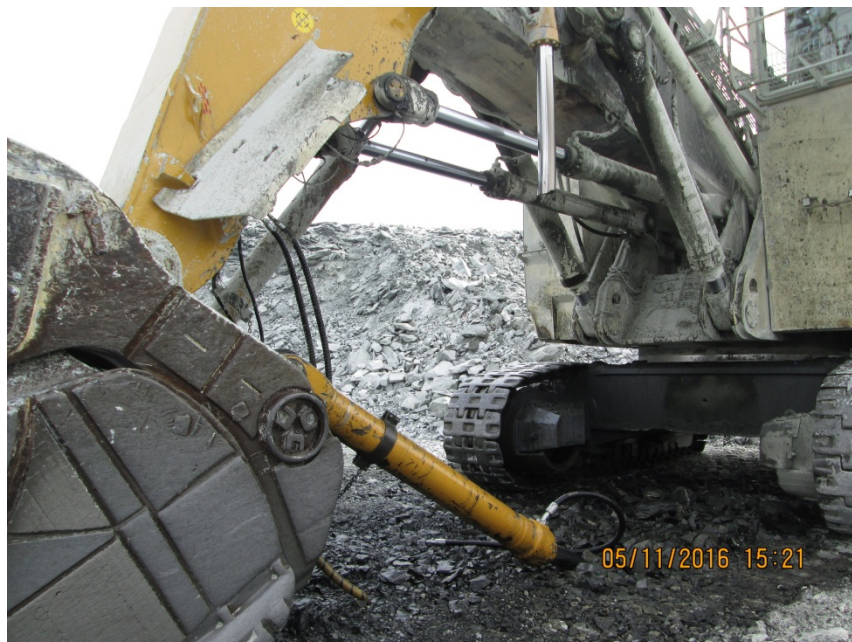
On May 11th, 2016, backhoe 10 was working in Vault pit when a cylinder of the bucket broke apart causing hydraulic oil to be spill on the ground

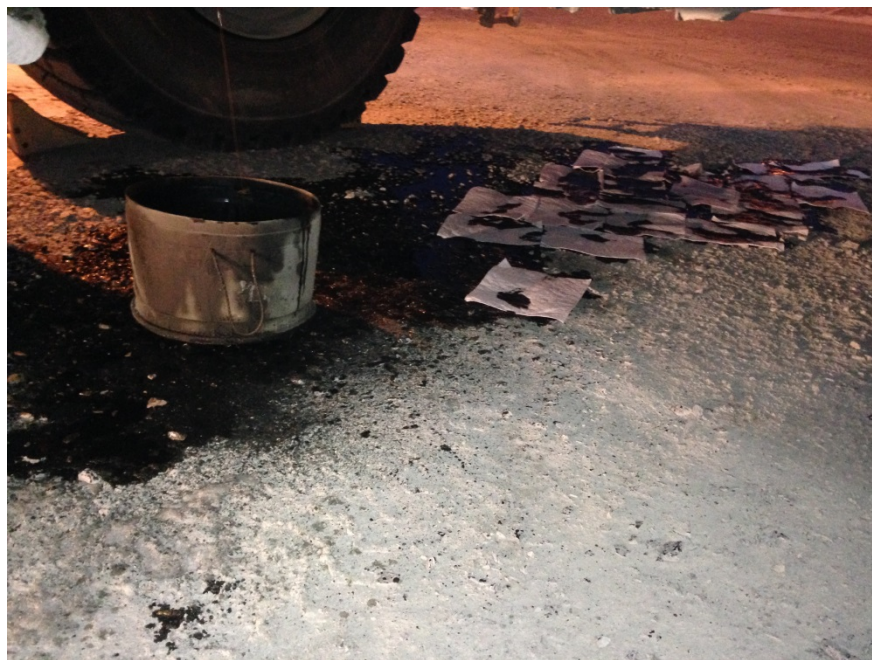
On May 14th, 2016, haul truck #34 was parked at Vault area when the hydraulic pump failed causing hydraulic oil to be sprayed on the ground

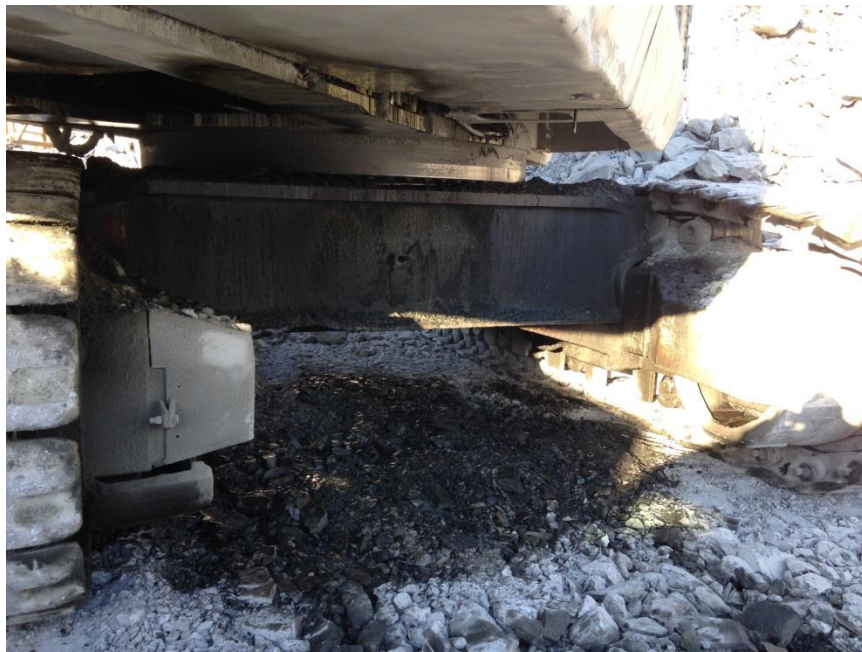
On May 15th, 2016, backhoe #10 was working in Vault pit area when the hydraulic pump seemed to failed causing hydraulic oil to be sprayed on the ground

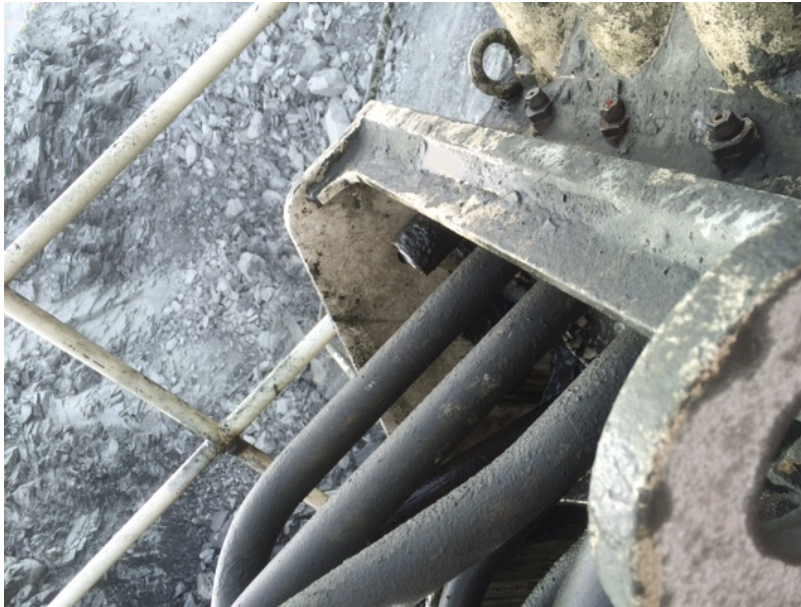
The spill was caused by a main hydraulic hose failure on the boom stick.

The backhoe was stopped immediately then repaired and removed from the location as soon as possible; the area was then cleaned with a loader. An estimated volume of 16m³ of contaminated material was collected and brought to the Landfarm

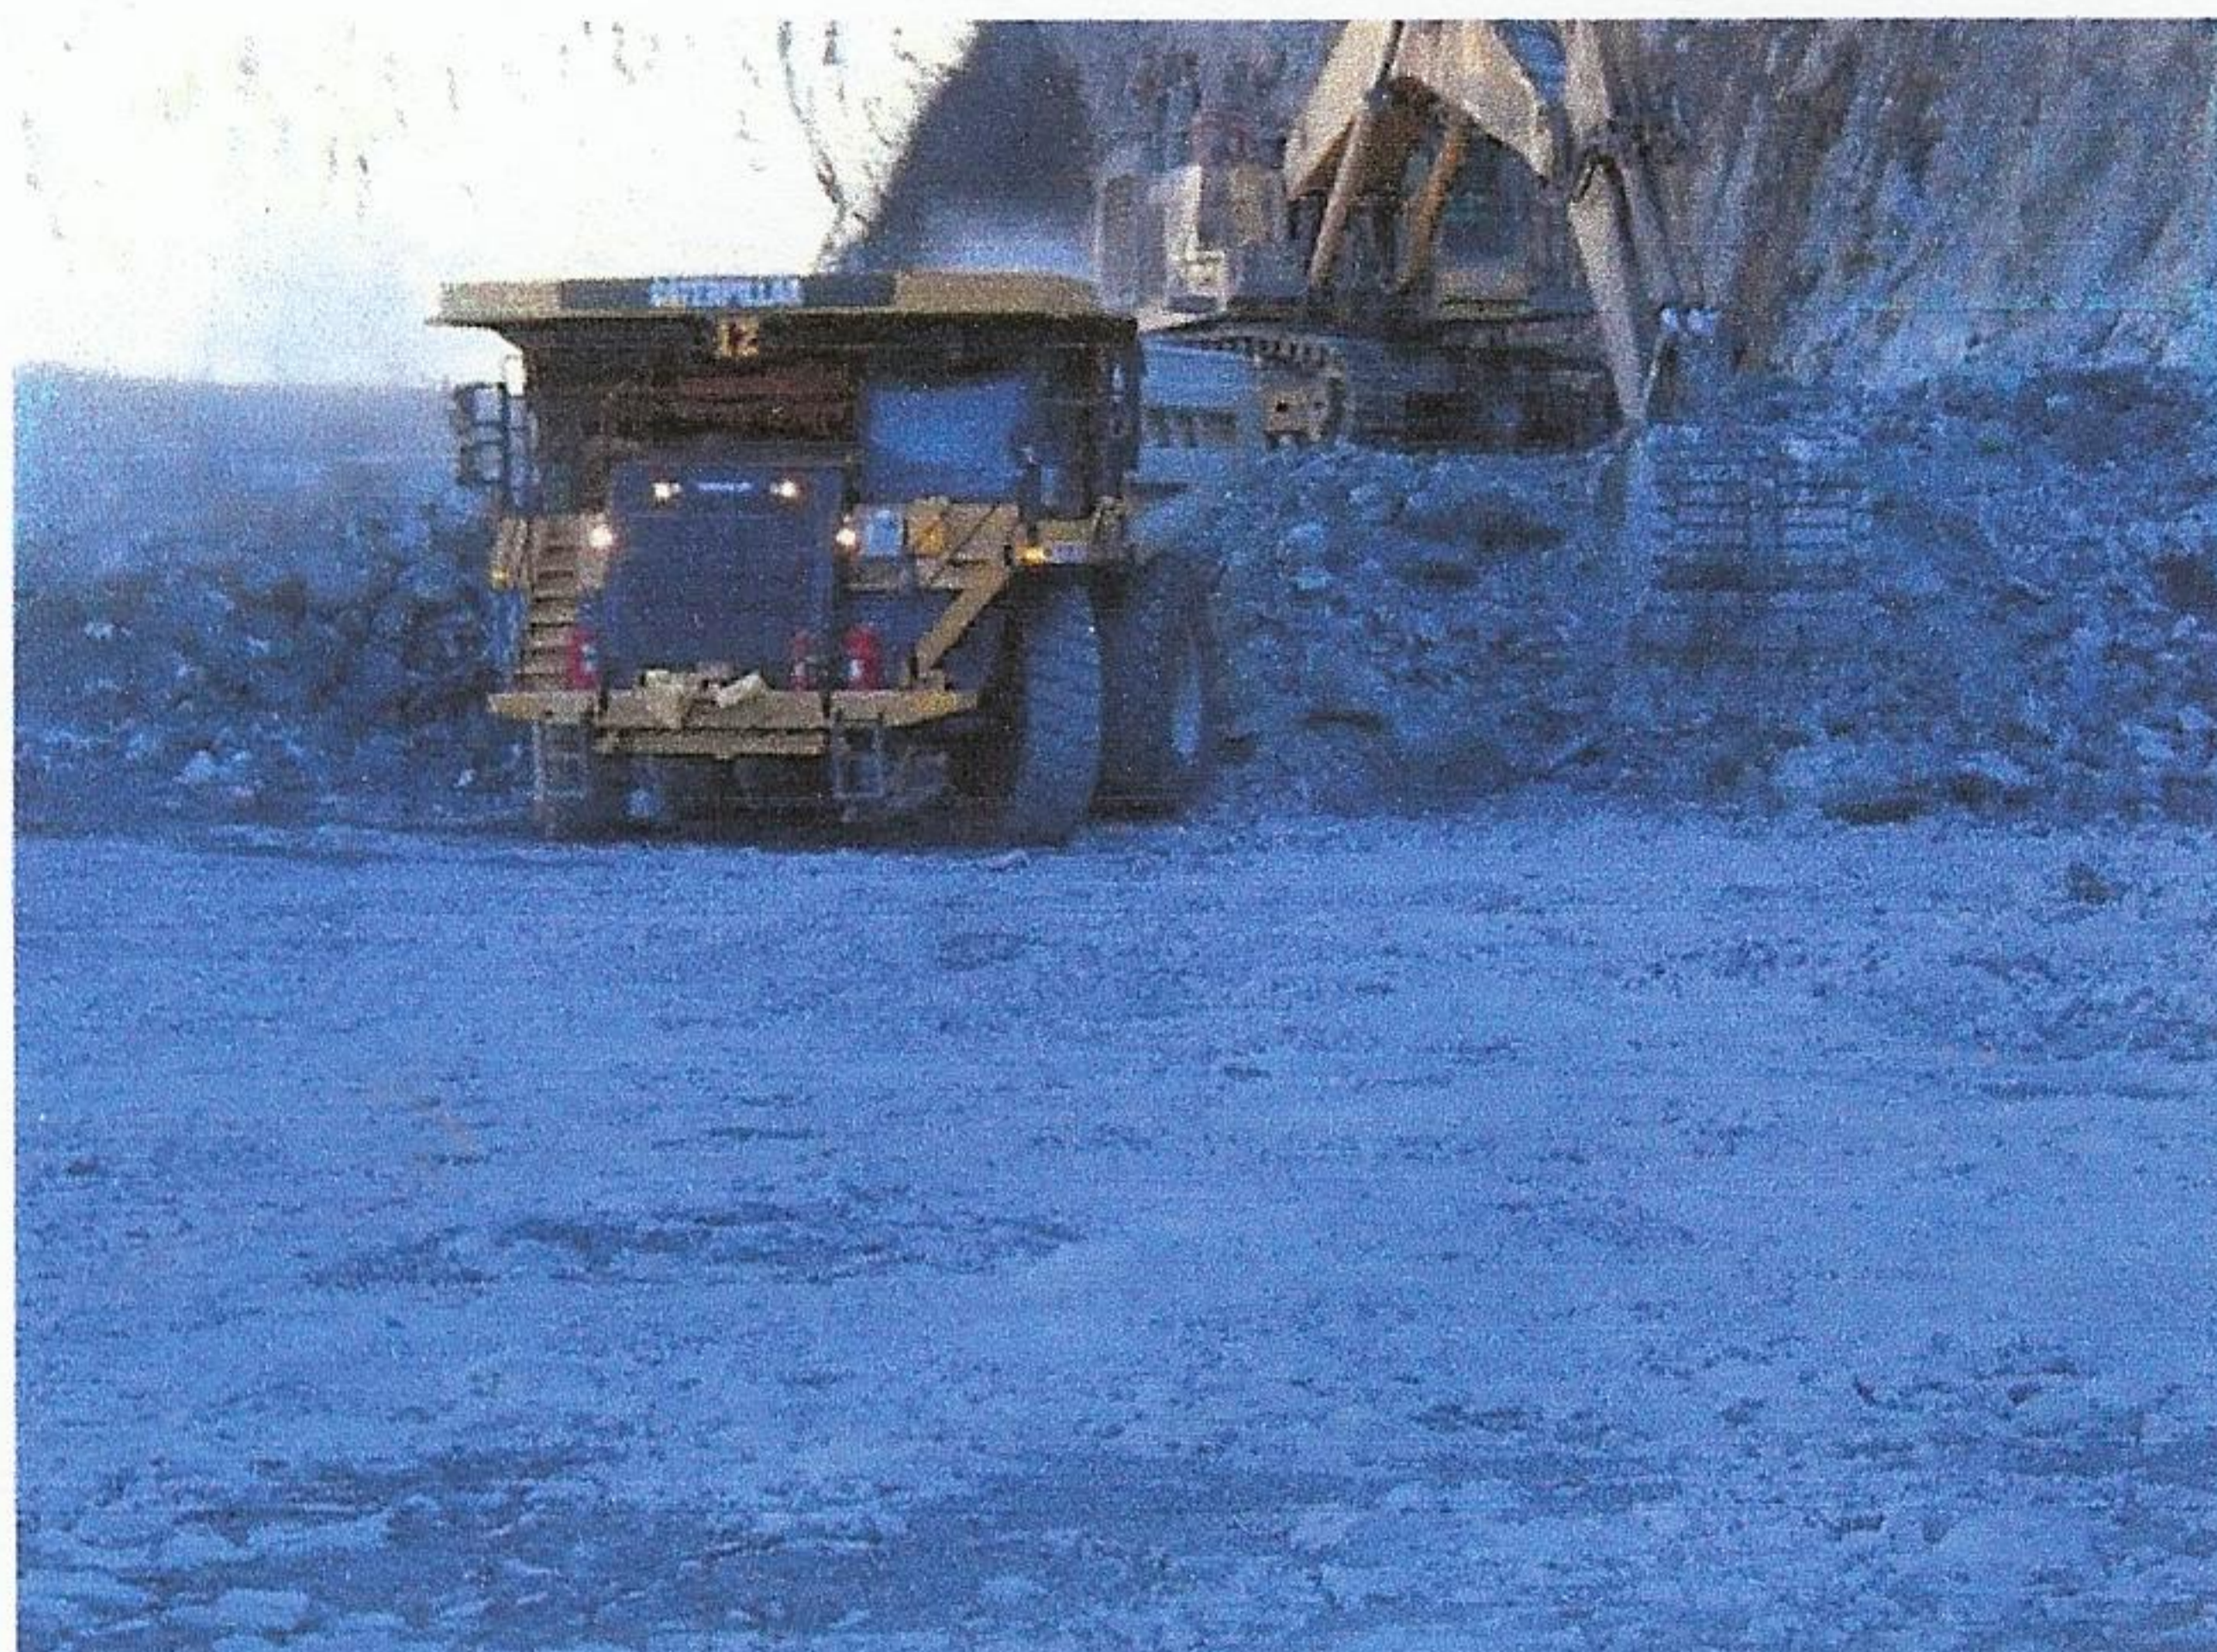
Photo 1: after cleanup of contaminated soil

The machine was shut down immediately to prevent further spilling, placed absorbent pads on the ground to prevent further contamination on the ground. Absorbent pads were picked up and disposed of at the HAZMAT area and contaminated soil was removed and brought to the Landfarm

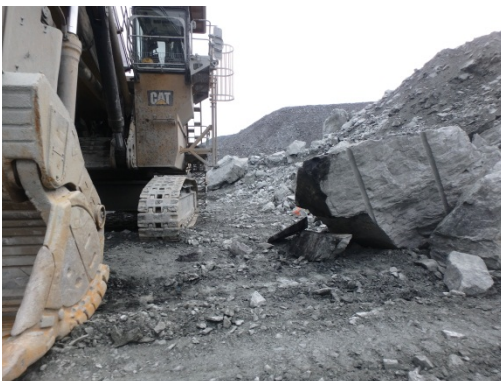
A rock falling from a wall face hit the hydraulic fan motor.

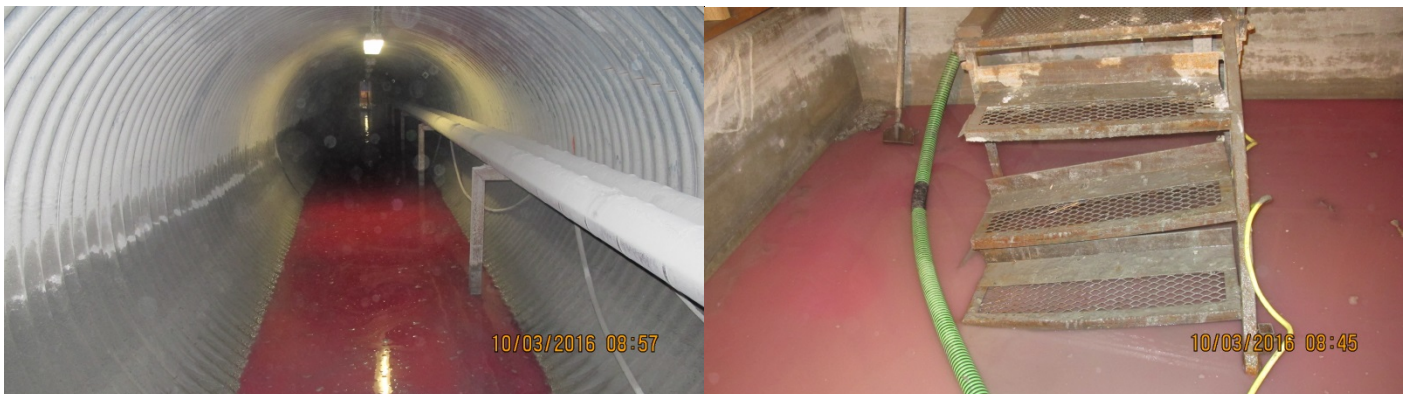
During routine inspections, an operator noticed glycol leaking from a pipe in the emergency underground access tunnel from the crusher to the dome area. Quickly the valve of the system was closed to prevent more spillage. A volume of 12 000 liters was estimated to have leaked inside the enclosure.

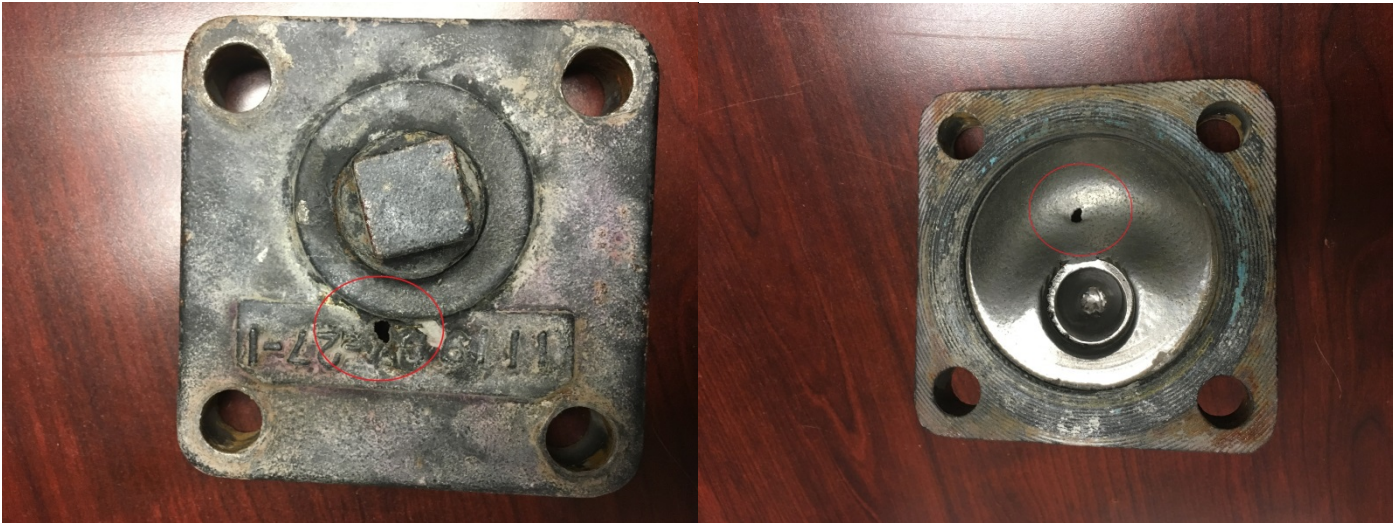
Upon further inspection, an end cap was found to have a hole causing glycol to leak from the line

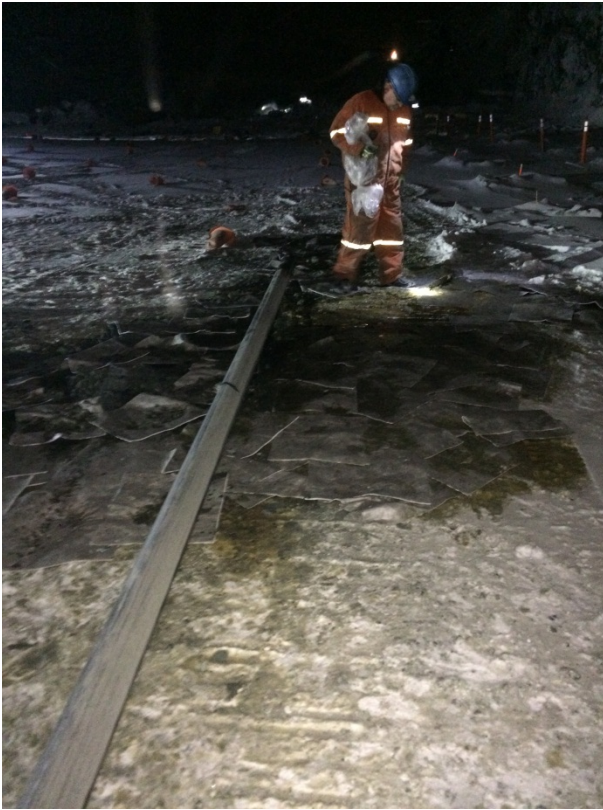
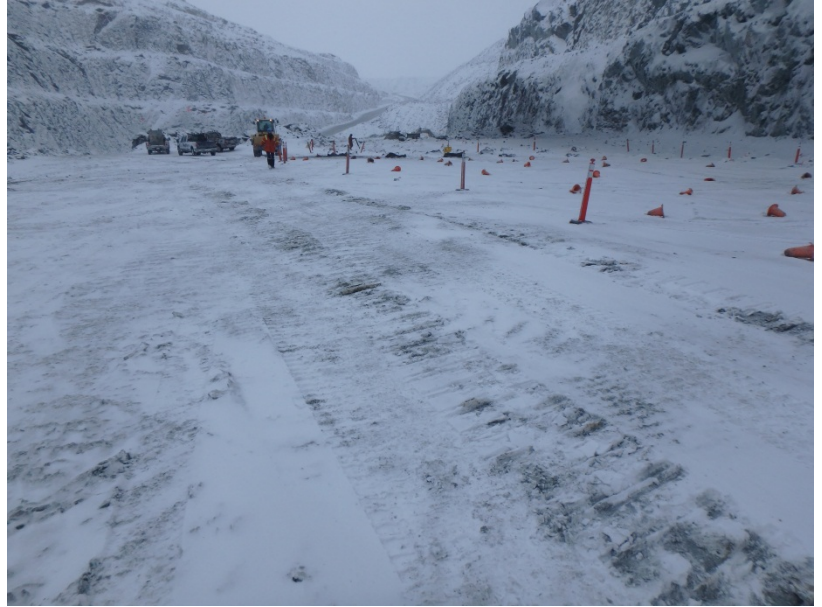
The spill was caused by a loose fitting on a hydraulic hose

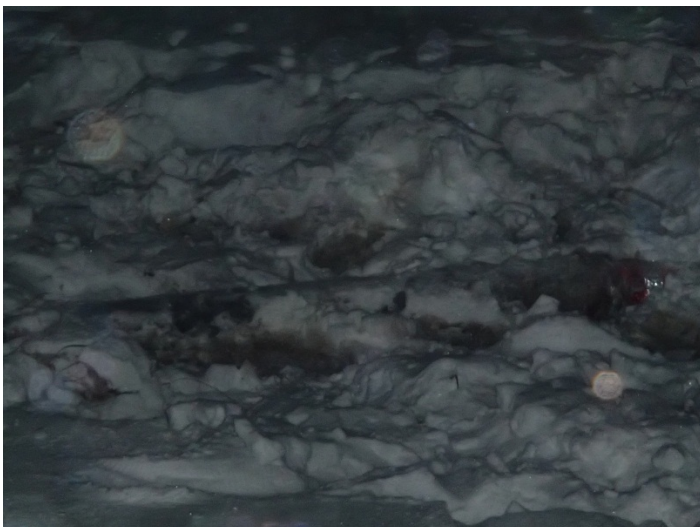
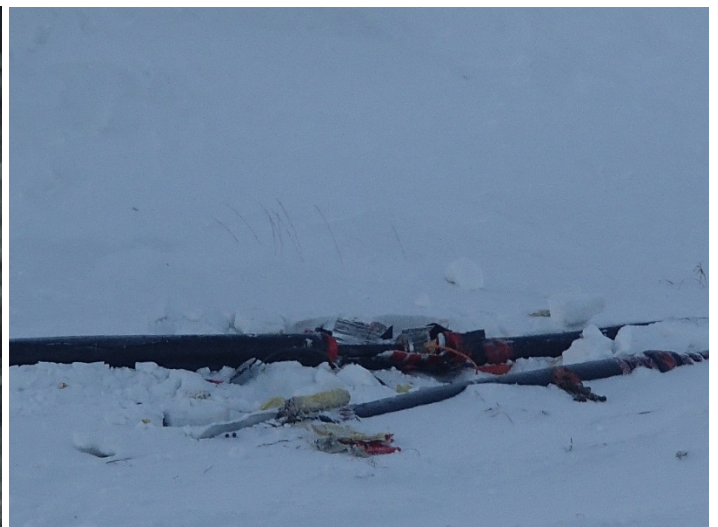
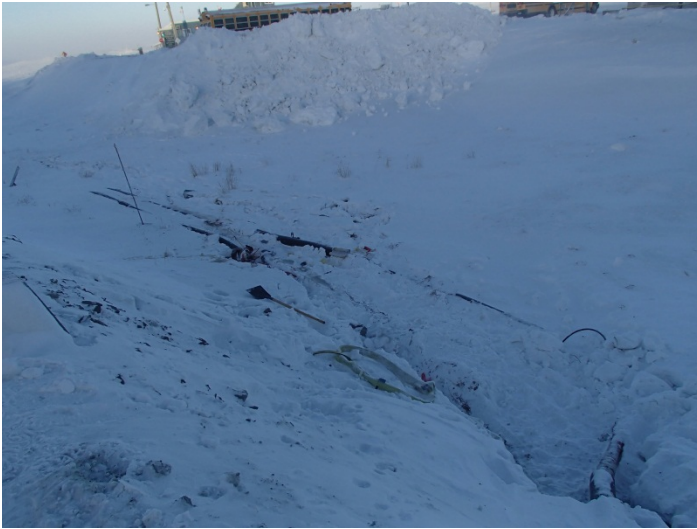
The spill was caused by a broken coupling on the sewage line
