## **Appendix F1**

### **GN Spill Report**

## January 28<sup>th</sup>, 2017 LOA 12 oil spill

Please find the following information as a follow up to the Spill report submitted January 29th, 2017 by Agnico Eagle Meadowbank division. This detailed report is submitted to the Inspector in compliance with the conditions under the Nunavut Water Board License 2AM-MEA1525, Part H, Item 8c.

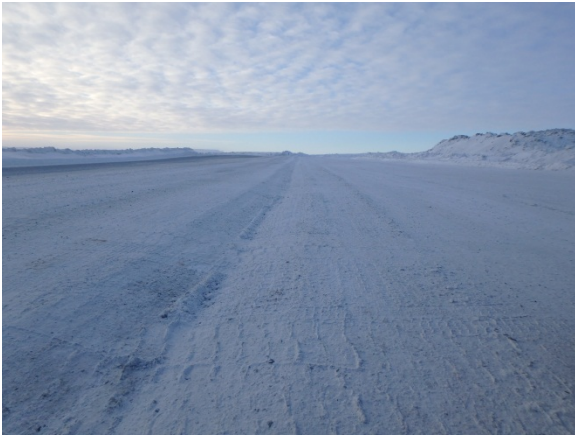
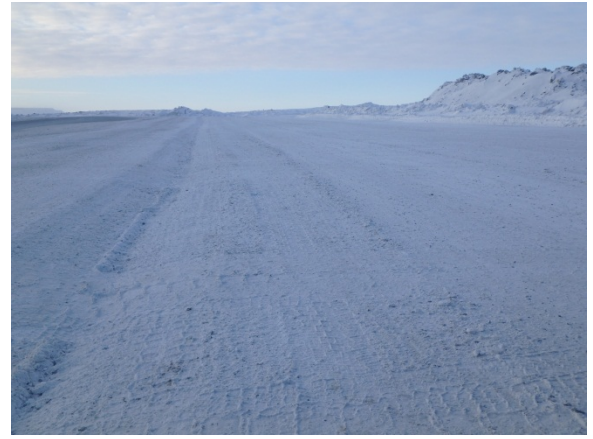
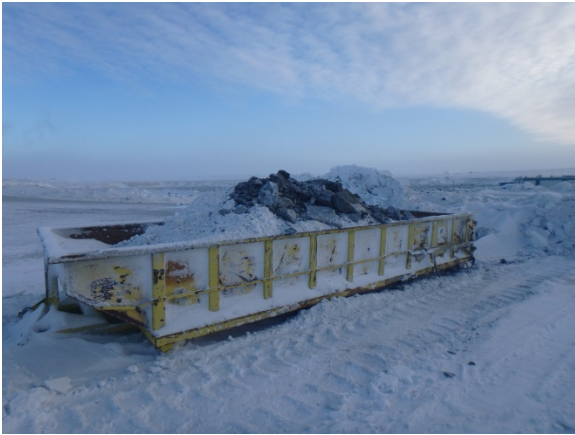
During operations at Vault, a hydraulic hose failed on Loader 12

Hose failure

Operator of the equipment stopped the engine right away to stop spilling more products on the ground. Operator contacted his supervisor immediately to have the equipment repaired.

All the contaminated material was graded and picked up with a 980 loader and taken to the Landfarm.

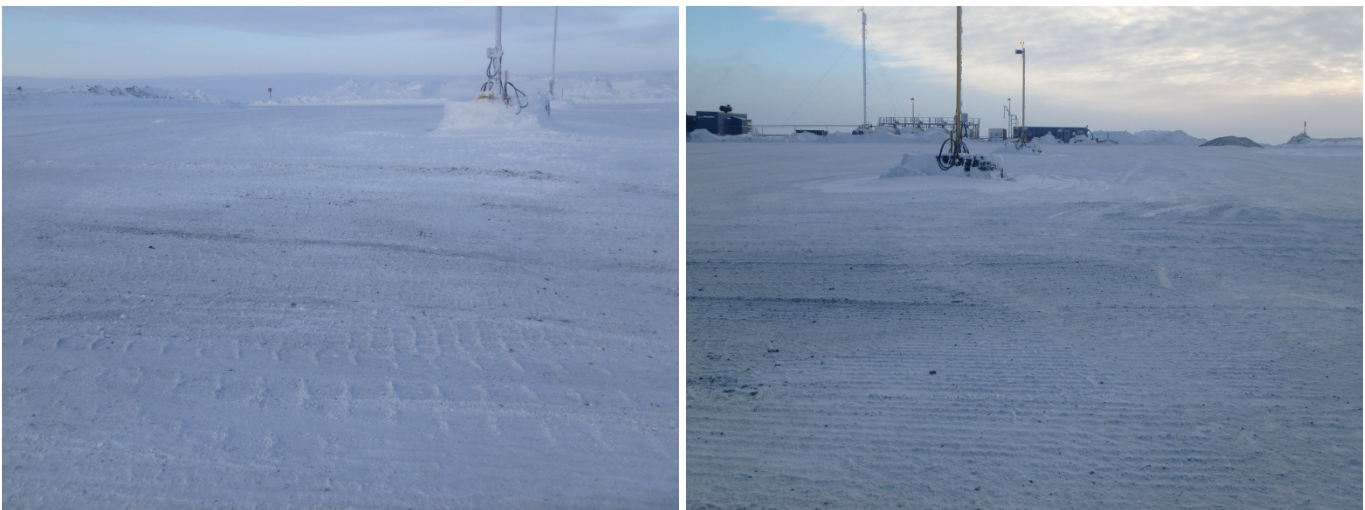
After investigation, it was observed that the wiggins on the Haul Truck caused the spill.

Investigation was made to identify the cause of the spill. All wiggins were inspected to avoid a second occurrence and information from the supplier was requested. The area was graded and a loader collected the contaminated soil and brought it to the landfarm.

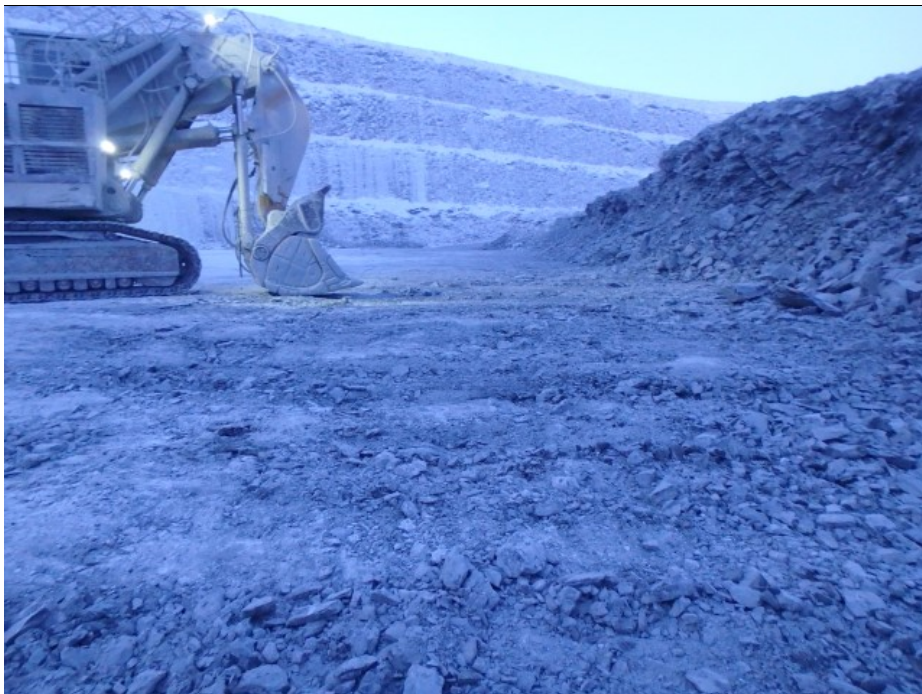
During operations at Vault pit, the operator of the backhoe noticed that the shovel of the equipment was leaking oil.

There were no off site impact or discharge to any receiving watercourses. The distance to the closest lake is estimated at 1050 meters.

The spill was caused by a broken fitting on the main hydraulic pump of the backhoe.

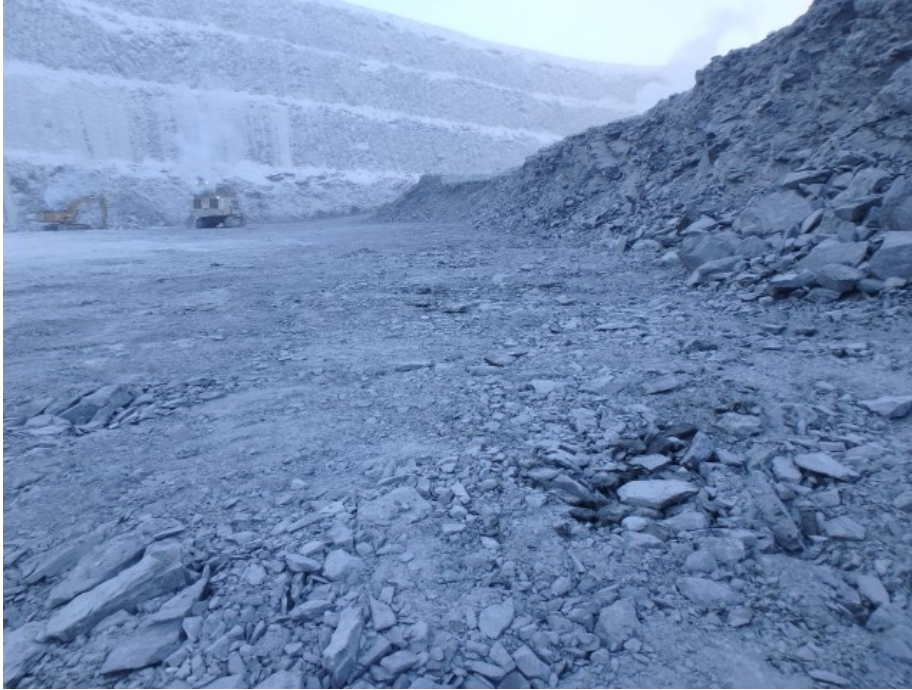
The equipment was stopped immediately. Once the equipment was repaired in field and could safely be removed, the area was cleaned. The contaminated material removed was brought to the landfarm area.

The hydraulic system including hoses and fittings are inspected as part of the preventive maintenance program done on site. Also, evidence of wear and/or fatigue is communicated during the daily pre-operational checks.

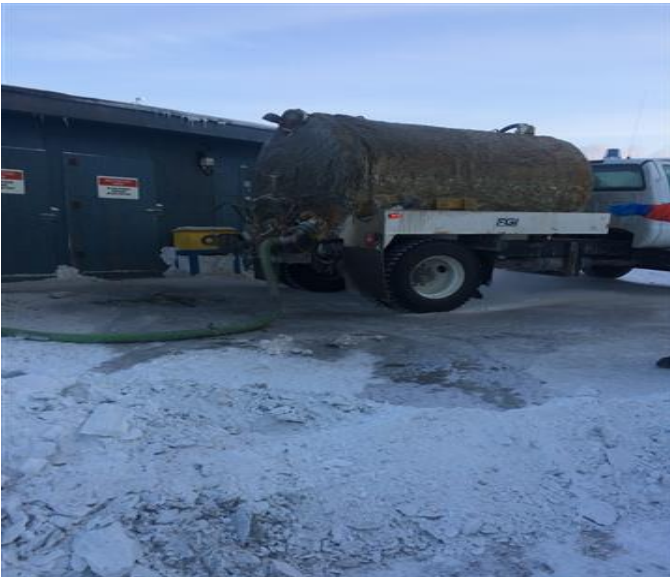
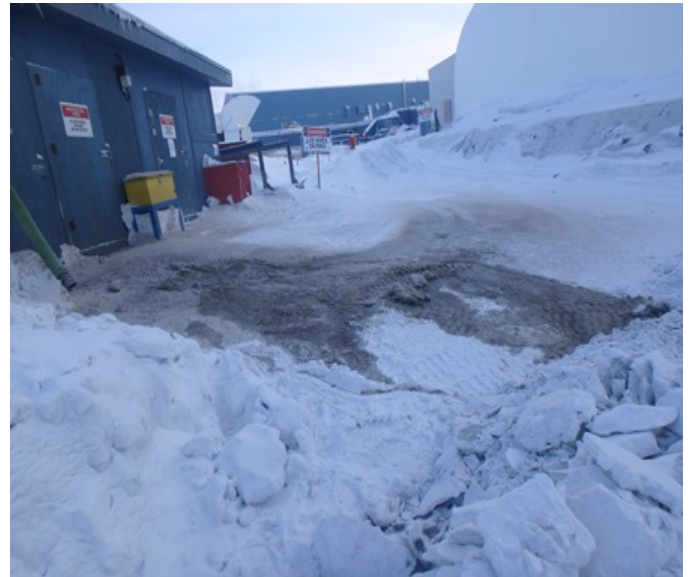
There were no off site impact or discharge to any receiving watercourses.

The spill was caused by broken transfer hose on the sewage truck.

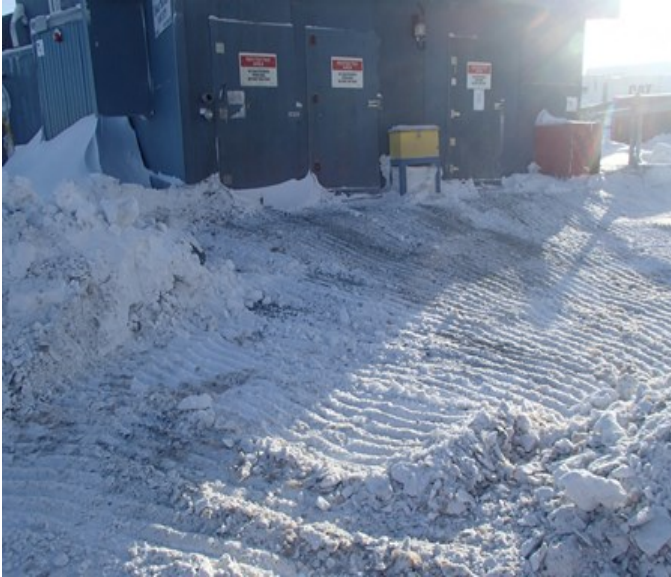
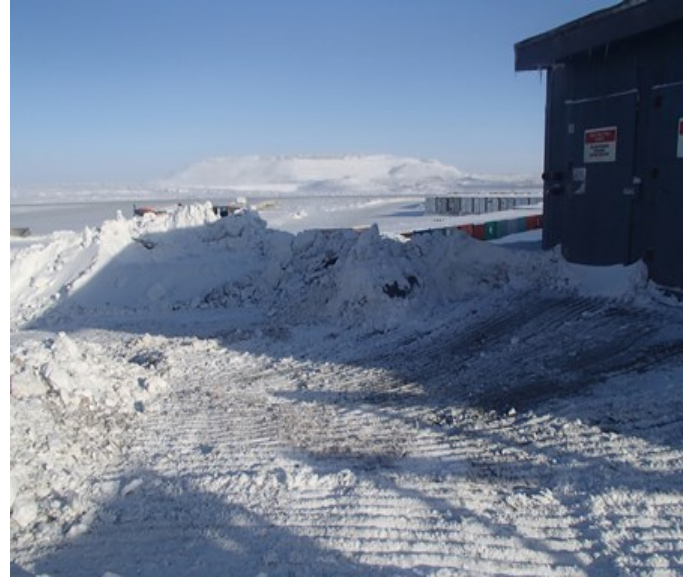
All the contaminated material and snow was excavated, picked up, and taken to the North cell tailings storage facility for disposal.

The transfer hose was replaced on the sewage truck. It will be visually inspected regularly for possible signs of fatigue and replaced and/or repaired, if necessary.

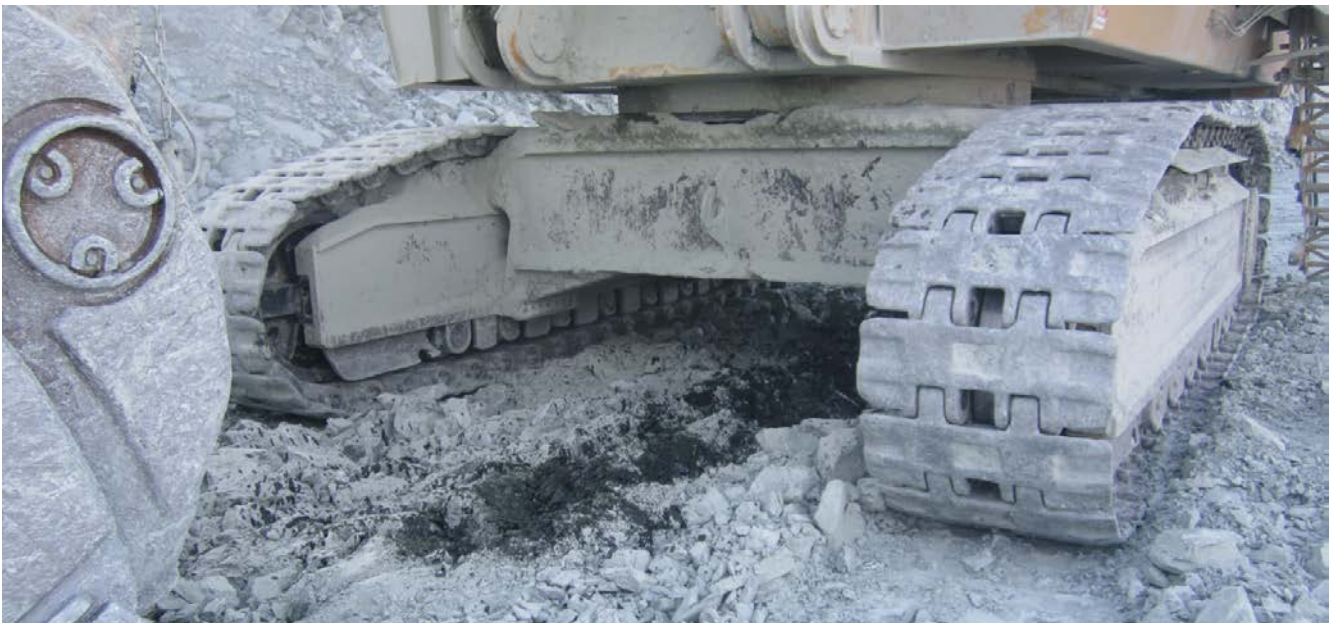
During operations at pit E5, a part of the backhoe swing pump failed causing hydraulic oil to spill on the ground.

There were no off site impact or discharge to any receiving watercourses. The distance to the closest lake is estimated at 150 meters.

The spill was caused when the swing pump and a seal failed on the loading unit.

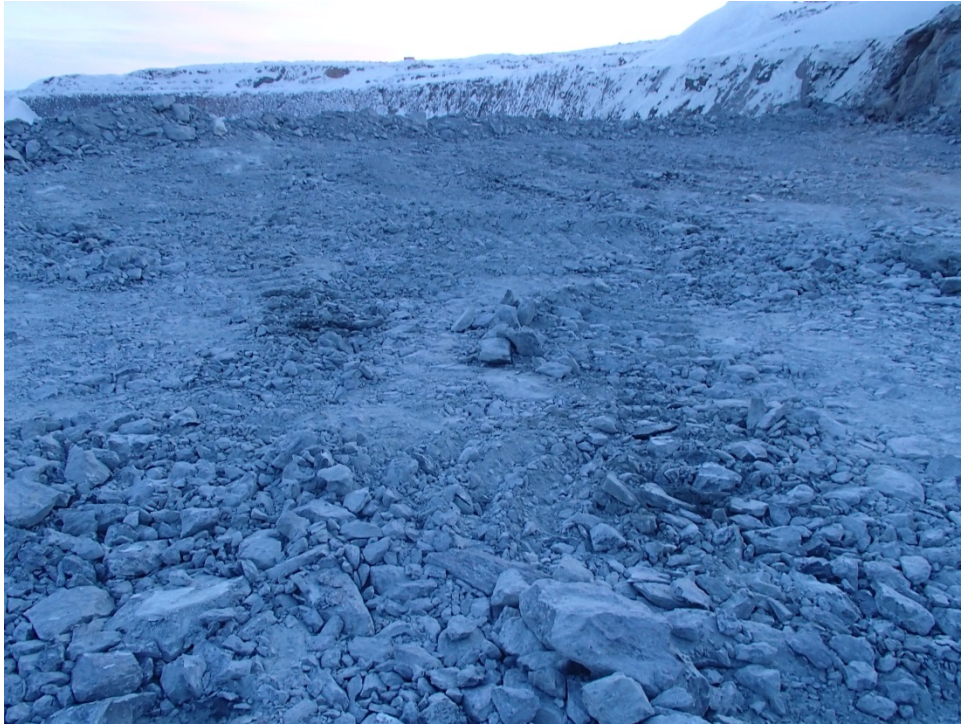
The equipment had to be moved to proceed to the field repair. This action caused some hydraulic oil to be spread in the movement zone. The surface of the affected area was cleaned, coarseness of the material making recovery difficult. The contaminated material removed was brought to the landfarm area.

The hydraulic system including hoses and fittings are inspected as part of the preventive maintenance program done on site. Routine visual inspection of the hydraulic system is also performed during pre-operations checks.

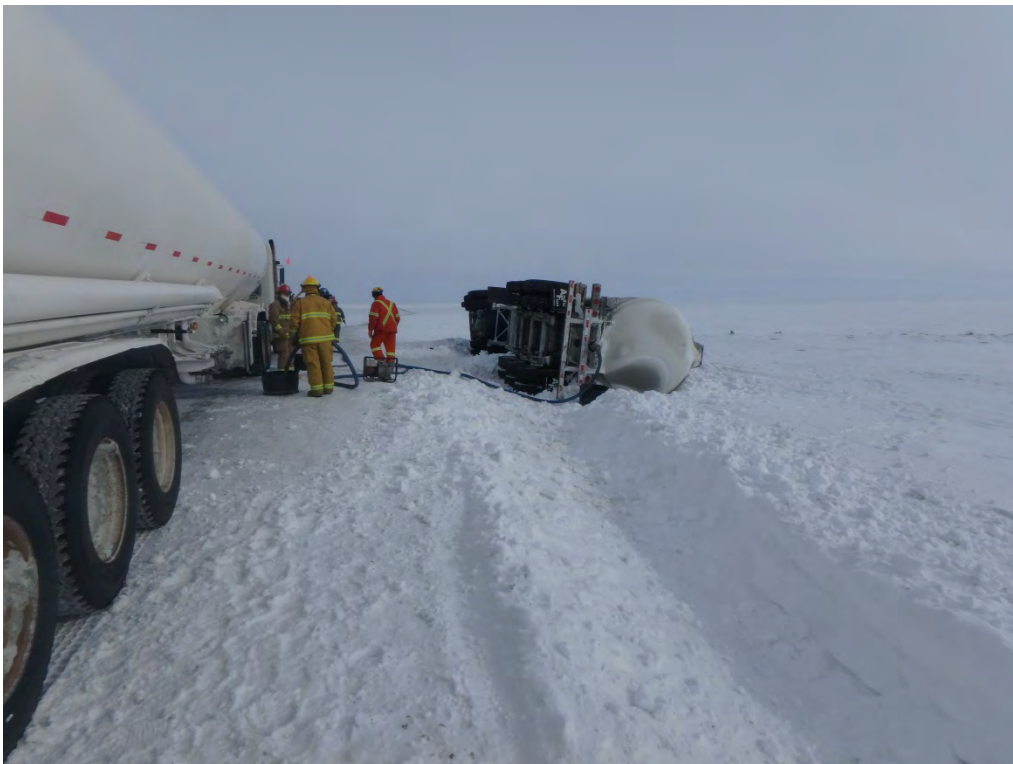
There were no off site impact or discharge to any receiving watercourses. The distance to the closest lake is estimated at more than 2000 meters.

The incident occurred when the tanker moved on the side of the road for traffic coming in the opposite direction. What the driver thought was the side of the road was hardened snow and caused the tanker to roll over on its side. A leak was observed from the tank once responders arrived on location.

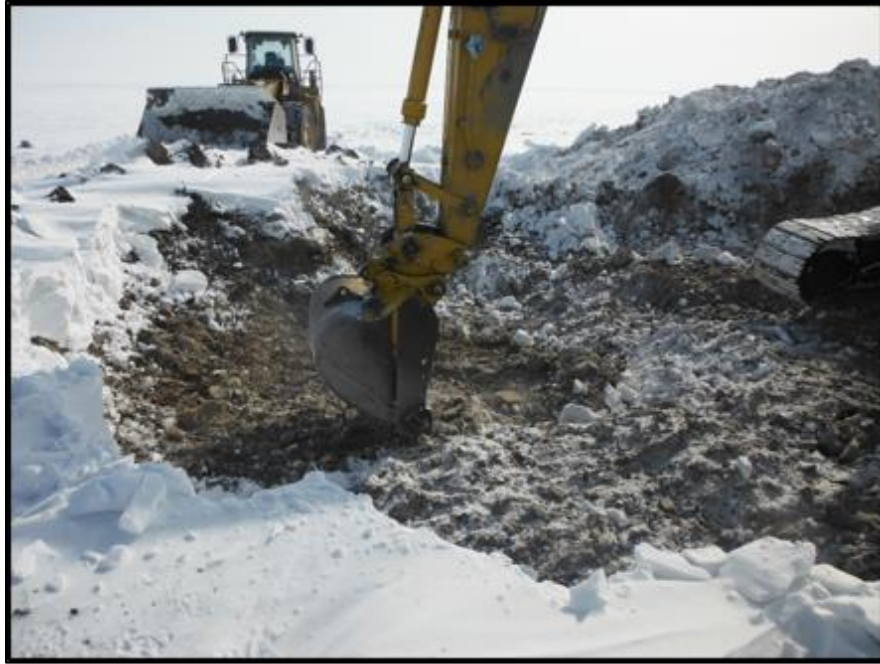
April 20: Excavation activities.

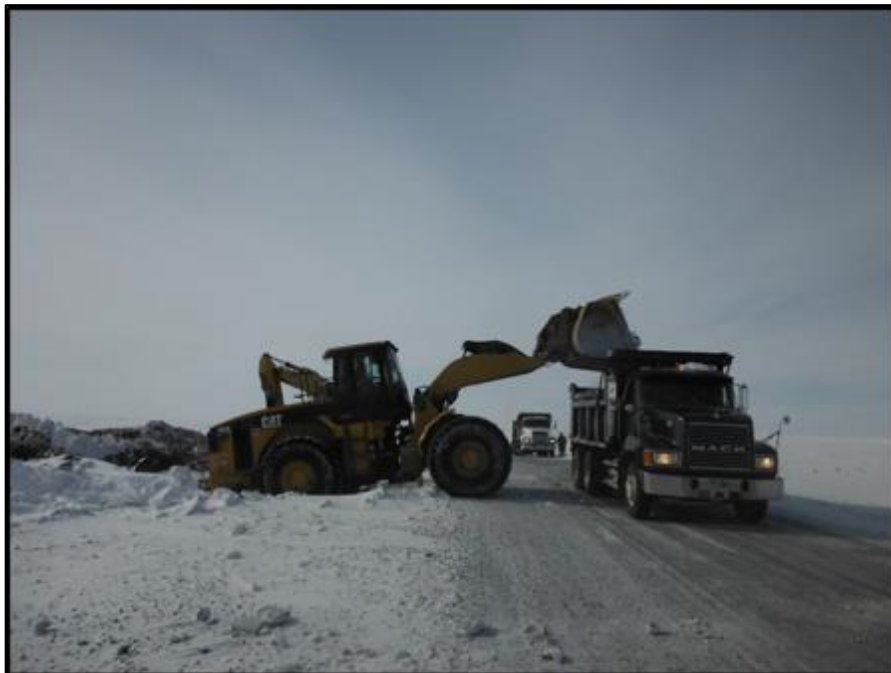
April 20: Loading trucks.

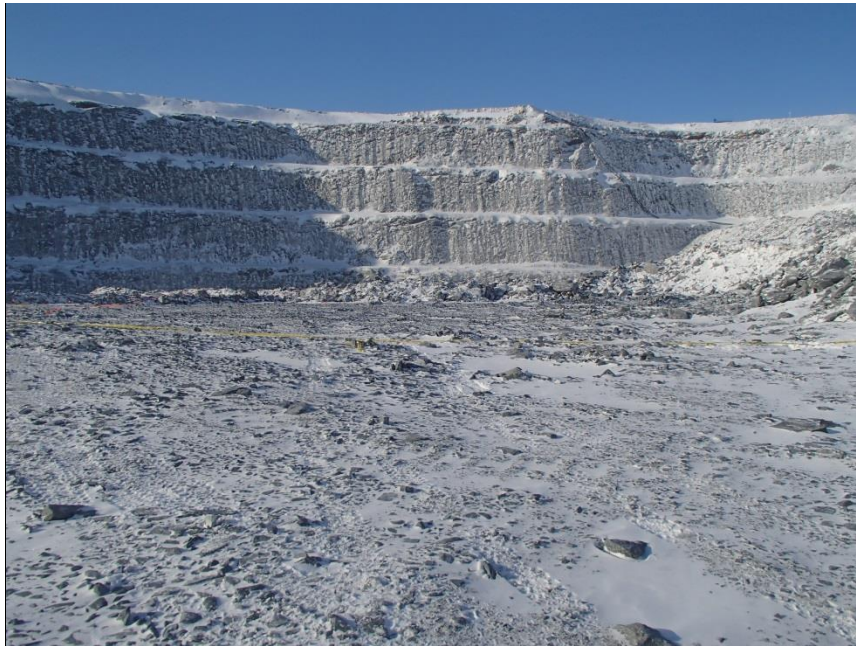
Once the equipment was repaired in field and could safely be removed, the area was cleaned. The contaminated material removed was brought to the landfarm area

The hydraulic system including hoses and fittings are inspected as part of the preventive maintenance program done on site. Routine visual inspection of the hydraulic system is also performed during pre-operations checks.

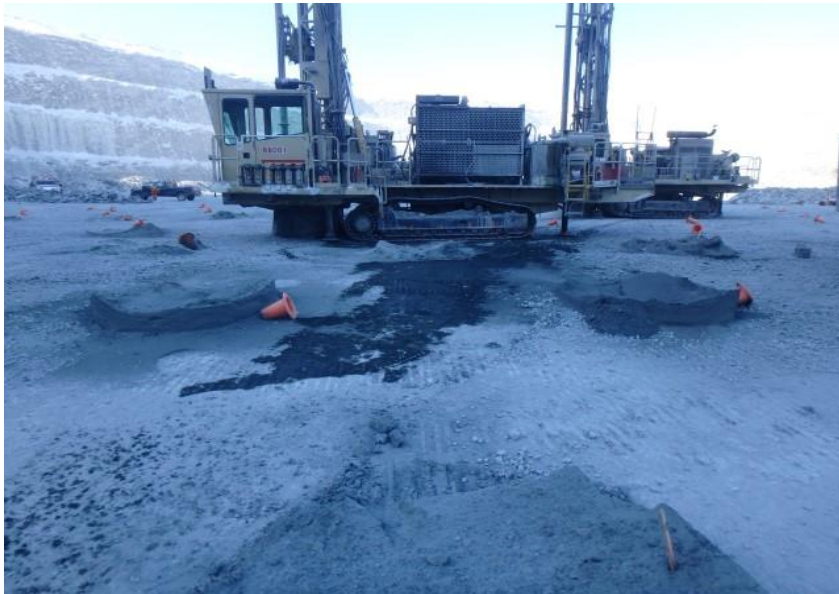
There were no off site impact or discharge to any receiving watercourses. The distance to the closest lake is estimated at 1.1 kilometers east of the pit.

A hydraulic hose ruptured caused due to regular wear and tear and constant movement of the equipment as it moves from

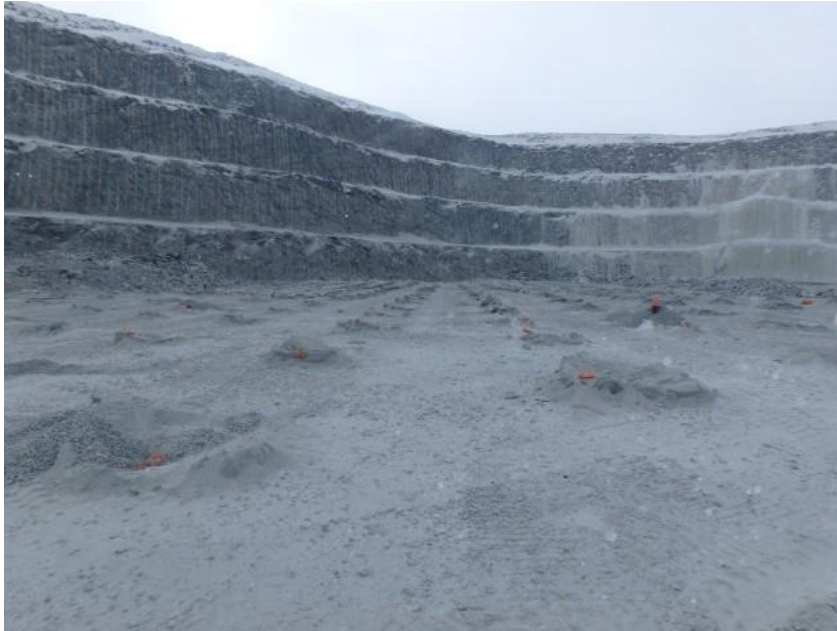
The drill was removed from the area to commence cleanup of the contaminated area using an IT14 loader which is used to fill drill holes. Mechanic was called to the drill to do the repairs and inspect other hoses. The contaminated soil removed was placed in a yellow roll off bin which was disposed of at the Landfarm

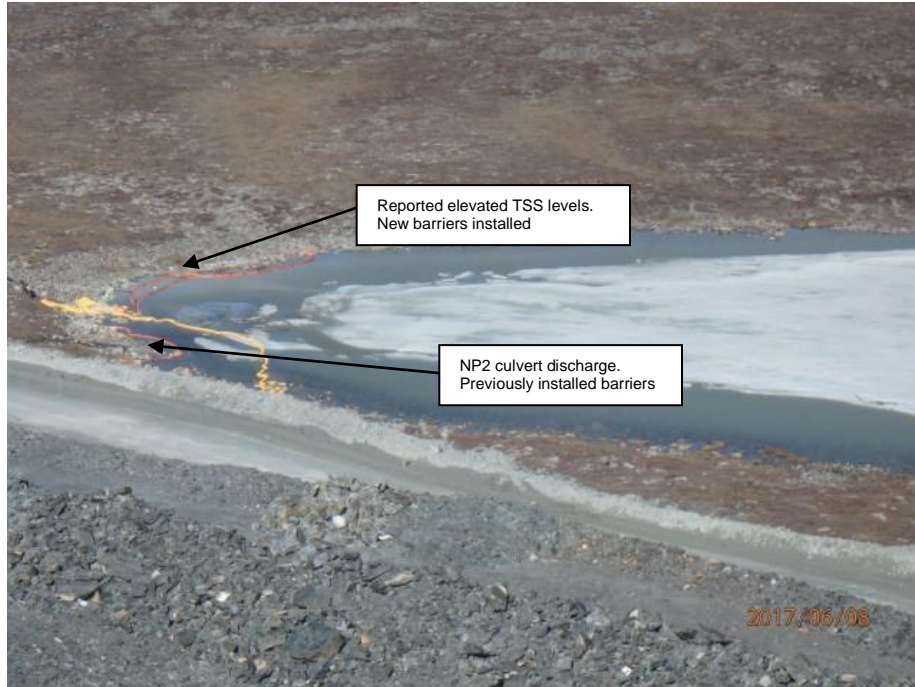
Photo 2: Mitigation measures

As a precautionary measure, additional barriers were placed on the north lake banks limiting TSS arrival speed in the lake on June 6<sup>th</sup> (Photo 2). It is important to note that barriers were already in place within NP1 Lake, as presented on the picture below. Silt fences and additional wood chip logs were installed on the upstream flows to prevent more sediments from entering water. As well, all remaining snow was removed from the road side up and downhill of the areas.

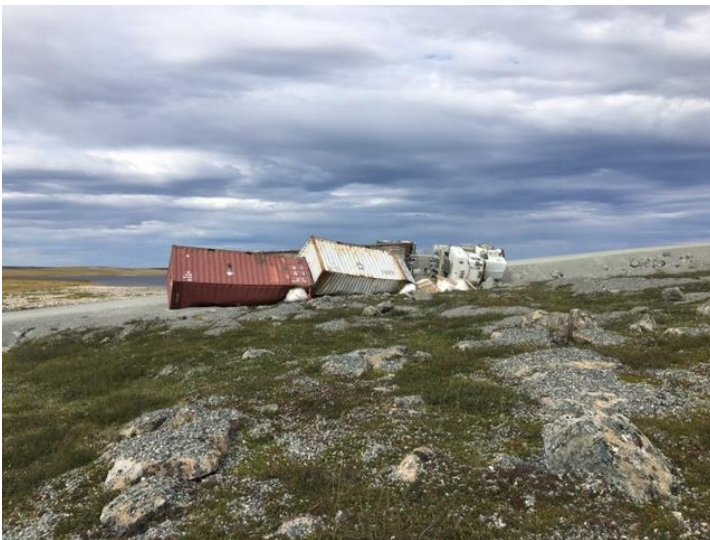
After observation on the incident scene by ERT personnel, a small amount of Sodium Hydroxide (NaOH) was observed on the ground, as well as fuel and oil from the engine of the truck.

Tractor and trailer off-road

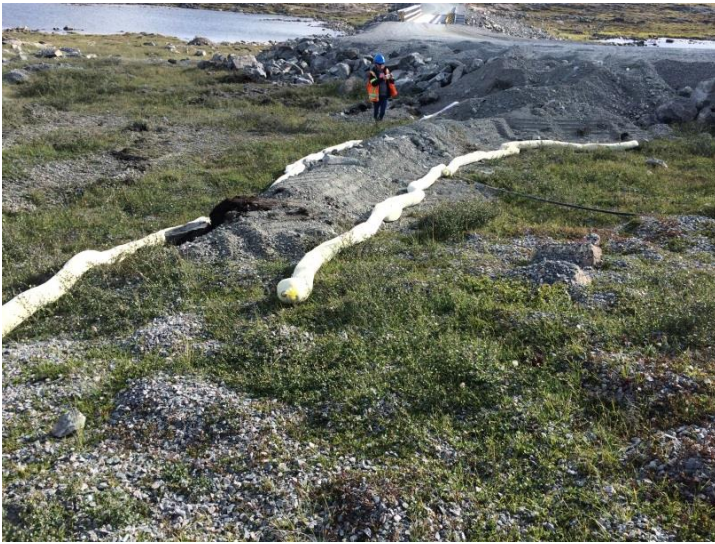
Berm and chemical booms

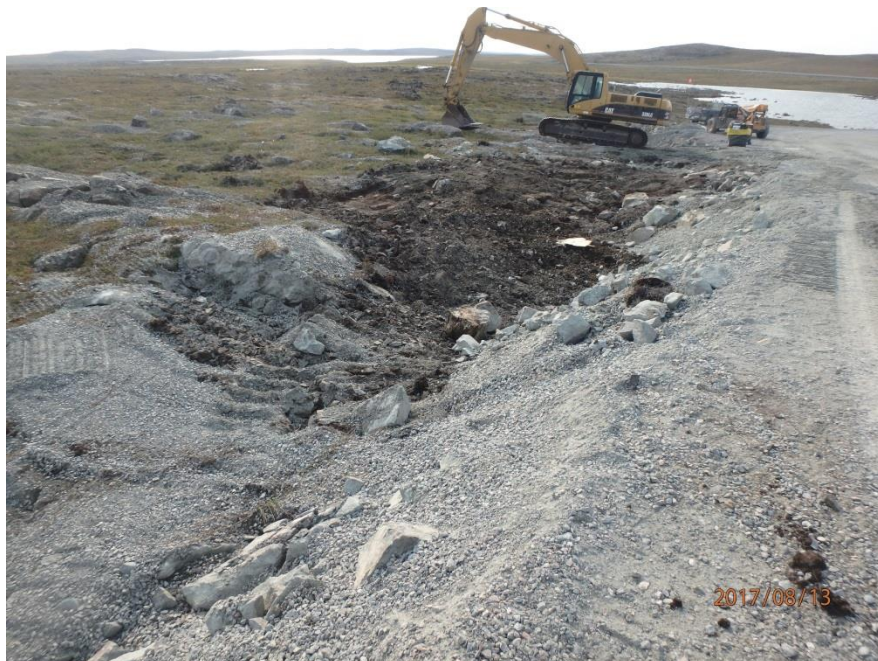
Clean-up completed
