### **2017 South Cell Internal Structure As-built Report**

**SOUTH CELL INTERNAL STRUCTURE AS-BUILT REPORT**

**AGNICO-EAGLE MINES LIMITED  
MEADOWBANK GOLD PROJECT**

**DECEMBER 31, 2017**

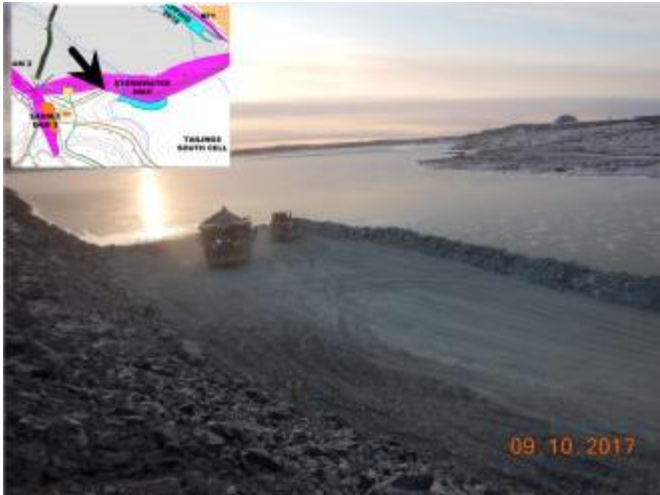
**Photo 1: Placement of rockfill over 2016 Stormwater Dike buttress (October 9, 2017).**

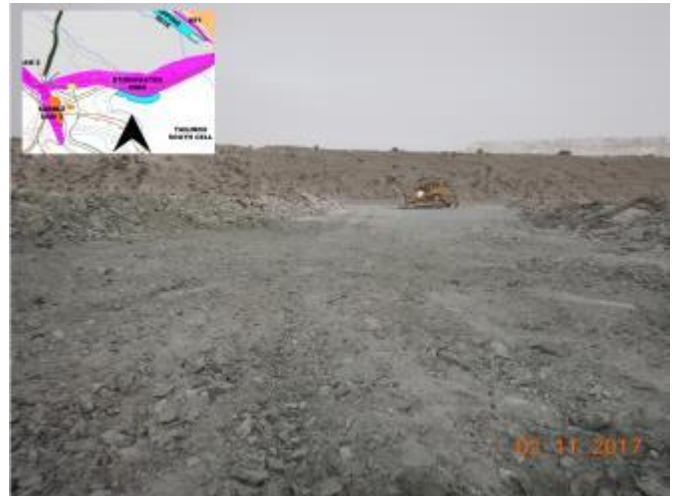
**Photo 4: View from the end of the structure on the platform (November 2, 2017).**

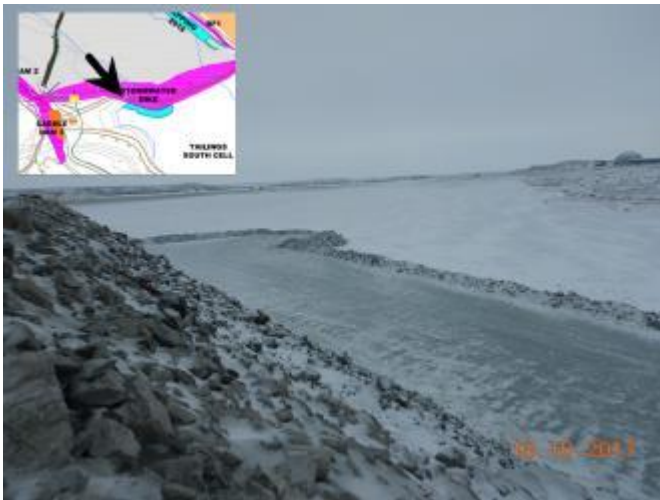
**Photo 2: Continued (October 18, 2017).**

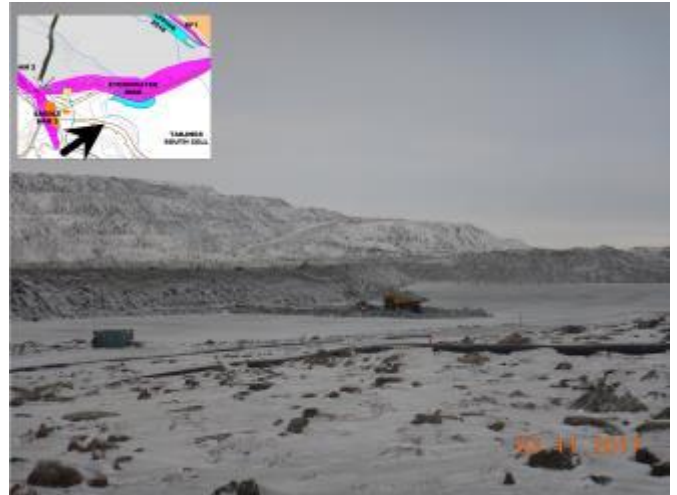
**Photo 5: View of the dumping process from Saddle road (November 3, 2017).**

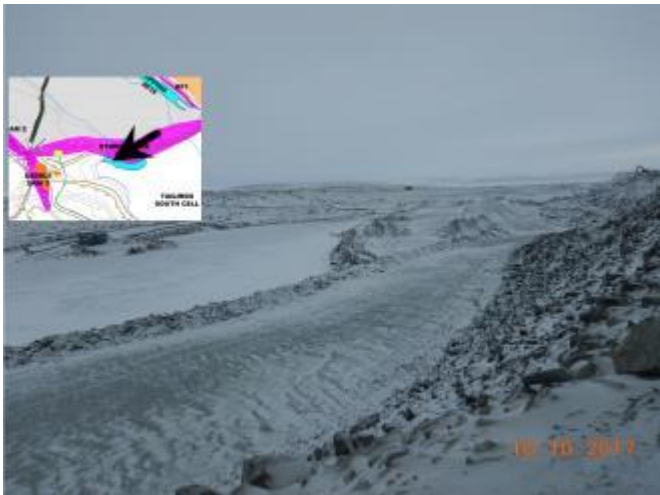
**Photo 3: Access area of internal structures over Stormwater Dike 2016 buttress (October 18, 2017).**

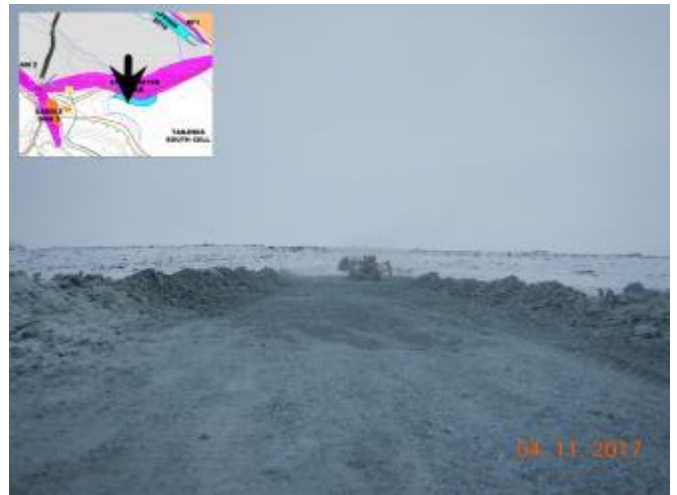
**Photo 6: View on the platform towards the end of the structure (November 4, 2017).**

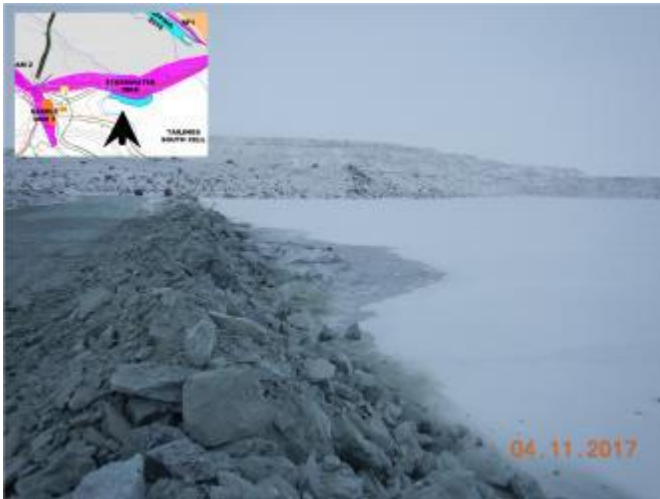
**Photo 7: Close up view of the ice sheet collapsing as material placement occurs (November 4, 2017).**

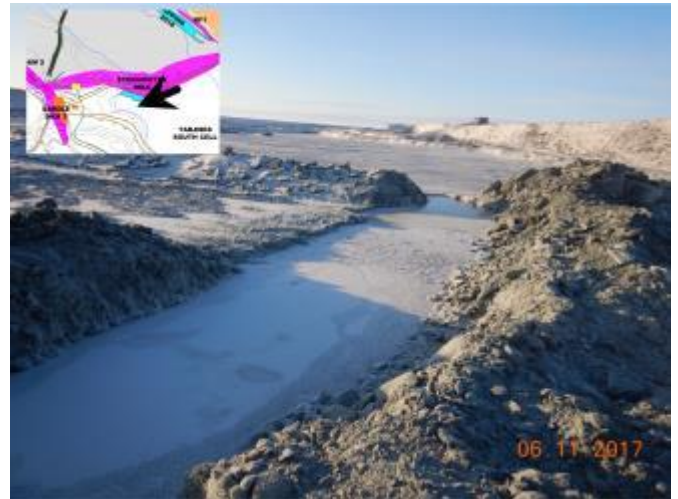
**Photo 10: View of the completed trenching (November 6, 2017).**

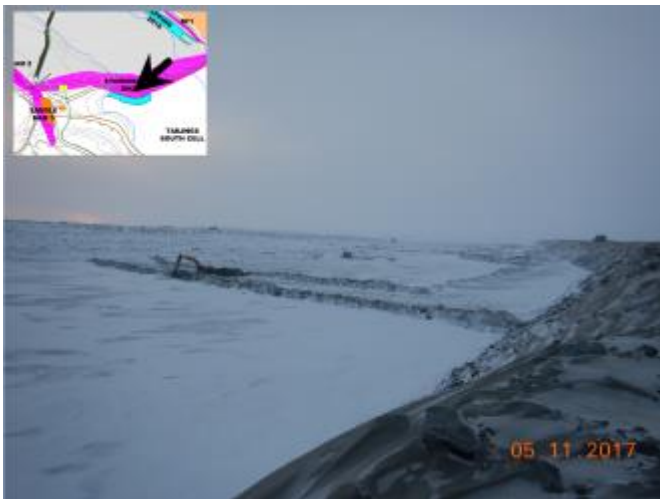
**Photo 8: Backhoe working on the first trench (November 5, 2017).**

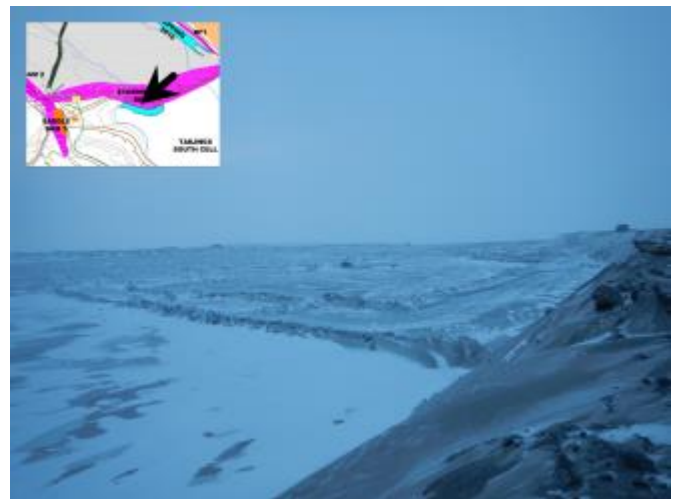
**Photo 11: General view of the completed internal structure (November 10, 2017).**

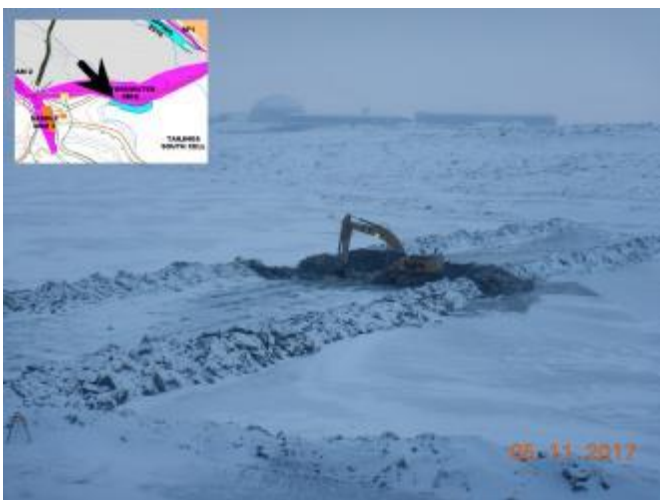
**Photo 9: Close up view of a backhoe working on the first trench (November 5, 2017).**

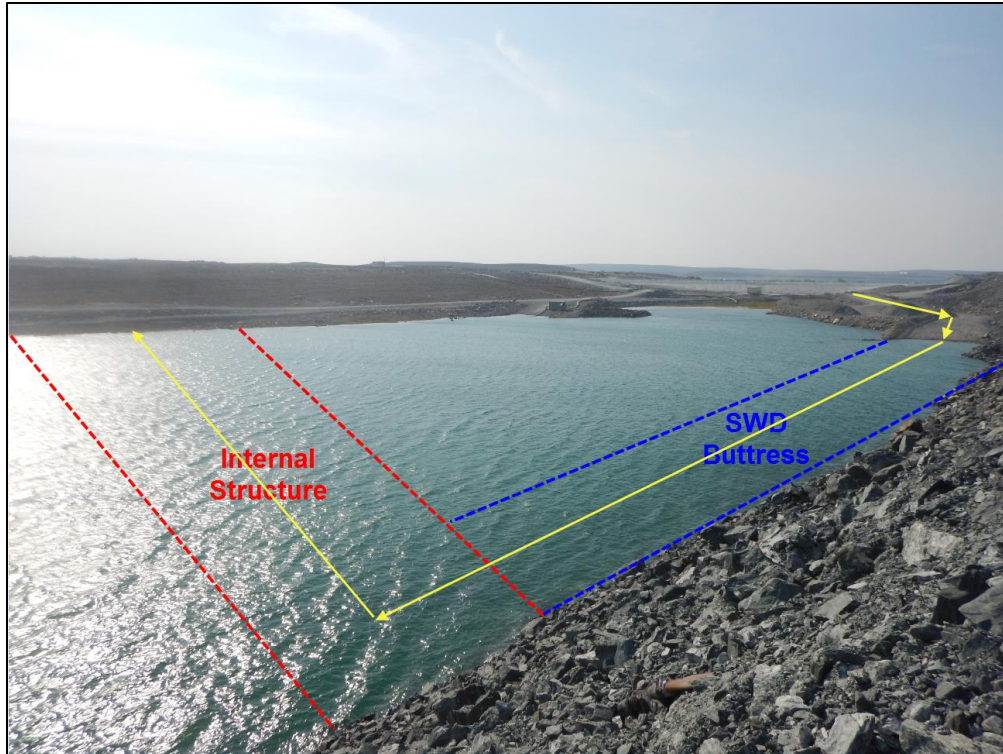
**Figure 2:** The construction area access, as seen from Stormwater Dike.

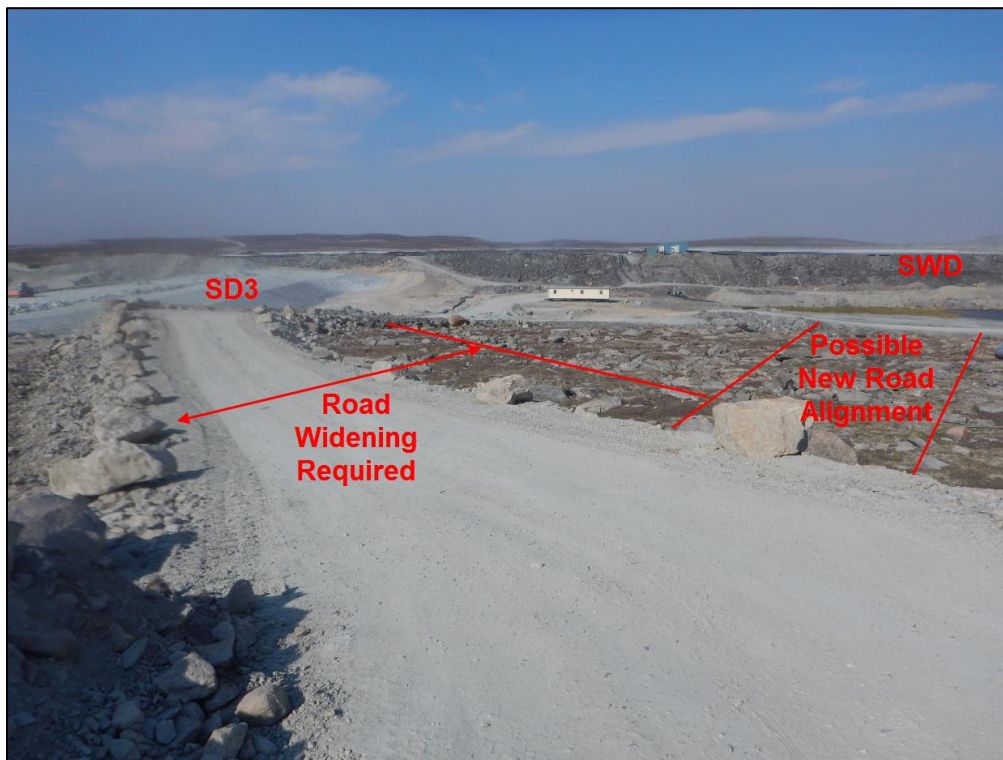
**Figure 3:** Road widening will be required on the Saddle Road as it turns toward Saddle Dam 3 since currently the road width is only enough for light vehicles. A new road could also be constructed to reduce the length of the hauling route, as seen on the right-hand side of the photo.
