APPENDIX 6 2023 ANNUAL GEOTECHNICAL INSPECTION REPORT

2023 Annual Geotechnical Inspection Meliadine Gold Mine, Nunavut, Canada

PRESENTED TO
Agnico Eagle Mines Limited

JANUARY 31, 2024
ISSUED FOR USE
FILE: 704-ENG.EARC03140-33
AGNICO EAGLE DOCUMENT NUMBER: 65-600-230-TCR-001

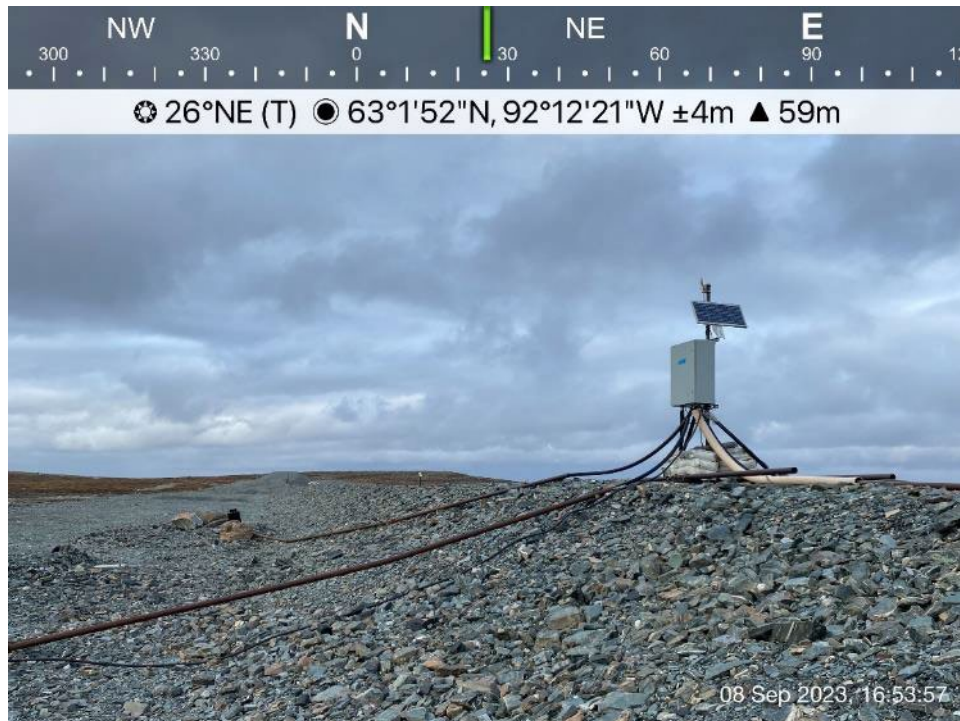
- Minor cracking and small settlement were observed along portions of the upstream and downstream crest (e.g., Photos 6, Appendix B). The largest cracks were up to 3 cm wide. The cracking was first observed during the 2018 geotechnical inspection and has not shown significant change since then.

D-CP1 - Photo 6: Dike D-CP1: Dike upstream crest - minor cracking, no change from previous years.

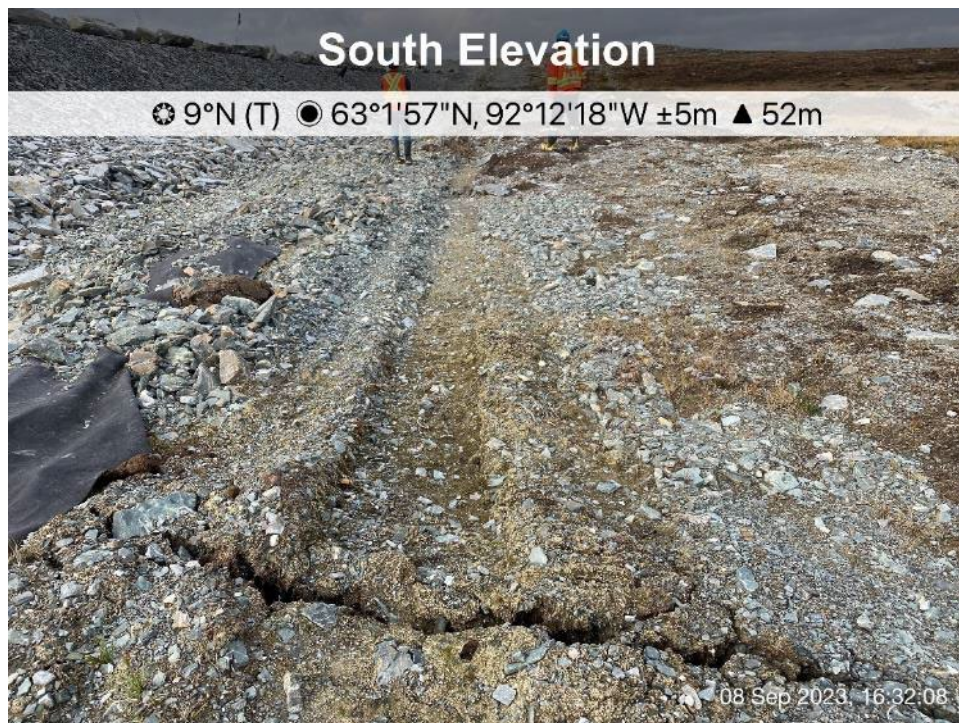
D-CP1 - Photo 12: Dike D-CP1: Dike downstream runoff/seepage collection north channel - cracking on east channel shoulder.

Additional rockfill should be placed to cover the east shoulder of the collection ditches to reduce permafrost degradation. It is recommended to closely monitor the ground temperatures at the HGTC-5 location to assess the impact of the pipeline crossing at Station 1+125 on the thermal performance of Dike D-CP1.

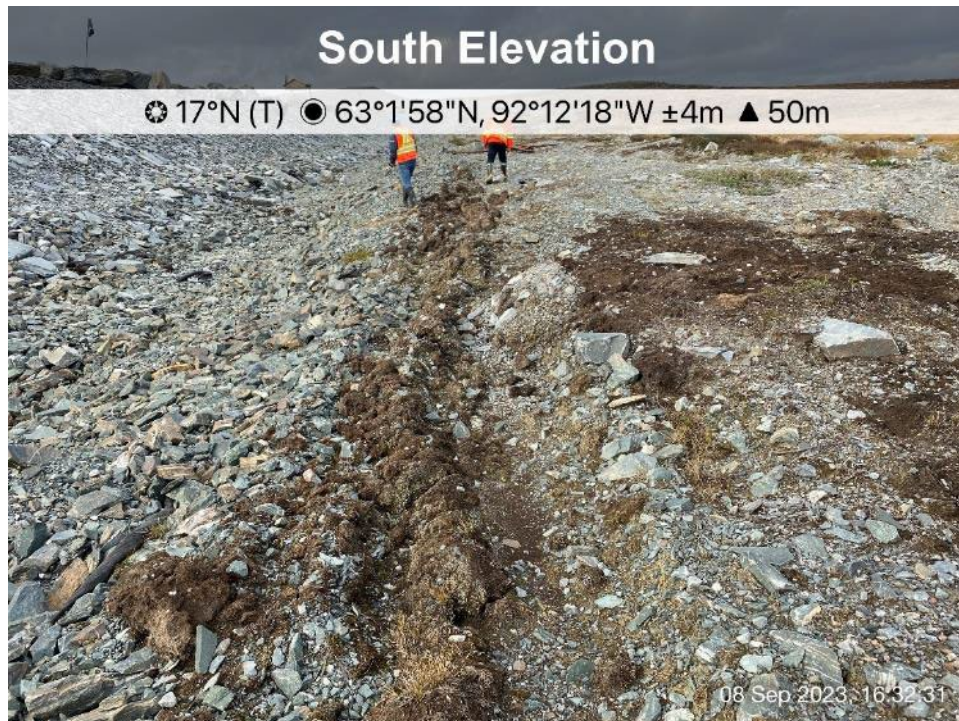
D-CP1 - Photo 13: Dike D-CP1: Dike downstream runoff/seepage collection north channel - thaw subsidence on east channel shoulder.

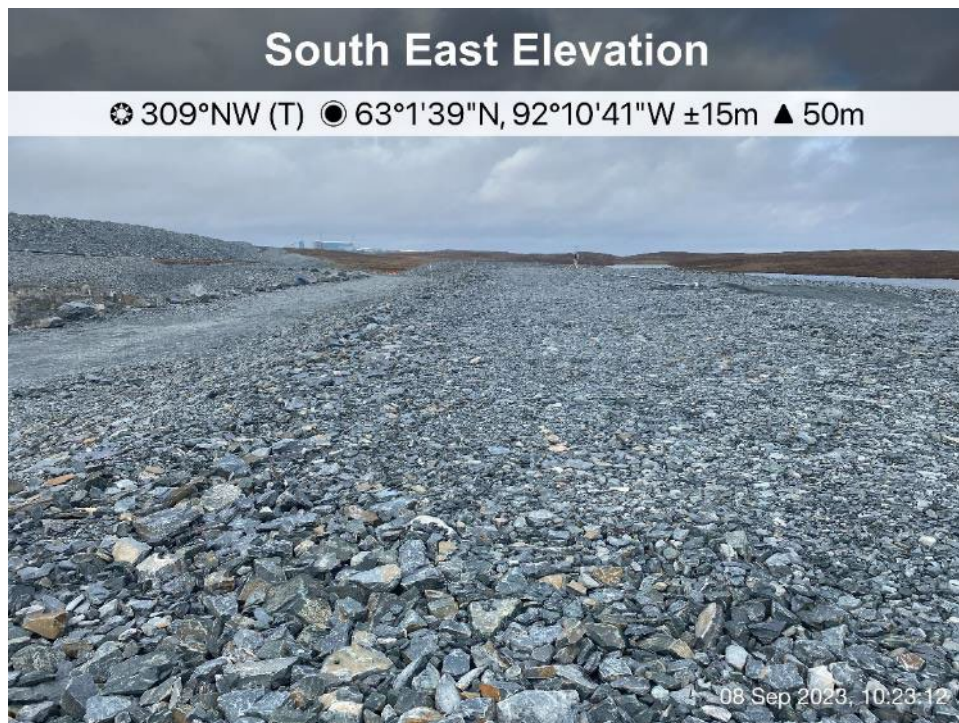
CP2 Thermal Berm - crest, minor settlement observed, no cracking.

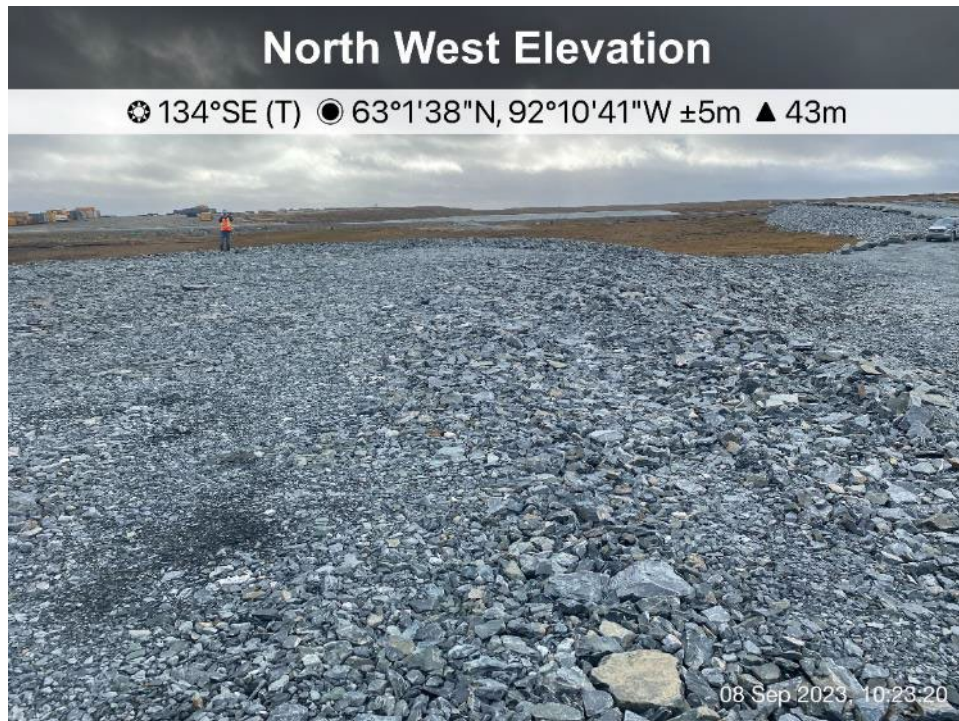
CP2 Thermal Berm - Photo 5: CP2 Thermal Berm - crest, east end, minor settlement observed, no cracking.

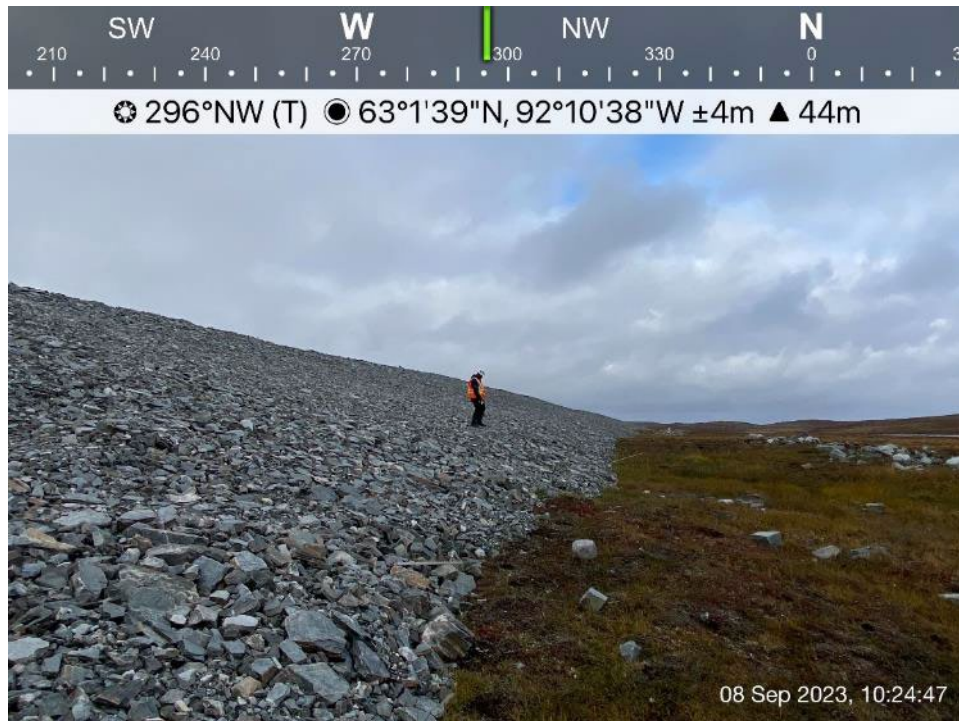
CP2 Thermal Berm - Photo 7: CP2 Thermal Berm - downstream slide slope, minor deformation observed at east end, no stability concern.

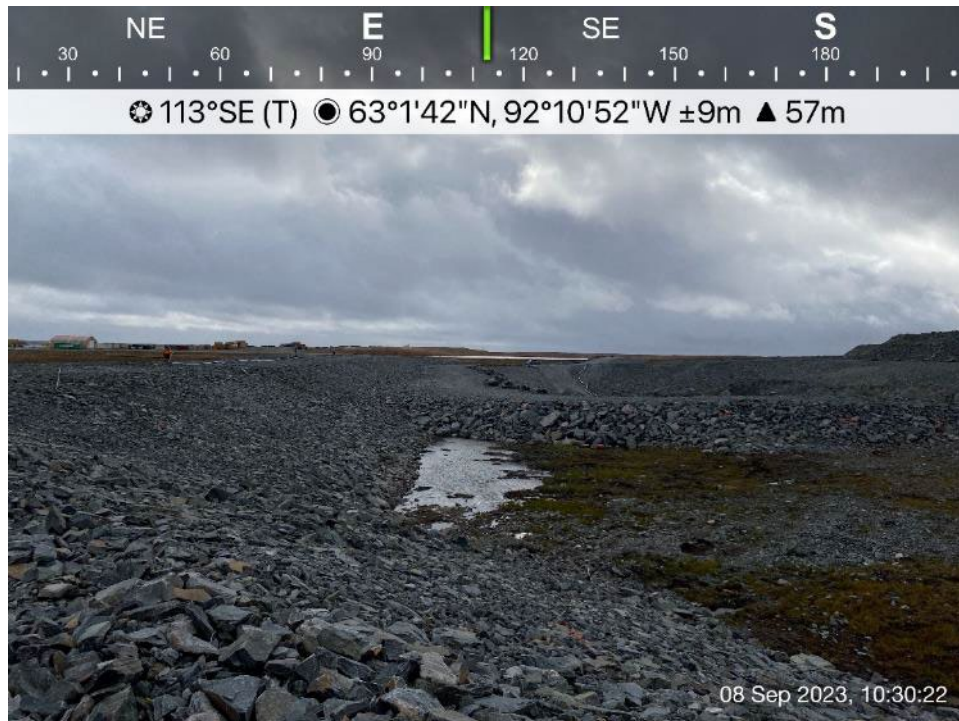
CP2 Thermal Berm - Photo 8: CP2 Thermal Berm - surface ponding observed against upstream toe of CP2 Thermal Berm.

CP2 and its associated infrastructure (Channel 9, Channel 10, and CP2 Thermal Berm) were constructed in Q1 of 2022 and is performing adequately. Minor ponding was observed against the thermal berm. Additional rockfill cover should be placed to prevent ponding in the area. It is recommended that a thermal cover be placed in the areas between CP2, Channel 9, and Channel 10 to prevent disturbance and permafrost degradation of the native ground.

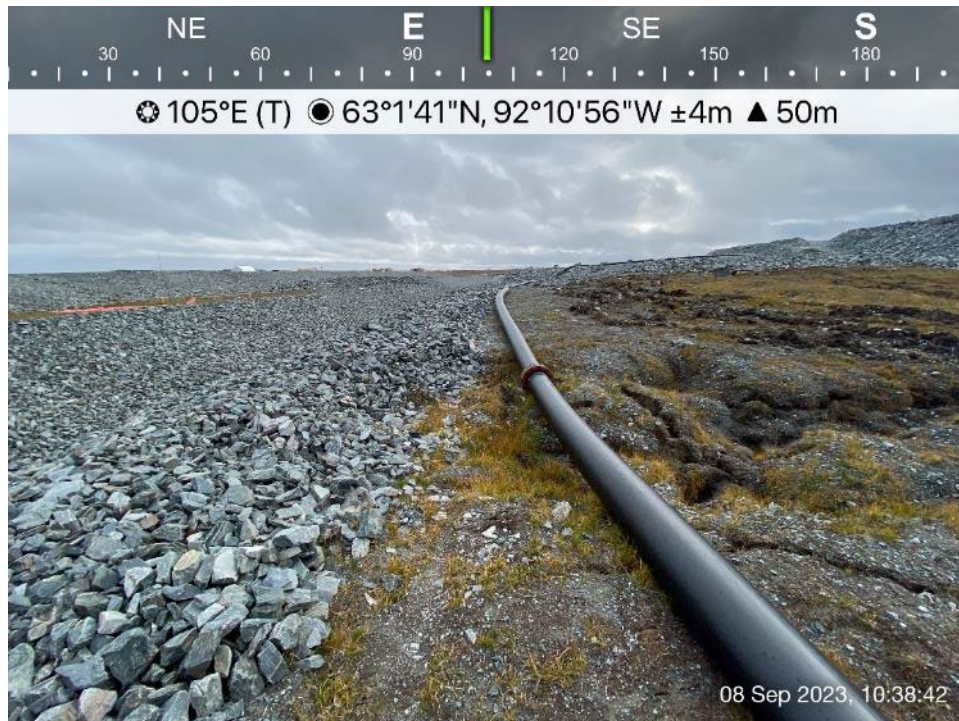
Channel 9 - Photo 11:

Channel 9 - thaw subsidence and cracking observed between south shoulder of Channel 9 and WRSF3.

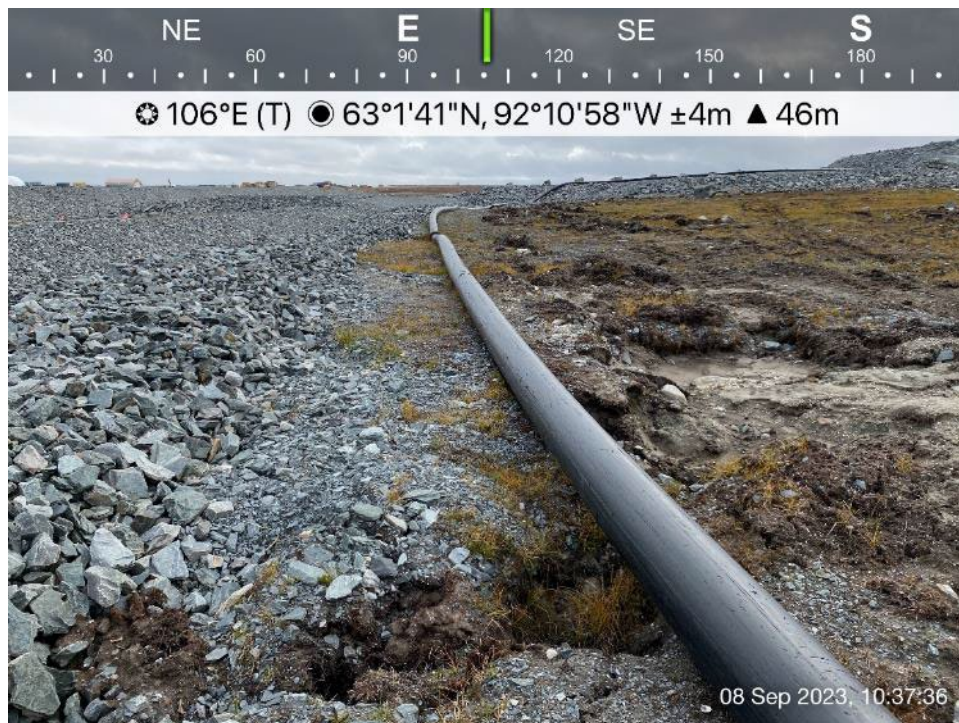
Channel 9 - Photo 12:

Channel 9 - thaw subsidence and cracking observed between south shoulder of Channel 9 and WRSF3.

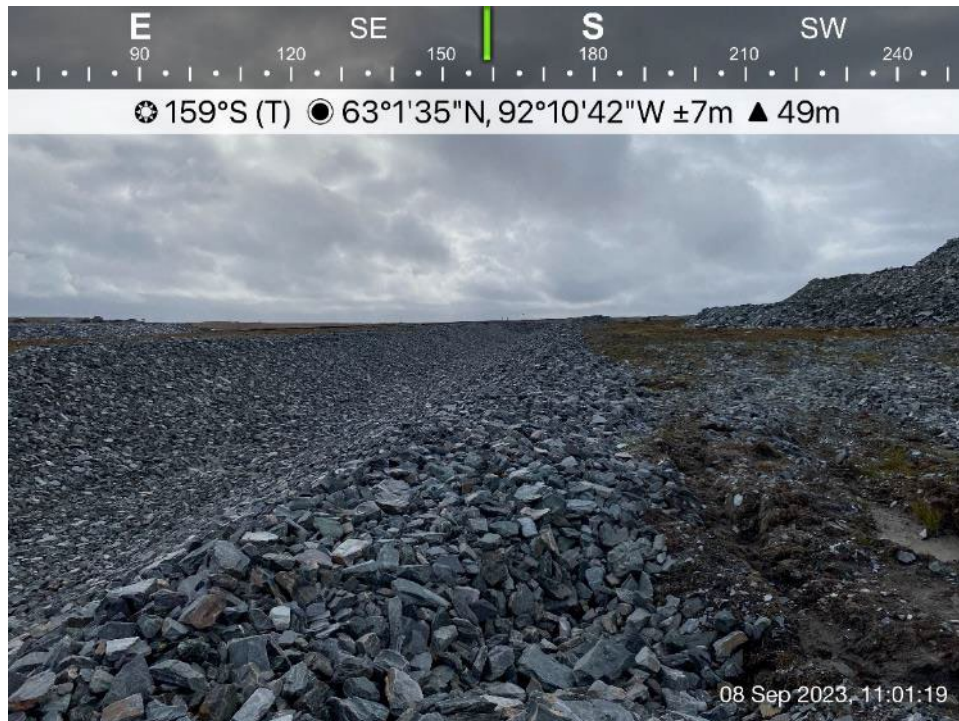
Channel 10 - Photo 13:

Channel 10 - view of Channel10, minor thaw subsidence observed along the south shoulder of the channel.

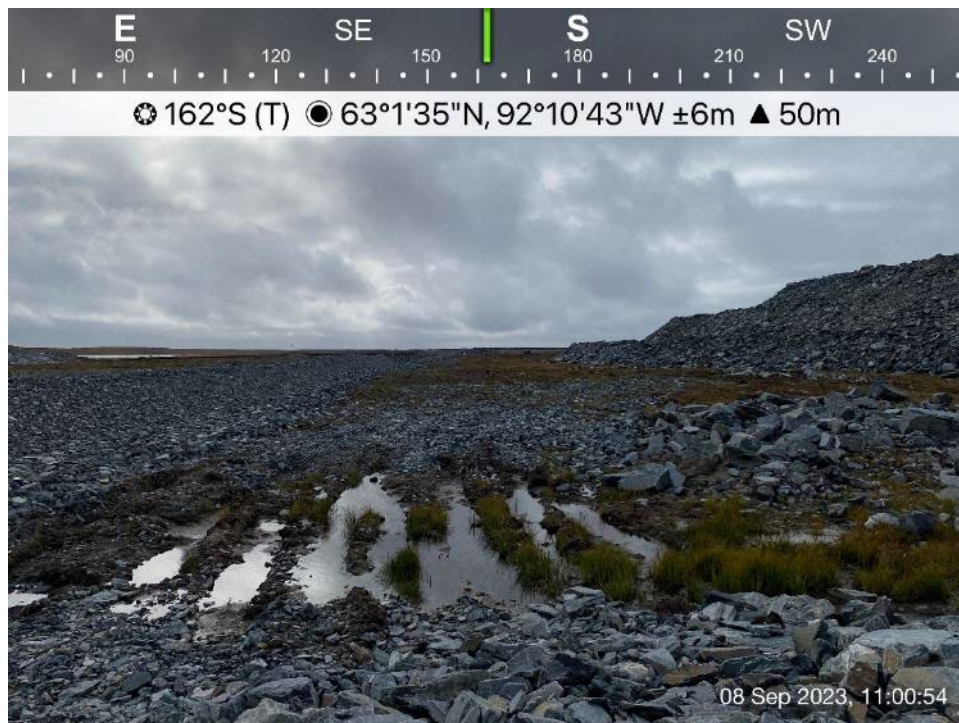
Channel 10 - Photo 14:

Channel 10 - rutting from traffic and ponded water observed between the channel and WRSF3.

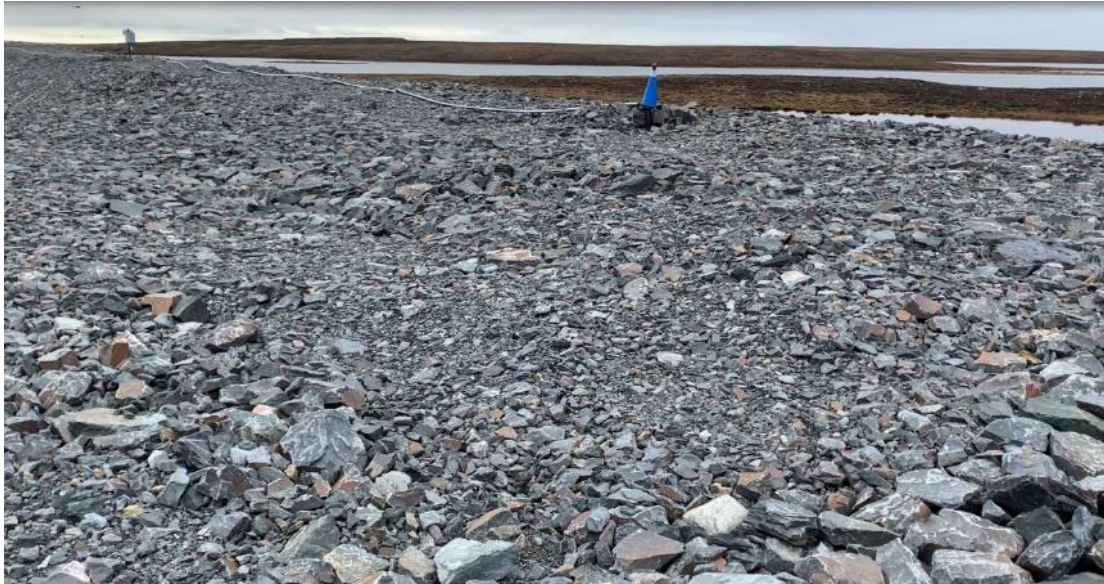
CP3 - Photo 5: CP3 Thermal Berm - Settlement observed on the crest of CP3 Thermal Berm due to thaw settlement.

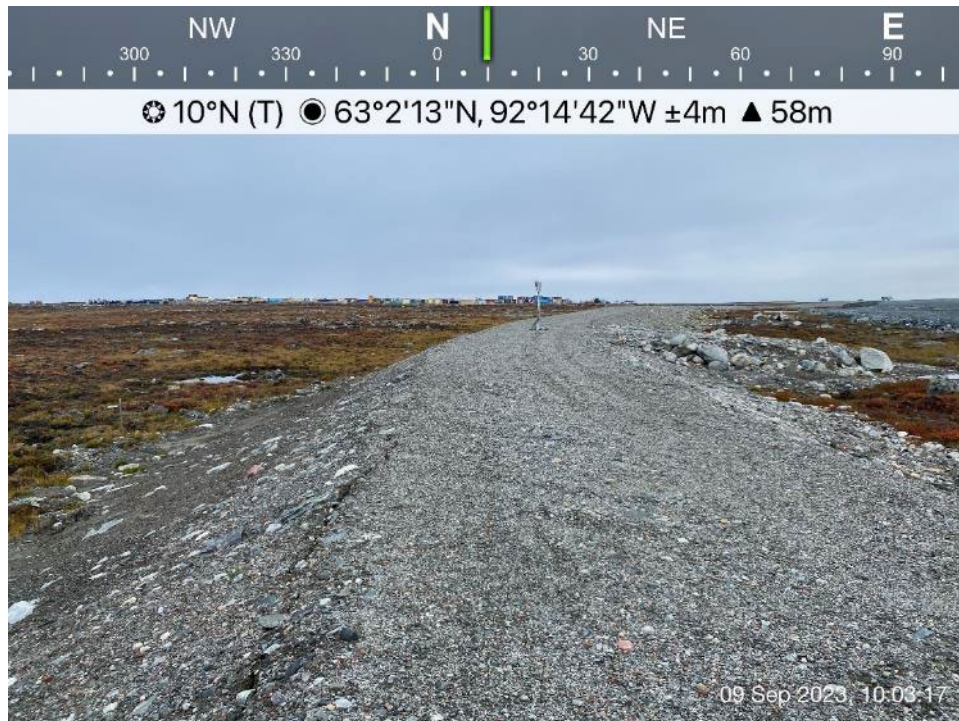
Berm 2 - Photo 10: Berm 2 - Berm 2 south portion, slope and crest, cracking observed on downstream slope.

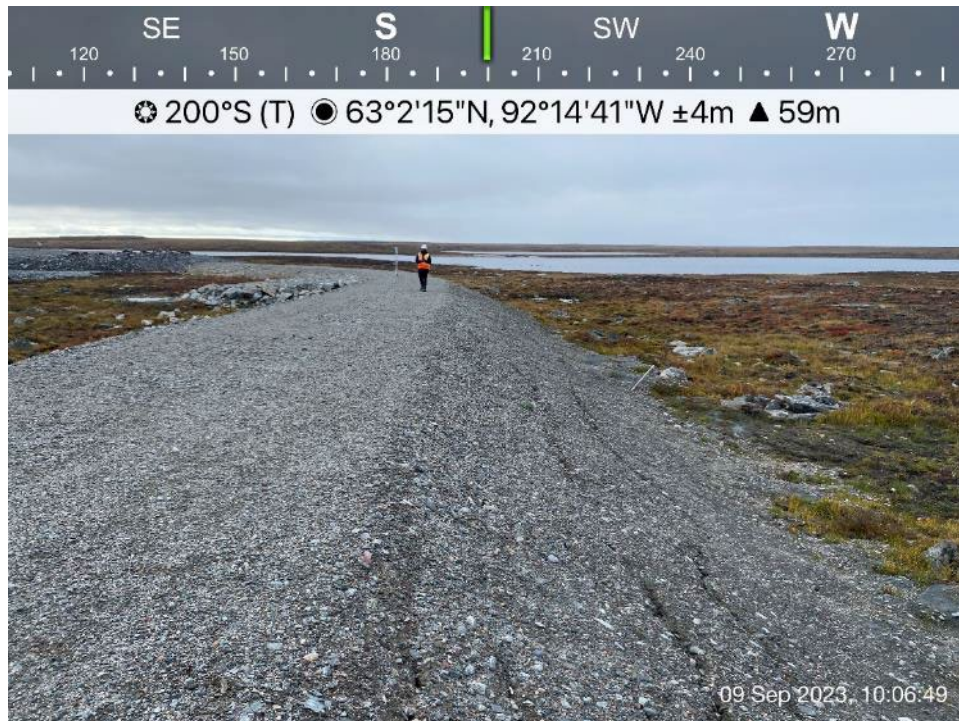
Berm 2 - Photo 11: Berm 2 - Berm 2 middle portion, slope and crest, cracking observed on downstream slope.

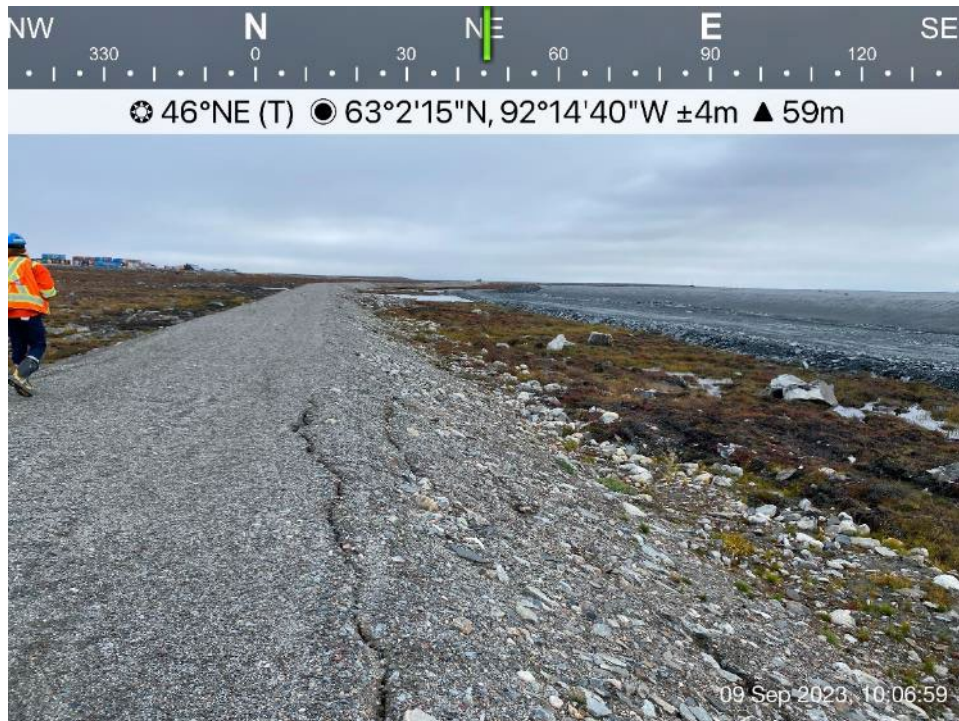
Berm 2 - Photo 12: Berm 2 - Berm 2 middle portion, slope and crest, cracking observed on upstream slope.

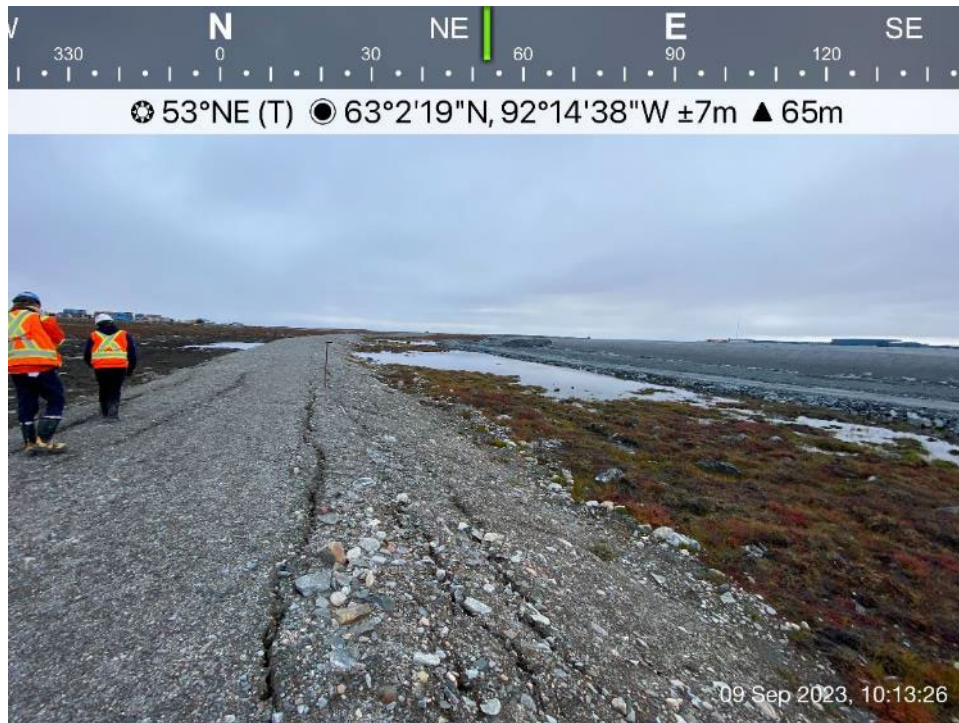
Berm 2 - Photo 13: Berm 2 - ponded water on both sides, cracking observed on slope and crest.

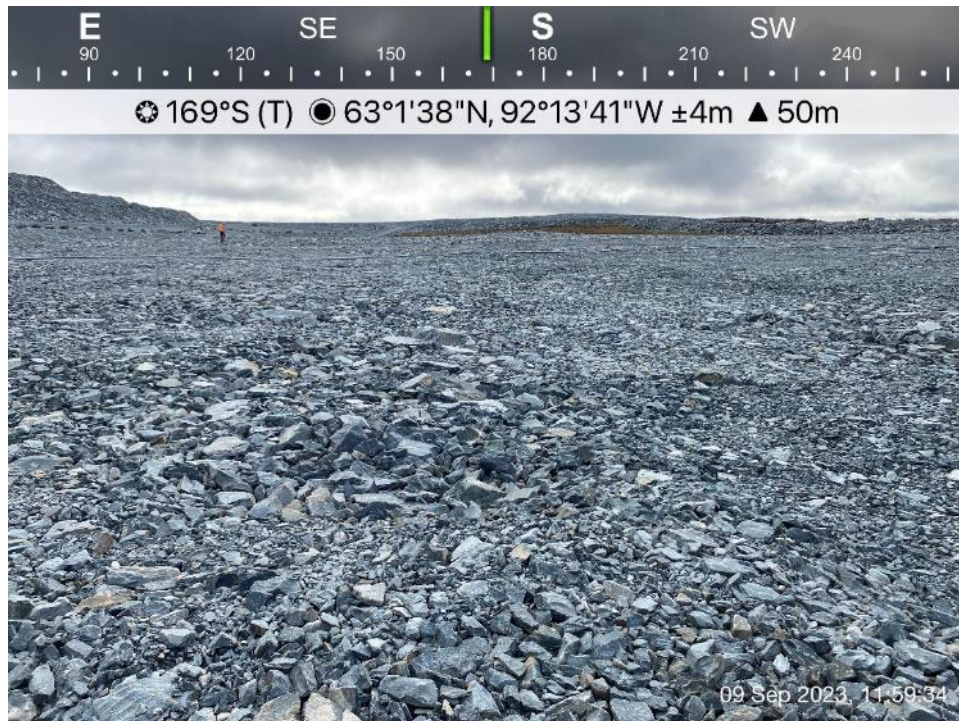
CP4 Thermal Berm - Photo 7: CP4 Thermal Berm - Looking south, even surface due to thaw settlement observed from the crest.

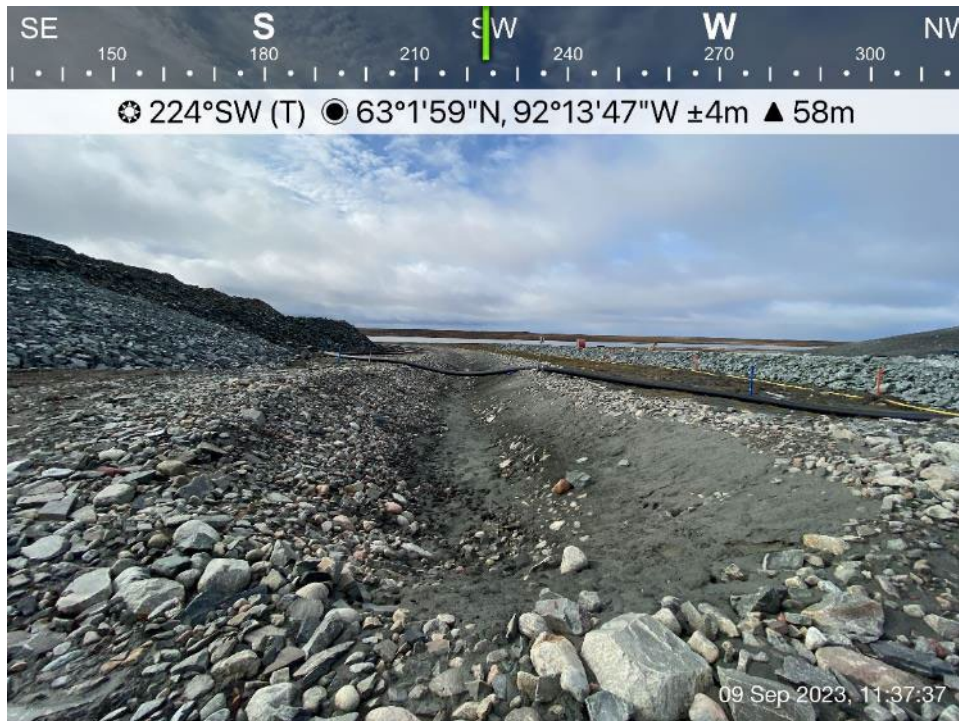
Channel 4 - Photo 9: Channel 4 - Upper reach of Channel 4, below landfill of WRSF1, infilling with sediments observed.

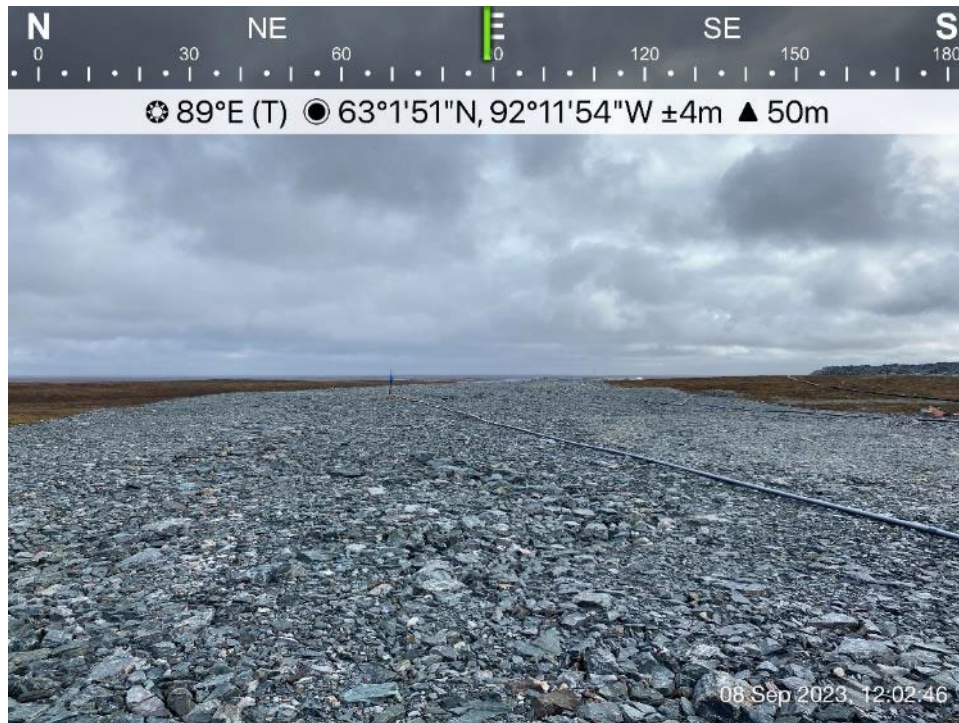
CP6 - Photo 7: CP6 Thermal Berm, looking east, crest, thaw settlement observed at various areas.

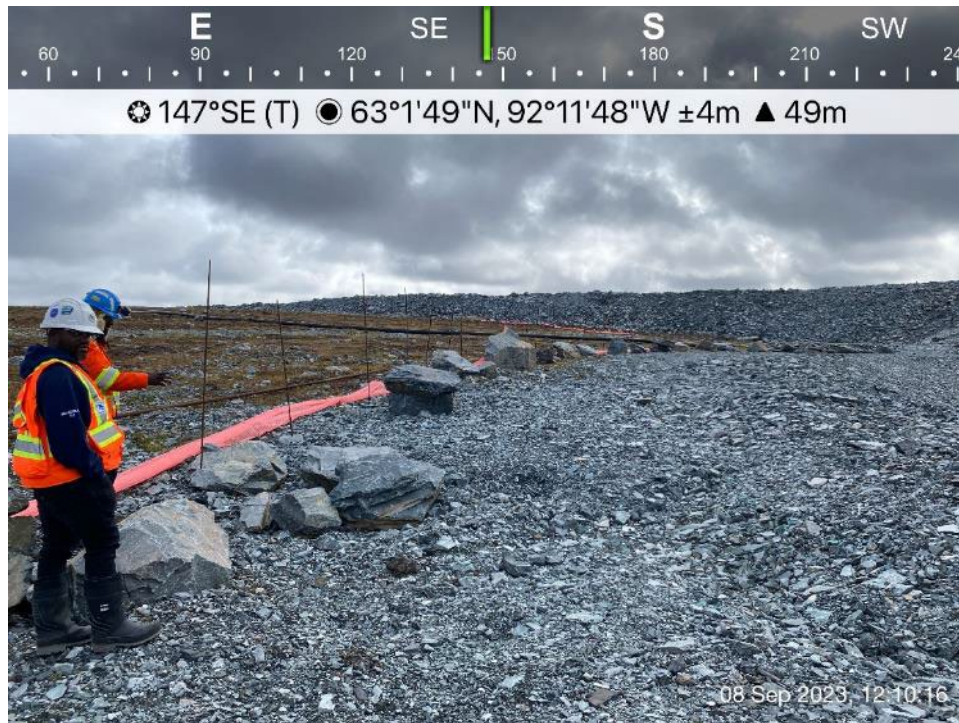
CP6 - Photo 10: CP6 East side perimeter, thaw settlement observed.

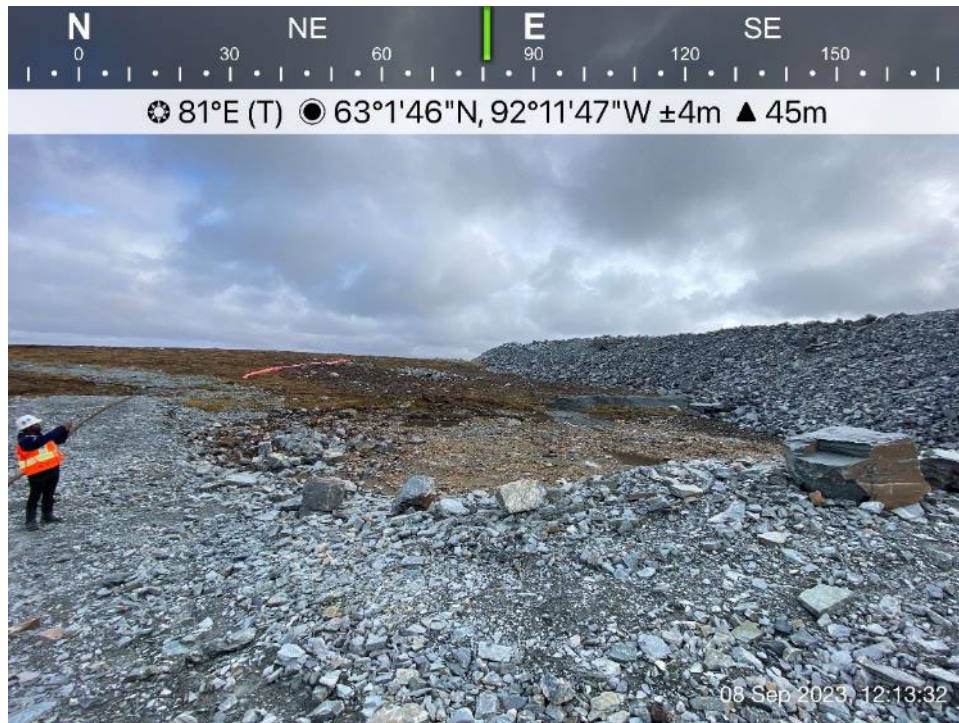
CP6 - Photo 11: CP6 - Ground between CP6 and WRSF3, not covered by rockfill, surface erosion observed.

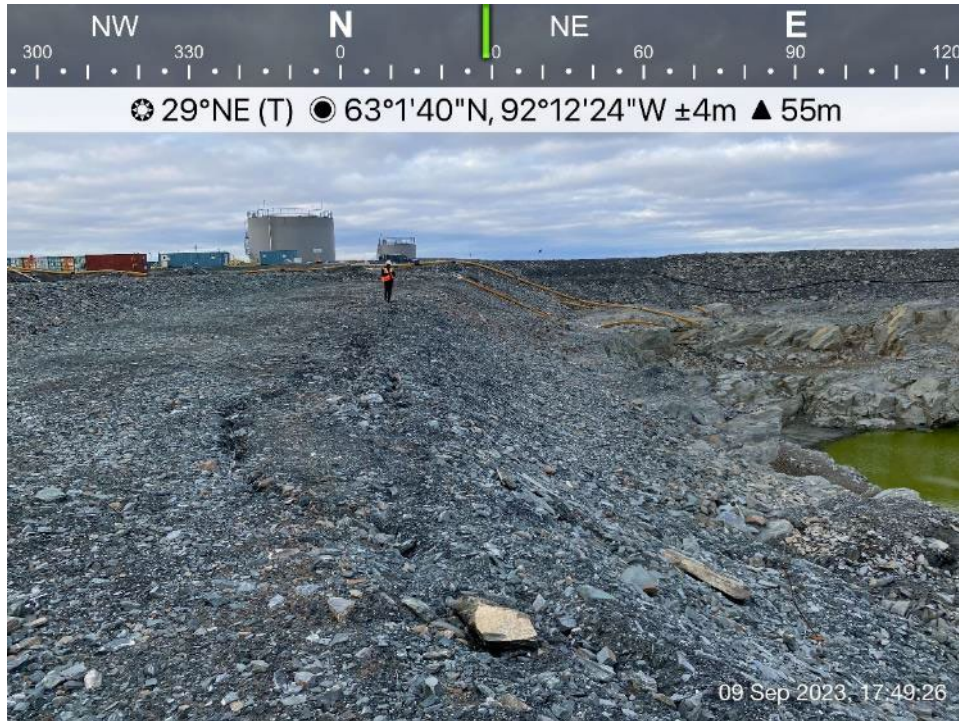
Saline Ponds (SP) 1 and 3 are performing adequately. The settlement and cracking observed around SP 1 should continue to be monitored. The safety berms located at the bottom of the access ramp into SP1 and the arrangement of the pipelines along the ramp should be improved for safety and easy access. SP4 was drained and incorporated into the Tiriganiaq 01 Open Pit in 2023, thus, it no longer exists as a saline storage pond.

SP1 - Photo 4: SP1 Saline Pond - deformation and cracking in top of overburden protected slope, southwest corner of SP1.

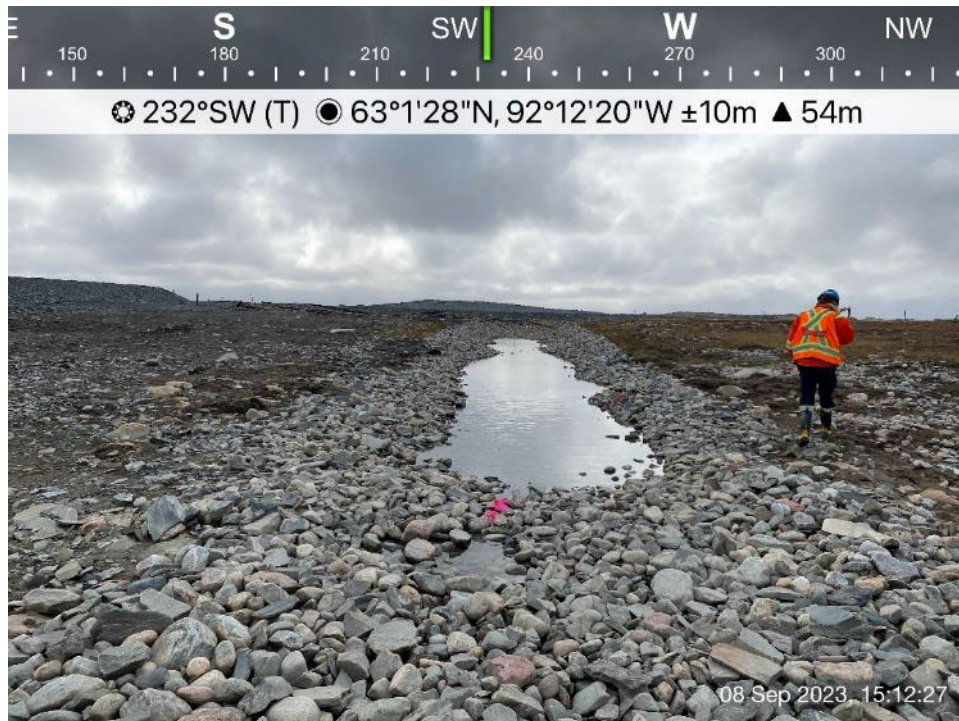
Channel 5 - Photo 9: Channel 5 - Lower reach of Channel 5, ponded water observed due to thaw subsidence.

- It is recommended to continue to monitor subsidence at the base of Channels 1, 2, and 7 to determine if they impact the channels' performance.
- It is recommended that the northern half of Channel 5 be reconstructed to the design grade and elevation. If practical, the base of the channel should be over excavated and backfilled with rockfill material to accommodate potential thaw subsidence after the reconstruction. The base of the southern half of the channel should be regraded to promote water flow and reduce further subsidence due to the water ponding.
- Minor erosion was observed during the inspection of Berm 3 as its cover materials are susceptible to erosion. Erosion of the slopes should be monitored, and consideration should be given to placing coarser material on Berm 3 to reduce the potential for erosion if it becomes substantial.

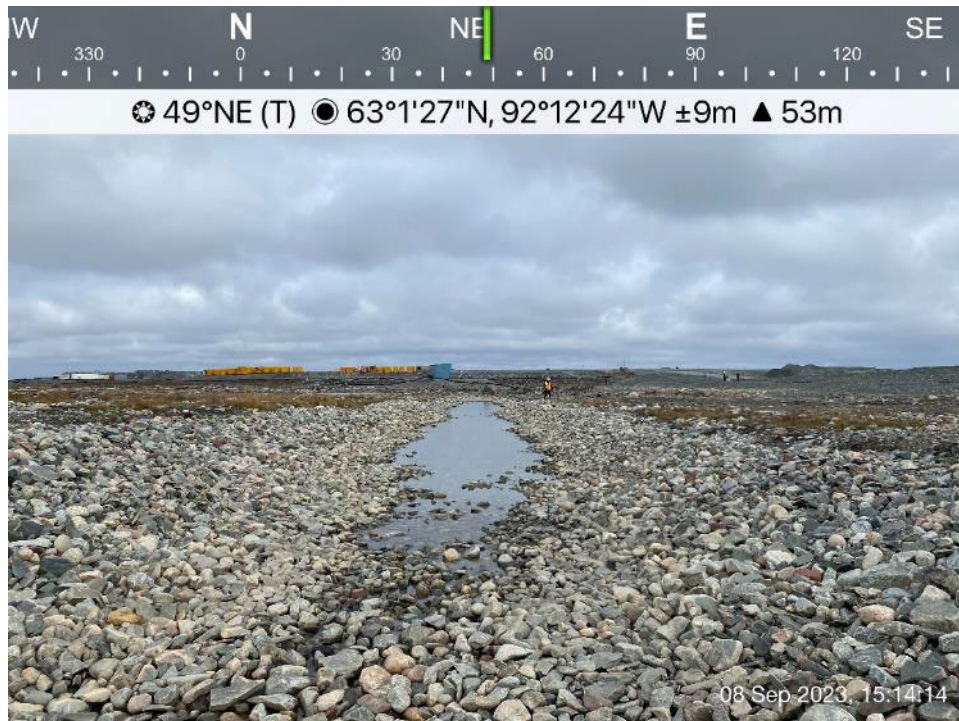
Channel 5 - Photo 10: Channel 5 - Middle section of Channel 5, ponded water observed due to thaw subsidence, looking northeast.

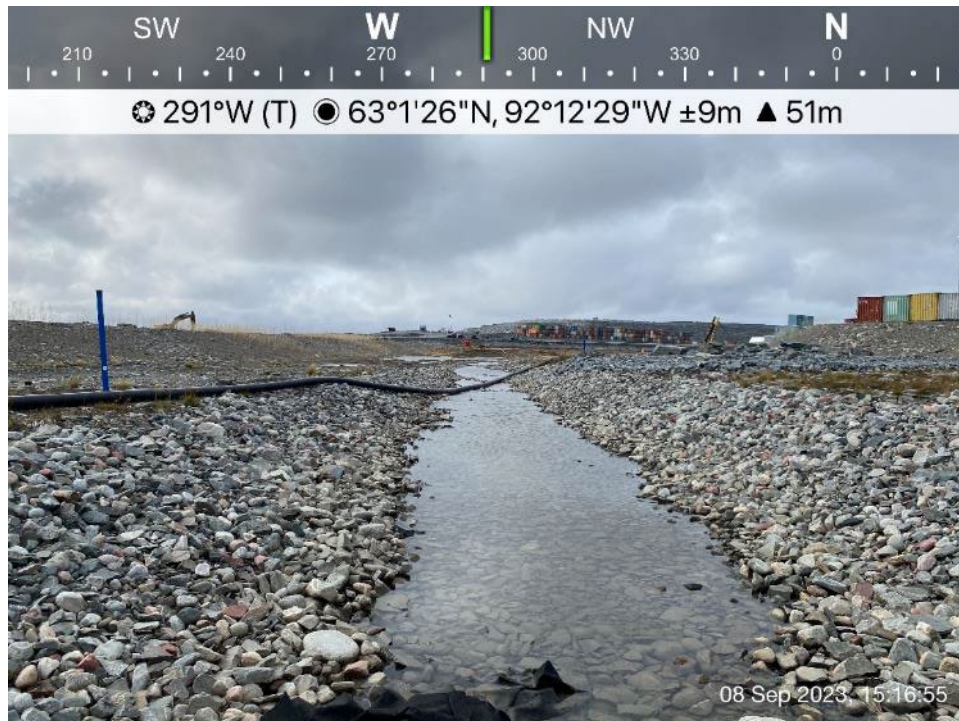
Channel 5 - Photo 11: Channel 5 - Middle section of Channel 5, ponded water observed due to thaw subsidence, looking west.

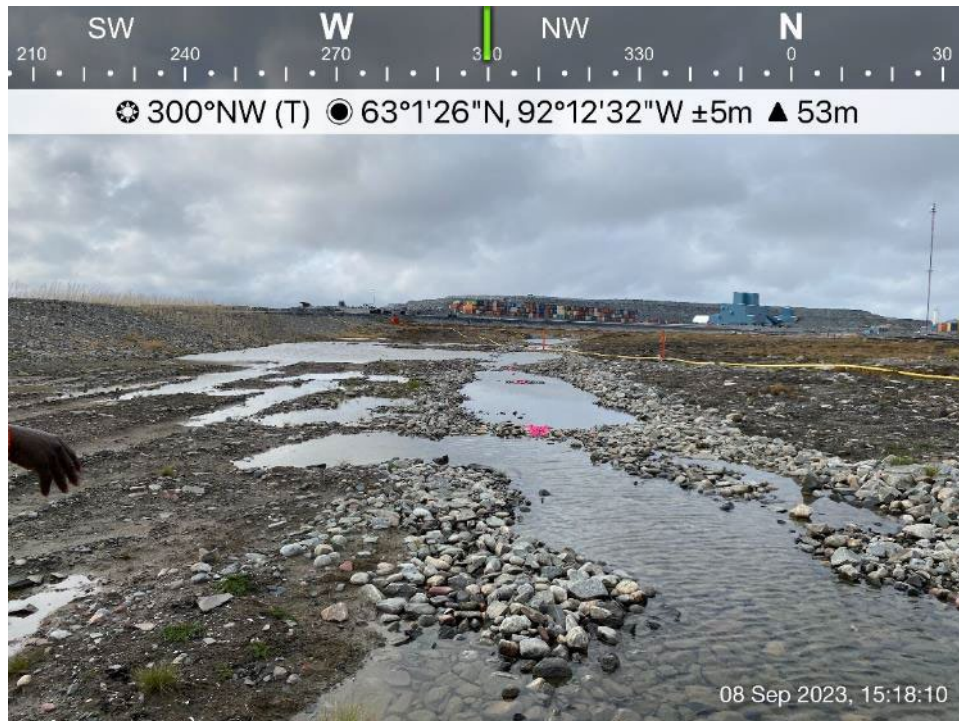
Channel 5 - Photo 12: Channel 5 - Upper section of Channel 5, ponded water observed due to thaw subsidence, looking northwest.

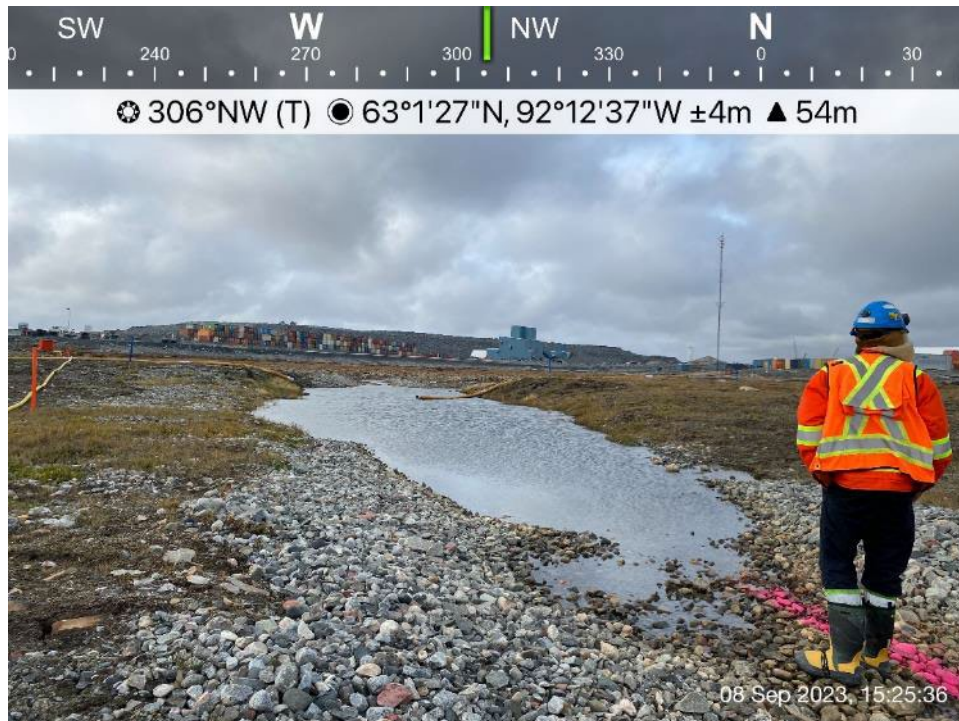
Channel 5 - Photo 13: Channel 5 - Upper section of Channel 5, significant subsidence and cracking along slopes with riprap settled below water level in channel.

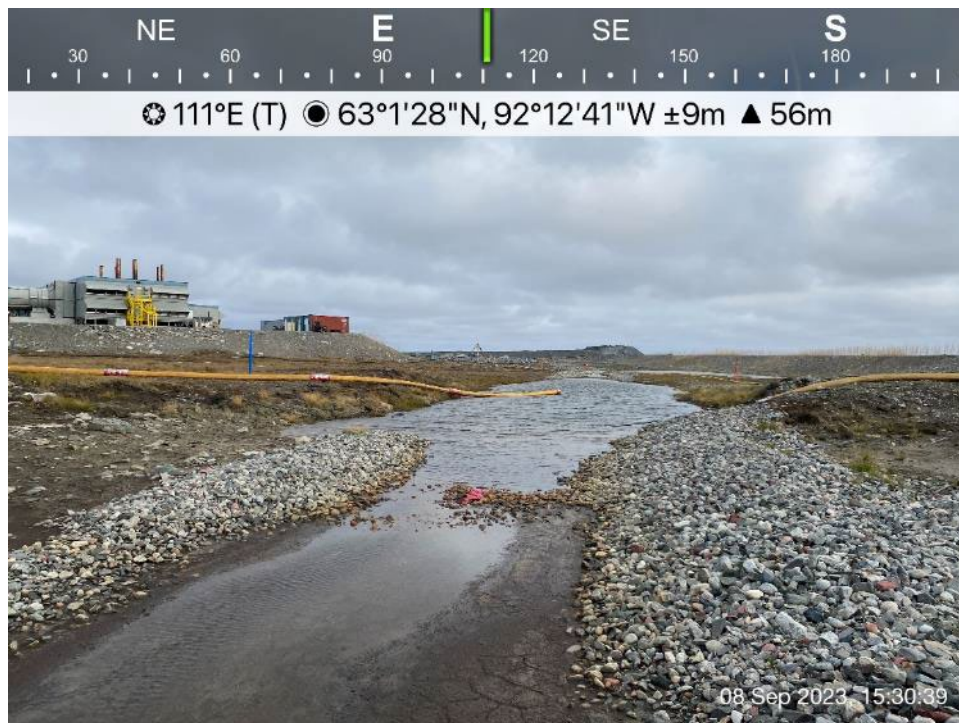
Channel 5 - Photo 14: Channel 5 - Upper section of Channel 5, significant subsidence and cracking along slopes with riprap settled below water level in channel, filled with sedimentation from surface erosion.

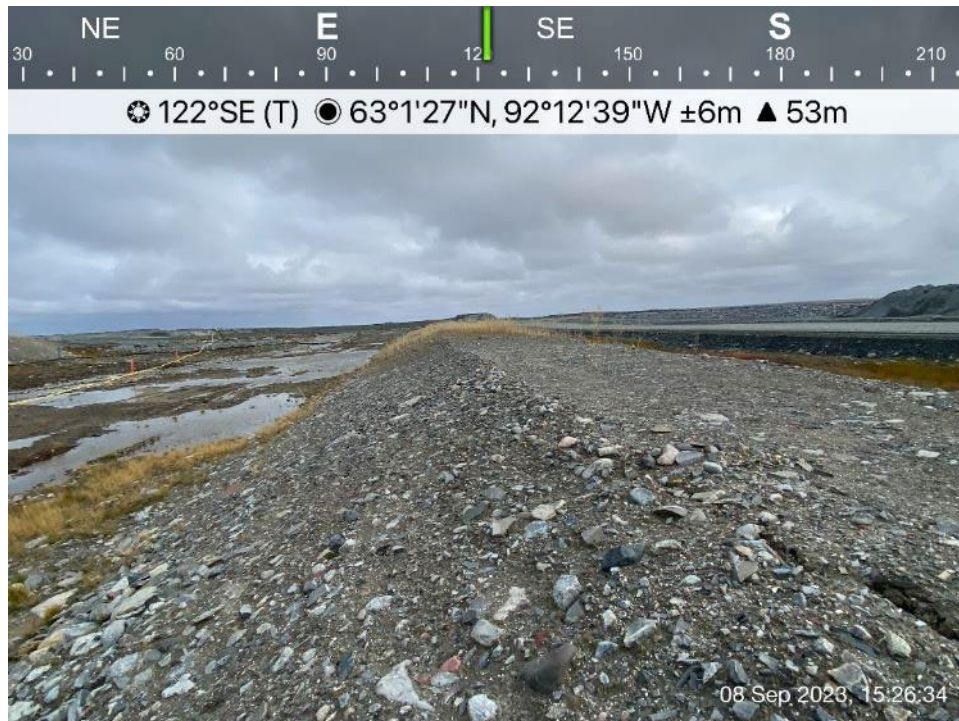
Berm 3 - Photo 17:

Berm 3 - Upstream side slope, cracking observed along the crest.

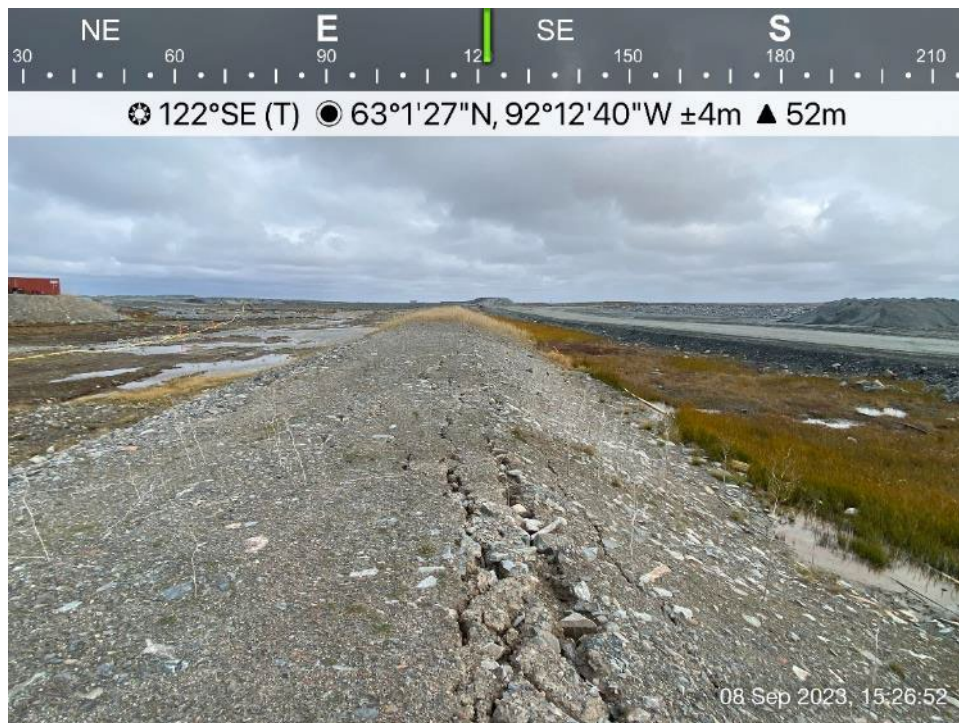
Berm 3 - Photo 18:

Berm 3 - Downstream side slope, cracking observed along the crest.
