APPENDIX 6 2023 ANNUAL GEOTECHNICAL INSPECTION REPORT

2023 Annual Geotechnical Inspection Meliadine Gold Mine, Nunavut, Canada

PRESENTED TO
Agnico Eagle Mines Limited

JANUARY 31, 2024
ISSUED FOR USE
FILE: 704-ENG.EARC03140-33
AGNICO EAGLE DOCUMENT NUMBER: 65-600-230-TCR-001

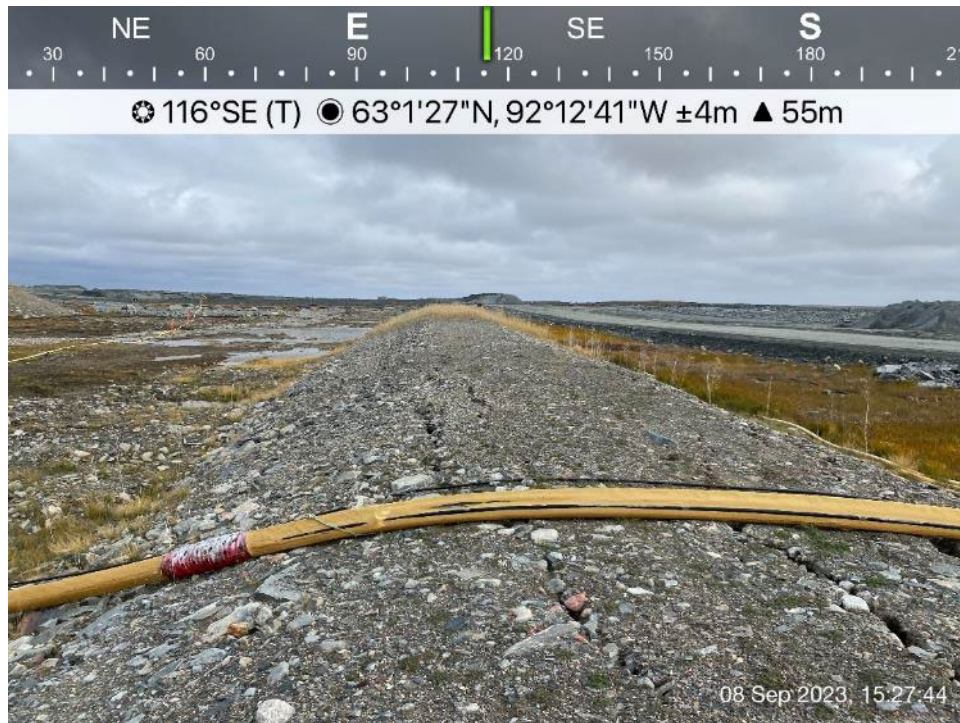
Berm 3 - Photo 19: Berm 3 - Berm crest, cracking observed along the crest.

- It is recommended to continue to monitor subsidence at the base of Channels 1, 2, and 7 to determine if they impact the channels' performance.
- It is recommended that the northern half of Channel 5 be reconstructed to the design grade and elevation. If practical, the base of the channel should be over excavated and backfilled with rockfill material to accommodate potential thaw subsidence after the reconstruction. The base of the southern half of the channel should be regraded to promote water flow and reduce further subsidence due to the water ponding.
- Minor erosion was observed during the inspection of Berm 3 as its cover materials are susceptible to erosion. Erosion of the slopes should be monitored, and consideration should be given to placing coarser material on Berm 3 to reduce the potential for erosion if it becomes substantial.

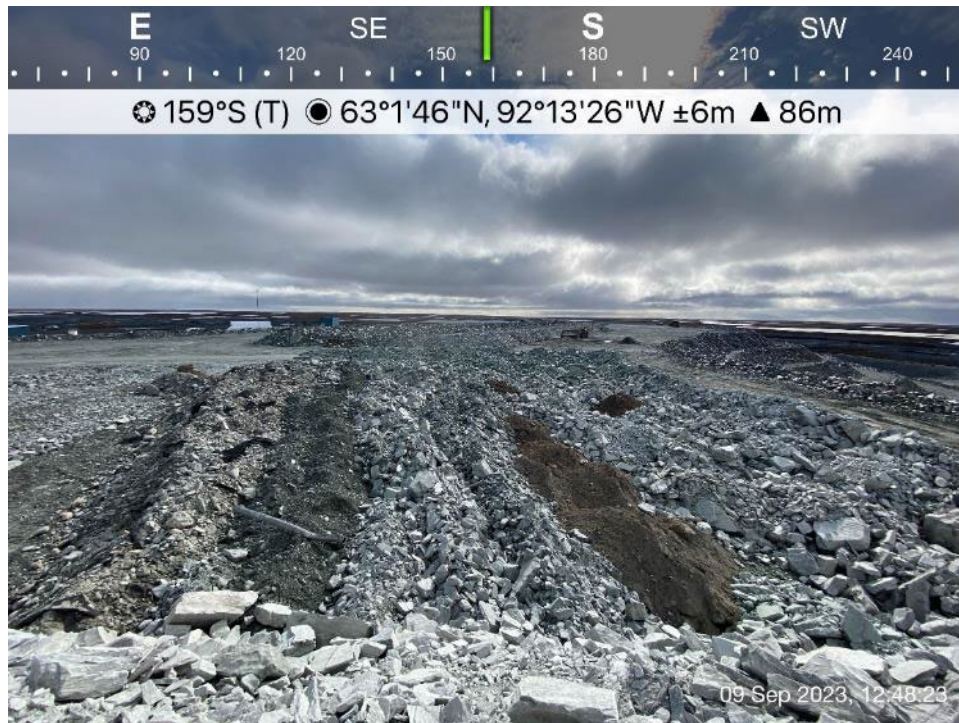
WRSF1 - Photo 5: WRSF1 - Free dumps observed on bench 97 m, looking south.

Material placement on the pile is generally executed according to the WRSF1 design. No significant geotechnical issues were observed. Till and rock mixed free dumps were observed on the 97 m bench. It is recommended that the free dumps be spread and compacted to avoid settlement and cracking. New waste material should be placed as per the construction protocol established in the Operation Management and Surveillance (OMS) manual. The performance of the facility should continue to be monitored on an ongoing basis as outlined in the OMS Manual.

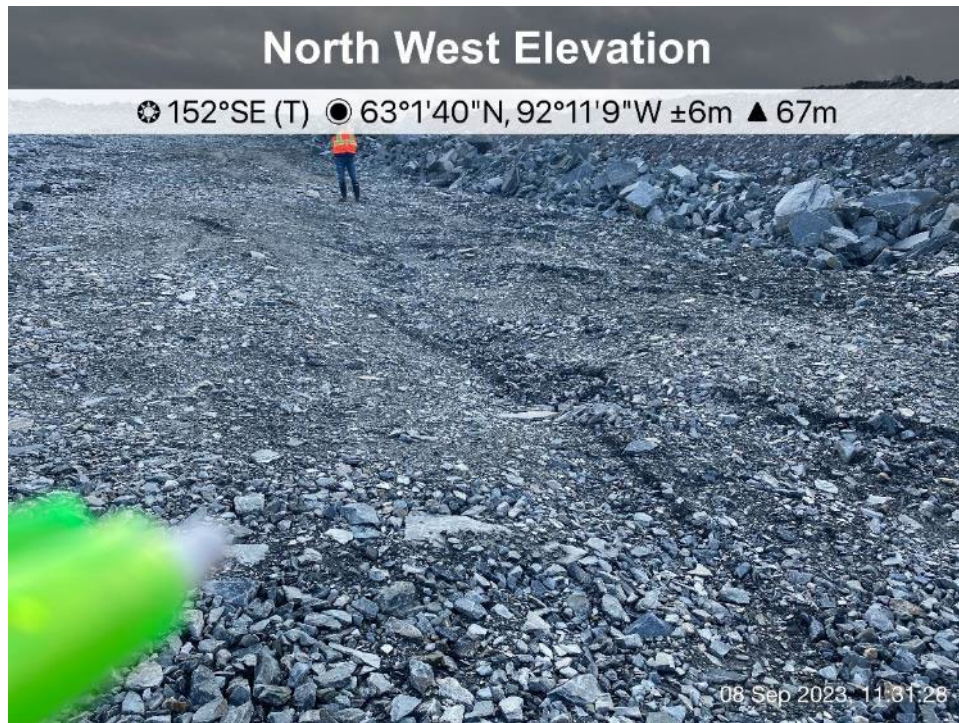
WRSF3- Photo 1: WRSF 3 - settlement observed on Bench 72 m.

- The area of depression and cracks observed on Bench 72 m be filled with waste rock and traffic compaction applied.
- The ponded water observed at the southwest corner of WRSF3 should be pumped out regularly during the mine operation or consideration be given to construct a channel and sump if possible within the lease boundary to divert/collect runoff water and prevent any potential for permafrost degradation at the WRSF3 toe.
- Waste material placement should continue to follow the construction protocol established in the OMS manual.
- The performance of WRSF3 should continue to be monitored on an ongoing basis as outlined in the OMS Manual.

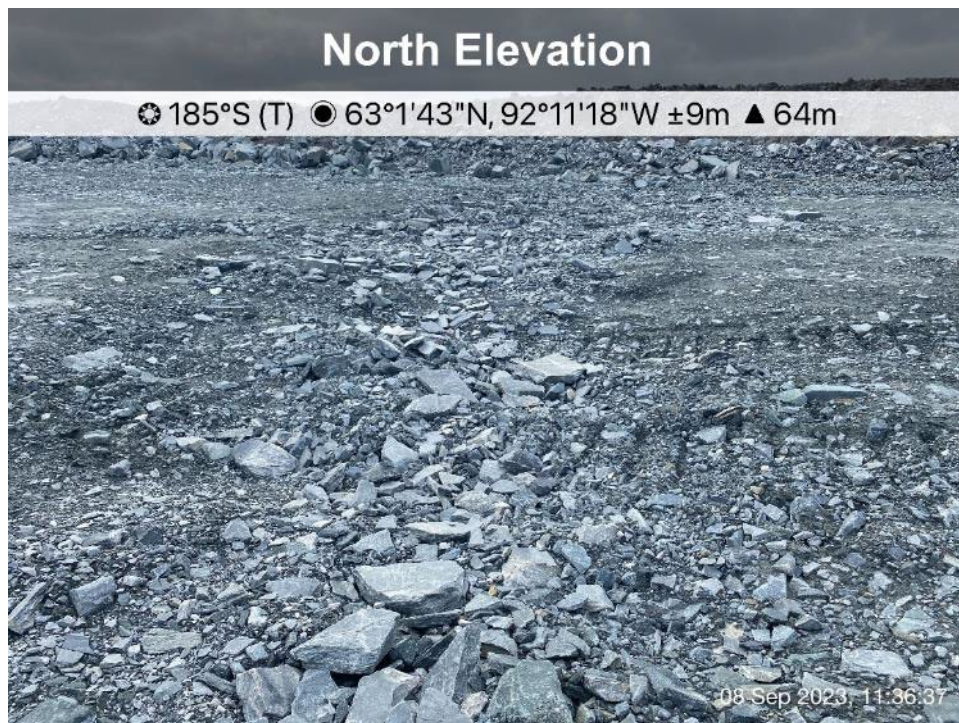
WRSF3- Photo 2: WRSF 3 - depression area observed on Bench 72 m.

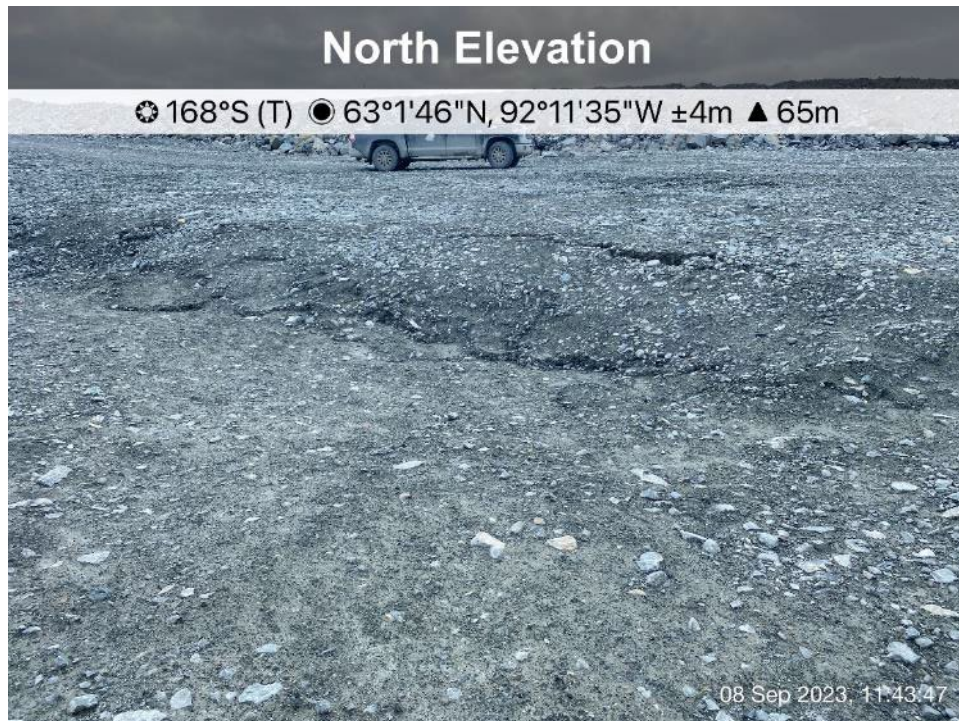
WRSF3- Photo 5: WRSF 3 - settlement and cracking observed on Bench 72 m.

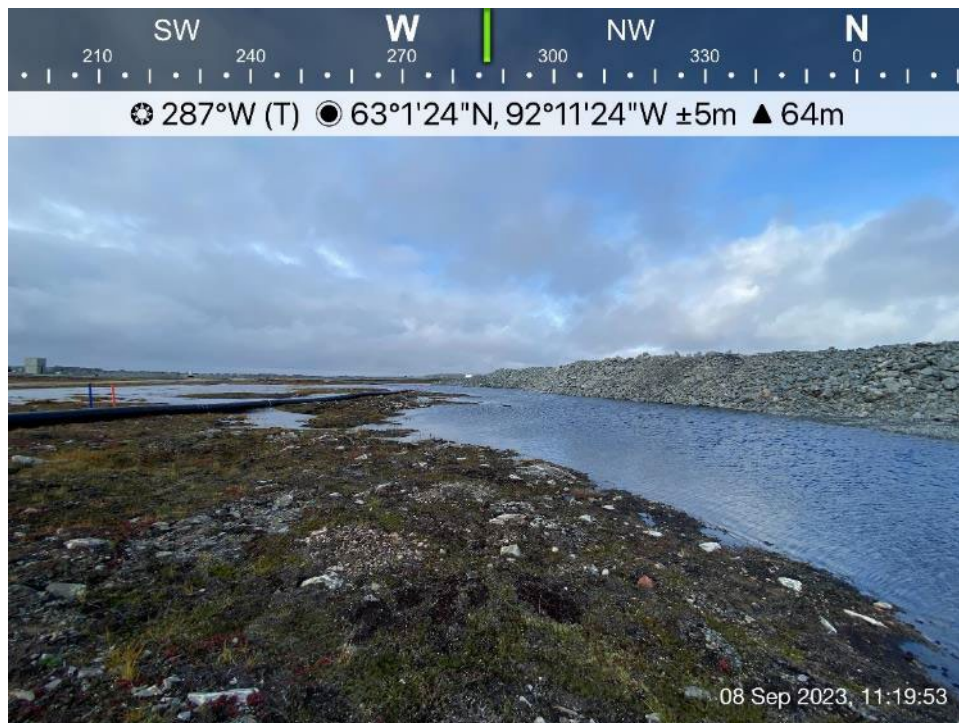
WRSF3- Photo 6: WRSF3 - Ponded water observed at southwest corner of WRSF3, looking west.

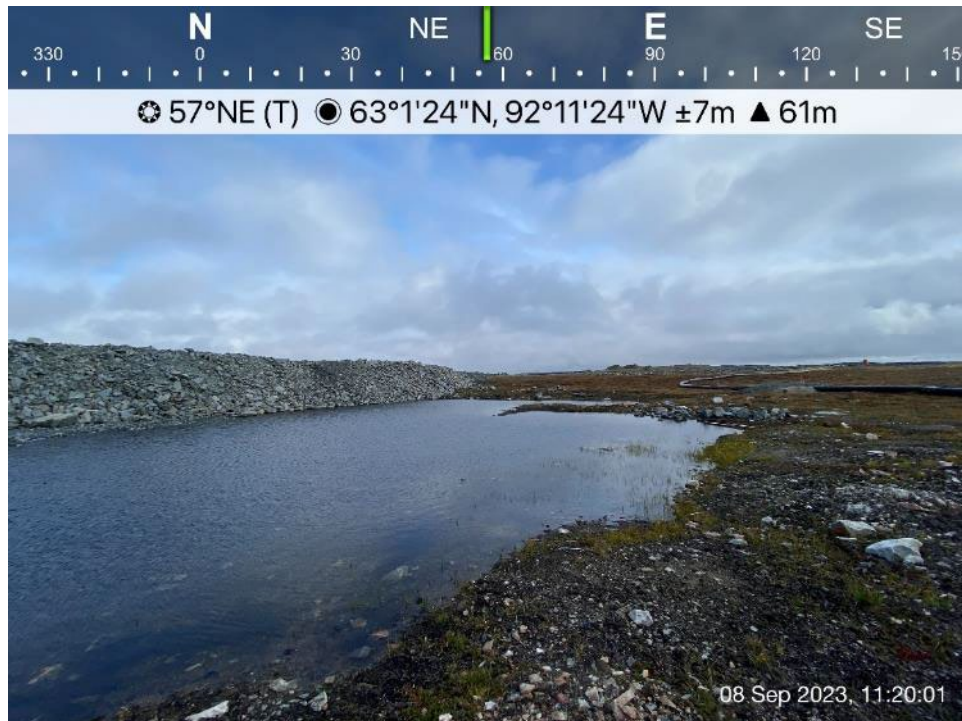
WRSF3- Photo 7: WRSF3 - Poned water observed at southwest corner of WRSF3, looking northeast.

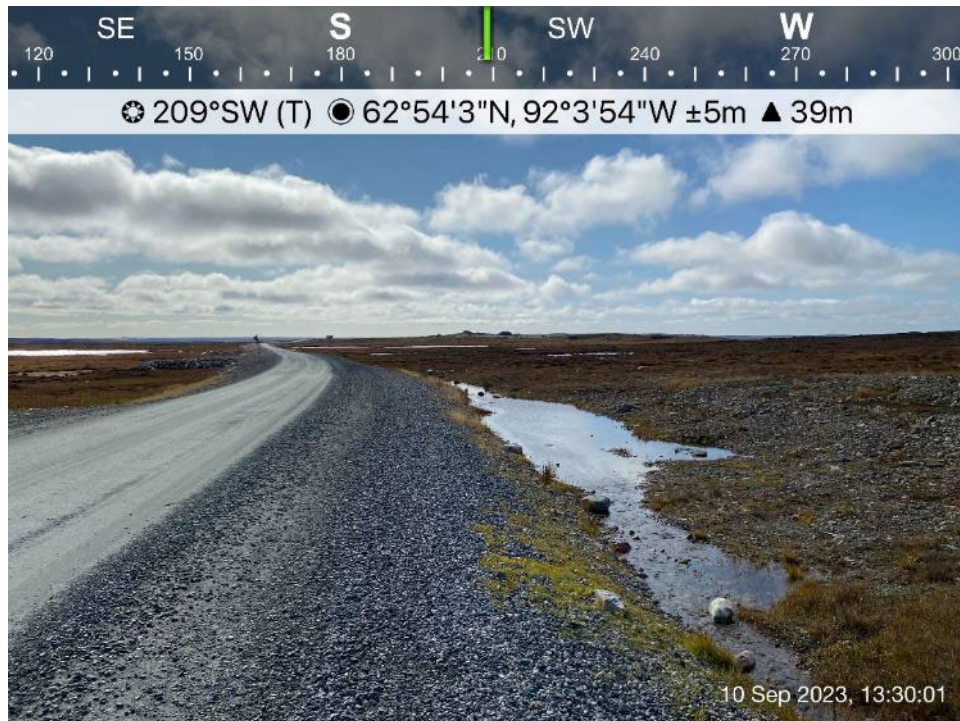
AWAR Road/Culvert - Photo 33: KM 12.6 - No culvert installed, poor drainage condition, no sign of water flow.

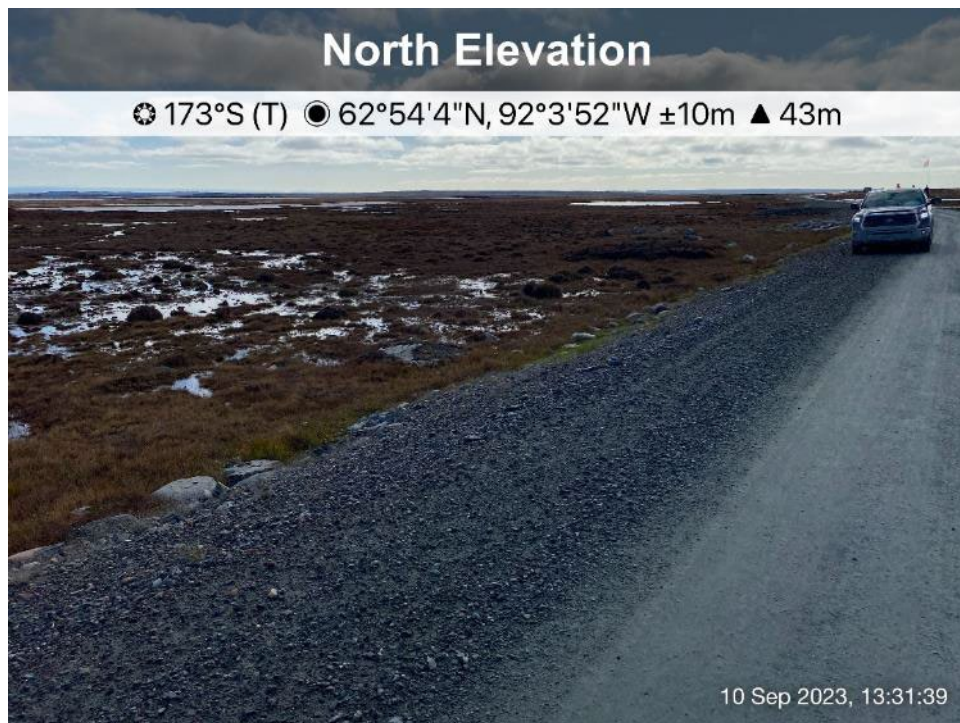
AWAR Road/Culvert - Photo 34: KM 12.6 - No culvert installed, poor drainage condition, no sign of water flow.

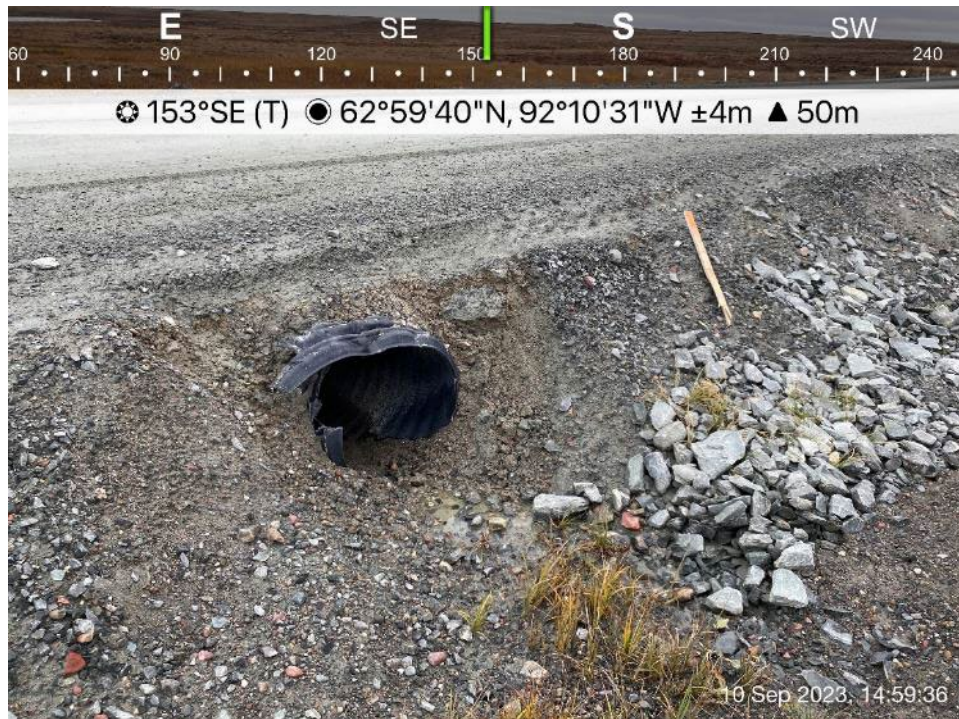
AWAR Road/Culvert - Photo 57: Culvert KM 25.8 - HDPE corrugated culvert - sign of deformation observed.

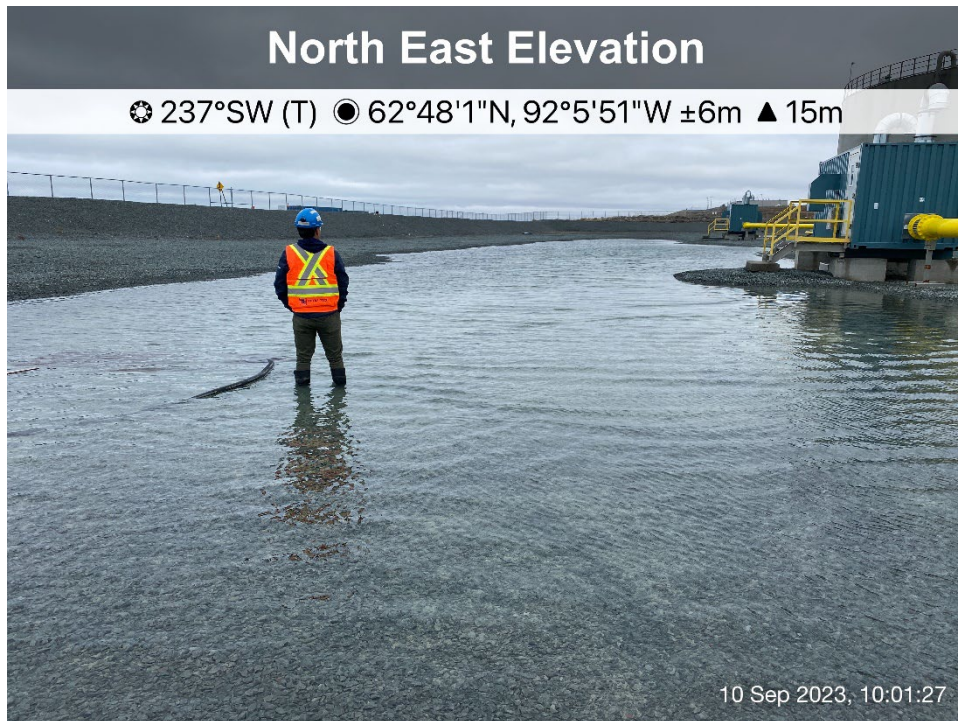
Itivia Fuel Tankfarm - Photo 56:

Ponded water observed in Tankfarm
