APPENDIX 14 2023 REPORTABLE SPILLS

Re: Follow-up Report Spill #2023-009 – Release of 5 L of Sewage at the Meliadine Gold Project

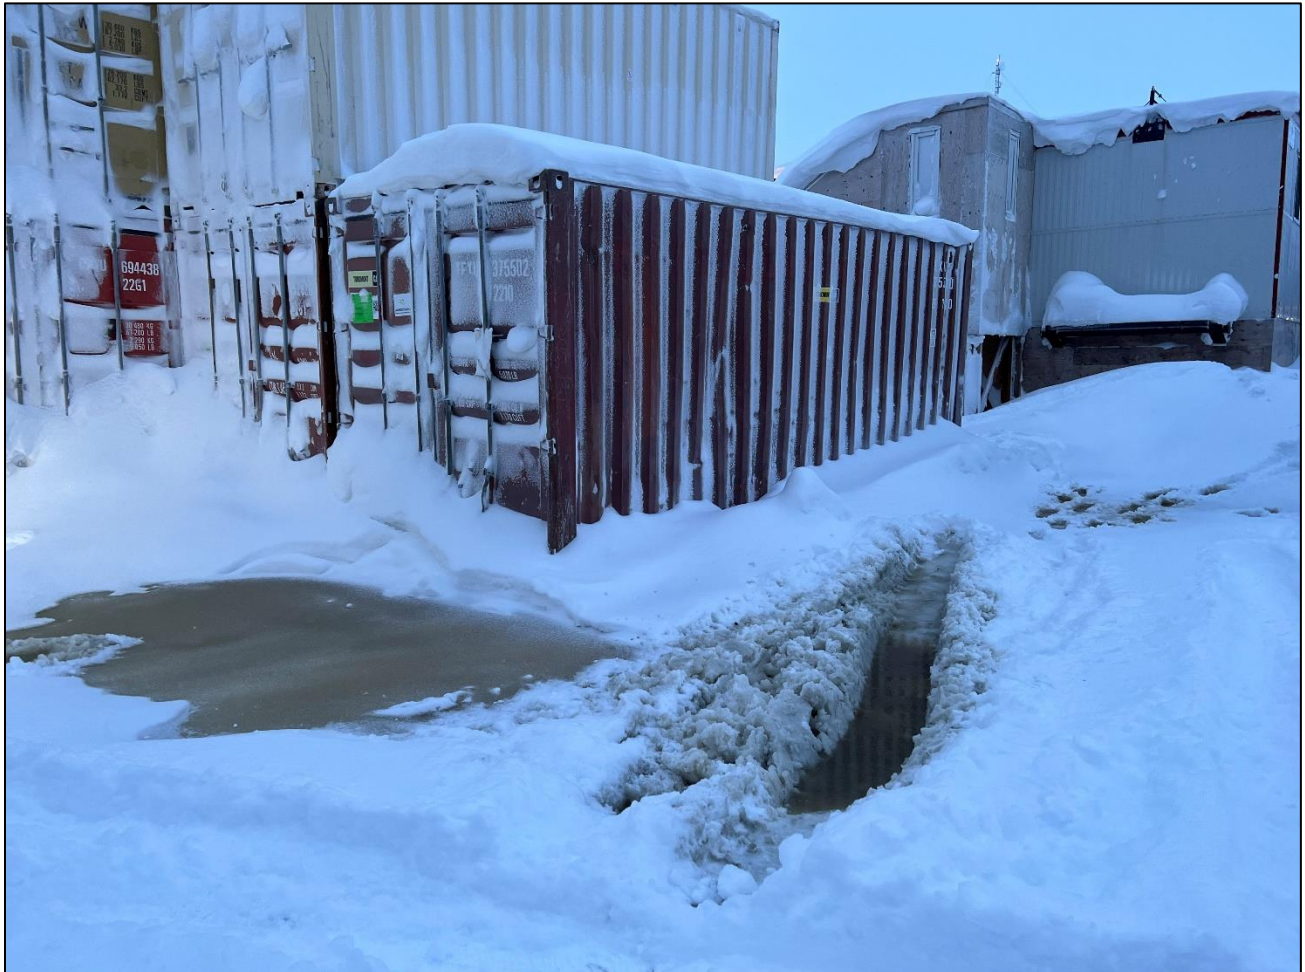
- The float detection system failed, resulting in the overflow.

Photo 1: Sewage spill location.

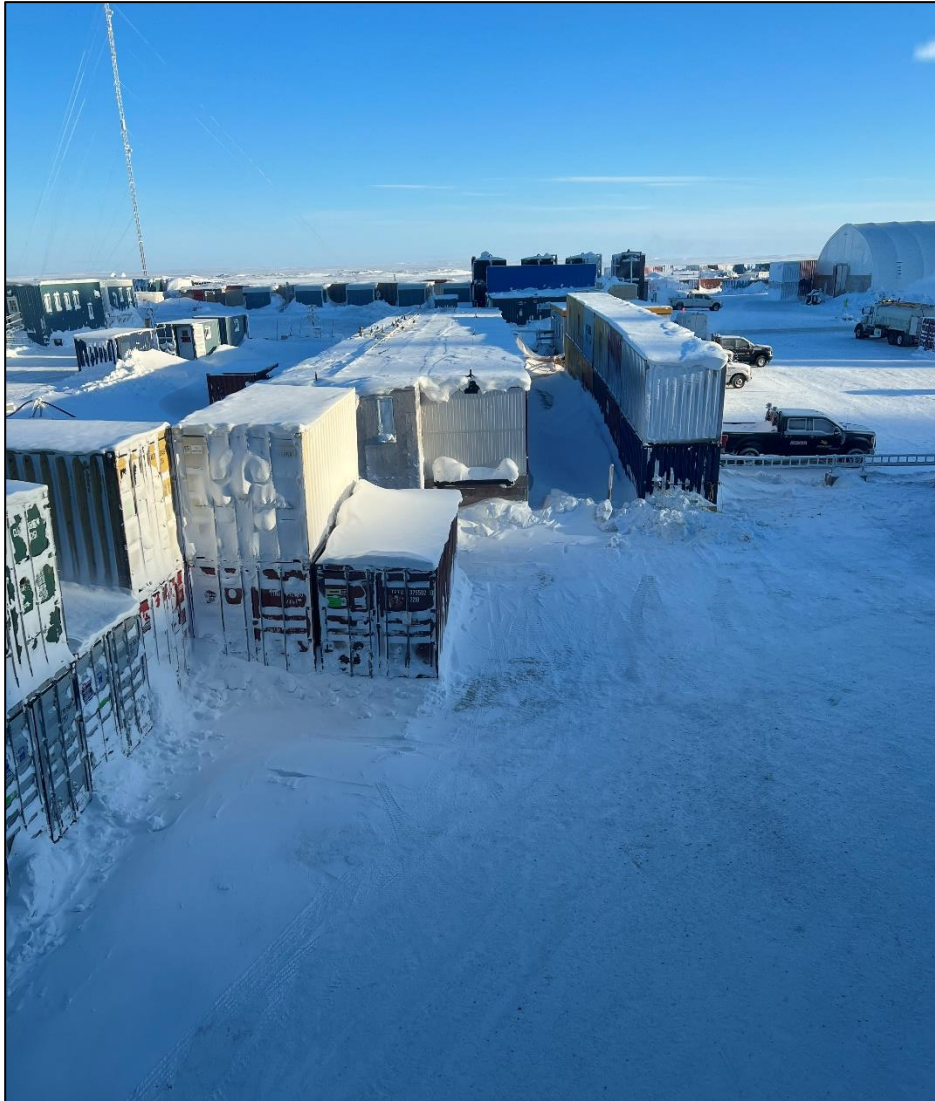
Photo 2: Sewage spill post remediation.

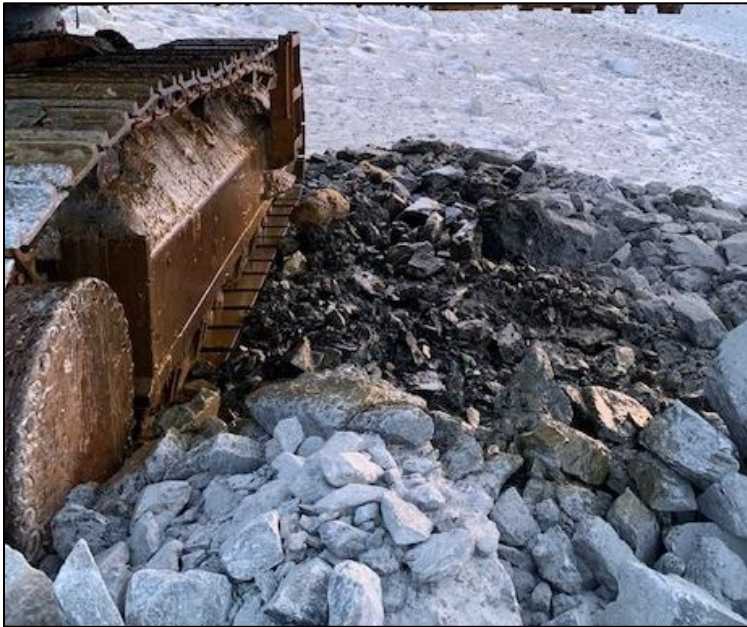
- Extreme temperatures placed additional stress on the hydraulic system causing a system failure.
- Preventive maintenance inspection of the Hydraulic pump compartment and associated equipment was not included in the preventative schedule

Photo 1: Hydraulic oil spill area.

- Frost fighter will be used on hydraulic compartment when starting up in cold temperatures.
- Preventive maintenance schedule has been updated to include visual inspection of the hydraulic pump compartment and associated equipment every 1000 hours.

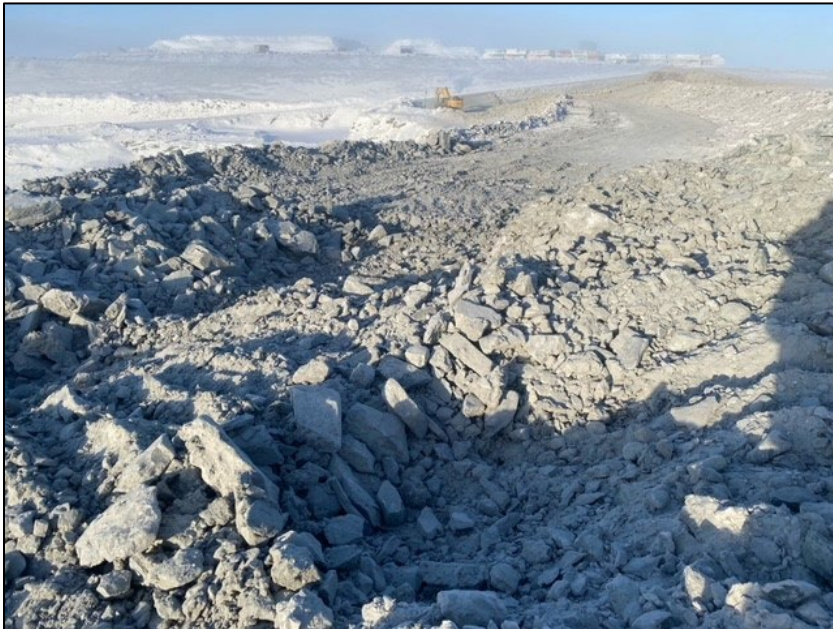
Photo 2: Hydraulic oil spill remediated.

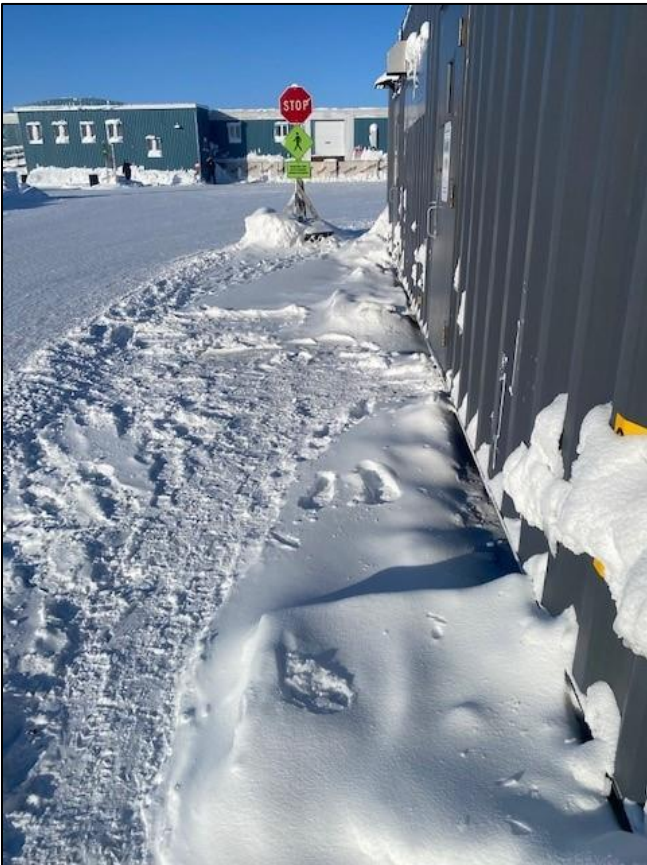
Photo 3: Spill remediation area.

- A PM schedule to be created for monthly inspection of the chemical distribution lines within the STP.
- Plug to be installed in the STP floor where a hole was present.
- A centralized caustic distribution system with a single tank to feed the STP will replace the existing three tanks.
- Valves will be locked out at the bottom of the tank and feed from 20 L pails or top feed from the tank when needed. This is a temporary measure until the central feed tank is installed.

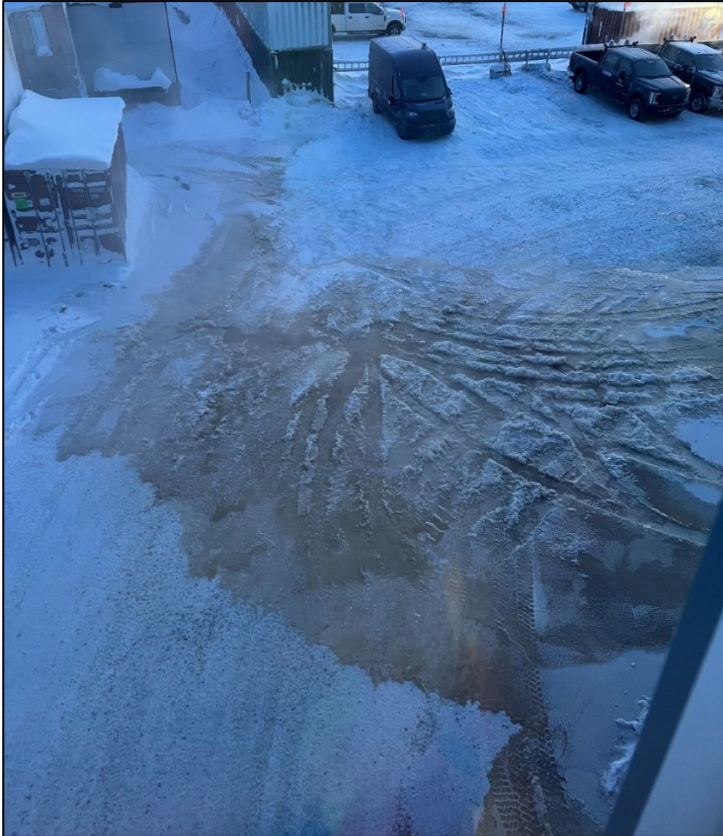
- The float level detection system failed, resulting in the overflow.

Photo 1: Sewage spill location.

- Installation of individual spill containment at wing lift stations – completed.
- Replacing pump blades at lift stations – completed.
- Development of reliability tracking tools to identify the cause of failure and improve response time – completed.
- Upgrades to lift station instrumentation to provide early warning of potential spills – in progress.
- Adding remote IO (input/output) panels to monitor each wing lift stations for faults – in progress.

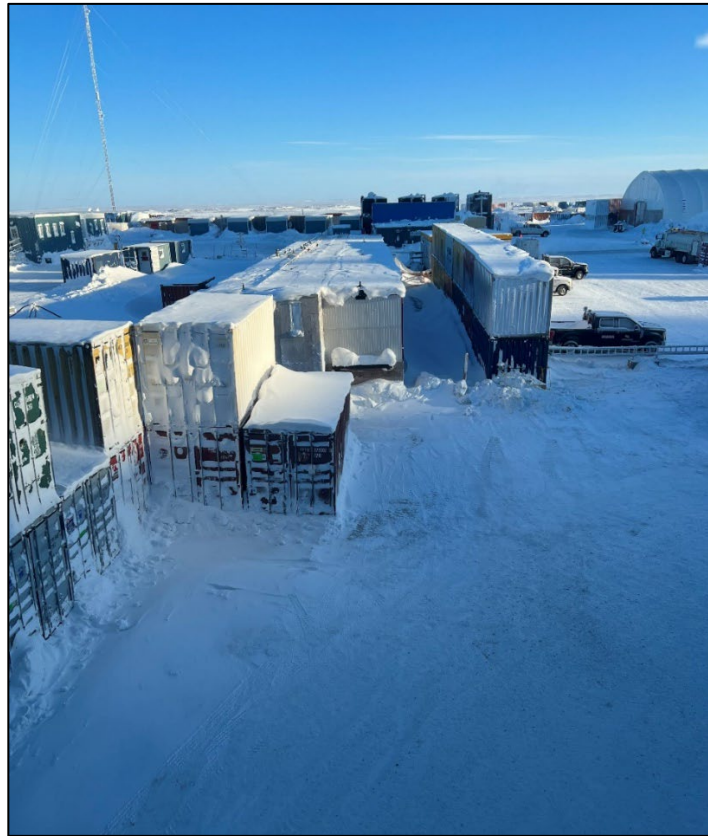
Photo 2: Sewage spill post remediation.

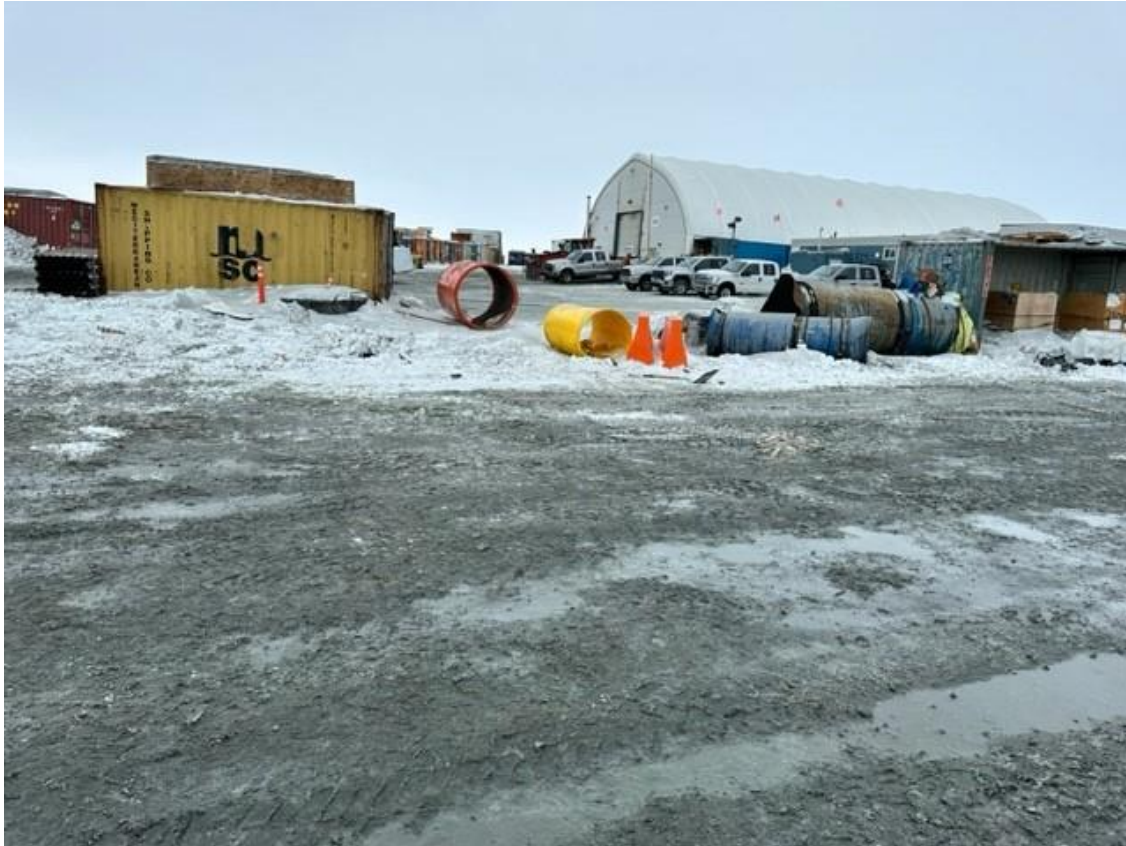
Photo 1: Post cleanup area

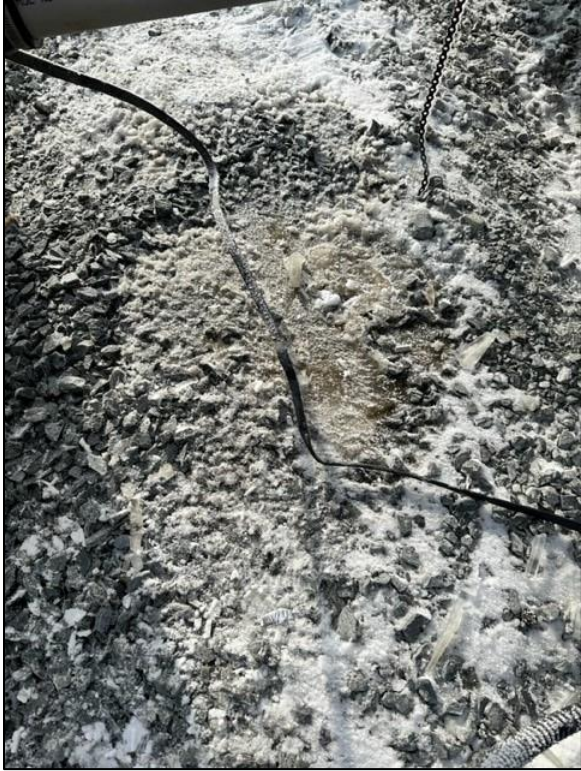
On May 4th, 2023, at approximately 23:00, an estimated 10 L of sewage was spilled onto the fusion pad by the fusion pad wash car due to a fracture in the sewage line. No water bodies were impacted by this spill. The closest water body (J6) is approximately 108 meters south, as seen in Figure 1.

Photos 1: Sewage spill location.

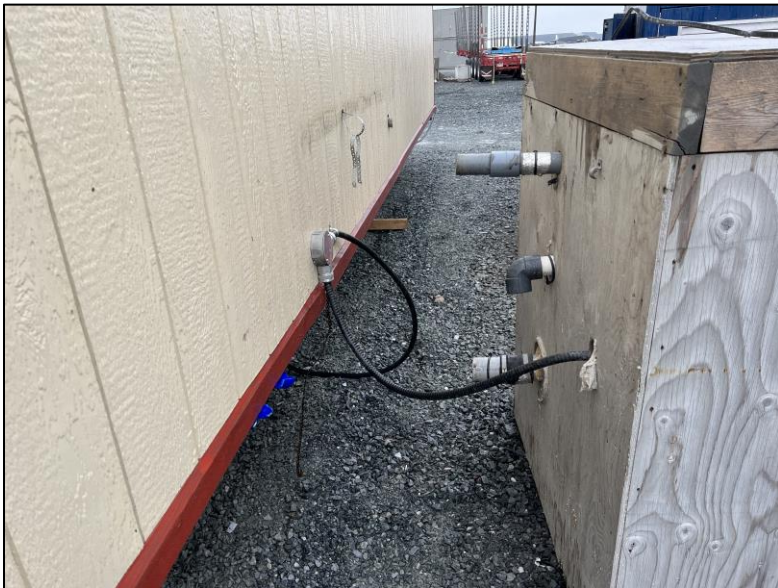
Photos 2: Spill location post remediation.

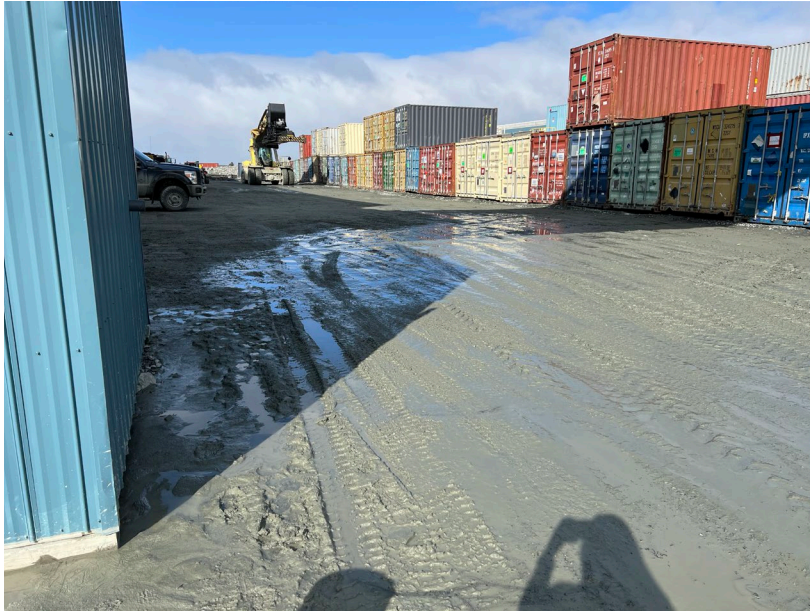
Photos 1: Sewage spill location.

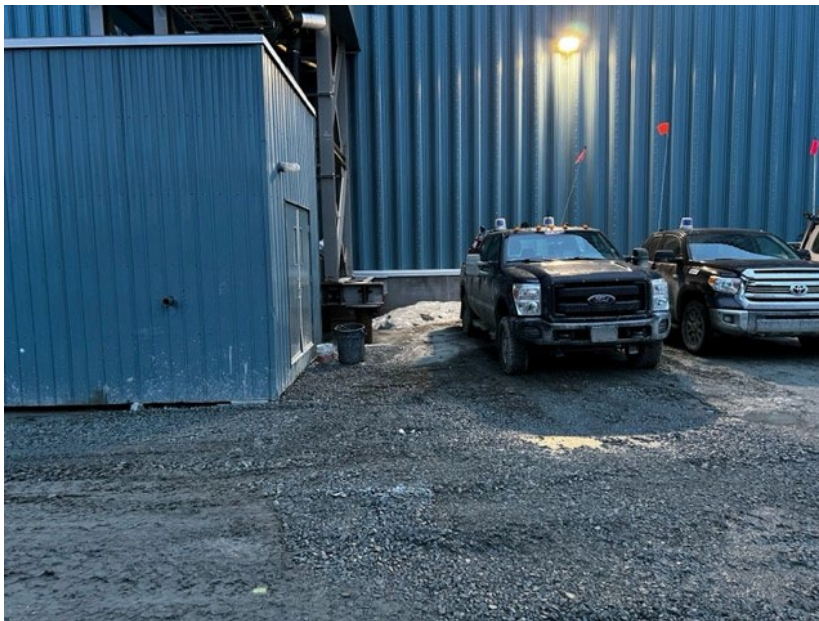
Photos 2: Spill location post remediation.

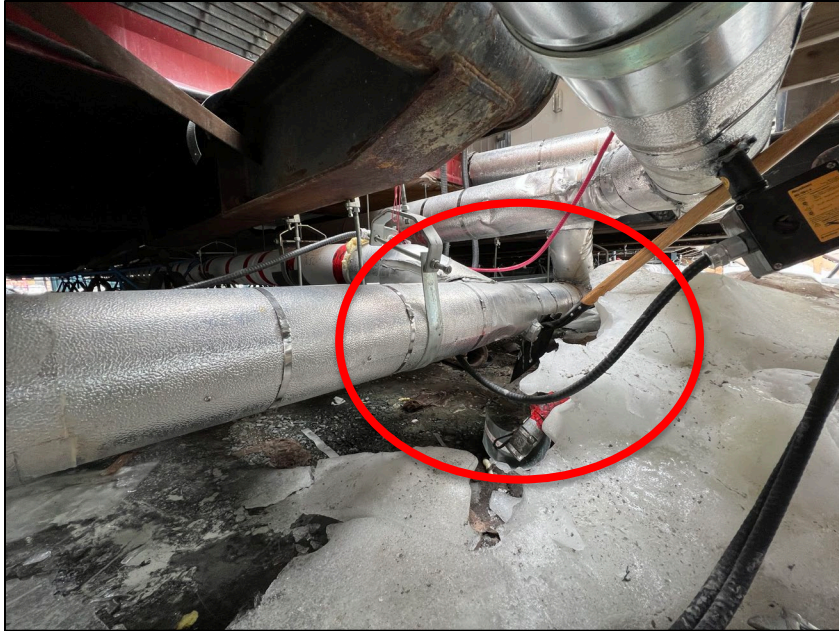
Photo 1: Grey water spill location and source.

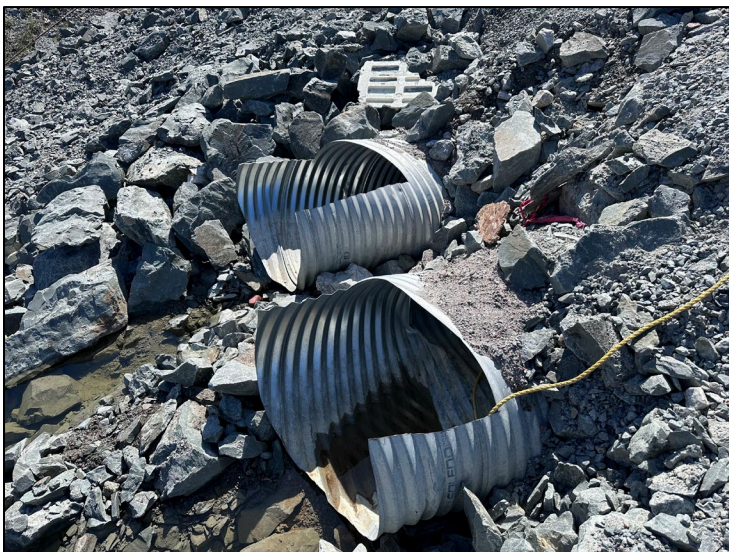
Photo 3 – Temporary repair to the culvert inlets.

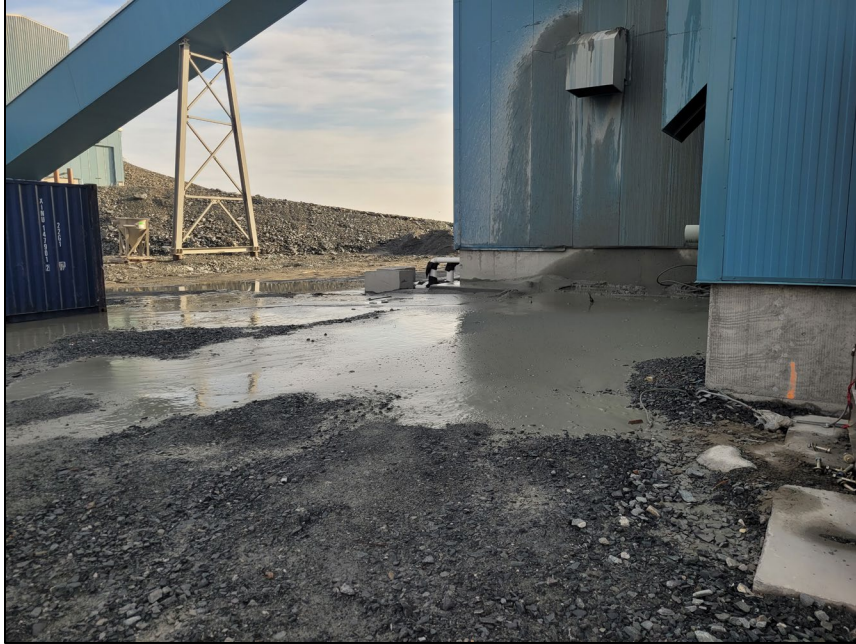
Photo 1: Spill location.

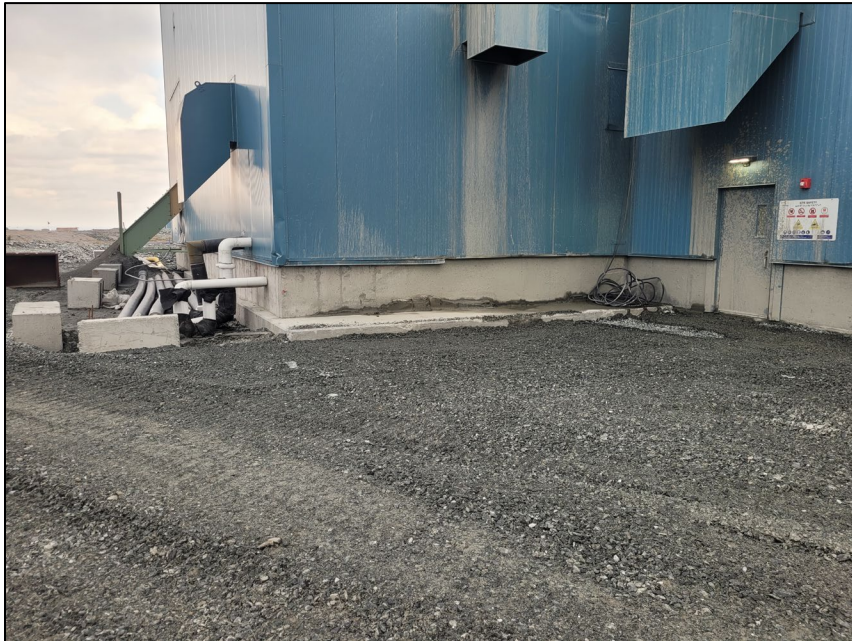
Photo 2: Post spill clean-up.

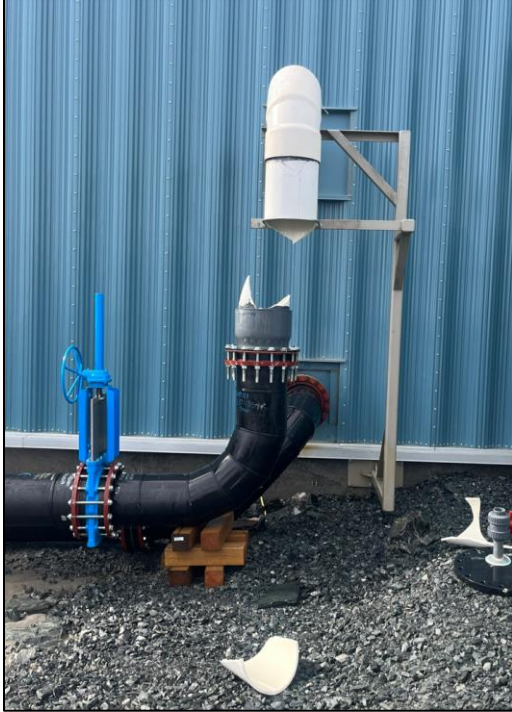
Photo 1: Broken segment of PVC pipe, facing southwest.

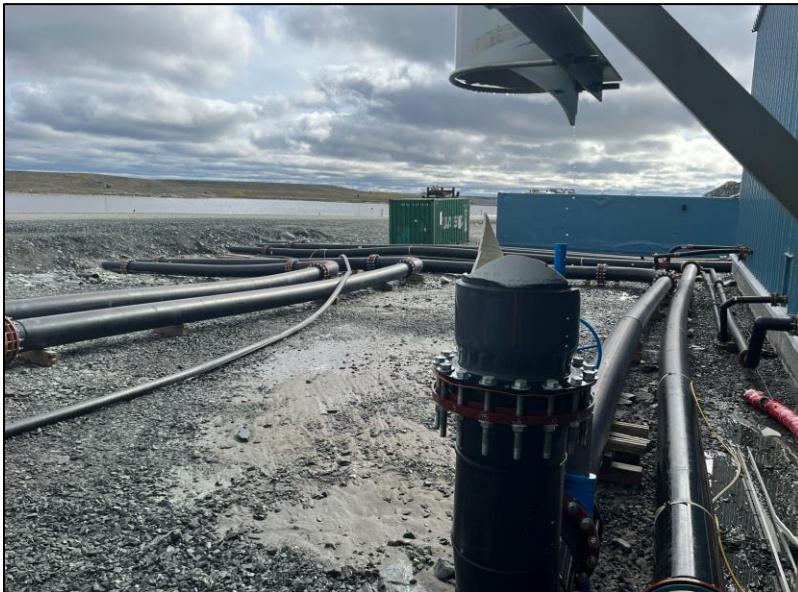
Photo 2: Broken segment of PVC pipe, facing southeast.

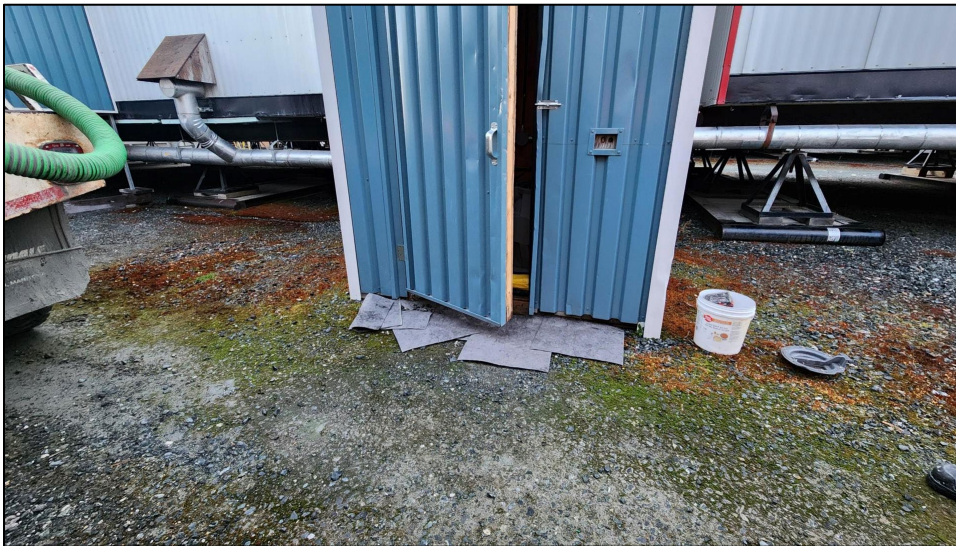
Photo 2: Sewage spill remediation.

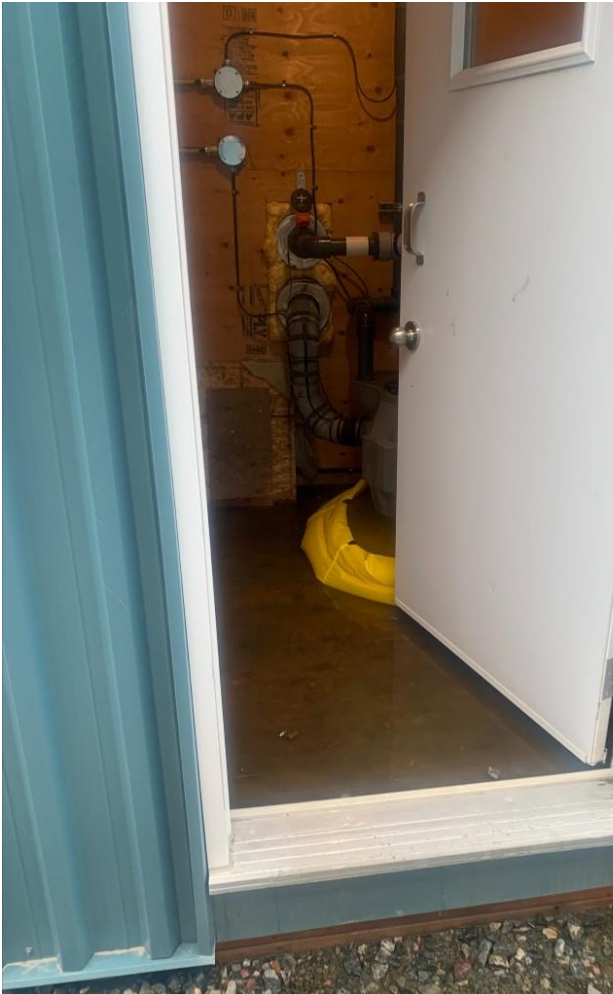
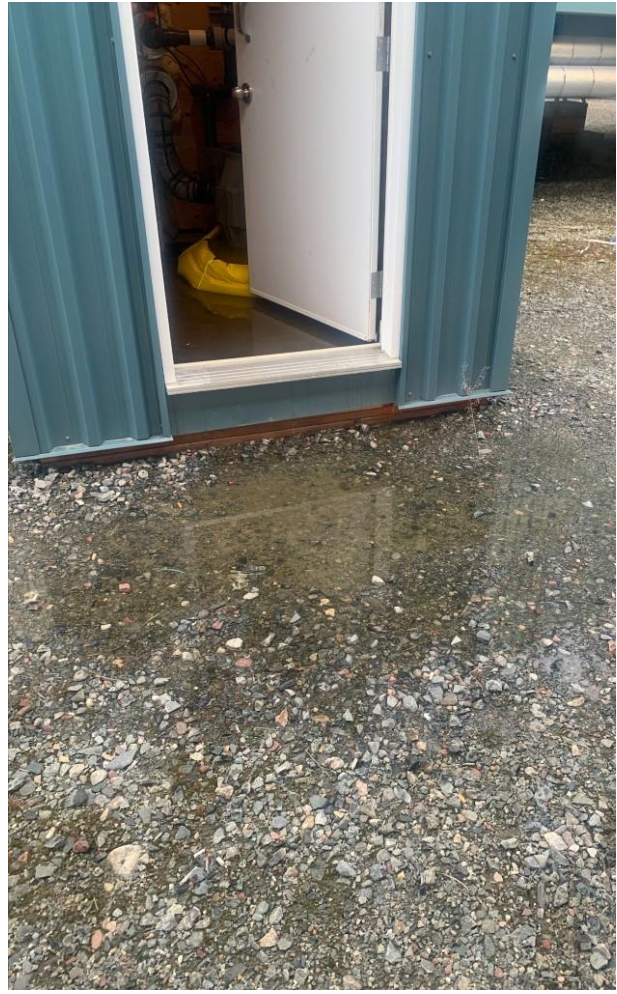
Photos 1 and 2: Sewage spill location.

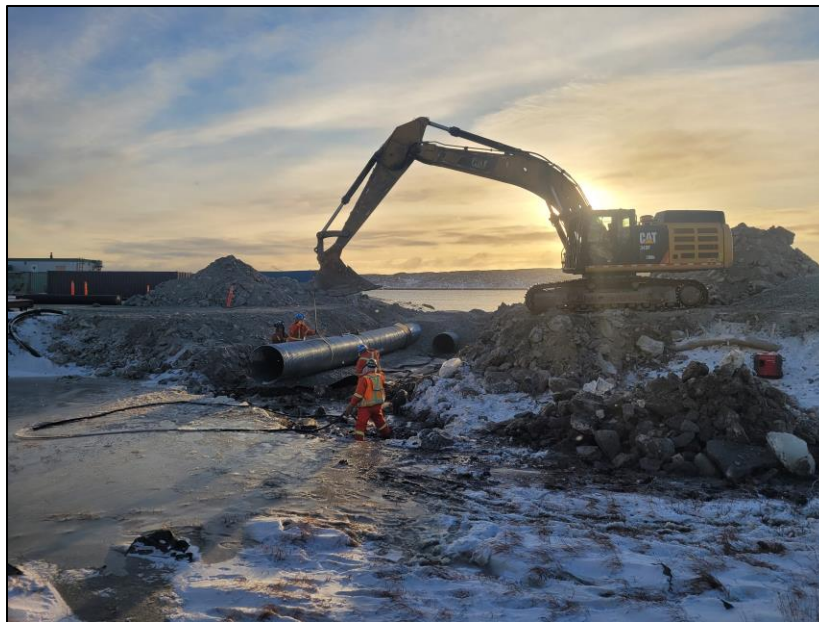
Figure 2: Dewatering of excavated area upstream of new Itivia culverts.

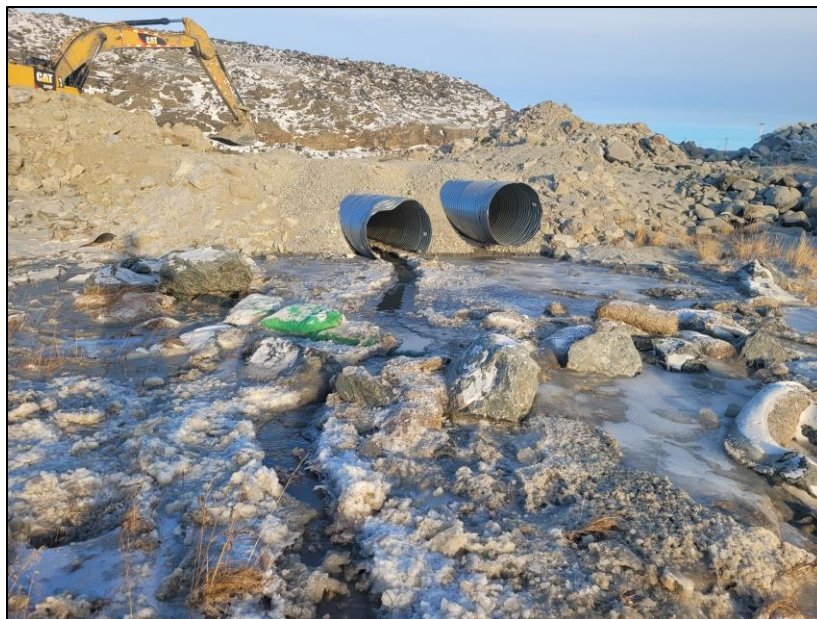
Figure 3: Discharge of pump dewatering downstream of Itivia culverts.

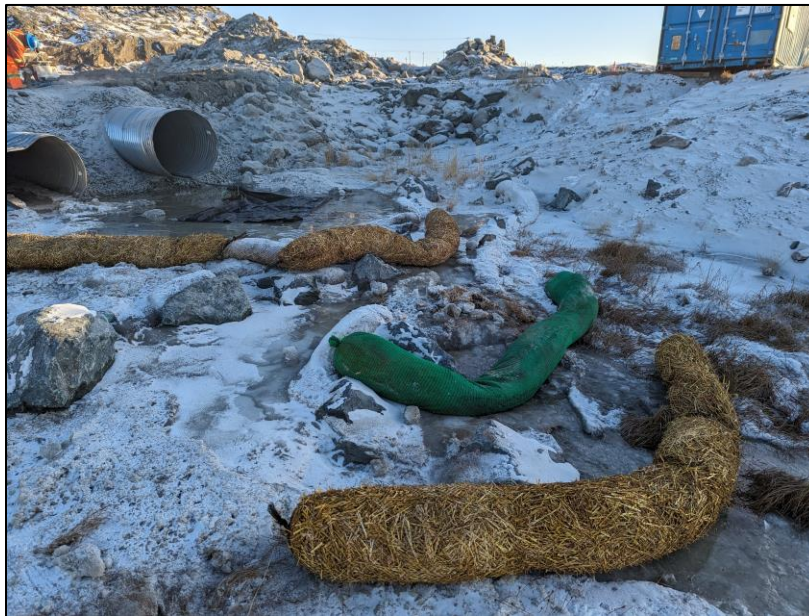
Figure 4: Sediment dewatering bag and straw/wood chip wattles installed downstream.
