## **Appendix 15**

### **Meadowbank and Whale Tail MDRB Report No 31**

Report No 31  
Meadowbank Mine Dike Review Board (MDRB)  
Site visit August 16<sup>th</sup> to 18<sup>th</sup>, and Montreal meeting December 6<sup>th</sup> and 7<sup>th</sup>, 2023.

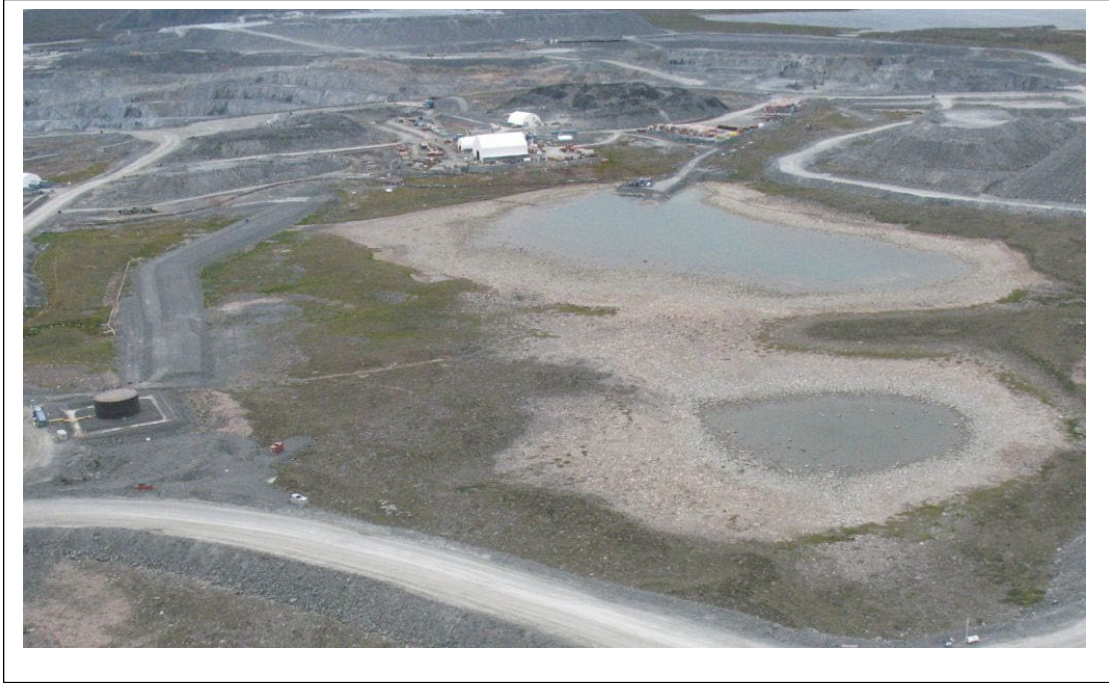
The IVR Dike status is stable with little or no observable additional settlement of the crest. Some surficial slope movement, potentially related to local permafrost degradation has however been noted.

Photo #1 IVR Dike. Note low U/S pond level.

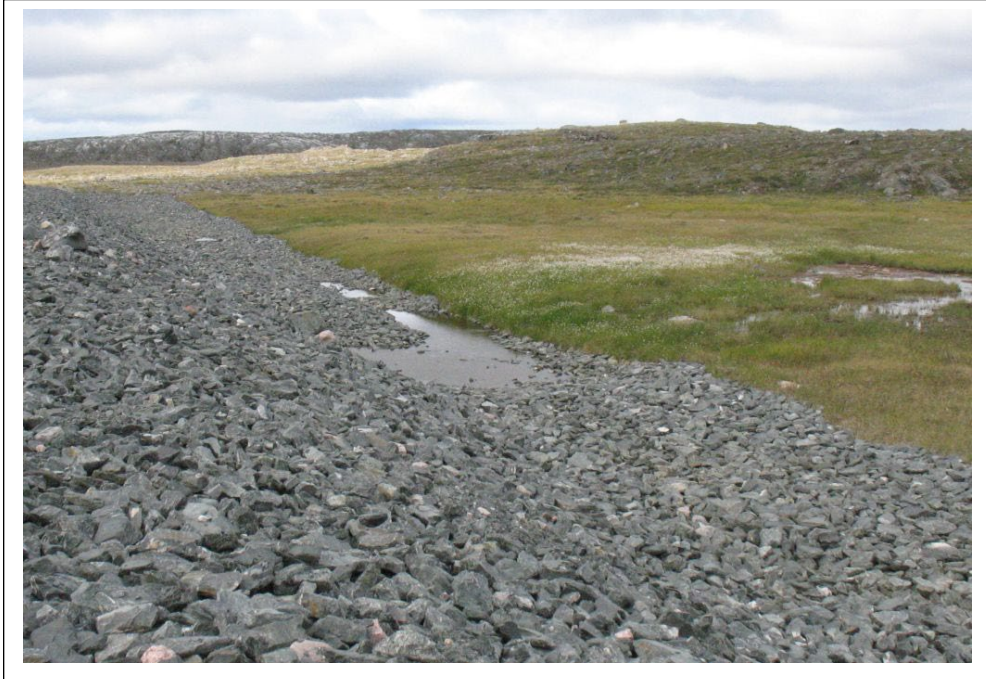
The IVR Ditch functions as intended, however there may still be potential for permafrost degradation induced settlement of the ditch invert.

Photo #3 IVR Diversion Ditch. Localized thaw settlement.

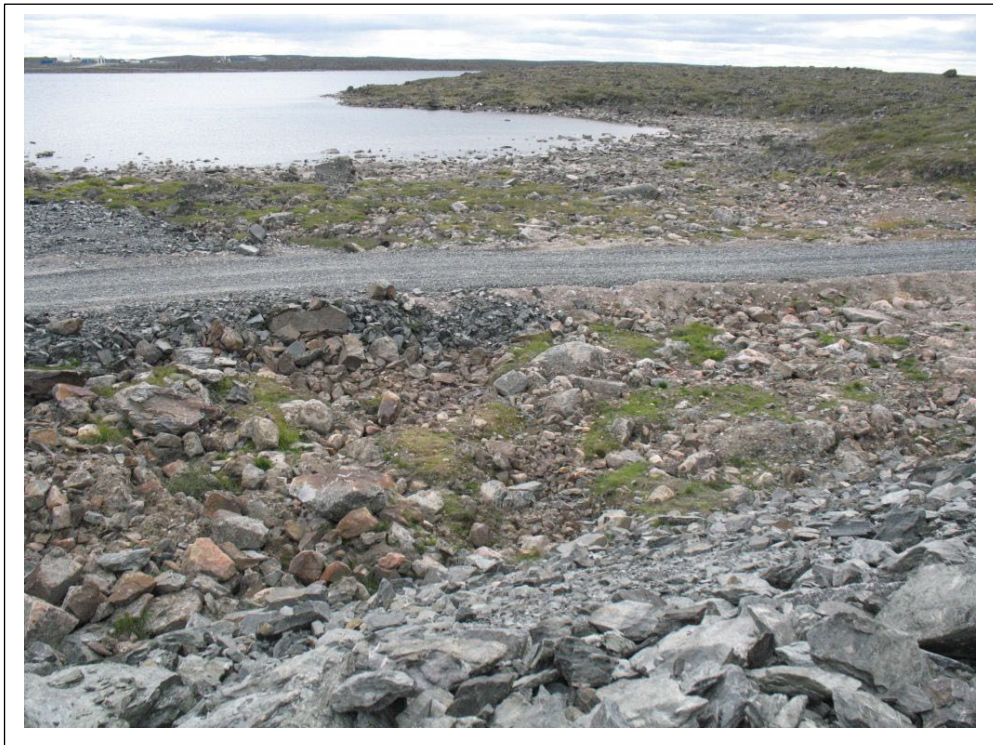
Satisfactory performance is noted for the Waste Rock Storage Facility Dike. This is a structure that merits attention (inspection frequency) as a function of the accumulation of water during freshet and any evolution in behaviour.

Photo #4 WRSF Dike. D/S area.

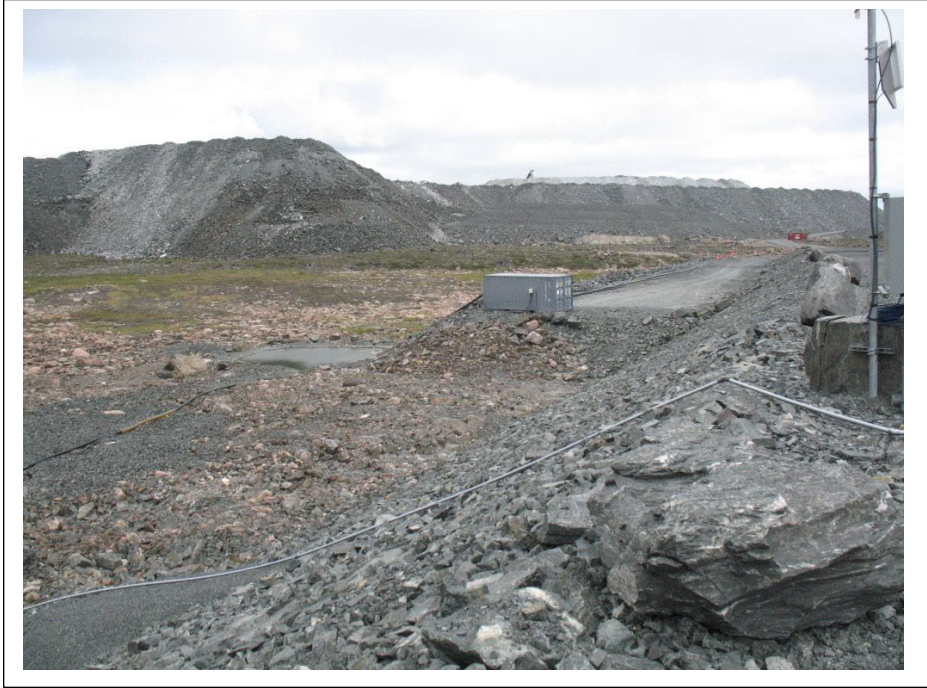
Photo #5 WRSF Dike. U/S area, little or no ponded water at time of visit.

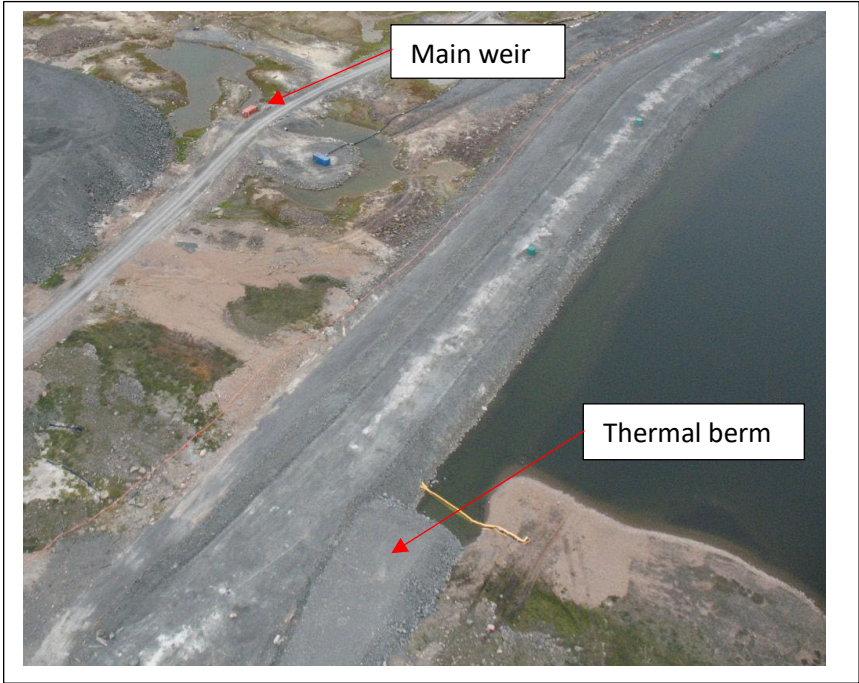
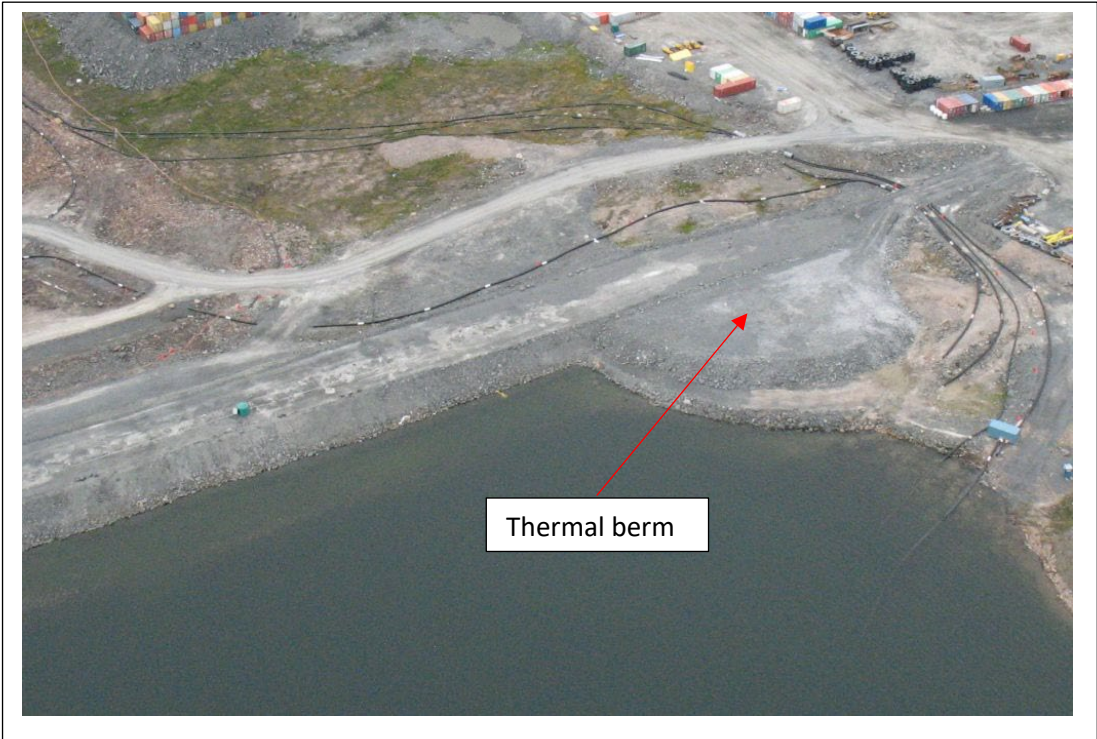
Improvements have been made to the Whale Tail Dike, an important component of water management at the site. Thermal berms have been added to the west and east abutments (Photos #7 and #8) on the lake side to encourage regeneration of frozen ground as this contributes to upstream slope stability and maintaining the seepage control measures of the Dike. Following poor drainage performance at the toe of the Dike during freshet 2023, the toe access road has been raised and reprofiled, the seepage collection trench has been remediated, and a SeaCan shelter has been added to the main weir for seepage monitoring. A piezometer installed in the culvert (Photo #9) enables continuous recording of flow rates for the collected seepage. However, given the significant run-off catchment area downstream of the dike, visual observation of conditions and rainfall/temperature measurements are required for interpretation of the measurements. Ice accumulation could also affect the piezometer readings but access to the weir is improved by the shelter. The current system provides a somewhat accurate means of documenting total seepage through the Dike (during low precipitation periods), however it is more suitable to identifying significant changes in the seepage rates that may be indicative of a problem with the Dike.

Photo #7 Whale Tail Dike west abutment area.

Photo #8 Whale Tail Dike, east abutment area.

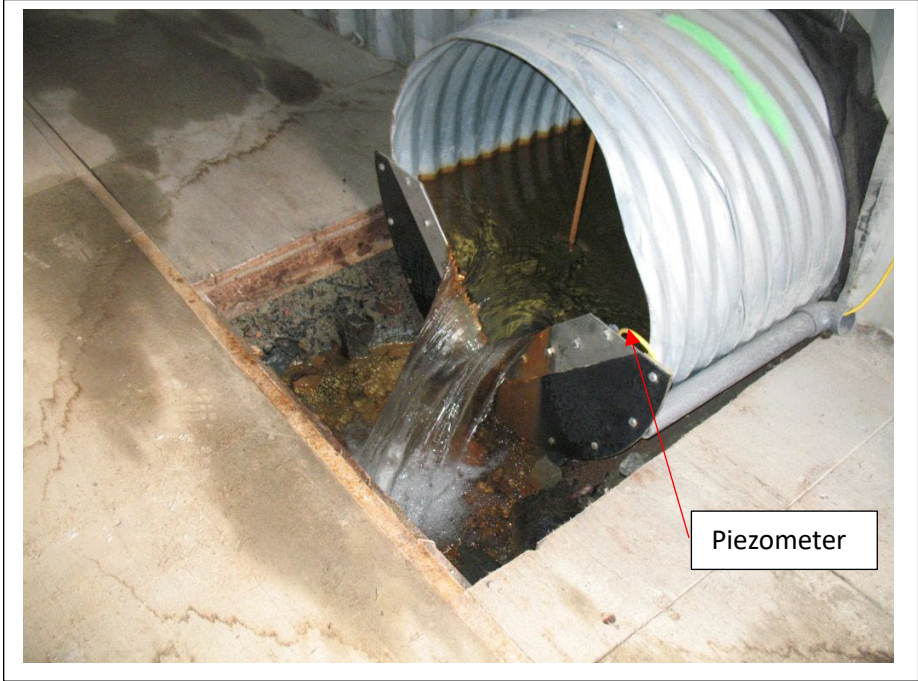
Photo #9 Main weir at Whale Tail Dike.

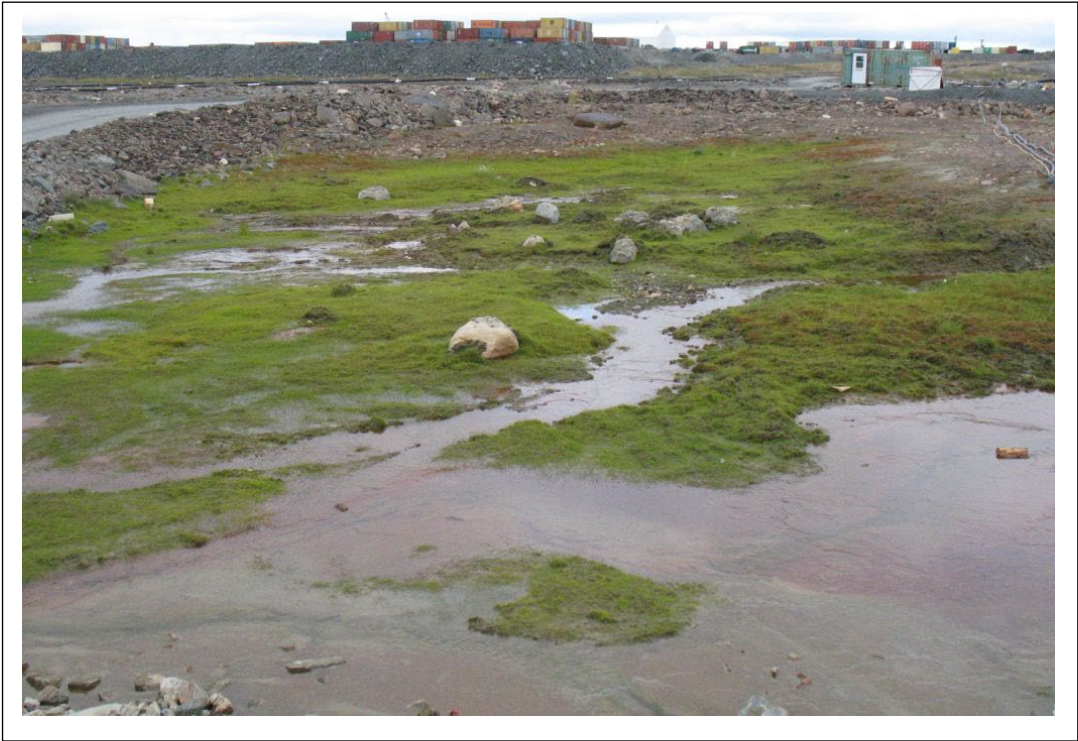
Photo #10 Whale Tail Dike area of seeps not accumulated at main weir.

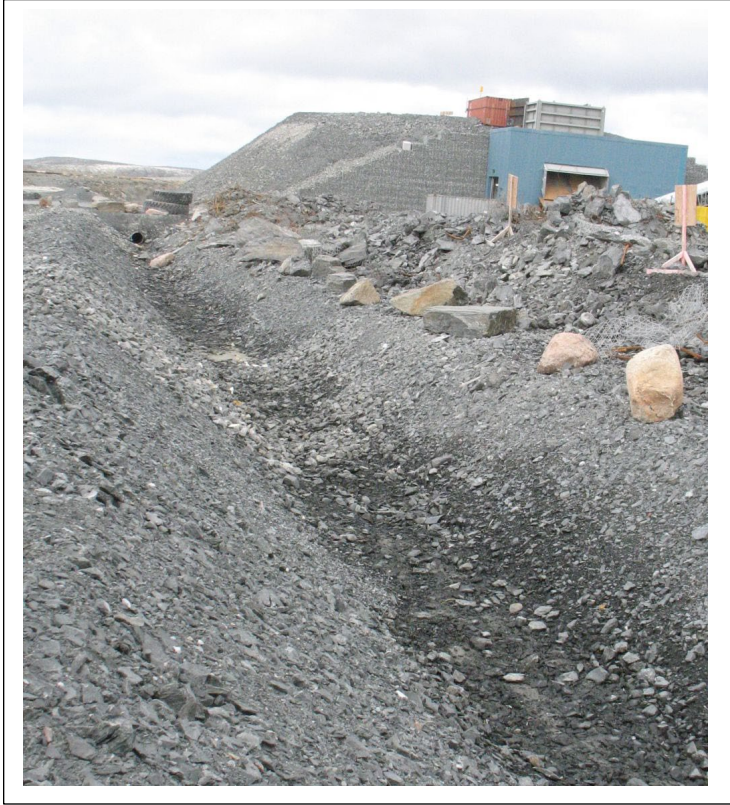
During freshet, the alert level was temporarily raised for the saline ditch (Photo #11) around the stockpile of underground sourced rock until a clean-out operation was carried out. No spill was recorded, but maintenance procedures will be enhanced in future years.

The Saline Ditch required some remedial work in the spring due to inadvertent accumulation of debris, snow and ice over the winter. The situation is now under control, and operating protocols have been established.

Photo #11 Saline ditch.

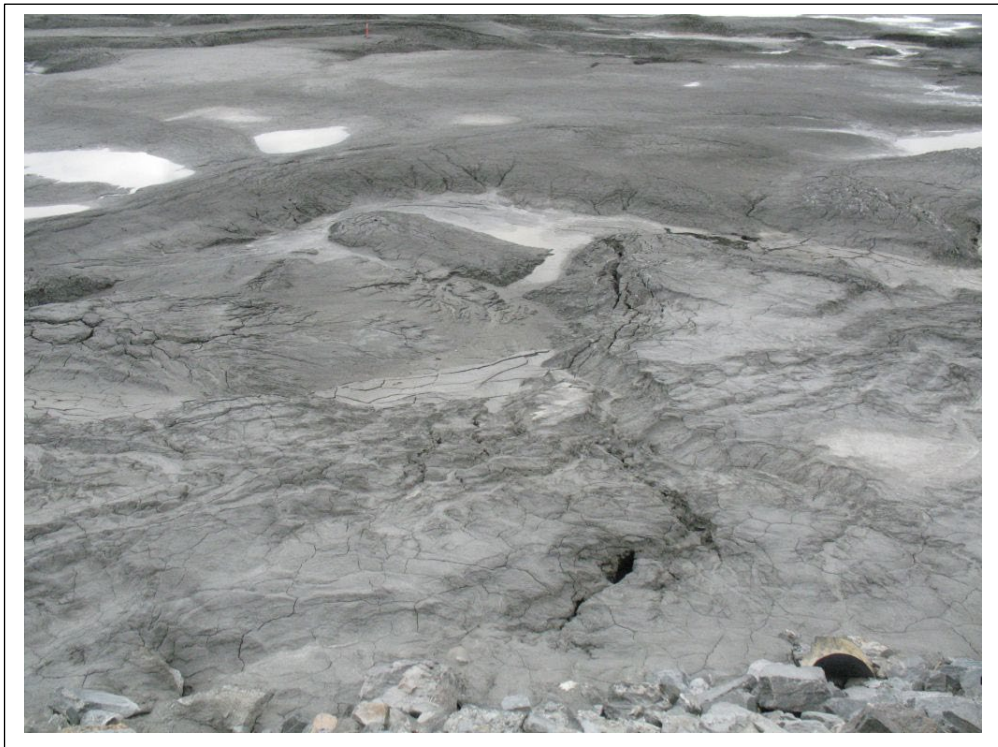
At the time of the visit, no “landscaping” deposition had been carried out in the NC or the SC of the TSF in 2023. The Board noted the irregular surface of the SC adjacent to the SWD (Photo #18) and agrees that continuation of warm weather deposition is appropriate to prepare the final tailings surface for NPAG capping rockfill.

Photo #18 South Cell consolidation settlement and inflow areas that contribute to groundwater recharge.

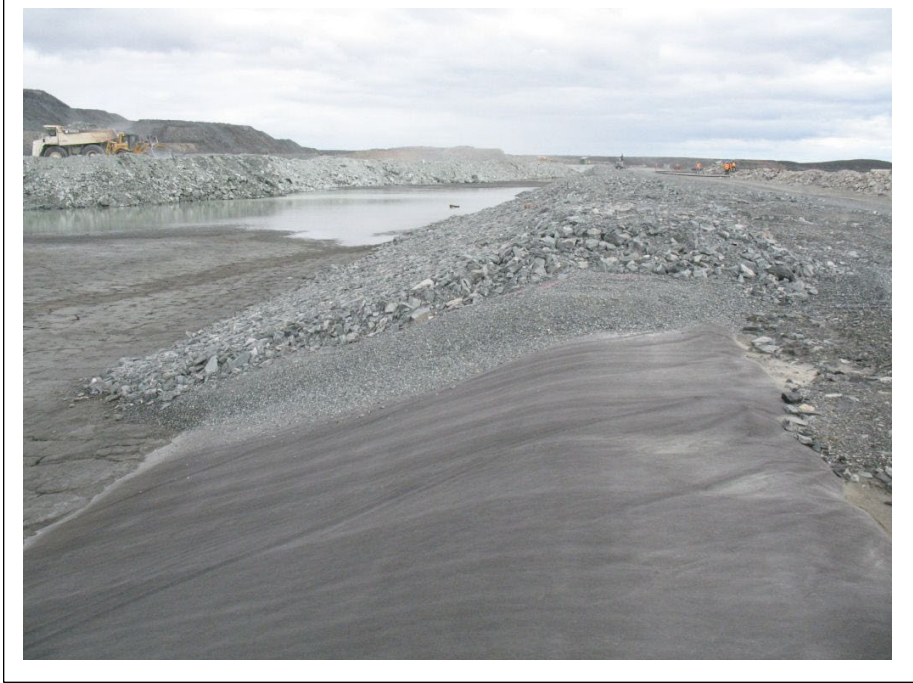
At the Storm Water Dike (SWD) a few repairs have been carried out on the exposed upper parts of the geomembrane liner. Fine and coarse filter protection, as suggested by the Board, have been added over the geomembrane in advance of the rockfill closure cover (Photo 19).

Photo #19 Fine and coarse filter protection of Stormwater Dike geomembrane.

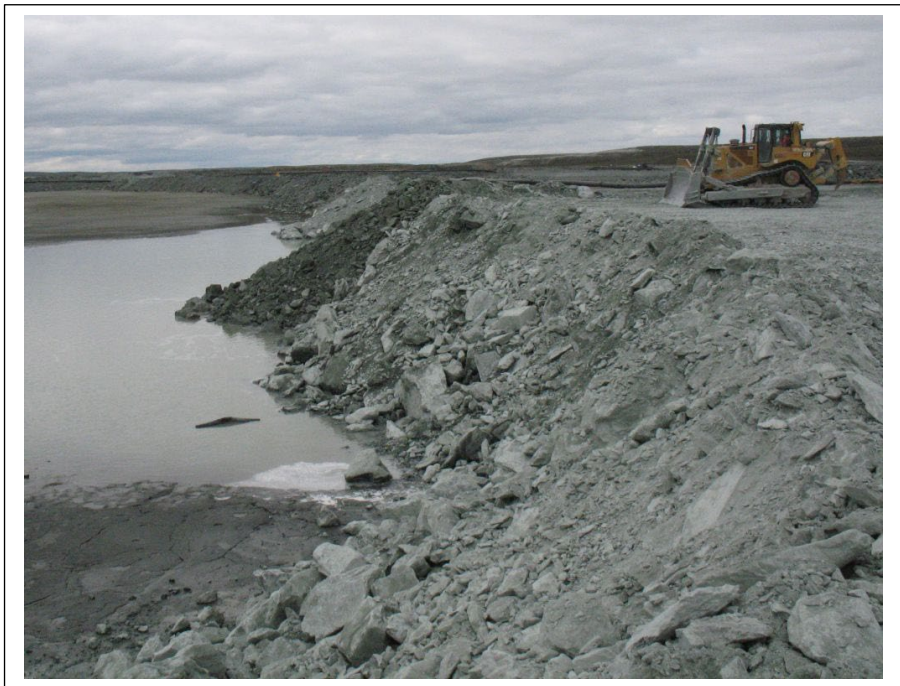
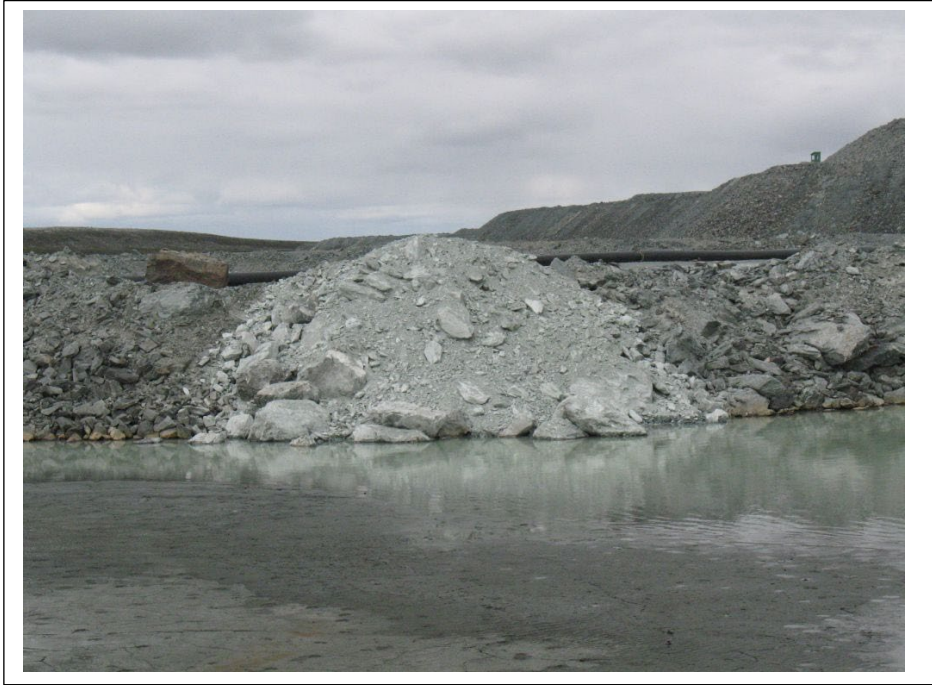
In addition to protection being added to the exposed liner on the upstream crest of the Stormwater Dike, placement of rockfill as capping on the NC is ongoing. (Photos #20 and #21) The Board members observed this work and wish to comment on the fact that the lift thickness of the rockfill is more than 2 m, and the manner in which some material, at least, is dumped directly over the advancing face is conducive to segregation. Thinner lifts insofar as is possible according to the bearing capacity of the tailings would be preferable. The placement methods and the resulting stratification of whatever sequence is obtained should be consistent with the intended cover performance strategy adopted for closure.

Photo #20 Progressive closure capping on North Cell of TSF.

Photo #21 Segregation in dumped rockfill.

MDRB#31-08	Closure	2023	A review of closure concepts is needed to better inform the specifications and directions for the progressive closure capping work.	AEM agrees. Studies are ongoing regarding the TSF cover at closure. Results will inform the design specifications moving forward with capping work.	Ongoing
MDRB#31-09	General - Instrumentation	2023	The performance of the water-retaining and tailings structures is satisfactory though seasonal variations in instrument readings are common and are to be expected. The Board concurs with the initiative to establish alert/alarm levels for instruments linked to the data acquisition system. The Board also agrees with the alignment to optimize the inspection frequencies though cautions that these should be flexible and the AEM team should be alert to conditions, meteorologic or behavioural, that could be cause for increased frequency.	AEM already started implementing the alarms to aid in the routine instrumentation follow-up and analysis. AEM will also evaluate and consider adding a rate of change to the alarms already in place to upgrade the efficiency of the instrumentation analysis.	Ongoing

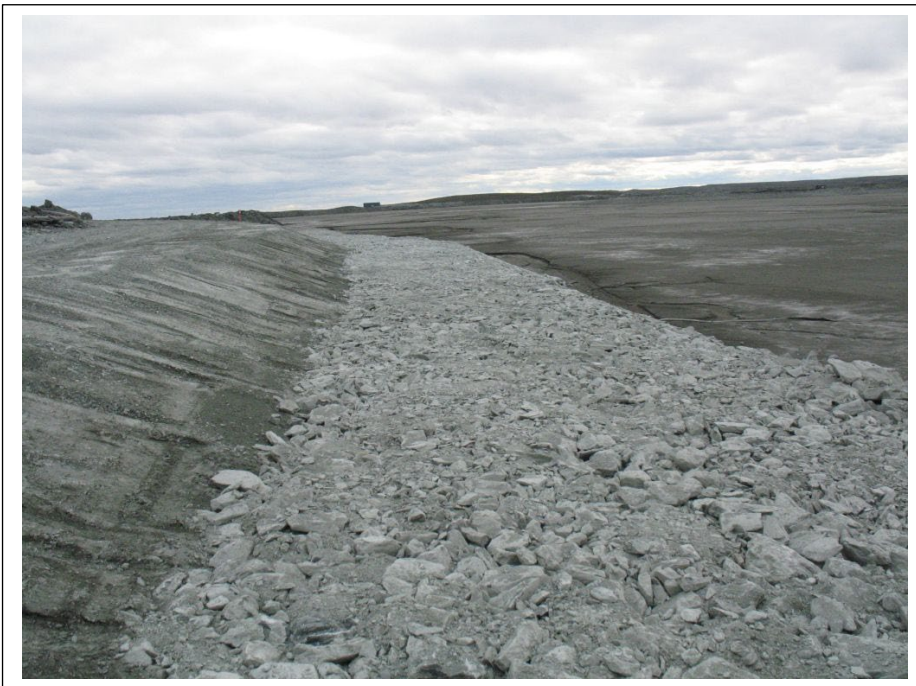
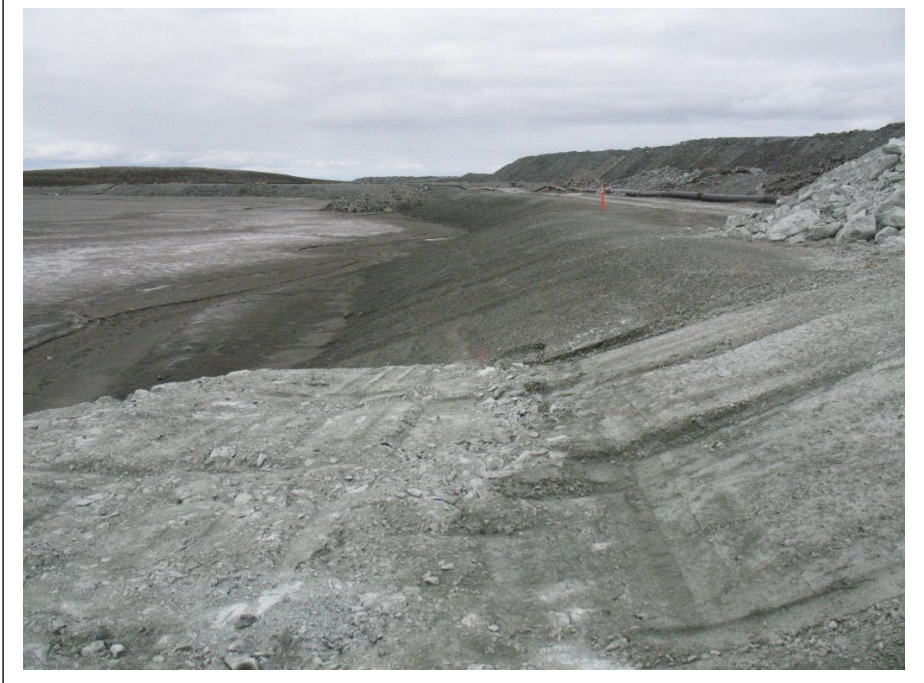
A rockfill berm has been added to the toe of the North Cell Internal Structure (Photos #22 and #23) to alleviate local erosion from seepage and local run-off flows.

Photo #22 North Cell Internal Structure (NCIS). Protective toe berm, looking south.

Photo #23      NCIS protective berm, looking north.
