Meadowbank Thermal Monitoring Report 2023

MEADOWBANK PROJECT

Thermal Monitoring Report

Prepared by:
Agnico Eagle Mines Limited – Meadowbank Division

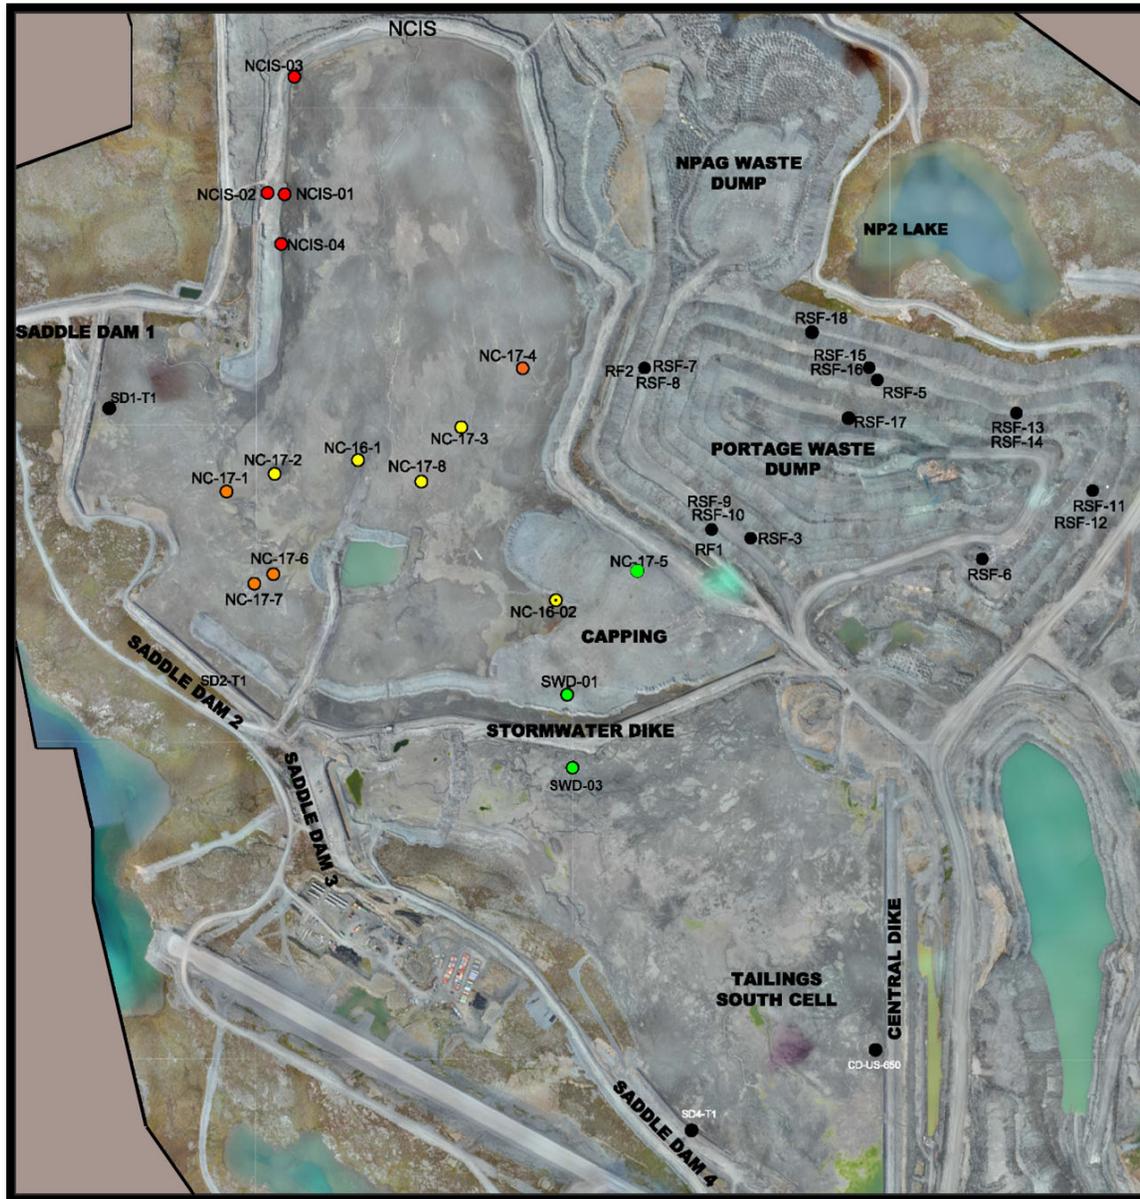
Instruments located near the pond of water of the North Cell are showing a portion of unfrozen tailings at depth with frozen tailings at surface (with a 4-5 m active layer) and a progression of the freezing front advancing at depth. This is represented by yellow dots on Figure 1 (NC-16-1, NC-16-2, NC17-3, NC-17-2, NC-17-8). Instruments located away from the water pond show that the tailings and its foundation are entirely frozen with an active layer depth of 4-5 m. This is represented by red and orange dots on Figure 1 (NC-17-1, NC17-4, NC-17-6, NC-17-7, NCIS-01 to NCIS-04).

Instruments installed below the capping show that the active layer is contained within the rockfill. This is represented by a green dot on Figure 1 (NC-17-5).

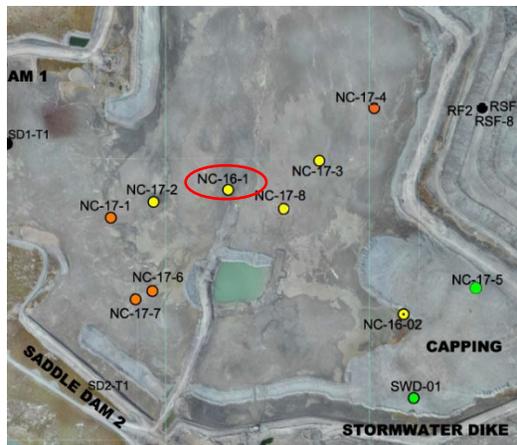
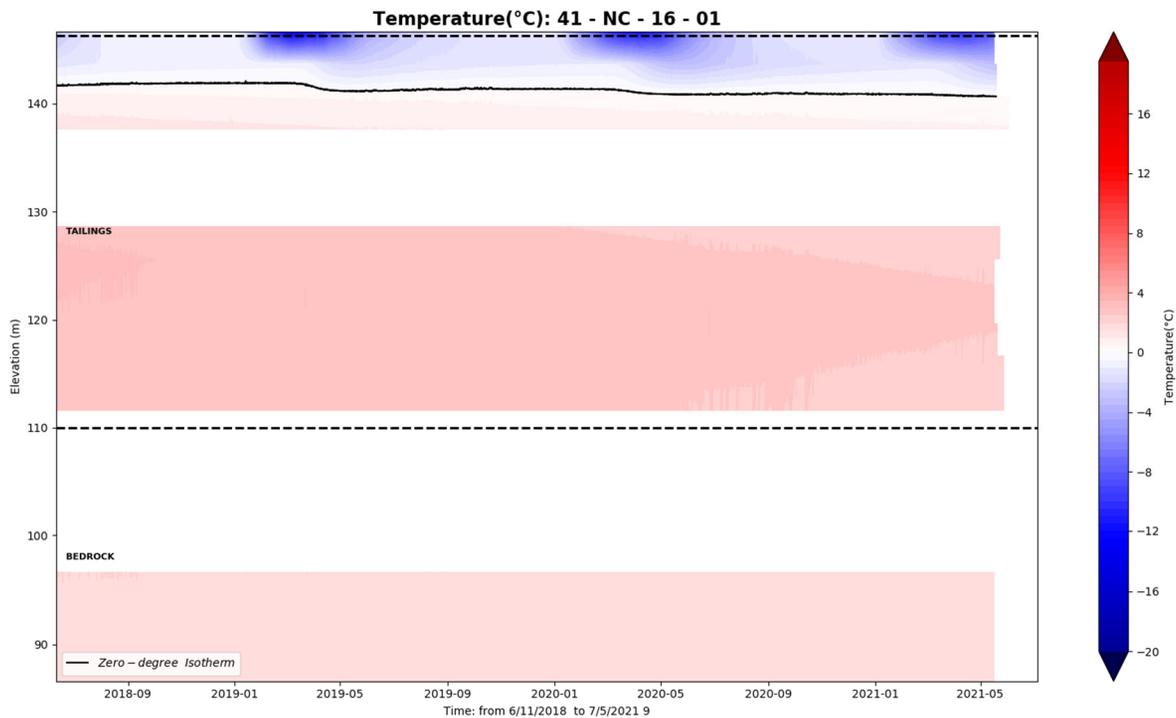
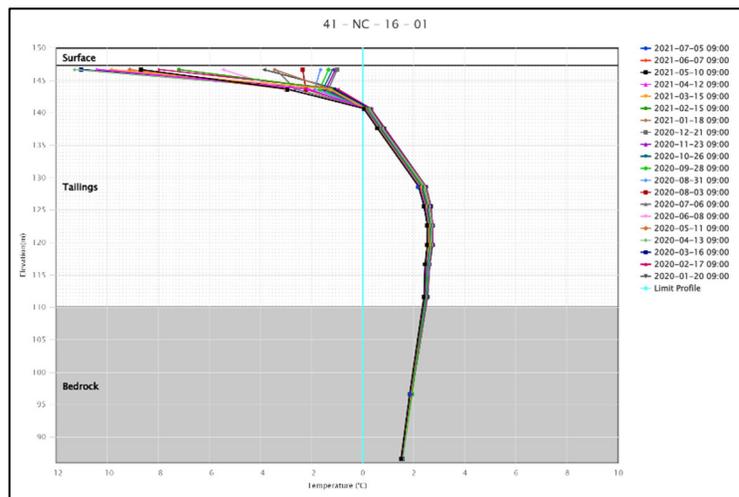
NC-16-01

This instrument is broken and not sending anymore data, since July 2021.

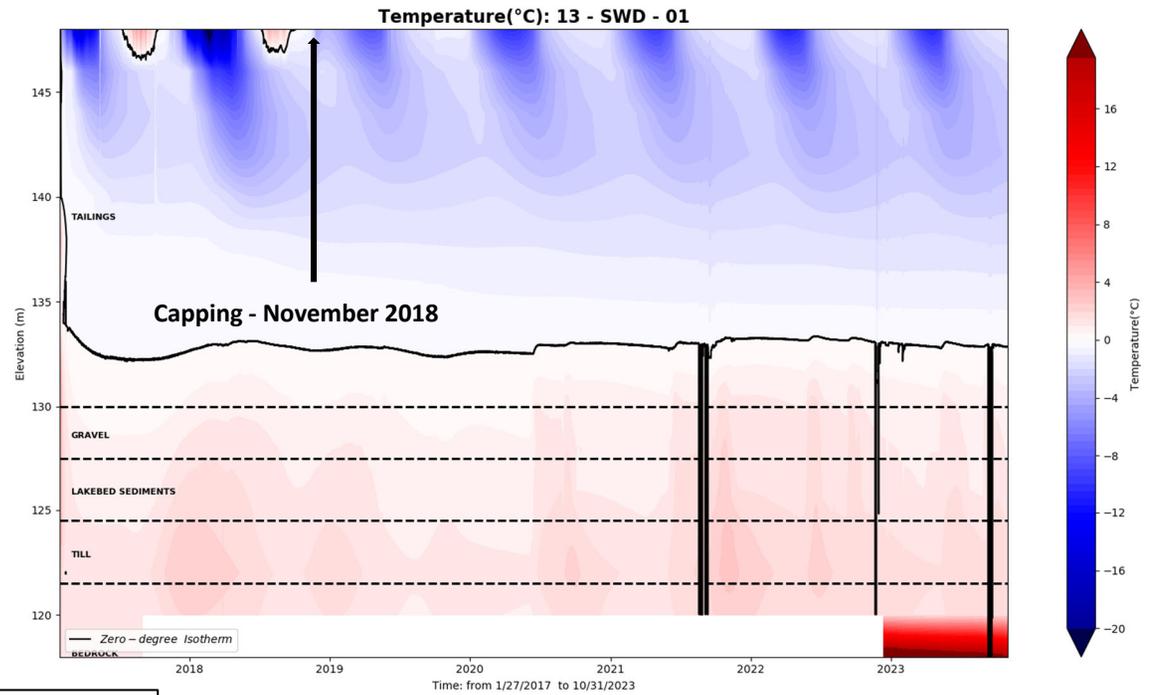
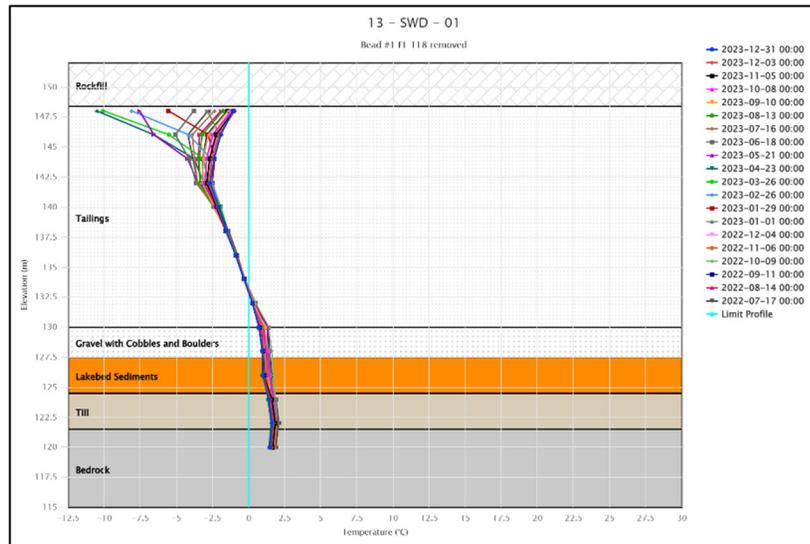
SWD-01 shows a stable unfrozen condition in the foundation below the frozen tailings and capping.

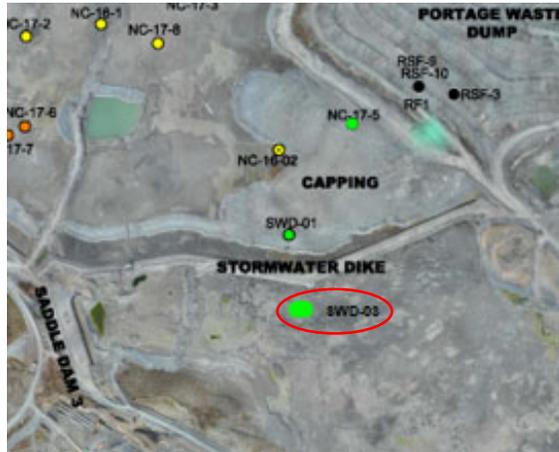
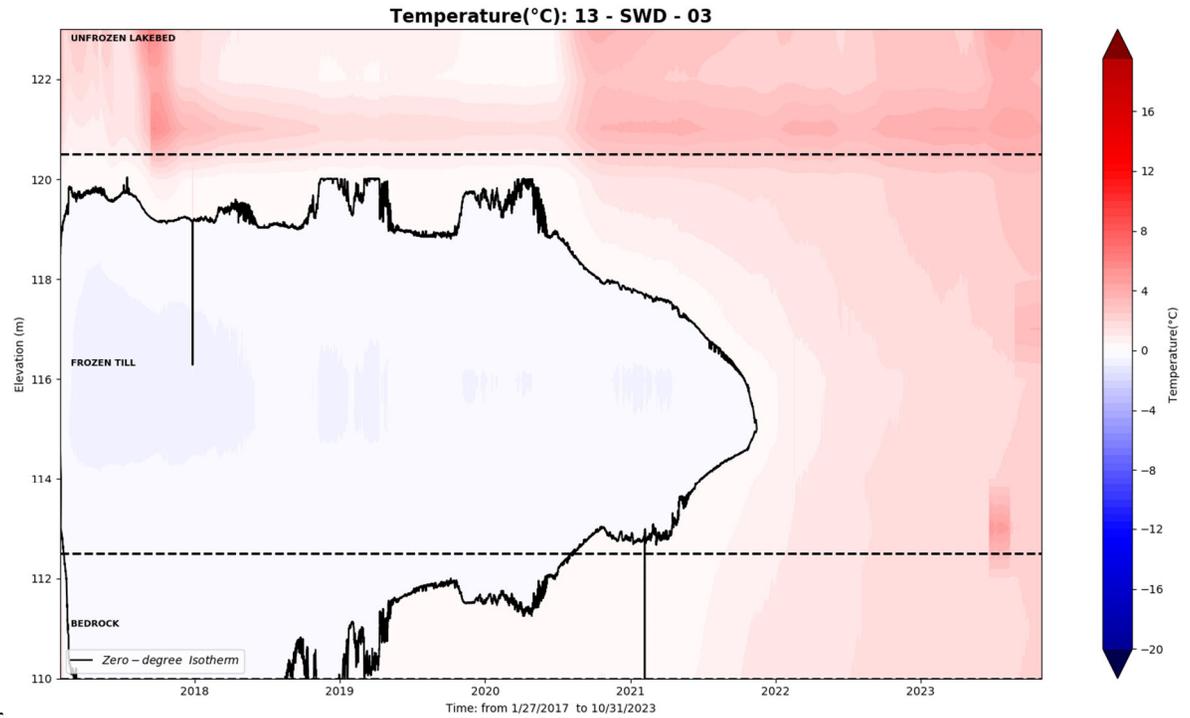
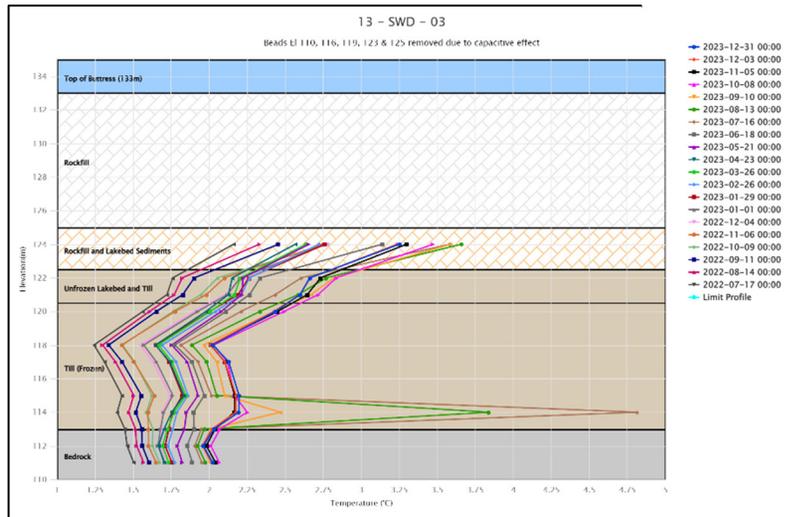
SWD-03 indicates the return to a talik condition in the South Cell near Saddle Dam 3.

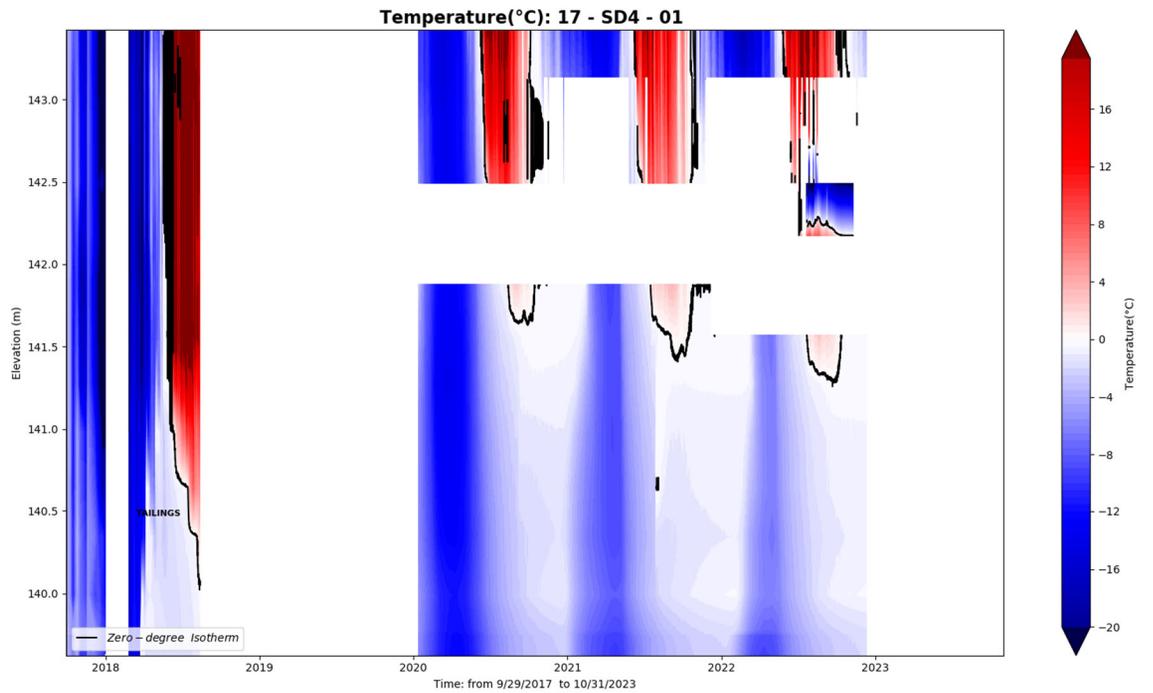
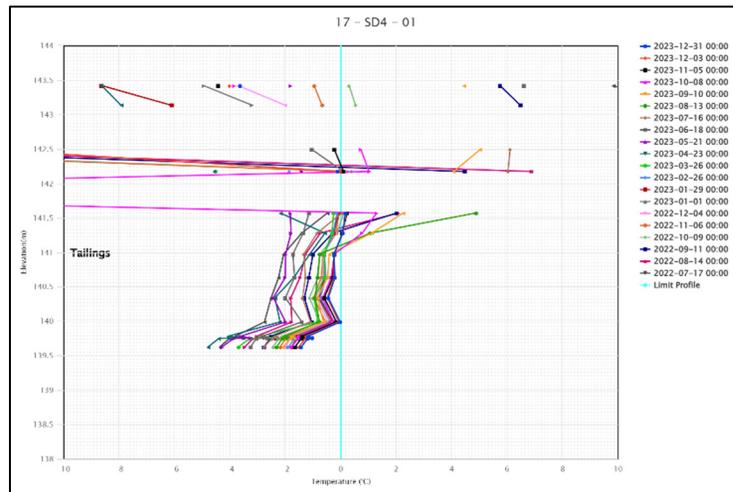
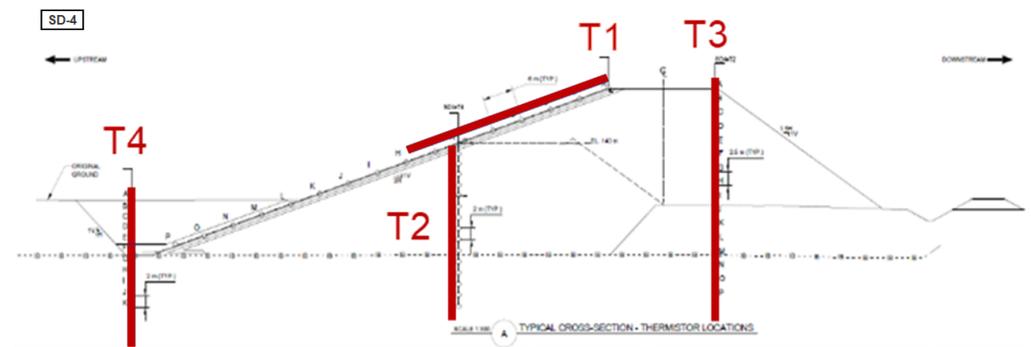
SD4-1

This instrument is along the liner. Note that the beads are no longer functioning properly, as seen on the graphs.

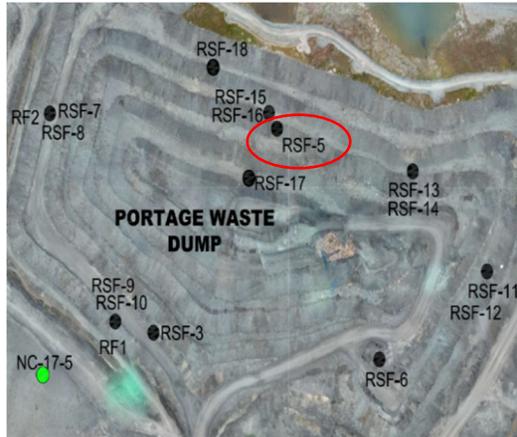
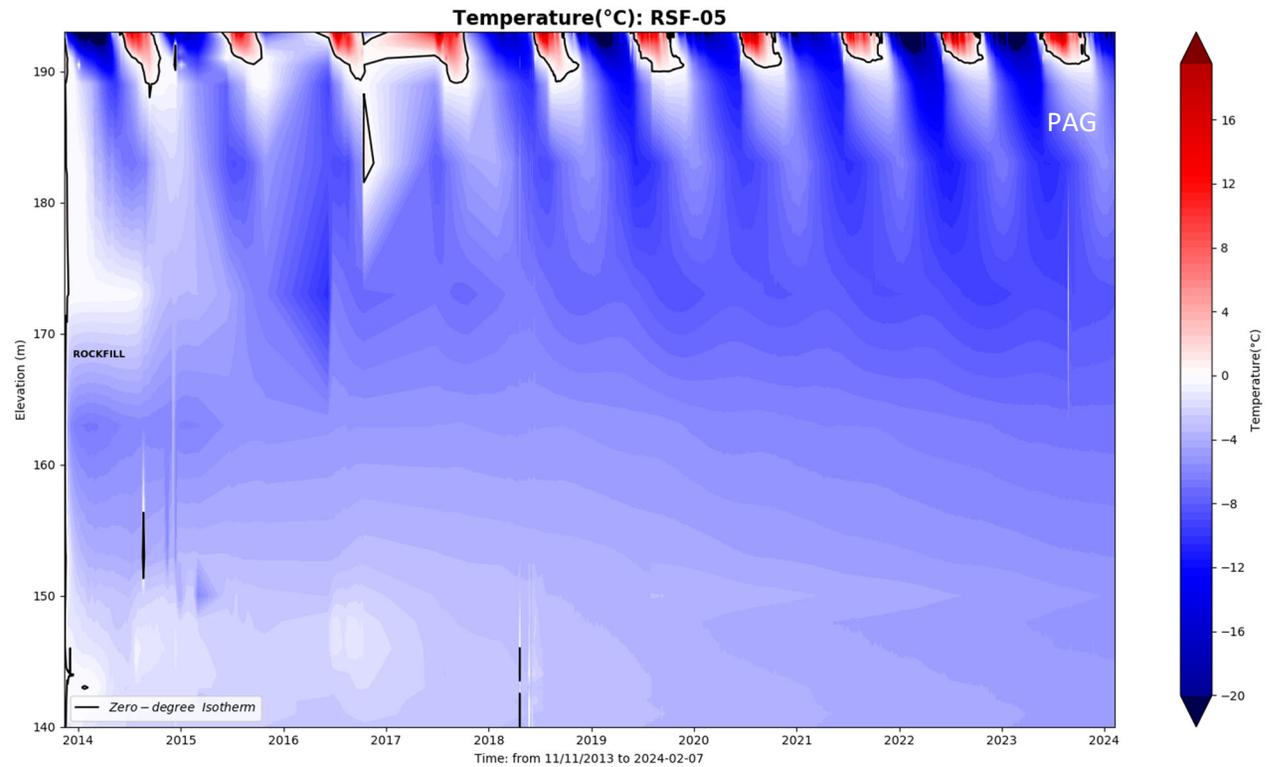
RSF-5

This instrument is broken and not sending data.
