Appendix 23

Meadowbank 2023 GN Spill Reports

GN reference #: 2023-004

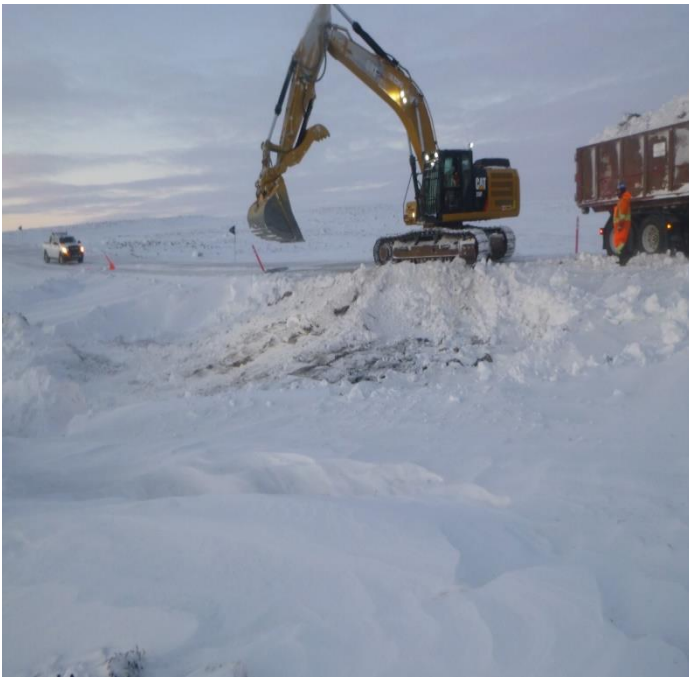
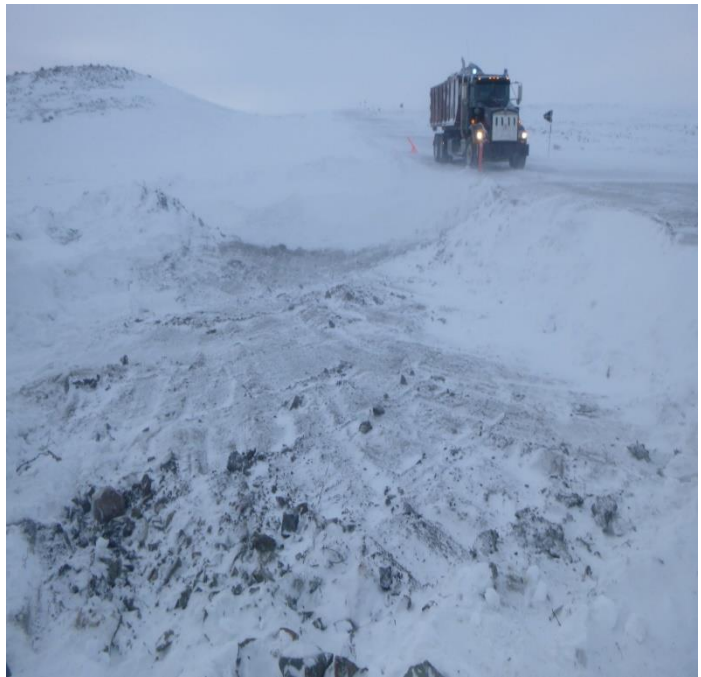
ERT and Environment were called to the scene. Spill pads and spill booms were immediately placed on the ground. A tarp was used to create a secondary containment at the fuel leak and immediately pumped back into the vacuum truck. The fuel in the tanker on its side was transferred into an empty tanker. Fuel collected in the secondary containment was pumped into the vacuum truck. The fuel tanker contained 36,075L and 35,675L was recovered, accounting for a loss of 400L of Diesel fuel. The area was scraped clean and approximately 21m³ of contaminated snow and material was collected and brought to the Meadowbank landfarm.

The All-Weather Access road and Whale Tail haul road transportation standard operating procedure will be modified to include “all vehicles/equipment must come to a complete stop when using the dial function on a Sepura base radio”. Site wide communication package will be sent to ensure all workers/operators of vehicles understand the changes to the transportation procedure. AEM will also investigate the possibility of having a hands-free communication device for all mobile equipment.

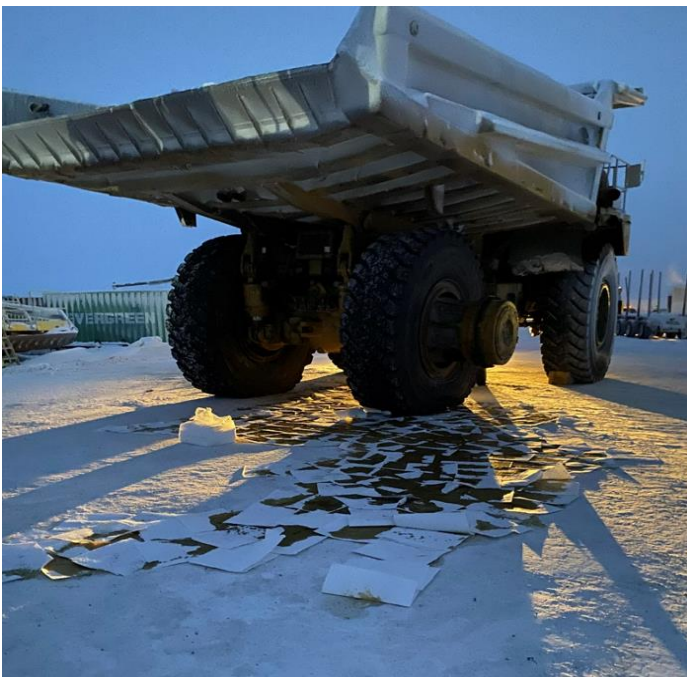
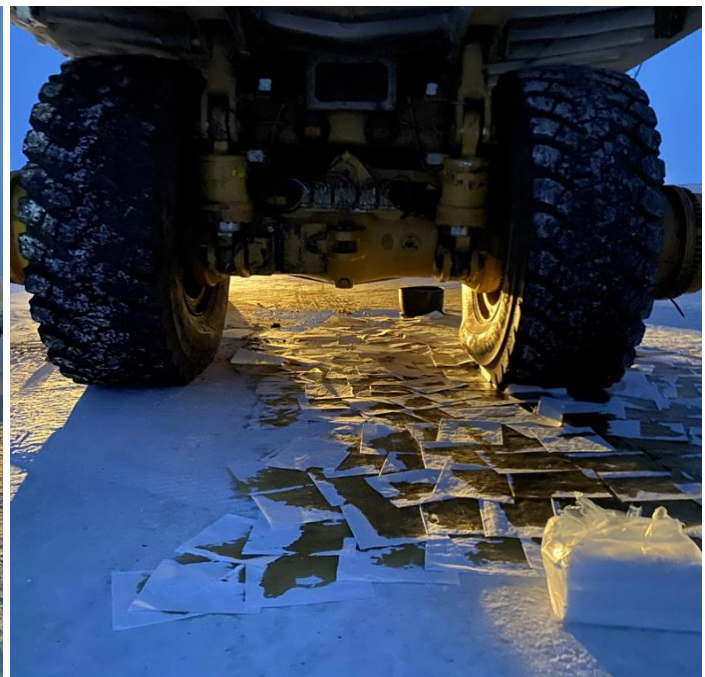
During operations at Meadowbank, Haul truck 28 was parked with the engine running during shift change. When the work returned to the haul truck, the spill was observed on the ground.

The spill was caused due to a torque converter filter hose failure on Haul Truck 28.

Routine visual inspections during pre-op checks will continue as part of AEM's preventative maintenance program. AEM is also working on a mechanical performance review and improvement plan to reduce mechanical issues causing spills.

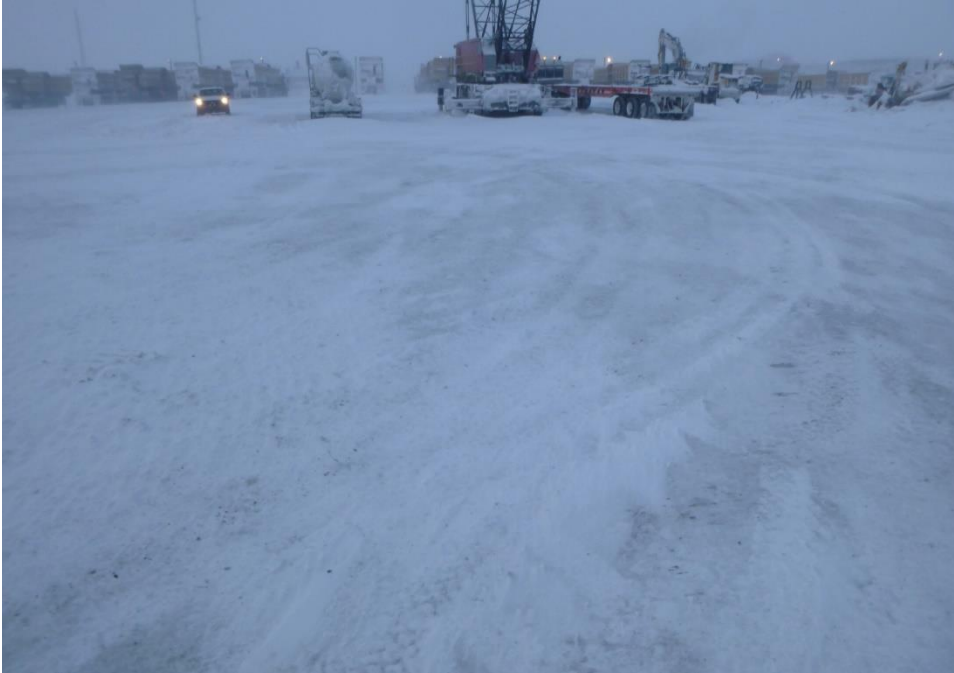
Maintenance was called to shut down the unit. Secondary containment was placed under the leak and spill pads were immediately placed on the ground over the spill area. The area was scraped clean with a loader and approximately 10m³ of contaminated snow and material was collected and brought to the Meadowbank landfarm.

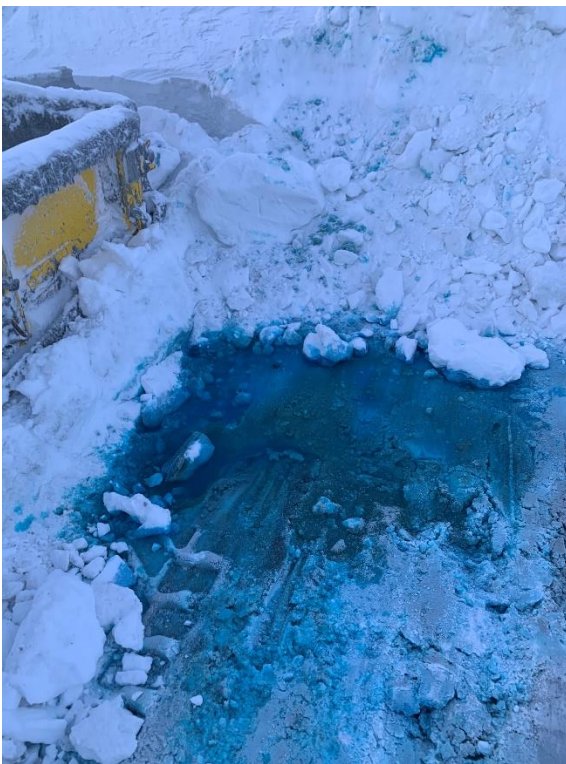
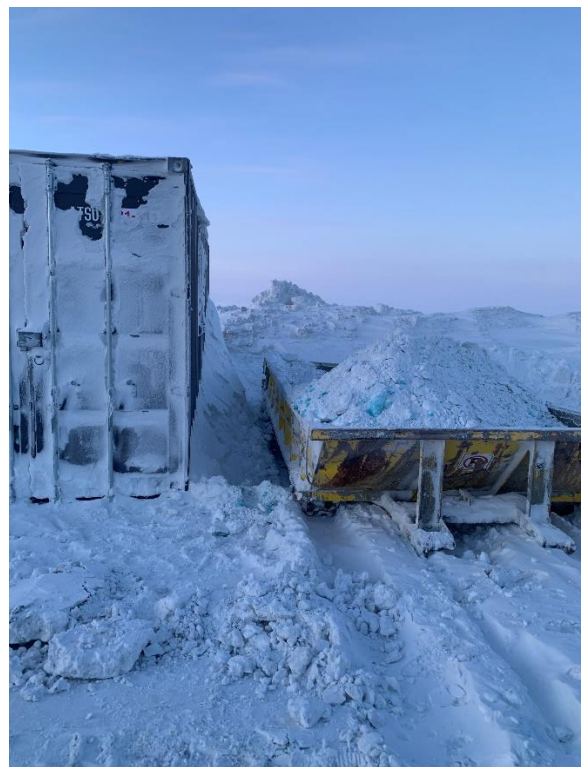
During operations at Meadowbank, a tote with a damaged valve was being transferred into a new tote. During the transfer, the worker observed a leak coming from the new tote. Upon investigation, the new tote had a small puncture near the bottom of the tote. The new tote containing approx. 250L of washer fluid was placed into a roll off bin. The operator left the damaged tote in the roll off bin and the tote emptied itself through the puncture and spilled onto the ground.

An investigation into the root causes of the spill has been completed. The procedure for the transfer of fluids from damaged reservoir is being updated to ensure the visual inspection phase of the new container is included and captured in the process. This procedure will then be communicated to the department's workers.

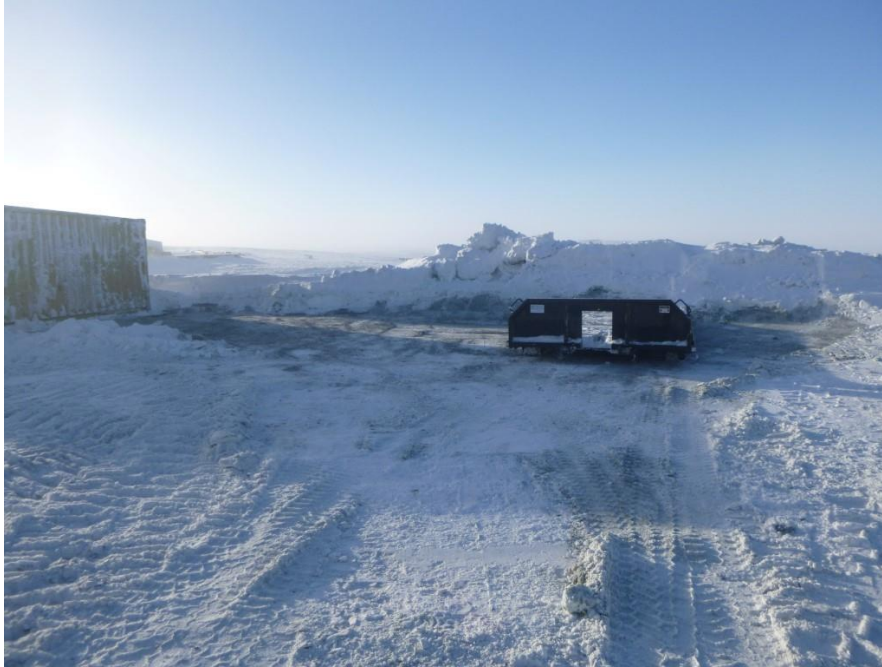
Upon discovery of the spill, a loader was mobilized to scraped clean the area. Approximately 4m3 of contaminated snow and material was collected and brought to the South cell tailings area.

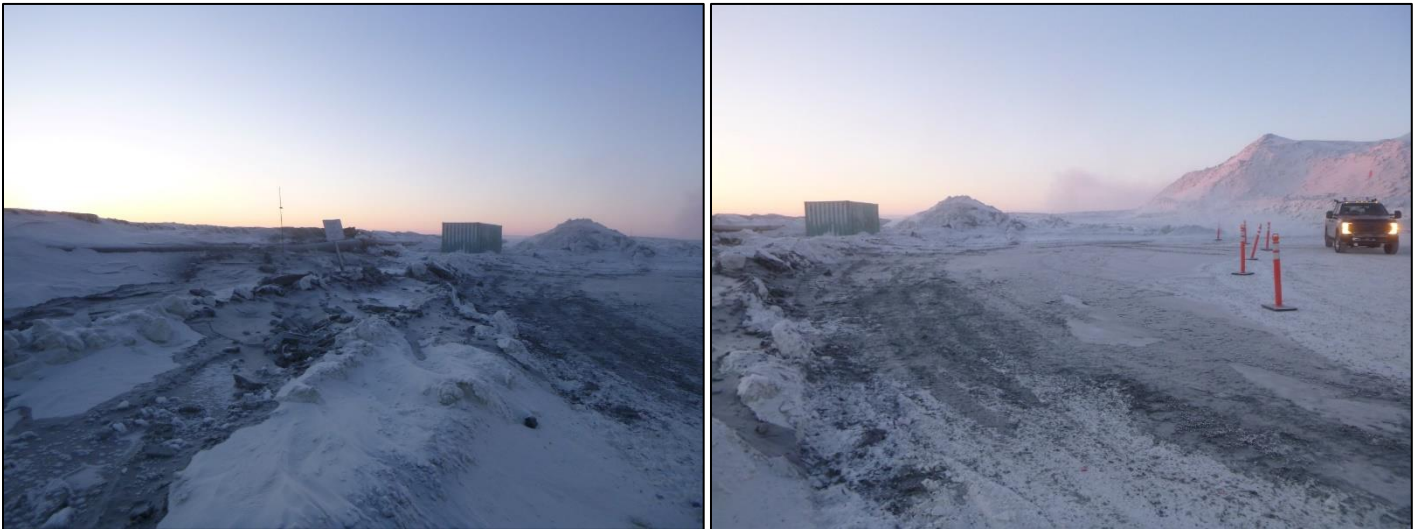
During routine maintenance of the tailings line at Meadowbank, the device used to descale the line got stuck. After an assessment of the tailings line to determine where the blockage occurred, the tailings line was un-flanged, and air was put into the line to retrieve the device. After retrieving the device, the remaining tailings in the line spilled onto the ground of the Pushback parking adjacent to the tailing deposition pit (Pit E).

Failure of descaling pump resulted in excess accumulation of tailing residue in the line, which in turn lead to higher pressure in the line, blocking the descaling device.

An investigation into the root causes of the spill has been completed. The procedure for descaling of tailings/contact water is being updated to include areas along the tailings line where un-flanging could occur inside the tailing's footprint. In addition, a flow monitoring system will be installed on each anti-scale distribution system as an additional control measure.

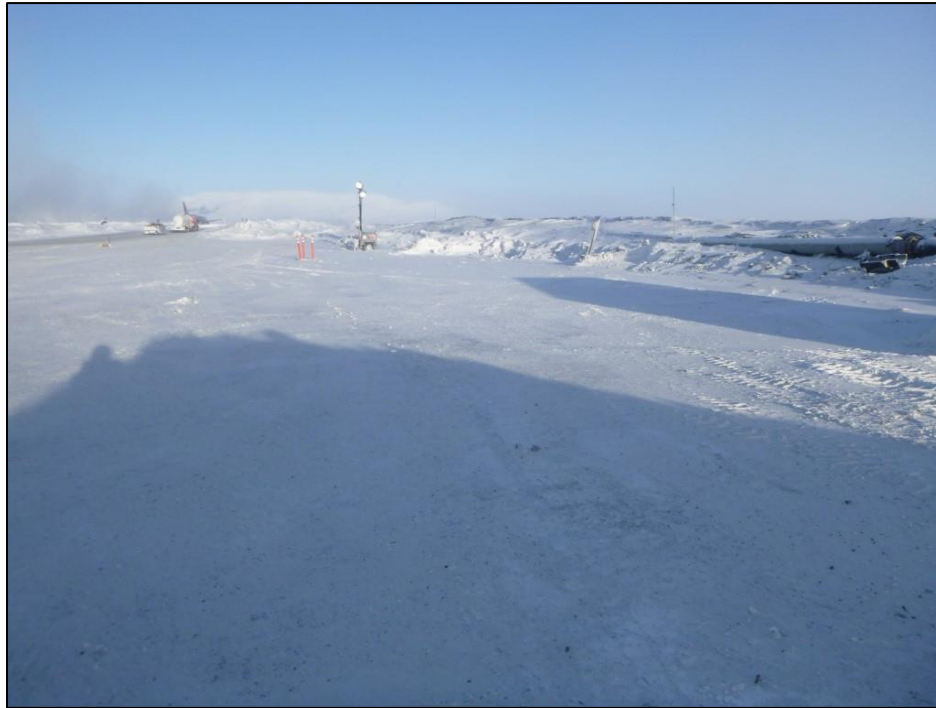
An excavator was mobilized to excavate the contaminated material. Approximately 92 m³ of contaminated material was brought to the South cell tailings area.

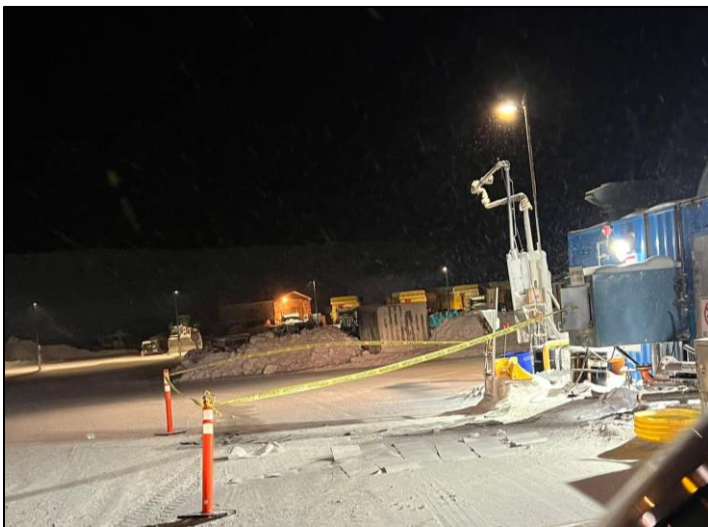
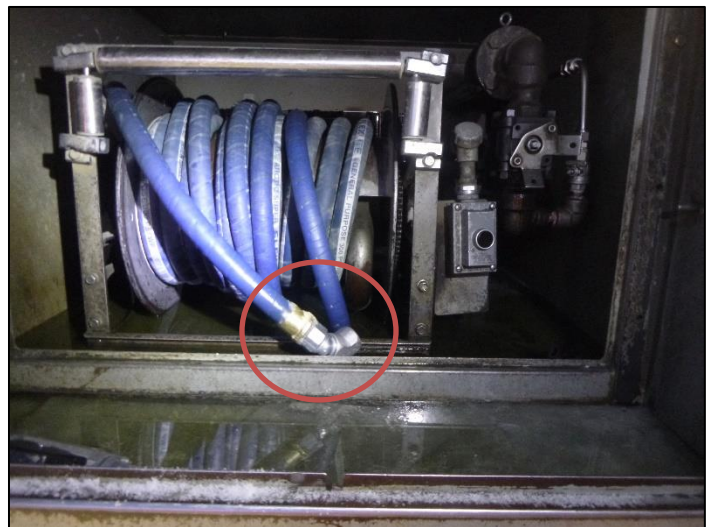
During operations at Meadowbank, the diesel fuel nozzle was dropped onto the ground breaking the swivel adapter. The damaged resulted in a spill of approximately 150L of diesel fuel from the fuel line onto the ground. The operator was unable to immediately stop the flow using the standard stop switch and had to use the emergency stop switch to gain control.

Equipment failure

The standard stop switch was modified and the fuel line was repaired. In addition, the fueling procedure was reviewed by crews and an audit was performed on all fuel stations to ensure all stop buttons are compliant as per operational standards.

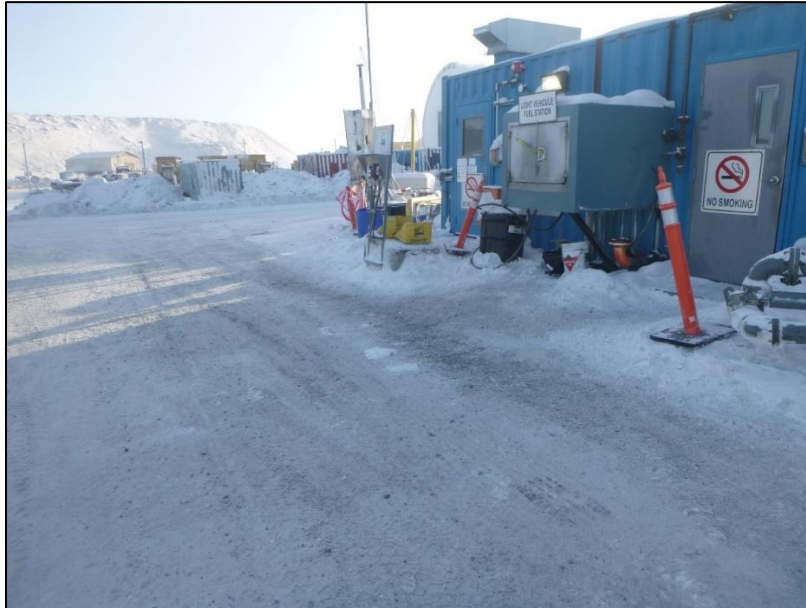
The operator utilized the emergency stop switch. Absorbent material was placed down, and a loader was called to clean the area. Approximately 4m³ of contaminated snow/soil material was brought to the Meadowbank Landfarm. Absorbent material was collected brought to the Hazmat area for processing.

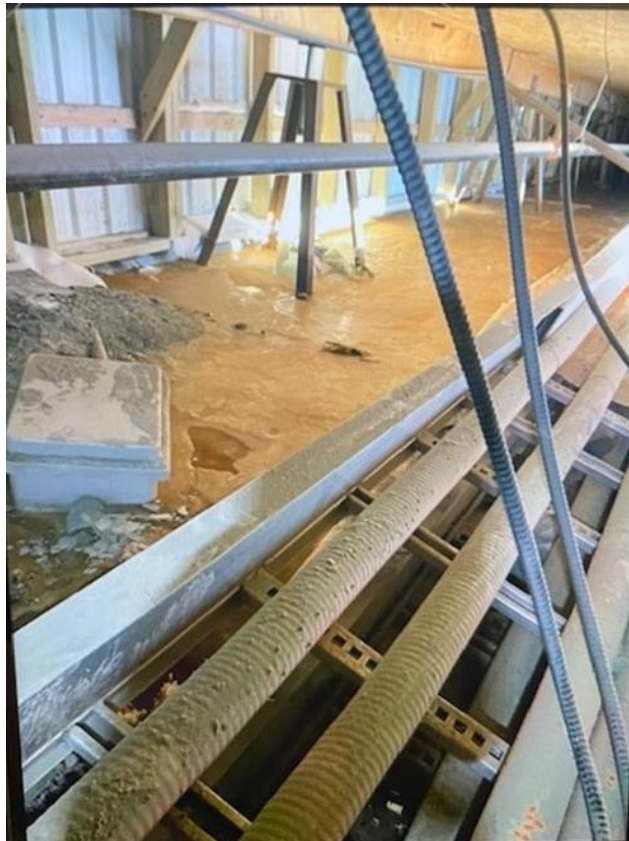
During process of investigating issues in the sewage drain line of the Meadowbank Camp, the sewage pipping under the arctic corridor was found to be cracked and frozen. As a result of the break, approximately 300L of sewage water was spilled under the building and onto the frozen ground.

Broken Joint on piping.

New conduit was installed as a replacement for the deteriorated piping, and a comprehensive visual inspection of all sewage infrastructure within the campgrounds is scheduled to take place during the upcoming summer season.

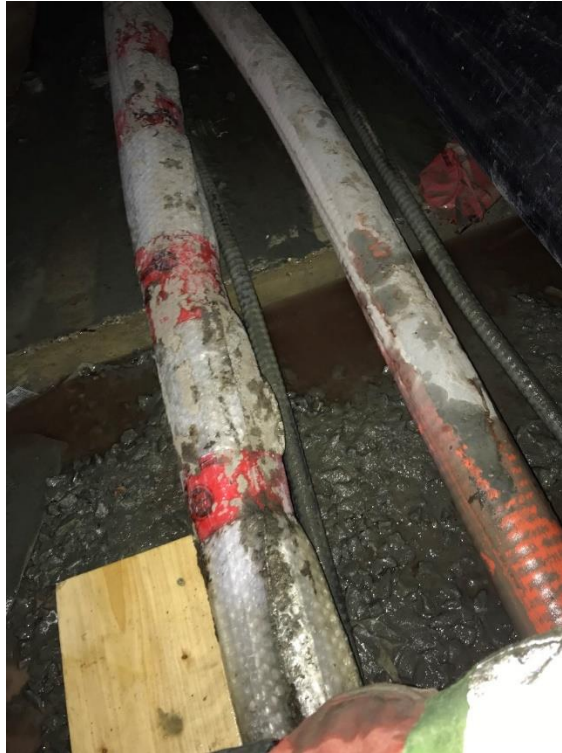
Heating equipment was utilized to thaw the frozen sewage in the contaminated area, enabling the vacuuming of the liquid using a sewage truck. About 0.3 cubic meters of contaminated material were transported to the Tailing Storage Facility. Additional remediation efforts will be undertaken during warmer temperatures when the ground has thawed to facilitate the recovery of the contaminated material, considering the spill's location, timing, and nature.

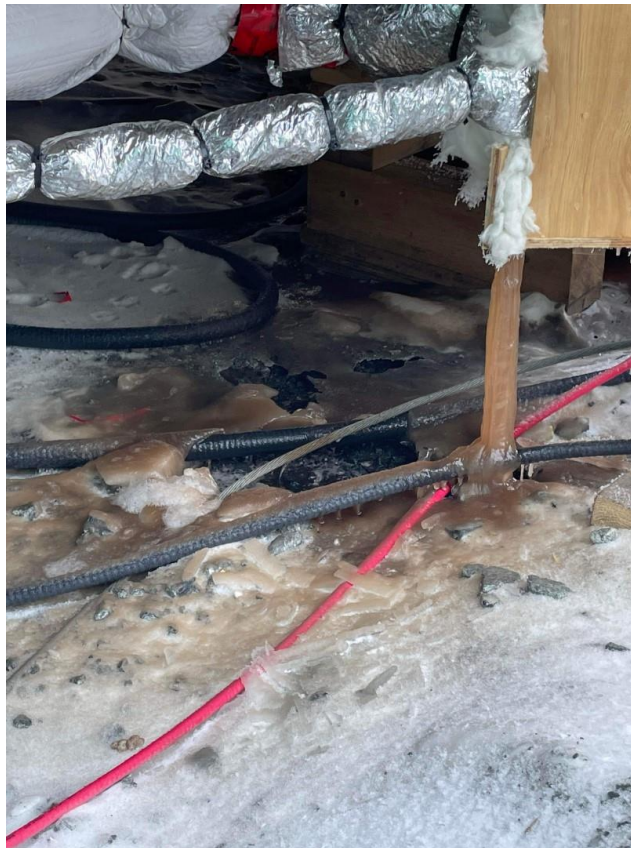
During a field inspection of the PEL shop, the sewage piping under the building was found to be leaking onto the ground. As a result of the leak, approximately 20L of sewage water was spilled under the building and onto the frozen ground.

Broken pipe from building movement

The broken Y pipe was replaced by the plumber. A comprehensive visual inspection of all sewage infrastructure within the campgrounds is scheduled to take place during the upcoming summer season.

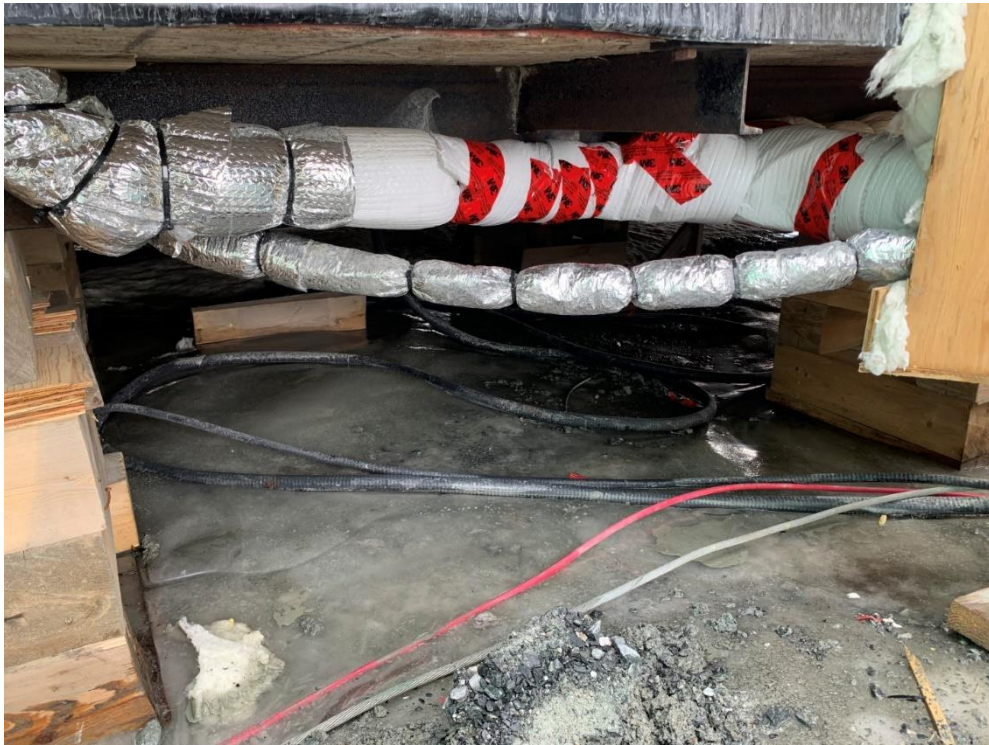
Heating equipment was utilized to thaw the frozen sewage in the contaminated area, enabling the vacuuming of the liquid using a sewage truck. About 1 cubic meter of contaminated material was transported to the Tailing Storage Facility. Additional remediation efforts will be undertaken during warmer temperatures when the ground has thawed to facilitate the recovery of the contaminated material, considering the spill's location, timing, and nature.

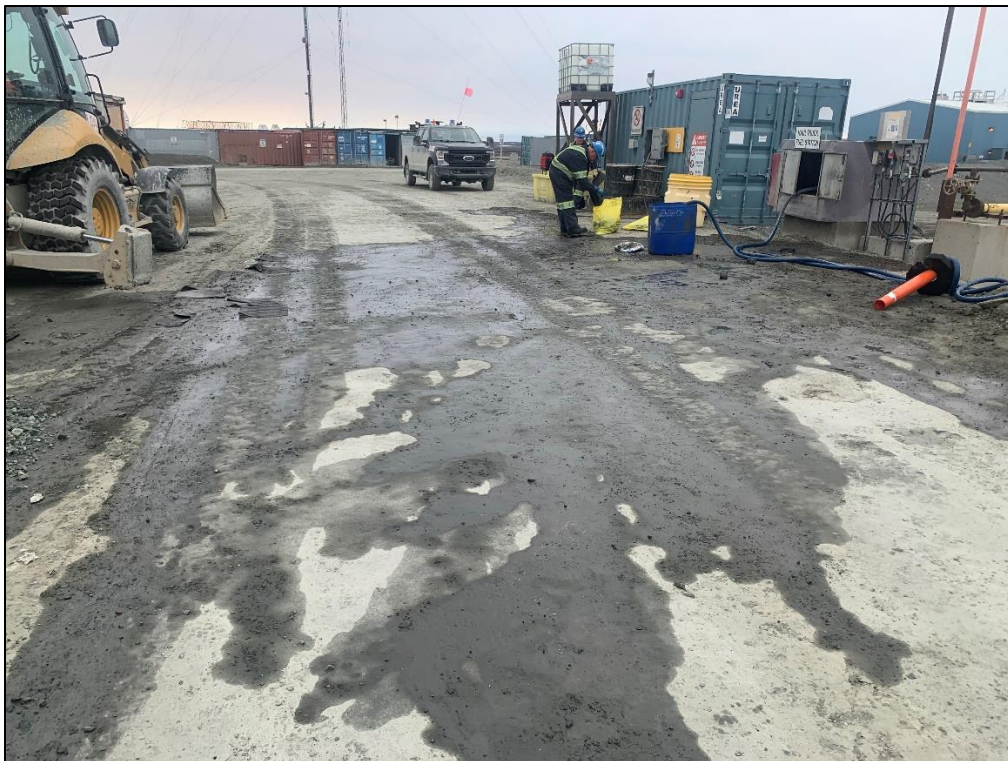
During refueling operations at the Meadowbank fuel farm, an LHT operator pulled away from the refueling station with the nozzle and hose still attached to the fuel tank, causing the damage to the fuel nozzle and hose., within the lined portion of the fuel farm.

The fuel pumping system and visual indicator were repaired to ensure all operators can see when the fuel system is on. In addition, the incident and the fueling procedure were reviewed and present to both LHT crews.

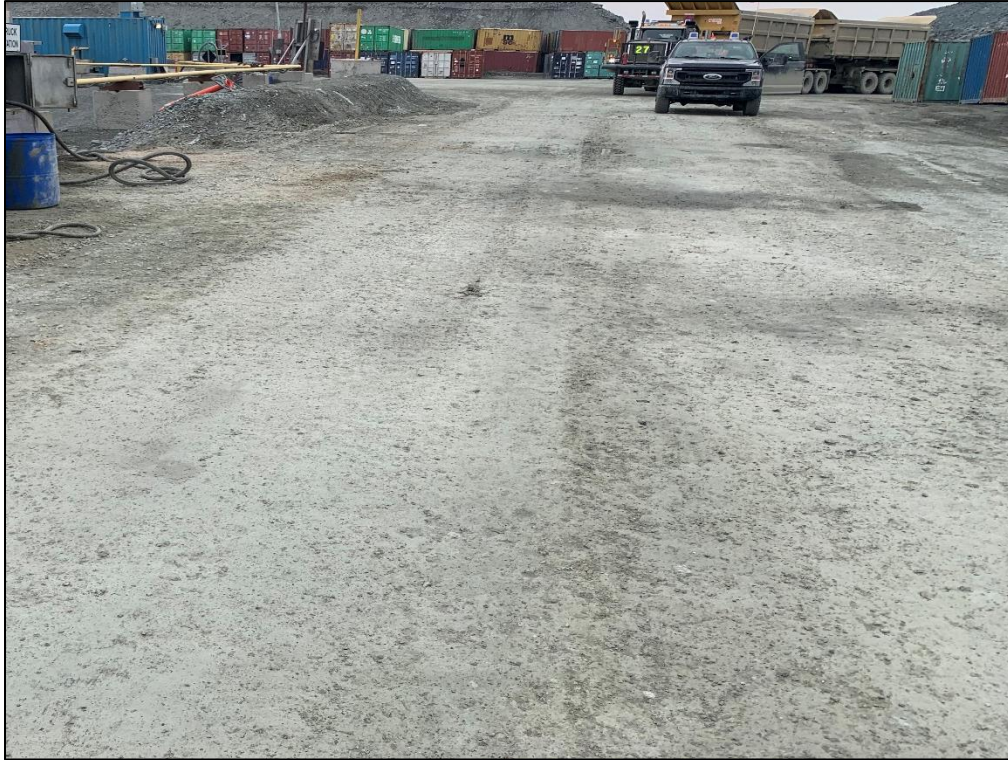
The contaminated area was immediately scraped clean with a loader and approximately 7m³ of material was collected and brought to the Meadowbank landfarm.

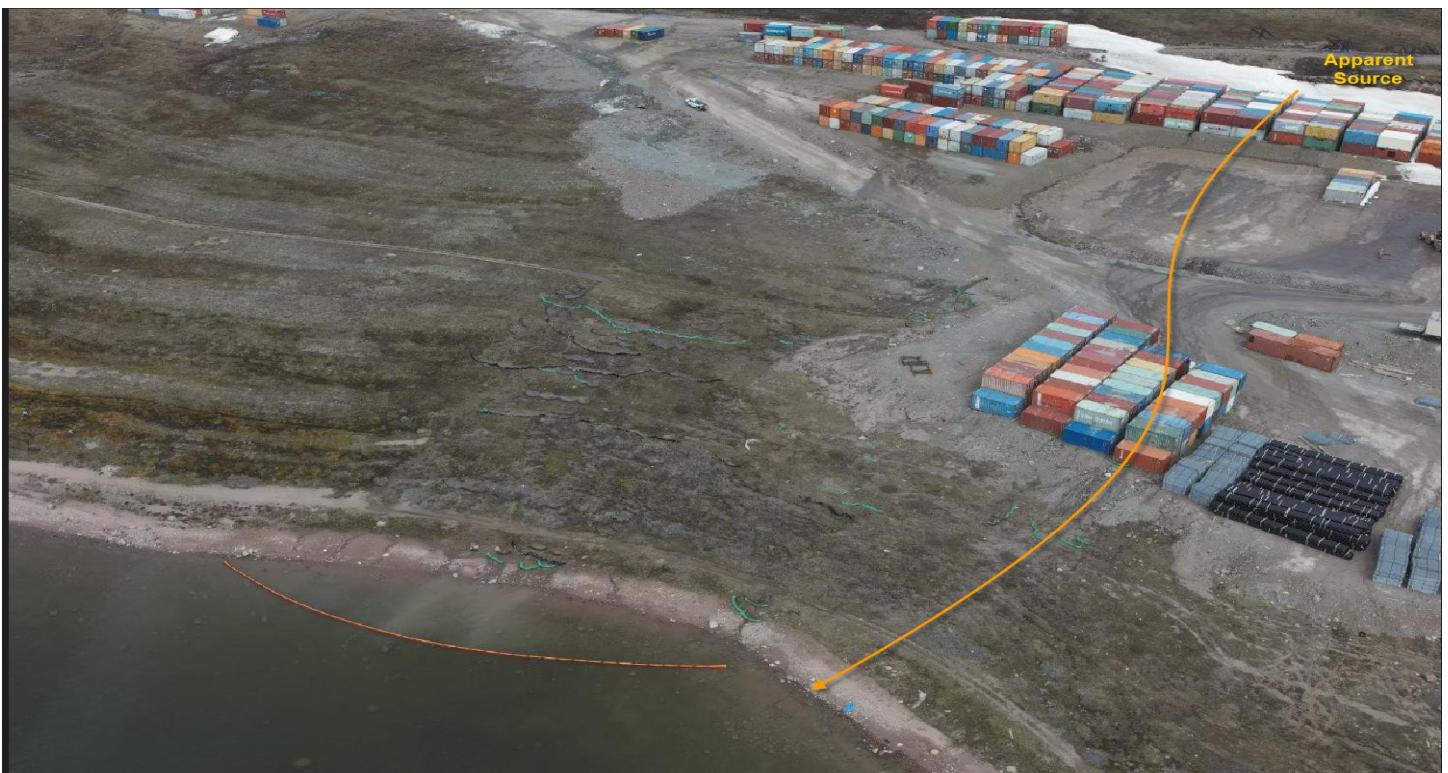
During a regular inspection of the Baker Lake Marshalling Facilities, a turbid flow of water was observed heading into the shore of Baker Lake, creating an apparent plume of total suspended solids (TSS) along the shore of the lake. The flows of water appeared to flow through the Agnico Eagle facilities, where heavy equipment was travelling to prepare the area for the upcoming maritime shipping season. The visible plumes in Baker Lake were mostly contained within a few meters from the shoreline, after which the water appeared clear based on visual observations in the field. See figure 1 below for general site layout information and flow path estimate.

Figure 1. Overall Layout - Aerial Picture with the original flow path observed on prior to Agnico Eagle's intervention.

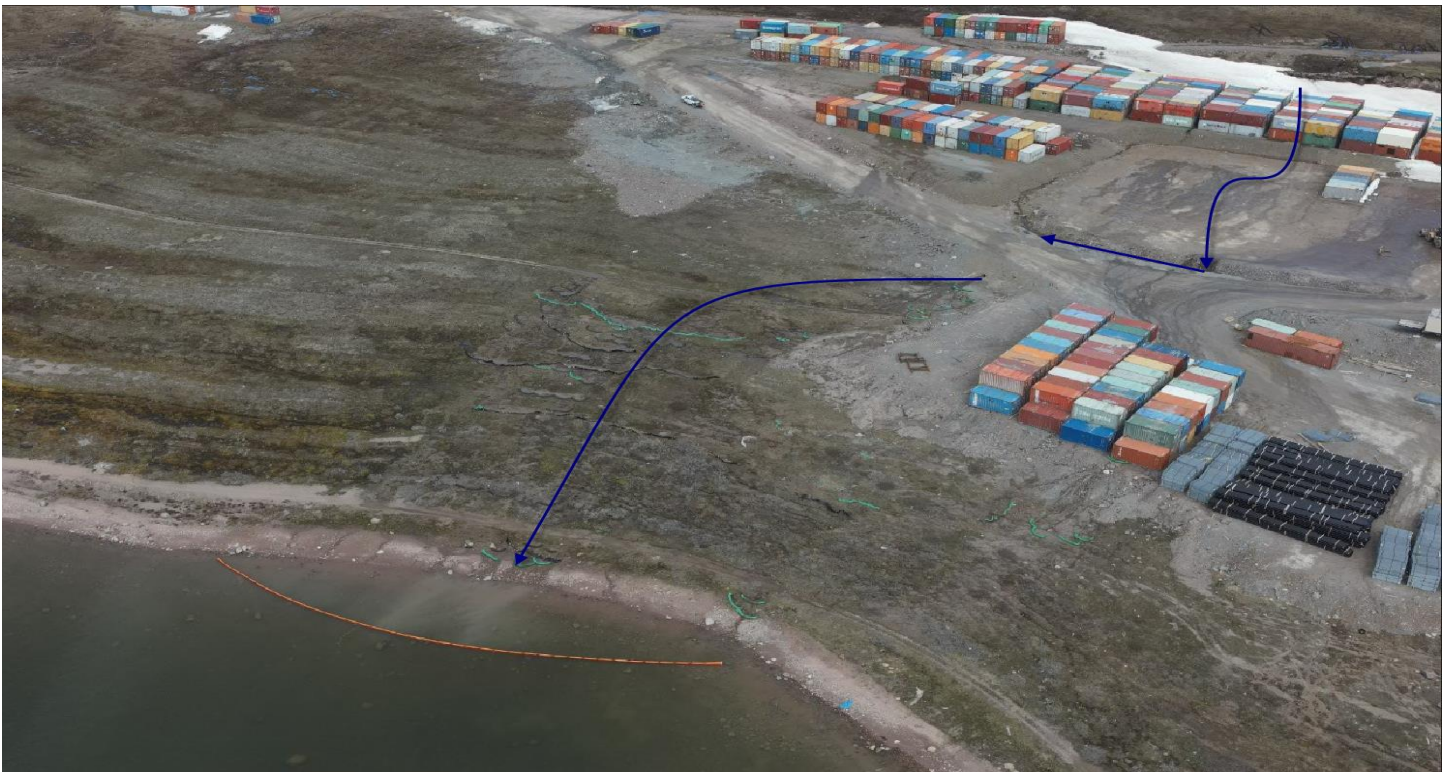
Figure 2. Aerial view of Baker Lake shore after Agnico Eagle's intervention and deployment of turbidity control measures showing the new flow path

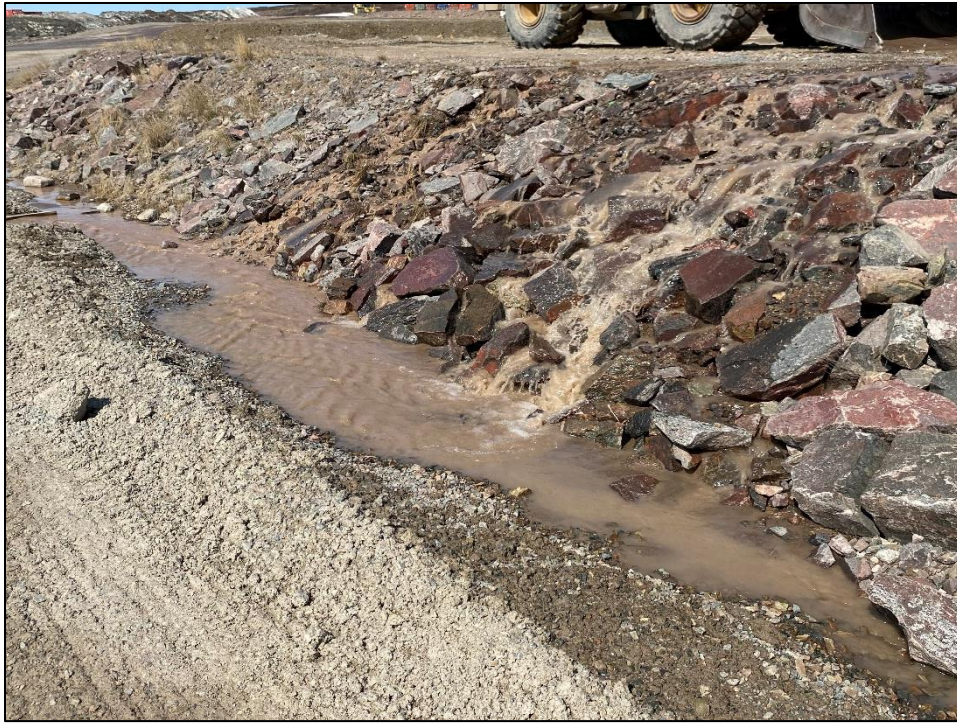
Figure 3. Upstream water flow prior to Agnico Eagle's mitigation (2023/06/03)

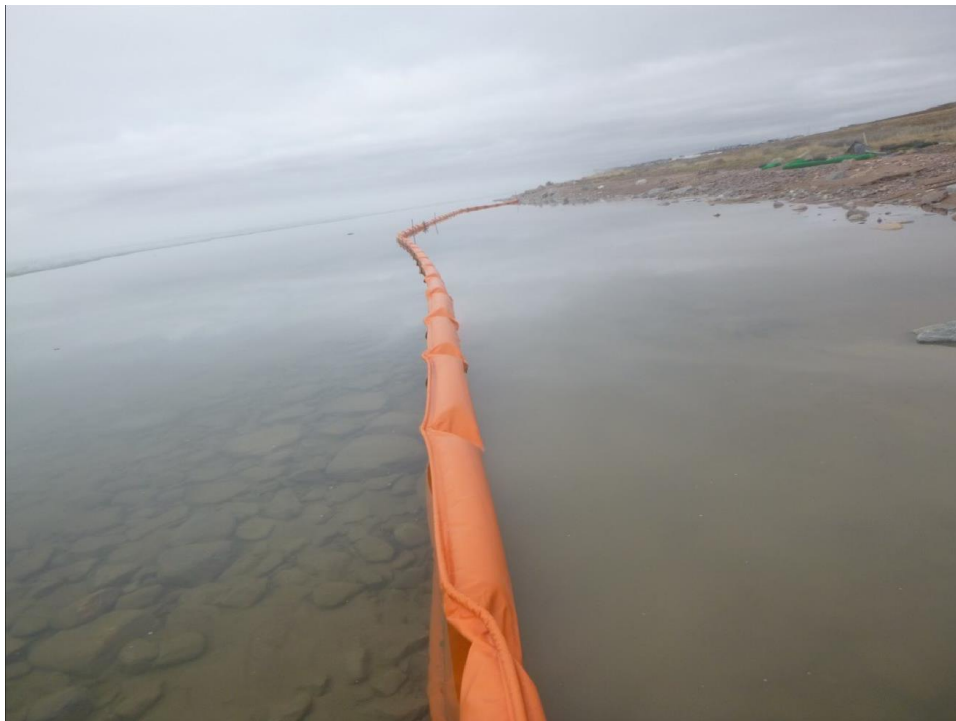
Figure 6. Contained turbidity & sediments at Baker Lake (2023/06/07)

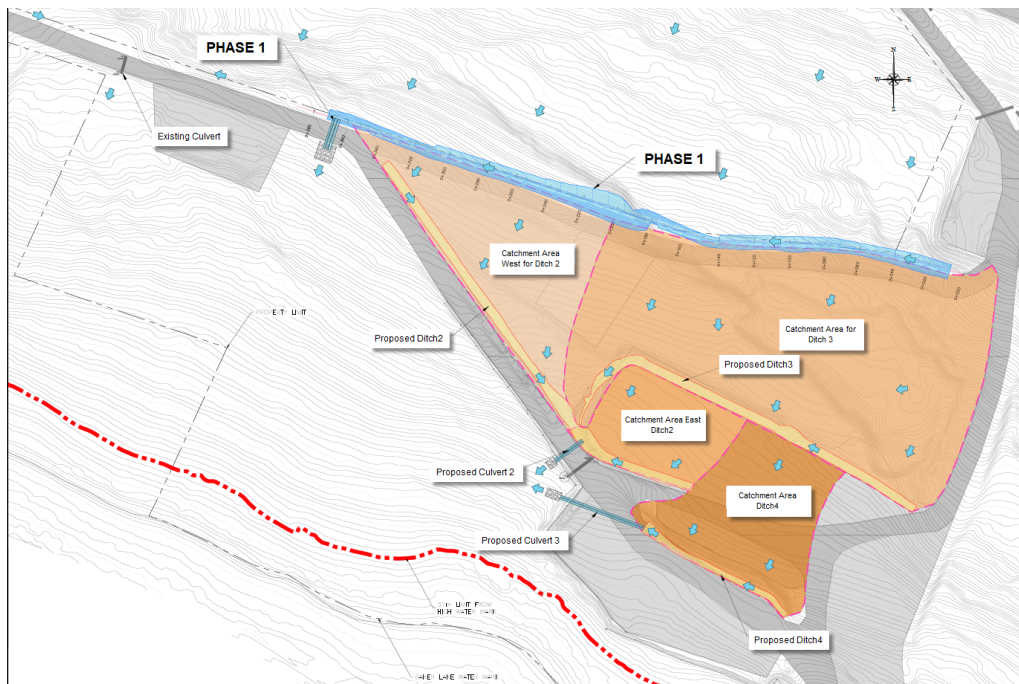
Figure 7. Design stages from the Water Management Improvement at Baker Lake Design Report

During the fall of 2022, Agnico Eagle hired an engineering consulting firm to develop a long-term solution to water management challenges encountered at the Baker Lake Marshalling facilities. The design includes a water diversion ditch, which will minimize water inflows onto the pad. Agnico Eagle submitted a 60-day design notice and a modification to the Water License, for which authorization was received on March 24th, 2023, to build a diversion ditch structure. The construction work for the first phase of this infrastructure is scheduled for late August/early September to avoid construction in the high-water flowing season and limit the chance of TSS transportation. The completion of the first phase will provide the most immediate benefit by creating a catchment area of ~46ha and will have the capacity to divert up to 1.9 m³/s of water upstream of the marshaling facility. Figure 7 below presents the designed infrastructure layout.

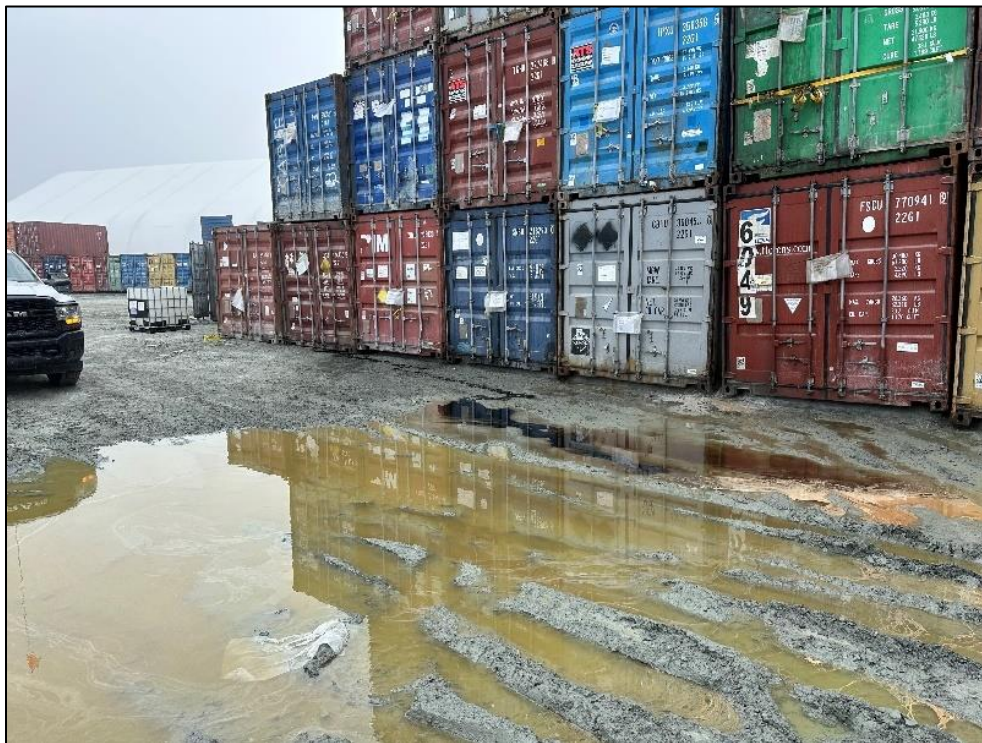
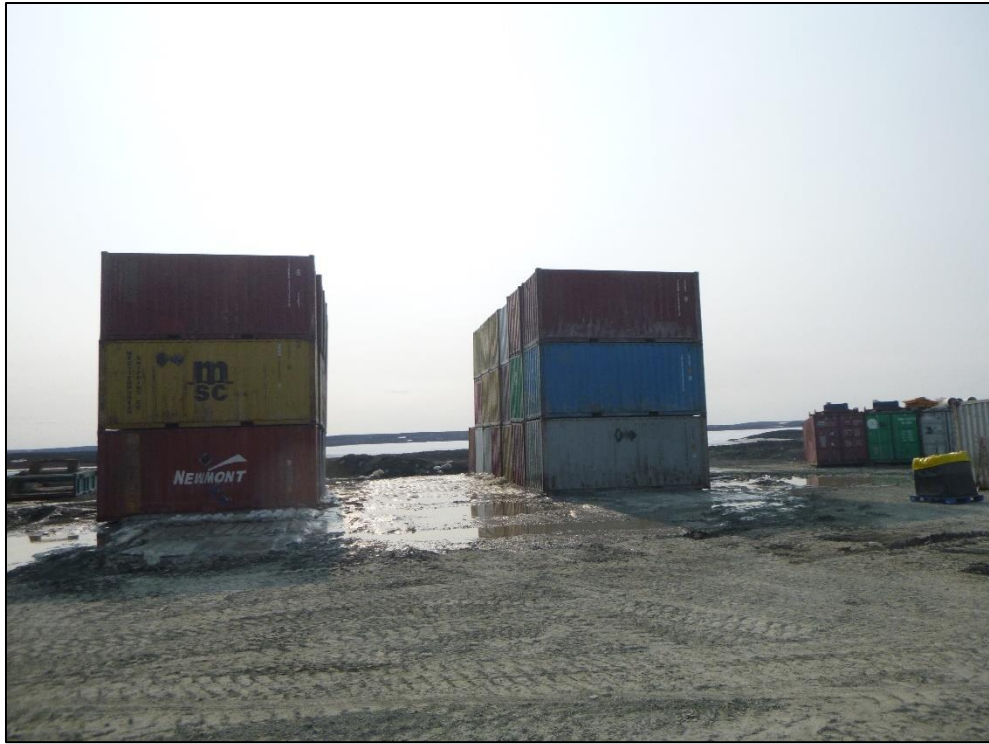
During an inspection of the warehouse laydown area, oil was observed leaking from a sea-can in the Waste Oil sea-can row. The sea-can was placed on the ground and the totes were removed. Upon further inspection, two totes had frozen and expanded causing oil to leak onto the sea-can floor as well as onto the ground within the laydown area.

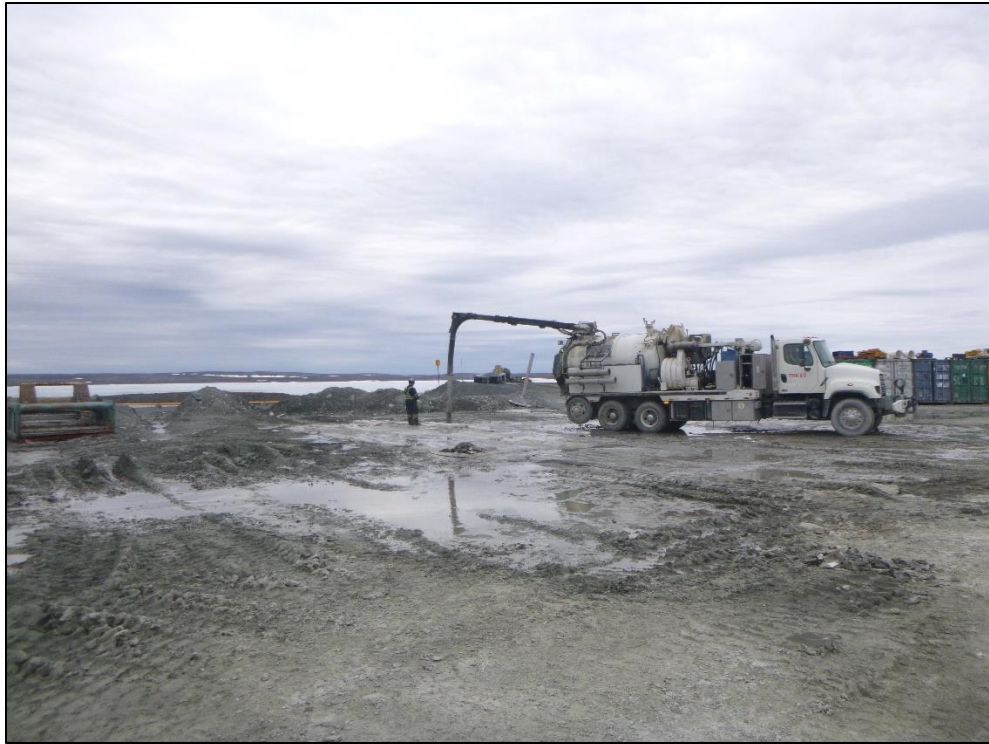
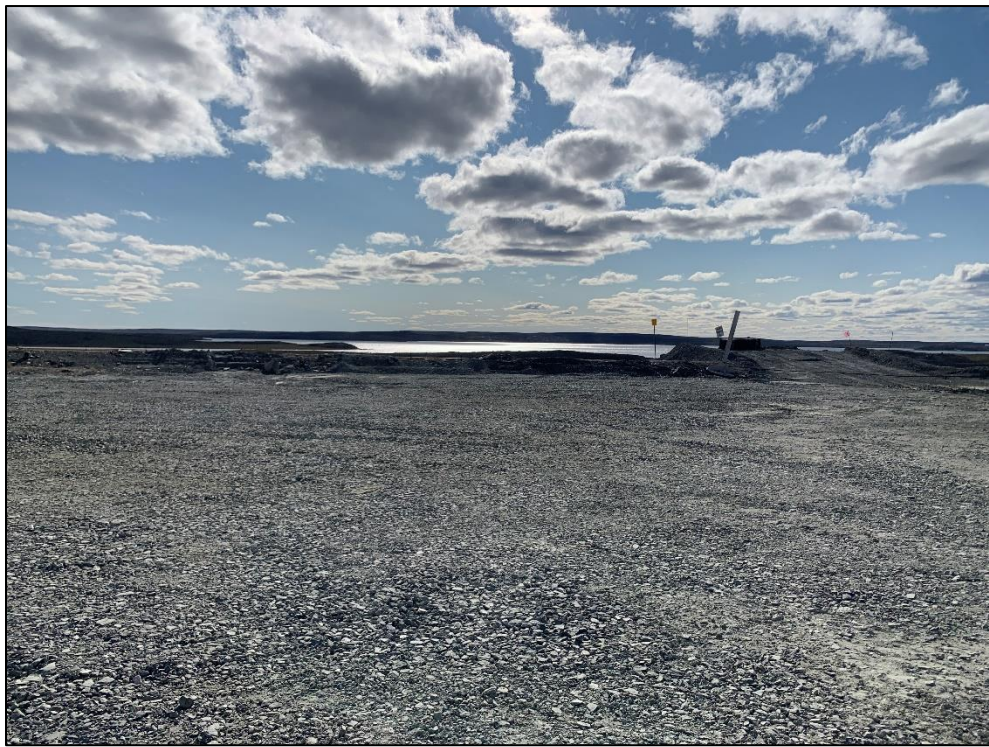
Absorbent materials were immediately placed on the ground to contain and collect the spill and additional sea-cans were removed to access the area. The vacuum truck, absorbent material and loader were used to collect and clean the area. ~ 6.5 m³ of contaminated soil was brought to the Meadowbank Landfarm. In addition, ~58m³ of contaminated water was collected and brought to the Storm Water Management Pond as per the Meadowbank Water Management Plan. This volume was due to freshet conditions around site during the time of the spill. A total of 2 quatrex bags (~2m³) filled with contaminated absorbent material was disposed of at the Meadowbank Hazmat in accordance with the waste management plan.

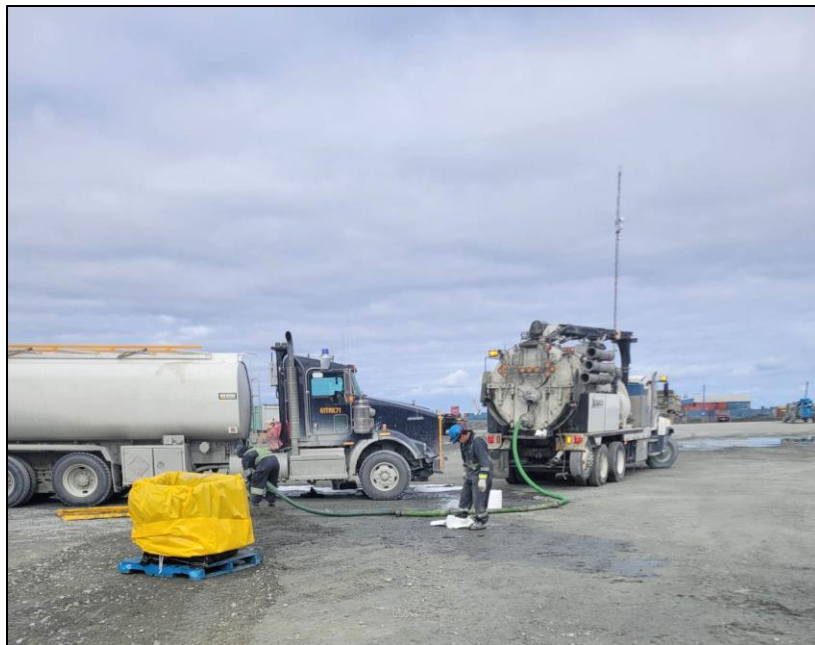
During refueling operations at the Meadowbank Mine, a fuel truck was fueling a piece of equipment when the fuel system failed. The failure resulted in the release of approximately 150L of diesel fuel onto the ground. The pump was immediately stopped, and a mechanic was called to investigate the spill.

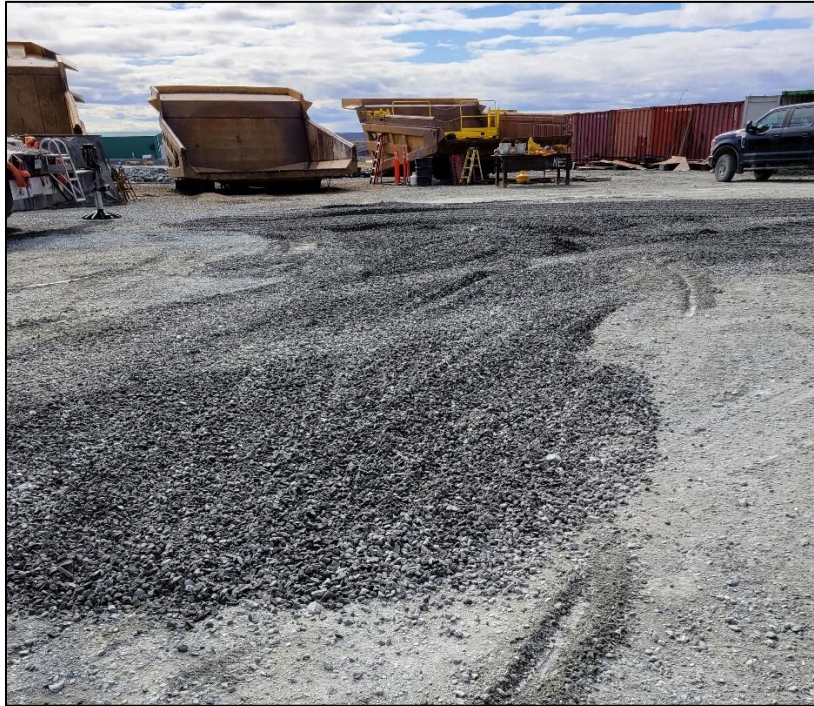
The contaminated area was immediately cleaned with a vacuum truck and loader. Approximately 10m³ of material was collected and brought to the Meadowbank landfarm. Absorbent material and all recovered liquid fuel was segregated and disposed of at the Meadowbank Hazmat.

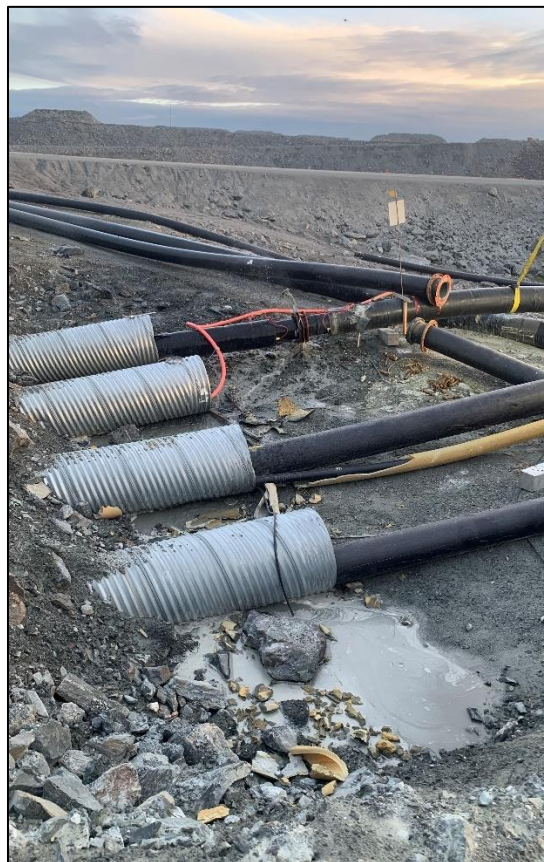
During maintenance of the tailings line at Meadowbank, a draining "pig" got stuck in the line. After an assessment of the tailings line to determine where the blockage occurred, the tailings line was disconnected at a flange to retrieve the "pig" and the tailings remaining in the line spilled onto the ground at the intersection of the west road and saddle name #4 intersection. The area where the spill occurred drains towards the Tailings Storage Facility.
