Appendix 23

Meadowbank 2023 GN Spill Reports

GN reference #: 2023-004

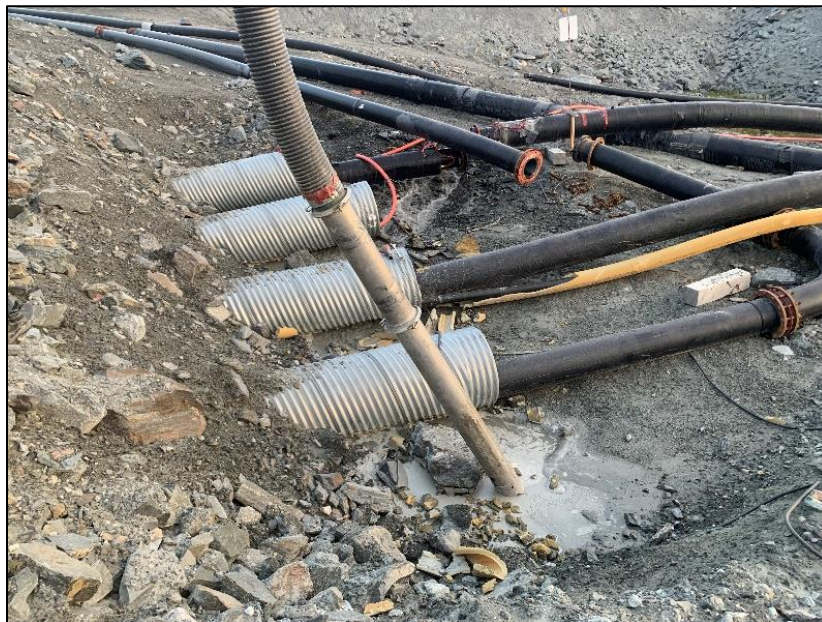
Before launching the draining pigs, two slurry pigs were introduced into the line to eliminate scaling and slurry buildup. As an added precaution, the line was then flushed with water for approximately 8 hours. Subsequently, draining pigs were deployed using air pressure to extract what was initially presumed to be water from the line but encountered an obstruction, causing them to get lodged in the pipeline. To address this issue, the tailings line was disconnected within the footprint of the Tailings Storage Facility. However, it was discovered that the obstruction was located further upstream, which compelled the operations team to open a flange away from the TSF vicinity. Prior to disconnecting the flange, a vacuum truck was on standby to collect as much residue as possible. Approximately 1 cubic meter of reclaim water and tailings residues was collected using the vacuum truck. The remaining contaminated material will be collected during the next scheduled maintenance operation.

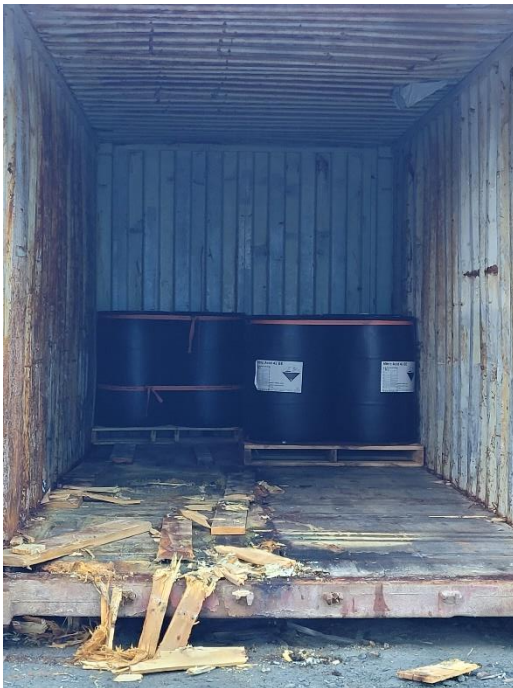
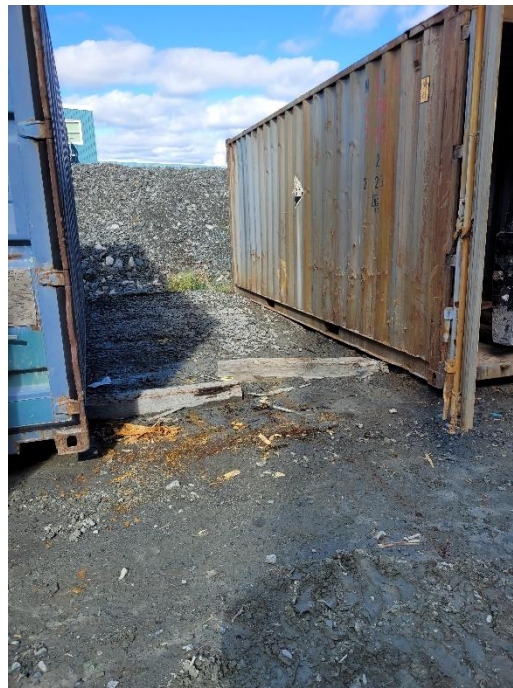
During operations at Meadowbank, drums of Nitric Acid were found in to be damaged in a sea can, resulting in areas of the sea can floor to be dissolved. Approximately 30 liters of nitric acid spilled onto the ground of the mill pad.

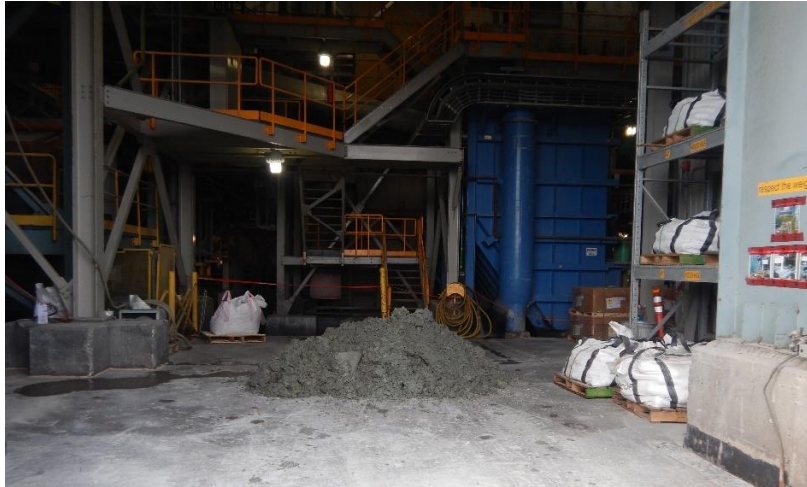
The drums were carefully extracted from the shipping container in order to enable the container handler to relocate it from the area for the purpose of excavating and removing the contaminated soil. An excavator was mobilized to excavate the contaminated soil, which was subsequently disposed of through the milling process.

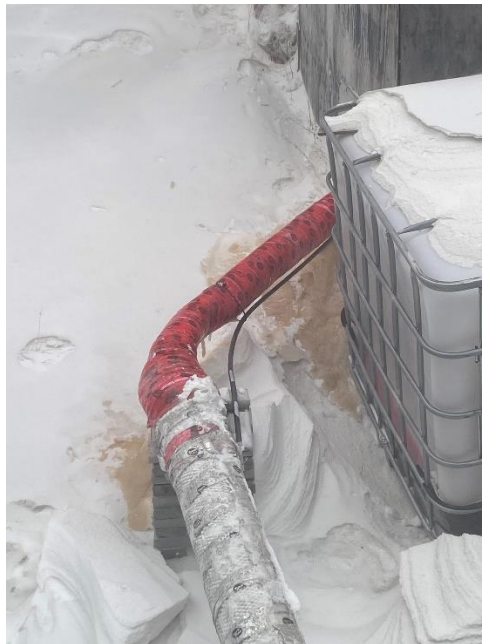
During a visual inspection of the gymnasium lift station (lift station 12), the sewage piping leading into the building was found to be leaking. As a result of the leak, approximately 15L of sewage water was spilled onto the frozen ground.

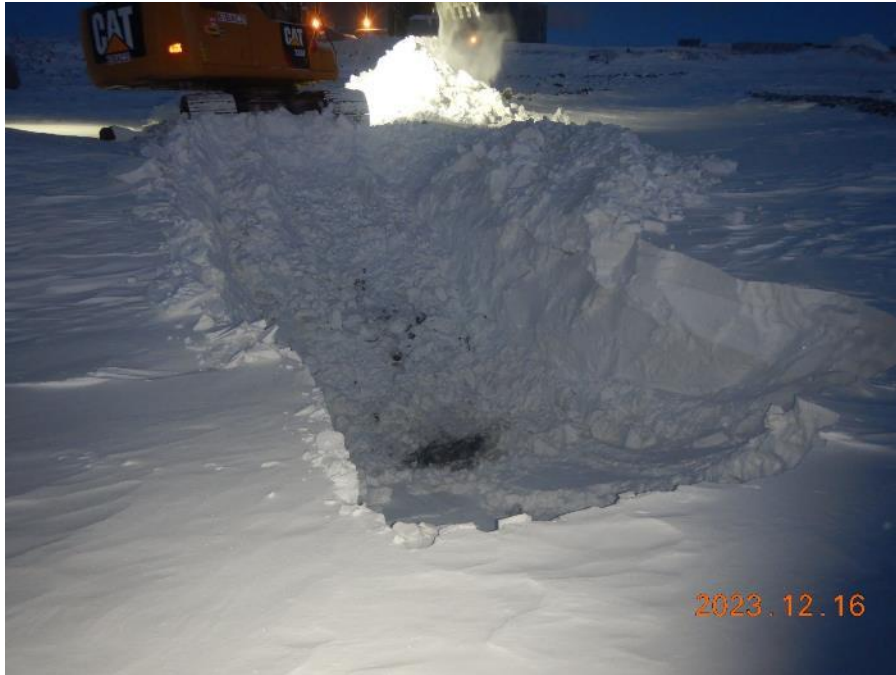
Figure 3. Snow removal from the Mill Seepage intercer trench Dec. 16th, 2023

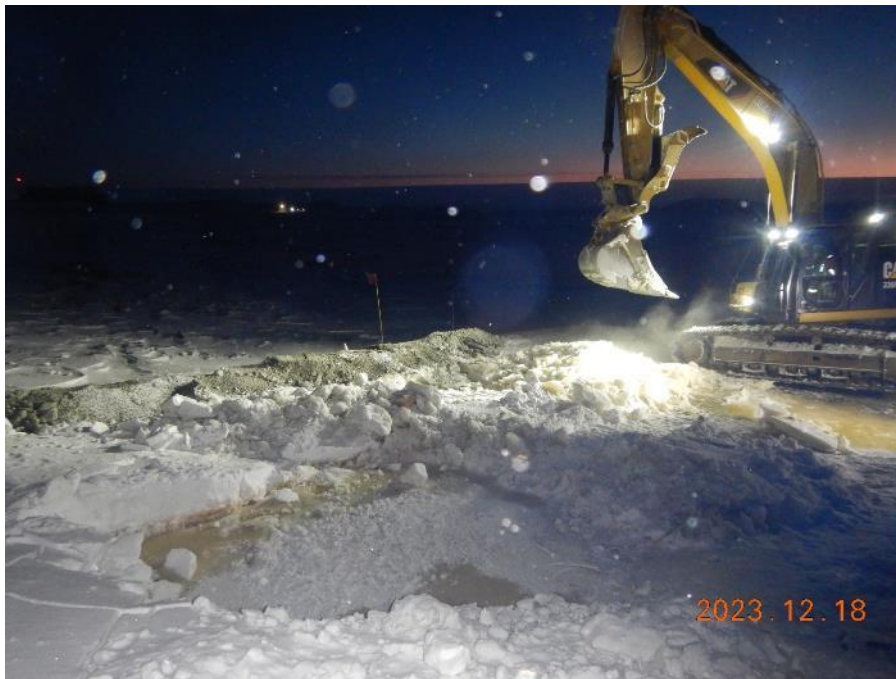
Figure 4. Containment berms being raised prior to excavation of snow/ice.

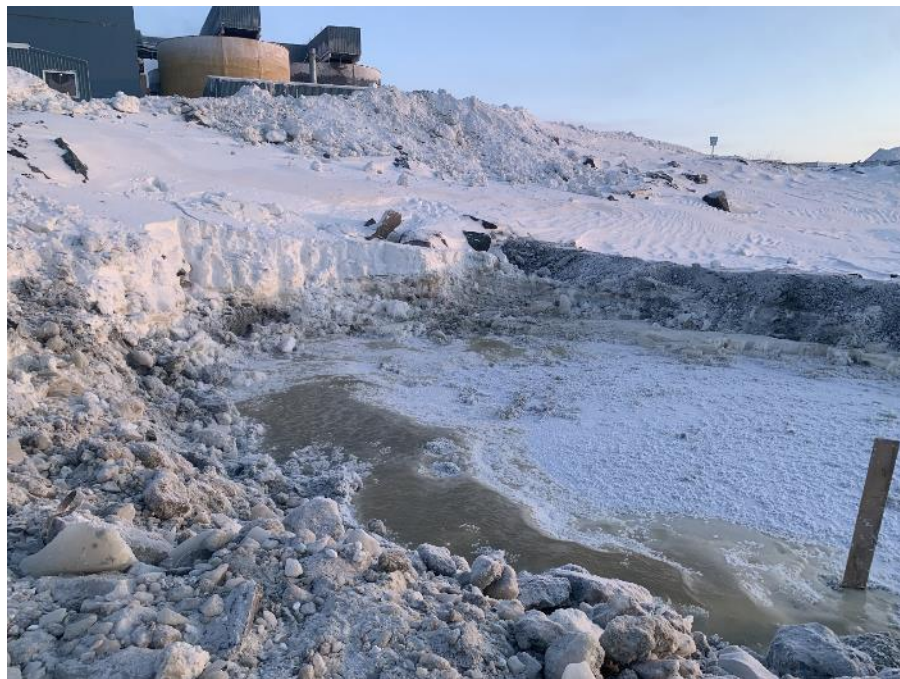
Figure 6. Water inflow on Dec. 20th, 2023

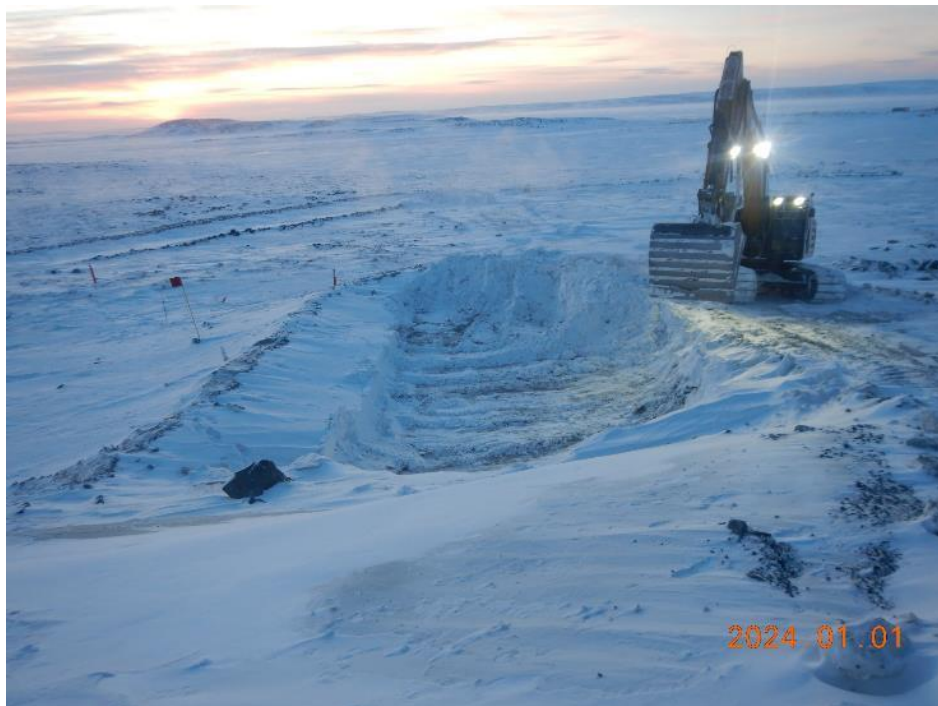
Figure 8. Water Inflow investigation Jan 1, 2024

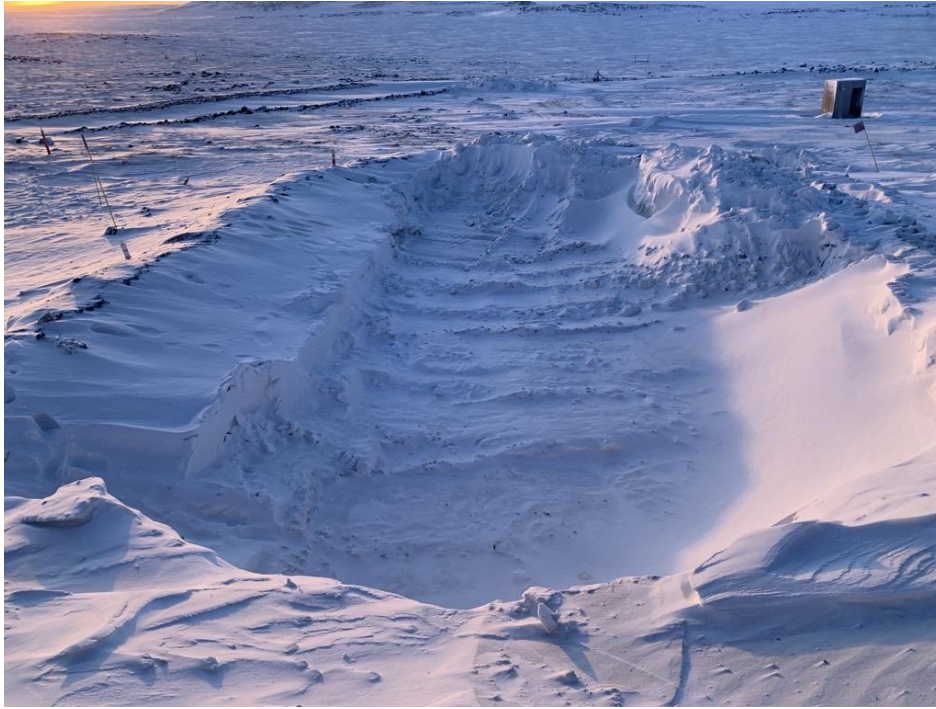
Figure 9. Water inflow investigation Jan 11th, 2024
