Appendix 24

Whale Tail 2023 GN Spill Reports

2023-01-14 WTM 900L Windshield Washer Fluid

GN reference #: 2023-015

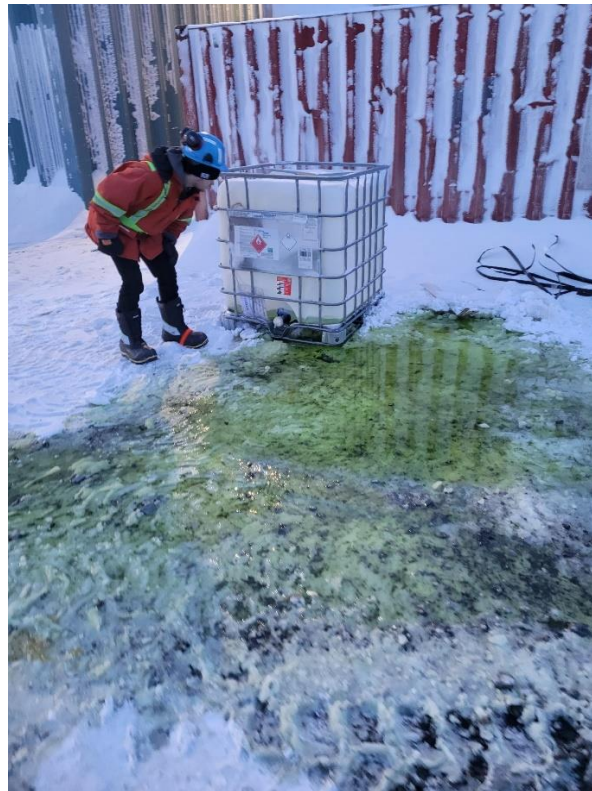
During operations at the Whale Tail Mine, a loader operator was collecting a tote of windshield washer fluid from outside the warehouse. The loader's forks punctured the reservoir resulting in its contents being empty onto the ground.

Punctured tote caused by misalignment of the equipment forks.

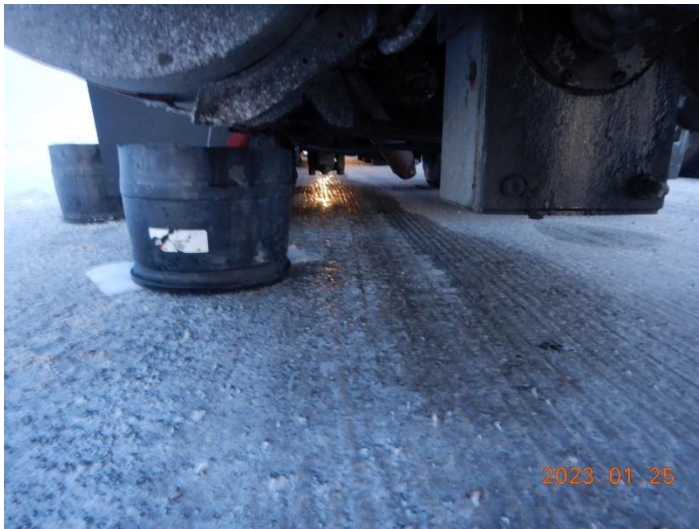
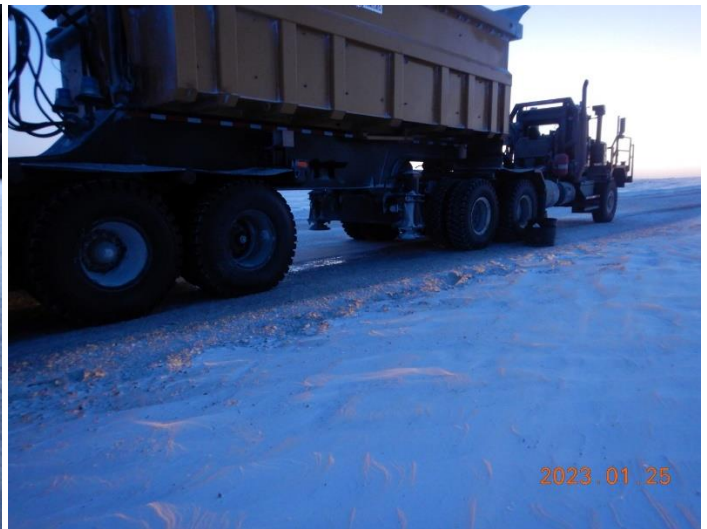
While travelling southbound of the Whale Tail Haul Road, a Long-Haul Truck broke down at km 136.7. The operator stopped the equipment on the side of the road to inspect the damage. During the assessment, the driver notified that a mechanical part had punctured the fuel tank.

Equipment Failure

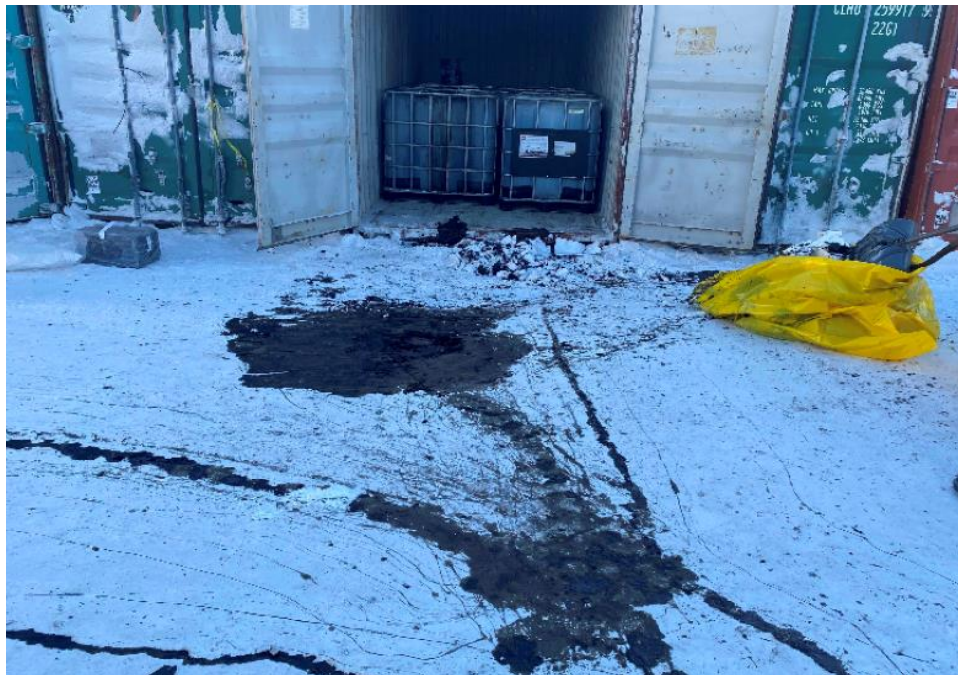
During operations at the Whale Tail Mine, a loader operator was placing waste oil totes into a seacan when they noticed the corners of both totes were leaking onto the ground.

Punctured/damaged tote caused by the equipment forks.

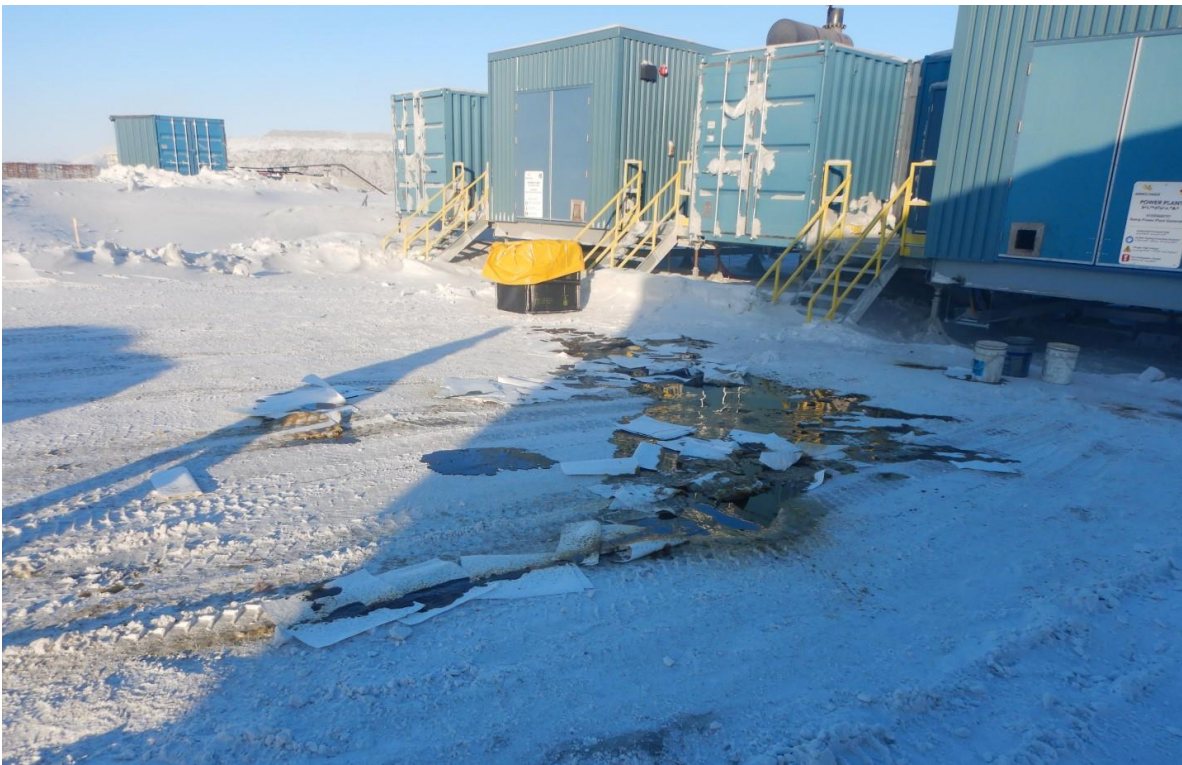
During operations at the Whale Tail Mine, a worker was draining the oil from GENSET07 into a tote. The worker went inside the GENSET enclosure and when they returned to the tote, it was overflowing into the maintenance truck and onto the ground.

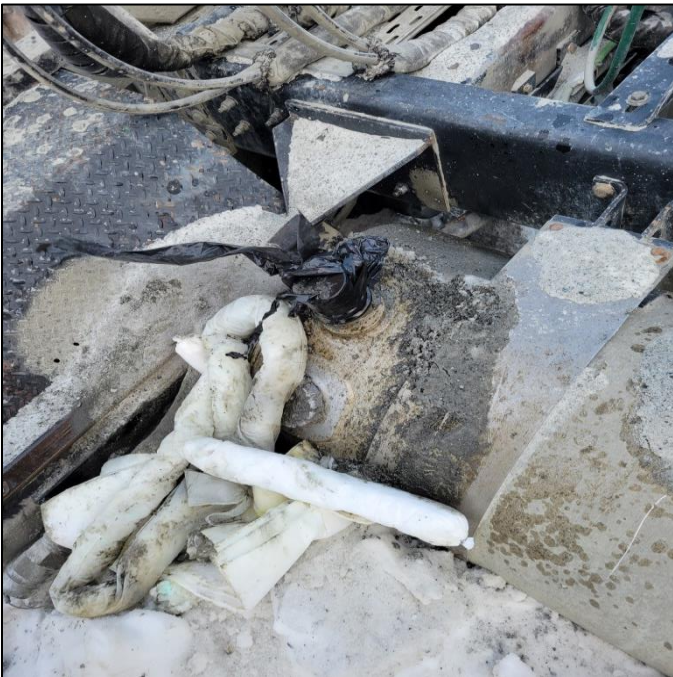
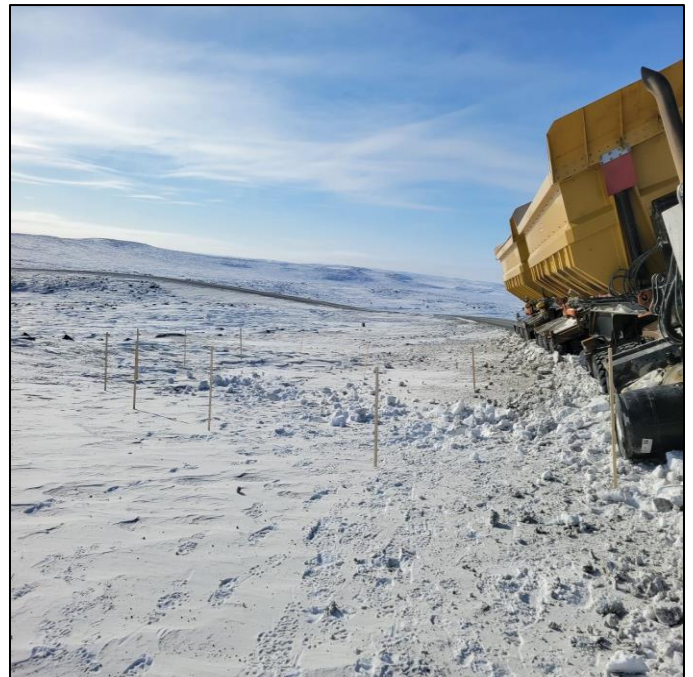
During operations at the Meadowbank complex, a Long Haul truck (LHT) was traveling northbound on the Whale Tail Haul Road and yielded right of way to a loaded southbound LHT. The operator of the northbound LHT was too close to the shoulder of the road and was pulled into the snowbank off the road. Upon investigation, a fuel leak from the filler neck on the side fuel tank was observed.

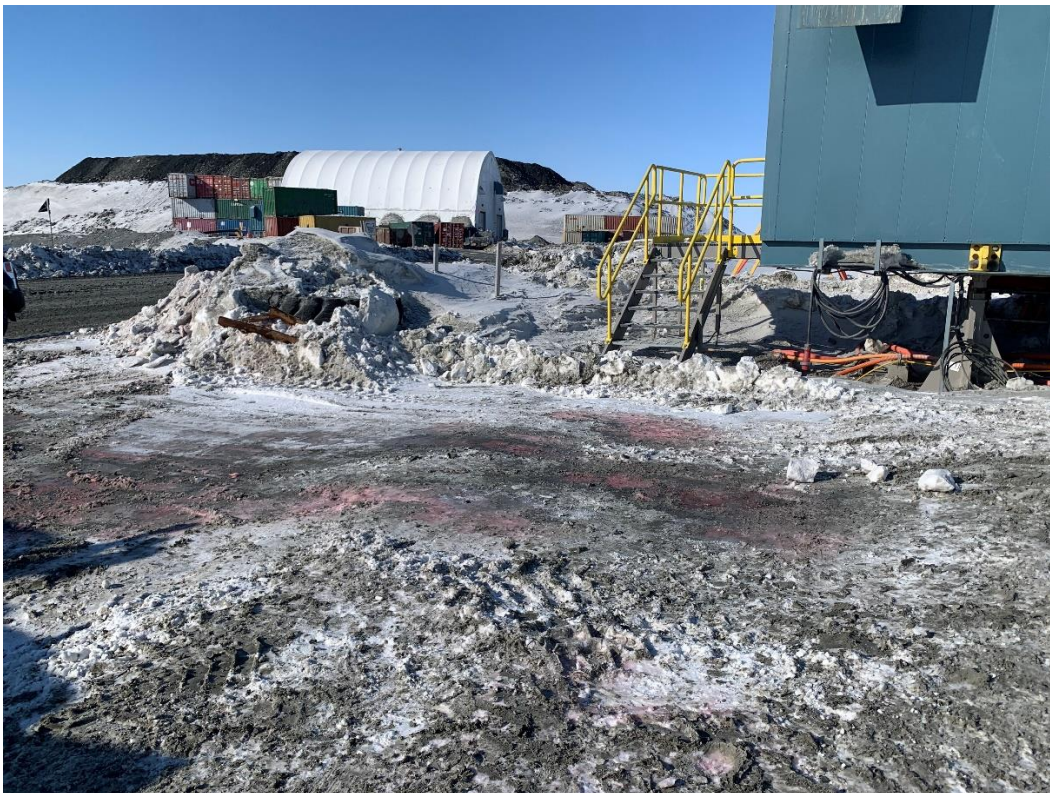
During operations at the Whale Tail Mine, an operator went to move a tote of coolant with a skid steer and punctured the tote with the forks causing the tote to leak on the ground. The operator placed the tote on its side to stop the leak.

Punctured tote caused by misalignment of the equipment forks.

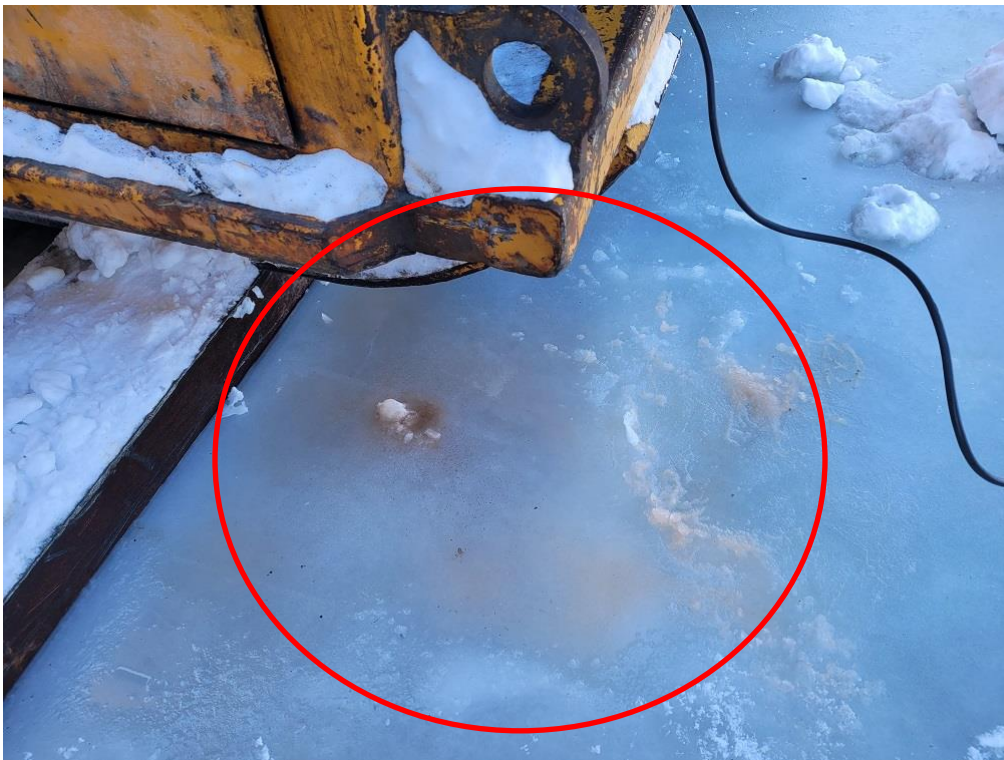
During operations at Whale Tail Mine, an employee was refueling the diamond drill and noticed that fuel was coming out of the small hole (breather) on the connection cap located on top of the drill reservoir.

Defective fuel cap in combination with Human Error

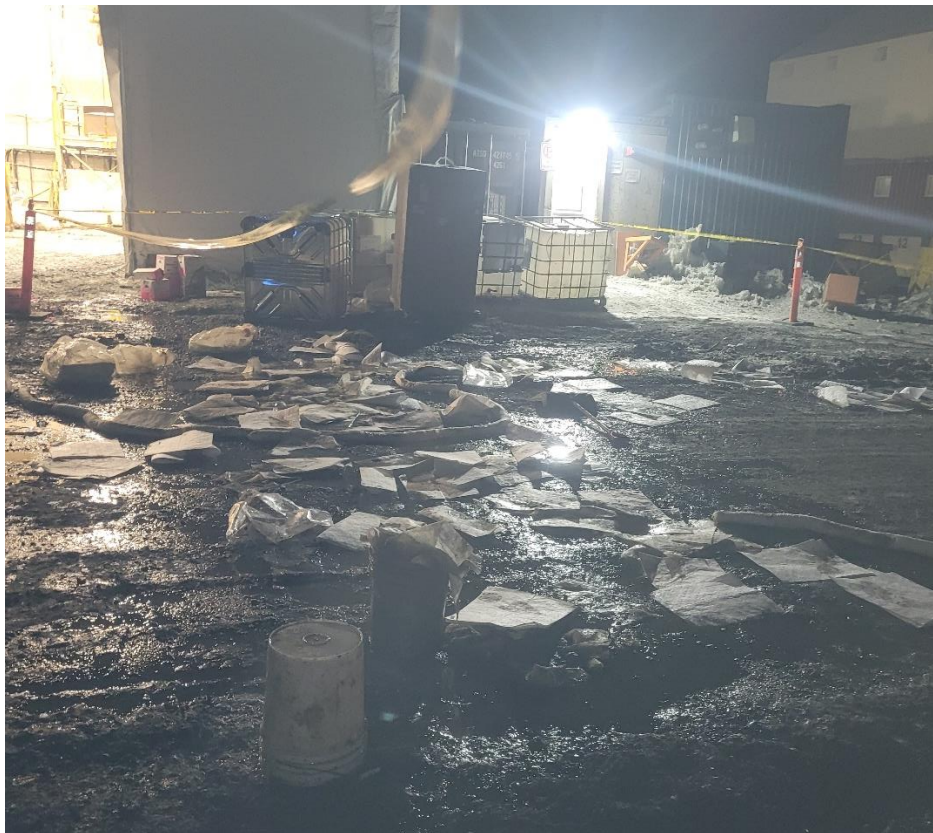
During night shift operations at the Whale Tail Mine, a tote containing 1000L of hydraulic oil was punctured by equipment during the process of moving the reservoir, causing about 500L of oil to leak onto the ground of the service building pad. The tote was flipped over to prevent additional oil from leaking out of the container.

Punctured tote caused by misalignment of the equipment forks.

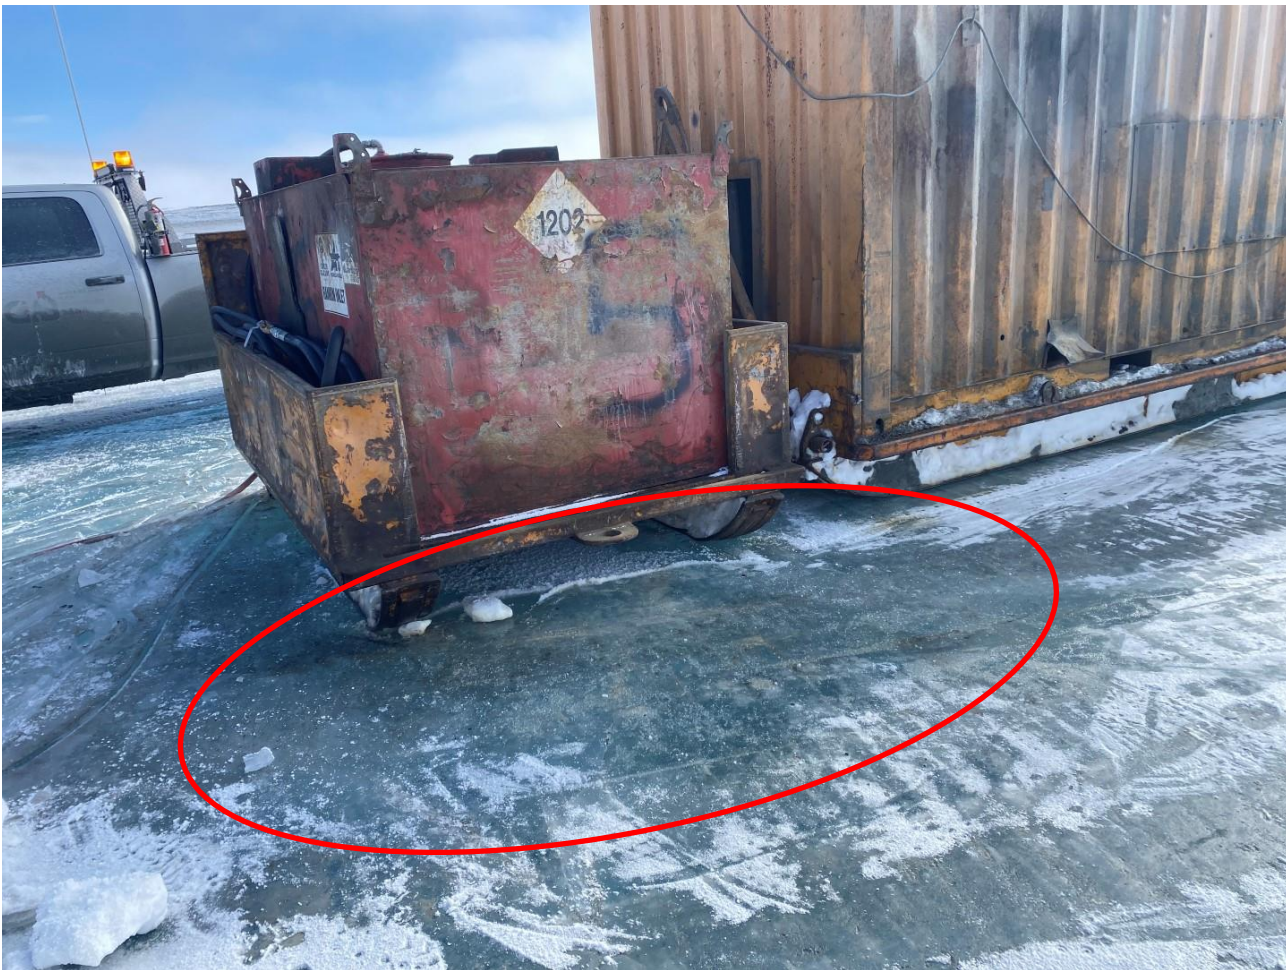
During an inspection of the fuel containers an employee observed a small leak coming from the sleigh holding the fuel tank. Upon further investigation the fuel line connected to the tank was found to be leaking from a faulty valve.

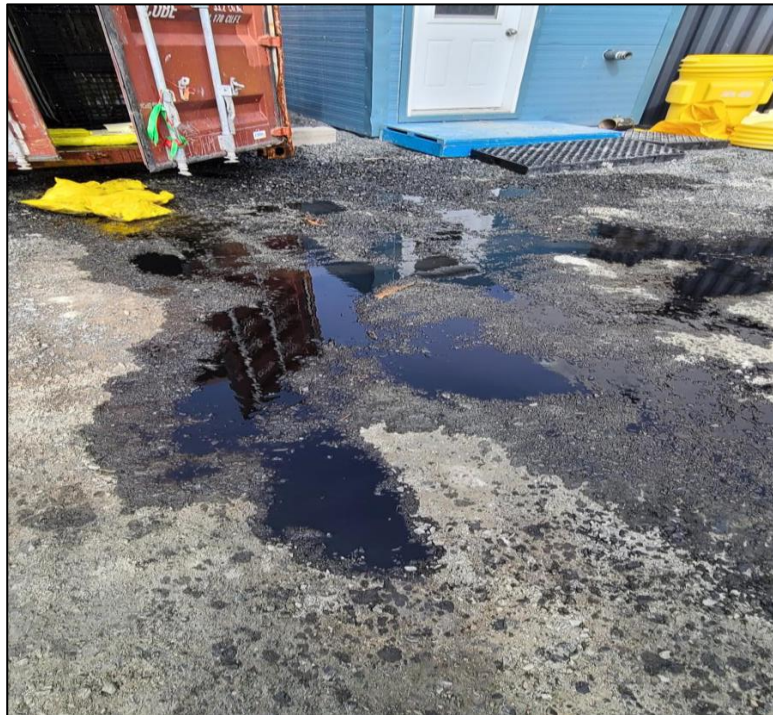
During operations at the Whale Tail Mine, an operator was placing a waste oil tote into the seacan with a forklift. While trying to adjust the tote, the forks on the forklift punctured 2 totes of waste oil, causing a spill onto the ground and floor of the seacan.

Punctured tote caused by misalignment of the equipment forks.

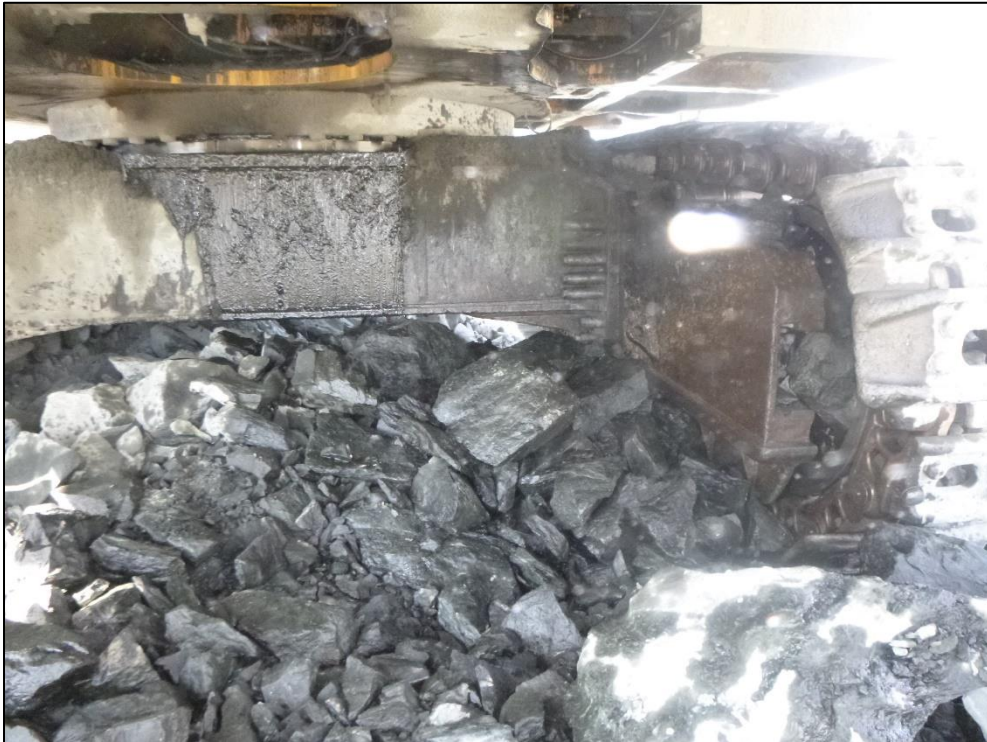
During operations at the Whale Tail Mine, the excavator was in the motion of turning around on a pad when a rock boulder made contact and damaged the hydraulic system of the equipment resulting in 2.8m3 of hydraulic oil to spill onto the ground of the Whale Tail Pit. The spill occurred in an active excavation area.

Hydraulic system was damaged by a large boulder.

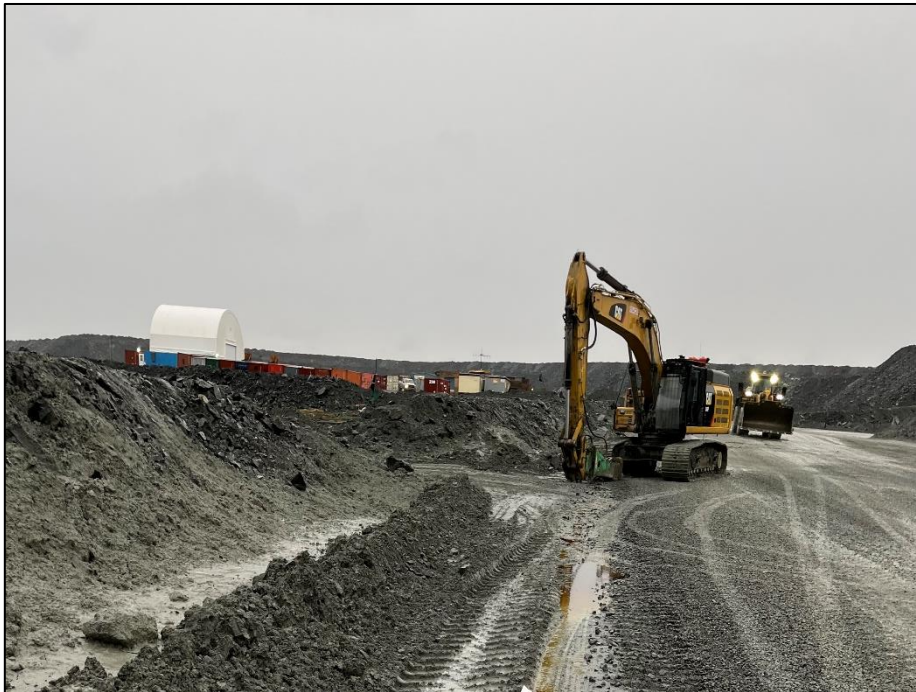
During operations at the Whale Tail Mine, the excavator was in the motion of walking to a pad when a hydraulic hose broke resulting in 250L of hydraulic oil to spill onto the ground of the Whale Tail Pit Road. There is no plan currently to excavate this area of the roadway.

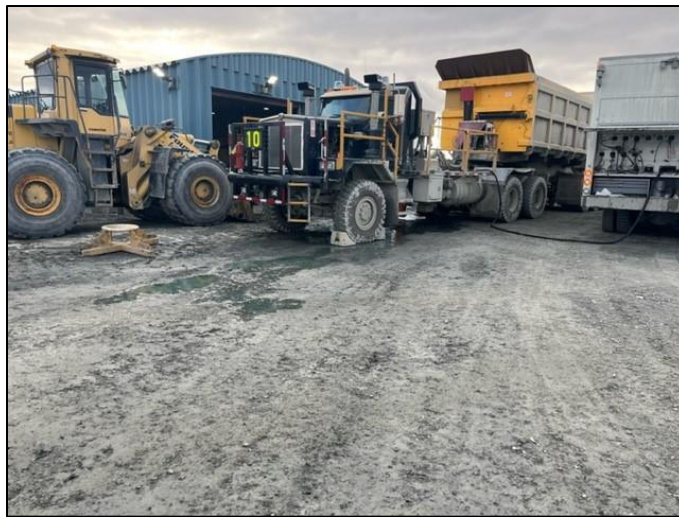
While replacing a tire on long haul truck 10 at the Whale Tail Mine, a loader made contact with the refueling adapter. The damage from the contact resulted in the release of approximately 200L of diesel fuel on the ground.

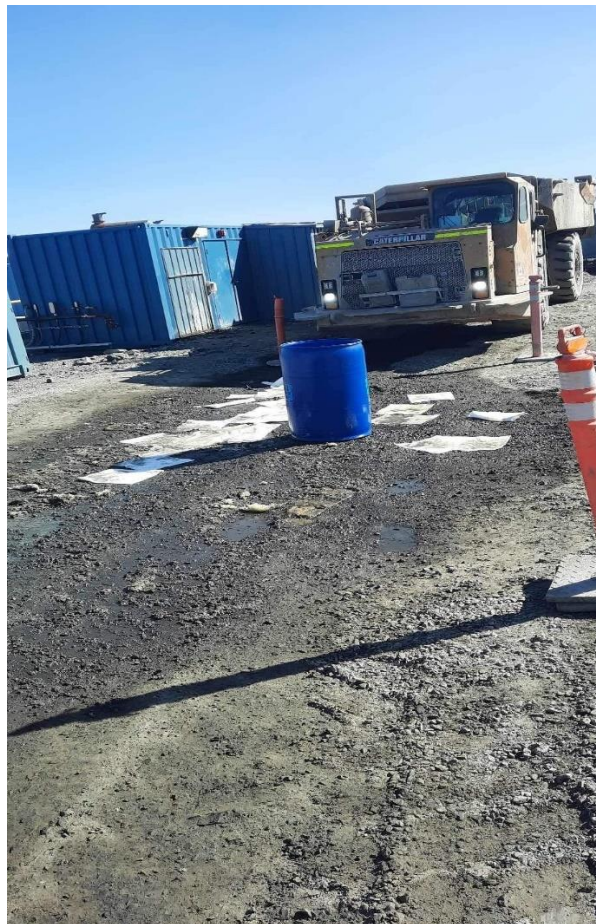
While refueling an underground scoop at Whale Tail Mine, the operator left the fuel line unattended to perform another task behind the scoop. When the operator returned from behind the scoop he observed the fuel overflowing, resulting in ~150L of diesel fuel to spill onto the ground.

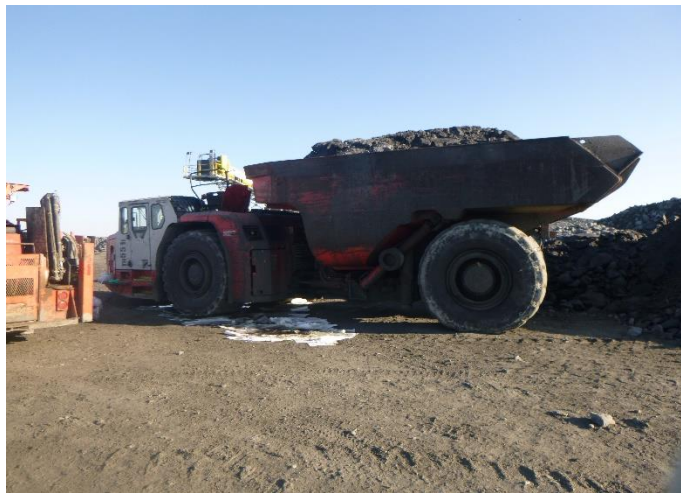
A haul truck experienced a hydraulic hose failure while dumping its load, resulting in an accidental spillage of 250L of hydraulic oil on the ground at the underground ore pad.

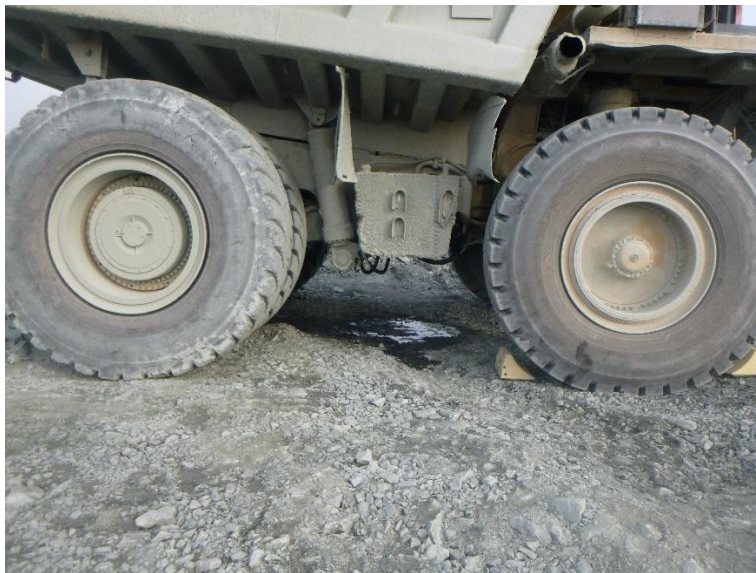
During the operations at the Whale Tail Mine, the haul truck's hydraulic system was damaged when it accidentally made contact with a rock while maneuvering into position for unloading. This incident led to the spillage of approximately 600 liters of hydraulic fluid onto the ground of the Whale Tail Rock Storage Facility. The spill occurred in an active deposition area.

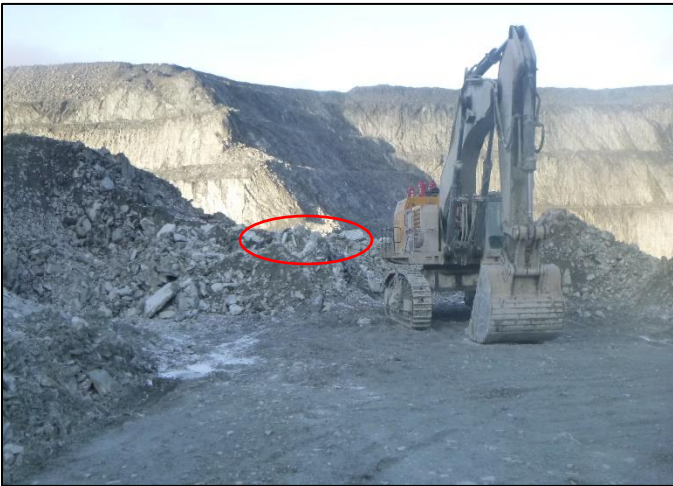
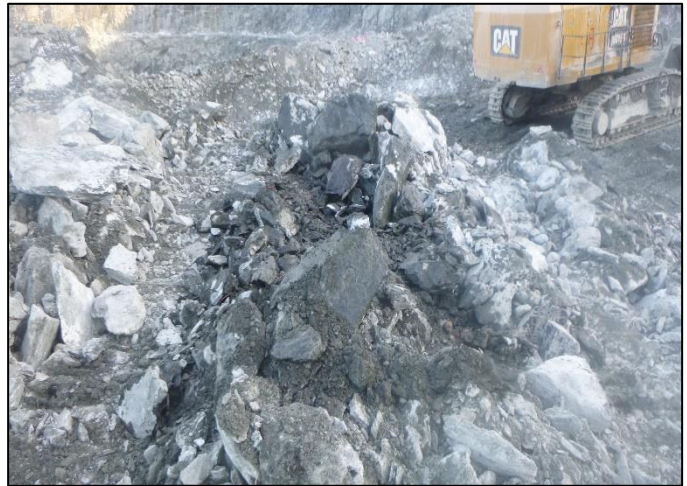
During operations at the Whale Tail Mine, an excavator suffered a hydraulic component failure while loading equipment, causing 200 liters of hydraulic oil to spill onto the ground at the bottom of the IVR pit. The spill occurred in an area of active excavation within the IVR Pit.

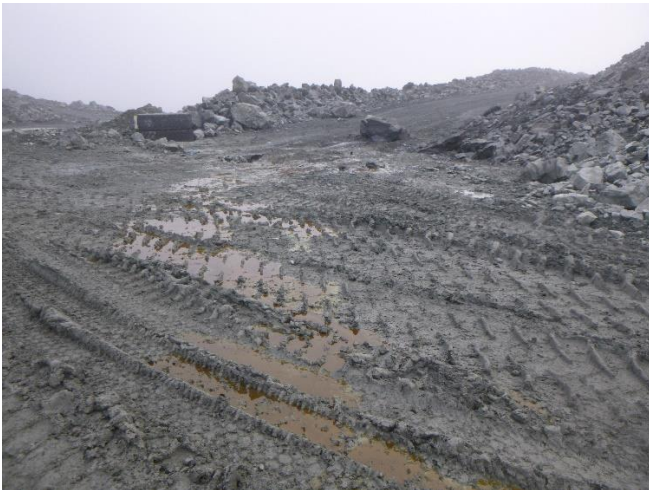
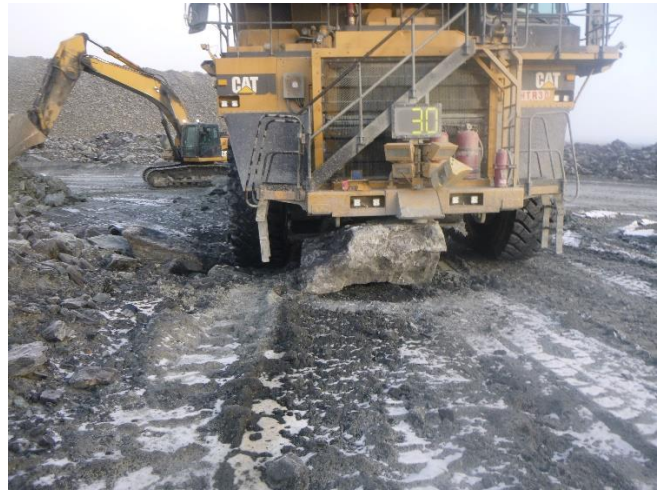
During operations at the Whale Tail Mine, a haul truck ran over a large rock as he was heading to the stockpile. This cause the hydraulic hose to disconnect from the equipment, causing 300 liters of hydraulic oil to spill onto the ground at the Pad K.

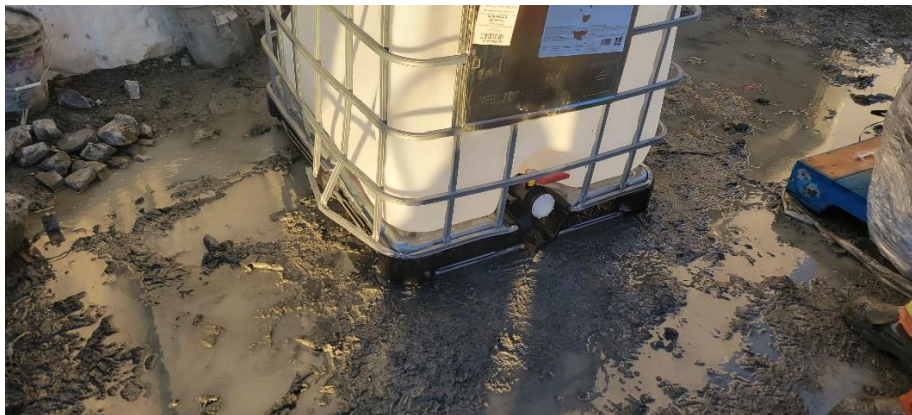
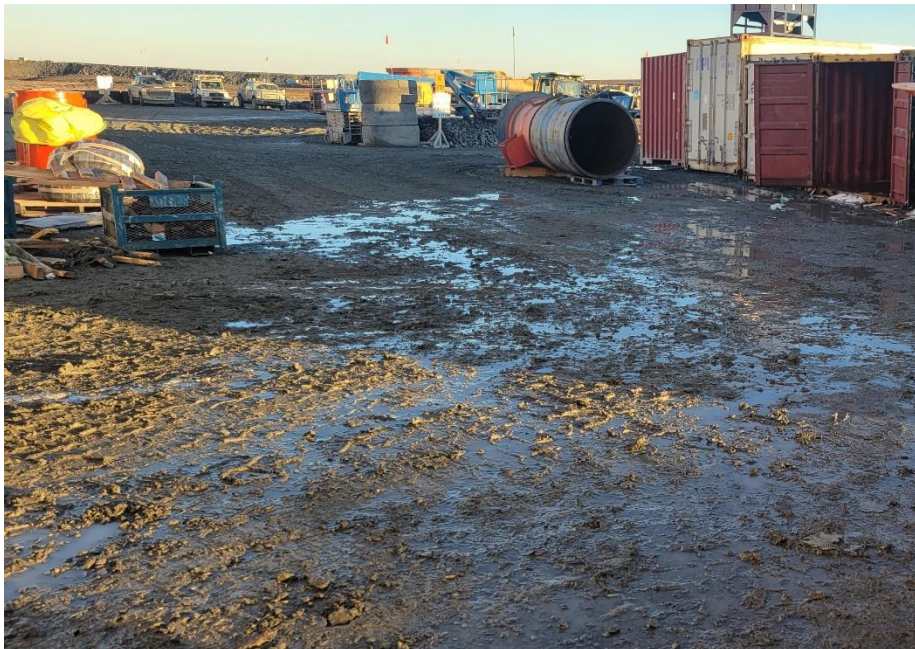
During operations at the Whale Tail Mine, an operator was trying to move a tote with a forklift, but due to bad visibility caused by the sun, the tote was punctured causing a spill onto the ground.

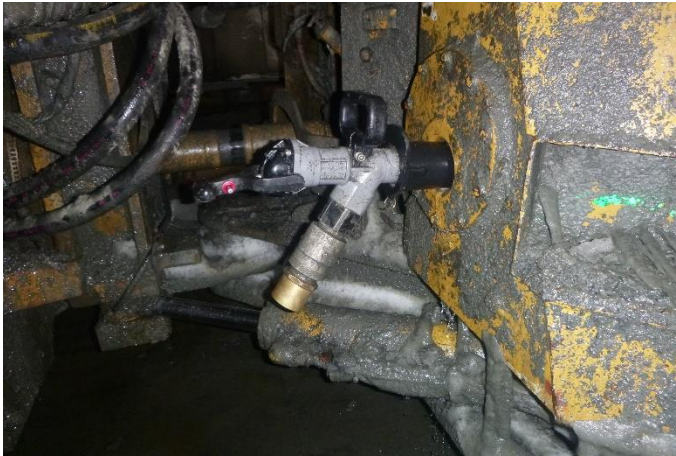
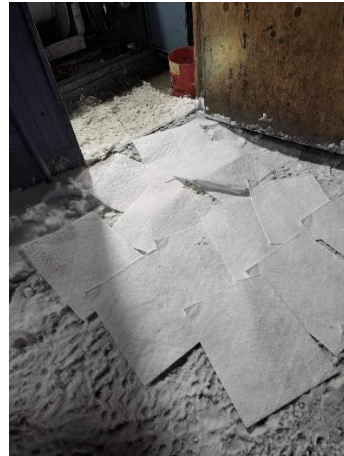
During the refueling process at Whale Tail Mine, an operator forgot to remove the fuel nozzle from their equipment prior departing the underground fuel farm. The damage to the fuel line resulted in ~300L of diesel fuel to spill within pump shack and onto the ground within the lined area of the fuel farm.

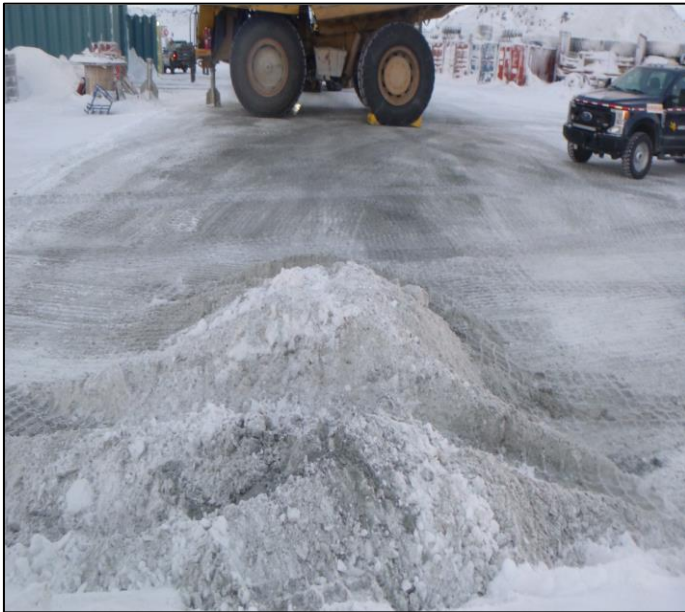
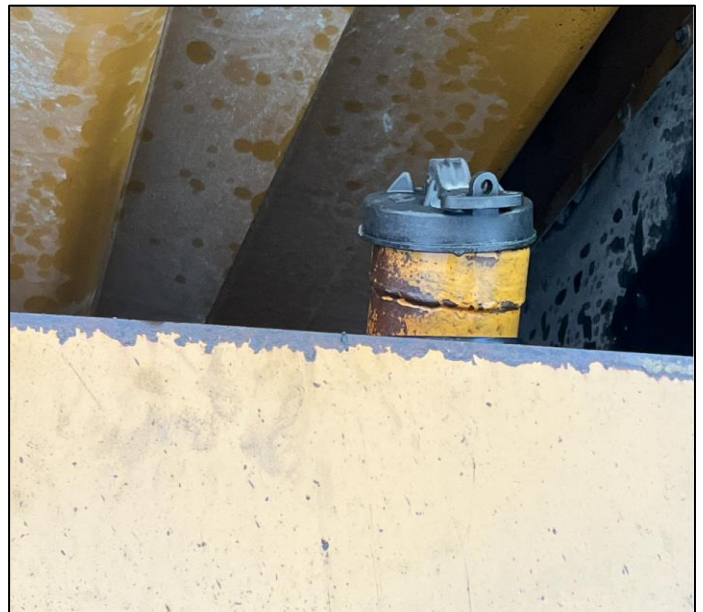
During operations at Whale Tail Mine, a fuel truck operator was fueling Haul Truck # 7 at the Fountain tire parking lot and over fuelling of the tank resulting in a spill of ~200L of diesel fuel.
