Meadowbank and Whale Tail 2023 Annual Geotechnical Inspection

2023 Annual Geotechnical Inspection

Meadowbank Complex, Nunavut

1623-2146800623-RA-Rev0

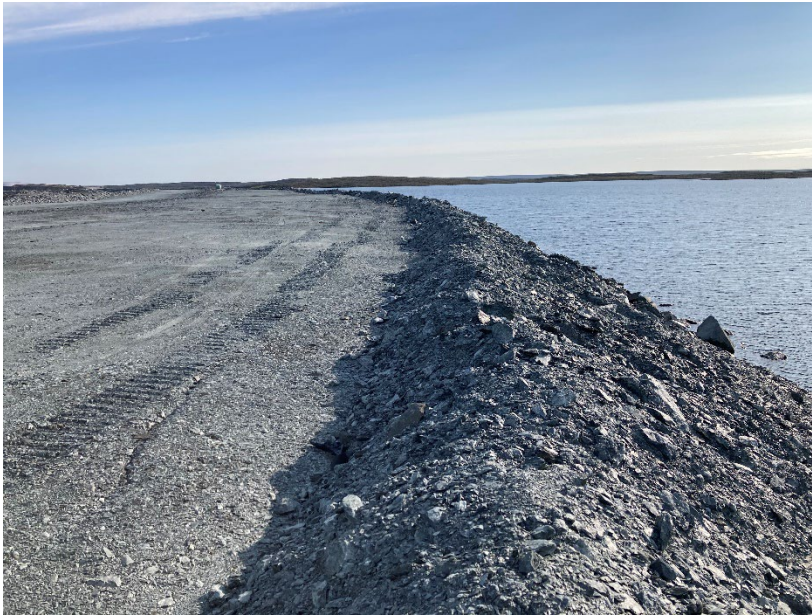
Photograph A3-19 Bay Goose Dike

Description: From approximately Sta. 31+475, looking west at the crest. Old cracks are disappearing.

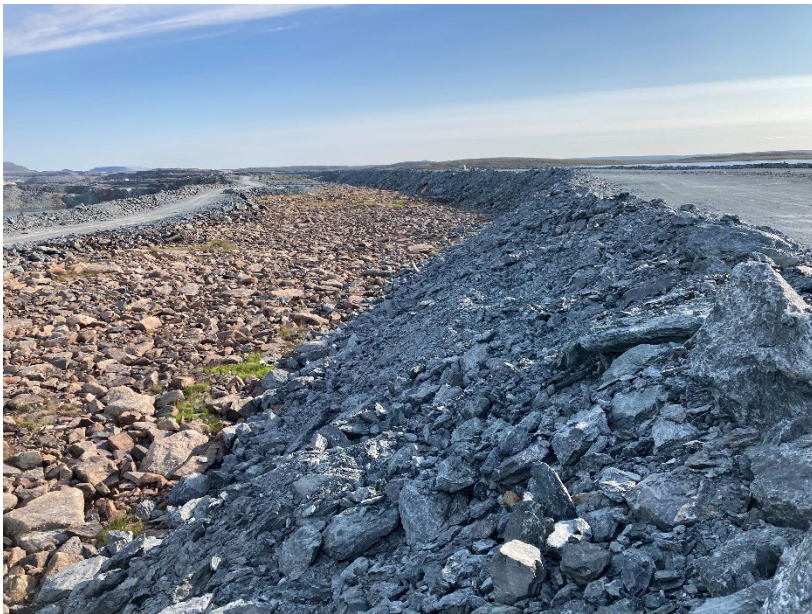
Photograph A3-20 Bay Goose Dike

Description: From approximately Sta. 31+475, looking northeast at the crest. Old cracks are disappearing.

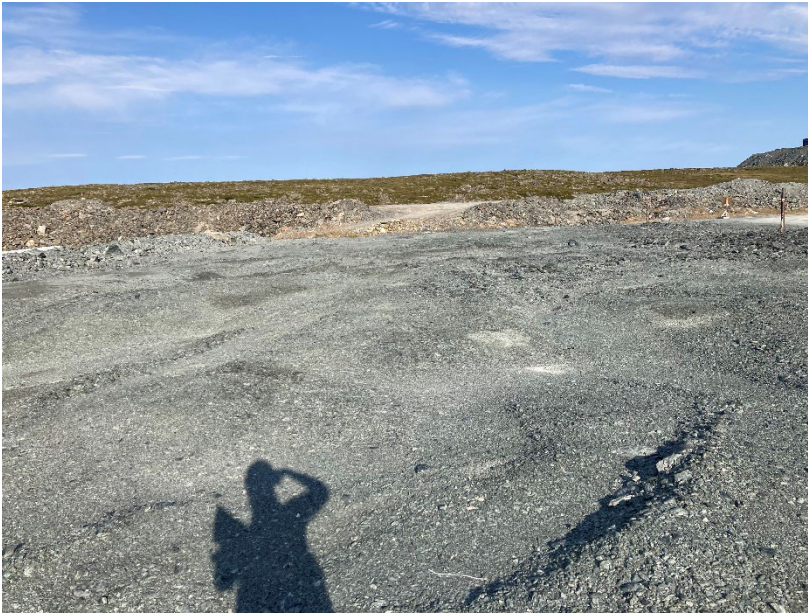
Photograph A3-37 Bay Goose Dike

Description: From approximately Sta. 32+025 (south abutment) looking east at the crest and upstream slope. Zone of high magnitude settlement in the ultramafic cap. The tension cracks seem no longer active.

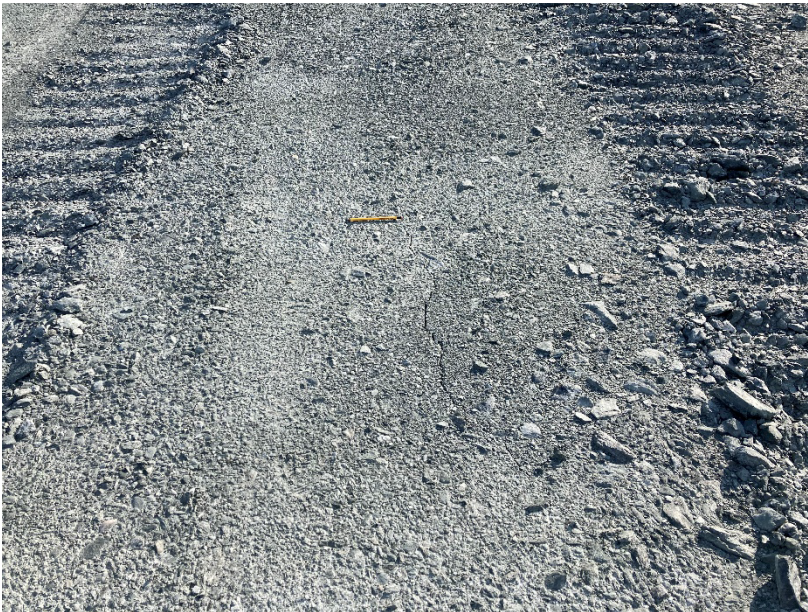
Photograph A3-38 Bay Goose Dike

Description: From approximately Sta. 32+025 (south abutment) looking west at the crest. Zone of high magnitude settlement in the ultramafic cap. The tension cracks seem no longer active.

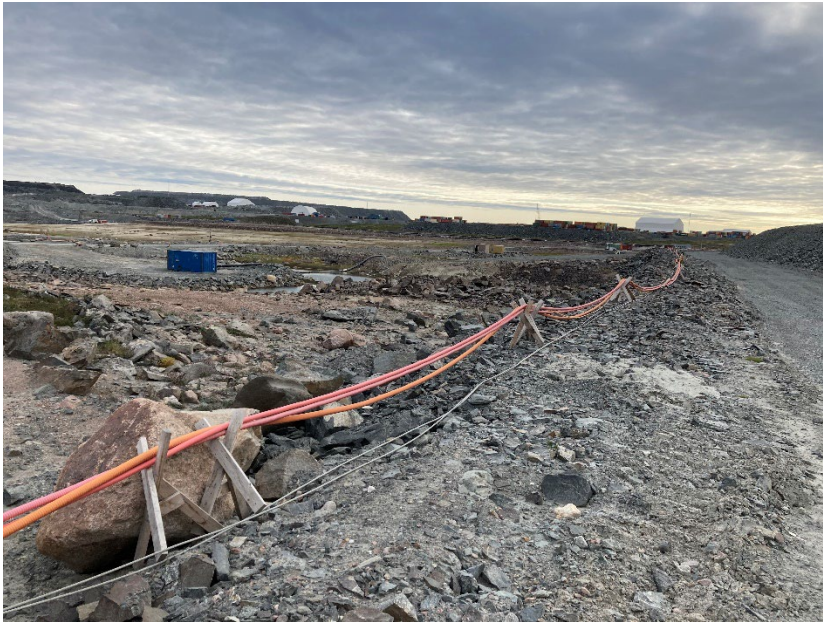
Photograph A5-21 Whale Tail Dike

Description: From approx. Sta. 0+200 (west abutment), looking northeast at the downstream slope and downstream platform. A slight depression is observed in the crest (~150 mm).

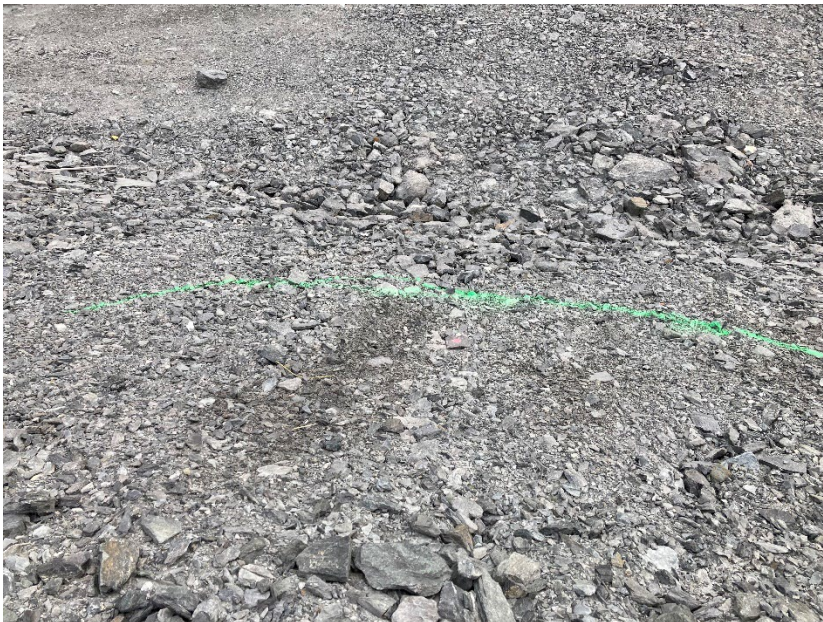
Photograph A5-24 Whale Tail Dike

Description: From approx. Sta. 0+725 downstream, looking northwest at the downstream side of the crest where tension cracks are visible.

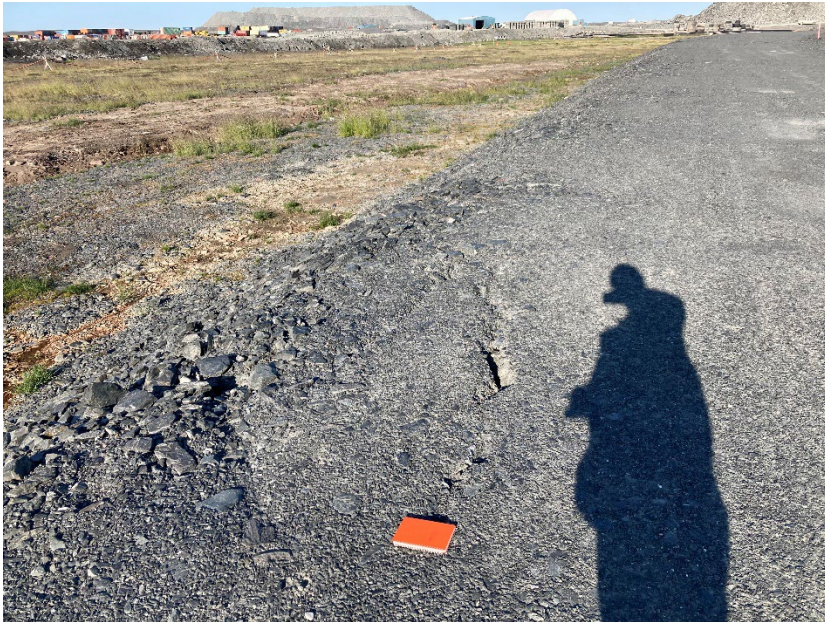
Photograph A6-5 IVR Dike D-1

Description: From approx. Sta. 0+430, looking west at the crest and upstream slope. Presence of old tension cracks ~ 1 m from crest edge.

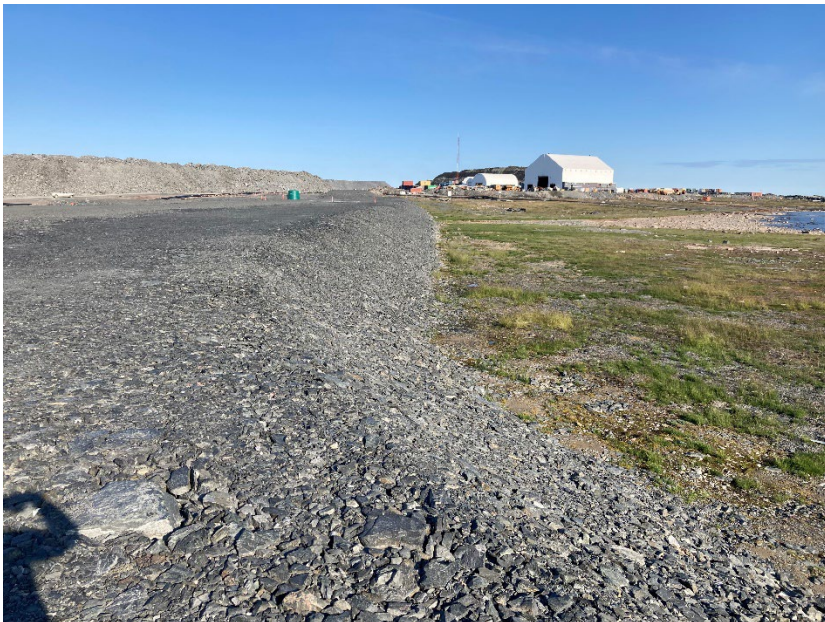
Photograph A6-6 IVR Dike D-1

Description: From approx. Sta. 0+430, looking west at the crest and downstream slope. Presence of tension cracks (inactive).

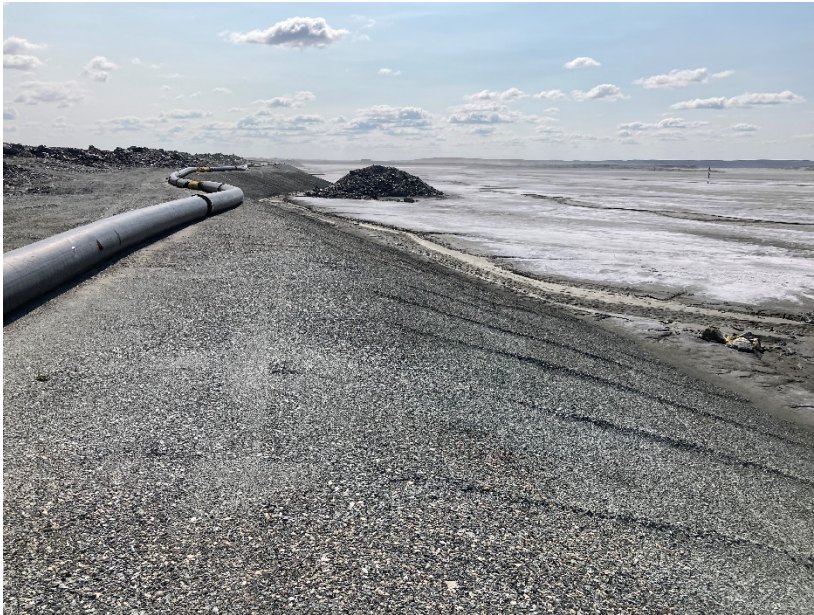
Photograph B1-11 Tailings Storage Facility

Description: From the North Cell Internal Structure at approx. Sta. 2+700, looking northwest at the upstream slope. Presence of tension crack on upstream slope (approx. 10-20 mm wide)

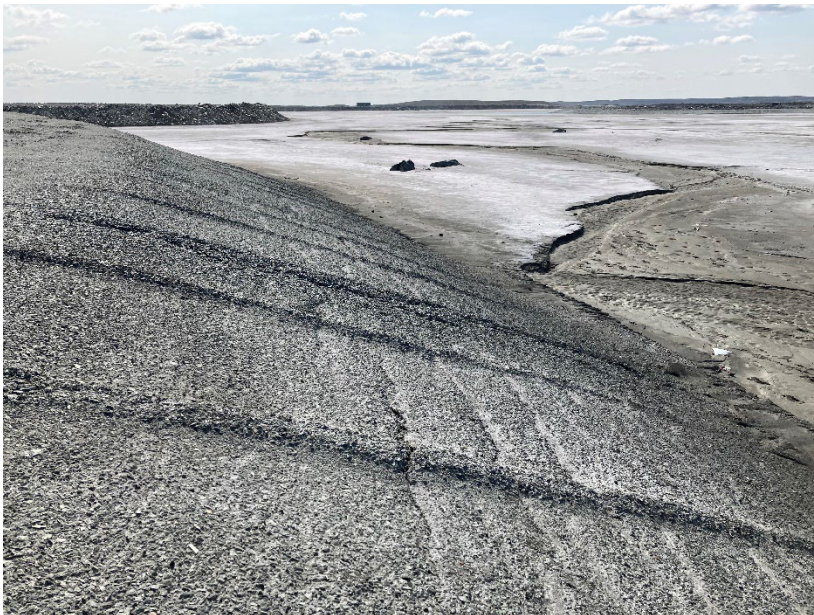
Photograph B1-12 Tailings Storage Facility

Description: From the North Cell Internal Structure at approx. Sta. 2+700, looking northwest at the upstream slope. Presence of tension crack on upstream slope (approx. 10-20 mm wide) and water channeling at the toe.

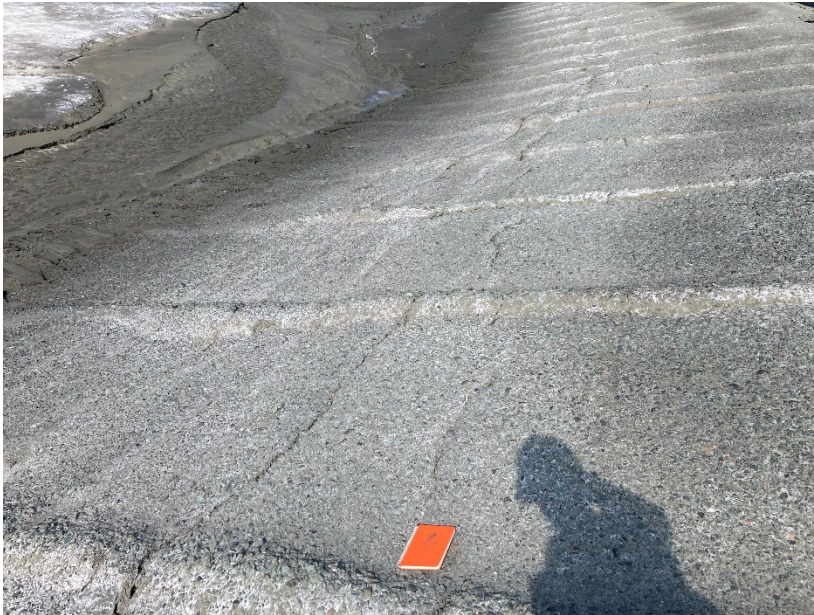
Photograph B1-13 Tailings Storage Facility

Description: From the North Cell Internal Structure at approx. Sta. 3+100, looking southwest at the upstream slope. Presence of tension crack on upstream slope (approx. 10-20 mm wide)

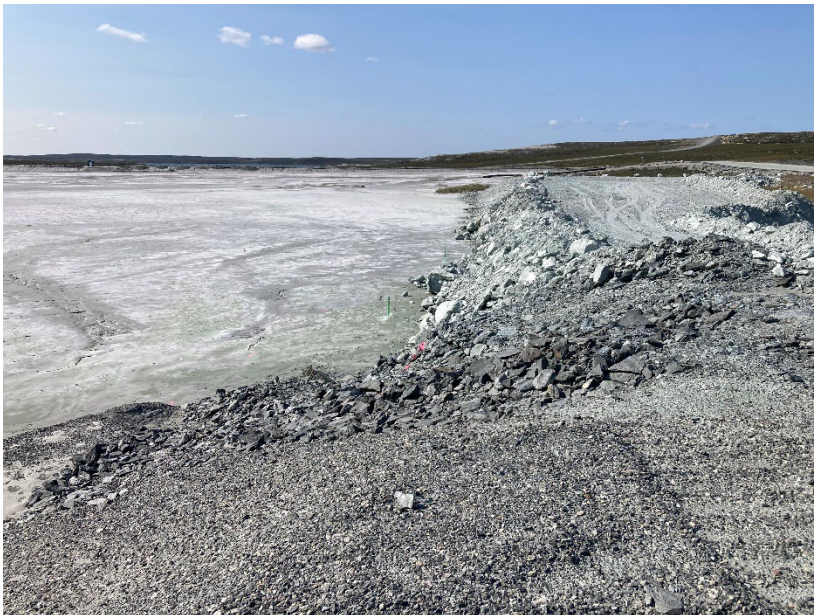
Photograph B1-14 Tailings Storage Facility

Description: From the North Cell Internal Structure at approx. Sta. 3+100, looking northeast at the upstream slope. Presence of tension crack on upstream slope (approx. 10-20 mm wide) and water channelling at the toe.
