# **Meadowbank 2023 Annual Open Pit Geomechanical Inspection**

**RE: Meadowbank Complex - Meadowbank Site - 2023 Annual Open Pit  
Geomechanical Inspection**

# Meadowbank Complex - Meadowbank Site

## 2023 Annual Open Pit Geomechanical Inspection

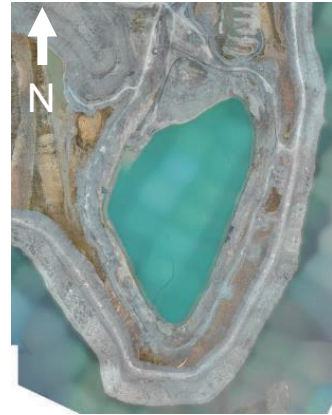
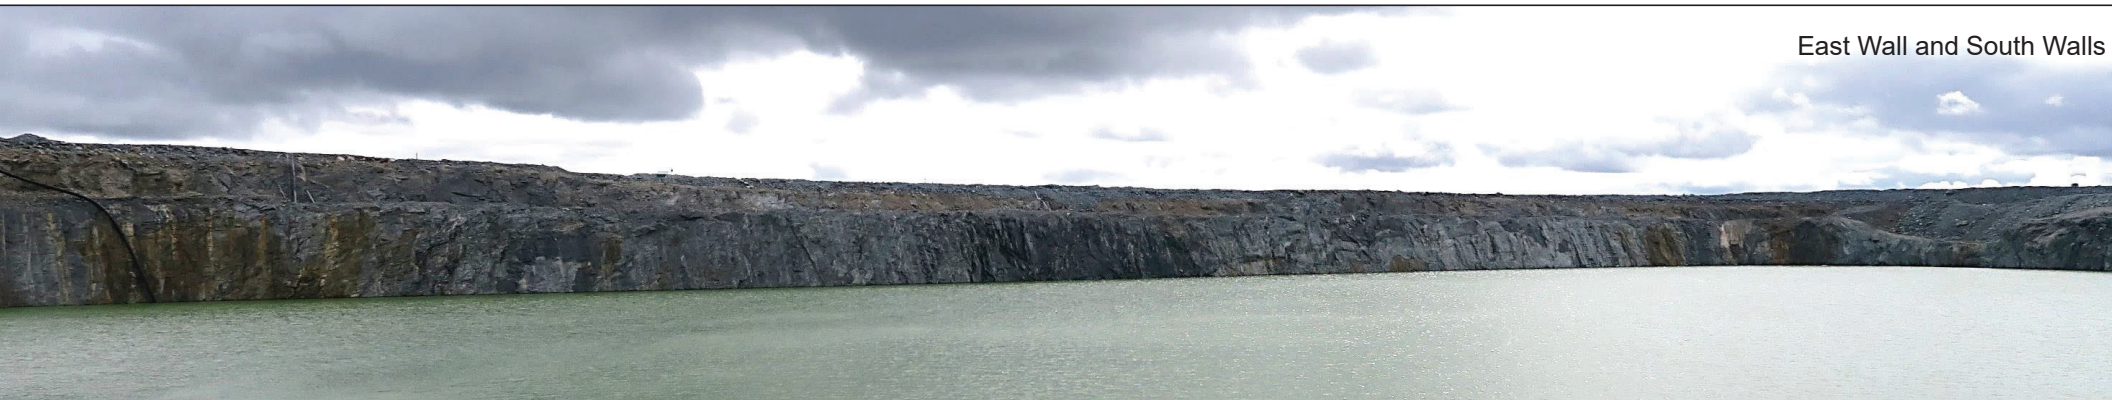
East Wall and South Walls

- A portion of a single bench is exposed above the current pit lake.
- The walls are performing well and no particular geomechanical concerns were noted.
- The exposed bench faces along the ramp at the northern end of the pit are relatively low and there is ample room to transit and work away from the wall. As a result, the rockfall risk is considered to be low.
- At the time of the inspection, the barricade at the top of the ramp had been knocked over. The barricade was moved back into place during the inspection.

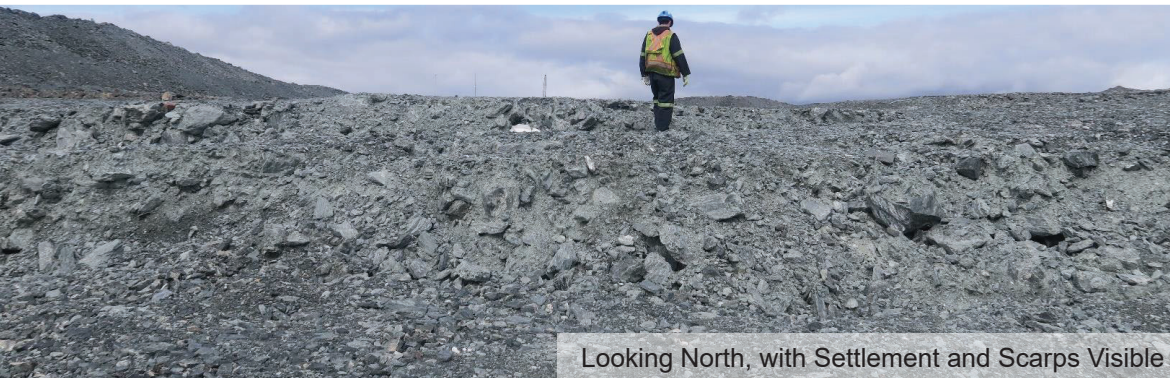
- The dump is inactive and access is prevented by both a rockfill berm and the presence of water pipes across the access point.
- The dump has been subsiding since 2015. The settlement is attributed to the deposition of water in the open pit, through a combination of thawing and increasing porewater pressure. The concern is that a sudden failure of the dump would create a wave that poses a hazard to personnel conducting water quality or tailings sampling in the pit lake.

- The settlement is monitored as part of monthly inspections by the Geotechnical Group. Four survey pins were installed in August 2022 and measurements made in September 2022, May 2023 and June 2023. The cumulative displacement is between 20 and 100 mm. The rate is less than 0.5 mm/day.

Looking North, with Settlement and Scarps Visible

- The visual monitoring and the survey pin measurements should continue on a monthly basis while access is still required to the open pit. There is a need to better quantify the extents and total deformation. Recommend using drone photogrammetry to assess this on an annual basis.

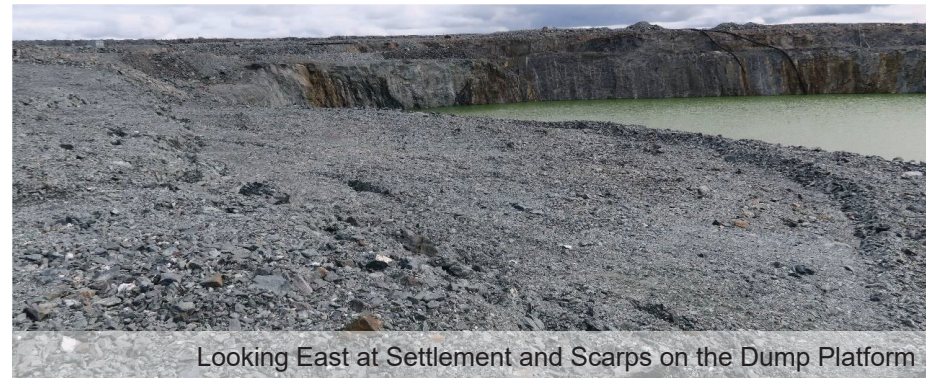
Looking East at Settlement and Scarps on the Dump Platform

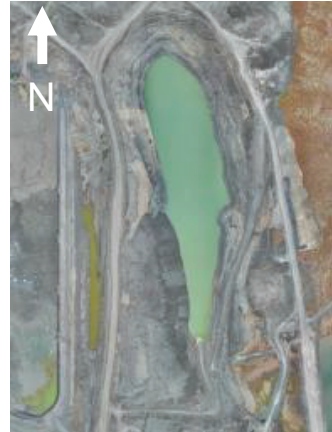
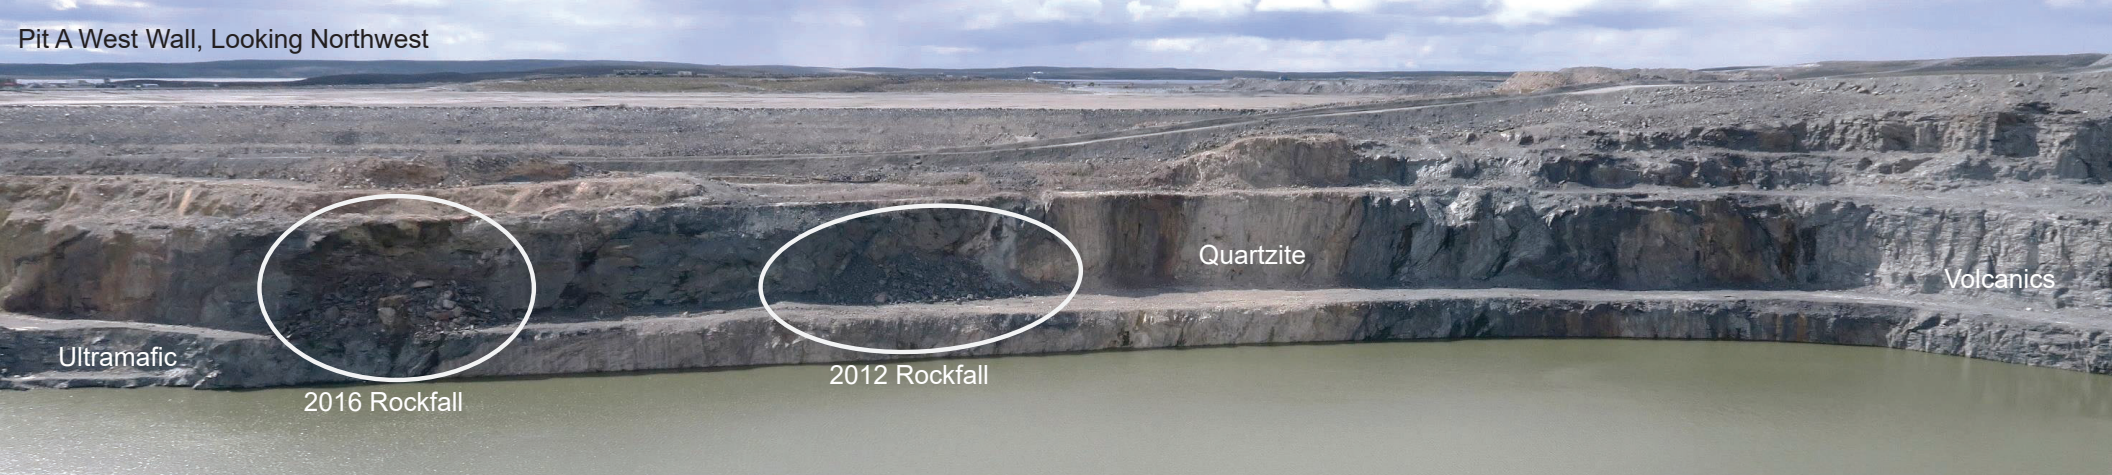
- Approximately one and a half benches are exposed above the pit lake.
- No significant change was observed in the pre-existing bench-scale failures remaining above the pit lake since the 2022 inspection.
- Access to the East Ramp is restricted by berms at the top and bottom of the ramp (not shown in photo below).
- No particular geomechanical concerns were noted.

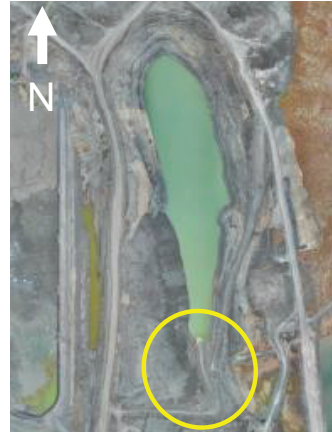
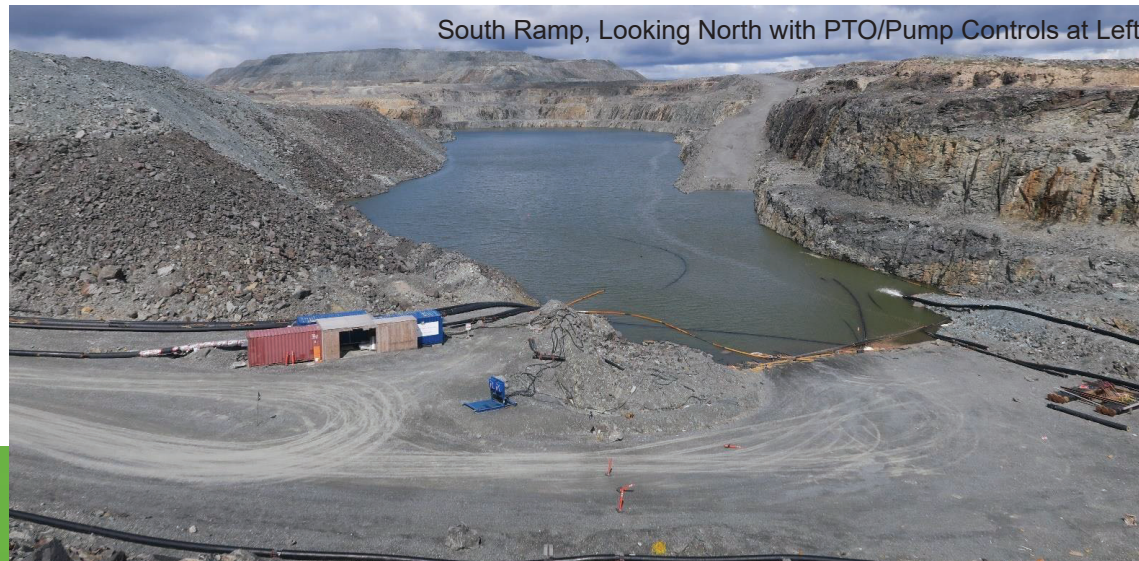
- The south ramp is used to access the pit lake and water management infrastructure is present along the ramp.
- No particular geomechanical concerns were noted. With the rising water level, the ramp is no longer exposed to rockfall hazards associated with the pit slopes.
- The PTO / Pump controls are located well up the ramp, away from the pit lake, mitigating the risk associated with a wave caused by a failure of the open pit slope or the dump.
- Access below the pump controls is restricted by pylons.
- Specific geomechanical considerations relating to Dump B are discussed on the next slide.

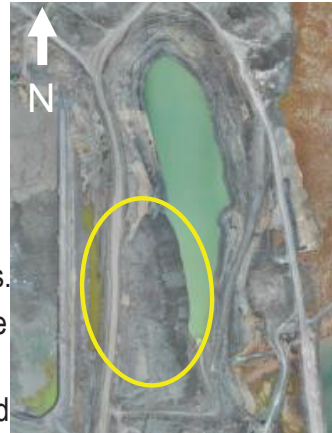
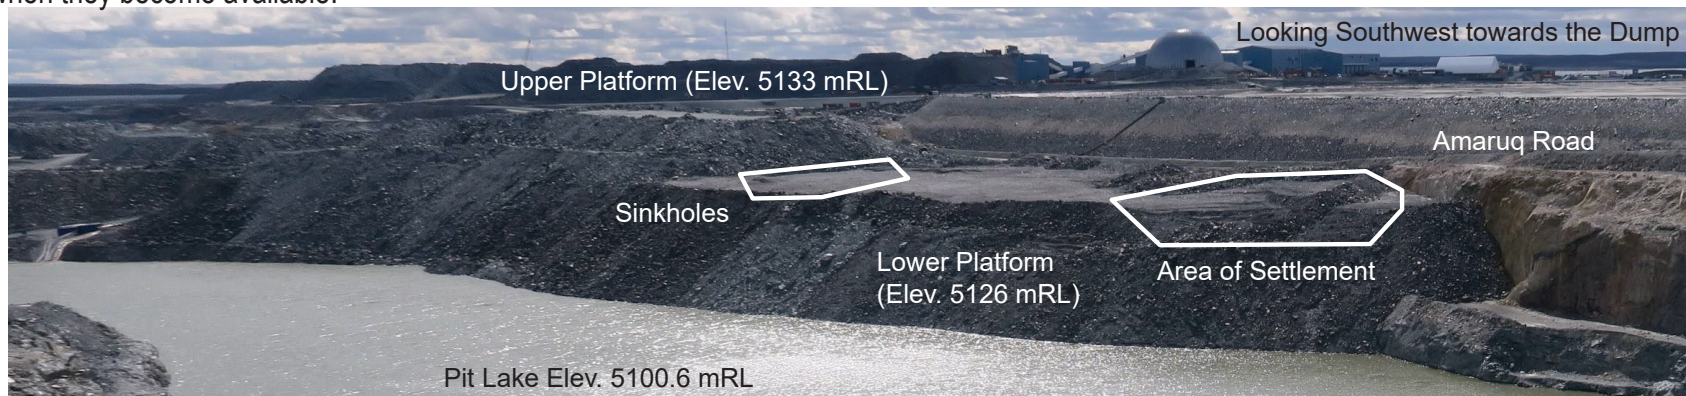
- The Pit B Dump consists of an Upper and Lower Platform, both of which are inactive. Access to both platforms is prevented by berms.
- Failures of the dump slope are possible as the pit lake elevation rises but have not been observed to date. Such a failure could cause a large wave in the pit lake that poses a hazard to personnel conducting water sampling or managing the reclaim water lines.

- Tension cracks are observed on both platforms. The northern end of the Lower Platform has settled, and sinkholes have also formed at the southern end of the Lower Platform. These are discussed on the following slides.

- A visual inspection of the dump is completed on a monthly basis. Recommend continuing the inspections while access continues to the Pit A South Ramp below the dump. An extensometer has been installed on the lower platform and this is described further on a following slide.

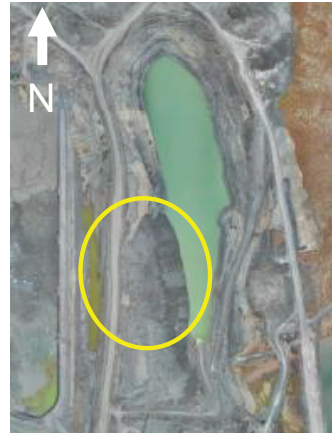
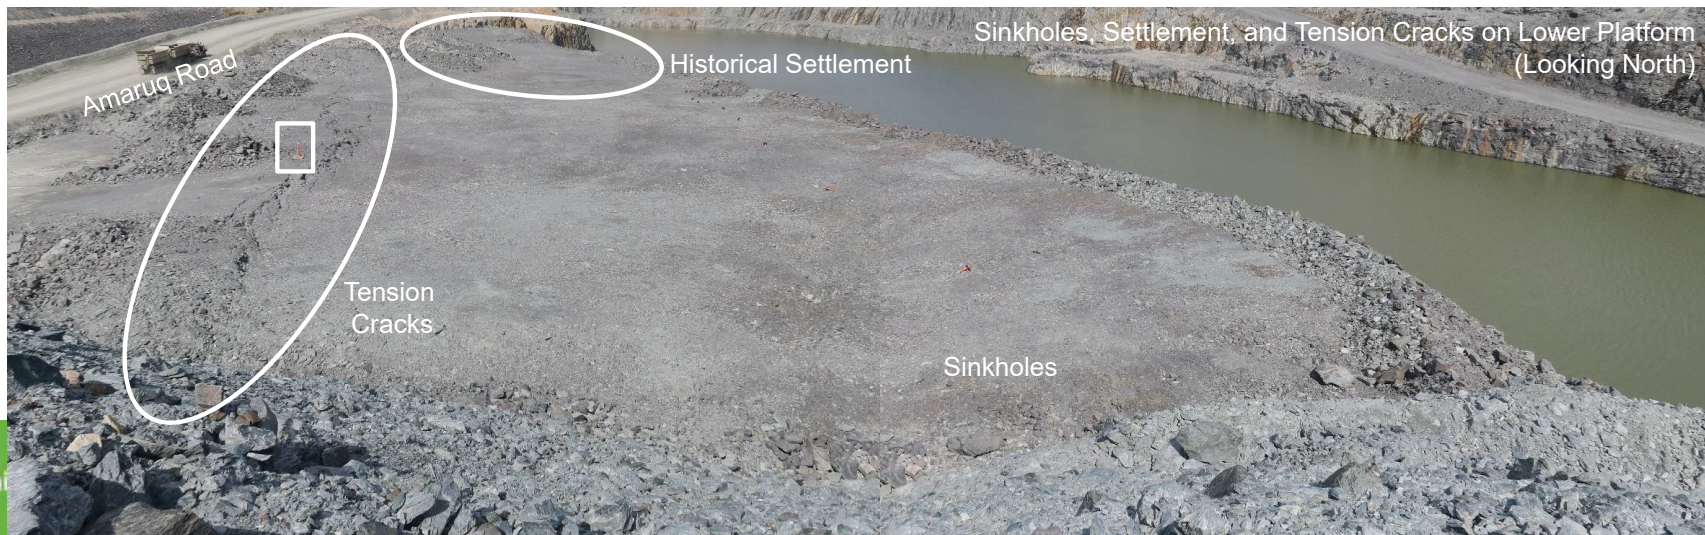
- Tension cracks are present along the western limit of the dump and are believed to be above the crest of the East Ramp of the open pit. The tension cracks and associated settlement appear to have progressed since the 2022 inspection.

- The interpretation of the tension cracks (i.e., whether they indicate deep-seated movement of the dump or simply differential settlement across the position of the bench/ramp below the dump) relies on their position relative to the underlying pit ramp. Recommend surveying the cracks to confirm their position relative to the geometry of the pit slope below the dump.

- An extensometer was installed in September 2022 and readings have been taken approximately monthly. The displacement over 9 months has been 26 cm and the displacement rate has been steadily decreasing from a high of 1.4 mm/day in December 2022 to just under 1 mm/day at the time of the visit.

- There has been limited change in the sinkholes and area of historical settlement since the 2022 inspection.
- Recommend continuing to monitor the settlement and tension cracks on the dump.

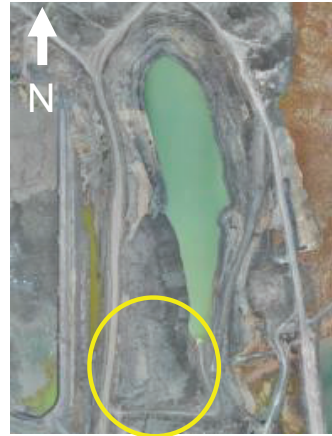
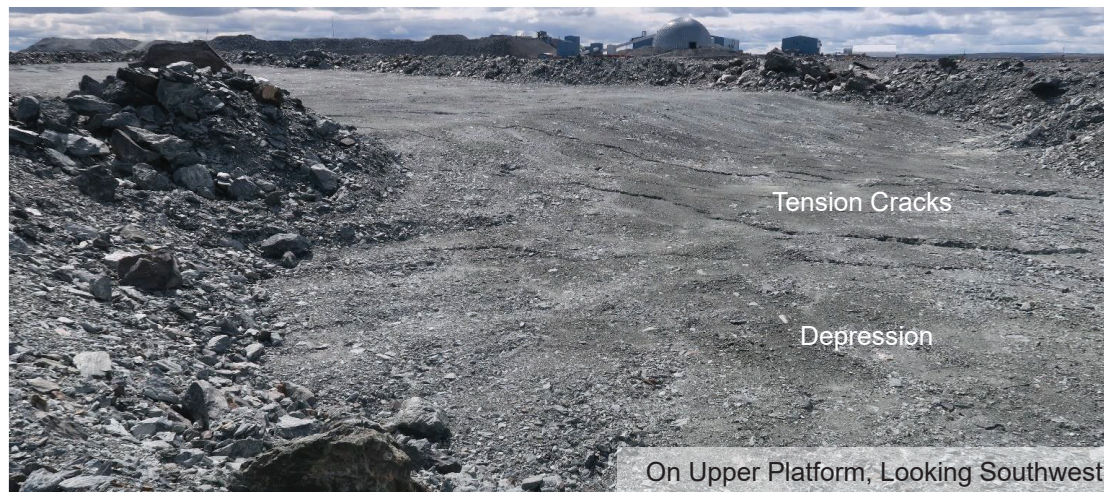
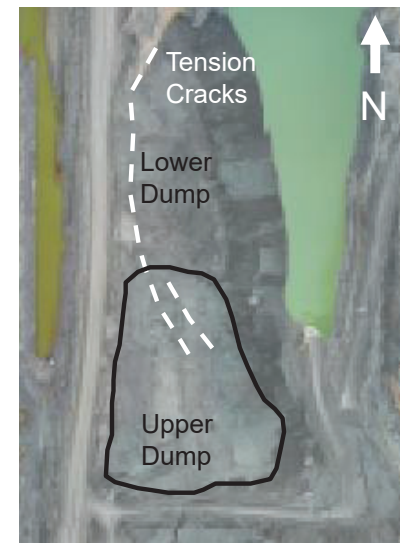
- Tension cracks have developed on the Upper Platform since the 2022 inspection. The cracks are oriented roughly NW-SE and appear to be a continuation of those observed on the Lower Platform, suggesting that they are also linked to the geometry of the underlying pit slope. The position of the cracks should be surveyed to confirm this.
- The Upper Platform is graded so that water flows to a low point above the area of the Lower Platform where the sinkholes have formed. Previous annual inspections recommended filling the low point and re-grading the dump to reduce water infiltration. This work has not been completed. However, the dump performance is believed to be controlled by the pit water level rather than surface water infiltration and the recommendation is no longer considered necessary.

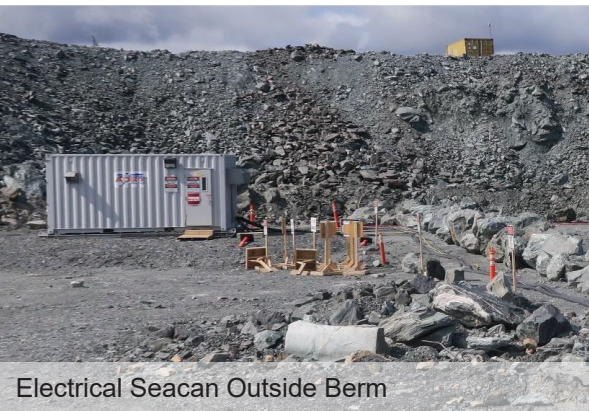
- A seacan used to provide power to the Pit A pumps was located inside the berm constructed along the crest. Since the 2022 inspection, the seacan has been moved outside of the berm. However, an electrical control panel remains inside the berm. Recommend relocating the control panel before the water elevation in Pit E reaches the base of the upper dam platform.

Electrical Seacan Outside Berm

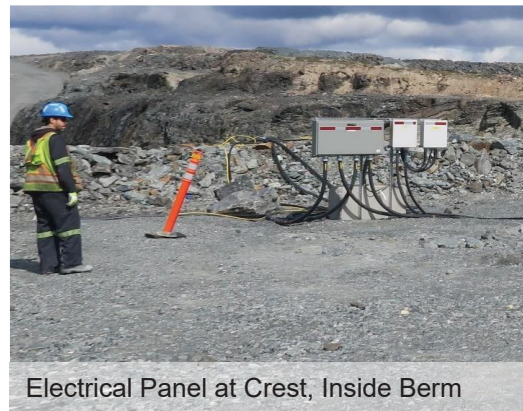
Electrical Panel at Crest, Inside Berm

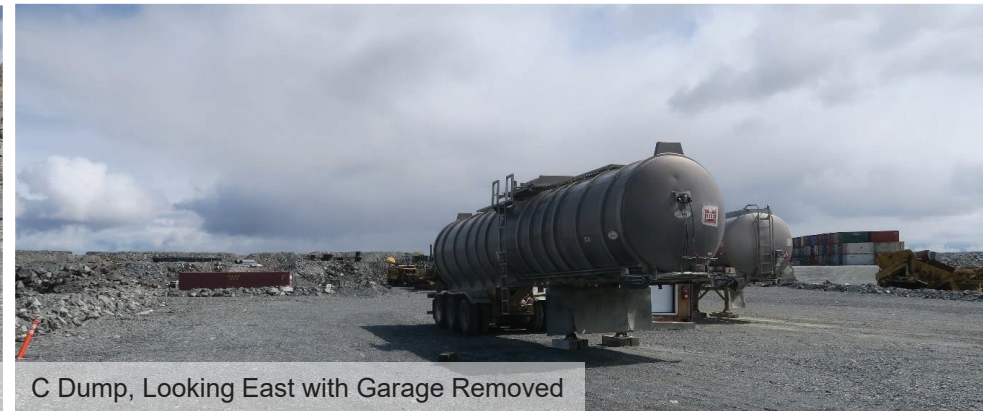
- The ABF Garage was constructed on the C Dump platform in 2020, approximately 35 to 45 m from the crest of the dump. Settlement of the dump is expected as the water elevation in Pit A and the water/tailings elevation in Pit E reach and surpass the base of the dump. As a result, it was recommended that the garage be relocated. Since the 2022 inspection, the ABF Garage has been dismantled and moved off of the dump.

- As no evidence of instability has been observed, the on-going use of the dump as a laydown is considered acceptable.

C Dump, Looking East with Garage Removed

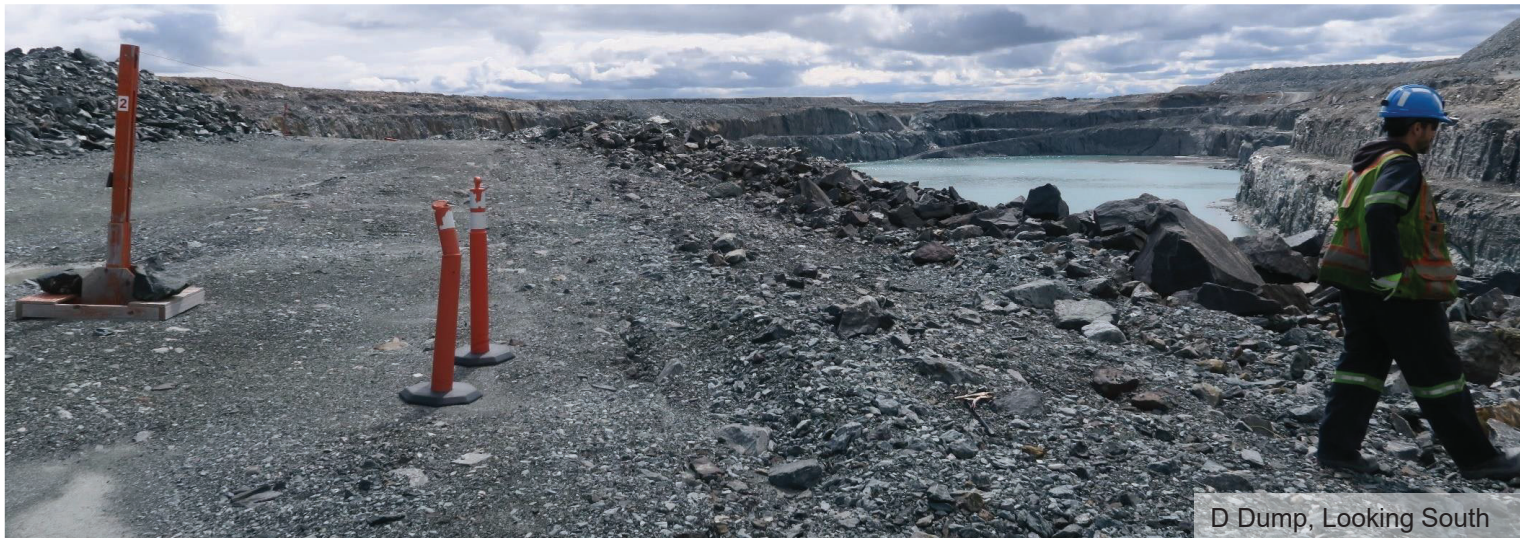
- The north end of the dump is adjacent the Pit E Northwest ramp. Tension cracks previously formed along the crest of the dump in this area. There has been limited change in the tension cracks since the 2020 inspection and bulging of the toe of the slope was not observed.
- Seepage was observed at the toe of the dump in this area during the 2022 inspection. The seepage has been monitored and has reduced significantly.
- Wireline extensometer #2 was installed at the crest of the dump in the area of the tension cracks in 2019. The extensometer is monitored monthly. The data are discussed later in this presentation, but the deformation rate is currently less than 1mm/day.
- The monitoring and the monthly visual inspections should continue while access to the Pit E Northwest ramp is still required.

D Dump, Looking South

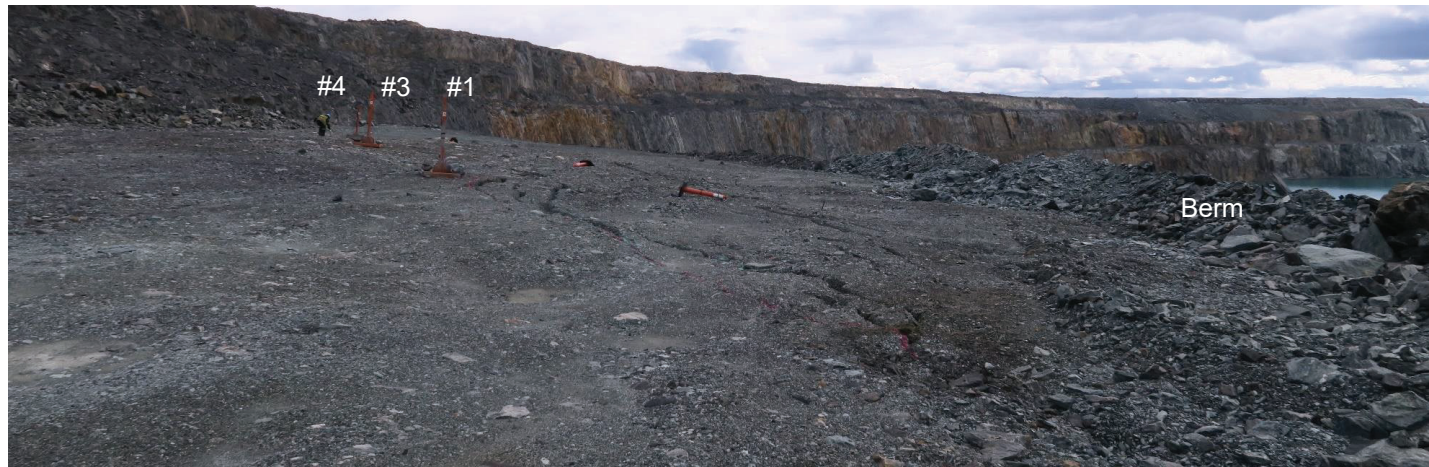
- Since the 2021 inspection, a network of tension cracks have developed on the dump platform and the extensometers have been installed to monitor displacement across them.

- The Geotechnical Group has been painting the cracks to track their change over time. This is endorsed and should continue.
- The tension cracks suggest that the direction of movement is oriented more to the southwest (i.e., towards the point where the Pit E Ramp terminates in the pit lake) than to the south, directly towards the pit lake. The reason for this is not currently known. The tensions cracks should be surveyed to confirm this.

- On-going deformation of the dump could result in a rockfall hazard to the ramp. A berm is currently in place at the toe of the dump but its capacity and evidence of rockfalls should be monitored and documented.

Tension  
Cracks on  
Dump,  
Looking  
Southeast

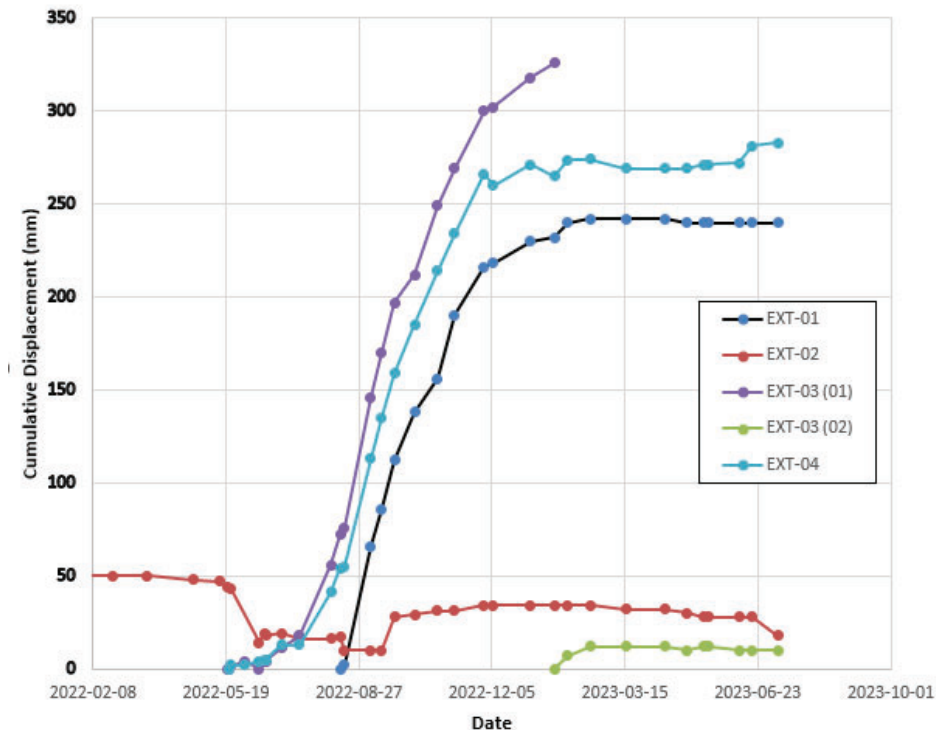
- The Geotechnical Group commit to monitoring the extensometers on a monthly basis. In practice it is typically done every two weeks.
- Monthly readings are available since June 2021 for the first two extensometers and since May 2022 for the second two extensometers. As the tensions cracks have progressed behind the extensometers, they have been moved, resetting the data. The data are shown at right.

- The reason for the increase and subsequent decrease is unclear. While evidence of tension cracks has been observed behind several of the extensometers, it is considered unlikely that this explains the change in behaviour.

- In all cases, the current rate of <1 mm/day is much less than the 50 mm/day threshold that would trigger a response under the procedure. Continue monitoring the extensometers and relocate them if cracks extend behind them.

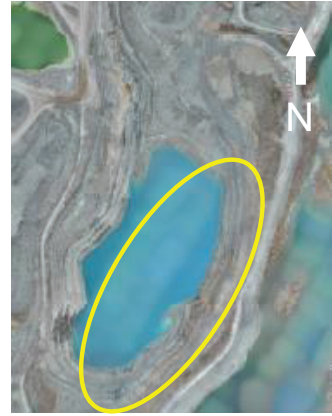
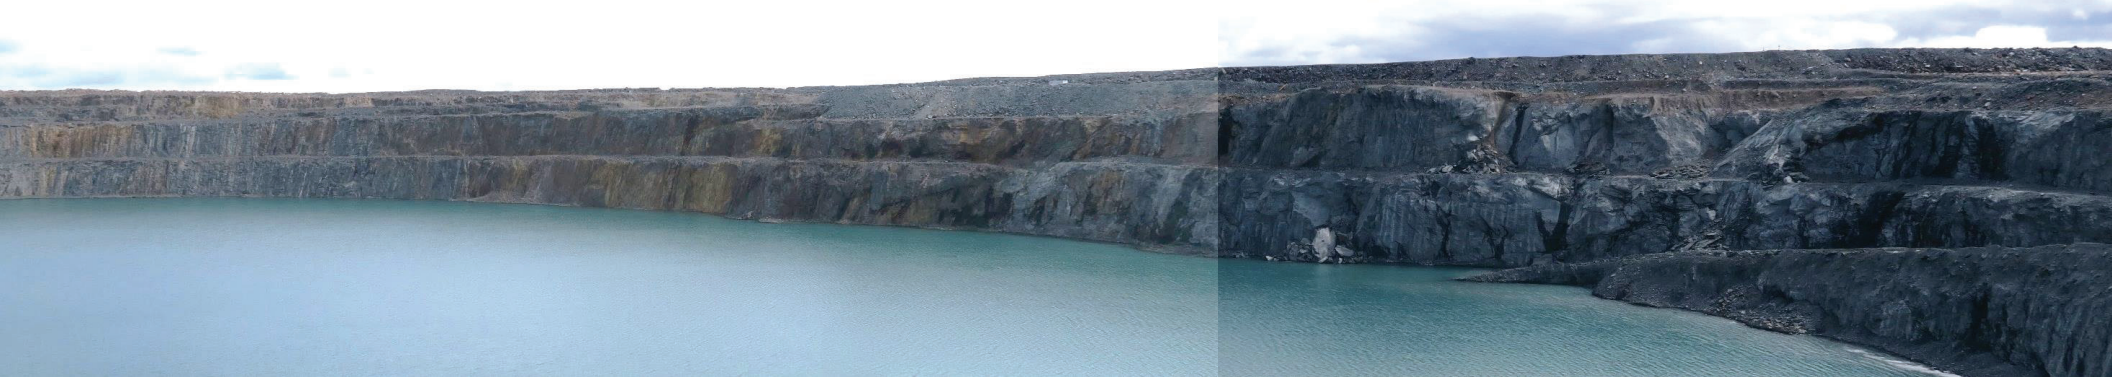
- Approximately two and a half benches are exposed above the pit lake.
- The wall is performing well and no particular geomechanical concerns were noted.
- No significant change in the historical bench-scale instabilities along the south wall were observed.
- The ramp along the south wall is closed with a berm.
- The ramp at the north end of the open pit is described on a following slide.

East and South Walls, Looking East

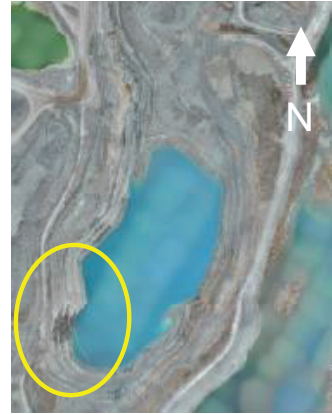
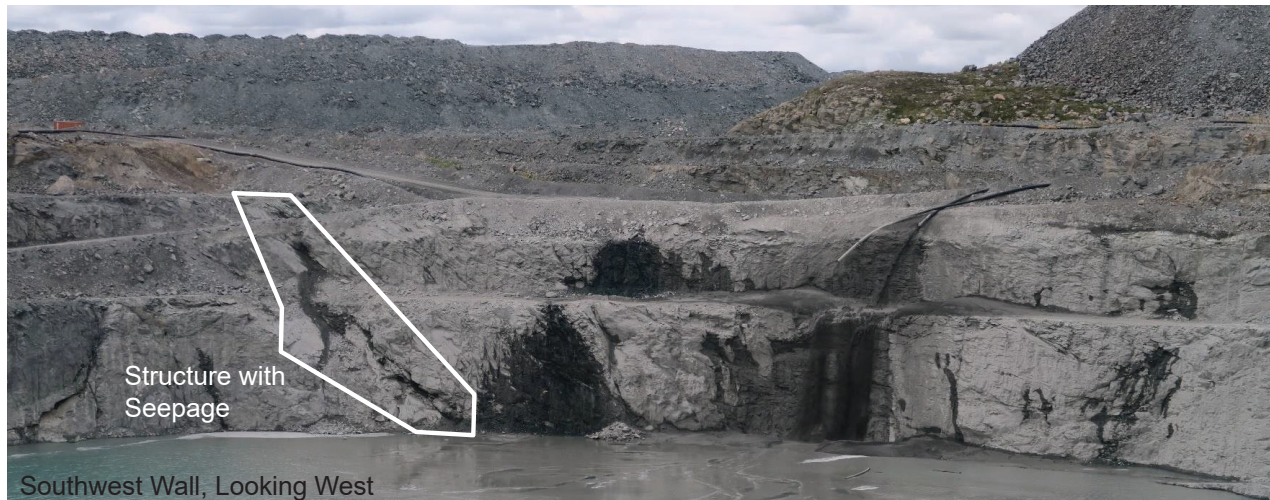
- Approximately three benches in the Ultramafics are exposed above the pit lake. The wall is within talik.
- Tailings are discharged from a line at the crest of this wall. There have been concerns about the potential for erosion of the benches or slope instability due to water infiltration. Limited erosion (crest loss) of the bench directly below the discharge point has been observed, but no evidence of slope instability has been observed. The wall is performing well.

- Seepage was observed from the prominent structure to the left of the tailings discharge point (outlined below). Seepage has not been observed during previous inspections. However, the structure does not appear to have deteriorated over the past several years and there is no obvious evidence of movement.

- Recommend continuing the monthly visual inspections to monitor the area for bench degradation, erosion, tension cracks, seeps, etc.

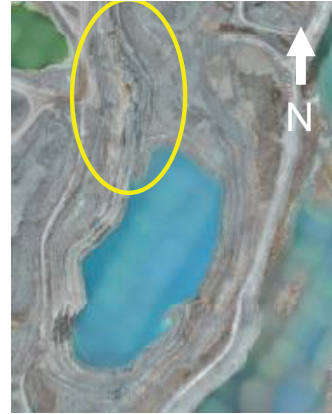
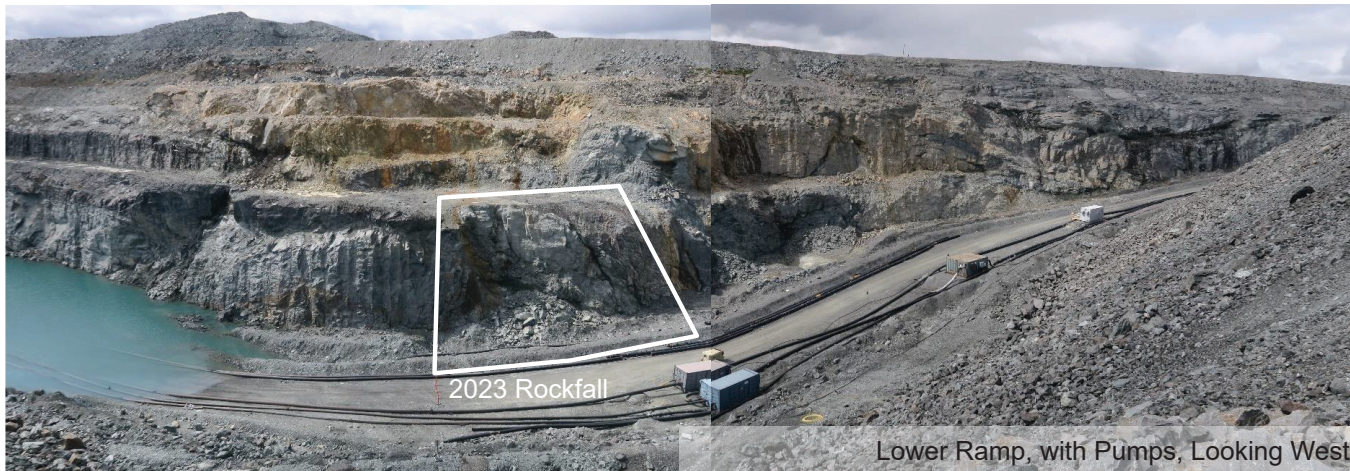
- The Northwest Ramp is used to access the pit lake and water management infrastructure is present along the ramp.
- Several rockfall hazards were identified during previous inspections. Many of these hazards have been flooded by the rising pit lake and no longer pose a risk to personnel. However, rockfall hazards remain on the Northwest Wall adjacent to the pumps. As the water level rises and the pumps are moved up the ramp, the exposure to personnel and equipment will continue to reduce.

- A rockfall berm has been in place for several years and has been effective at managing rockfalls. A second berm was constructed in 2021 further from the wall.

- A 450 tonne rockfall occurred in early June 2023 where the Bay Fault intersects a nose in the wall (outlined below). The failed material was contained by the rockfall berms. This area was identified as a hazard during previous inspections and it is likely that rockfall will continue to occur in the area. The berms have capacity to retain additional rockfalls, but geomechanical inspections of the area should continue while access to the ramp is still required.

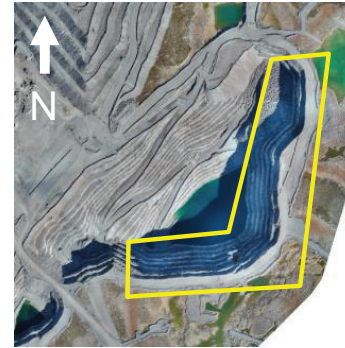
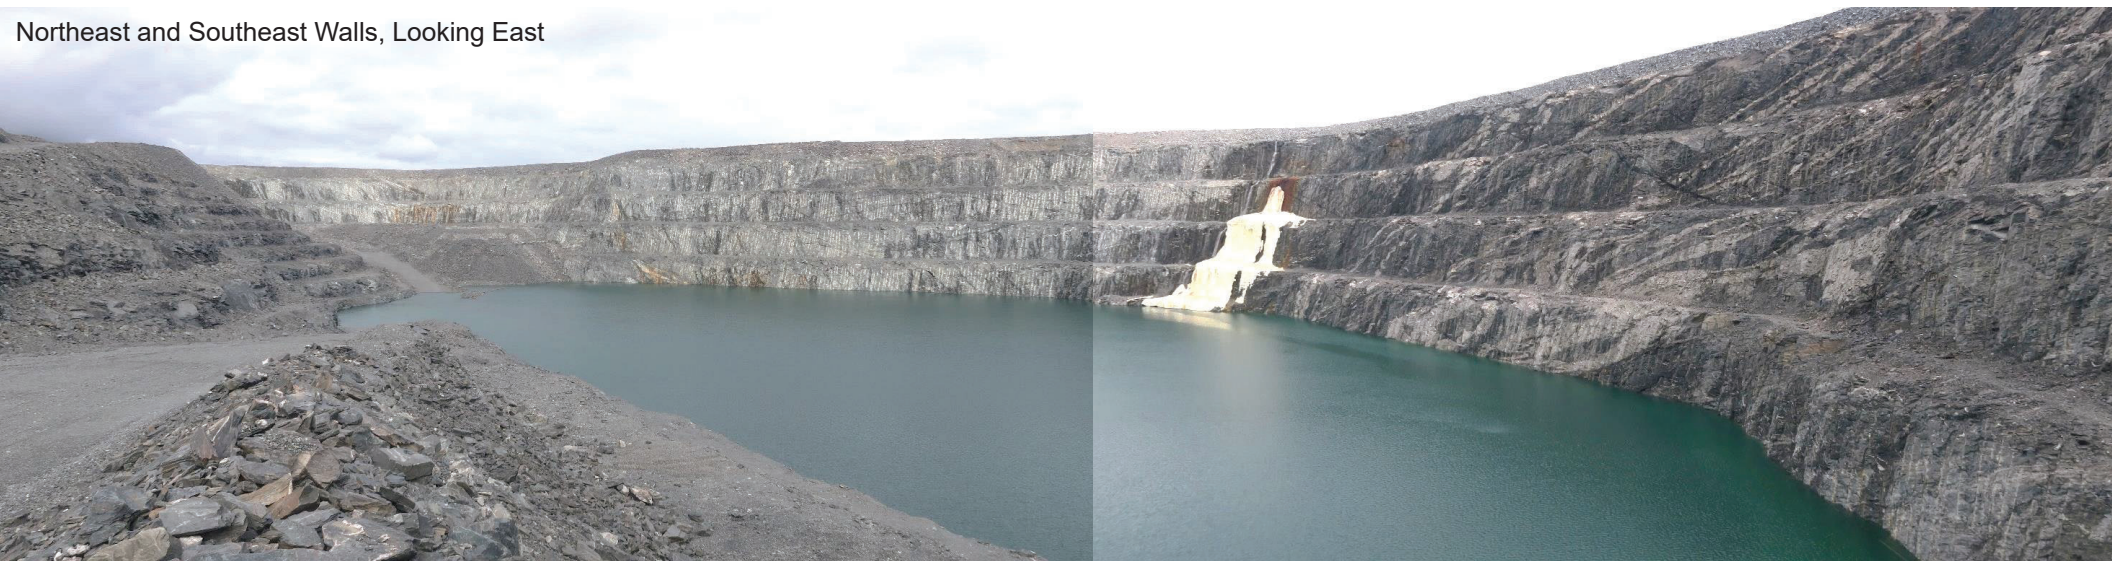
- The walls are performing well. No particular geomechanical concerns were noted.
- The ice wall continues to form each winter on and below the talik zone in this wall. Limited seepage through the rock was observed at the time of the inspection. Water was also observed flowing from Pond D, to the south of the pit, under the ring road and down the wall.
- Access to / below the North Waste Rock Dump is no longer possible, reducing the risks associated with a failure of the dump.

Northeast and Southeast Walls, Looking East

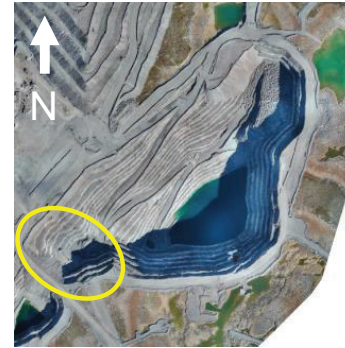
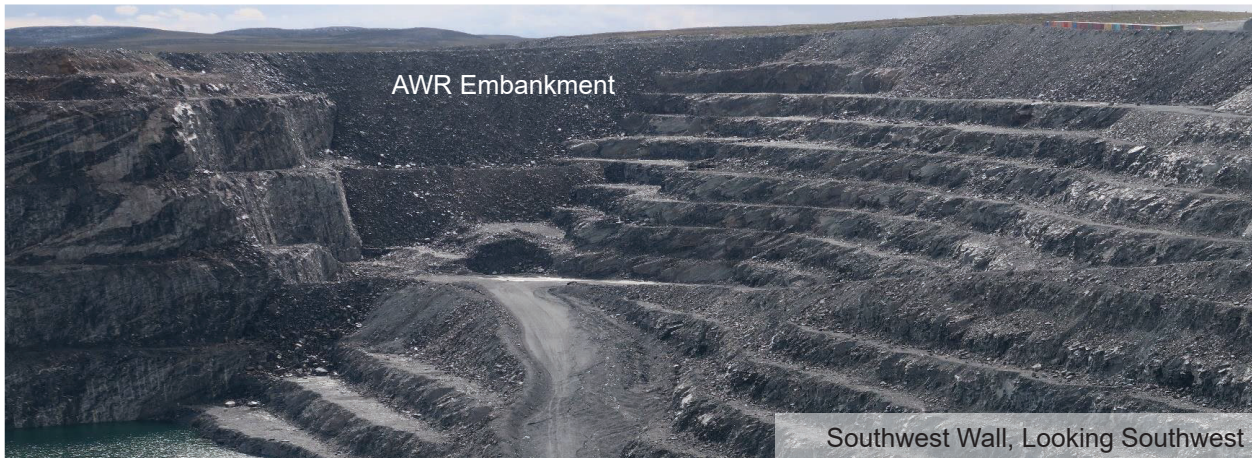
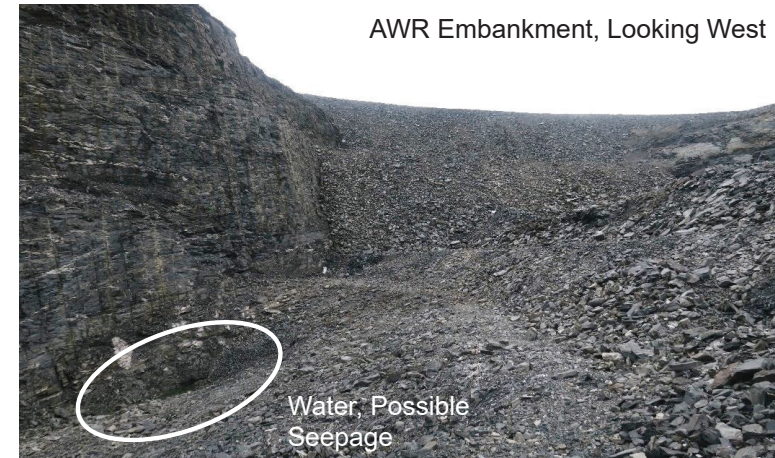
- The Amaruq AWR crosses a saddle between the Vault and Phaser pits on a rockfill embankment.
- During the winter, the visual inspections identified tension cracks on the surface of the road, perpendicular to the axis of the road. The reported positions of the cracks do not correlate with the underlying open pit benches and the cause of the cracks is not known. The mine responded in a reasonable way by temporarily increasing the frequency of inspections. The cracks have not been observed since February.

- No evidence of instability in the AWR embankment was observed during the inspection (e.g., no tension cracks on the road surface or bulging of the embankment toe)

- The stability of the Amaruq AWR embankment could be impacted if the water level in the Phaser Pit on the other side of the embankment increases and water ponds behind the embankment. This has not occurred. A small pool of water was observed near the base of the embankment at the time of the inspection and may be associated with seepage. The presence of seepage should continue to be evaluated as part of the monthly inspections. Recommend noting the importance of this in the GCMP.

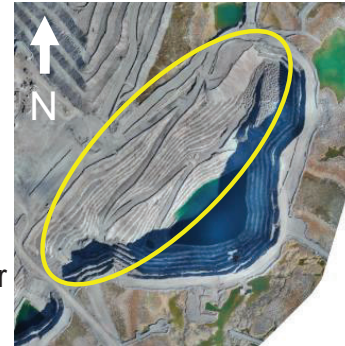
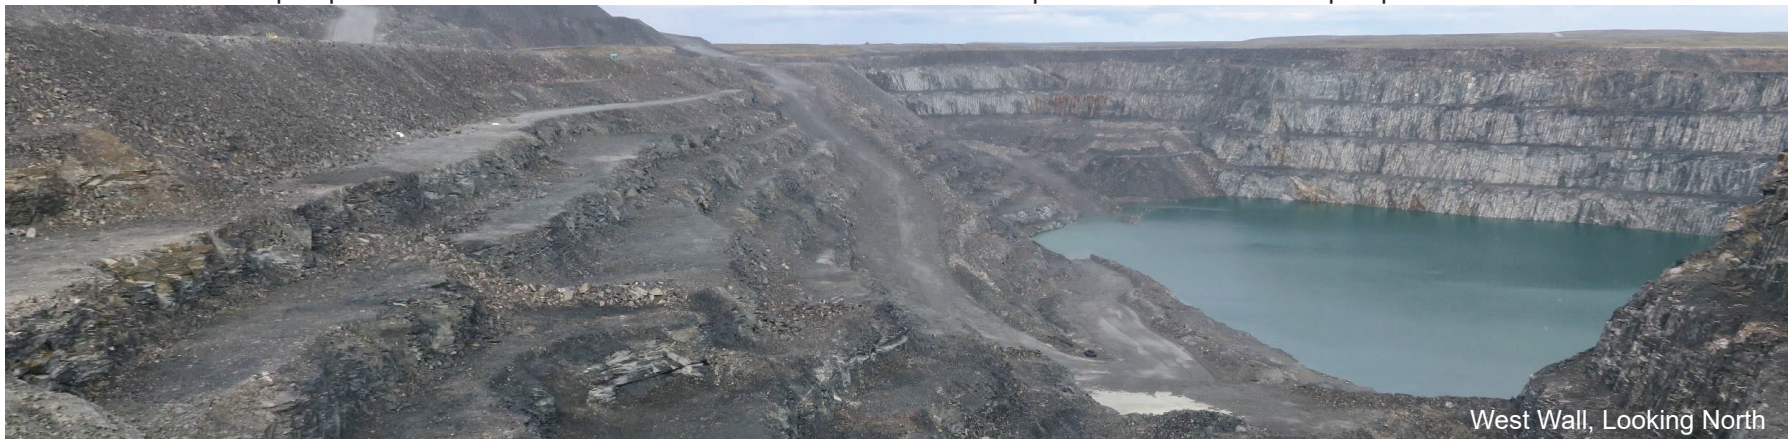
- The West Wall is located along the footwall of the deposit. The wall was established with 7 m high single benches without pre-shear and commonly failed or were scaled back to the foliation. The ramp is located along this wall.

- Rockfall hazards are present along the ramp. However, the ramp is sufficiently wide that personnel are able to stay well away from the benches when accessing the pit. Limited evidence of rockfall was observed at the toe of the benches during the inspection.

West Wall, Looking North

- While the ramp is inspected as part of the monthly geomechanical inspections, the condition of the ramp is not documented in the inspection report. The ramp should be included in the inspection report. The inspections should continue to consider the open pit walls and in-pit dumps, as well as the integrity of the Ring Road between the open pit and Vault Lake as a failure could result in a wave in the pit lake or inrush to the open pit.

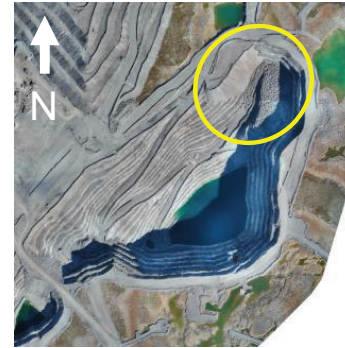
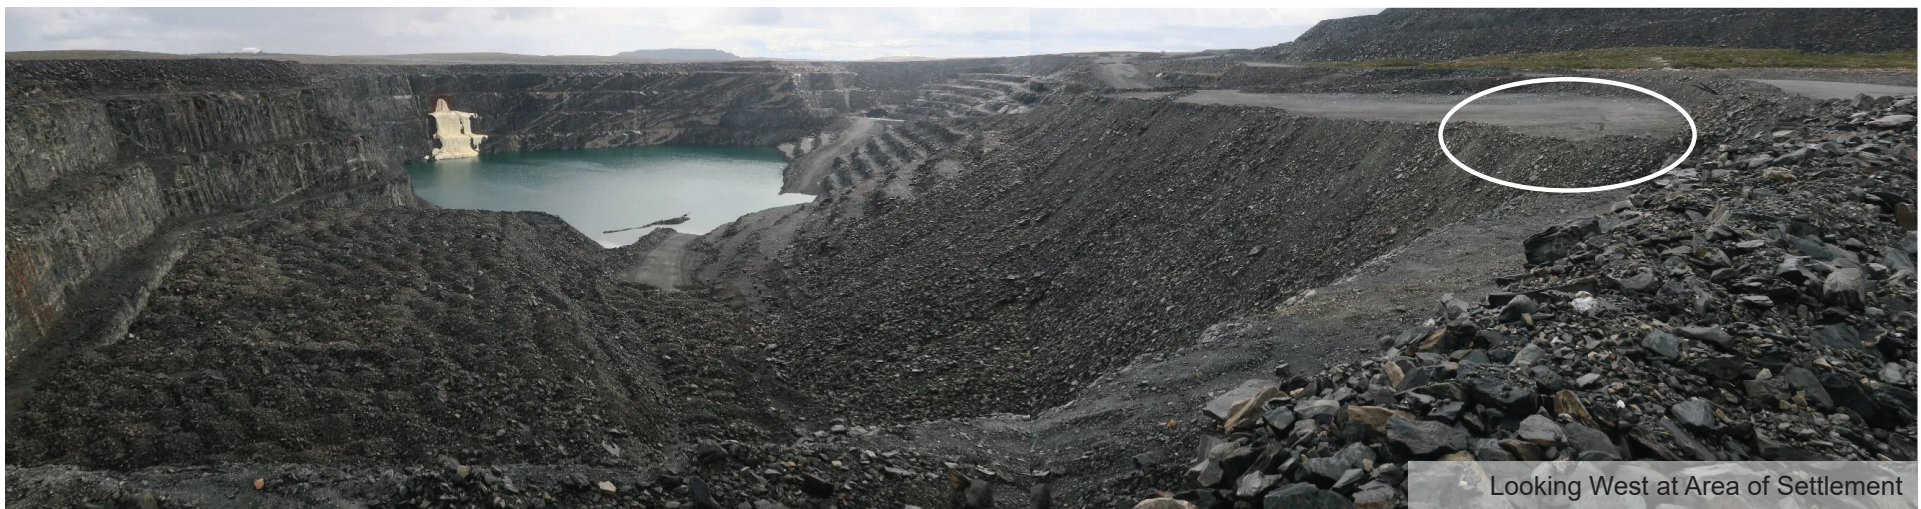
- A waste rock dump was constructed at the north end of the Vault Pit. The dump is inactive and consists of two platforms with elevations at approximately 5133 mRI and 5082 mRL.
- Settlement and tension cracks were observed at the crest of the upper platform at the north end of dump during the 2019 inspection. There appears to have been little change since that time. The affected area is relatively small and is not above the ramp.
- No other evidence of instability was observed during the inspection.
- Access to the dump is prevented with a berm.

Looking West at Area of Settlement

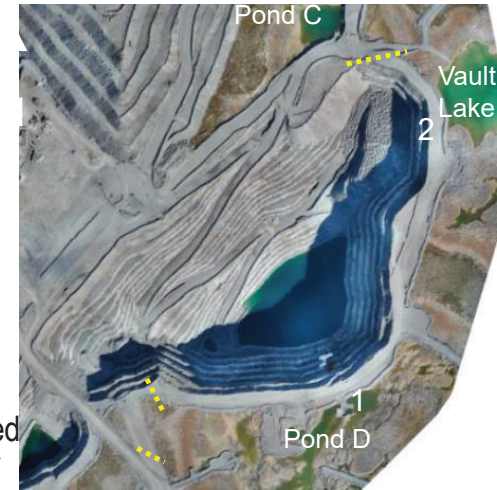
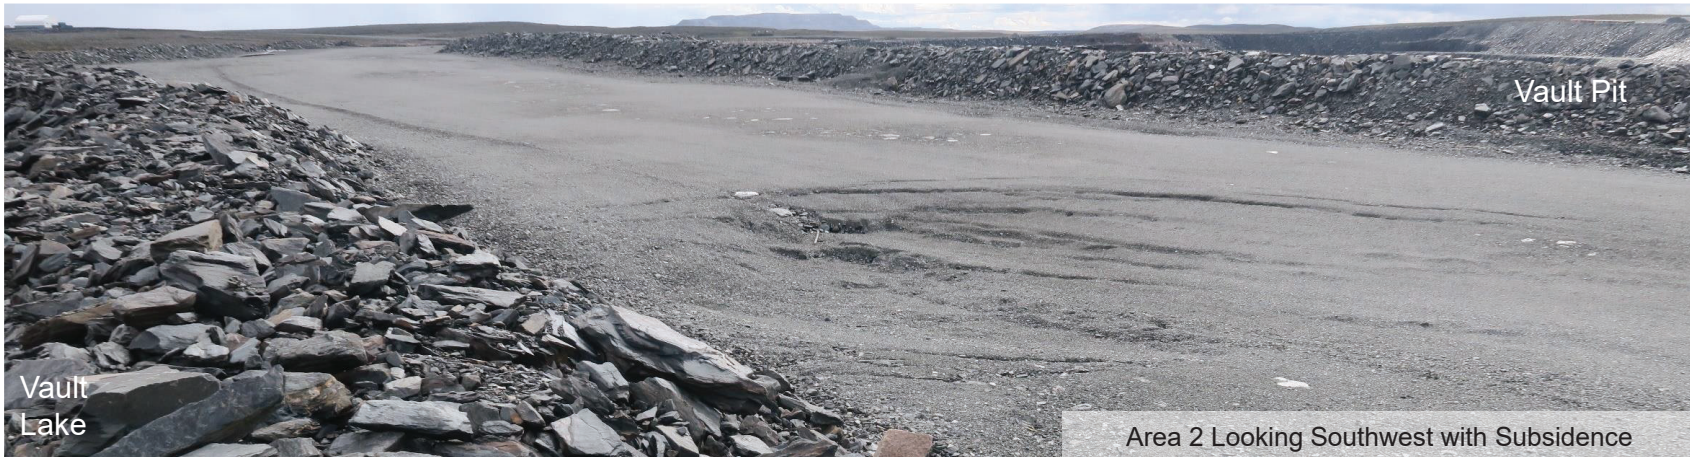
- A berm has been constructed at both ends of the Ring Road to prevent access (yellow dashed lines at right). Several geomechanical hazards have previously been identified along the road (numbered at right):
  1. Seepage from Pond D has flowed under the road and down the pit wall in 2019, 2021, and again in 2023.
  2. Subsidence of the road has occurred adjacent Vault Lake. The subsidence appears to be largely unchanged since the 2022 inspection. Limited seepage was observed below road. The potential for a sudden inrush of water from Vault Lake into the open pit was previously identified as a hazard in the event of a breach or erosion of the Ring Road in this area. As a result, the area should continue to be inspected prior to accessing the open pit. Alternatively, the road could be purposely breached in this area to eliminate the hazard.

Area 2 Looking Southwest with Subsidence

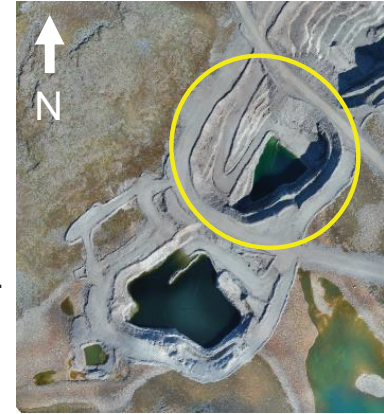
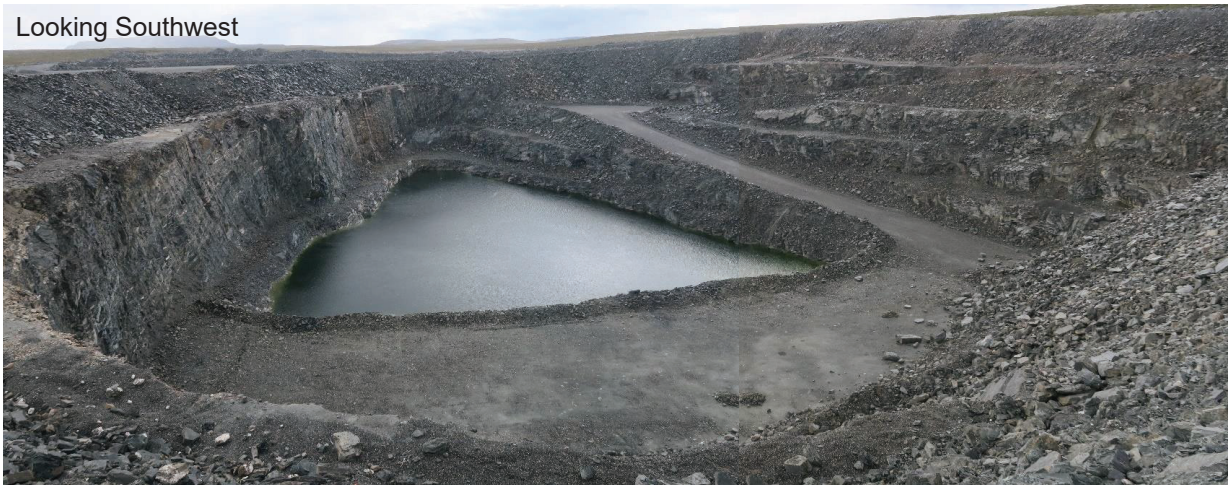
- The open pit is partially flooded, limiting the current rock exposures to a single bench. No particular concerns were noted.
- Access to the open pit is prevented by a berm.
- No evidence of instability was observed in the Amaruq AWR embankment.
- Water inflow, likely from the BB Phaser pit, was observed at the south end of the pit. The stability of the Amaruq AWR embankment could be adversely impacted if the water level in the Phaser pit increases and water ponds behind the embankment. A visual assessment of the water level in the open pit has been incorporated into the monthly inspections since the last inspection. The pit lake elevation does not appear to have significantly changed since the 2021 inspection.

Looking Southwest
