# **Meadowbank 2023 Annual Open Pit Geomechanical Inspection**

**RE: Meadowbank Complex - Meadowbank Site - 2023 Annual Open Pit  
Geomechanical Inspection**

# Meadowbank Complex - Meadowbank Site

## 2023 Annual Open Pit Geomechanical Inspection

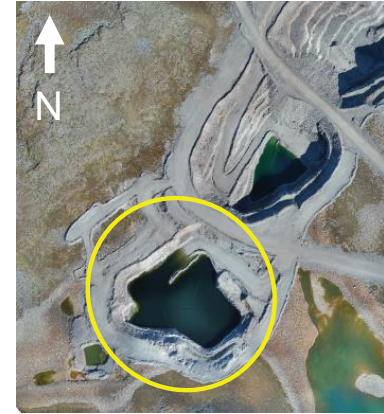
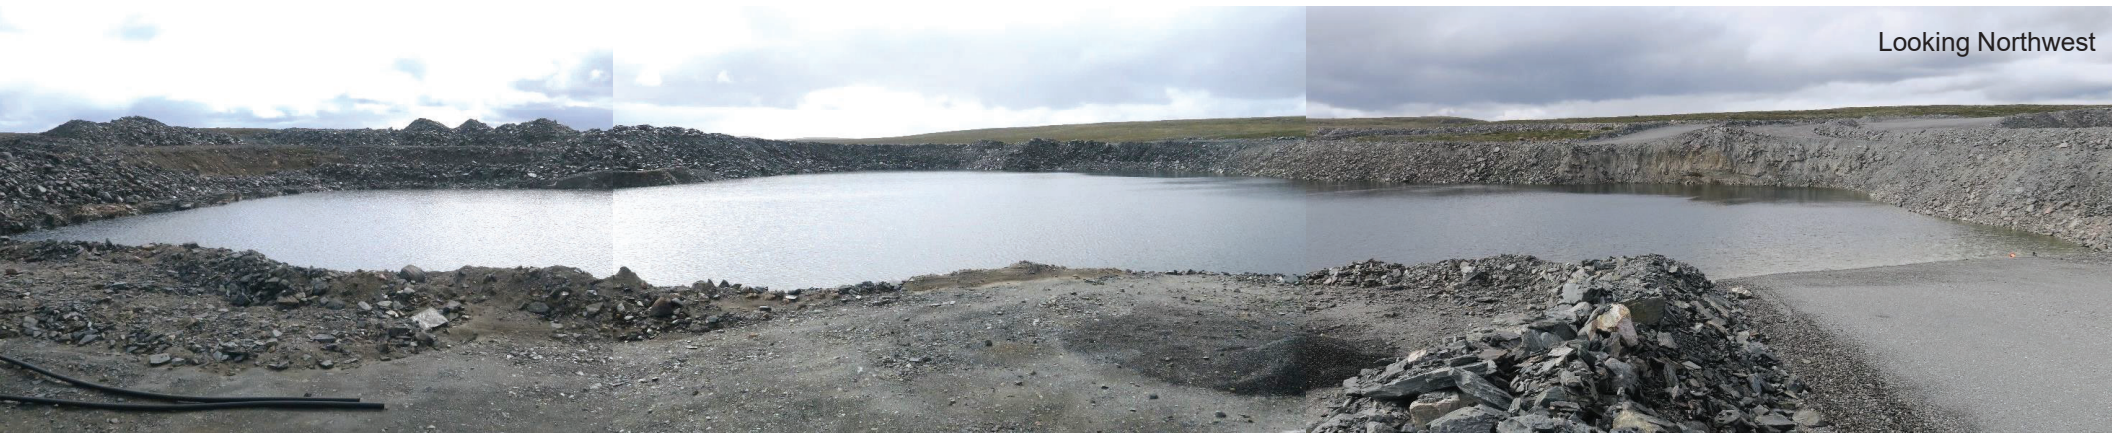
- The open pit is flooded, with no rock slopes visible.
- Access to the open pit is prevented by a berm.
- No particular geomechanical concerns were noted.

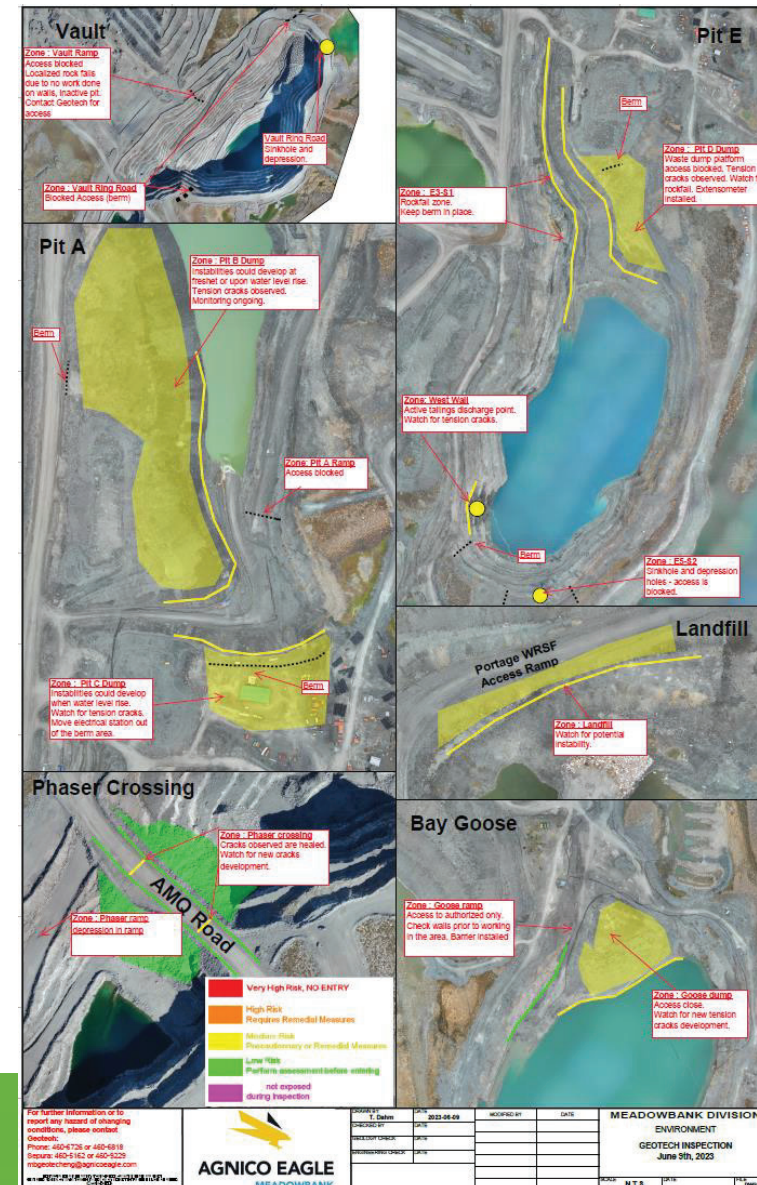
- The most recent hazard assessment map (June 9, 2023) was reviewed. A summary is shown at right and comments are provided below.
- All of the hazards identified during the annual inspection have been captured by the hazard assessment.
- The risk ratings assigned to the identified hazards are thought to be generally reasonable.
- The drone photos used for the hazard map are significantly out of date and do not reflect the reduction in slope hazards / accessible areas as the pit lake elevations rise. The drone photos should be updated to reflect the current conditions.
