# **Whale Tail 2023 Annual Open Pit Geomechanical Inspection**

## **RE: Meadowbank Complex - Amaruq Site - 2023 Annual Open Pit Geomechanical Inspection**

## 2023 Annual Open Pit Geomechanical Inspection

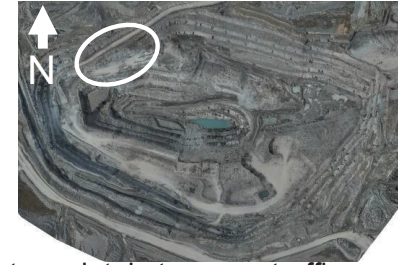
- Overbreak of the bench directly below the Phase 2 ramp (red outline) resulted in adjustments to open pit design in order to maintain two-way traffic.
- The 5109 bench on the inside of the ramp was slashed out to increase the available space and a small step-in was implemented below the ramp to accommodate a buttress on the inside of the ramp. Line drilling was implemented along the remainder of the ramp to reduce blast-induced damage.
- The overbreak occurred within the Komatiite. The structural model indicates that several Brittle/ High Strain Structures intersect the area.
- The performance of the benches in the Komatiite varies significantly along this wall, with poor performance observed in the area outlined in yellow and generally good performance observed elsewhere. The wall performance was a focus of the inspection and is discussed further on the next slides.

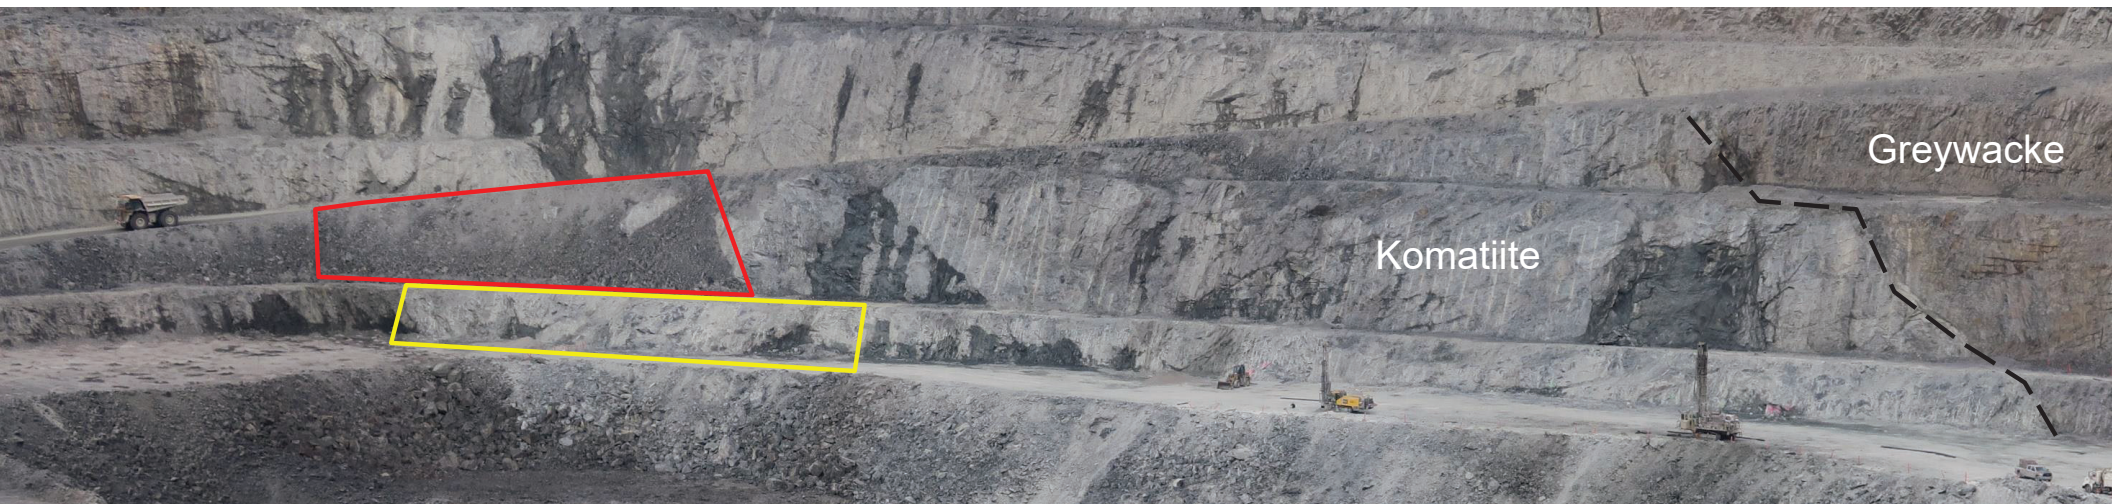
- The western end of the wall, near the ramp, is of notably lower rock mass quality. A prominent structure defines the eastern limit of this zone (yellow dashed line below). The reduction in rock mass quality is believed to be due to the presence of multiple Brittle / High Strain Structures (see next slide). The foliation in this area is distorted and at least locally has a much shallower dip (white dashed lines below, possibly the S3 foliation).

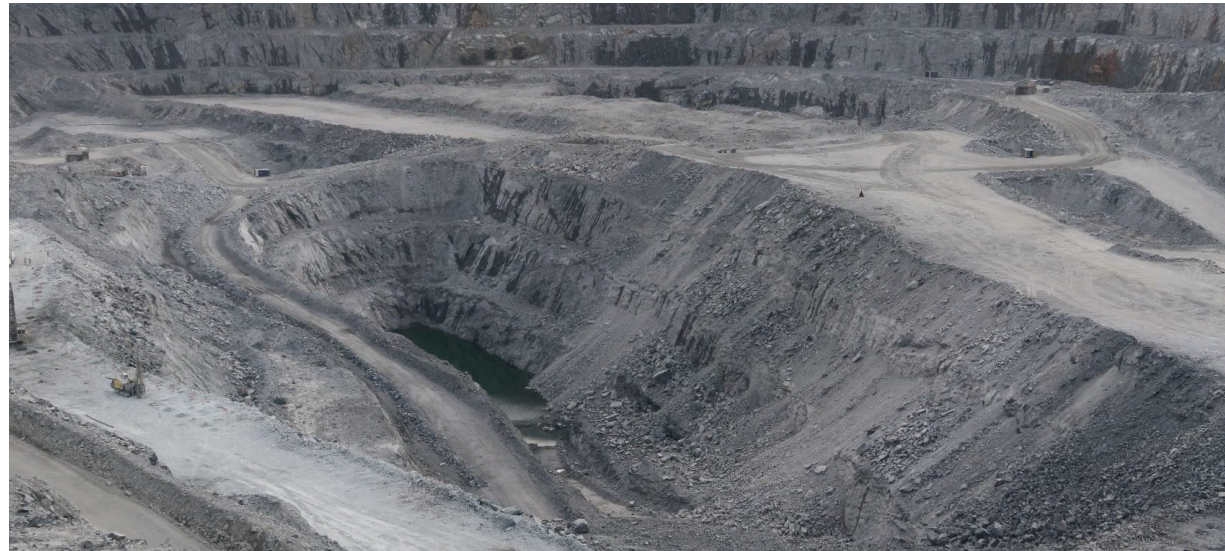
- Mining of Phase 1 was completed in the first half of 2023. The ramp to Phase 1 is currently bermed off.
- The North Wall wall was established in the Komatiite, parallel to the foliation and experienced a series of bench-scale planar failures. Mining along the North Wall was successfully prioritized during winter to minimize the rockfall risk to personnel. A berm was installed at the toe of the slope prior to freshet to retain the expected rockfall. This approach was successful.

- A multi-bench instability occurred on the North Wall on May 14, 2022. As the first multi-bench failure to occur at Amaruq, it is important that this failure be back-analyzed to understand the failure mechanism. This has not yet been done.

- It is understood that access may be re-established to Phase 1 for dewatering purposes. The risks associated with on-going access below the failure, as well as the rockfall hazard associated with on-going mining of Phase 3 should be reviewed and mitigation measures implemented as appropriate.

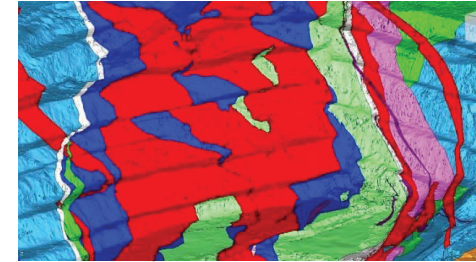
- Two “Major” High-Strain / Brittle Structures intersect this wall (BS1 and BS5). These structures have strongly influenced the slope performance and contributed to many of the bench-scale failures to date. Jonathan Servais (3D Modelling Geologist) of AEM has high confidence in the interpretation of both structures.

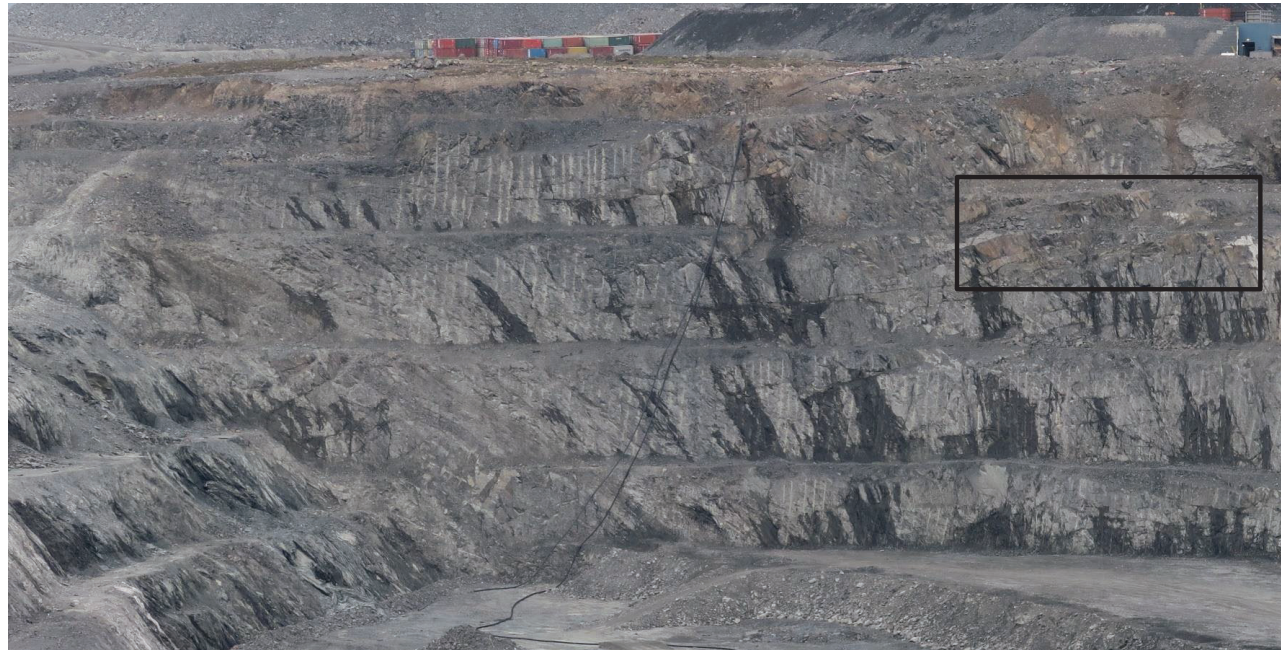
- Final wall in Design Sector E4.
- Mining of the Phase 3 pushback allowed limited scaling of an area that has been identified as a rockfall hazard for several years (outlined in black).
- Significant variation was observed in the rock mass quality exposed in the lowermost bench of the wall. This is discussed further on the next slide.
- The benches have generally performed well. Increased crest loss was observed where either a north dipping structure (Joint Set B?) or a sub-horizontal structure (Joint Set C) is present.
- The foliation strikes roughly perpendicular to the wall, which is favourable for bench stability. Half barrels are observed in some instances in the Komatiite.

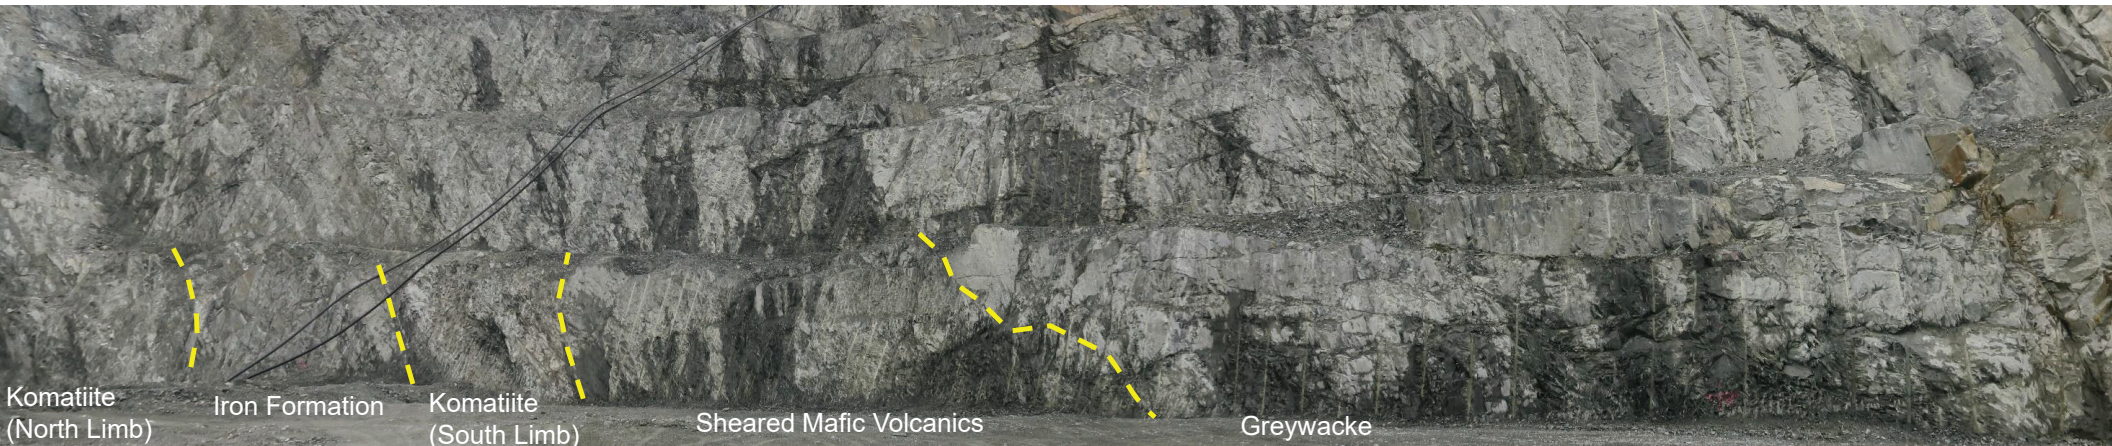
- The sheared Mafic Volcanics have not significantly impacted bench performance to date, primarily because the foliation is roughly perpendicular to the slope. However, the extents of this unit should be reviewed and the potential impact on subsequent benches assessed. It may be associated with Brittle / High Strain Structure #3.

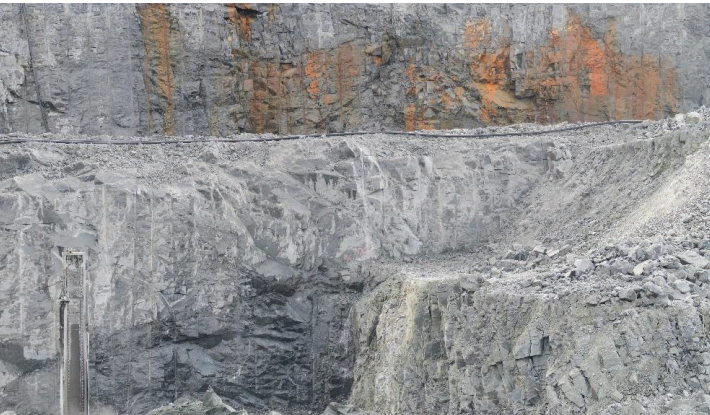
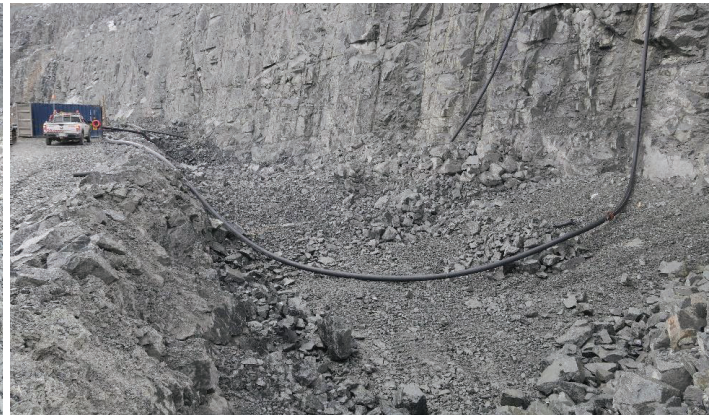
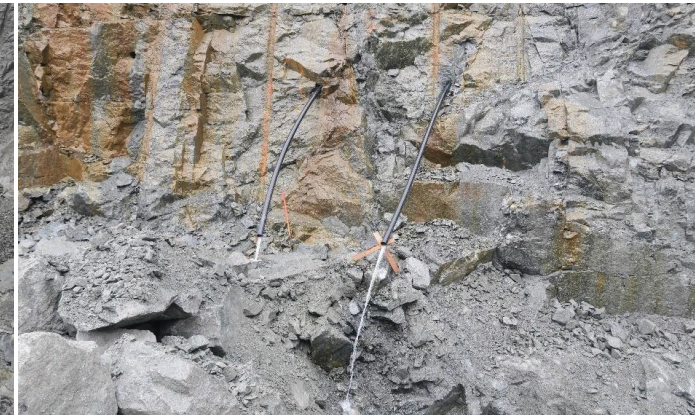
- AEM is currently reviewing options for improving the water management strategy in this area, including drilling additional drains to intercept and divert more of the seepage to the sump. This is endorsed. Recommend evaluating options for lining the sump to limit re-infiltration of the diverted water.

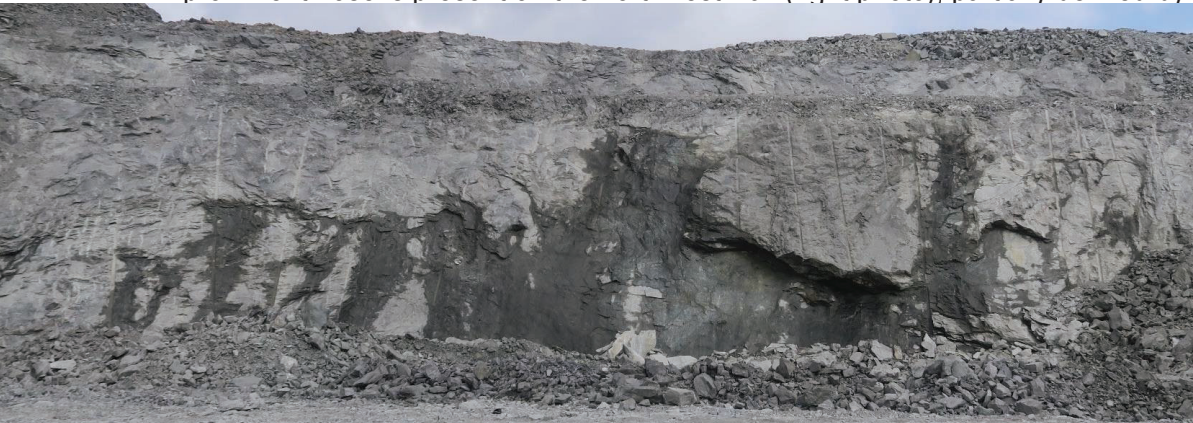
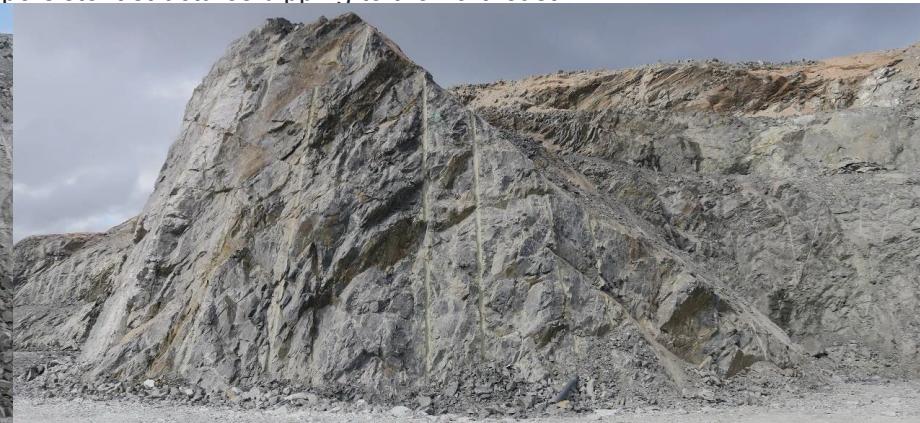
- A small planar failure occurred where the bench face was established a few degrees steeper than the foliation (left photo). The area was bermed off.
- A prominent nose is present on the northwest wall (right photo), partially defined by persistent structures dipping to the northeast.

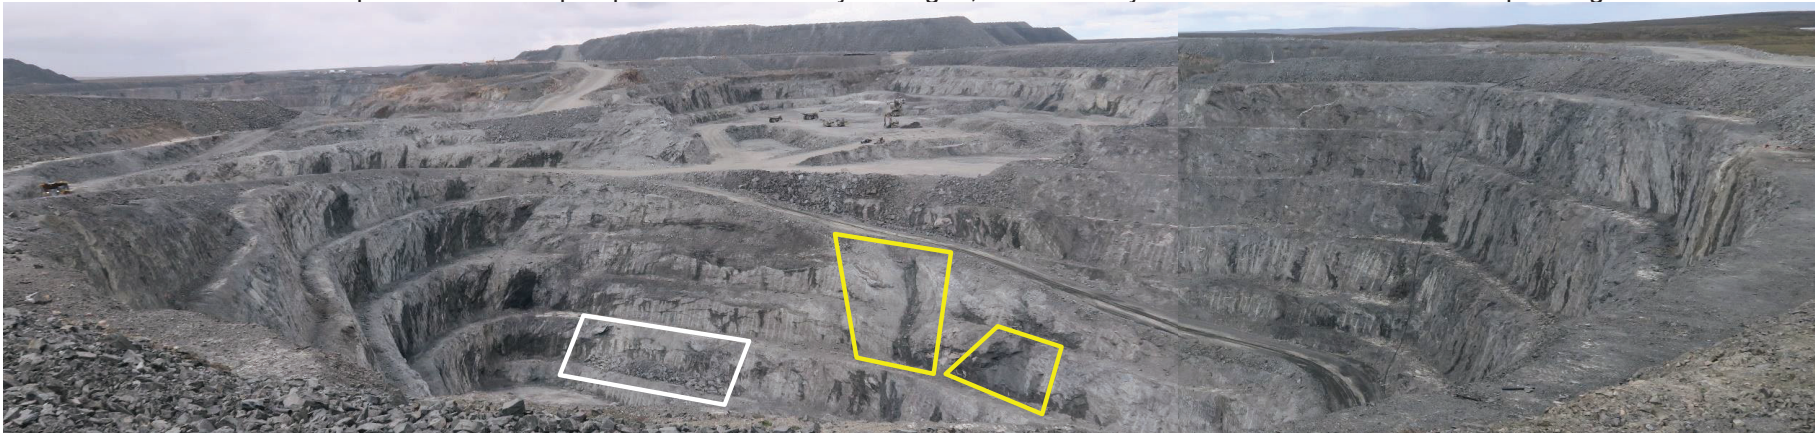
- This is the footwall of the deposit and is primarily within the Komatiite.
- The original design called for the use of staggered blastholes to establish the BFA at 45° in order to limit the potential for bench and inter-ramp scale failures on the foliation. This approach was unsuccessful due to a combination of poor blasting quality control and variability in the orientation of the foliation.

- It is understood that overspill from the V2 open pit was successfully managed, and that very little material reached the ramp during blasts.

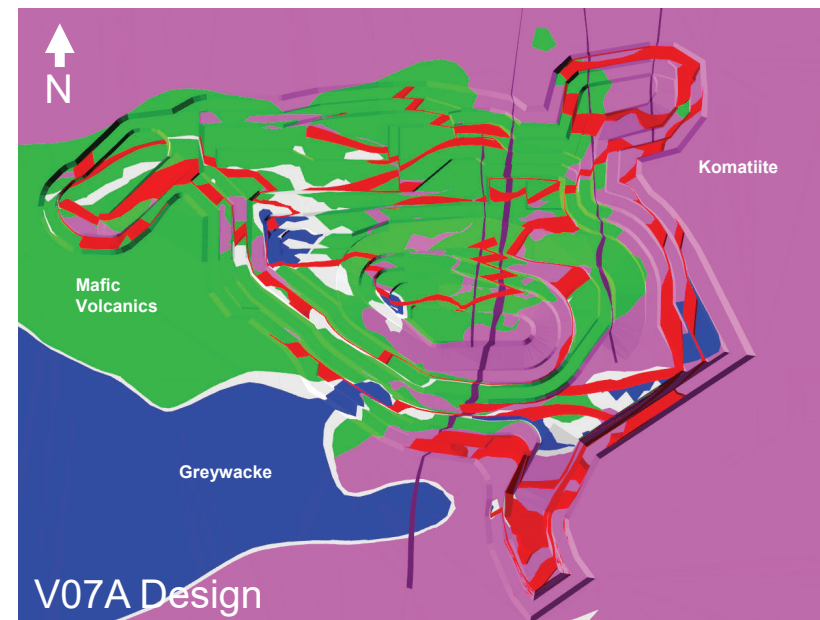
- The North Wall of the V2 open pit was designed to be within the Mafic Volcanics rather than the Komatiite in order to reduce the potential for bench- and inter-ramp scale planar failures on the foliation. If the wall is established in the Komatiite, a shallower slope would be required.
- The North Wall of the V07A design is still predicted to be within the Mafic Volcanics. However, Geology has noted that the lithological interpretation for IVR is complex and that the modelled lithologies do not necessarily agree with the drillhole data. The broad trends are still thought to be generally reliable. On-going geological mapping to verify that the North Wall is in fact being established in the Mafic Volcanics is recommended.

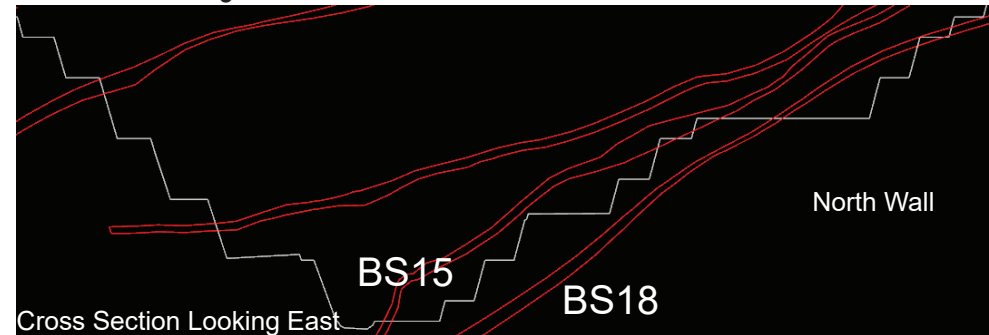
- KP is reviewing the slope geometry recommendations for this wall as part of an on-going study. Guidance is expected in late February 2024.
- Limited structural mapping is being completed in the open pits. It is recommended that mapping be completed regularly, focussing on large-scale structures such as the high-strain / brittle structures. The goal is to validate and refine the structural model and assess the potential for multi-bench or inter-ramp scale failures.

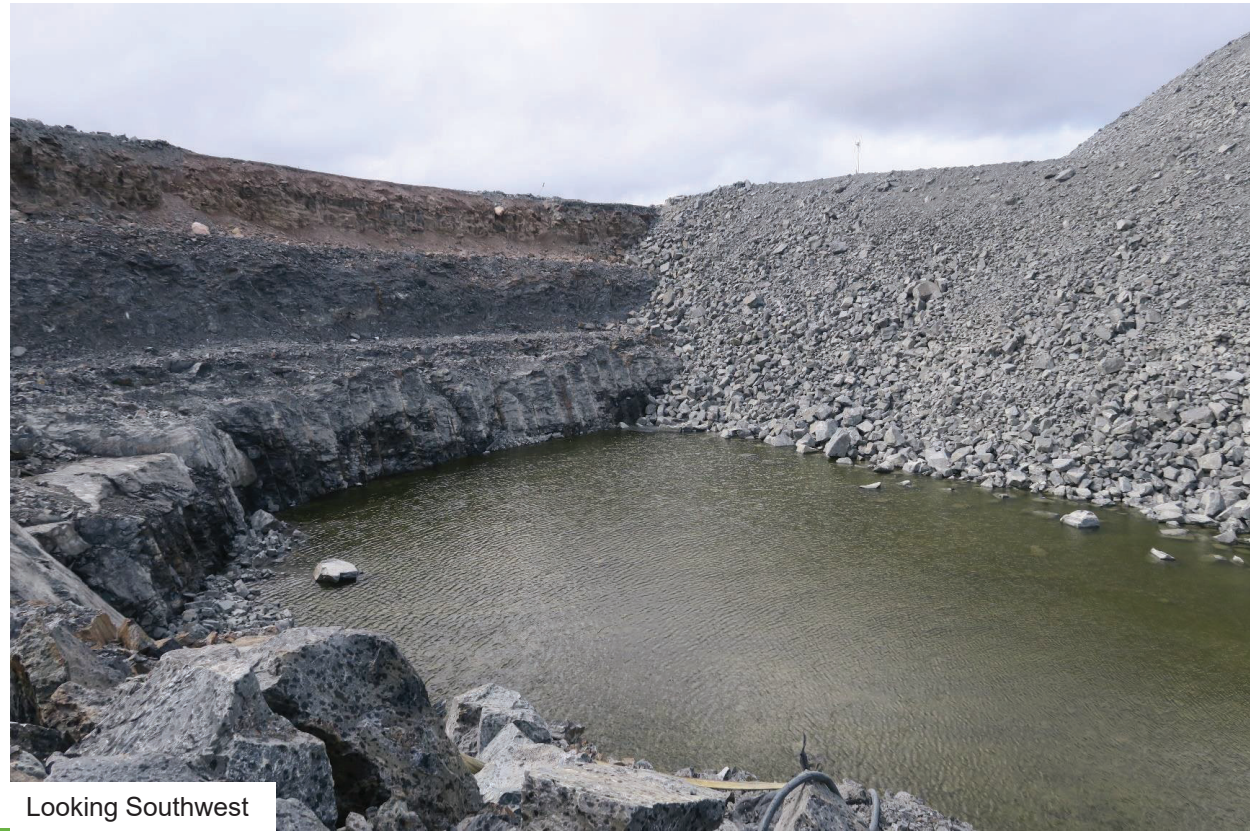
- Mining of the IVR West 1 pit is complete and the open pit is being backfilled with waste rock placed by end-dumping from the crest.
- A berm has been constructed on the ramp to prevent access to the open pit.
- The controls in place appear to be adequate to manage the expected hazards.

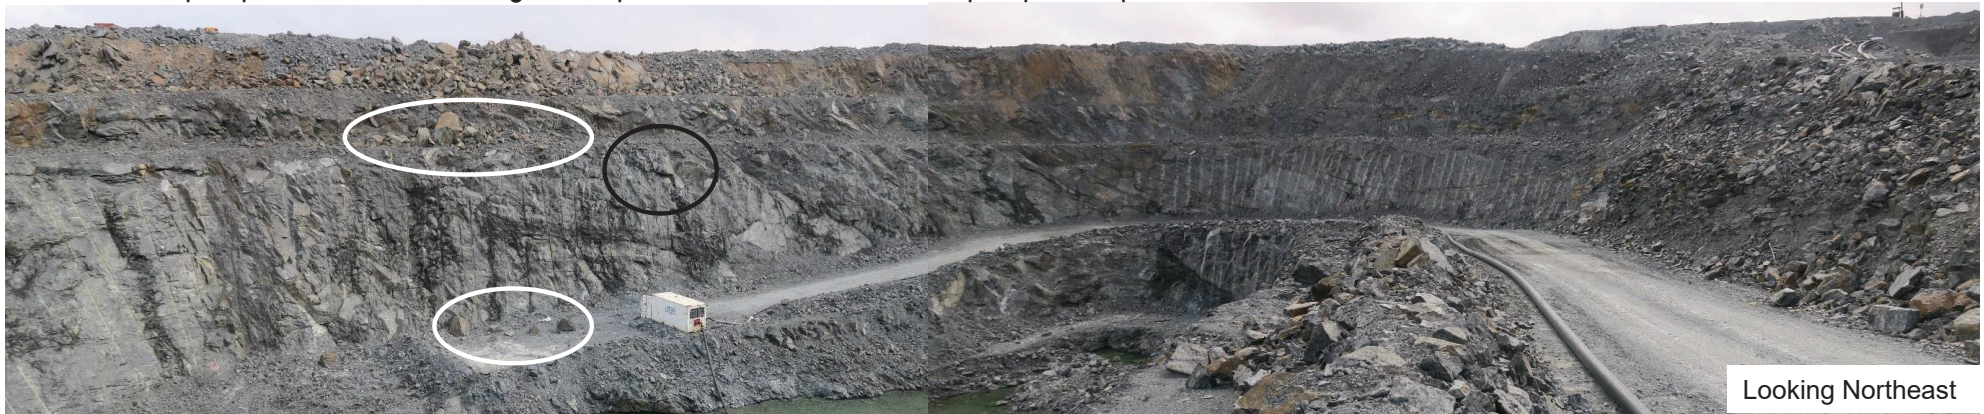
Looking Southwest

- The pump was removed during the inspection and access to the open pit was prevented with a berm.

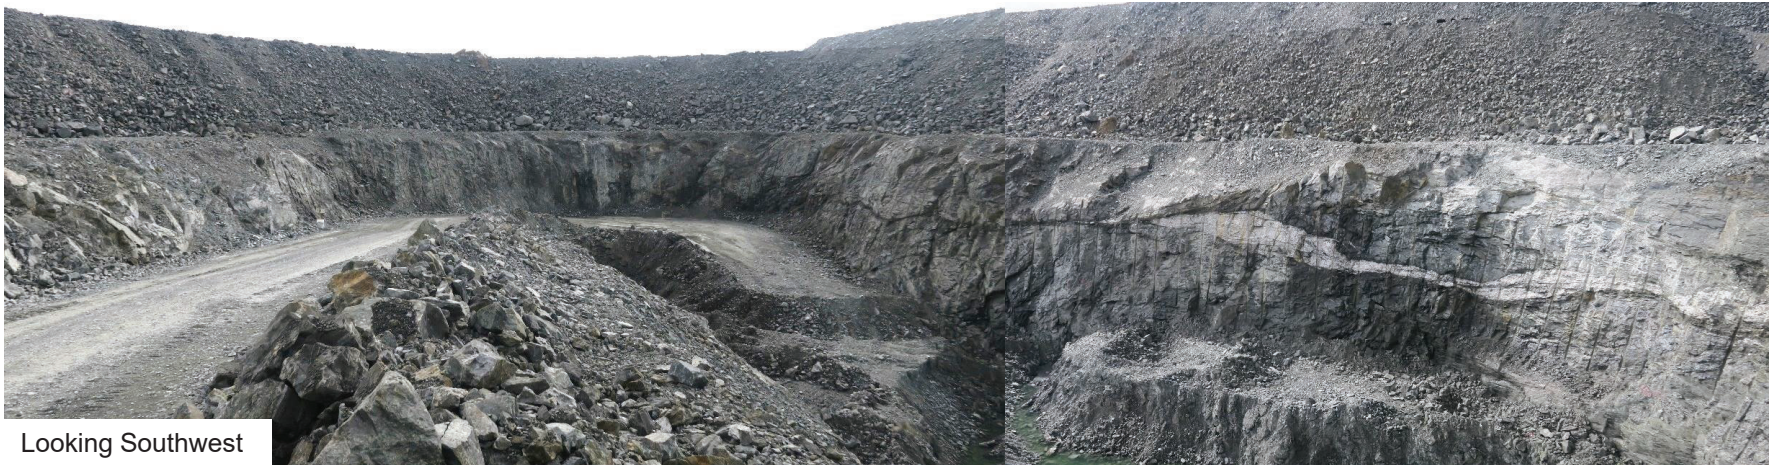
Looking Northeast

- Mining of the open pit is complete.
- Most of the open pit was established in the Mafic Volcanics, with limited intervals of Komatiite. The performance of the benches along the footwall have been influenced by the foliation dipping into the pit, with the crests breaking back to the foliation.
- Prominent quartz veining is observed.
- A berm has been constructed on the ramp to prevent access to the open pit.
- The controls in place appear to be adequate to manage the expected hazards.
