Project: CAPR003066
March 26, 2025

Subject Hope Bay Site-Wide – 2024 Annual Geotechnical Inspections

2024 Annual Geotechnical Inspection

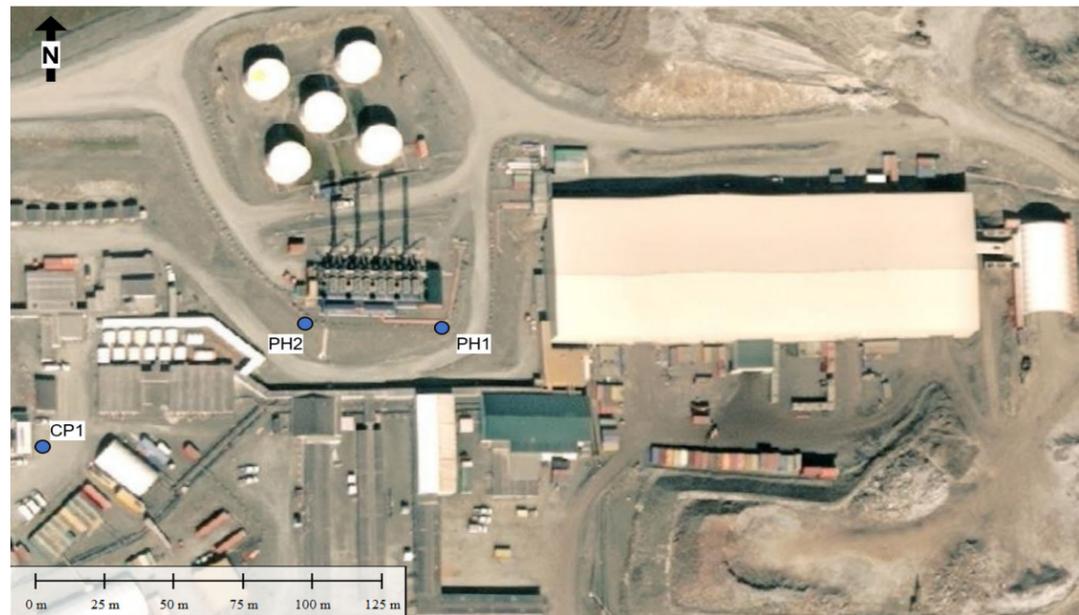
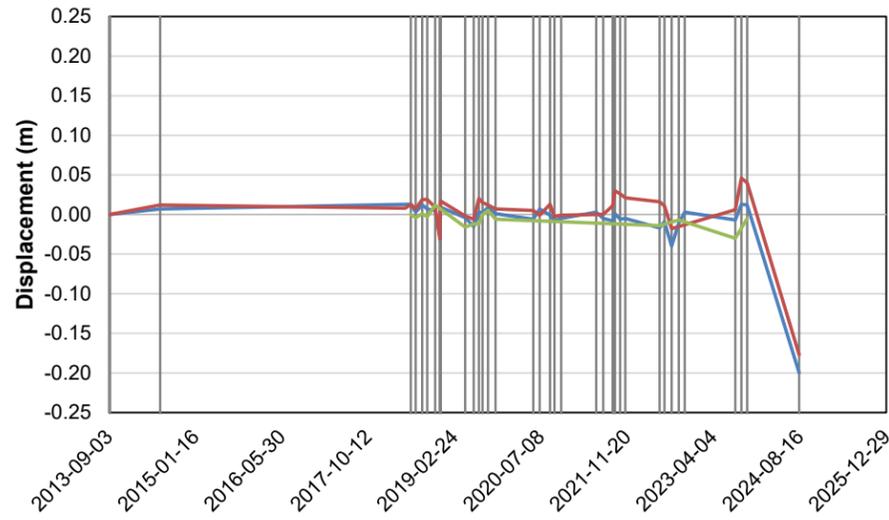
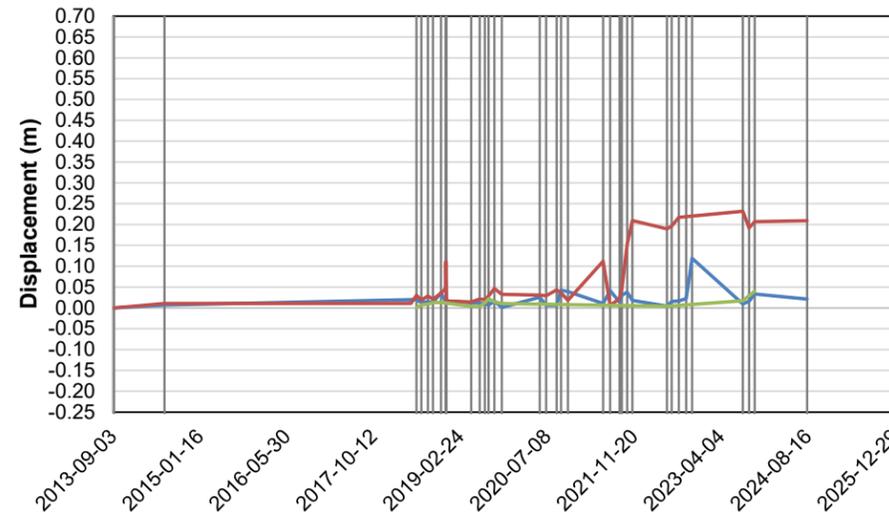
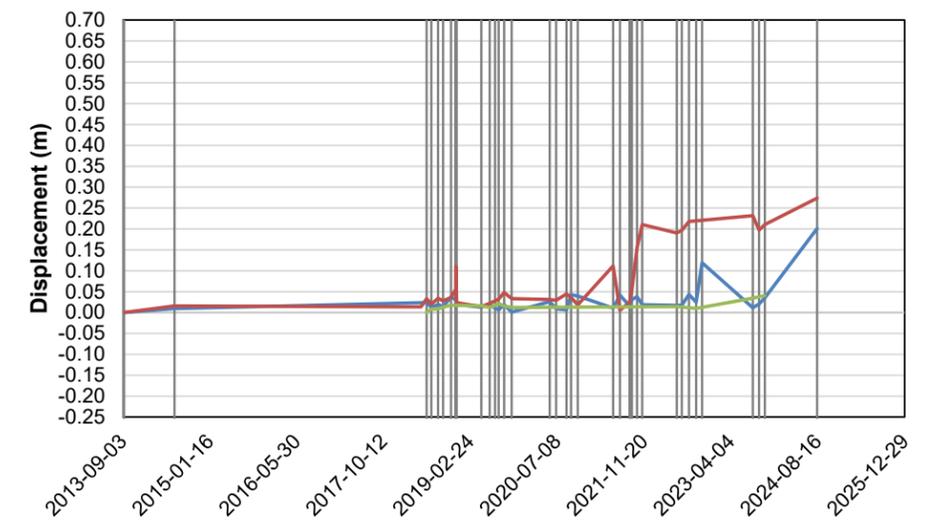
Pad B		
		Survey Monitoring Points Displacement Timeseries		
Job No: CAPR003066 Filename: HopeBay_PadB_PowerhouseSurveyMonitoringPts_2024AGI	Hope Bay	Date: Mar 2025	Approved: PDL	Figure: 1

1. CP1 corresponds to a control point (rock bolt in bed rock) that used as a check/secondary base point
2. PH2 is leaning at about 30 degrees to the west. This occurred in 2021, when the 0.2m displacement was observed.

- Monitoring frequency of survey points (Pad B, Madrid CWP (to be replaced in 2025), Naartok East CPRT) was below the target frequency. Only one survey monitoring event occurred in 2024. Survey monitoring should be conducted at the target frequency established based on the performance and use of the structure (at a minimum once every two months, between May and November). Completion of repairs to the ground temperature cables (GTC) SRK10-DCB1, SRK10-DCB2 and SRK-12-GTC-DH01 should also be completed. If repairs of cable connections are not

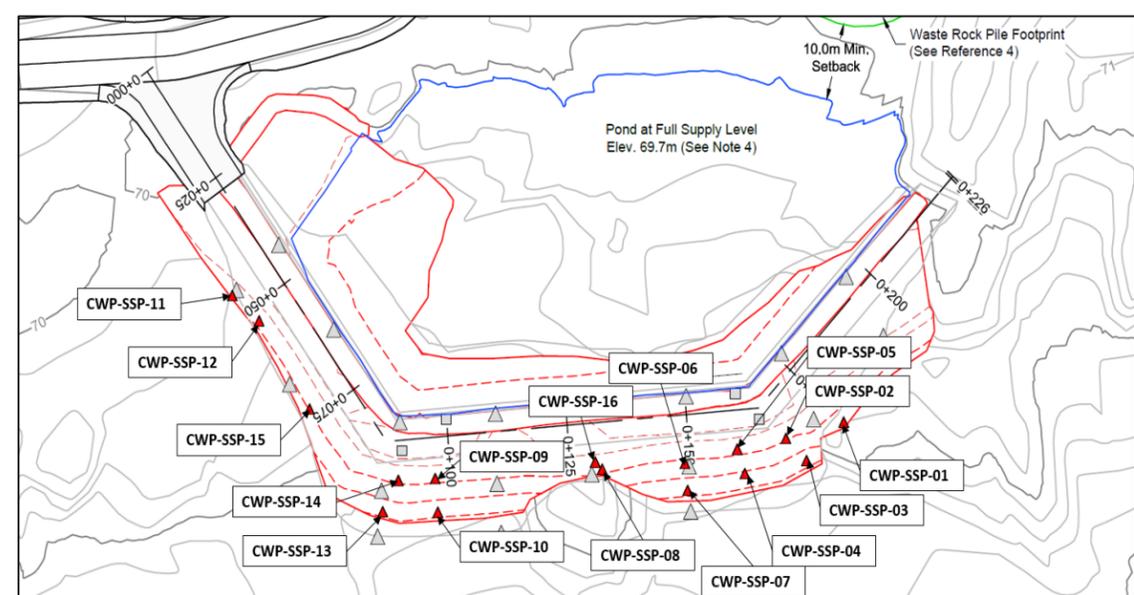
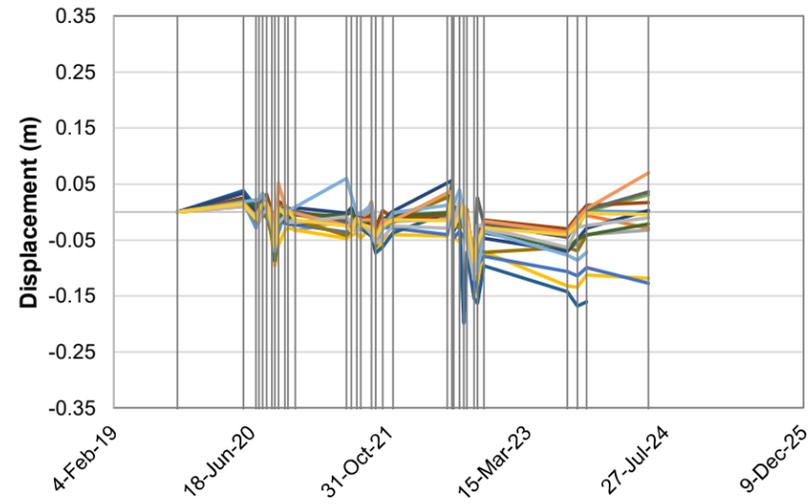
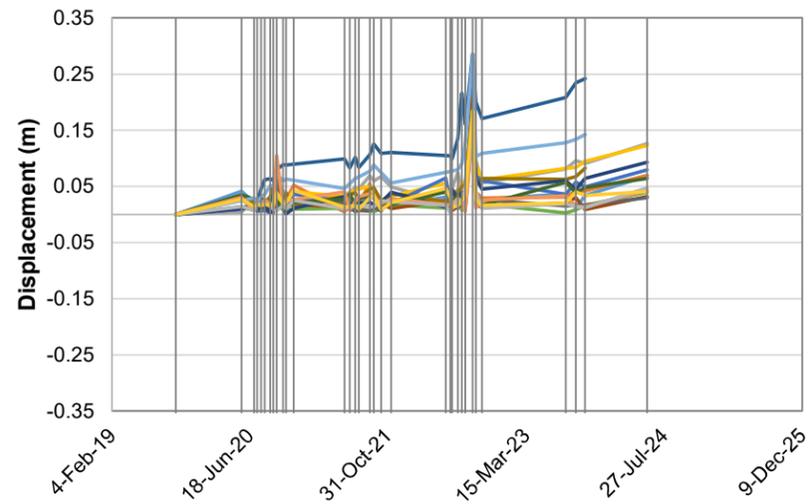
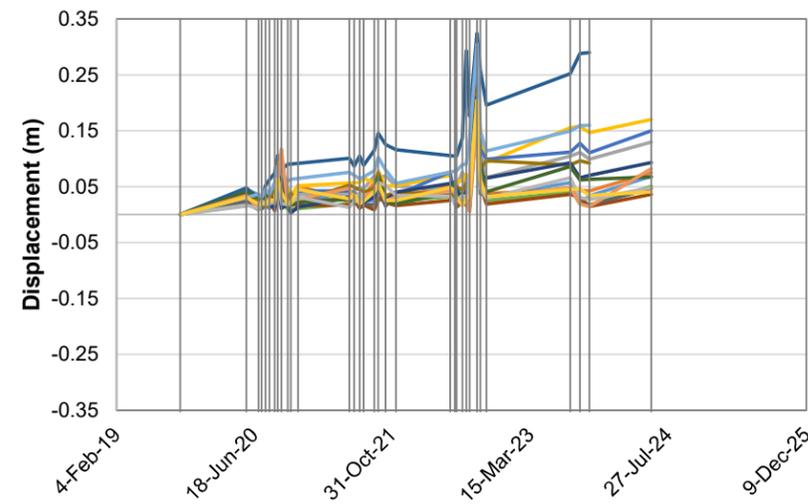
Madrid CWP
Surficial Settlement Monitoring Point (Rock Bolt) Displacement Timeseries

1) CWP-SSP-10, CWP-SSP-11 and CWP-SSP-13 were not surveyed during the single survey in 2024 due to snow build up along the toe of the CWP.

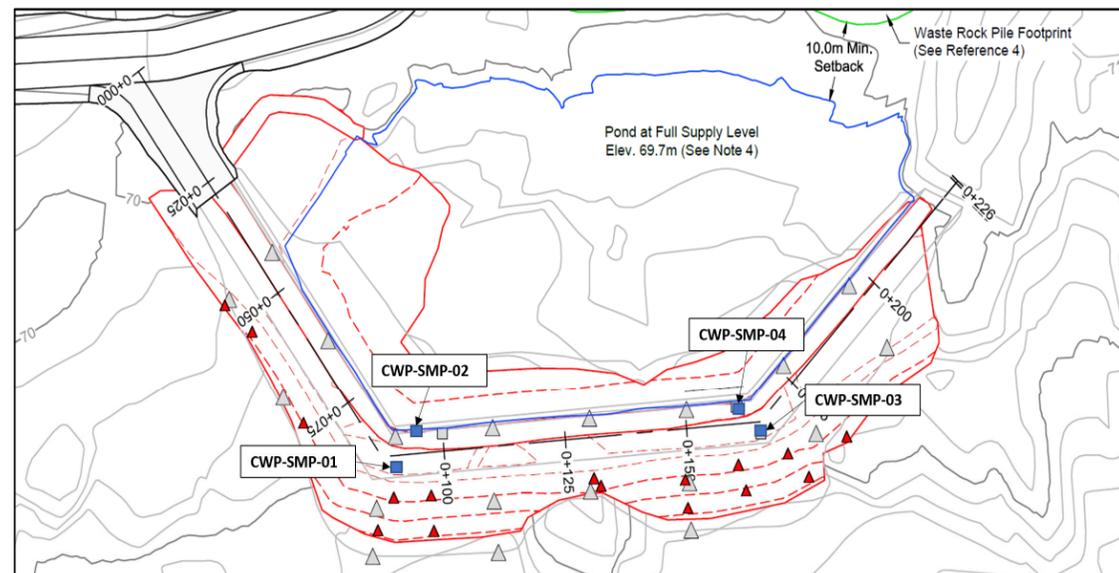
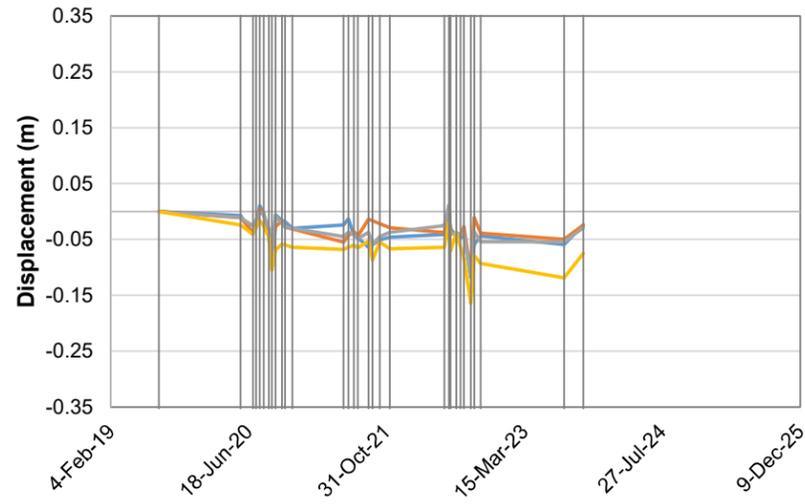
Madrid CWP		
		Settlement Monitoring Plate Displacement Timeseries		
Job No: CAPR003066 Filename: MadridCWP_SurveyMonitoringData_AGI2024.xlsx	Hope Bay	Date: Mar 2025	Approved: PDL	Figure: 3

No settlement monitoring plate survey data collected in 2024.

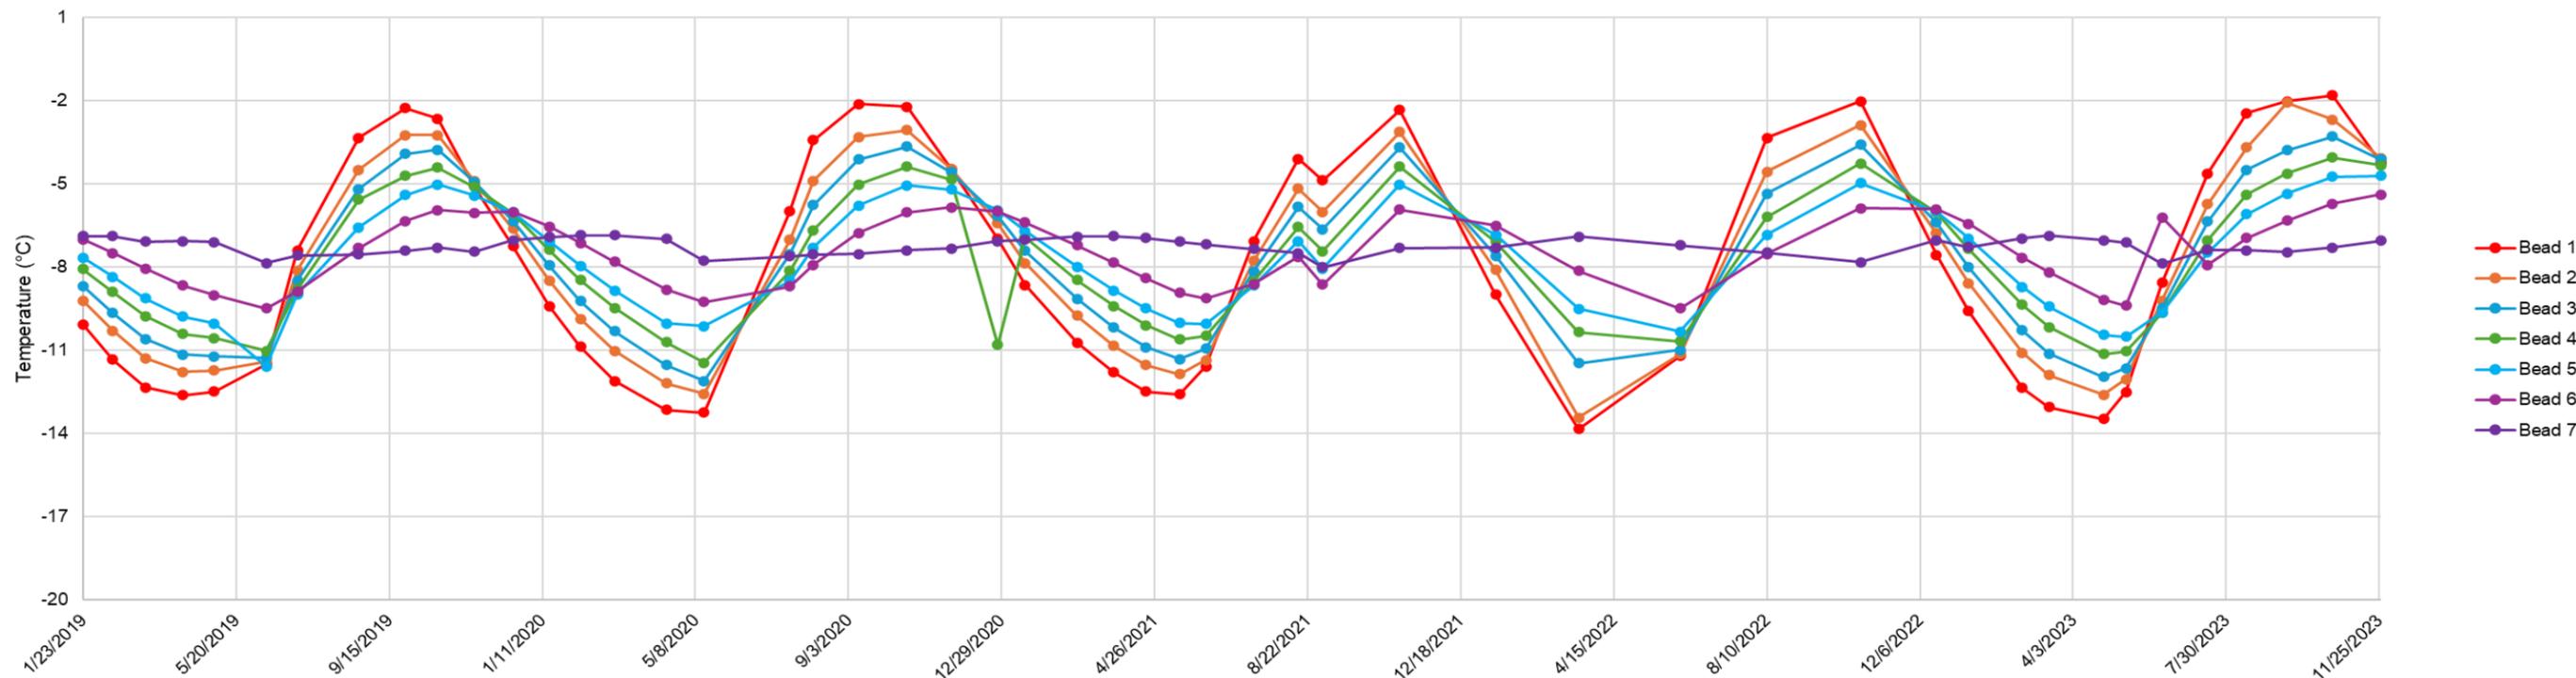
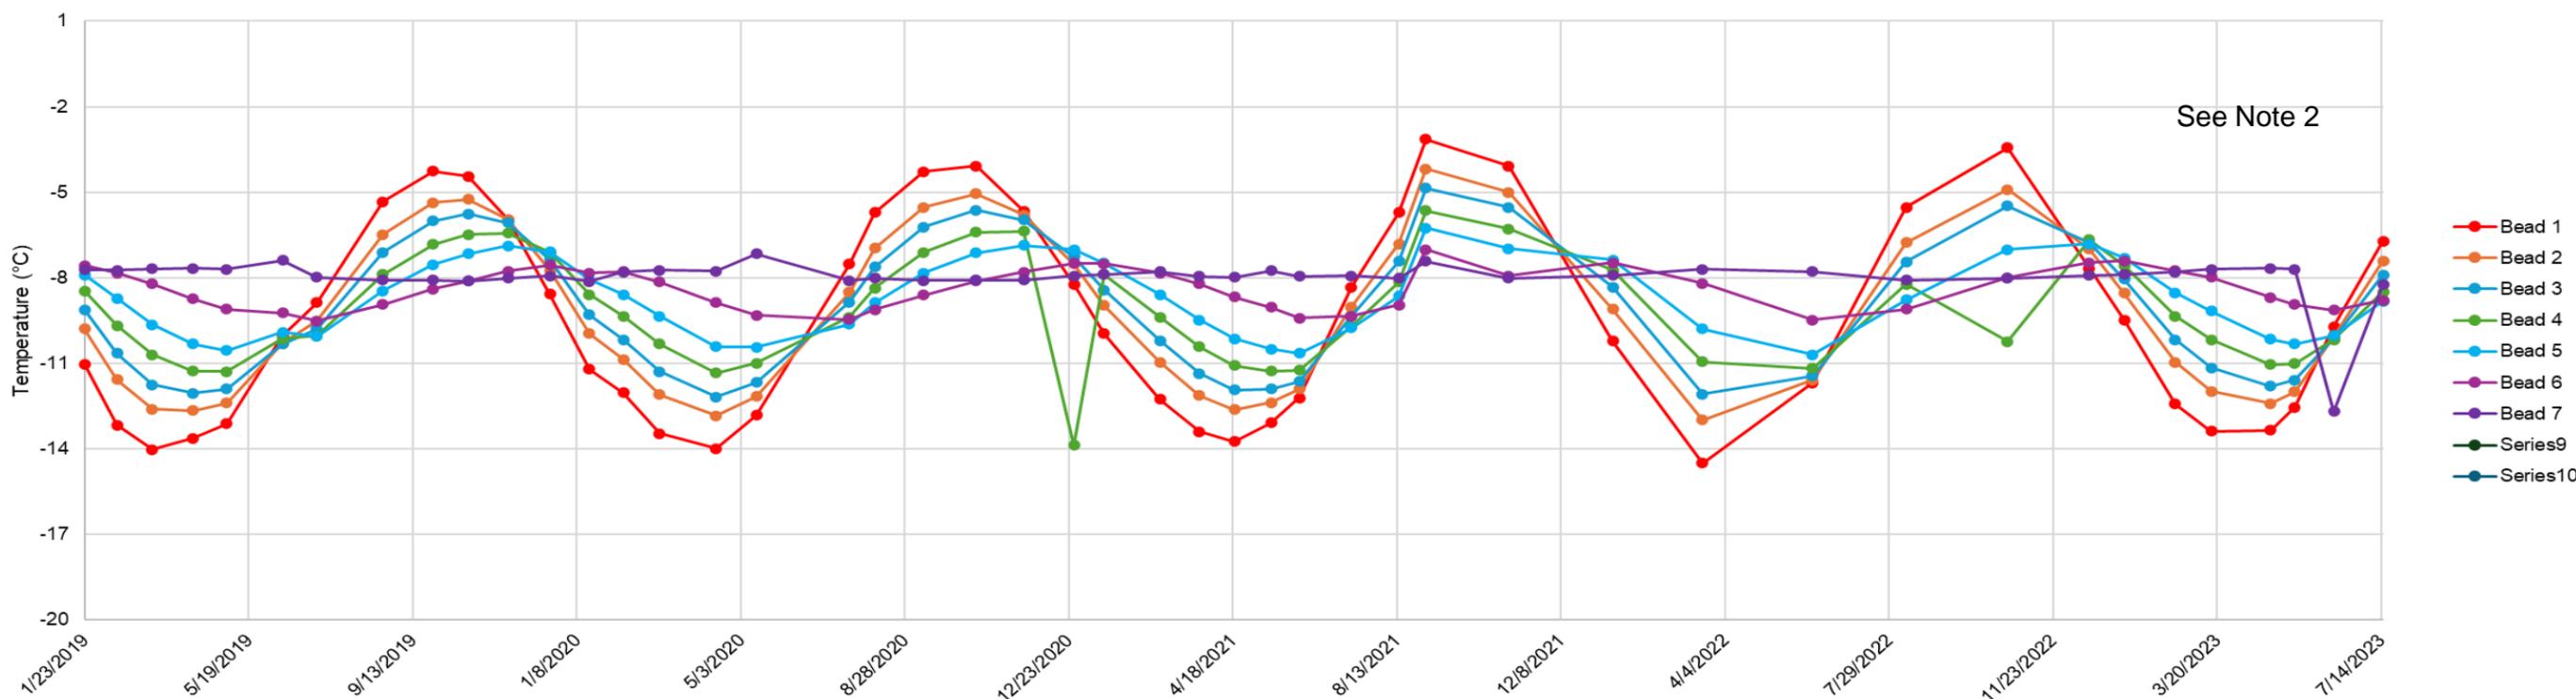
Hope Bay	Hope Bay Site-Wide – 2024 Annual Geotechnical Inspections		
		Doris Bridge Abutment Foundation Thermistors		
		Date: March 2025	Approved: PDL	Figure: 3

- 1) Data is presented for the past five years, between January 2019 and December 2024. Data records began in 2012.
- 2) Cable SRK10-DCB2 (Doris Bridge East) was noted to be damaged after July 2023.

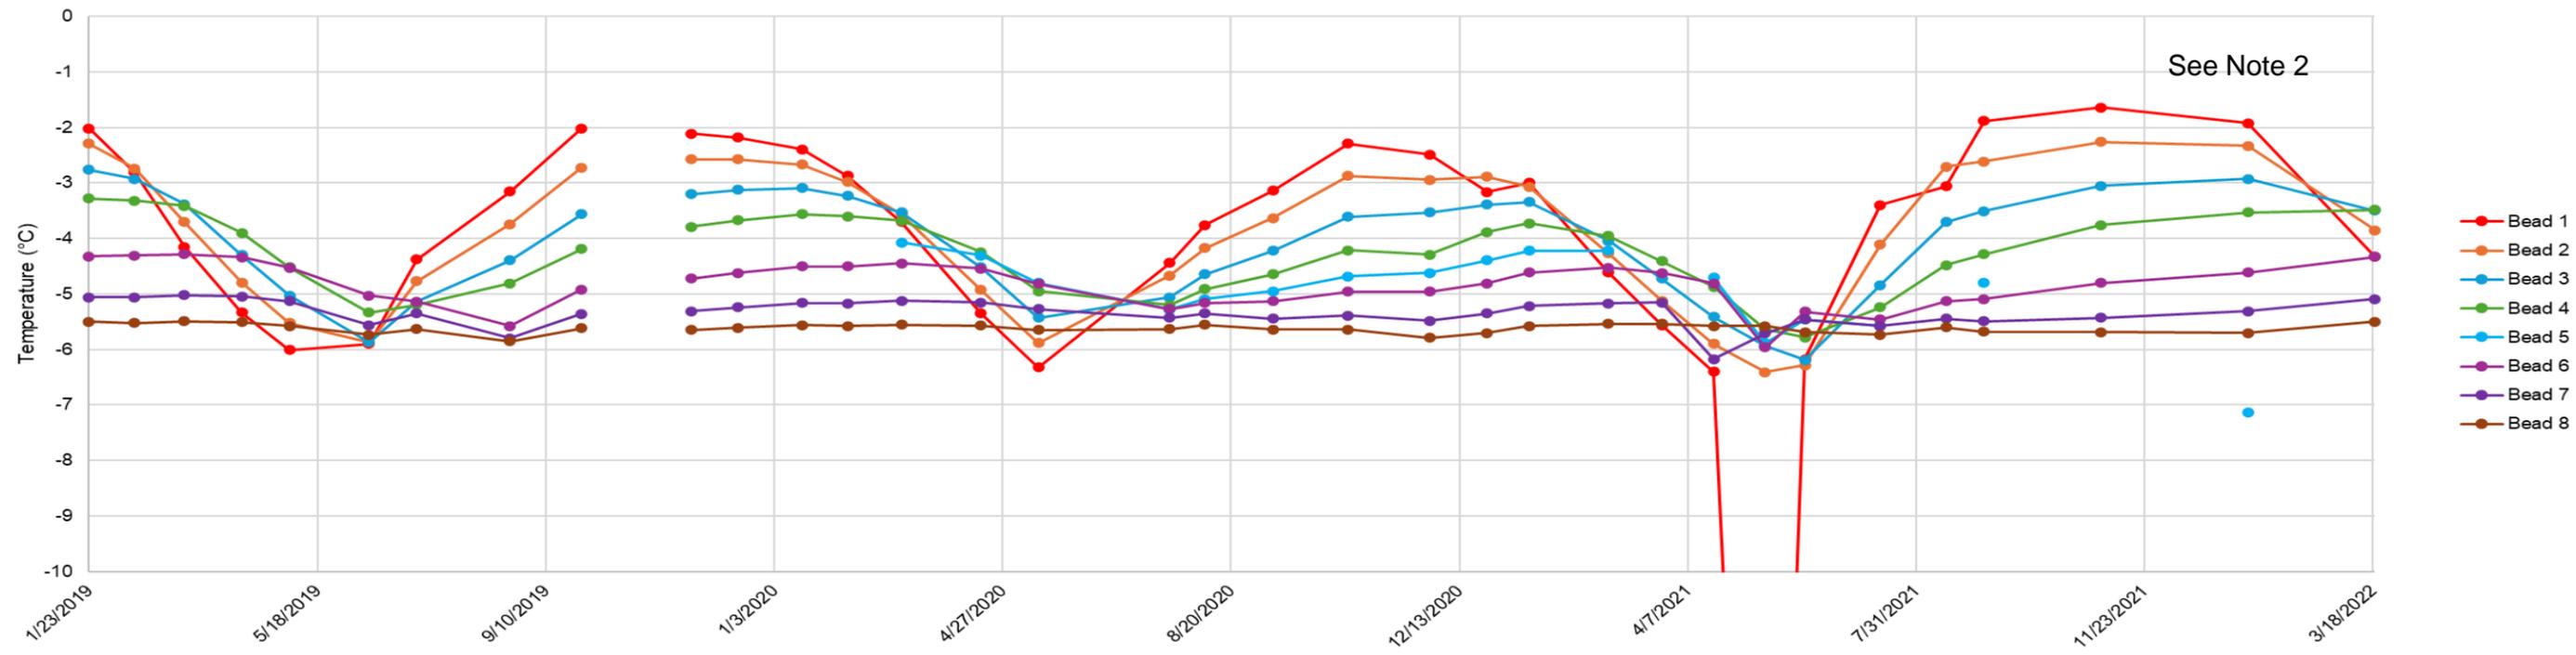
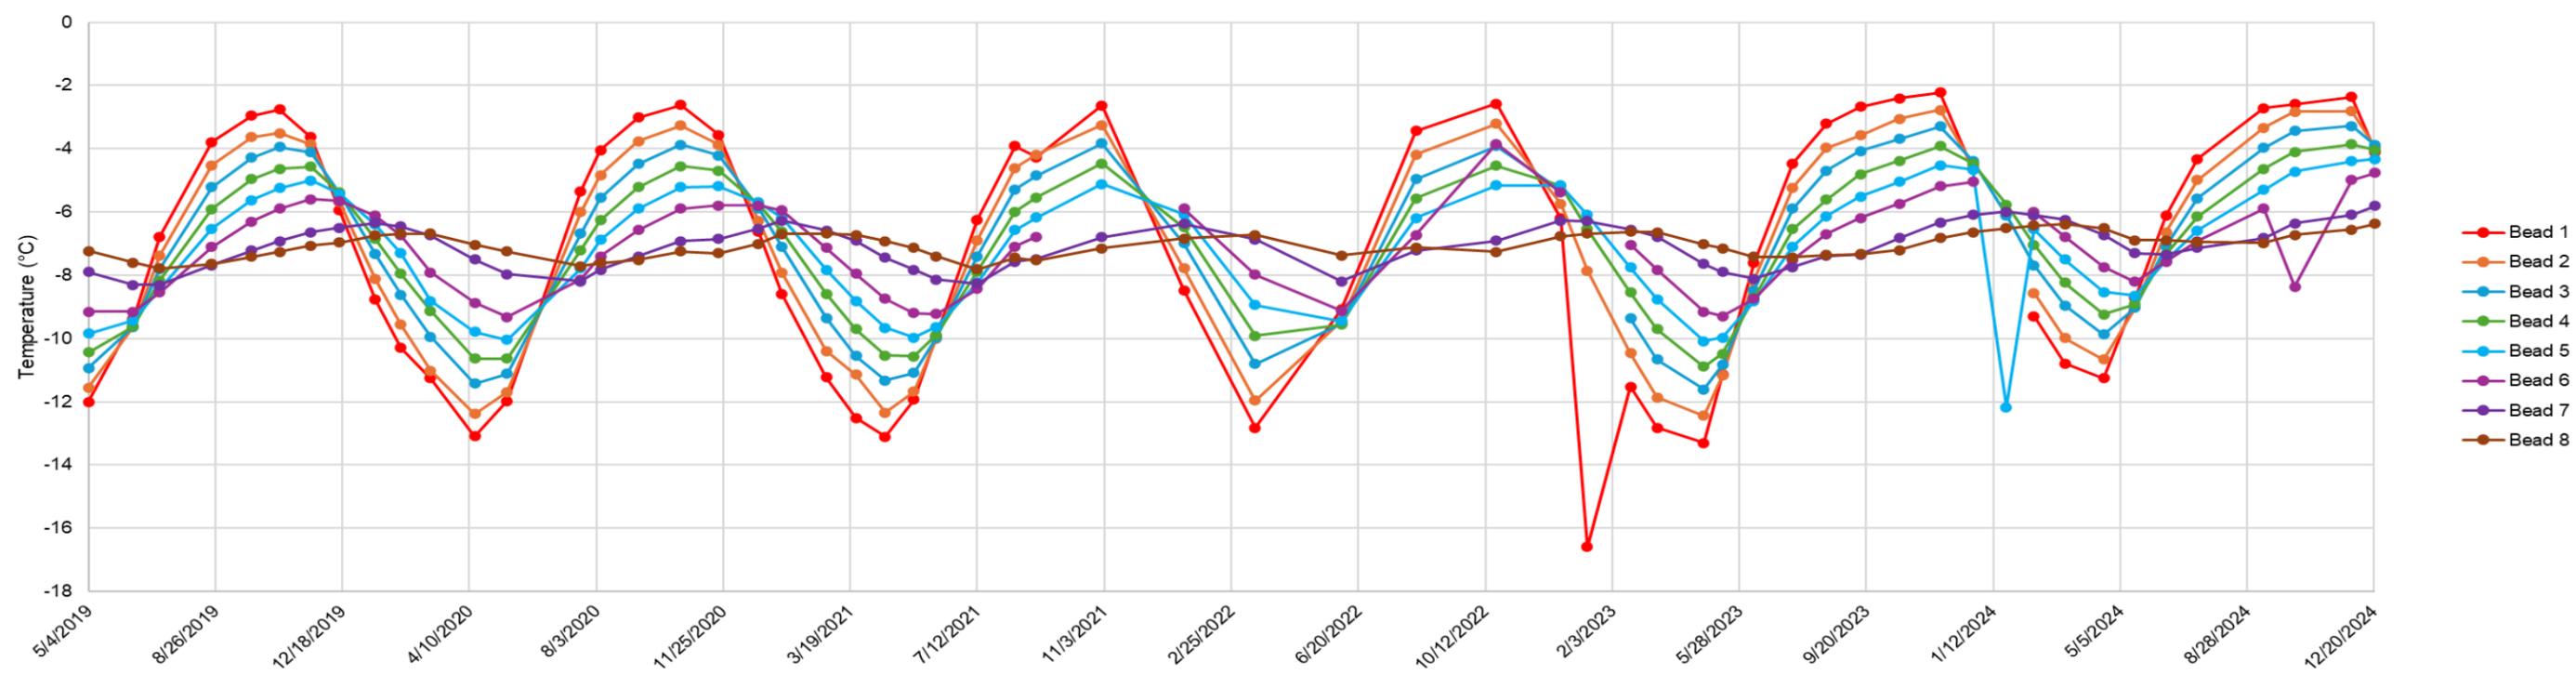
Hope Bay	Hope Bay Site-Wide – 2024 Annual Geotechnical Inspections		
		Doris Pollution Control Pond		
		Date: March 2025	Approved: PDL	Figure: 4

Infrastructure	Observations	Recommendations and Comments	Recommendation ID
	<ul style="list-style-type: none"> ■ SRK-12-GTC-DH02 and SRK-12-GTC-DH03 ground temperature measurements indicate slightly warmer minimum ground temperatures in 2024, which have been seen across site, but are also indicative of potential warming along the CWP berm and liner-in. 	<ul style="list-style-type: none"> ■ Although minimum monitoring frequency stated in the water license has been met for active cables, consider increasing frequency of readings to maintain resolution of data. Consider installation of a datalogger at SRK-12-GTC-DH02 and SRK-12-GTC-DH03 to increase the resolution of the thermal data collected in this location. 	<ul style="list-style-type: none"> ■ 2024-AGI-11
Doris Sediment Pond	<ul style="list-style-type: none"> ■ Several holes and cuts noted in liner, on slope near crest of berm. These are patterned cuts (parallel and perpendicular to the direction of the HDPE roll and appear to be located above the overflow culverts installed in the downstream berm of the pond. ■ Wrinkles in the liner are present in the north corner. 	<ul style="list-style-type: none"> ■ <i>Overall, the pond is in satisfactory condition, though repairs are needed to prevent the observed defects from getting worse, and to prevent water from leaking through the cuts when the pond is full.</i> ■ Inspect the liner for additional defects and confirm elevation of any observed defect is above the overflow culvert elevation. ■ Consider getting the holes and cuts observed in the liner repaired by a specialty liner contractor to prevent the cuts from getting larger. 	<ul style="list-style-type: none"> ■ <i>Comment</i> ■ 2023-AGI-32

- 1) Data is presented for the past five years, between January 2019 and December 2024. Data records began in 2012
- 2) Cable SRK-12-GTC-DH01 was noted to be damaged after March 2022.
- 3) For cable SRK-12-GTC-DH01, data collected in May 2021 were resistance corrected (from 3,000 to 2,252 Ohms).
- 4) For cable SRK-12-GTC-DH02, data collected in May 2021, December 2022, March 2023 and July 2024 were resistance corrected (from 3,000 to 2,252 Ohms).

possible, then consider direct wiring into dataloggers which can provide improved data resolution and simplified data collection.
