2024 Annual Geotechnical Inspection – Doris Tailings Impoundment Area

Hope Bay Mine, Nunavut, Canada
Agnico Eagle Mines Limited

SRK Consulting (Canada) Inc. ■ CAPR003066 ■ March 2025

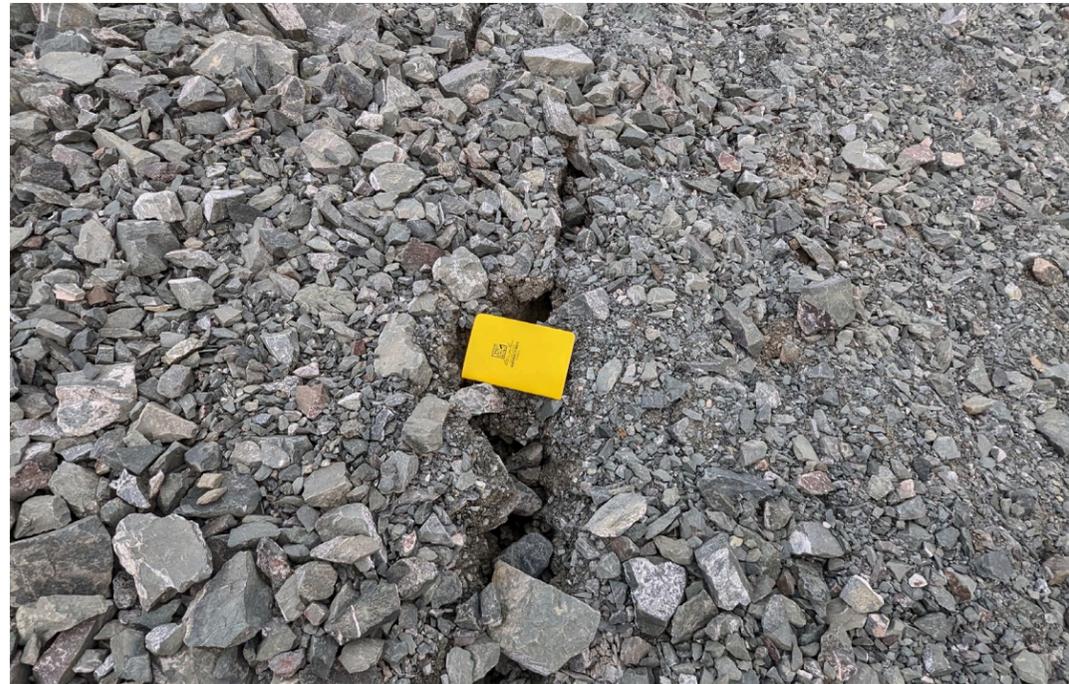
Photo 13: South Dam Cracking Downstream Face (Looking Southeast).

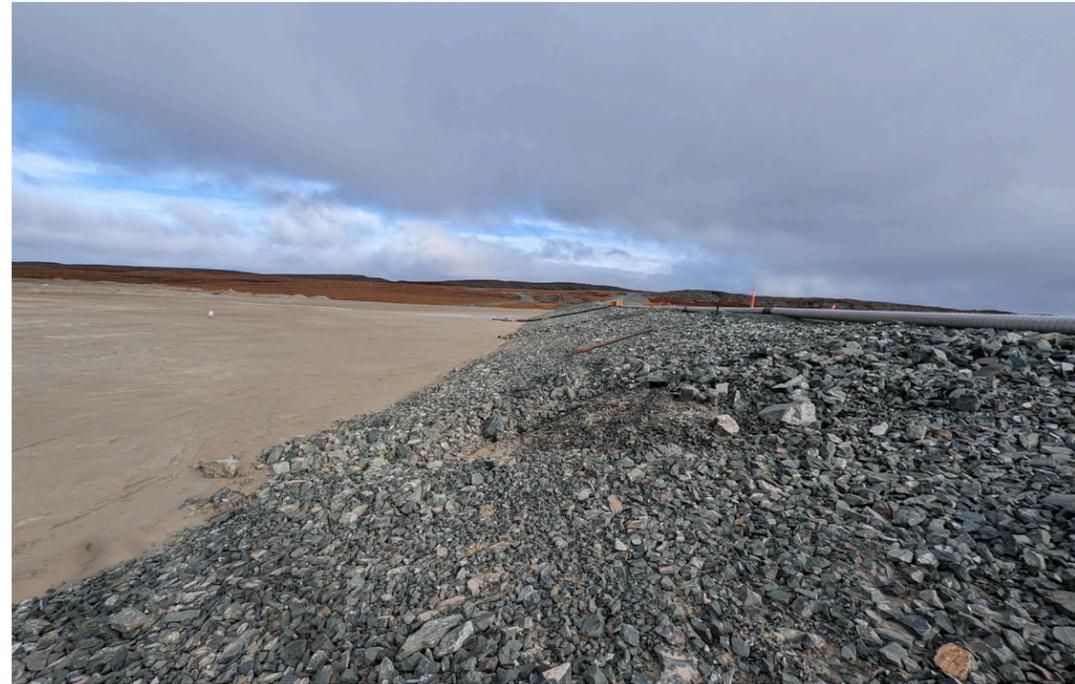
Photo 14: South Dam Upstream Face (Looking East).

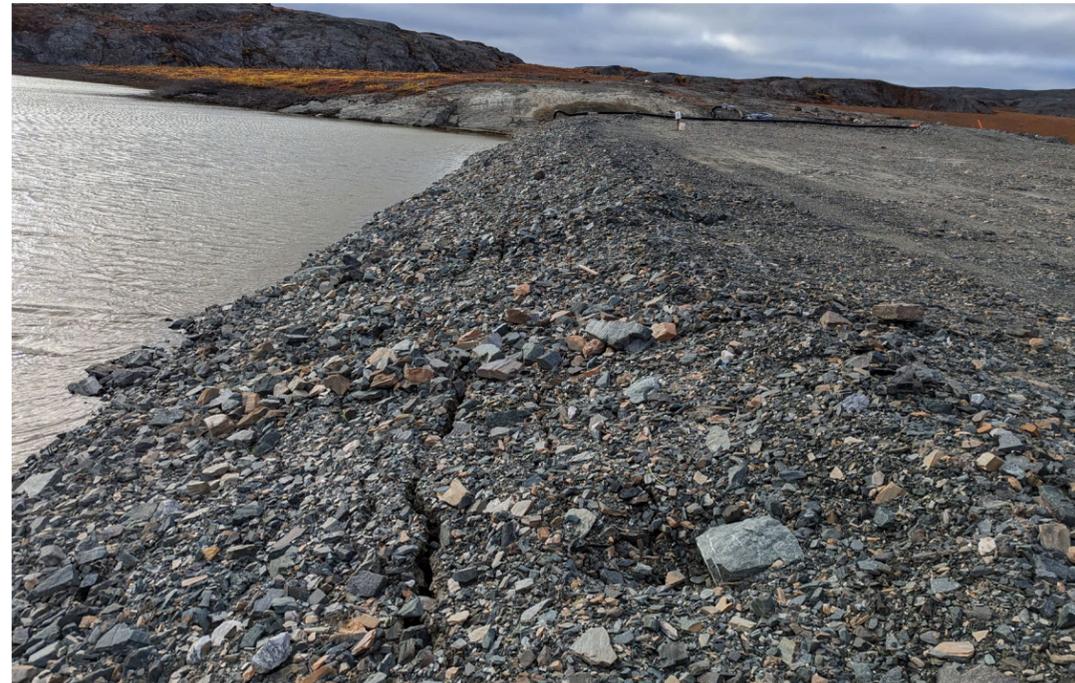
Photo 20: Interim Dike Upstream Face (Cracking) (Looking West).

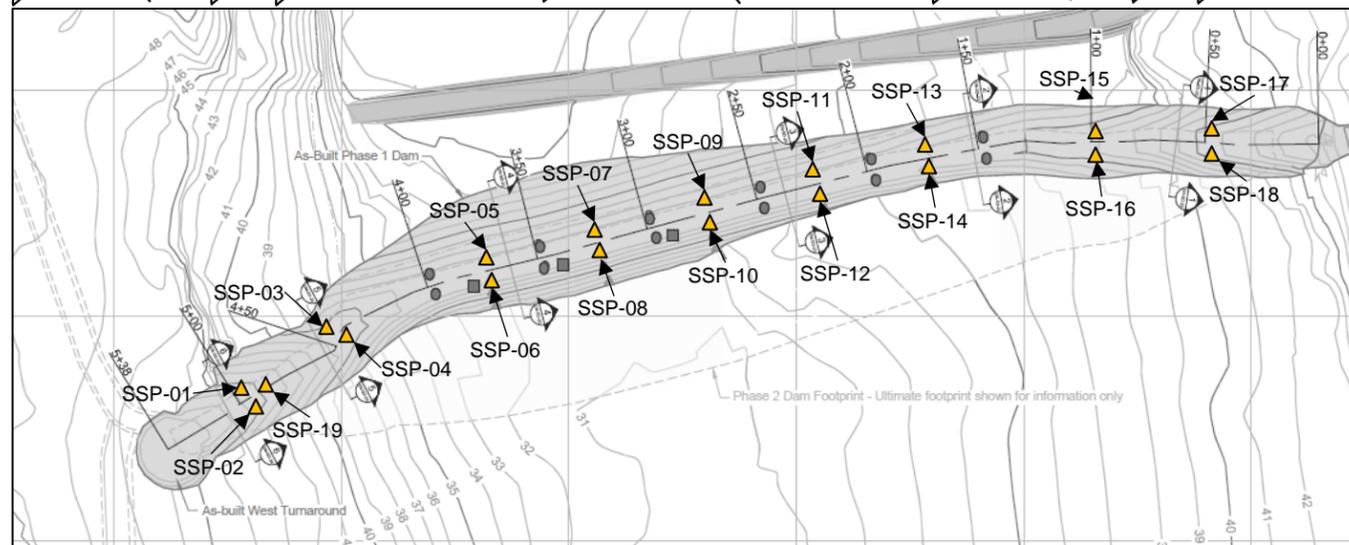
1. SD-SSP-08 was noted to be damaged on May 13, 2024.
2. Elevation data not received in August, 2024.
3. Erroneous data were eliminated.

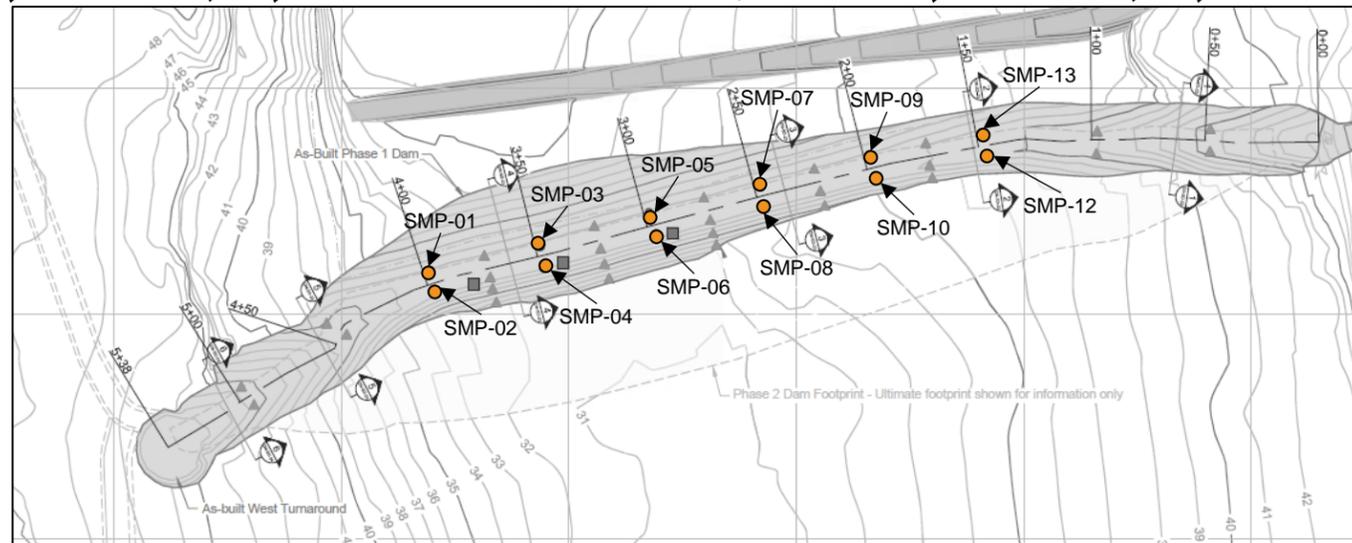
1. SD-SMP-04 was noted to be damaged on May 13, 2024.
2. Elevation data not received in August 2024.
