## **APPENDIX 6      2024 ANNUAL GEOTECHNICAL INSPECTION REPORT**

## 2024 Annual Geotechnical Inspection Meliadine Gold Mine, Nunavut, Canada

PRESENTED TO  
**Agnico Eagle Mines Limited**

MARCH 11, 2025  
ISSUED FOR USE-REVISION 1  
FILE: 704-ENG.EARC03140-39  
AGNICO EAGLE DOCUMENT NUMBER: 65-600-230-TCR-002

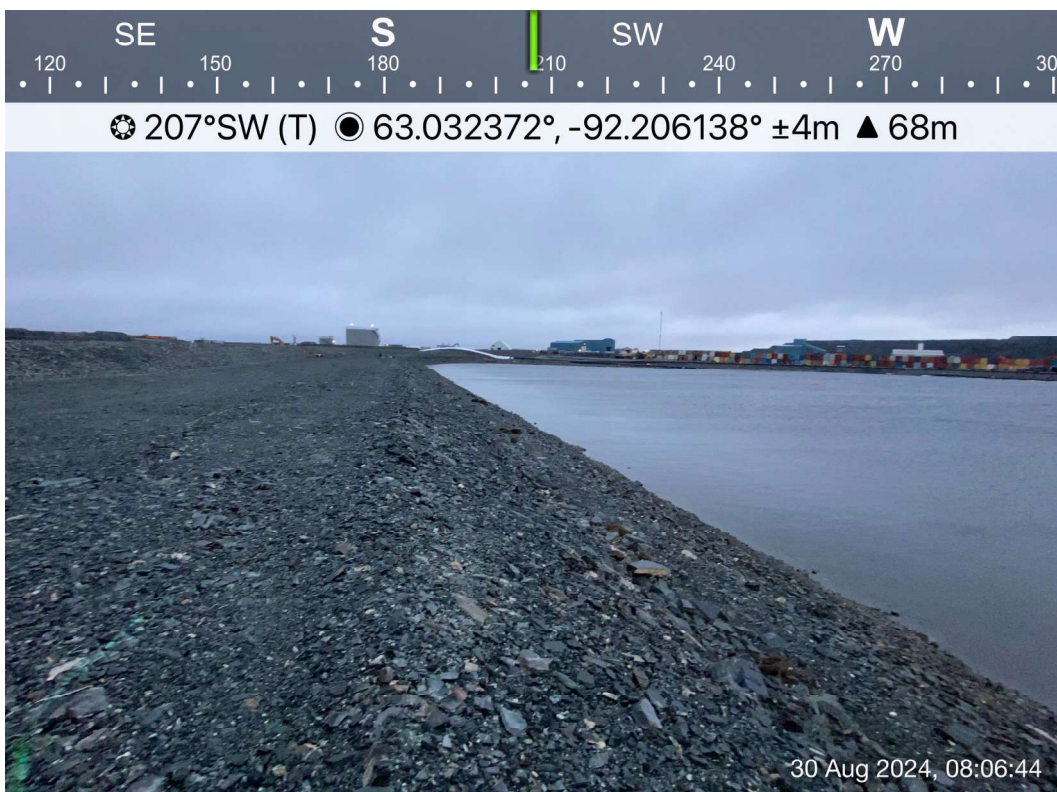
**D-CP1 - Photo 6:** Dike D-CP1: Dike upstream crest - minor cracking, no change from previous years. Facing southwest.

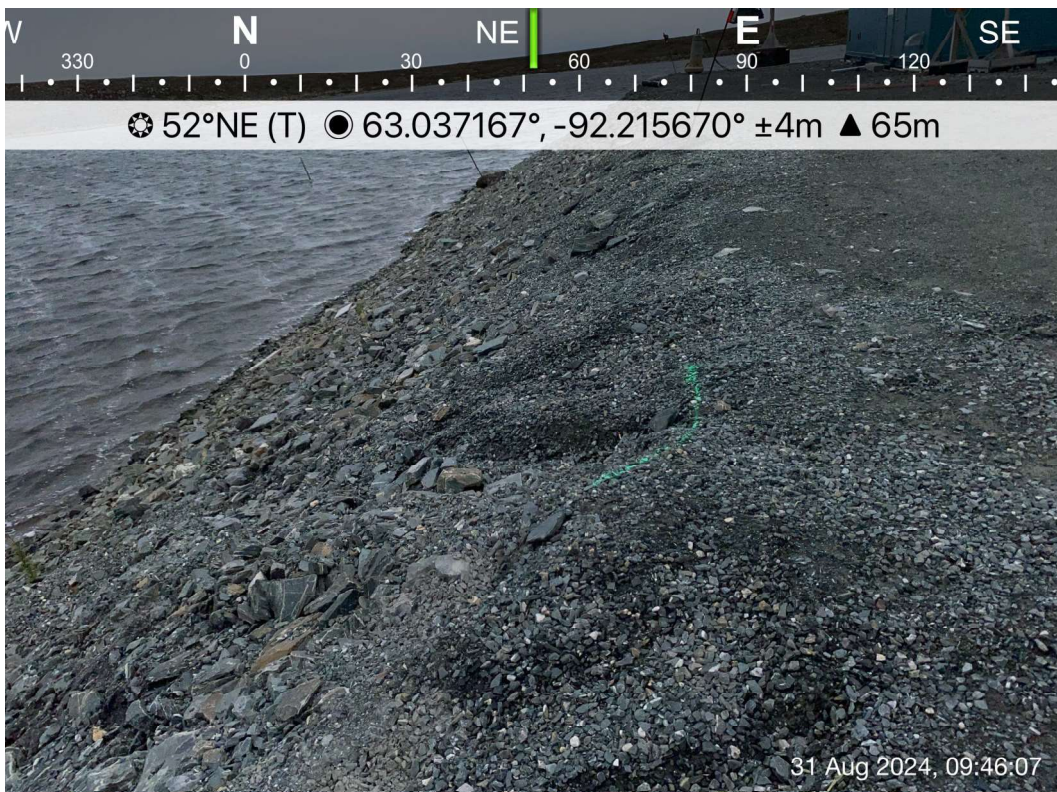
**D-CP1 - Photo 18:** Dike D-CP1: Jetty 1— side slope, minor erosion with similar conditions to the previous year. Facing northeast.

It is recommended that effective snow removal or snow fencing be applied to help mitigate the warming trend of the dike's foundation. Consideration should be given to refill and regrade the slope of the CP1 jetty where the erosion was observed.

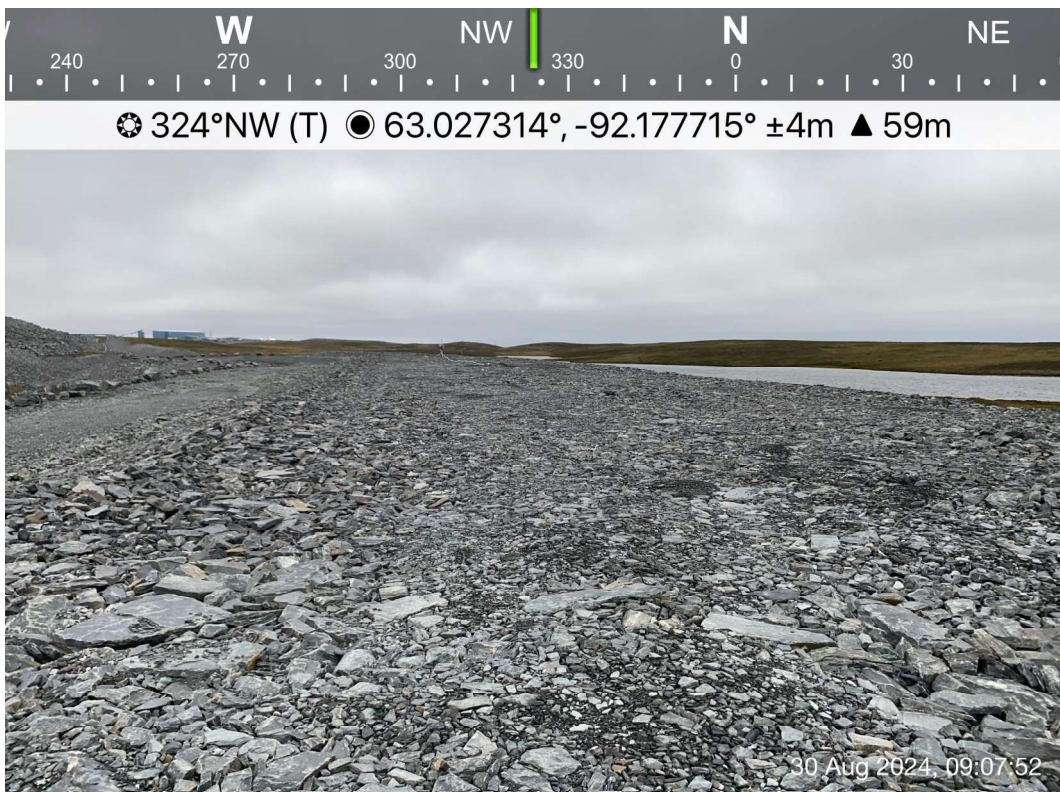
**CP2 Thermal Berm - Photo 4:** CP2 Thermal Berm - Crest, minor settlement observed, no cracking. Facing northwest.

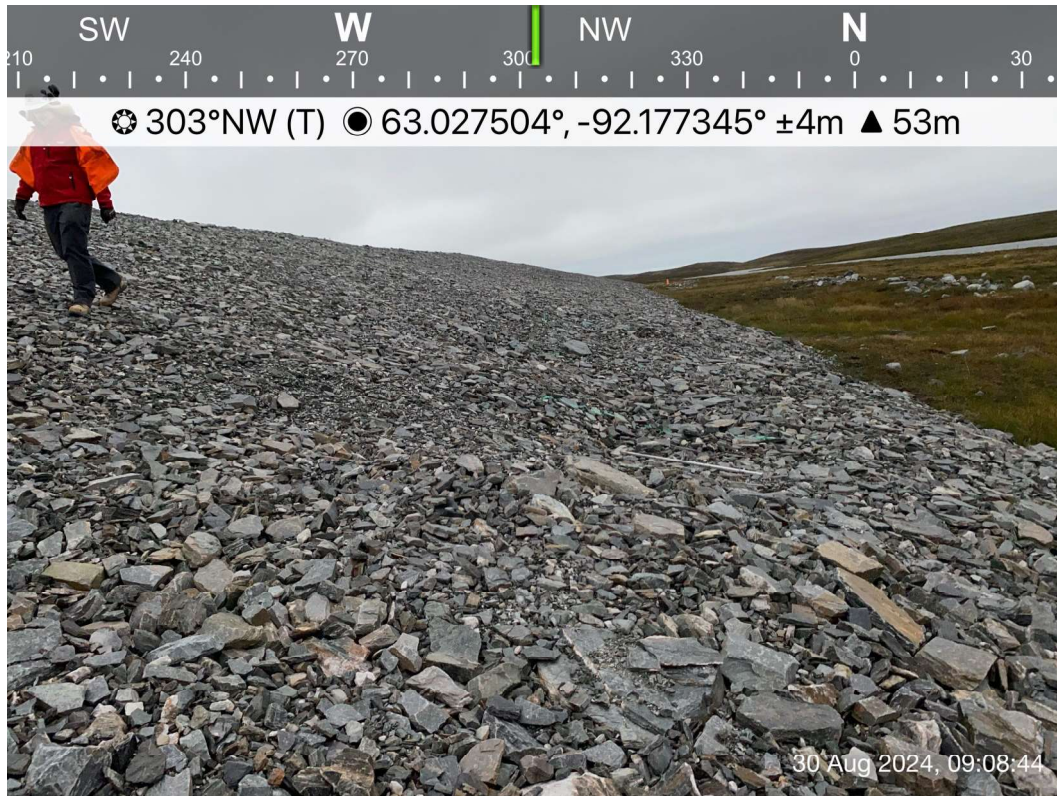
**CP2 Thermal Berm - Photo 5:**

CP2 Thermal Berm - Downstream side slope, minor deformation observed at east end, no stability concern. Facing northwest.

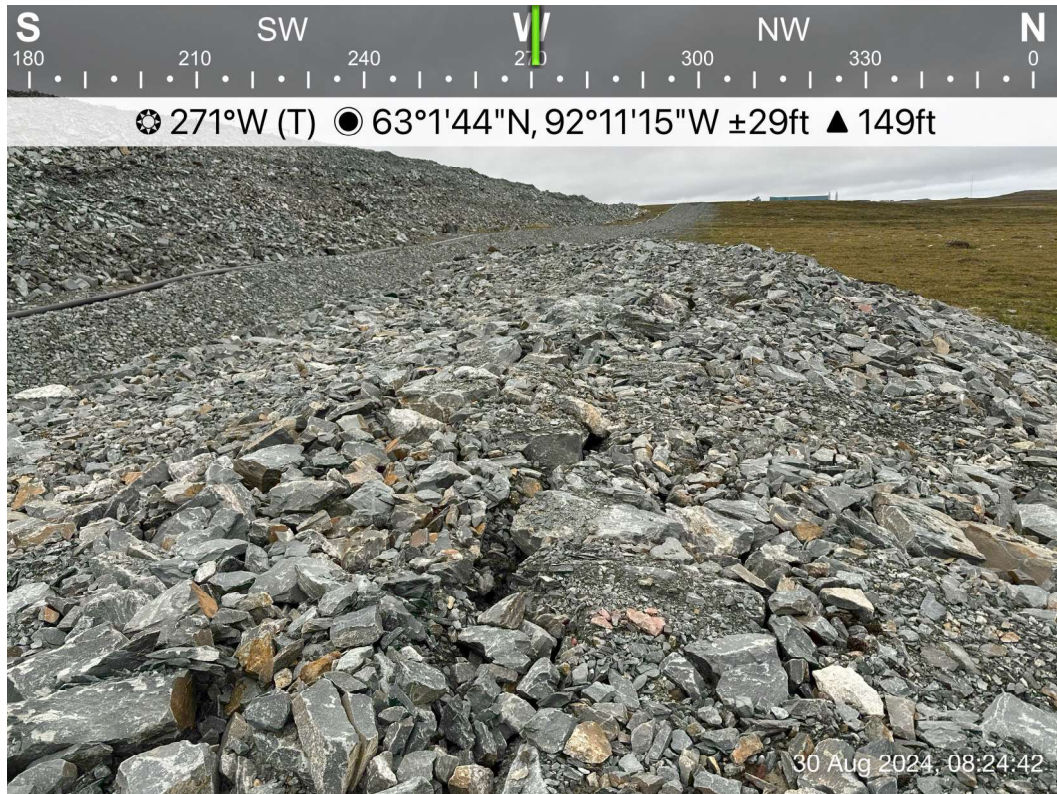
**Channel 9 Berm - Photo 9:** Channel 9 Berm: West end of Channel 9 Berm, minor settlement and cracking. Facing west.

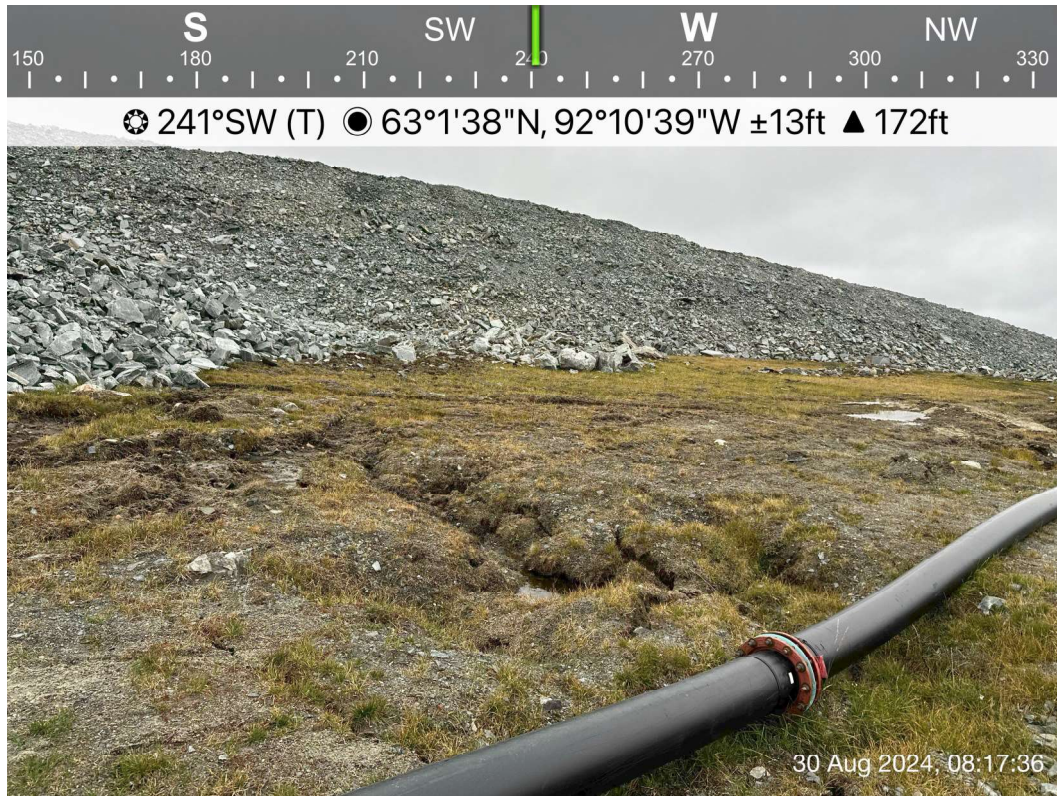
**Channel 9 -  
Photo 11:**

CP2 and its associated infrastructure (Channel 9, Channel 10, and CP2 Thermal Berm) are performing adequately. Thaw subsidence and cracking were observed at various areas between Channel 9, Channel 10, and WRSF3. It is recommended that a thermal cover be placed in the areas between WRSF3, Channel 9, and Channel 10 to prevent disturbance and permafrost degradation of the native ground.

Channel 9 - Thaw subsidence and cracking observed between the south shoulder of Channel 9 and WRSF3. Facing southwest.

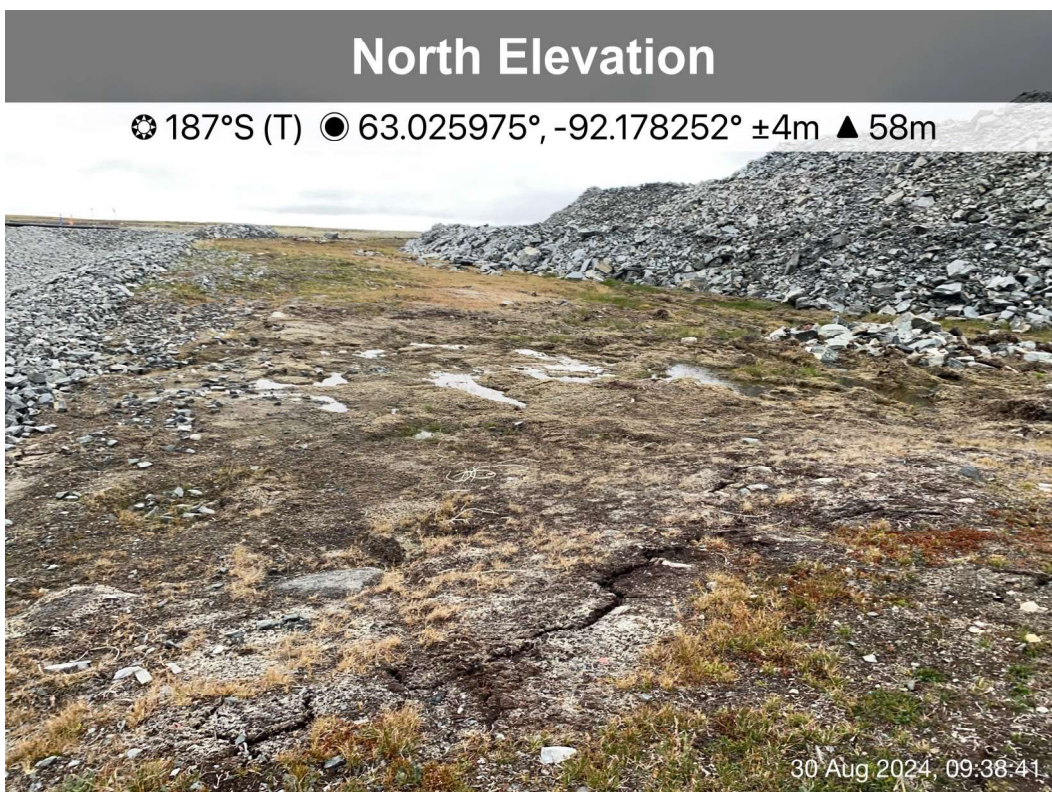
**Channel 10 -  
Photo 14:**

Channel 10 - Minor ponded water, thaw subsidence and cracking observed between the south shoulder of Channel 10 and WRSF3. Facing South.

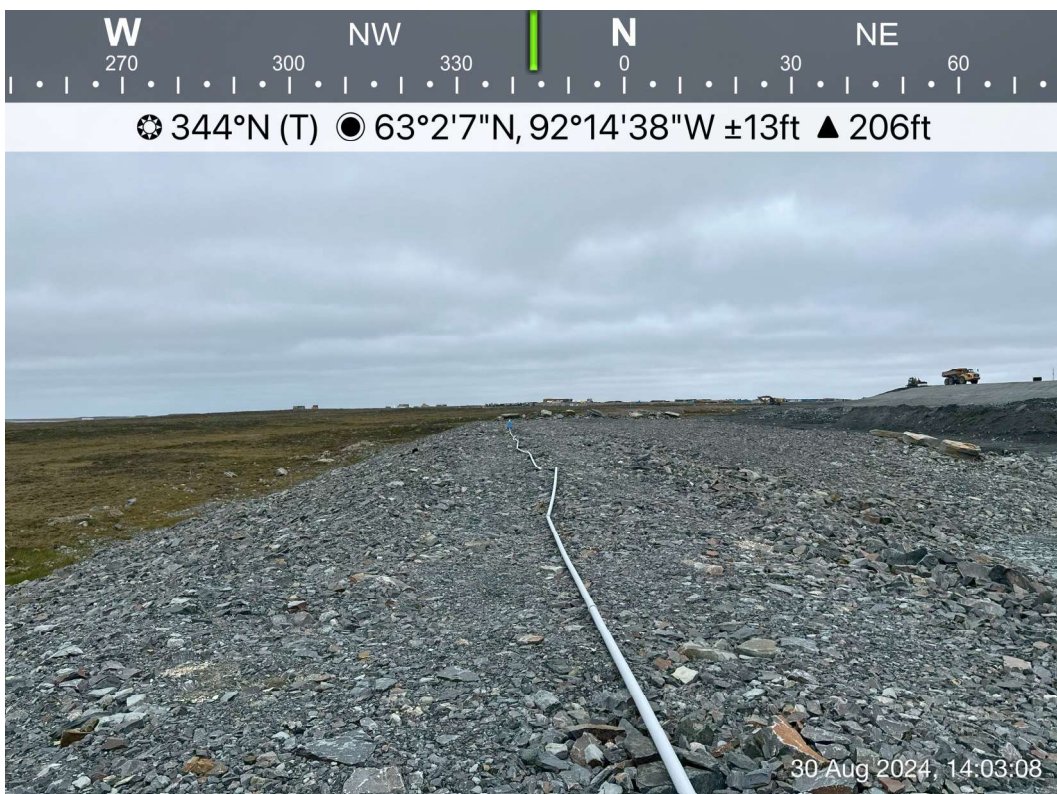
**CP3 Thermal Berm Photo 4:** CP3 Thermal Berm - Crest of CP3 Thermal Berm, minor thaw settlement observed, similar conditions to the previous year. Facing north.

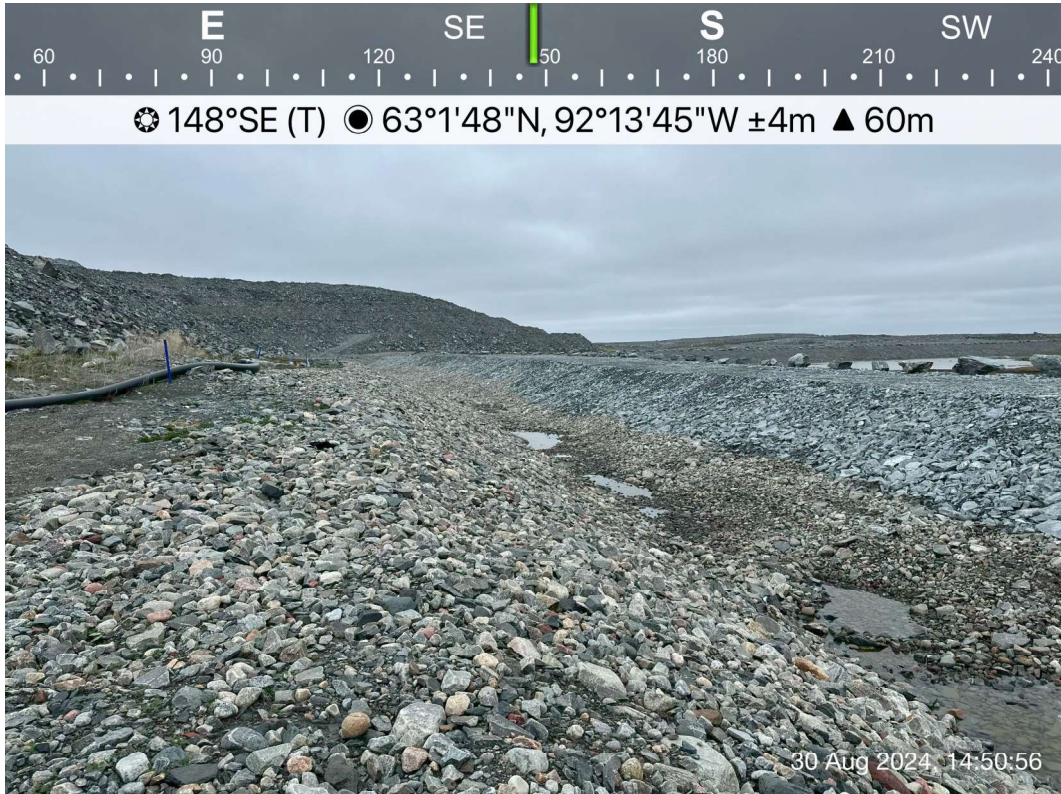
**Channel 4 -  
Photo 9:**

Minor ponding was observed at various localized areas along Channel 4. Based on the size of the ponded water area, the overall performance of Channel 4 is not expected to be undermined.

Channel 4 - Channel 4, ponding water at base of channel, some thaw subsidence observed between Channel 4 and WRSF1. Facing southeast.

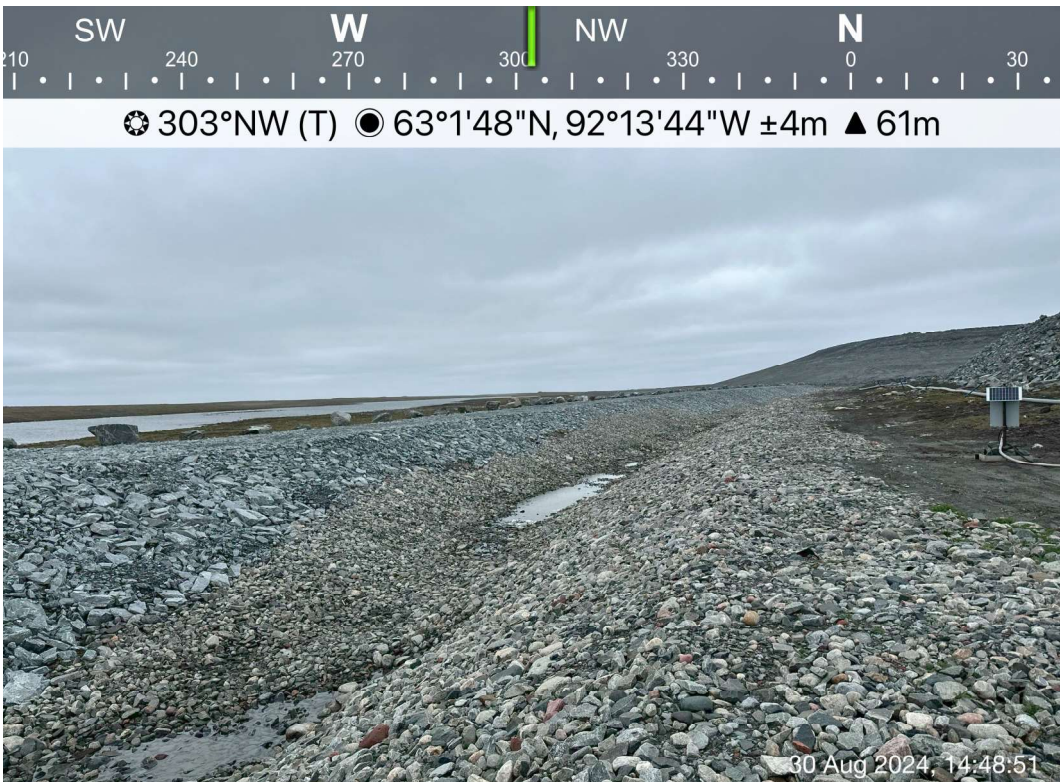
**Channel 4 -  
Photo 10:**

Channel 4 - Channel 4, ponding water at base of channel, some thaw subsidence observed between Channel 4 and WRSF1. Facing northwest.

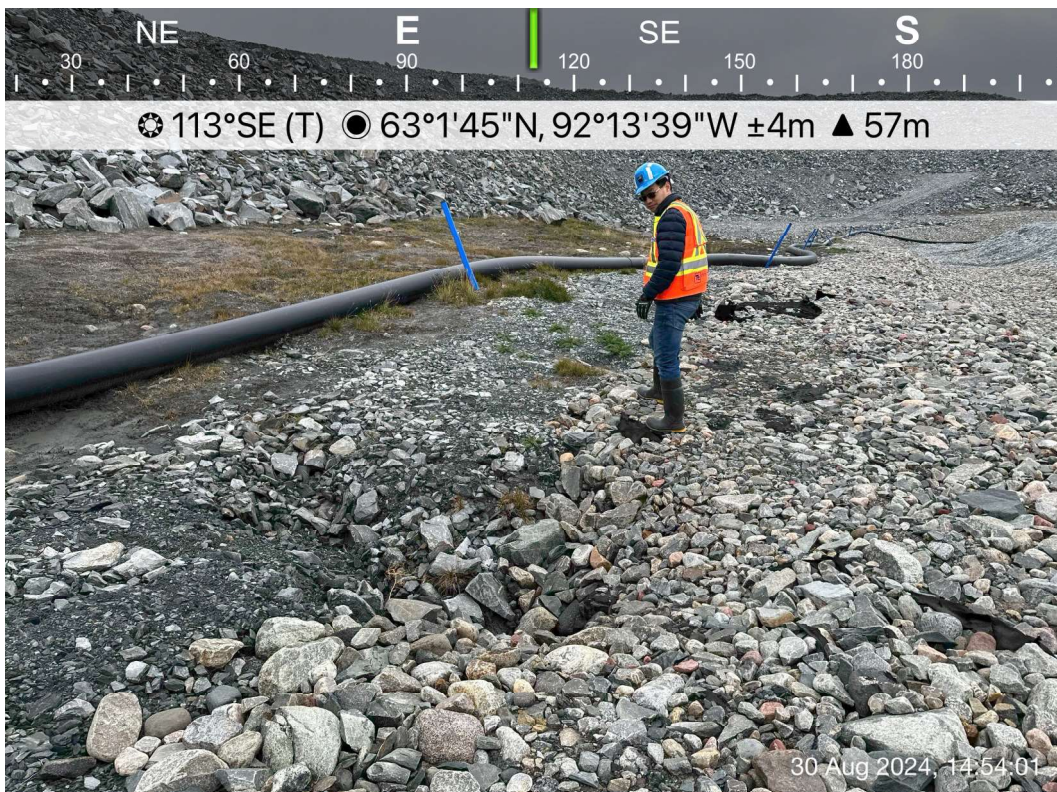
**Channel 4 -  
Photo 16:**

Thaw subsidence, exposed geotextile, cracking, and settlement of overburden material were observed at several areas along the upstream shoulder of Channel 4. The cracks and thaw subsidence are an indication of thermal degradation at localized areas and were likely caused by surface runoff flow over the area between WRSF1 and Channel 4. It is recommended to place rockfill as the thermal cover between Channel 4 and WRSF1 to mitigate the thaw subsidence and cracking.

Channel 4 - Southern portion, thaw subsidence, minor settlement, exposed geotextile and minor cracking. Facing southeast.

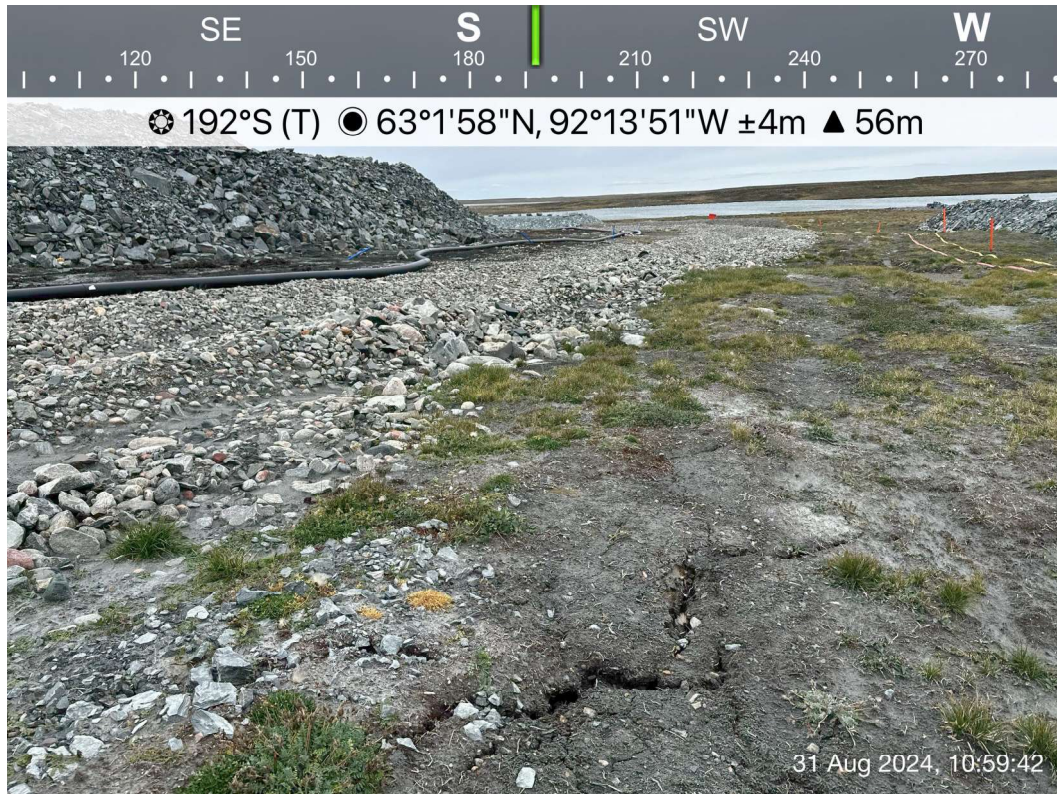
**Channel 4 -  
Photo 17:**

Channel 4 - Upper portion, thaw subsidence and minor cracking. Facing south.

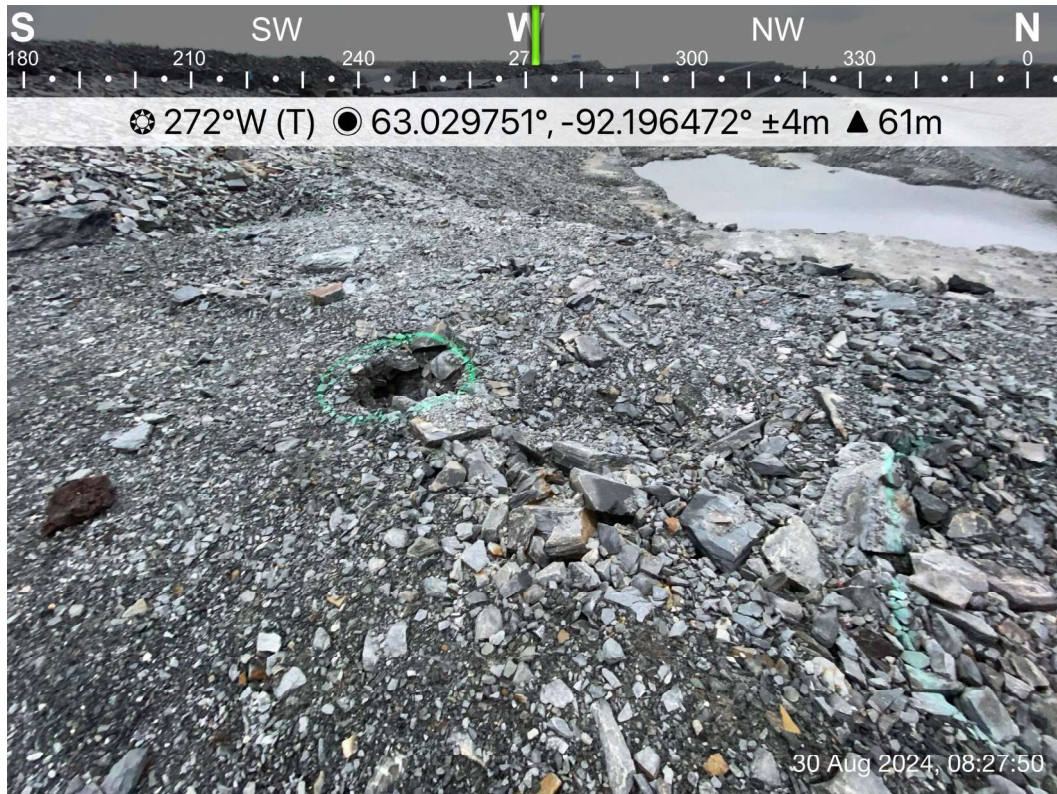
**CP6 - Photo 5:** CP6 - View of east side perimeter, thaw settlement and cracking observed. Facing west.

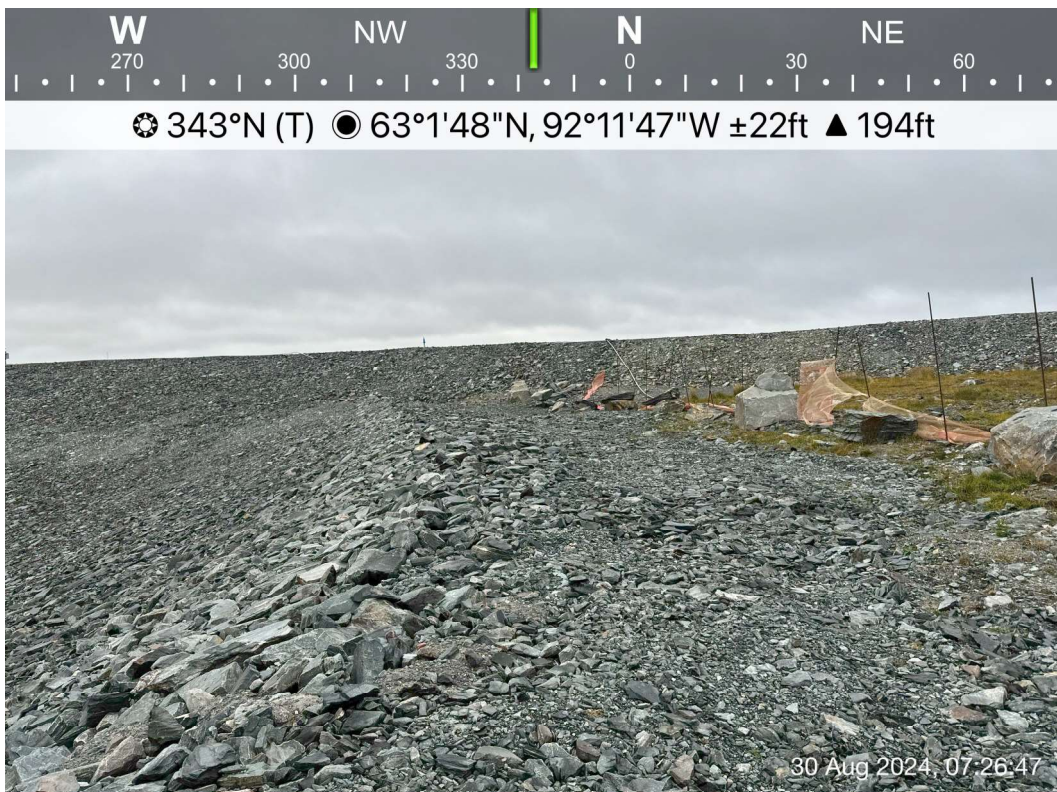
**CP6 - Photo 6:** CP6 - View of east side perimeter, thaw settlement and cracking observed. Facing north.

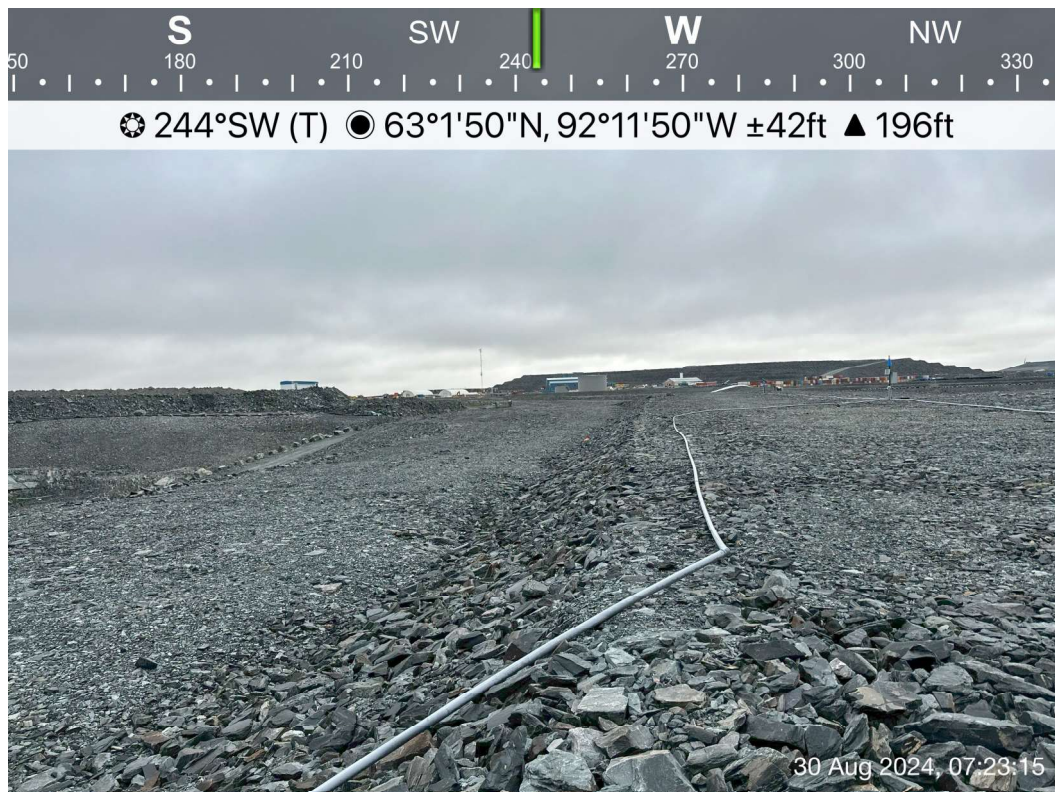
**CP6 Thermal Berm - Photo 8:** CP6 Thermal Berm - Crest view, thaw settlement observed at various areas. Facing southwest.

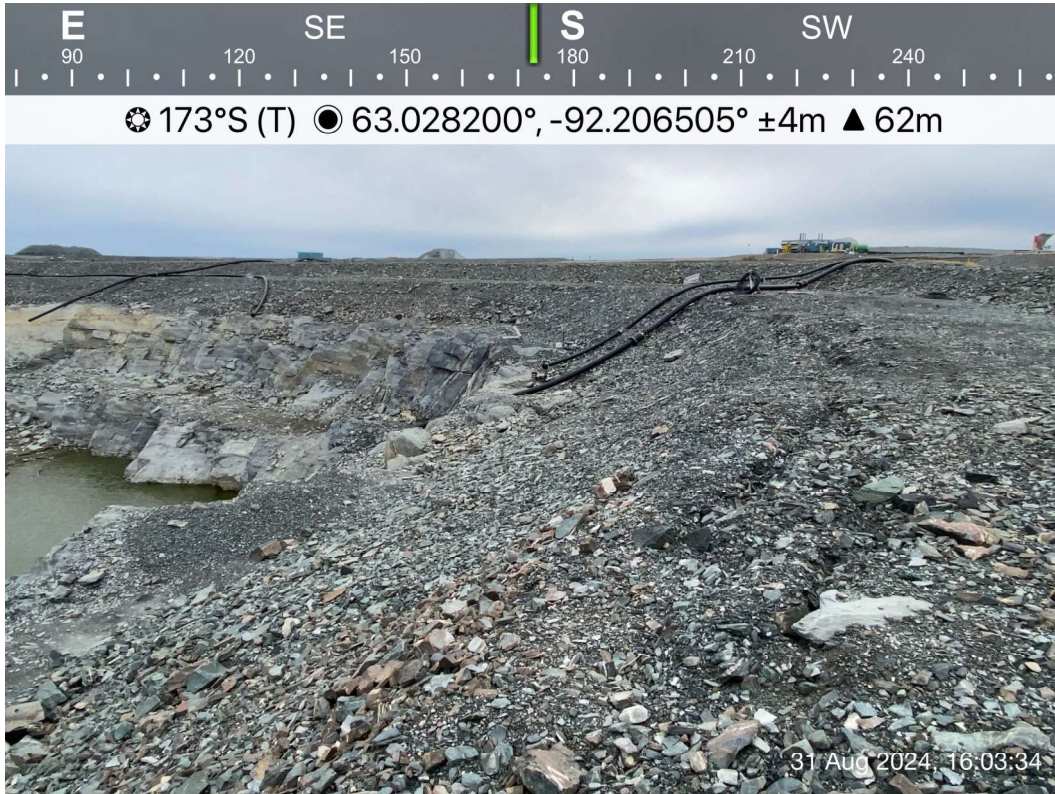
**SP1 - Photo 5:** SP1 Saline Pond - Deformation and cracking on top of overburden protected slope, southwestern side of SP1. Facing south.

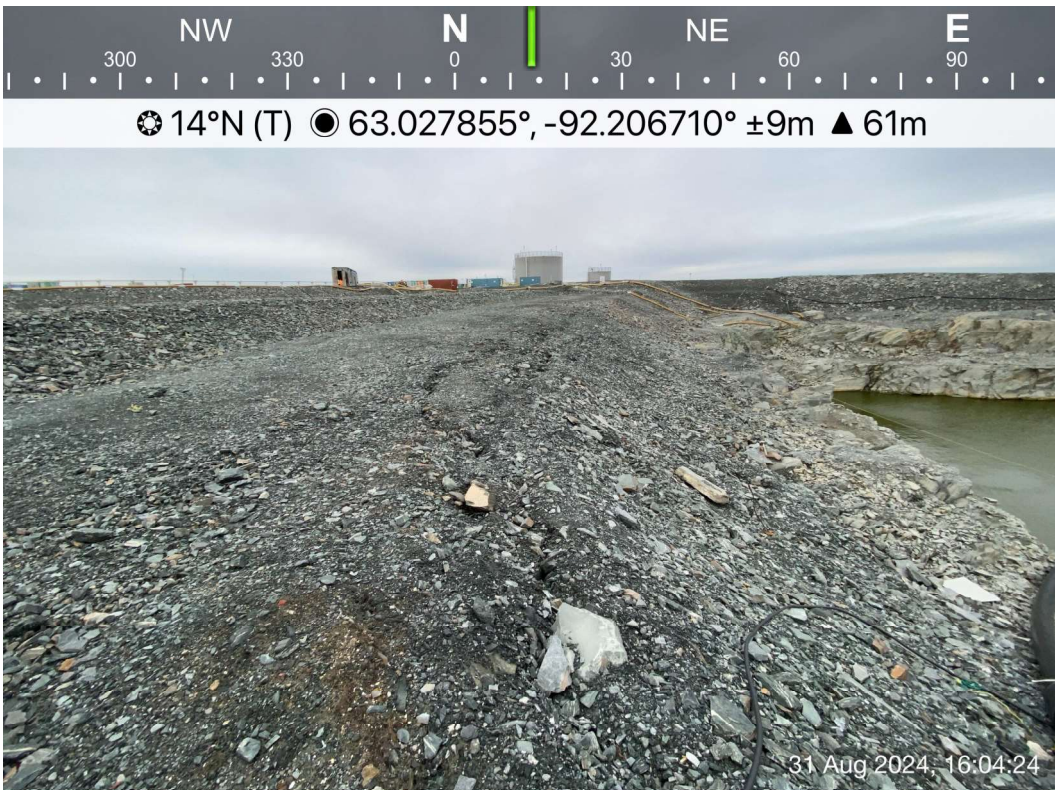
**SP1 - Photo 6:** SP1 Saline Pond - Deformation and cracking on top of overburden protected slope, southwestern side of SP1. Facing north.

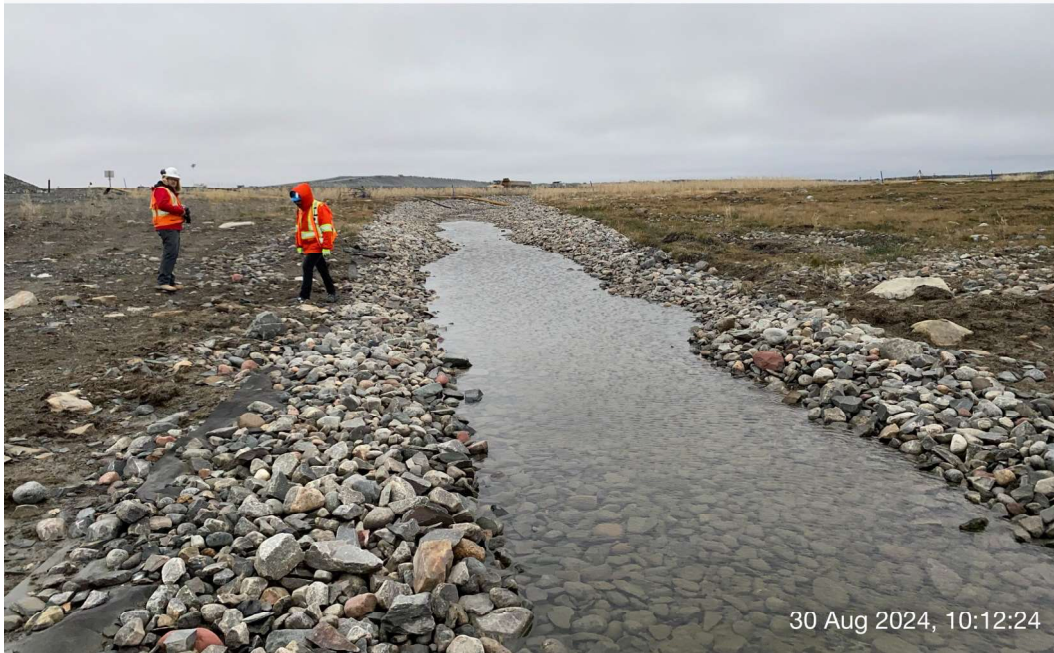
**Channel 5 -  
Photo 9:**

Channel 5 - Lower reach of Channel 5, ponded water observed due to thaw subsidence.

- Repairs and maintenance should be completed on Channels 1 and 7 to promote drainage.
- It is recommended that the eastern portion of Channel 5 be repaired and maintained. The western portion of the channel was reconstructed and is functioning well.
- Minor erosion was observed during the inspection of Berm 3 as its cover materials are susceptible to erosion. Erosion of the slopes should be monitored, and consideration should be given to placing coarser material on Berm 3 to reduce the potential for erosion if it becomes substantial.

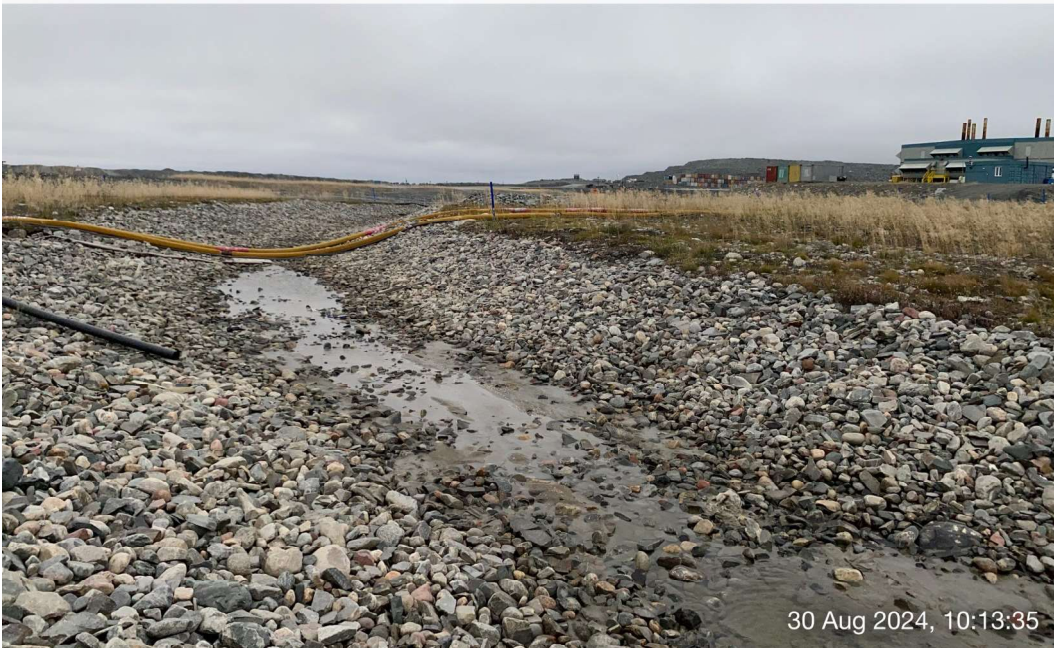
**Channel 5 -  
Photo 10:**

Channel 5 - Middle section of Channel 5, ponded water observed due to thaw subsidence. Facing west.

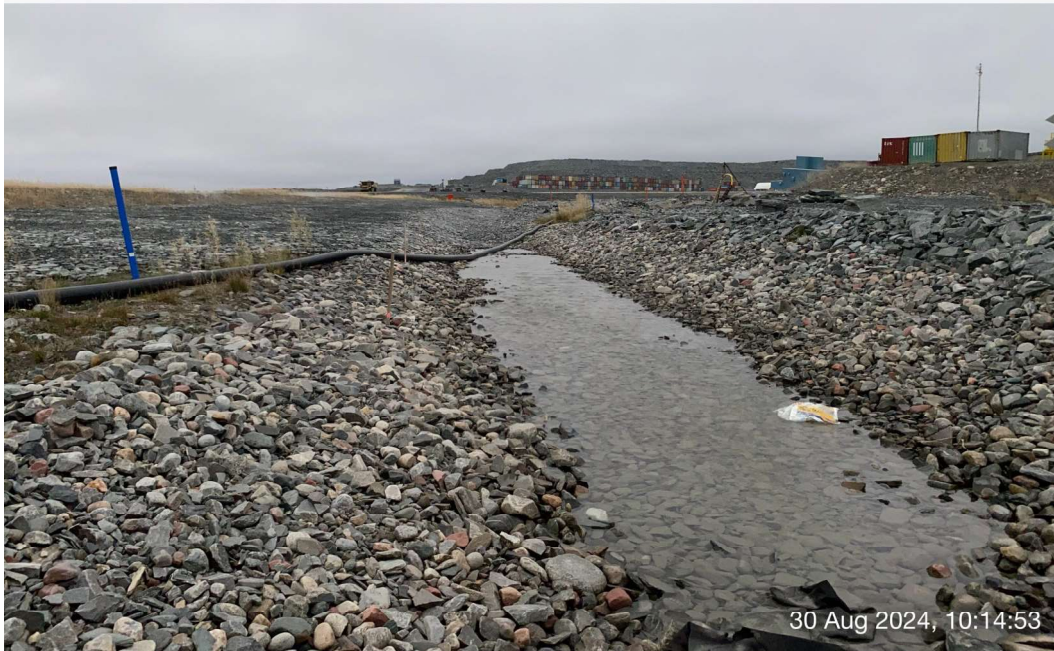
**Channel 5 -  
Photo 11:**

Channel 5 - Middle section of Channel 5, ponded water observed due to thaw subsidence. Facing northwest.

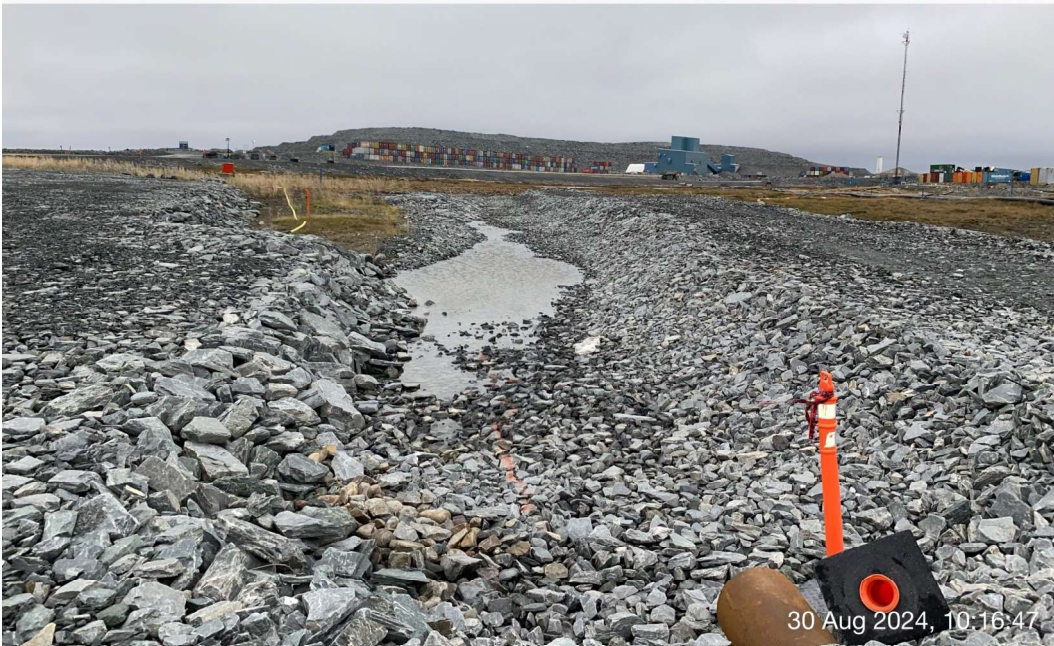
**Channel 5 -  
Photo 12:**

Channel 5 - Upper section of Channel 5, ponded water observed due to thaw subsidence. Facing southwest.

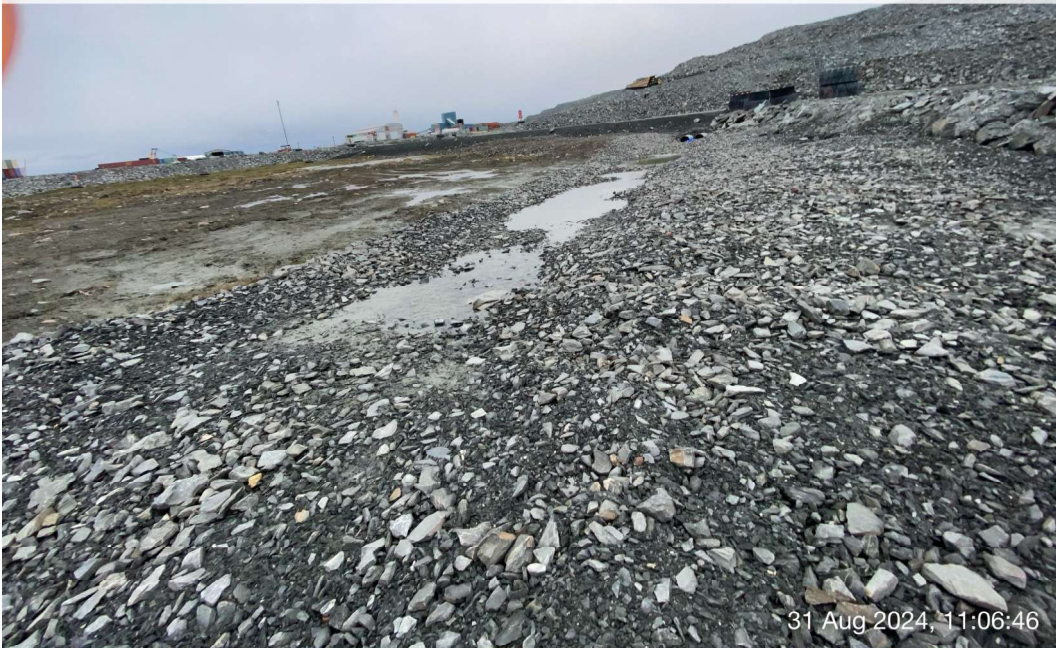
**Channel 7 -  
Photo 14:**

Channel 7 - Upper section of Channel 7, ponded water observed due to thaw subsidence. Facing south.

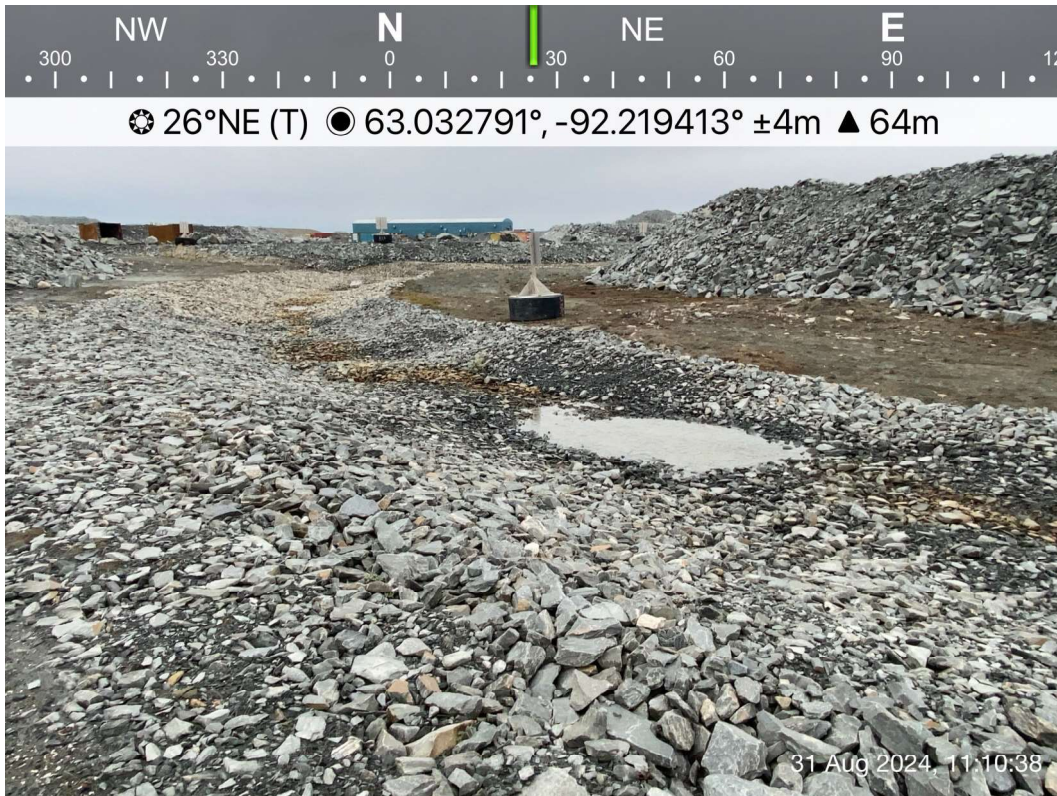
**Channel 7 -  
Photo 15:**

Channel 7 - Middle section of Channel 7, minor ponding water observed due to thaw subsidence. Facing northeast.

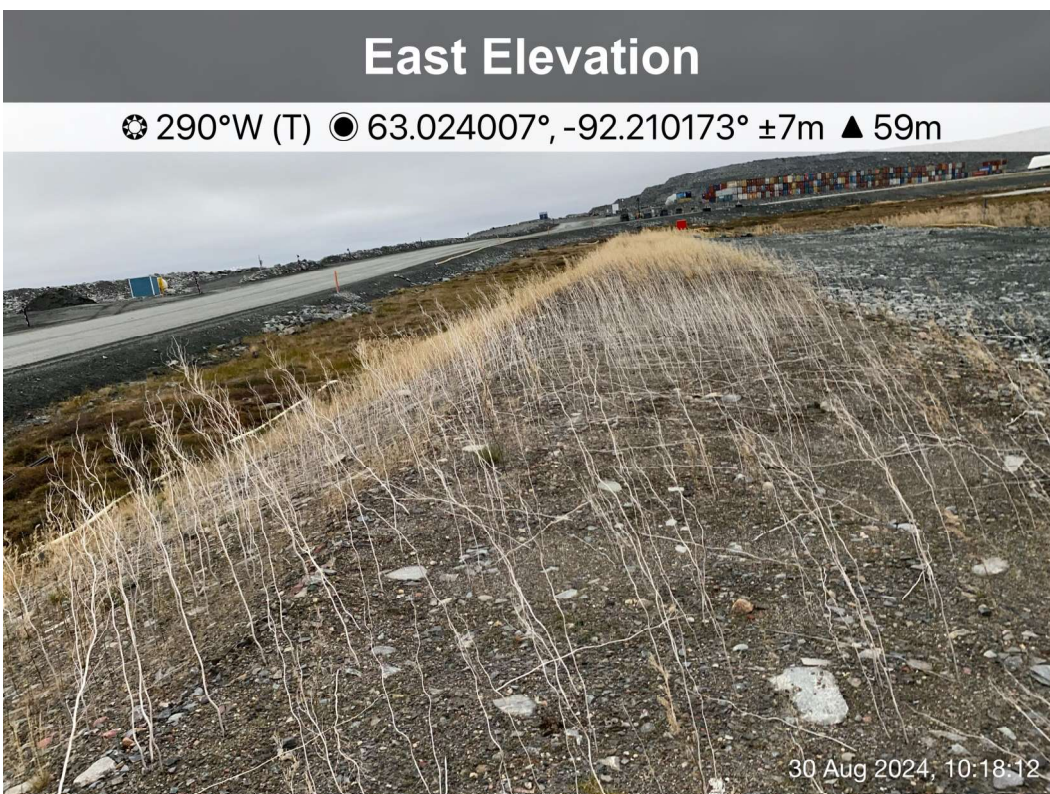
**Berm 3 -  
Photo 16:**

Berm 3 - Berm crest, cracking observed along the crest. Facing west.

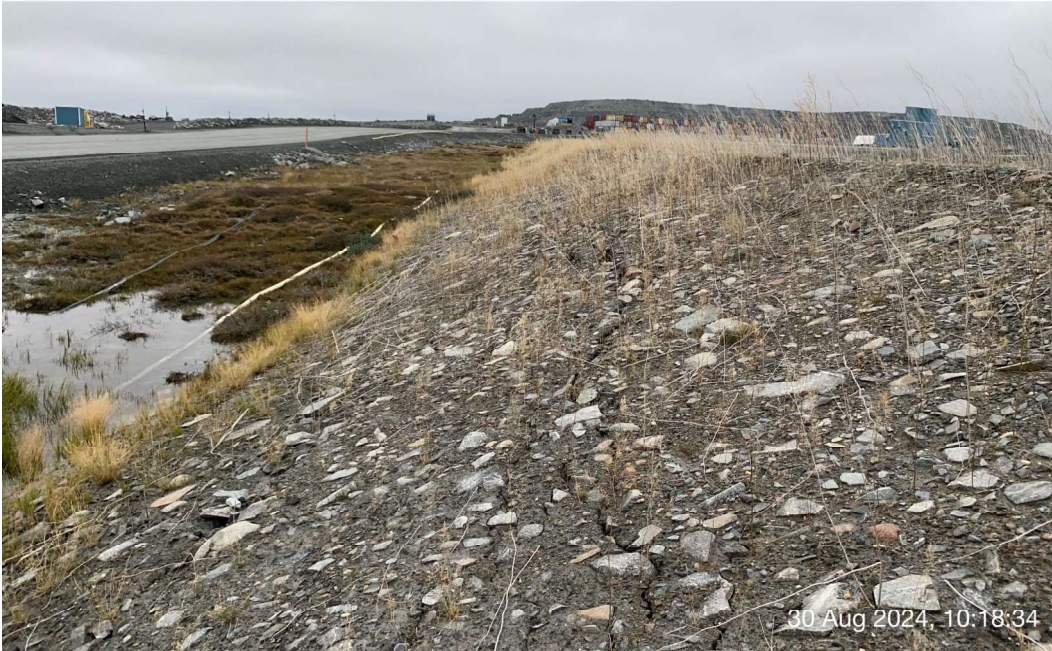
**Berm 3 -  
Photo 17:**

Berm 3 - Downstream side slope, cracking observed along the slope. Facing west.

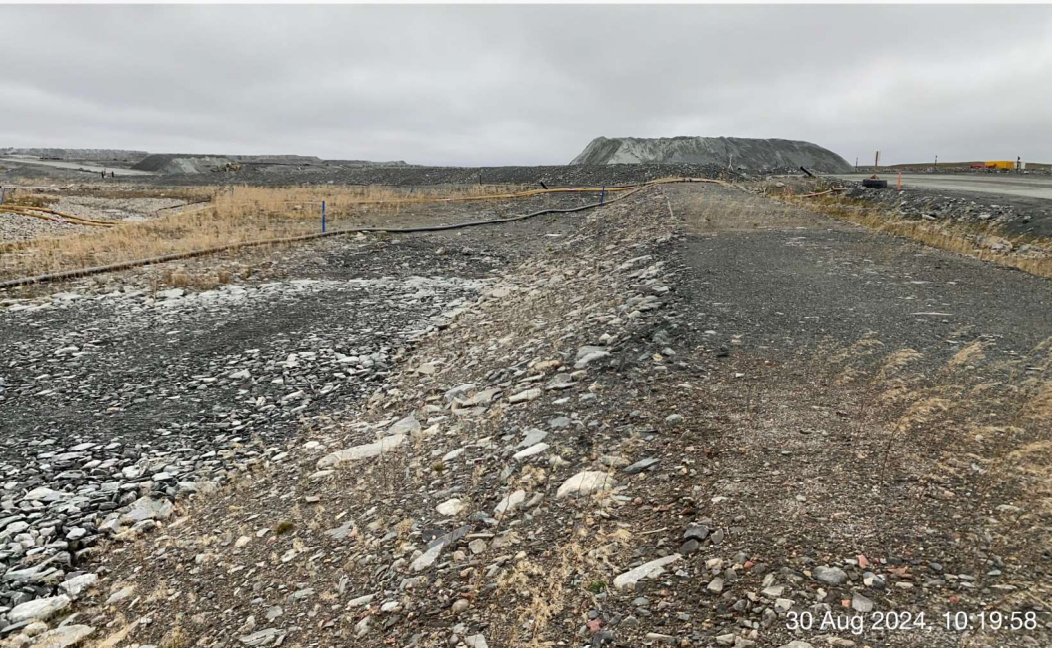
**Berm 3 -  
Photo 18:**

Berm 3 - Upstream side slope, cracking observed along the crest, ROM cover between Berm 3 and Channel 5. Facing east.

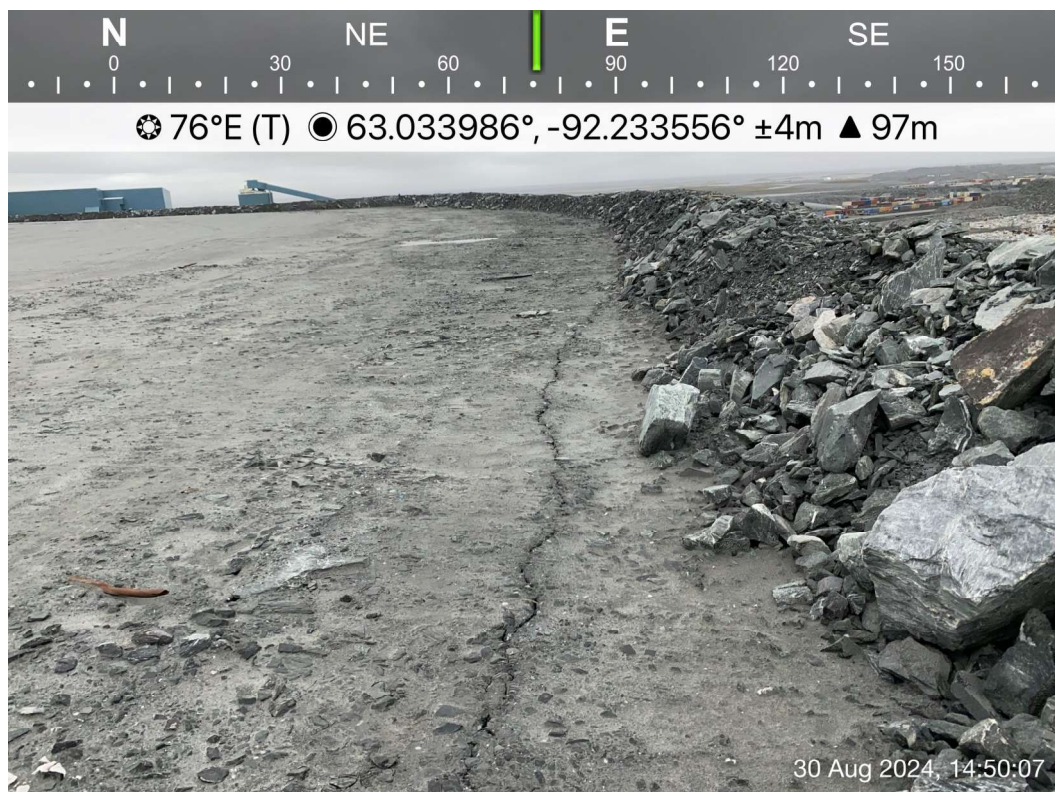
**TSF - Photo 6:** TSF - Crest of rockfill covered slope, minor cracking and settlement. Facing east.
