## **APPENDIX 6      2024 ANNUAL GEOTECHNICAL INSPECTION REPORT**

## 2024 Annual Geotechnical Inspection Meliadine Gold Mine, Nunavut, Canada

PRESENTED TO  
**Agnico Eagle Mines Limited**

MARCH 11, 2025  
ISSUED FOR USE-REVISION 1  
FILE: 704-ENG.EARC03140-39  
AGNICO EAGLE DOCUMENT NUMBER: 65-600-230-TCR-002

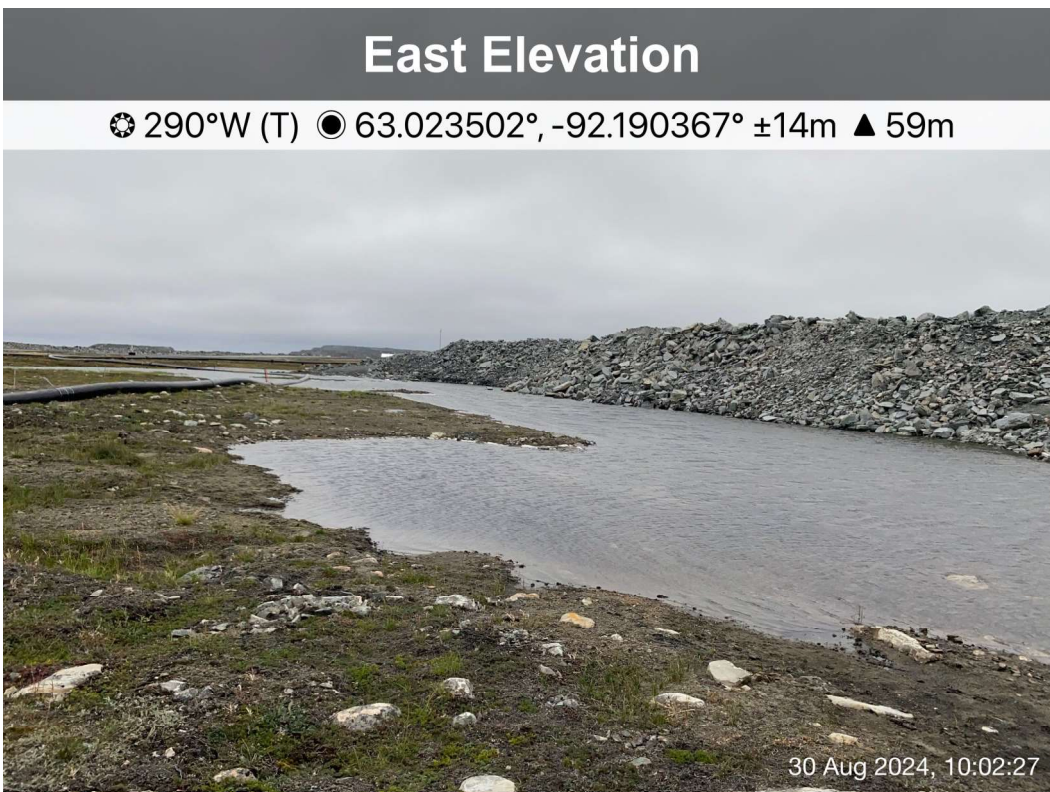
In general, WRSF3 is performing well. Areas of depression and cracking previously observed on the 72 m bench in 2023 were mitigated by placing additional material and traffic compaction. Ponded water was observed at the southwest corner of WRSF3 at the time of the inspection. It is understood that Agnico Eagle conducts regular pumping activities to manage the ponded water. Tetra Tech recommends that consideration be given to construct a channel and sump, if practical, within the lease boundary to divert/collect runoff water and prevent any potential for permafrost degradation at the WRSF3 toe and reduce the efforts required for regular pumping.

**WRSF3 - Photo 4:** WRSF3 - Ponded water observed at southwest corner of WRSF3. Facing west.

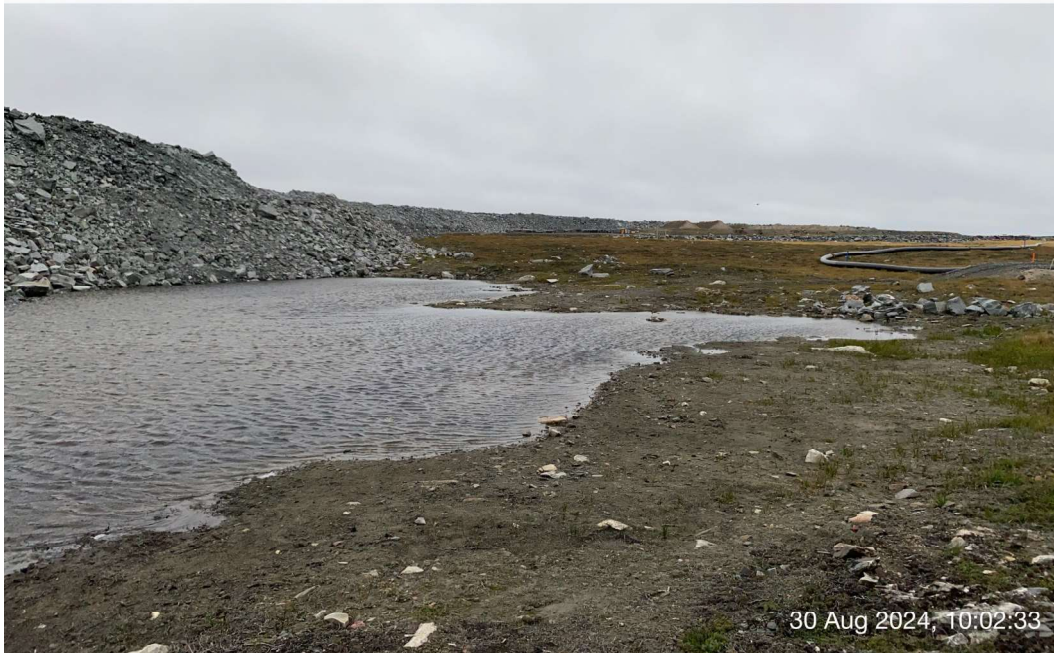
**WRSF3 - Photo 5:** WRSF3 - Ponded water observed at southwest corner of WRSF3. Facing northeast.

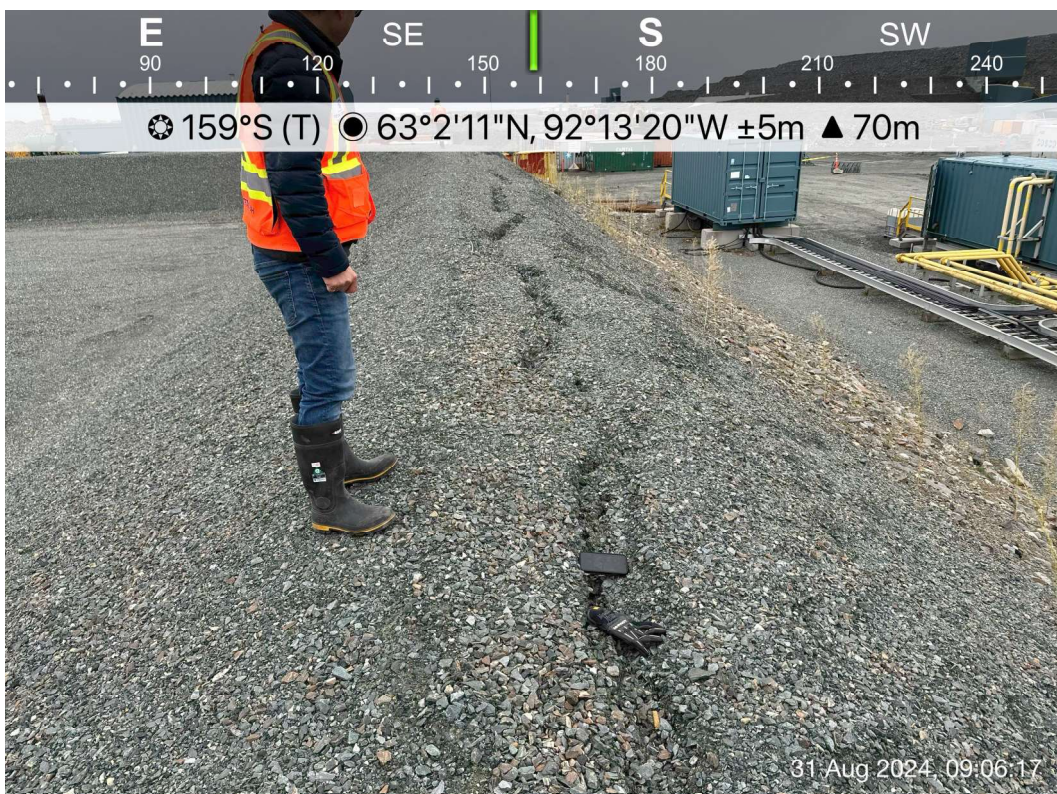
Cracking observed at the crest of the berms at Industrial Fuel Tank Farm have increased by 110 mm from 2023 to 2024. The crests of these berms should be repaired to remediate the cracking.

**Industrial Fuel Tanks - Photo 22:** Industrial Fuel Tanks - West side berm overview, cracking on crest. Facing south.

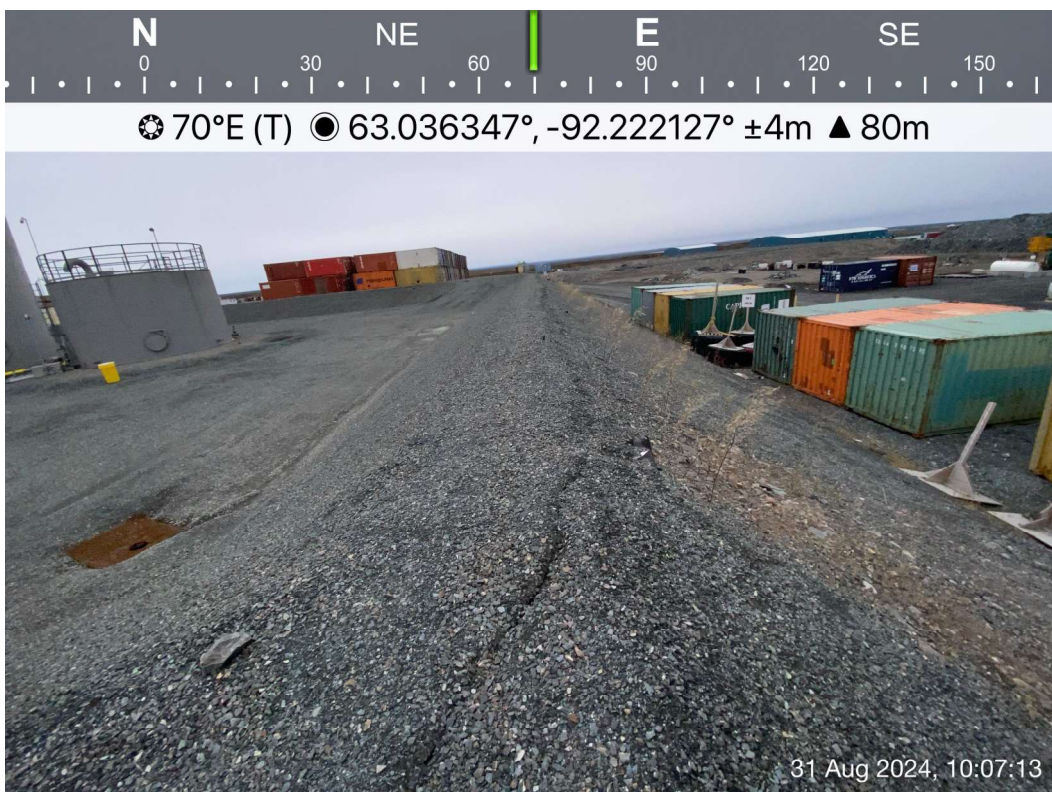
**Industrial Fuel Tanks - Photo 24:** Industrial Fuel Tanks - South side berm overview, cracking on crest. Facing east.

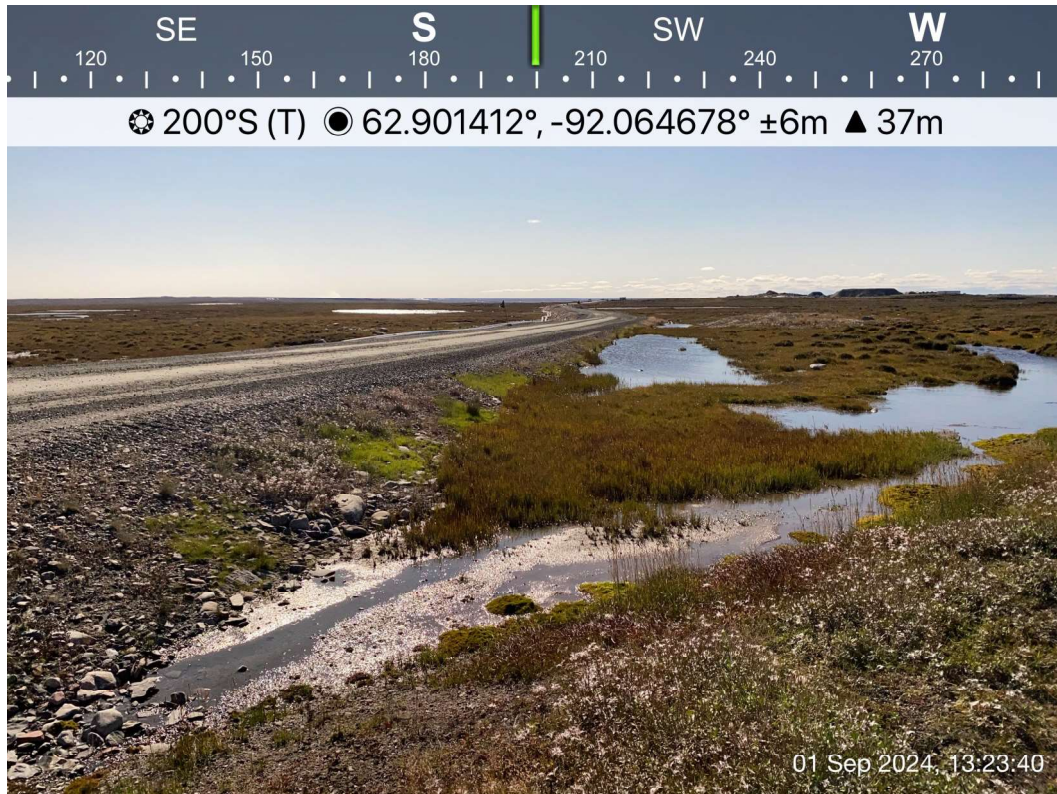
**AWAR Road/  
Culvert - Photo 31:** KM 12.6 - No culvert installed, poor drainage condition, no sign of water flow.

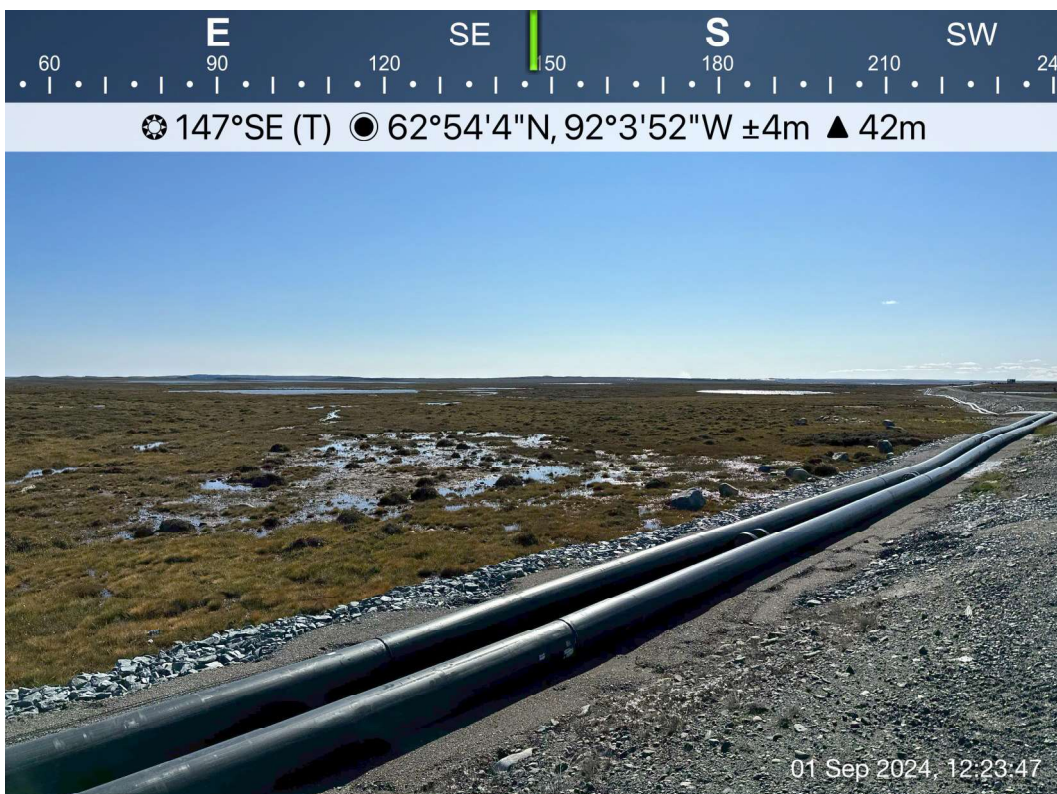
**AWAR Road/  
Culvert - Photo 32:** KM 12.6 - No culvert installed, poor drainage condition, no sign of water flow.
