Meadowbank and Whale Tail IRB Report No 32

January 30th, 2025

Reference: Report No 32
Meadowbank Independent Review Board (MBK IRB)
Site visit August 21st to 23rd, 2024 and meeting, Montréal, December 10th and 11th, 2024.

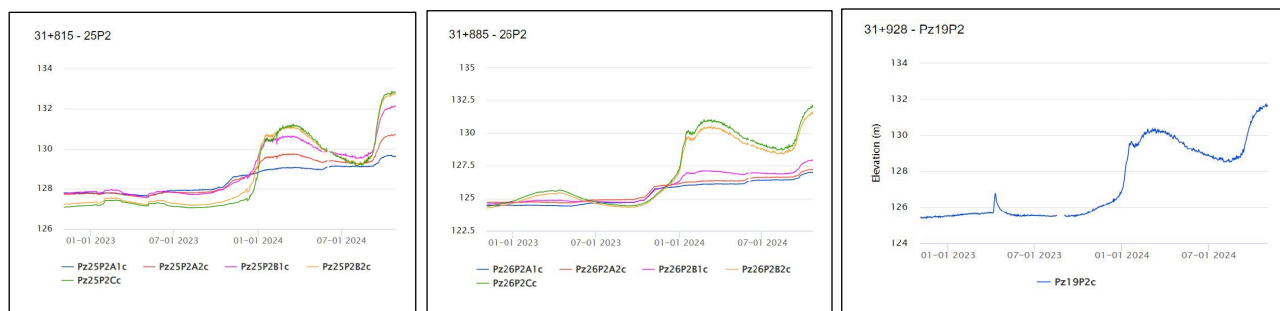
The comparison made on page 38 of part 3 of the December PowerPoint between piezometers at Stns. 31+815, 31+885 and 31+928 (copied below), indicates that piezometric pressures are highest at the former and decline towards the latter. Thus, the source of the seepage may be closer to the instrument at 31+815. All three instruments were installed in the fine filter material on the downstream side of the CSB cut-off. ***It is to be noted that soil-bentonite (SB) was used up to Stn. 31+790 and CSB in the deeper valley as far as Stn. 32+040. The SB is potentially more erodible, but the CSB could more easily hold open an ice generated fissure. The rate of seepage through a fissure would be controlled by the permeability of the fine filter. The migration of fine particles could lead to clogging of a fissure and stabilize the condition albeit with a non-zero residual flow.***

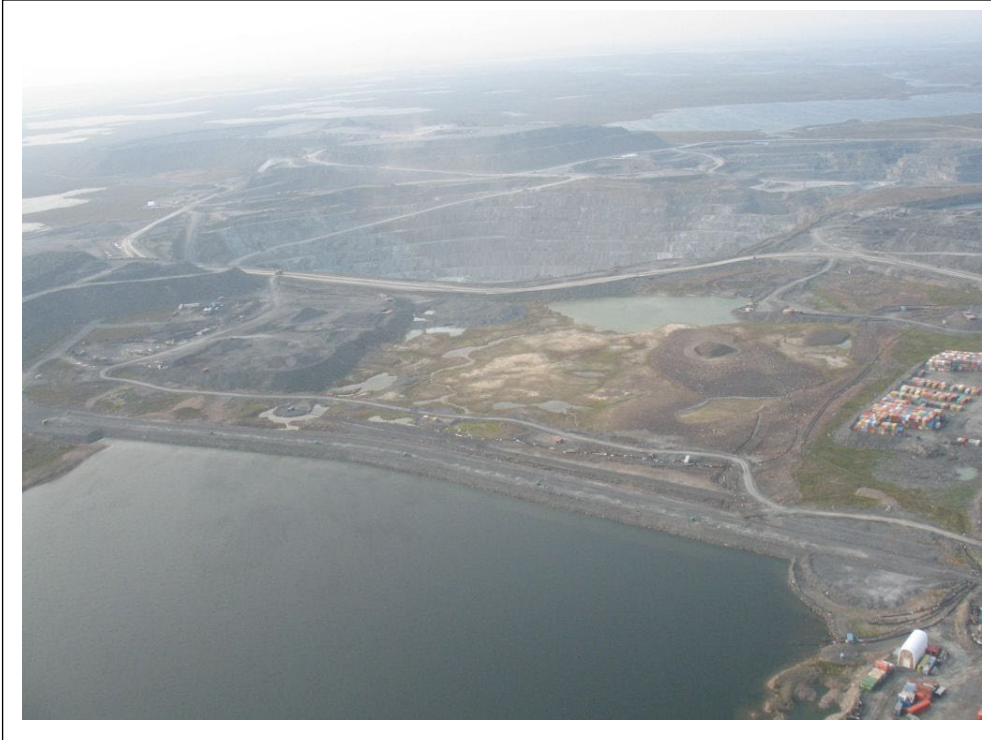
Photo #1 Whale Tail Dike

- The Whale Tail Dike is performing well, and no new deformation of the structure is reported. As previously mentioned, an additional thermal berm has been added on the downstream at the East abutment as can be seen in photo #3. The measuring weir (photo #5) collects most of the under-seepage water reporting at the dike toe and an additional weir is planned for the wet area to the East (photo #6).

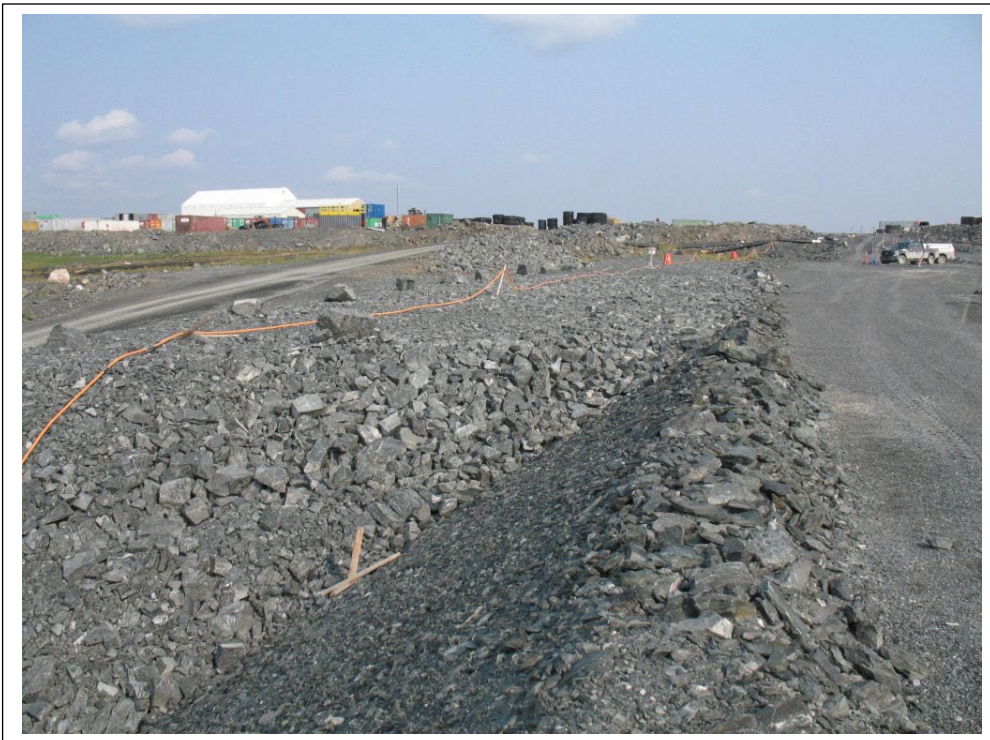
Photo #3 Whale Tail Dike, East abutment downstream thermal berm

Further improvements have been made to the Whale Tail Dike, with the addition of a thermal berm on the downstream side of the dike at the East abutment.

A downstream thermal berm was constructed on the right abutment in February 2024. The cracks previously observed in this area have now stabilized. The dike crest surface has been regraded.

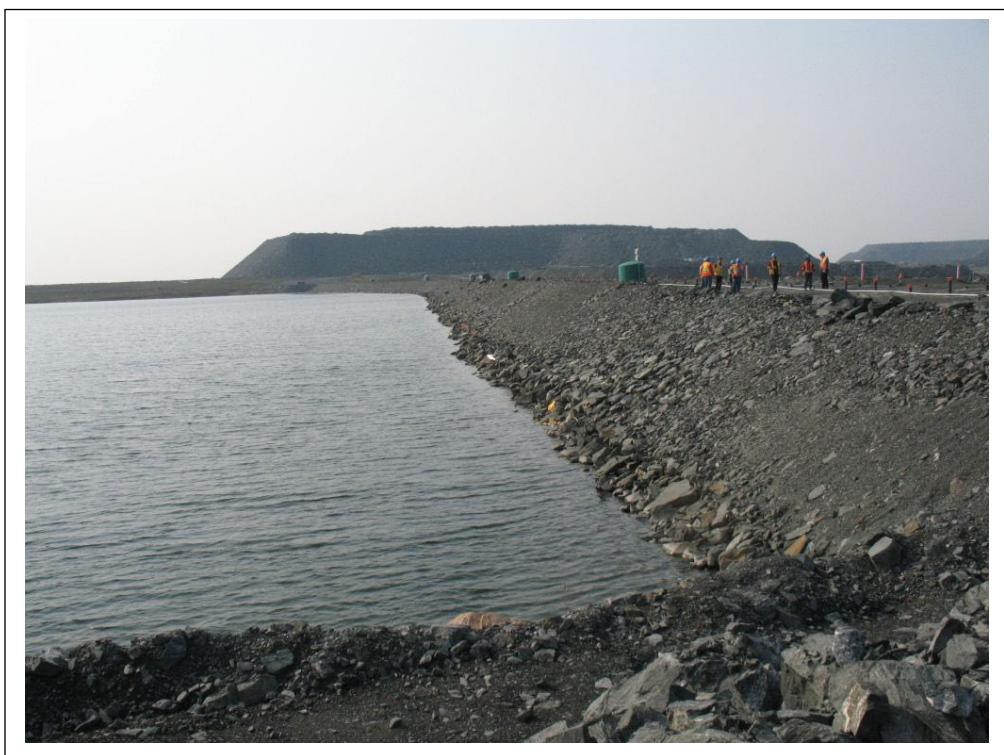
Photo #4 Whale Tail Dike, upstream face. Little if any wave damage.

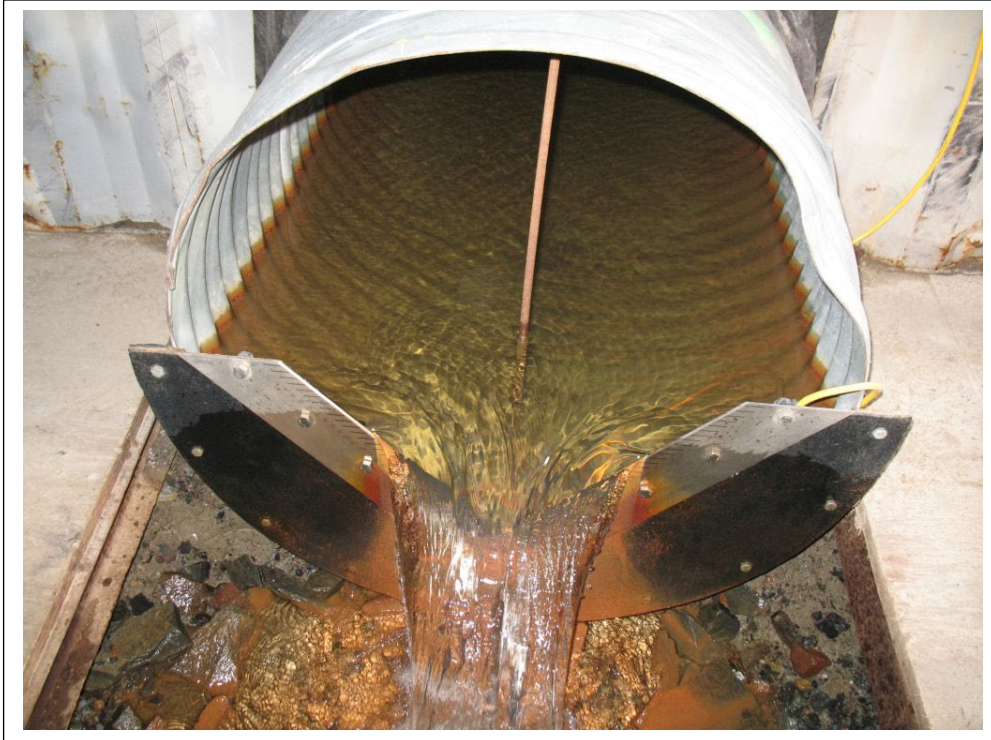
Photo #5 Whale Tail Dike, seepage measuring weir

The seepage reporting to the dike toe is stable. Further upgrades to the collection systems are planned as not all seepage is captured by the V notch weir. It was noted that 80 m³/hr. is measured at the weir, plus an additional 25 m³/hr. is estimated to occur downstream for a total flow rate of 100 to 125 m³/hr. in 2024. This is significantly lower than the 600 m³/hr. measured in 2019 prior to the remedial grouting program.

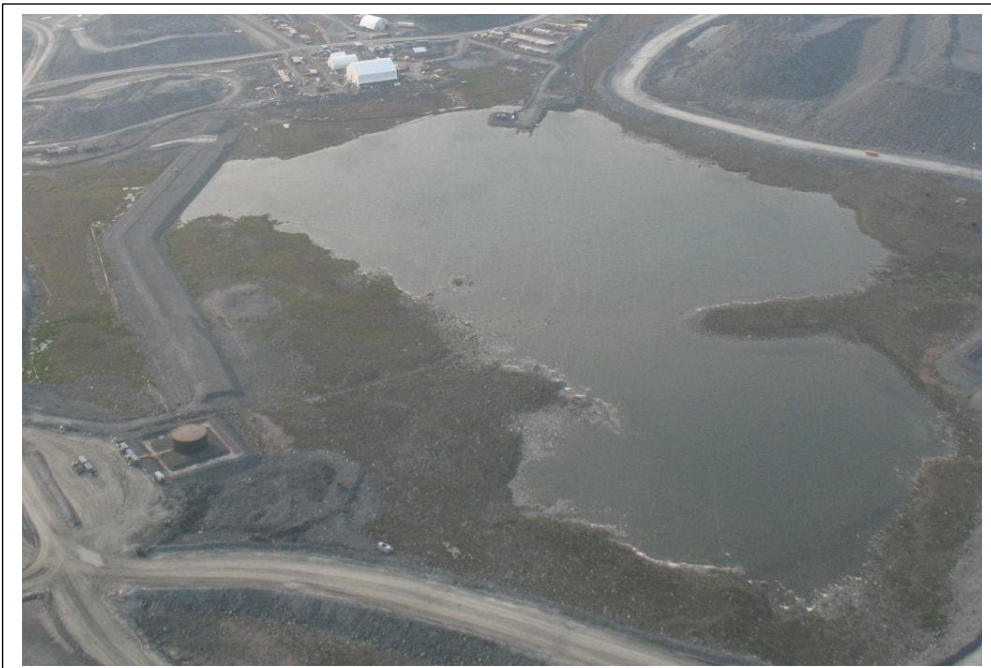
Photo #7 IVR Dike and pond

- The IVR dike (photo #7) is also performing as intended. A drone survey of the crest had been performed, and the interpretation of the results was awaited before proceeding with any required crest top-up and leveling. The crest re-leveling will proceed in 2025.

The TARP level is Green and the foundations remain frozen with no further progression of the previously observed cracks. The drone data indicates no further recent movements and therefore the dike crest will be regraded next year (2025). Water management has kept the operational pond levels within acceptable range.

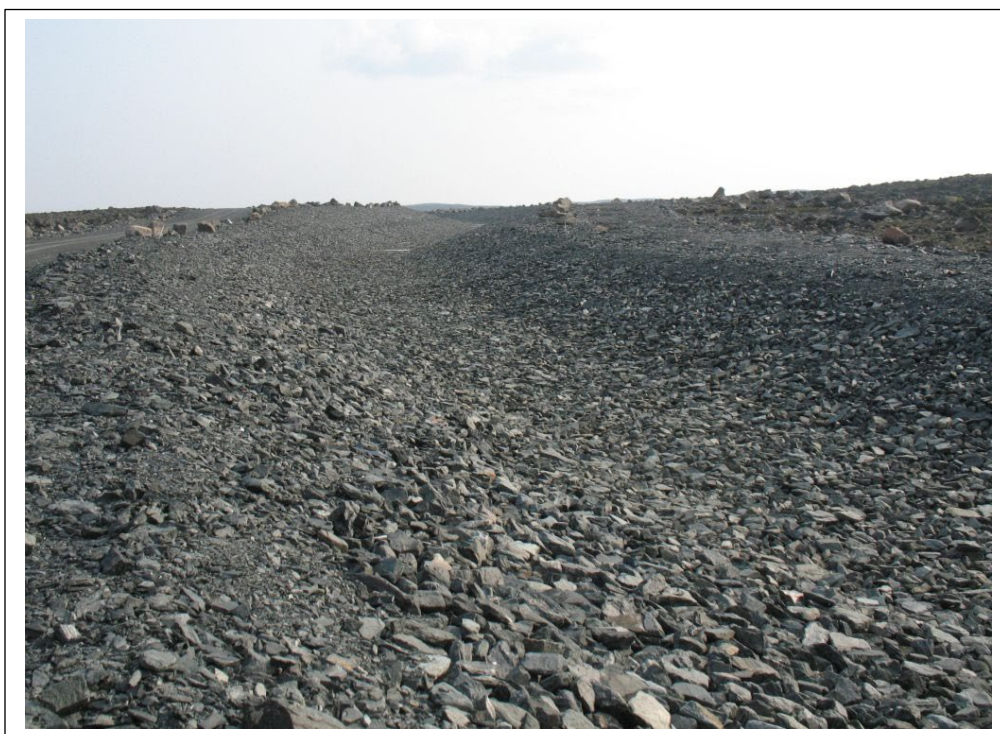
Photo #8 South Whale Tail Channel

- A visit was made to the South Whale Tail channel which is in excellent condition given the permafrost affected terrain in which it was constructed. Only minor local settlement of the invert has occurred as indicated by a few local water-filled depressions (Photos #8, 9 and 10).

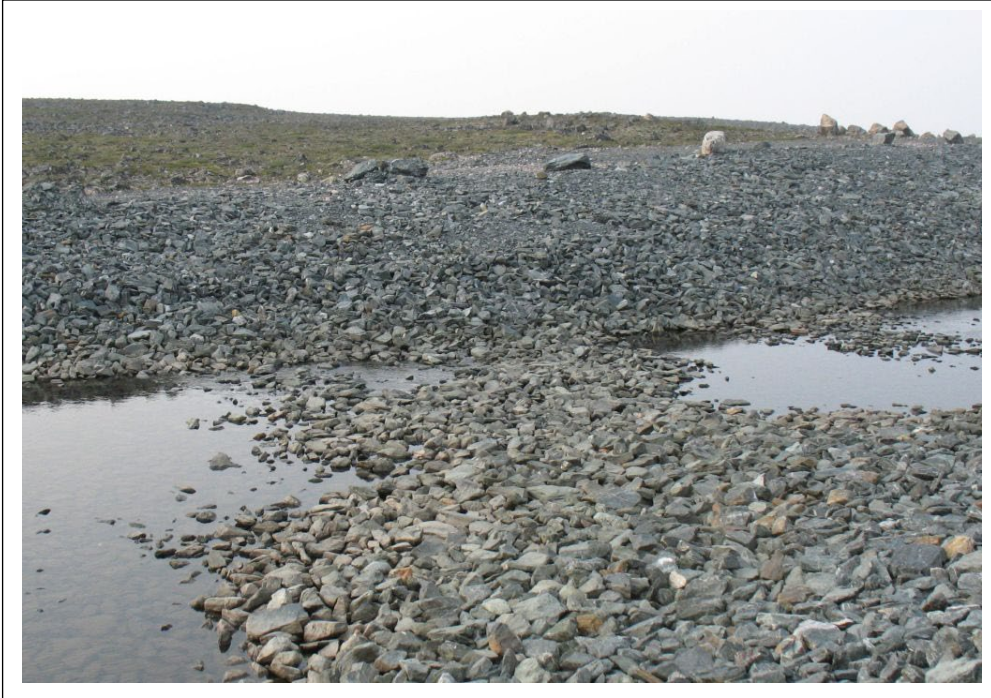
Photo #9 South Whale Tail Channel, minor flow only

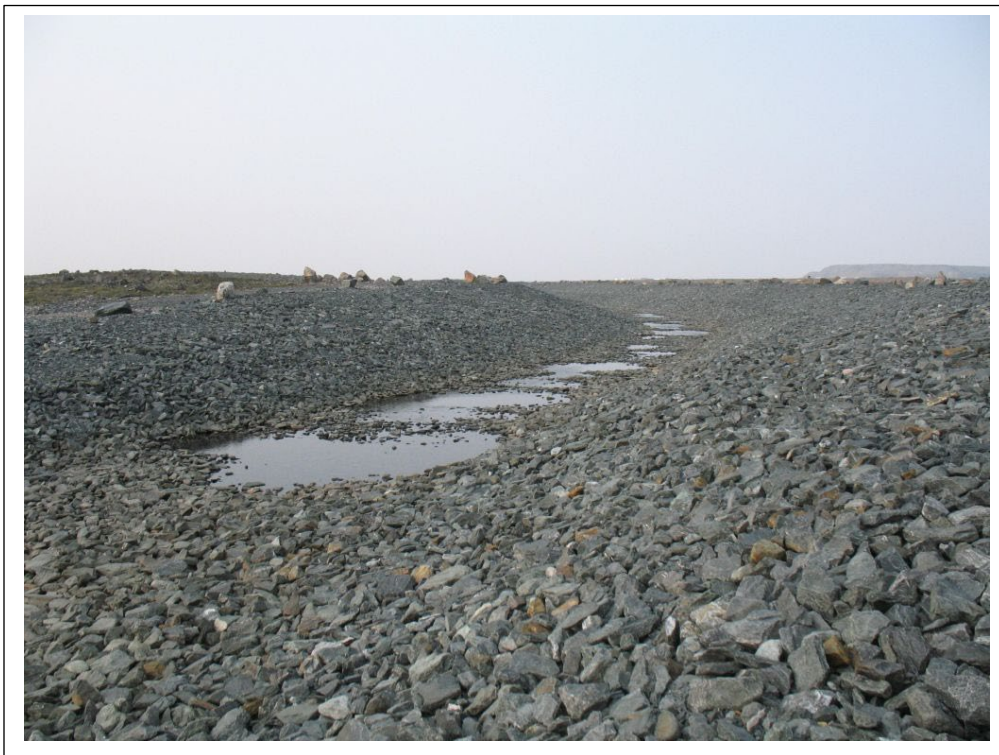
Photo #10 South Whale Tail Channel. Flow daylights in depressions

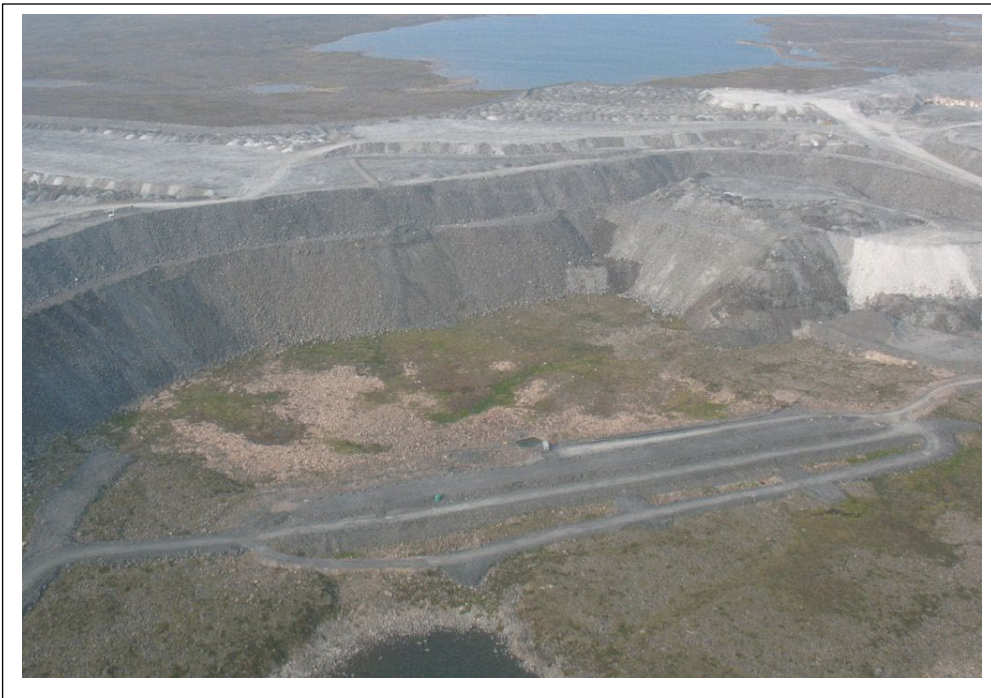
Photo #11 WRSF Dike and rock dump

- Mammoth Dike and the Waste Rock Storage Facility (WRSF) dike (photo #11) are both performing as intended.
- Annual maintenance is required at the Saline Ditch but otherwise no adverse observations are noted.

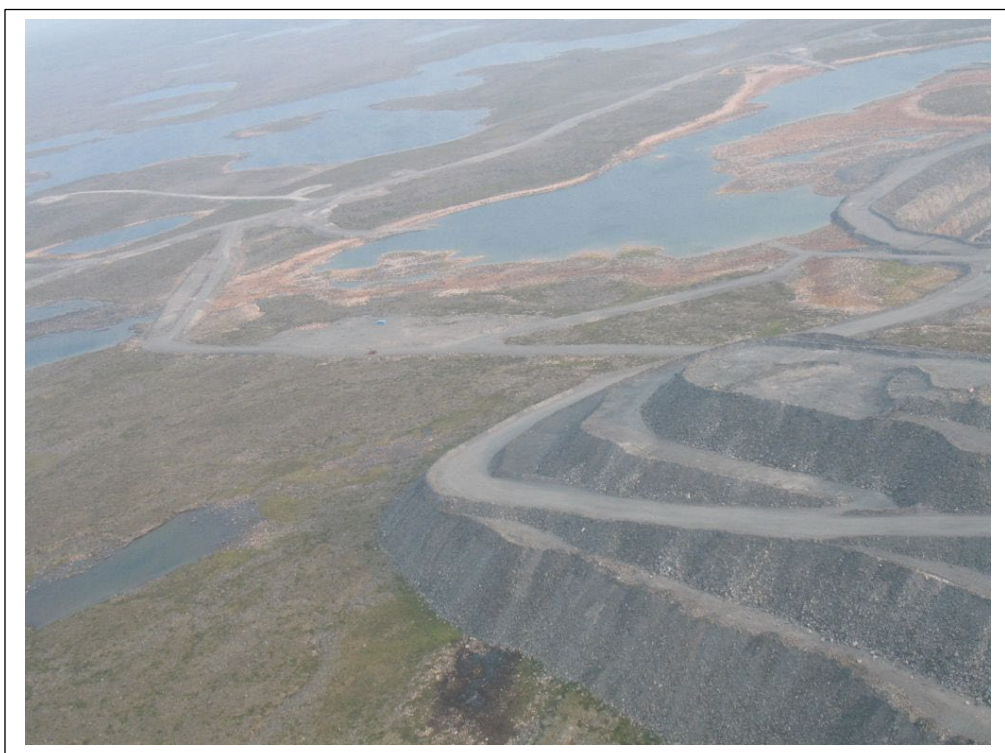
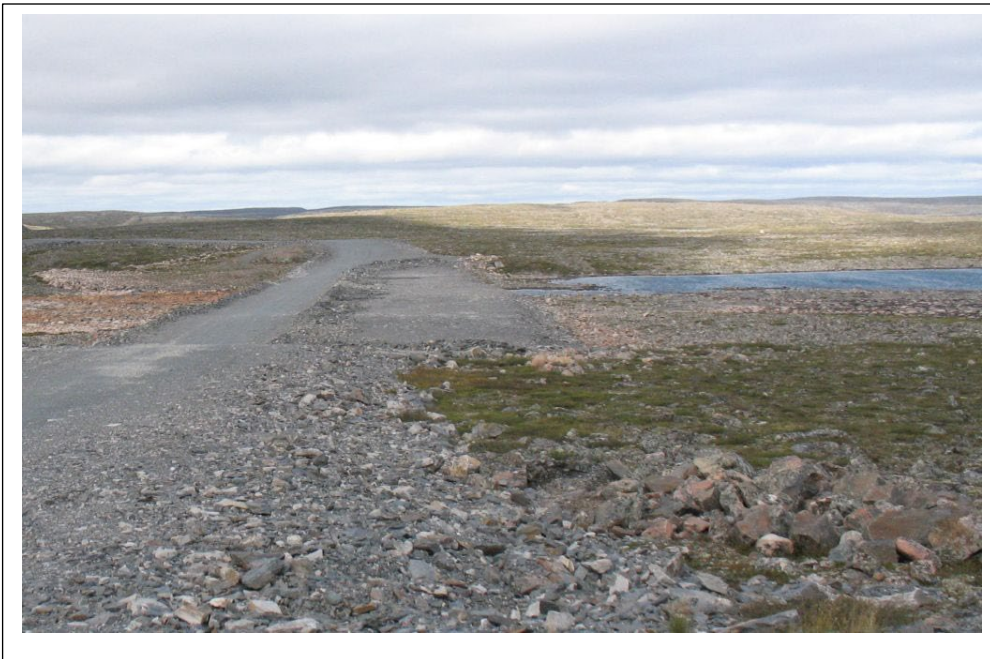
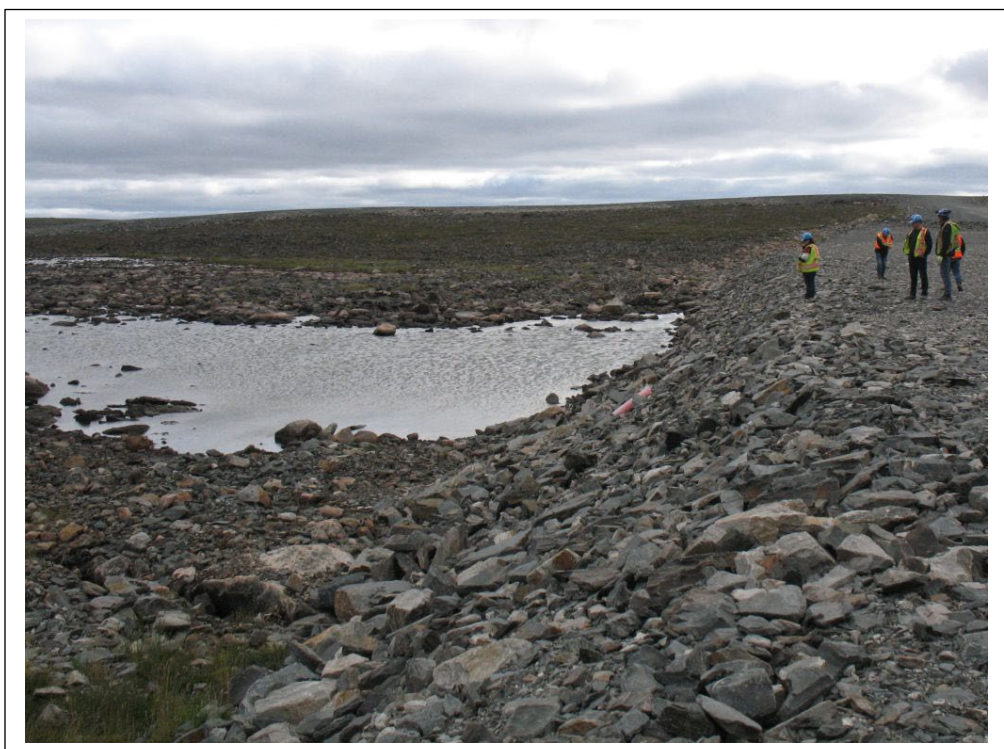
The following day, Vault Dike and the Vault deposit open pits were visited. The low, wide rockfill structure that comprises Vault Dike was noted, as was the shallow depth of water at the upstream toe (Photos #12, 13, and 14). More discussion on this structure is to be found in the section on the 2023 DSR.

The Consequence Classification of “low” assigned by the designer to Vault Dike may not be strictly speaking correct if the CDA guidelines are followed. A loss-of-life (LOL) potential of 0-10 had been used that would automatically place the structure in the “Significant” class. However, any risk of failure of this low structure (photos #13 and 14)

would be under readily observable storm conditions that would permit evacuation of temporary workers. The LOL potential would be essentially zero. Environmental damage would be minimal, and no economic loss would be incurred by a third party. AEM could therefore accept the “Low” risk status. It could also, for reasons of corporate policy, adopt the “Significant” classification. However, the question is now somewhat mute as exploitation of the mine pit at Vault has ceased.

Photo #12 Vault Dike and Vault Lake

Photo #13 Vault Dike. Vault Lake at left, Wally Lake at right

Photo #14 Vault Dike upstream face. Wally Lake at left

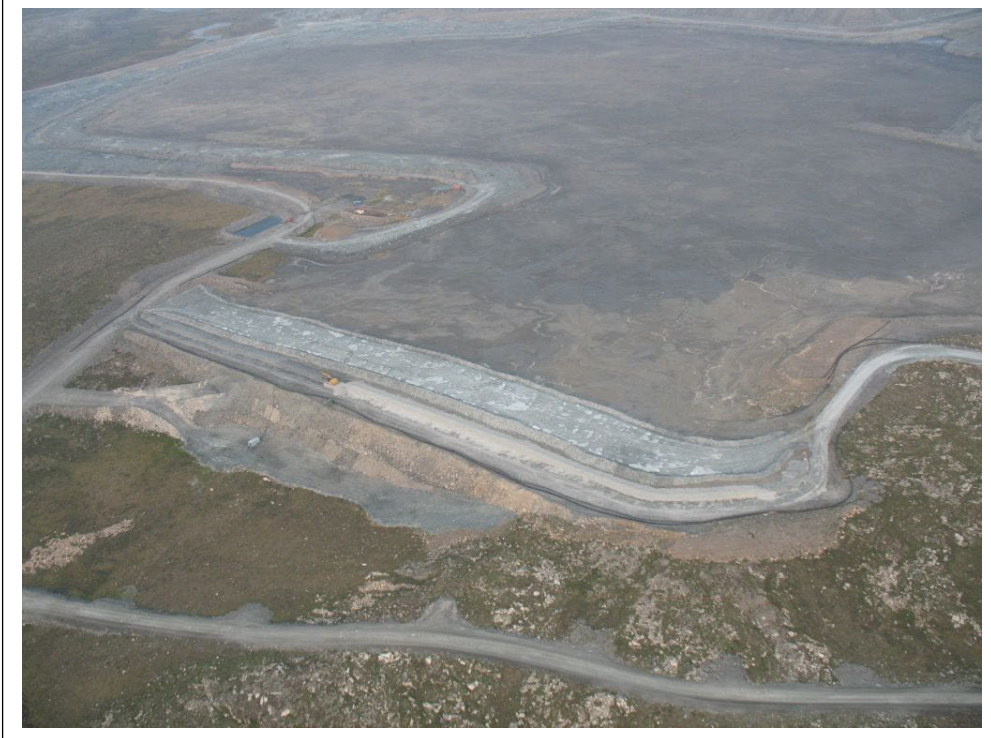
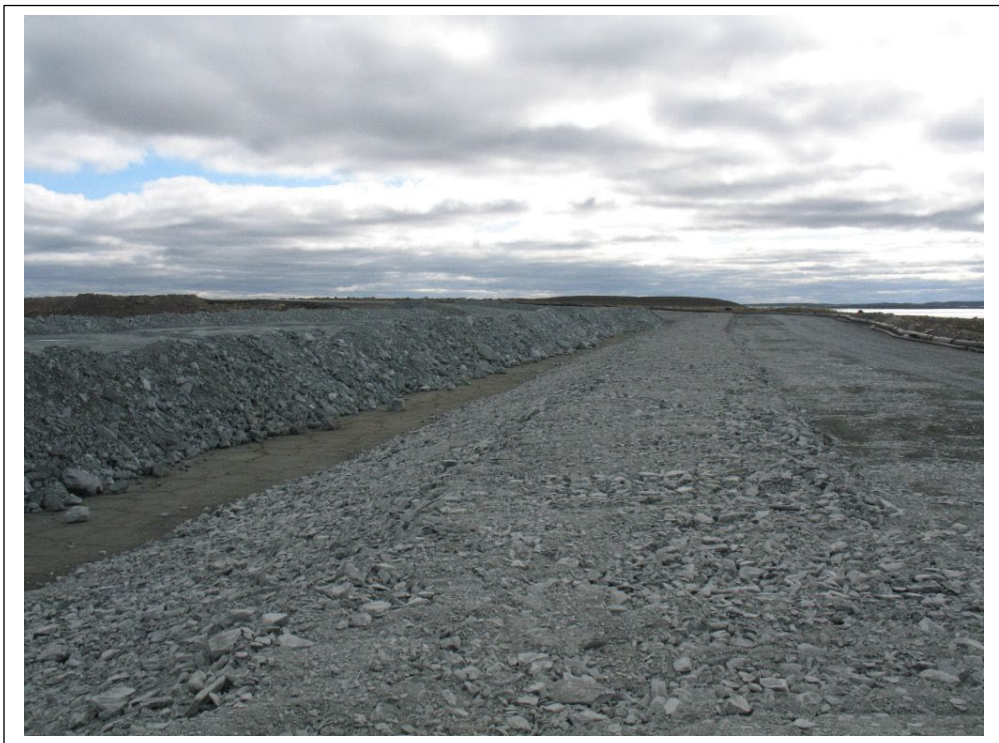
Photo #15 Saddle Dam 1

- At the TSF Saddle Dams, rockfill placement for protection of the liner at SD-1 was underway as a precursor to capping of the tailings (Photos #15 and 16). A similar operation will be carried out at the other containment structures of the TSF.
- At the TSF Stormwater Dike, additional capping has been accomplished in the vicinity of this dike but no tailings deposition for landscaping has been carried out this year (Photos #18 and 19).
- The TSF Central Dike is performing well, and the downstream pond (photos #20 and 21) is still being maintained at elevation 115 masl.

Photo #16 SD 1, new rockfill cover over liner

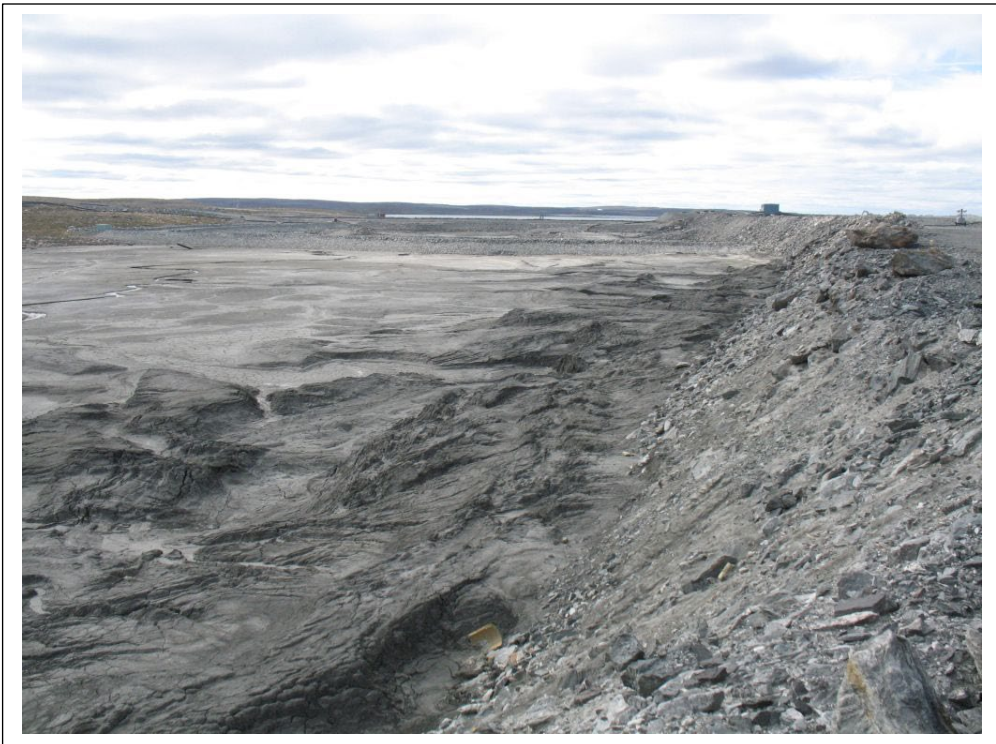
The Stormwater Dike is performing as intended however, the foundation remains unfrozen and the seepage beneath the dike is assumed to continue and report through the underlying talik to the Central Dike downstream pond. Liner weld repairs and protection, in addition to some capping were carried out upstream of the Stormwater Dike in 2024.

Photo #19 Stormwater Dike, TSF south cell tailings at downstream toe

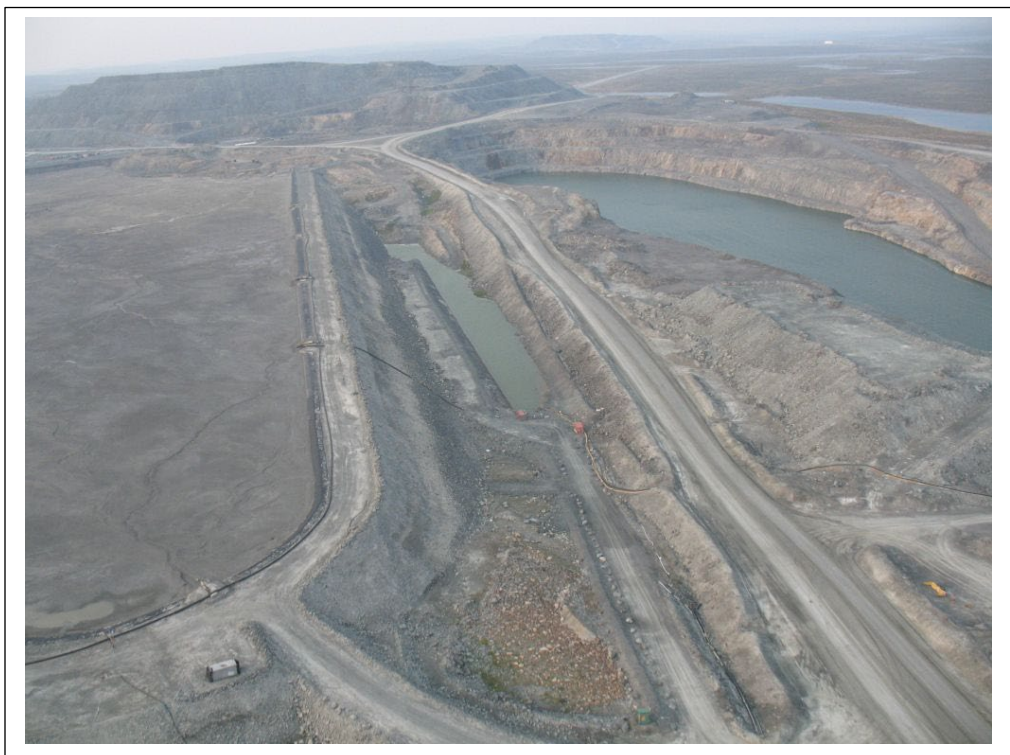
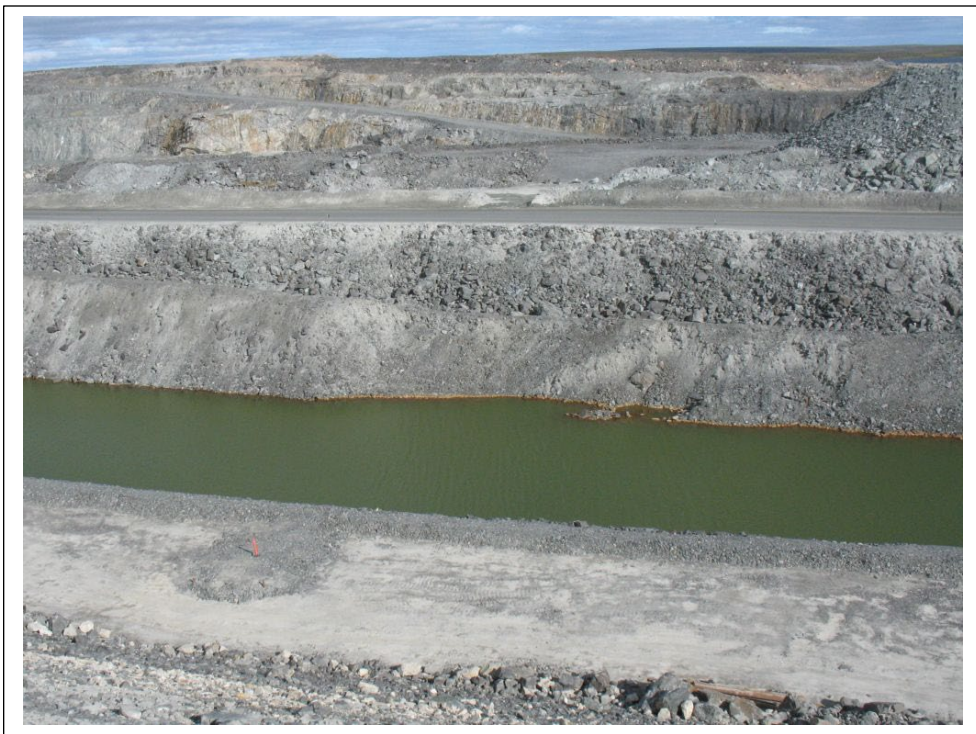
Photo #20 Central Dike, downstream pond and West Road

Photo #21 Pond at Central Dike. West Road in background. Pond at el. 115 m. Berm in foreground at el. 120 m

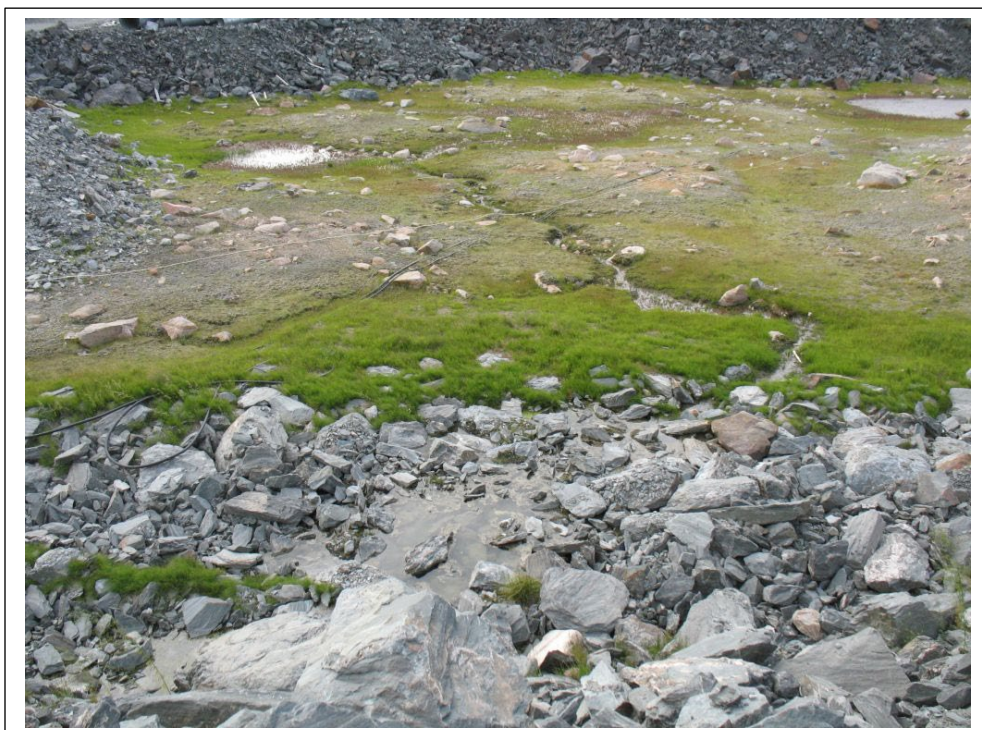
- Stops were made at the East Dike to observe features noted in the 2023 DSR. No change has been detected by the AEM team over the past year. The perceived uplift in the lakebed sediment is believed to date to the original rockfill placement period (Photo #22). The noted improvements to the seepage pump station were observed (Photo #23).

Photo #22 East Dike. Seepage and uplift? area noted in DSR

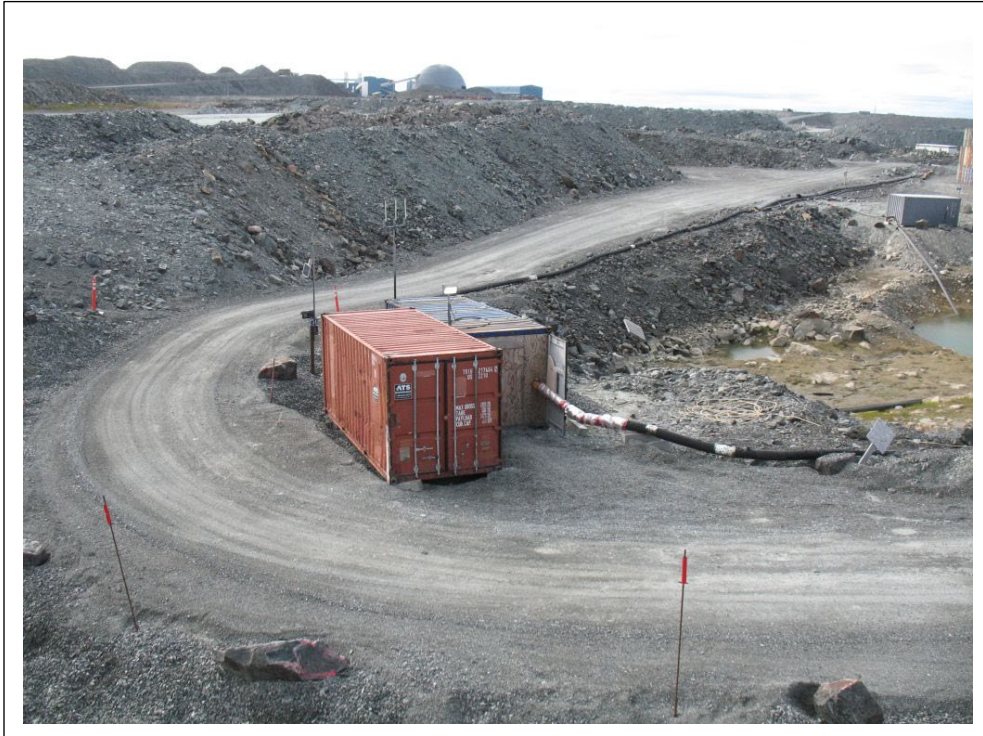
Photo #23 East Dike pump system

Improvements to the seepage drainage and monitoring system seem to have been effective, in that no road flooding was observed over the winter 2023/24 and all seepage appears to be reporting directly to the pump well, where it is measured with improved flow monitoring equipment prior to being transferred to Pits A and E (discharge point at waste rock dump between these pits) or directly to Second Portage Lake whenever water quality permits.

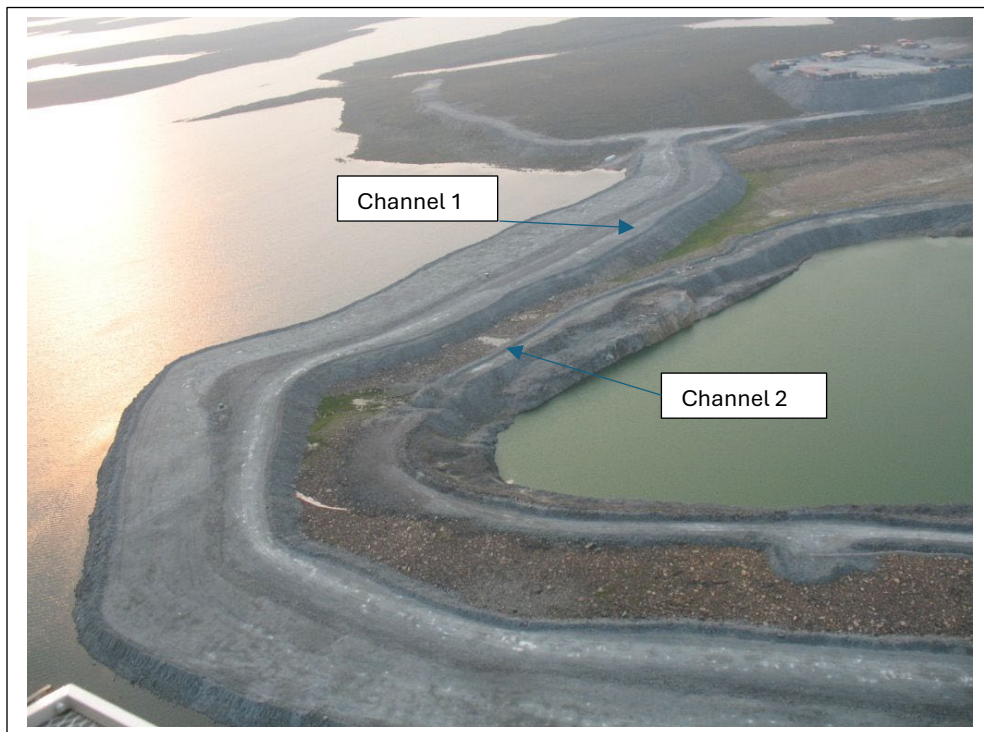
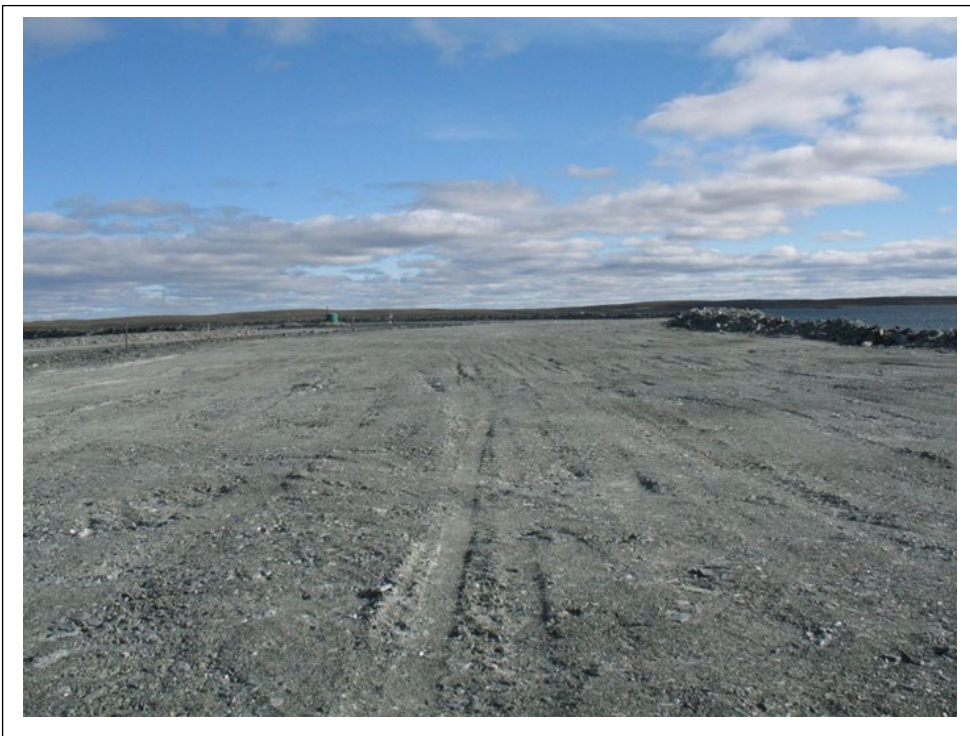
Photo #24 Bay-Goose Dike south and south-west. Channels 1 and 2

- At Bay-Goose dike (photo #24), extra fill has been placed and regrading carried out to facilitate more efficient visual observation of the condition of the dike crest (photo #25). It was observed that the material comprising the upstream face of the dike contains a significant proportion of finer material (photo #26) that could be either recently placed or due to progressive breakdown of the soapstone rock. However, little wave damage was noted, and the wide crest (80 m) would provide a large volume of sacrificial material in such an event.

Inspection of the crest of the Bay-Goose dike has revealed cracking and localised settlement in the recently placed and graded topping material but this may be related to heavy rain that occurred in the fall. It was also mentioned in the presentation that the sinkholes were not situated in the same area as the piezometric pressure rise.

Photo #25 Bay-Goose Dike. Crest in SW segment

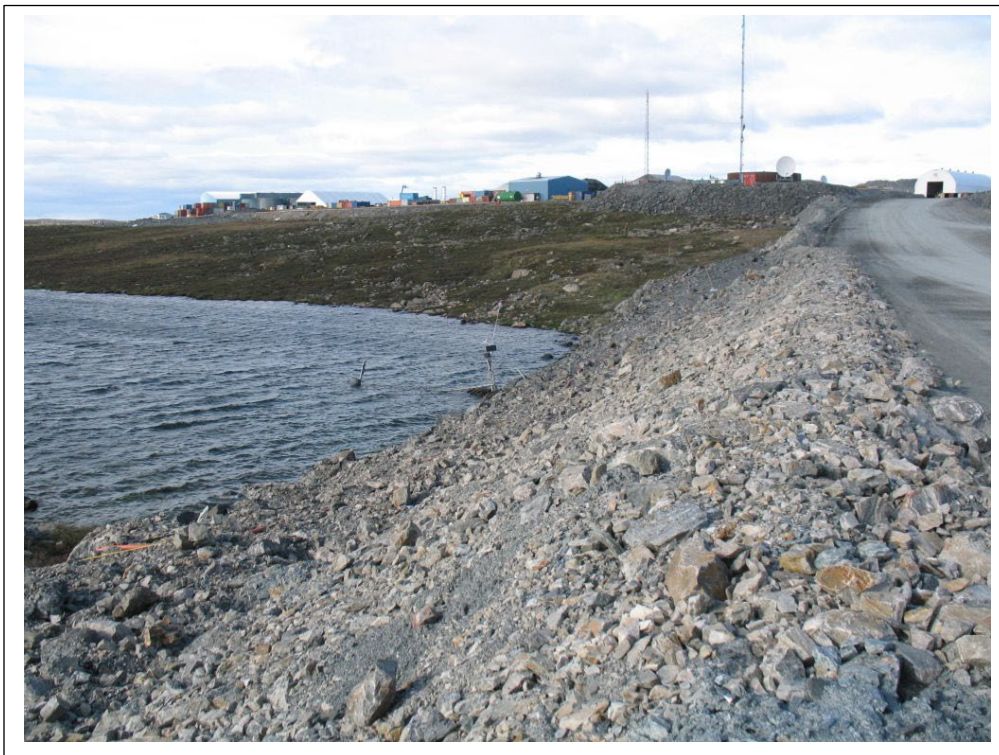
Photo #28 South Camp Dike. Upstream face

- At South Camp dike, the small water pond, noted in the DSR was observed to be smaller than illustrated in that report. Prolonged presence of a significant water body could indeed have an influence on the frozen condition of the foundation. ***The crest road is kept clear of snow all winter and cold ingress is therefore facilitated but improved drainage or backfill of this area of ponding water may be beneficial.*** The amount of available freeboard can be appreciated from photo #28.
