Appendix 23

Meadowbank 2024 GN Spill Reports

2024-01-10 MBK 500L Waste Oil

GN reference #: 2024-011

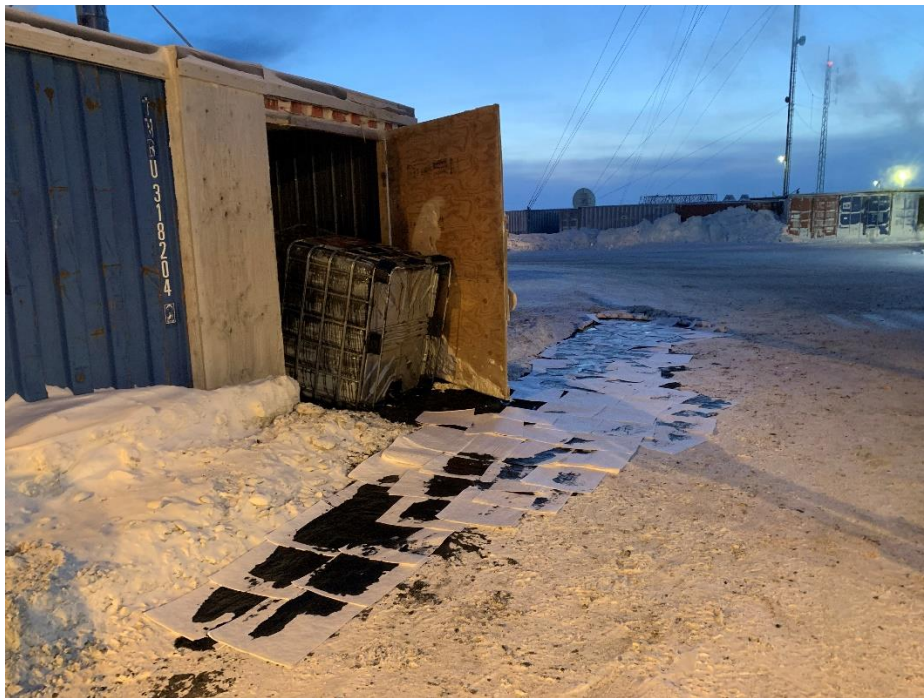
A telehandler operator was placing a tote of waste oil inside the LHT Service Dome, near the MBK Tankfarm, as the operator was angling the forks, the tote slid off and fell onto its side bursting the cap. As a result, approximately 500L of waste oil was spilled onto the frozen ground.

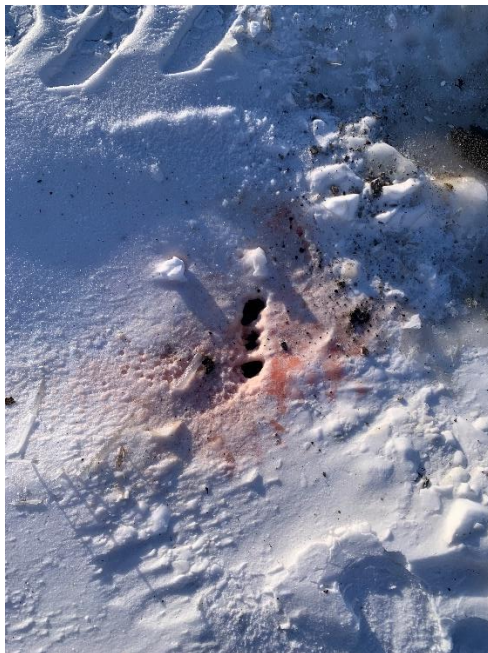
During some repairs on bridge #2 at KM 18. A telescopic forklift experienced equipment failure. Upon investigation, it was determined that the 2L of coolant spill occurred due to human error during the coolant refill process of the equipment.

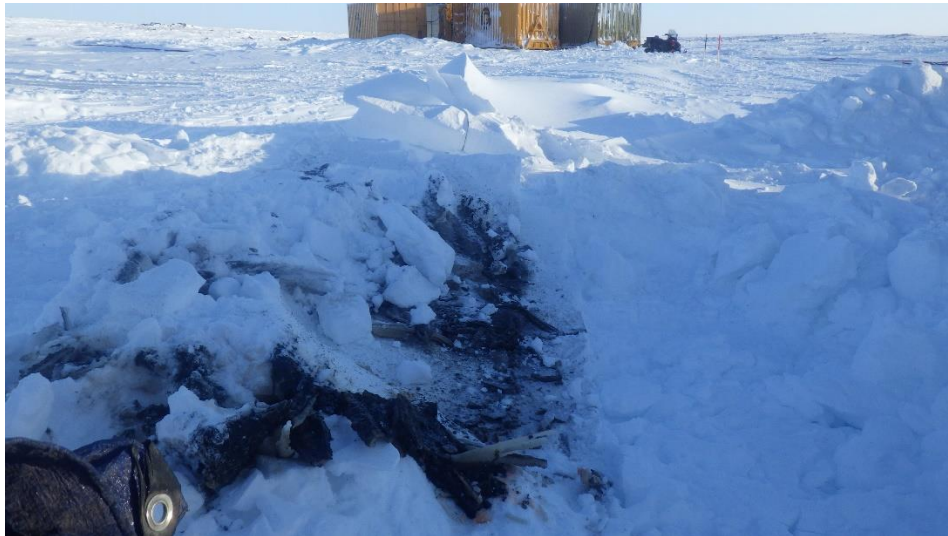
During exploration on an unnamed lake, approximately 320m N of Wally Lake, a frost fighter installed to warm-up an engine compartment of a bulldozer that suddenly stopped. While thawing the engine compartment, contaminated snow and ice melted resulting in a spill.

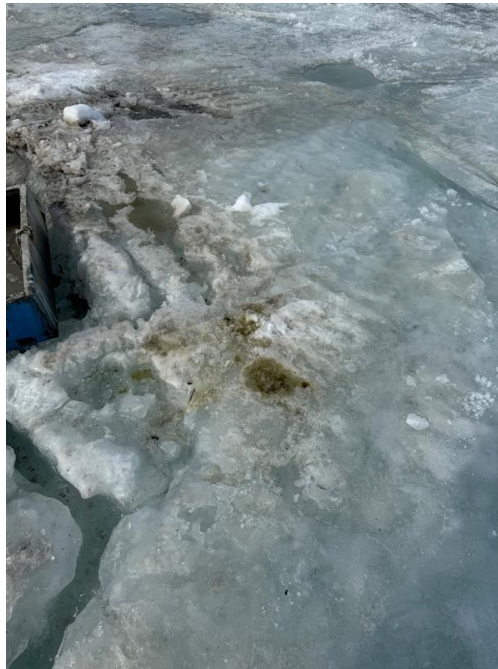
Following exploration on an unnamed lake, approximately 11km NE of Wally Lake, a small spill of engine oil was discovered. During the inspection it was found that while moving the drill rig to the new location a small hose was disconnected from the engine during as part of the routine moving operations. A cap was placed on the hose, however ~500 ml of oil leaked out on to the ice.

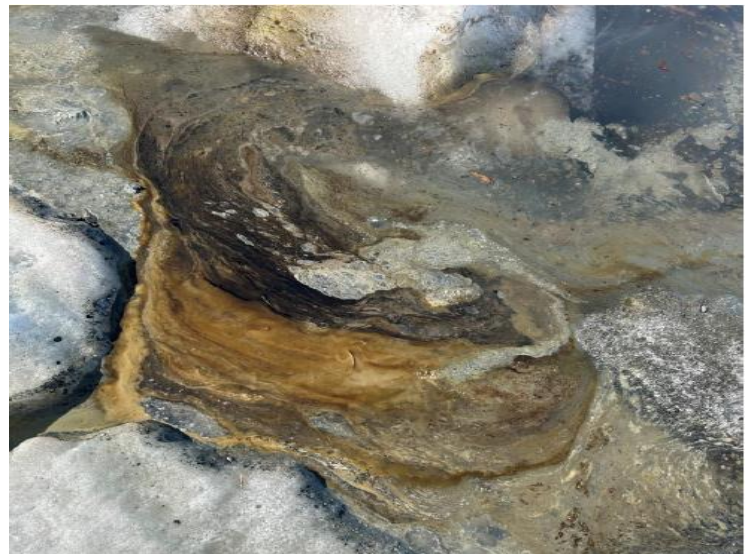
Figure 2 – Post Drill Inspection May 29, 2024

Equipment Failure – This spill is believed to have occurred during the winter operations and was attributed to a leaking rotation hose that was replaced on the drill rig operating in that area on February 26th, 2024.

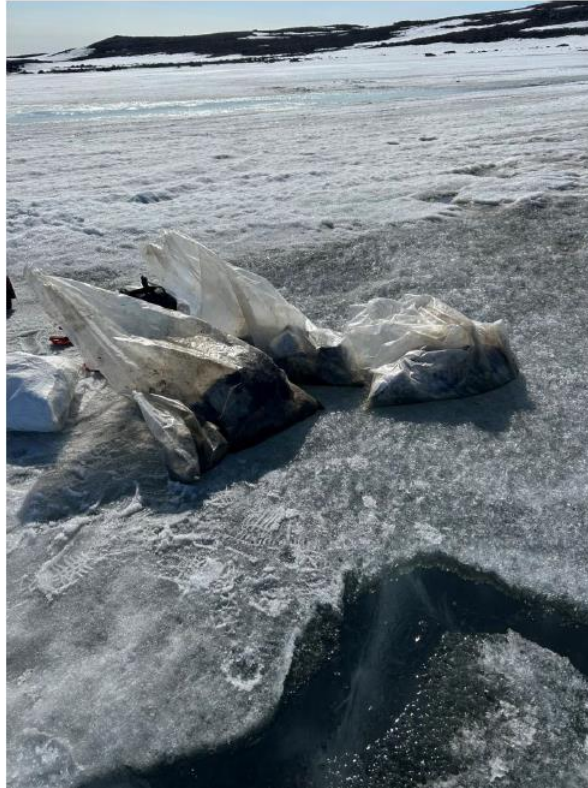
Figure 3 – Clean up May 29, 2024

Hand shovels were used to retrieve approximately three 20L bags of contaminated snow and ice, which was then brought to the Meadowbank Tailings Storage Facility. Spill absorbed material was used to collect the oil from ontop of the ice and brought to the Meadowbank Hazmat facility.

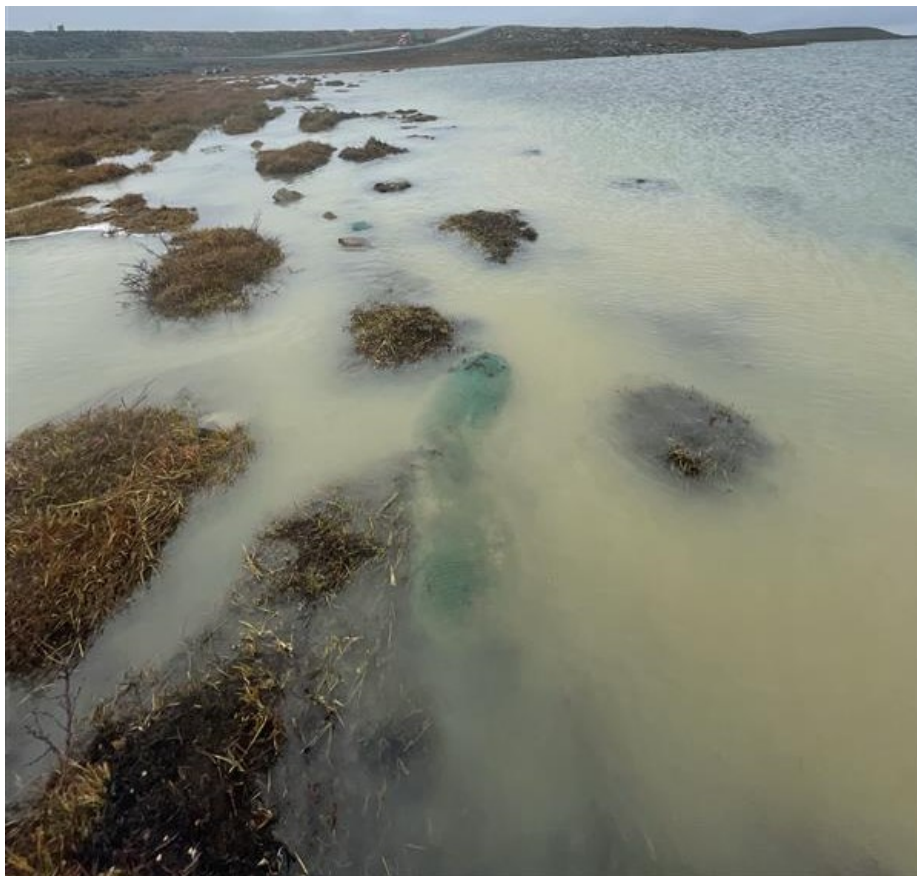
During a regular freshet inspection of the West Diversion Ditch, a turbid plume of water was observed at the exit of the diversion ditch where it connects to shore of Third Portage Lake at the registered sampling point ST-6. The plume extended ~2m into the lake and ~20m along the immediate shoreline area, with no observable impact further into the lake.

Figure 1. Third Portage Lake Shoreline at ST-6 Sample Location – September 20

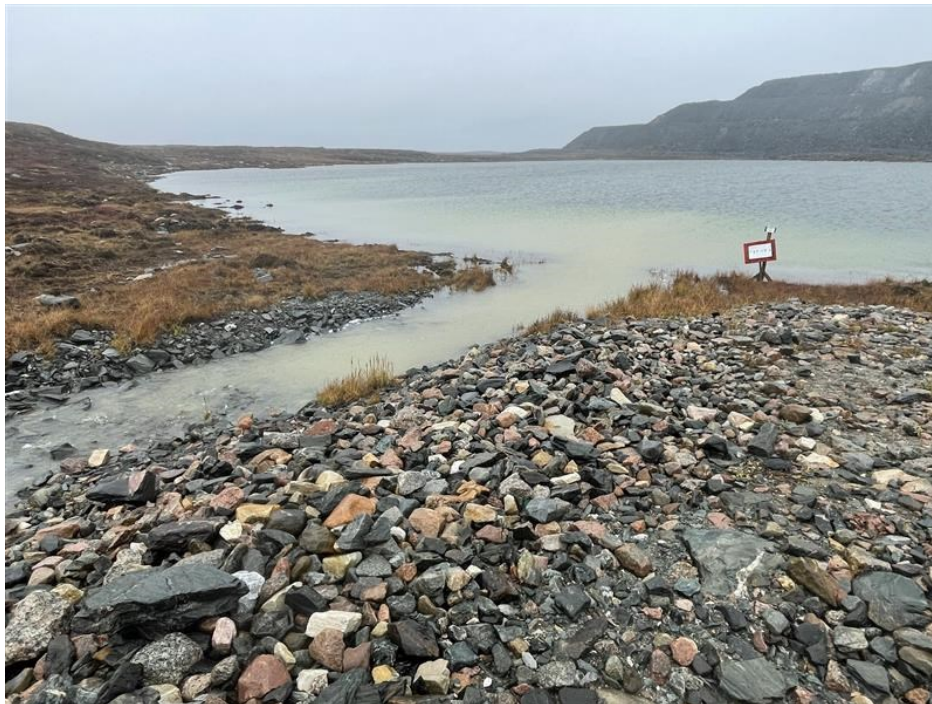
During a regular freshet inspection of the East Diversion Ditch, a turbid plume of water was observed at the exit of the diversion ditch where it connects to shore of NP2 Lake at the registered sampling point ST-5. The plume extended ~1m into the lake and ~5 m along the immediate shoreline, with no observable impact further into the lake.

Figure 1. NP2 Lake Shoreline at ST-5 Sample Location – September 20

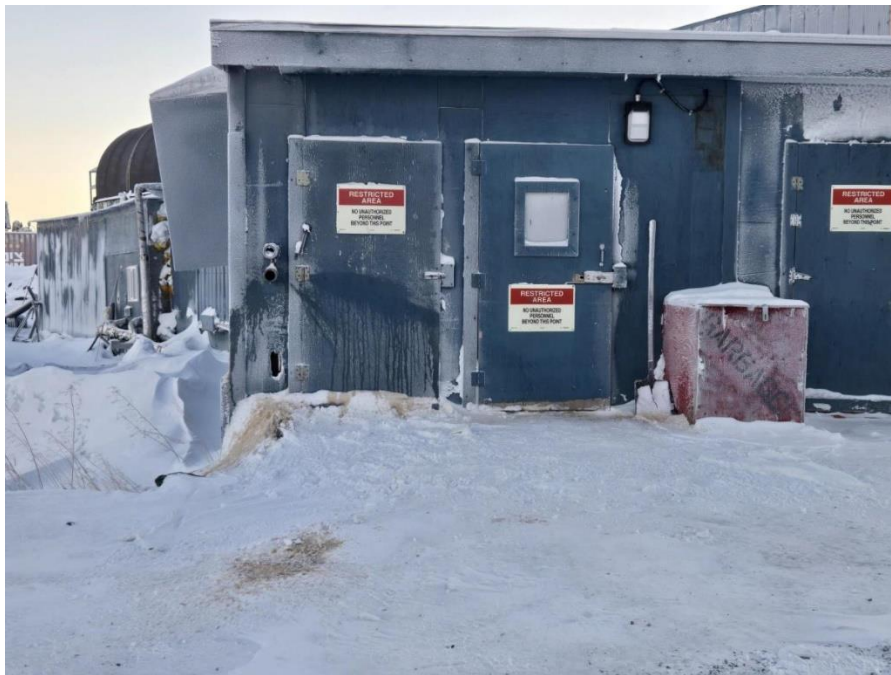
During the transfer of sewage from the sewage truck to the treatment plant in Meadowbank, a leak was observed during the offload. After investigating the transfer pipe was found to be broken. As a result, ~5L of sewage leaked from the coupling and onto the ground.

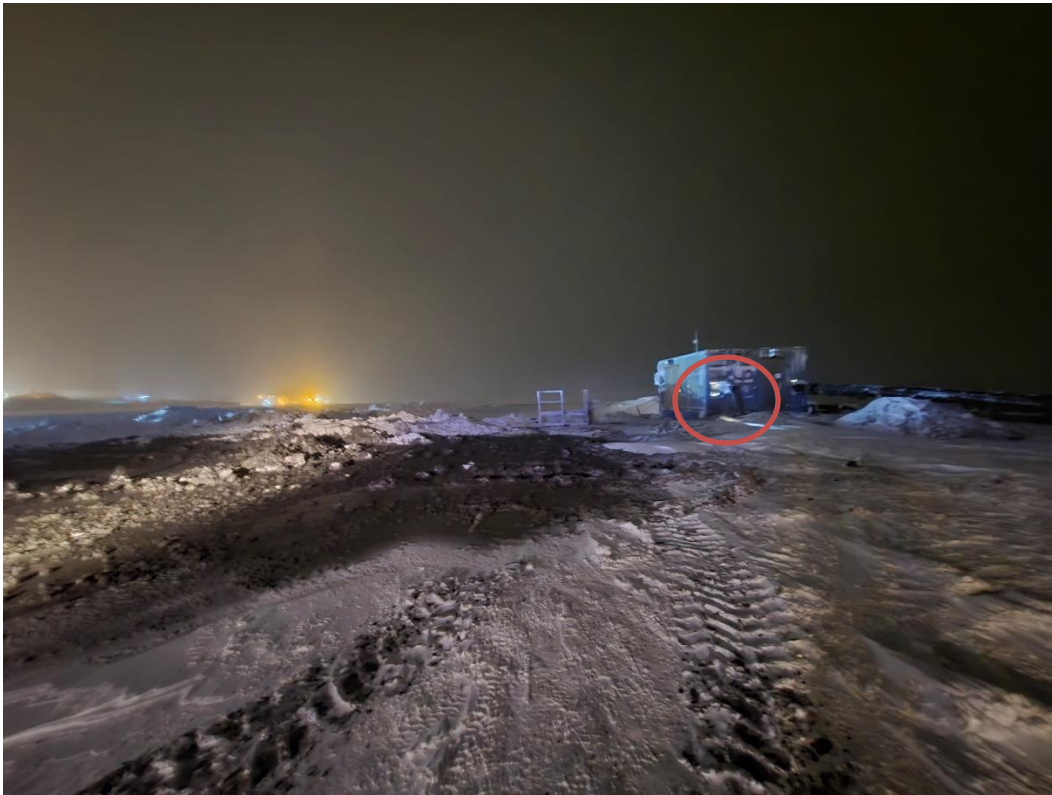
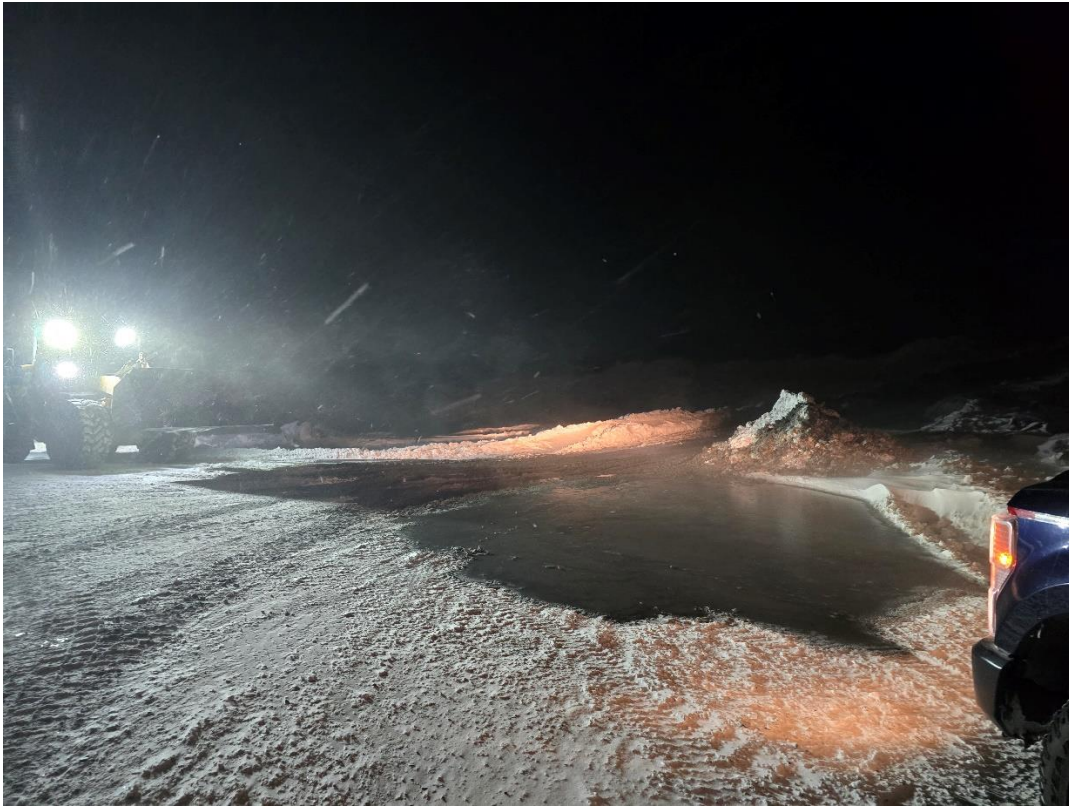
During regular operations, an operator noticed tailings leaking around the tailings line in the southern part of South Cell. Further investigation revealed that a section of the tailings line at the by-pass had failed, releasing approximately 15 cubic meters of material onto the ground.
