## **Appendix 24**

### **Whale Tail 2024 GN Spill Reports**

## 2024-03-25 WTM 200L Hydraulic Oil

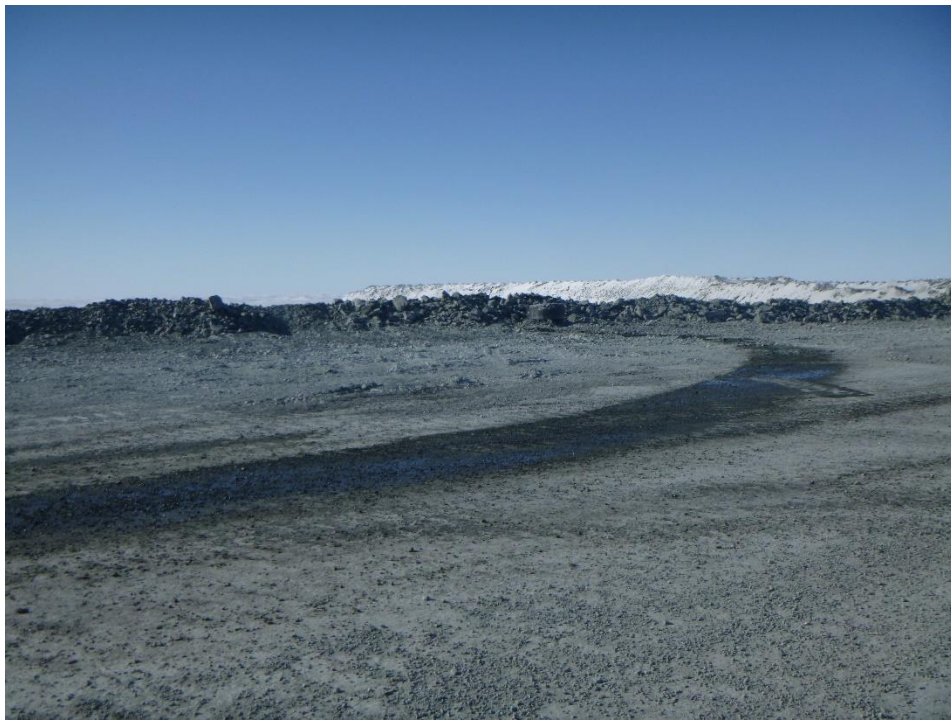
During the operations at the Whale Tail Mine, the haul truck's hydraulic system failed while unloading at the Whale Tail Waste Rock Storage Facility. This incident led to the spillage of approximately 200 liters of hydraulic fluid onto the ground of the WRSF. The spill occurred in an active deposition area.

Mechanic failure

The incident was reviewed with all crews, serving as a reminder of the criticality of conducting equipment walkarounds to prevent avoidable damage or leaks. Furthermore, an investigation was conducted in collaboration with the maintenance department to scrutinize preventive maintenance practices, aiming to uncover any potential issues or gaps.

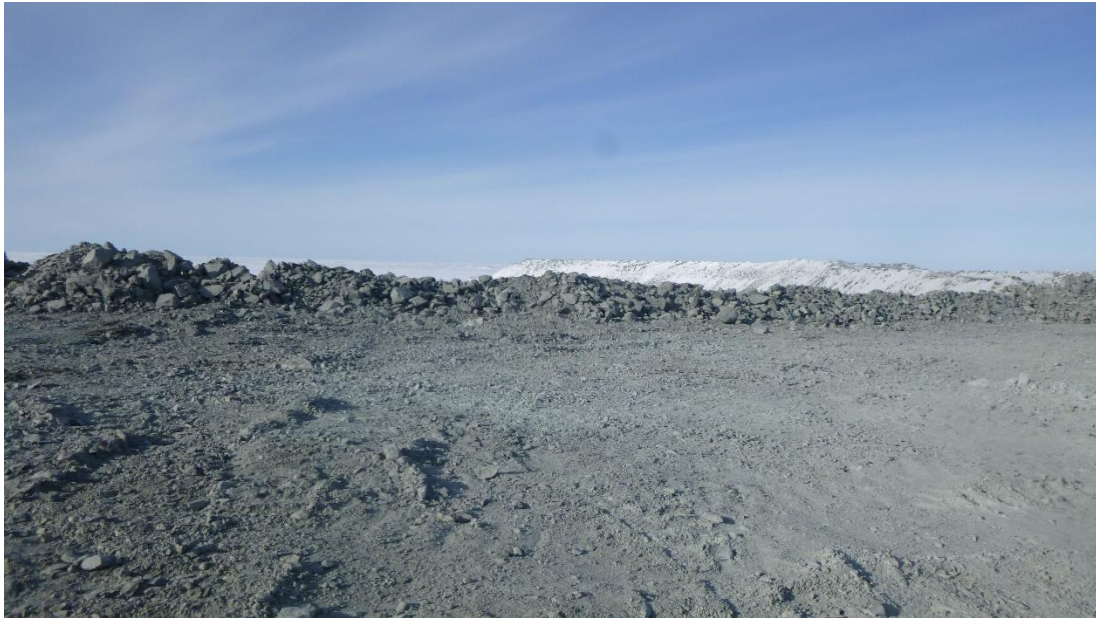
The operator promptly parked the equipment and powered it down upon noticing the spill. The contaminated material was collected and transported to the Whale Tail Landfarm.

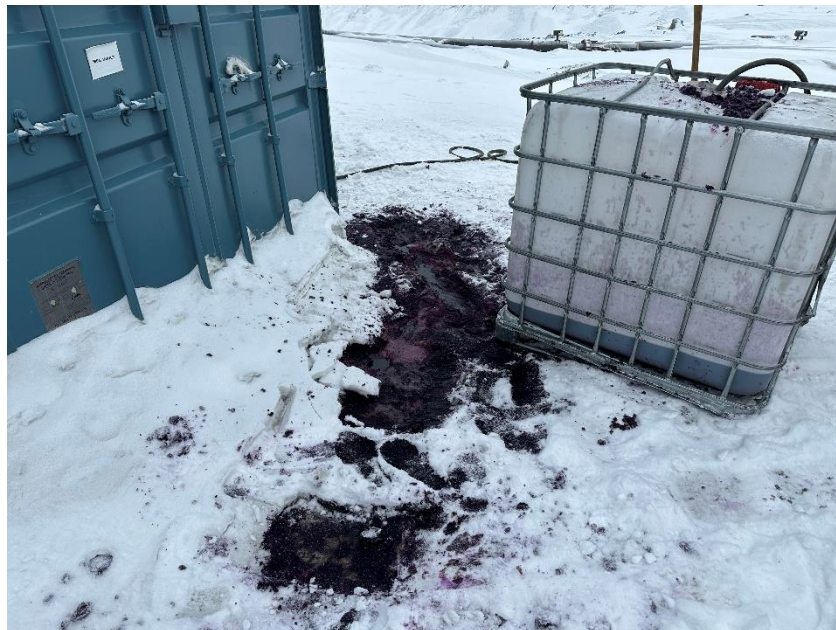
The mixing tank containing potassium permanganate at the Arsenic Water Treatment Plant required draining into a tote in order to perform plumbing maintenance. While transferring the chemical, a worker observed that the bottom valve of the tote had been left open inadvertently. This oversight resulted in approximately 50 liters of potassium permanganate spilling onto the ground outside the AsWTP.

An investigation was undertaken to identify necessary corrective actions. A protocol will be devised for the safe transfer of chemicals, aiming to pinpoint and rectify any procedural deficiencies. Additionally, alternative approaches to chemical storage will be assessed for the process.

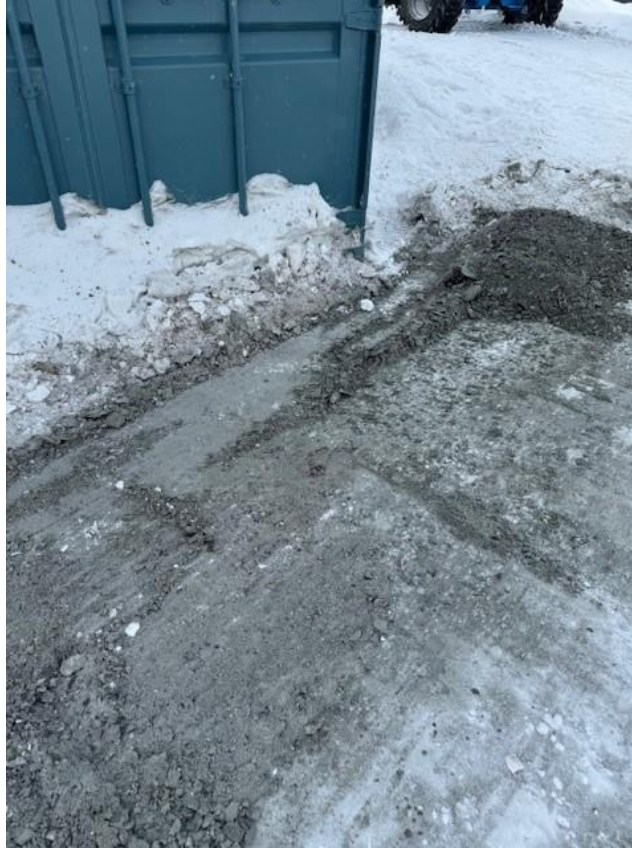
The operator quickly closed the valve and informed their supervisor of the spill. The contaminated material was collected and was transported to the Meadowbank Tailing Storage Facility for disposal.

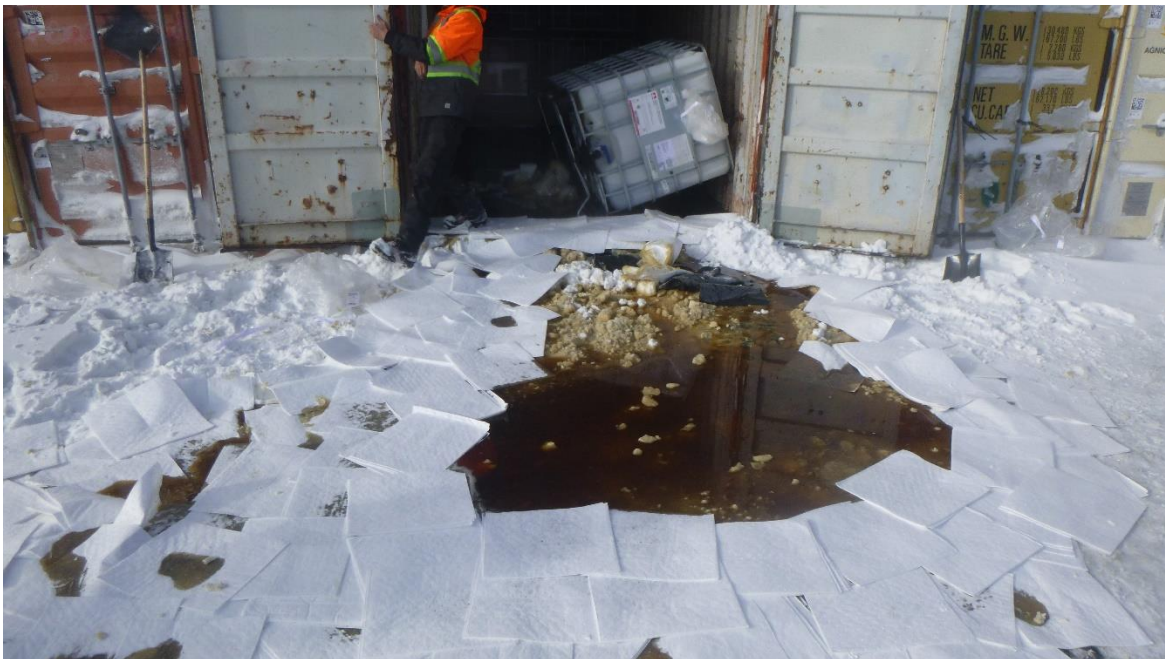
During the operations at the Whale Tail Mine, an operator attempted to extract a tote from the rear of a sea can using a telehandler. Due to a misjudged maneuver, the tote was pierced by the fork, resulting in the release of approximately 220 liters of transmission fluid onto the ground of the Whale Tail warehouse pad.

A comprehensive review of the incident and investigation, encompassing all crews, will be completed. To minimize the likelihood of a recurrence of such an event with that particular equipment, training will be provided to both current and future workers on the specific procedures for performing this task.

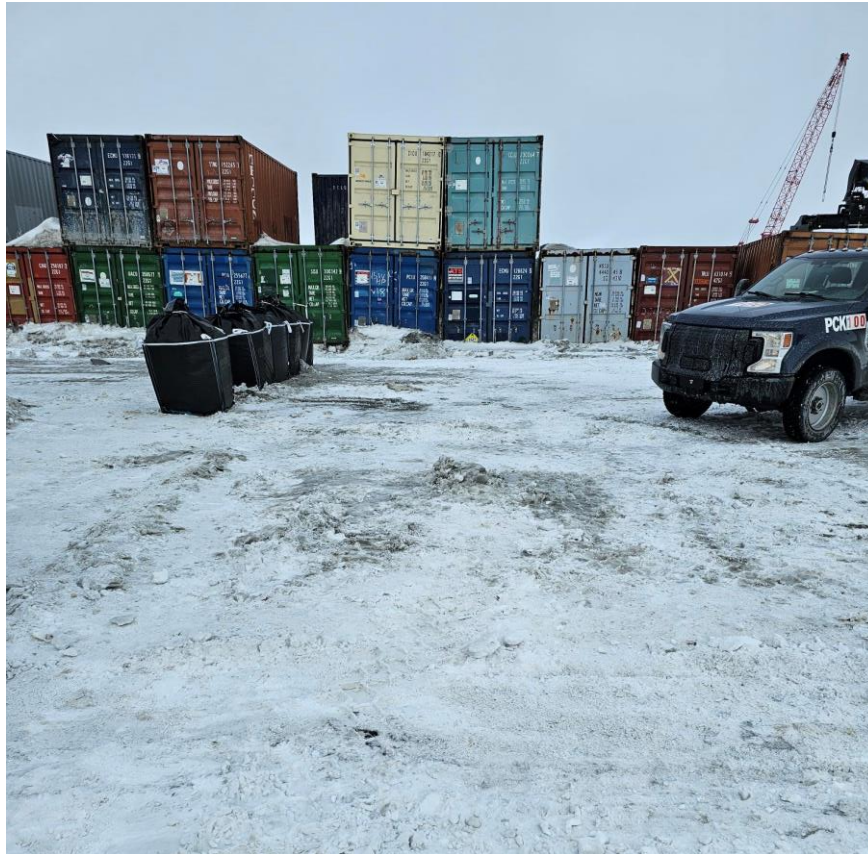
Spill pads were placed on the ground, the sea can was moved, and a loader was used to scrape and remove the contaminated material. The contaminated material was collected and disposed at the proper facility.

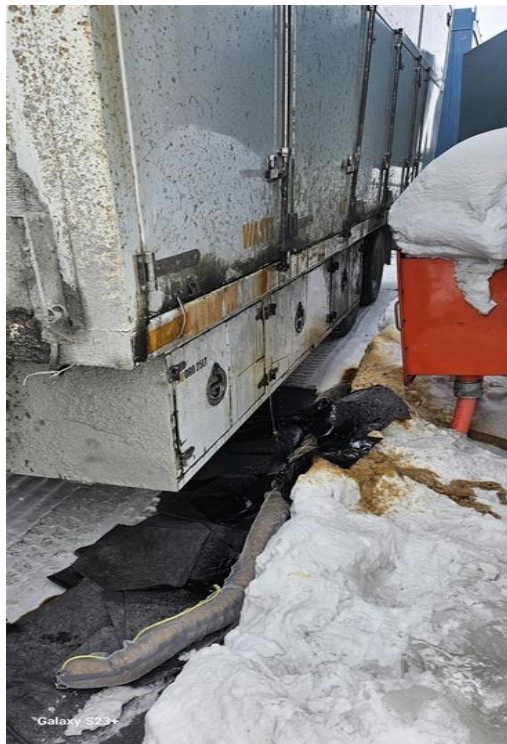
During the operations at the Whale Tail Mine, a lube truck operator noticed a hydraulic oil leak originating from the side compartments of the equipment. Upon further investigation, they found that the hydraulic hose connected to the PTO pump had ruptured at the crimped fitting, leading to the discharge of approximately 150 liters of fluid onto the ground in the underground genset parking.

Equipment failure

An investigation was conducted to scrutinize maintenance and operational practices, aiming to uncover any potential issues or gaps. Subsequent to the investigation, a new step was integrated into the task to mitigate the risk of a recurrence of such events. This addition was then communicated and reviewed by the users of the relevant equipment.

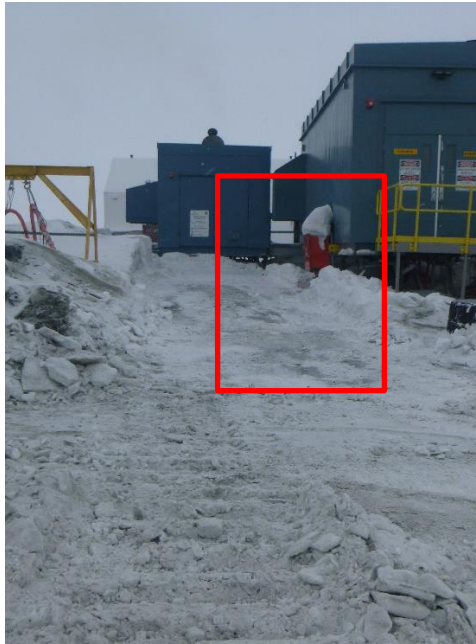
Spill pads were placed on the ground and a loader was used to scrape and remove the contaminated material. The contaminated snow was collected and disposed of at the Whale Tail Landfarm.

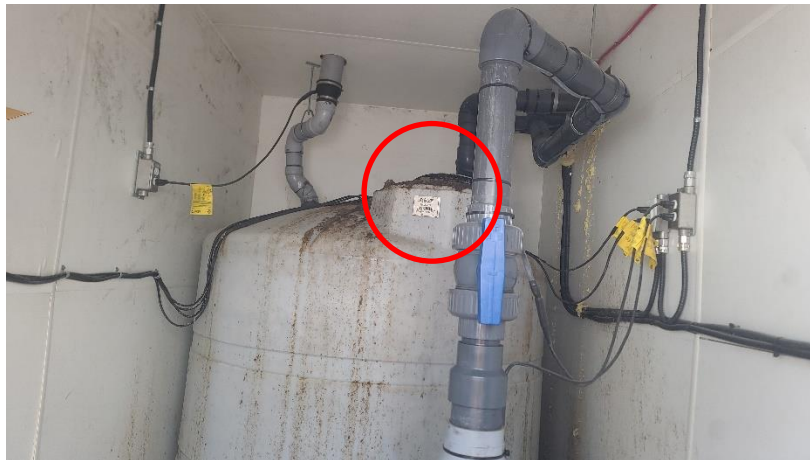
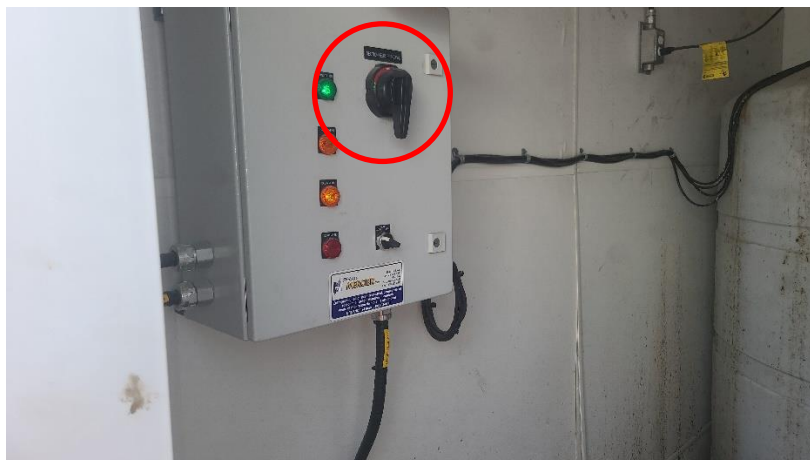
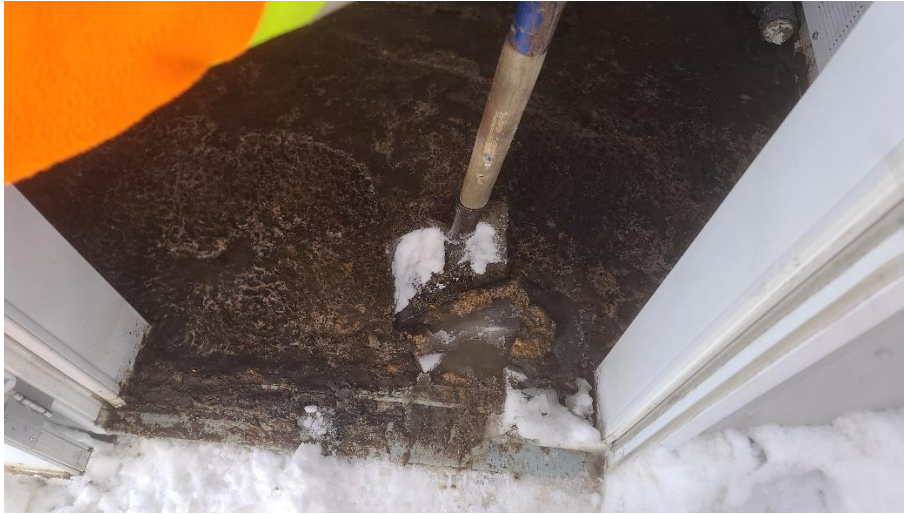
During a routine review inspection of the lift station between wings 24 & 25, an employee noticed a strong odor. Upon investigation the employee found that the lift station holding tank had overflowed. As a result, an estimated 25m<sup>3</sup> of sewage leaked out of the transfer tank filling the floor of the building before ultimately flowing under the camp. Upon investigation the switch that controls the automatic floats & pumps in the transfer tank was left in the off position. This resulted in a build up of pressure in the transfer tank and ultimately the failure of the transfer tank.

Additional alarm systems are being installed on all other transfer tanks that can connect to the on-site HMI system. A high-level alarm with flashing light will also be installed in an area visible to the operators.

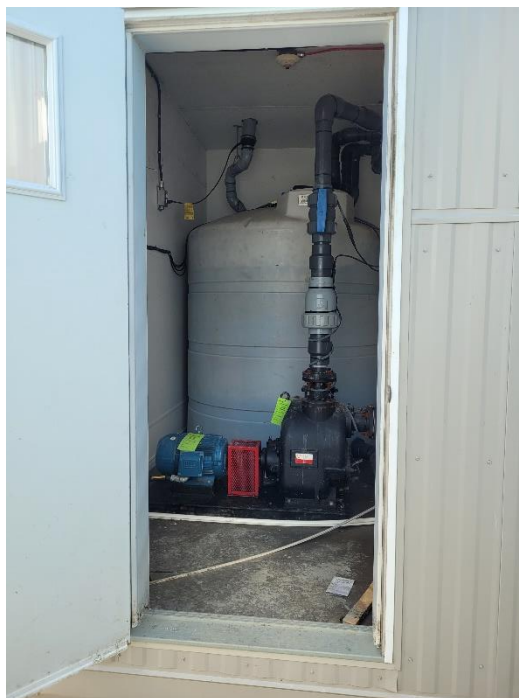
Upon discovery workers immediately collected the excess sewage contained in the building and repaired the transfer tank. The contaminated material that was accessible was collected with a sewage truck and disposed of at the Meadowbank tailings area. ~10m<sup>3</sup> of contaminated snow and ice was also disposed of at the Meadowbank tailings area. Due to the location, time and nature of the spill additional remediation work will occur later in the spring when the ground has thawed to allow for better recovery of contaminated material.

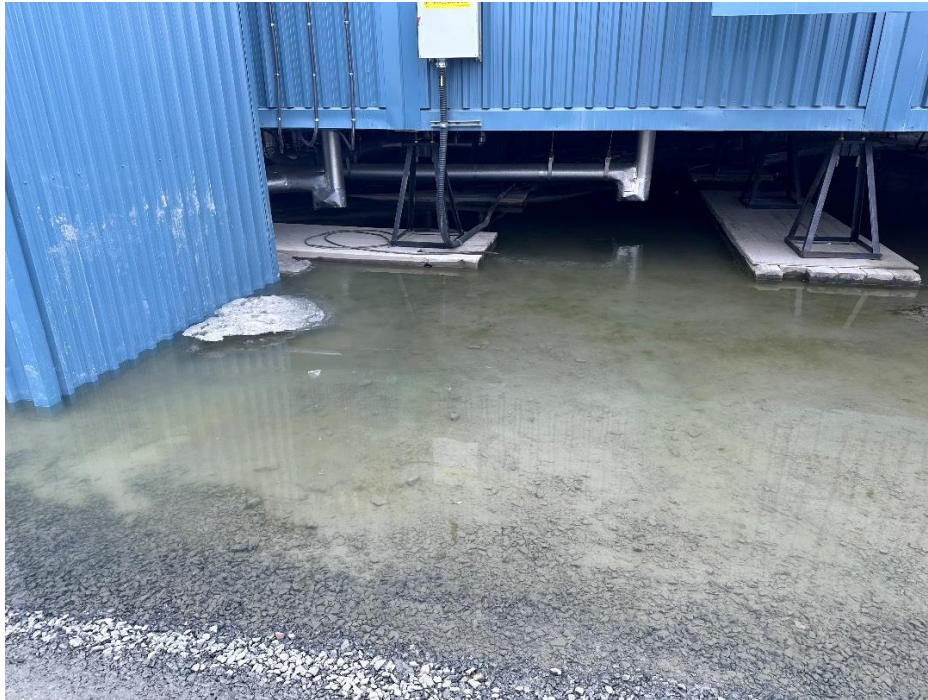
A vacuum truck was deployed to extract as much liquid as possible. The contaminated snow and material were collected and brought to the Tailing Storage Facility at Meadowbank.

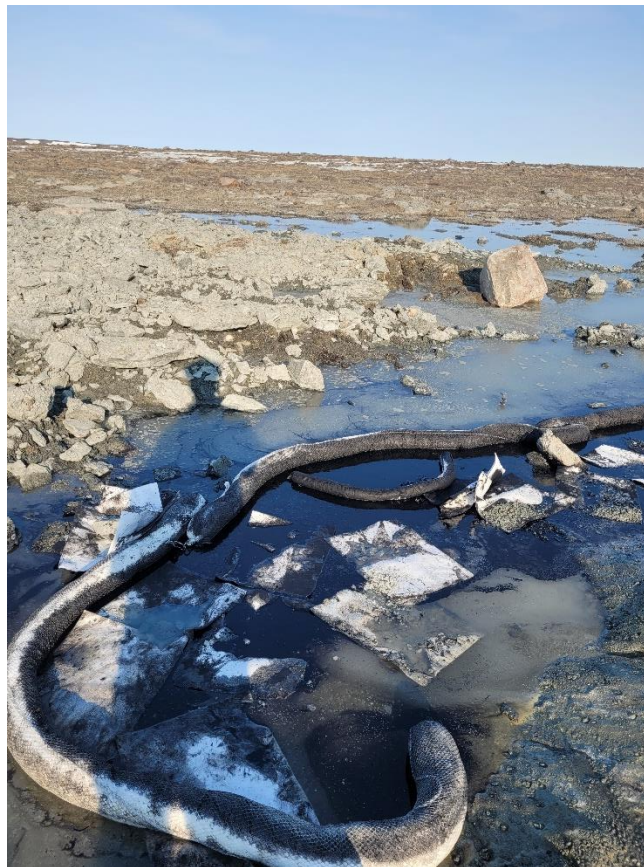
During a freshet inspection along the Whale Tail Haul Road a small spill was observed ~3m east of the road at KM173. Upon further investigation, a spill of ~20L of engine oil was found contained in a small depression on top of water and down the shoulder of the road.

Equipment failure on a long haul truck.

The incident was reviewed with all crews, serving as a reminder of the criticality of conducting equipment walkarounds to prevent avoidable damage or leaks. Furthermore, an investigation was conducted in collaboration with the maintenance department to scrutinize preventive maintenance practices, aiming to uncover any potential issues or gaps.

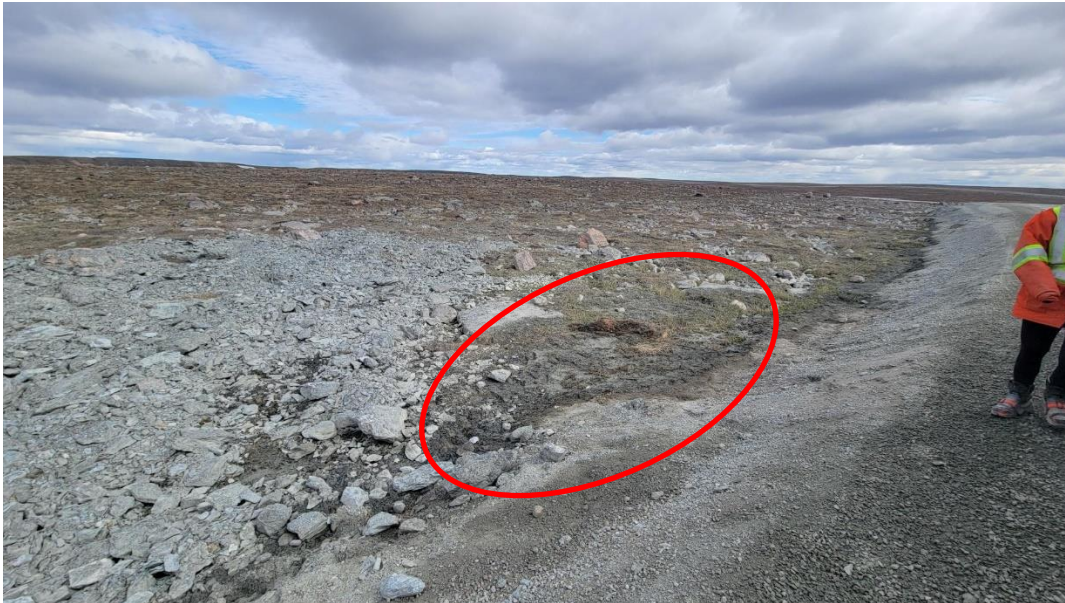
Spill containment booms and pads were used to contain and collect the spill. Oil was skimmed off the surface using a combination of a vacuum pump and shop vac. In total ~2m<sup>3</sup> of contaminated water was collected and ~2.5m<sup>3</sup> of contaminated soil was collected. All contaminated water and spill containment material was disposed of at the Whale Tail Hazmat area. All contaminated soil was brought to the Whale Tail Landfarm for treatment.

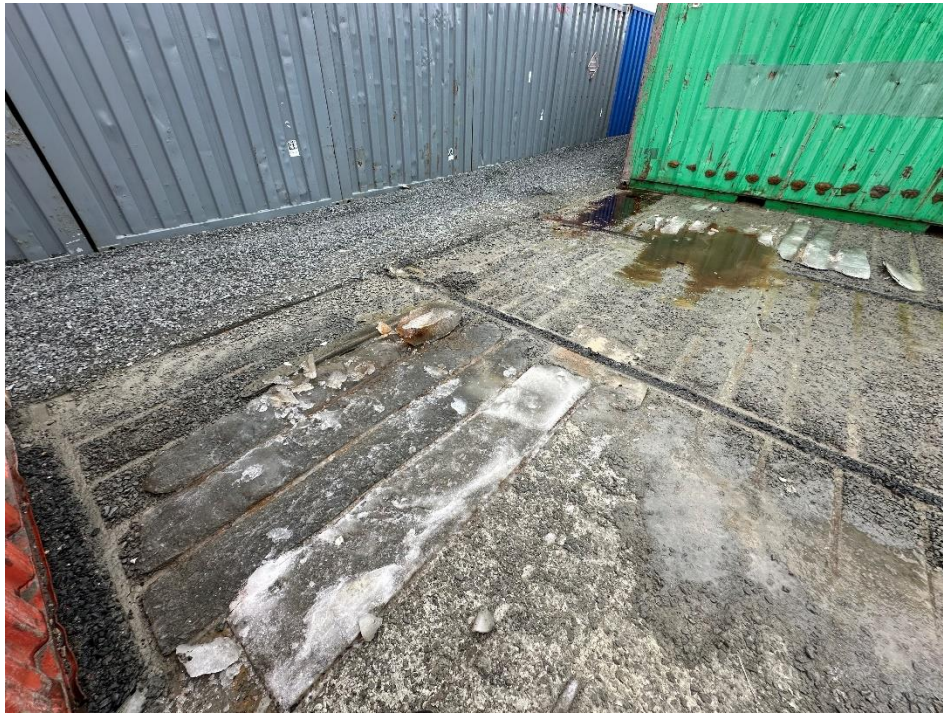
During the operations at the Whale Tail Mine, an unidentified substance was observed leaking from a sea can container on the warehouse pad. Upon further investigation, it was determined that the liquid originated from a sea can containing totes of MMATRIX-UW-450, an anti-washout admixture.

Upon completion of an investigation, it was determined that there is need to clarify the responsibilities between the owners of the product and the warehouse team. A tracking system is being implemented to improve collaboration between all departments and the warehouse to ensure products are identified, stored correctly, and inspected regularly based on the best practice for each product.

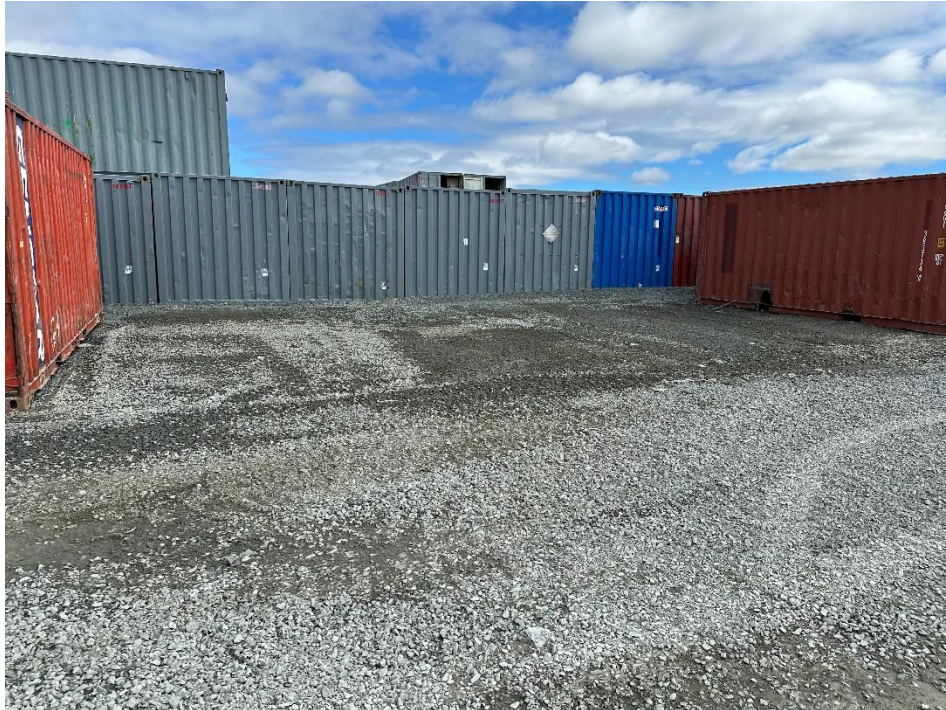
All nearby sea cans were relocated to allow a loader to scrape and remove the contaminated material. ~5m<sup>3</sup> of contaminated material was collected and be disposed of at the Meadowbank Tailings Storage Facility.

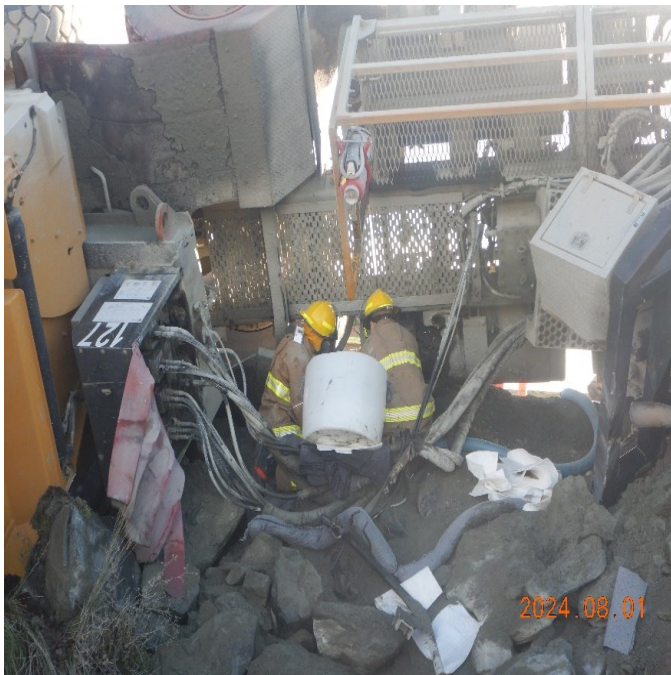
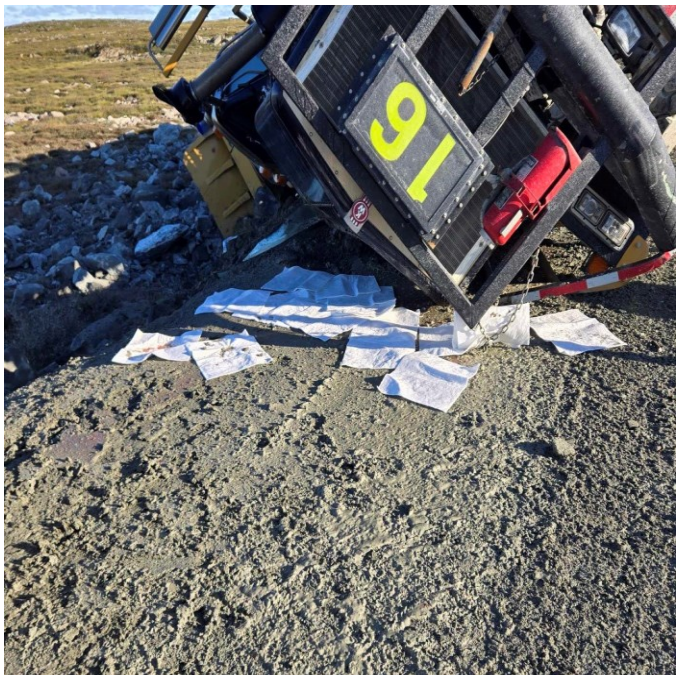
While heading southbound on Whale Tail Haul Road, a long-haul truck tipped over off the road at kilometer 124. A Code 1 was immediately initiated, and the emergency response team (ERT) was deployed. The ERT notified the environment department of a diesel fuel leak from the truck's fuel tanks. Secondary containment was placed under the leak, absorbent material was deployed on the contaminated surface, and a vacuum truck was brought in to collect the liquid. The spilled diesel fuel was contained within the road footprint. Following confirmatory discussion after the event it was determined that only 50L of diesel fuel and 20L of coolant leaked out of the equipment. At the time of the accident, it was calculated the long-haul would contain ~850L of fuel. Following the incident debrief it was discovered the vacuum truck collected a total of 800L of diesel fuel from the fuel tank.

Upon completion of an investigation, a review of operating procedures and best practices will be completed during safety meetings for all drivers. The dangers of distractions while driving will also be reviewed. LHT team will identify potential distractions for operators and address them to reduce or eliminate similar events from reoccurring.

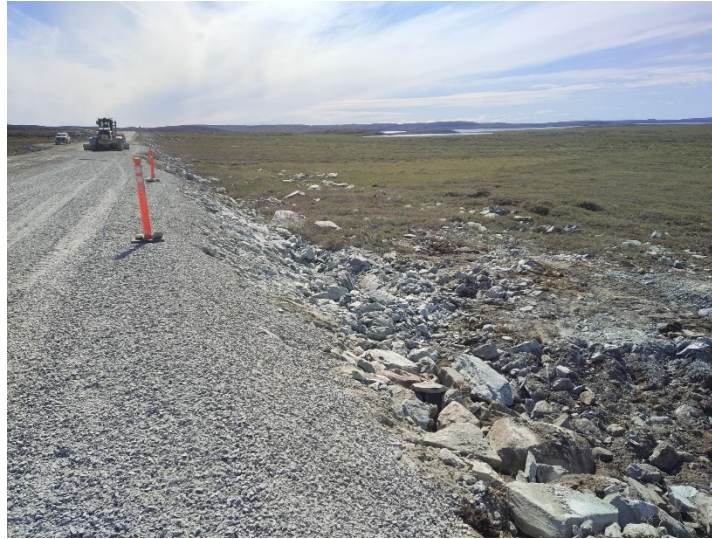
Following the retrieval of the equipment, material was collected and separated between the ore and the contaminated material. ~1m<sup>3</sup> of contaminated material was collected and brought to the Meadowbank landfarm. Absorbents were collected and brought to the Meadowbank hazmat storage area.

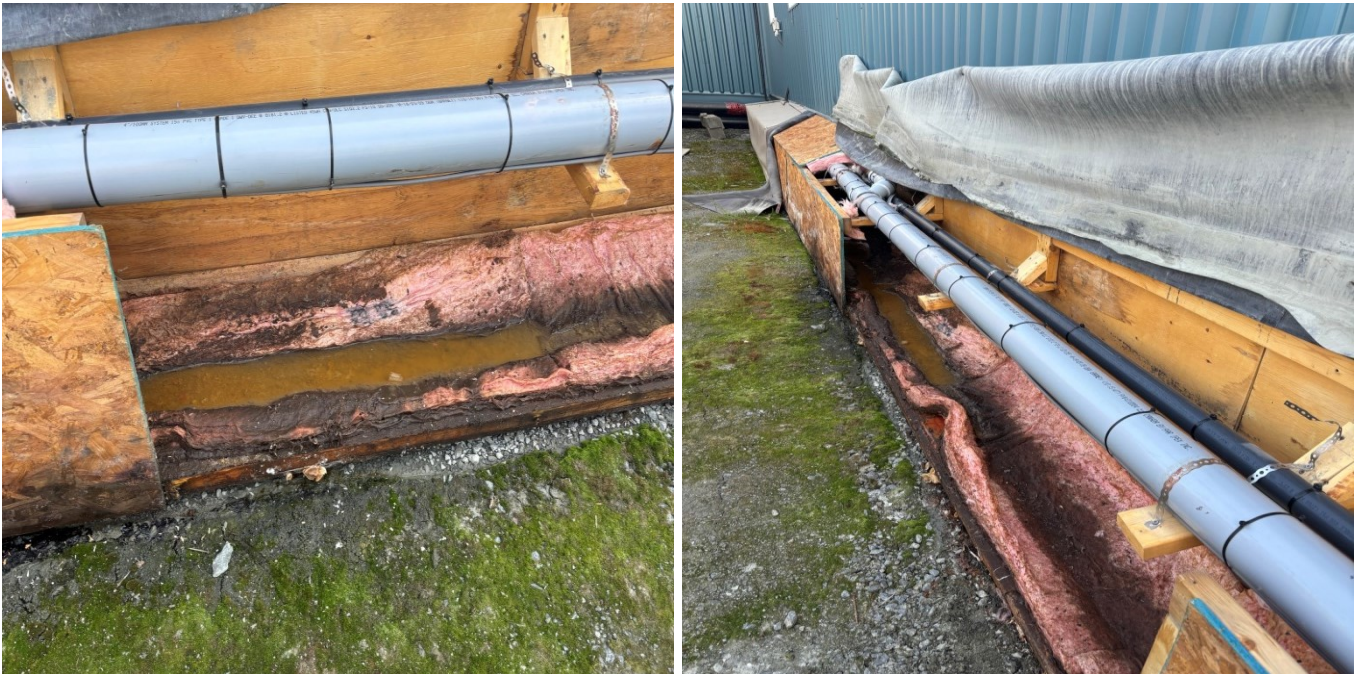
During a routine review inspection of the lift station between wings 15 & 16, an employee noticed sewage water had accumulated in the insulated piping box. Upon investigation the employee found that one of the pipe joints had failed causing a slow leak onto the pad between the wings.

Equipment Failure.

The joint was replaced with rigid PVC piping. A sewage line audit was completed which included an inspection of the sewage lines and joint connections.

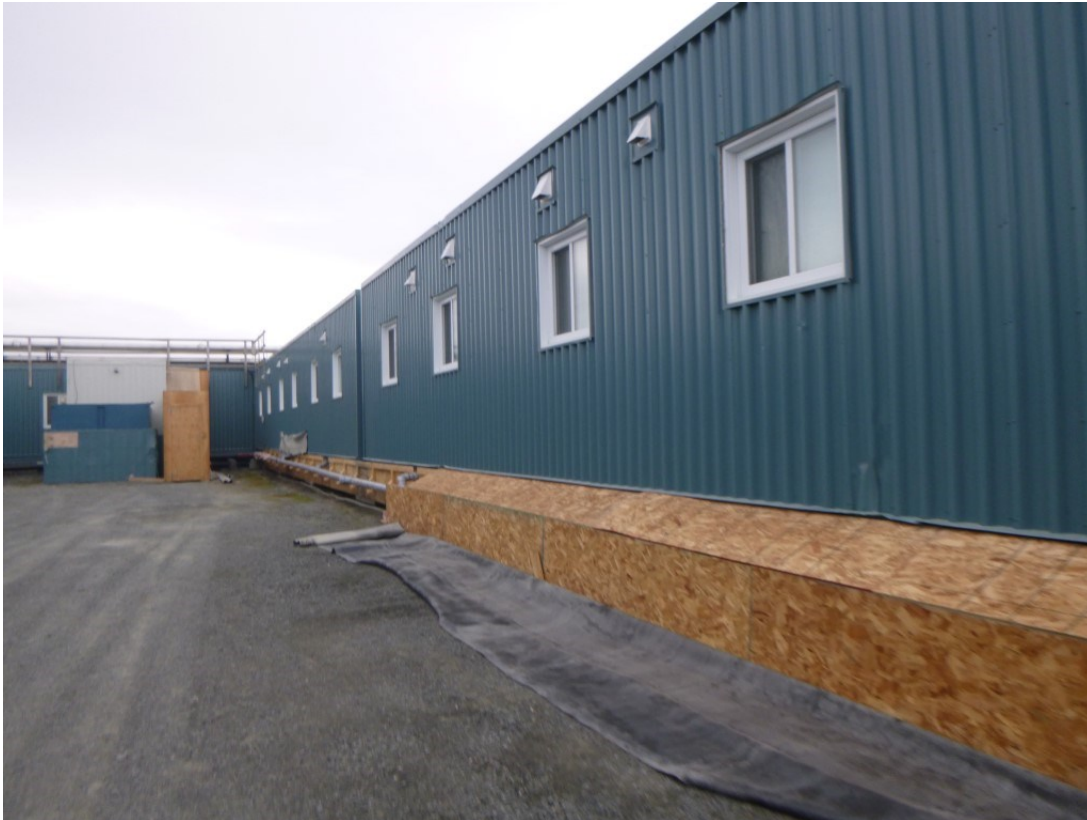
The contaminated material was collected with a sewage truck, scraped clean and disposed of at the Meadowbank tailings area.

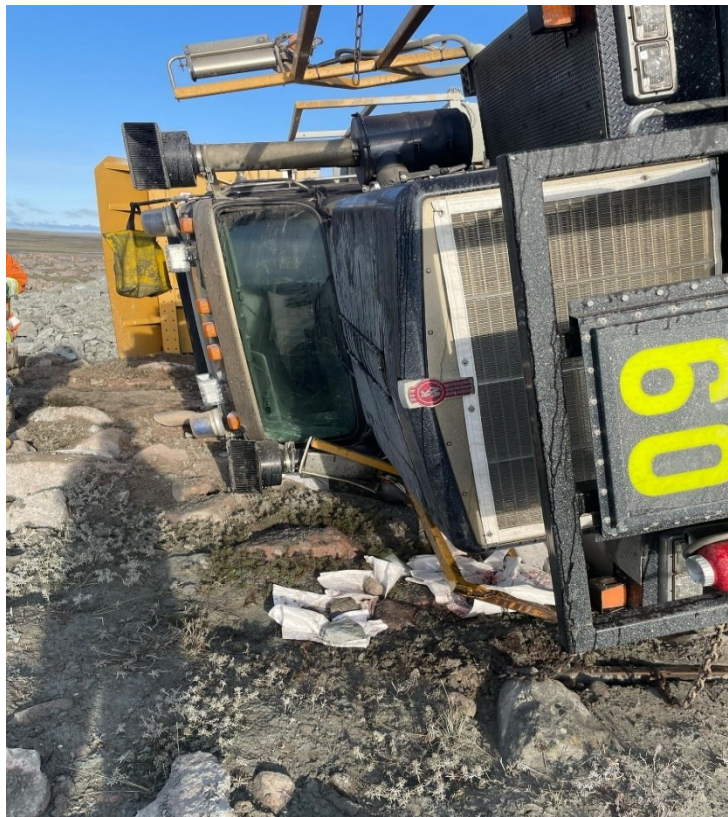
While heading southbound on Whale Tail Haul Road, a long-haul truck tipped over off the road at kilometer 166. A Code 1 was immediately initiated, and the emergency response team (ERT) was deployed. The ERT notified the environment department of a diesel fuel leak from the truck's fuel tanks as well as a hydraulic oil leak and coolant leak from the damaged equipment. Secondary containment was placed under the leak, absorbent material was deployed on the contaminated surface, and a vacuum truck was brought in to collect the liquid.

Upon completion of an investigation, a review of operating procedures and best practices will be completed during safety meetings for all drivers. The dangers of distractions while driving will also be reviewed. LHT team will identify potential distractions for operators and address them to reduce or eliminate similar events from reoccurring.

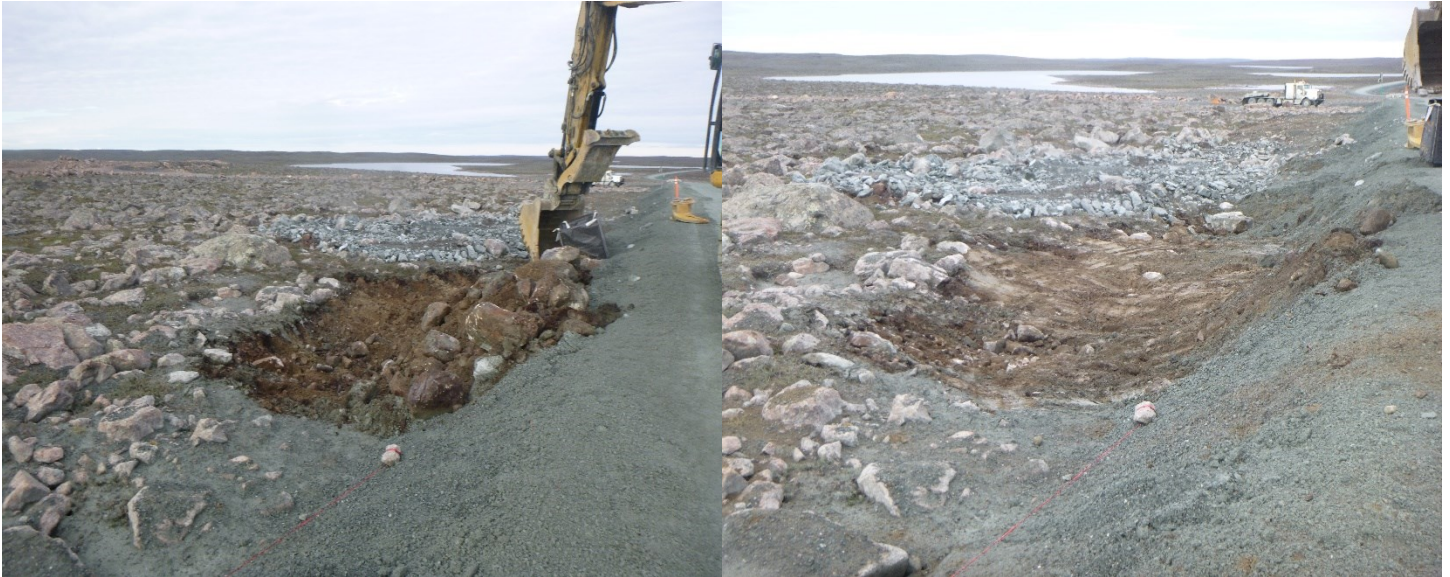
Following the retrieval of the equipment, approximately 20m<sup>3</sup> of contaminated material was collected and brought to the Whale Tail landfarm. Absorbents were collected and brought to the Whale Tail Hazmat storage area.

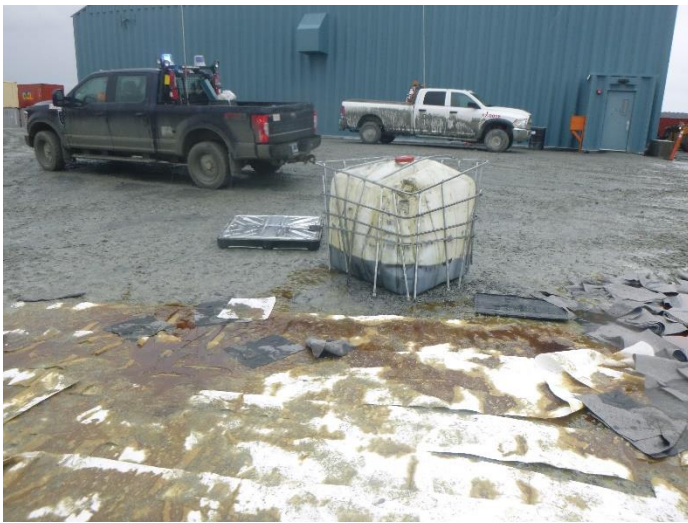
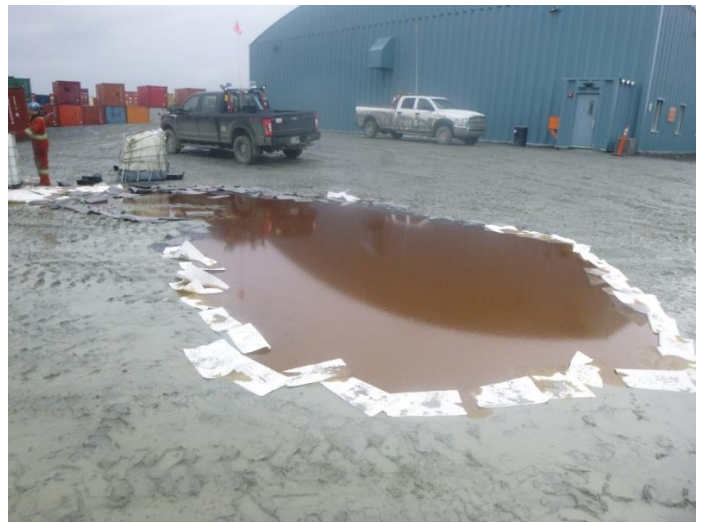
During operations at Whale Tail mine, the telehandler was removing an oil tote from the lube truck. When the operator made a change of direction, the oil tote frame separated from the base and fell to the ground. Upon impact, the oil cap on top of the tote came off causing oil to spill on the ground.

Equipment failure

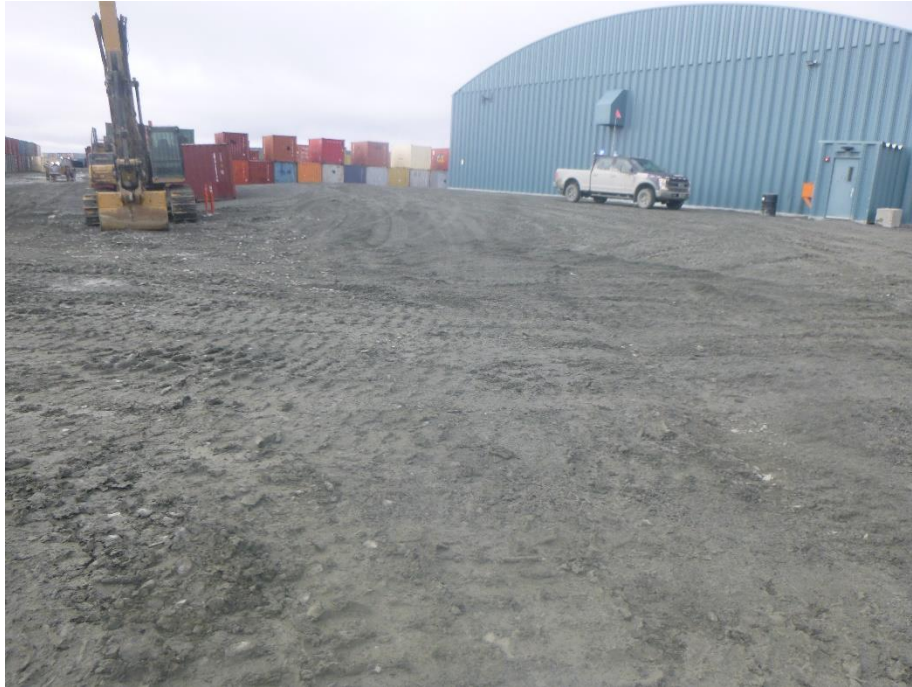
Spill pads were placed on the ground, and the pooled oil on the ground was pumped into another tote. The area was then scraped clean with an excavator and the contaminated material brought to the Whale Tail landfarm.

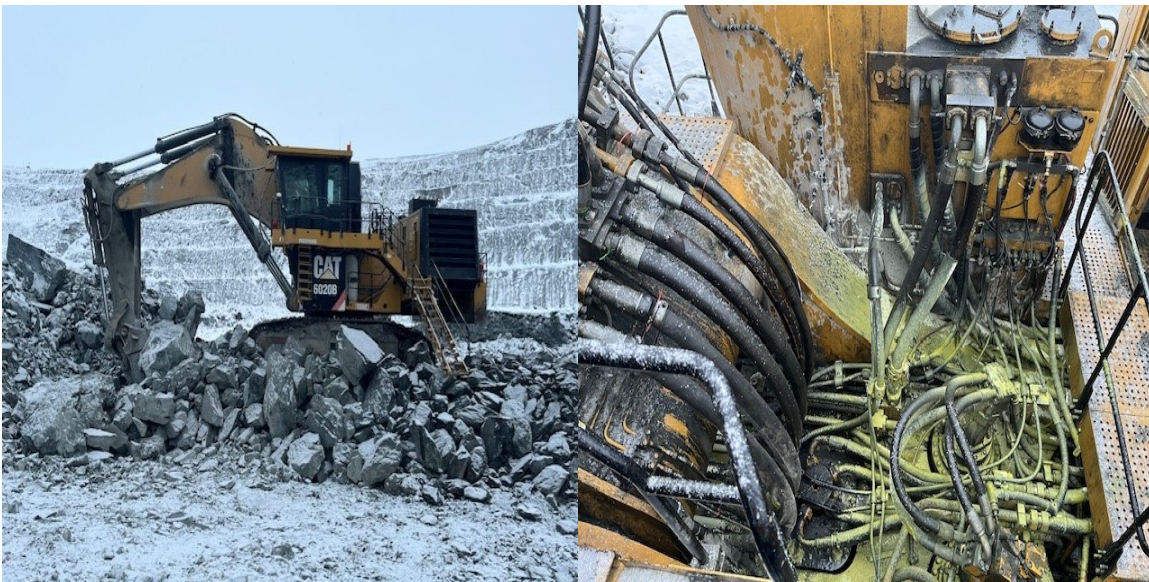
During the operations at the Whale Tail Mine, the excavator was performing work in Whale Tail Pit when it caught fire. This incident led to the spillage of hydraulic fluid onto the ore pattern. The spill occurred in an active mining area.

Upon investigation, a hydraulic hose failure causing an oil leak started a fire within the engine compartment.

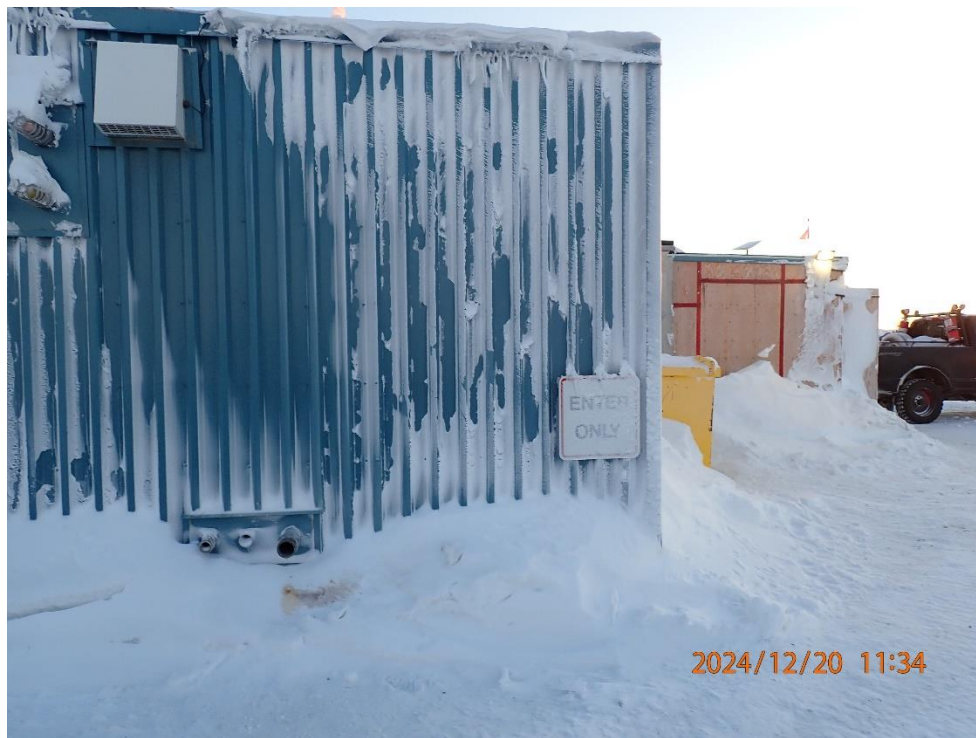
During the transfer of sewage between the emulsion facility offices and the sewage truck at the Whale Tail Mine, the operator disconnected the transfer pipe. The residual sewage in the outlet pipe leaked onto the ground under the connection.

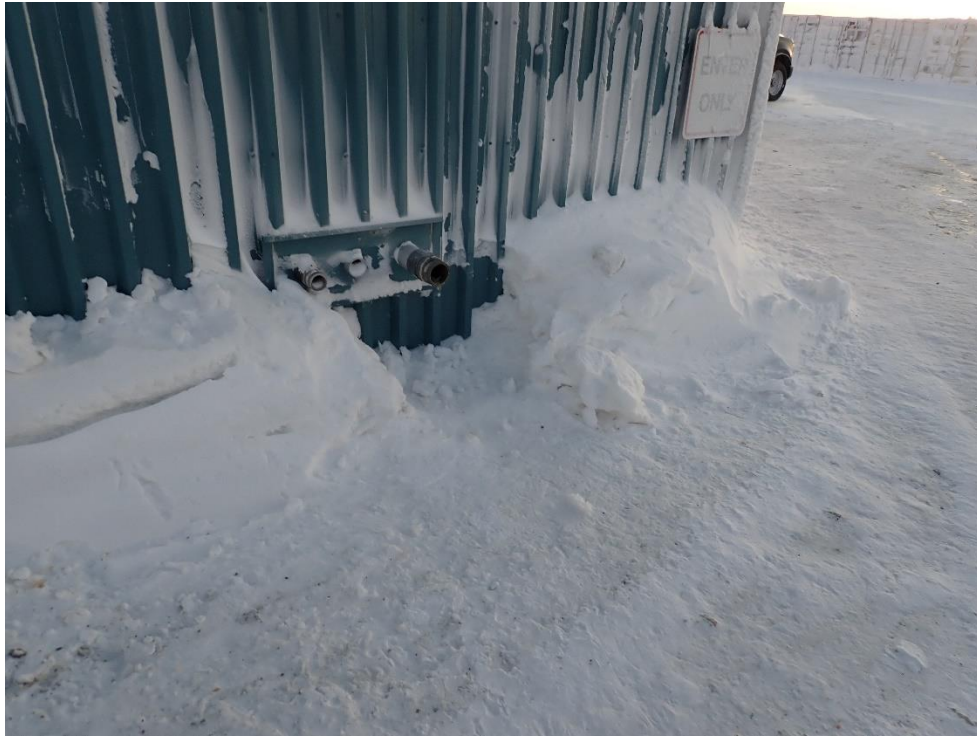
The contaminated snow and material was immediately collected and brought to the Whale Tail Landfarm.

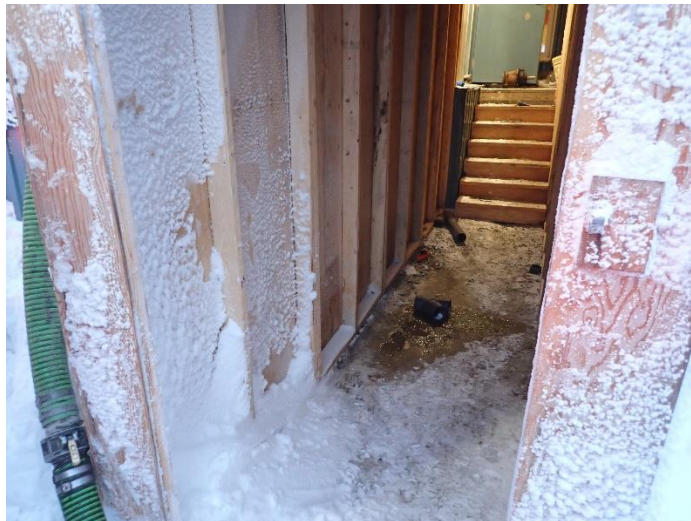
During the inspection of the camp lifting stations an employee found that the pump between the wing 15 and 16 had failed. As a result, the pump station being filled with contaminated water until it leaked out of the building. It was determined after investigation that approximately 35 liters of contaminated water had seeped through the building floor and made its way onto the ground.

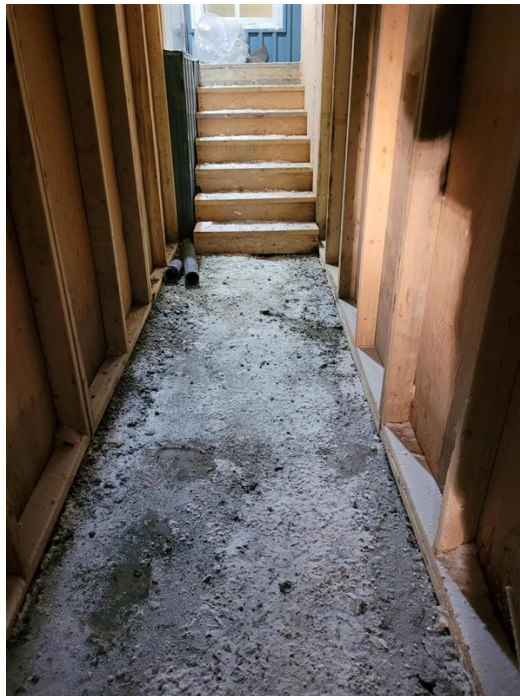
The contaminated snow and ice will be collected and brought to the Tailing Storage Facility at Meadowbank.
