Meadowbank 2024 Annual Open Pit Geomechanical Inspection

February 13, 2025

**RE: Meadowbank Complex - Meadowbank Site - 2024 Annual Open Pit
Geomechanical Inspection**

Meadowbank Complex - Meadowbank Site - 2024 Annual Open Pit Geomechanical Inspection

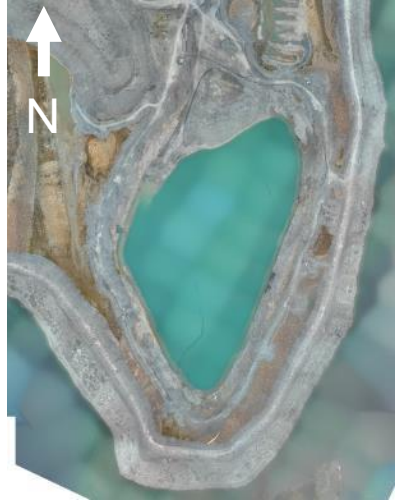
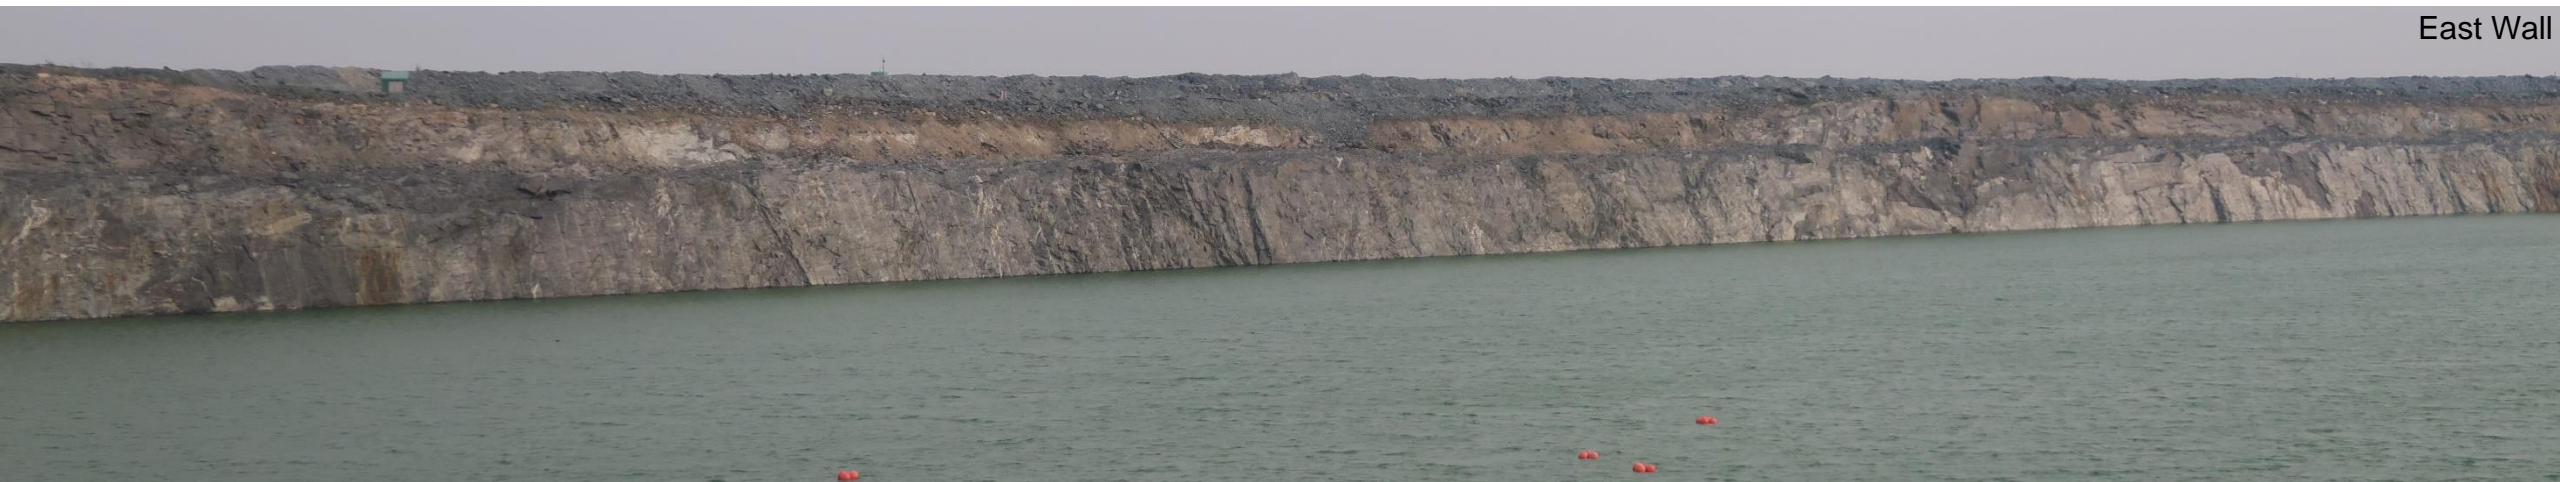
East Wall

- A portion of the upper bench is exposed above the current pit lake.
- The walls are performing well and no particular geomechanical concerns were noted.
- The exposed bench faces along the ramp at the northern end of the pit are relatively low and there is ample room to transit and work away from the wall. As a result, the rockfall risk is considered to be low.
- A barricade is no longer present at the top of the ramp. However, a restricted access sign has been installed.

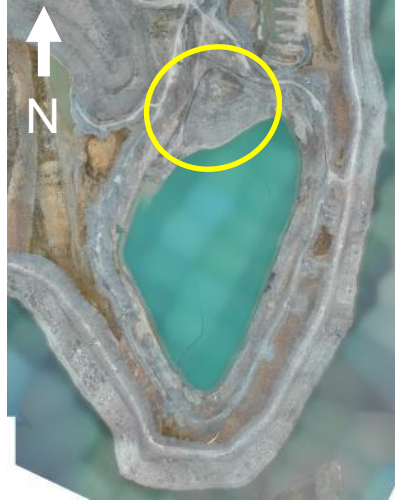
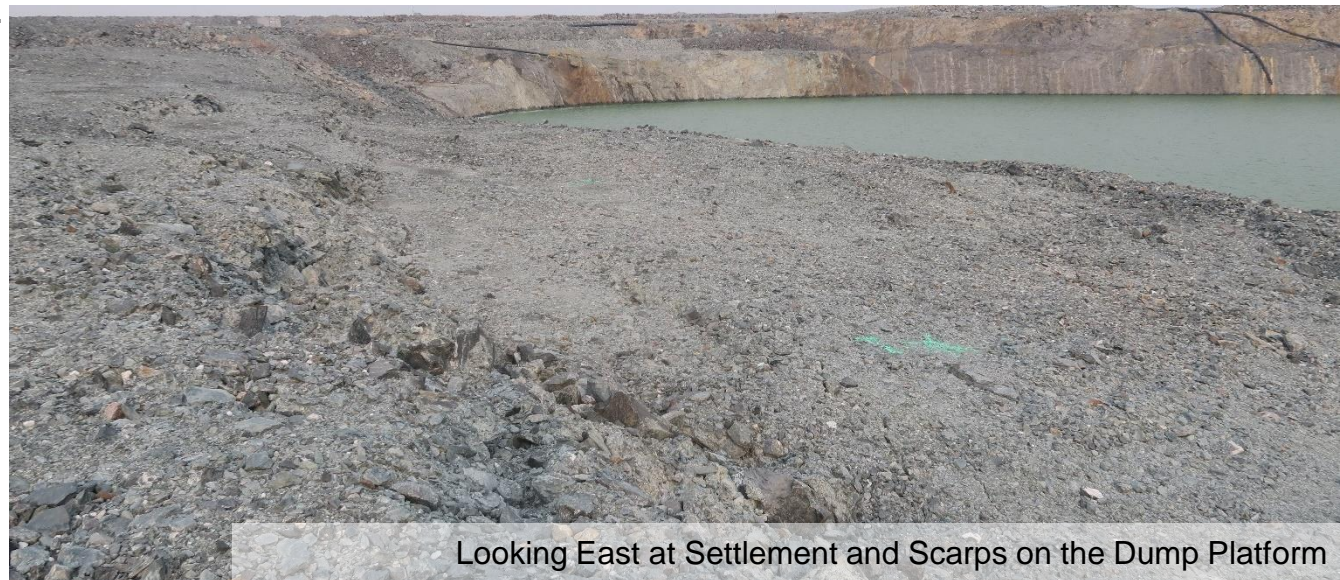
- The dump is inactive, and access is prevented by both a rockfill berm and the presence of water pipes across the access point.
- The dump has been subsiding since 2015. The settlement is attributed to the deposition of water in the open pit, through a combination of thawing and increasing porewater pressure. The concern is that a sudden failure of the dump could create a wave that poses a hazard to personnel conducting water quality or tailings sampling in the pit lake.

- The settlement has resulted in a series of scarps along the dump platform, that are now 2 to 3 metres in height (see photo below).
- The settlement is monitored as part of monthly inspections by the Geotechnical Group visually and using four survey pins installed in 2022. The observed deformation is discussed further on the following slide.

- Personnel are accessing the pit lake more often this summer due to Environmental monitoring and closure-related work. As a result, there is increased exposure of personnel to a dump failure.

Looking East at Settlement and Scarps on the Dump Platform

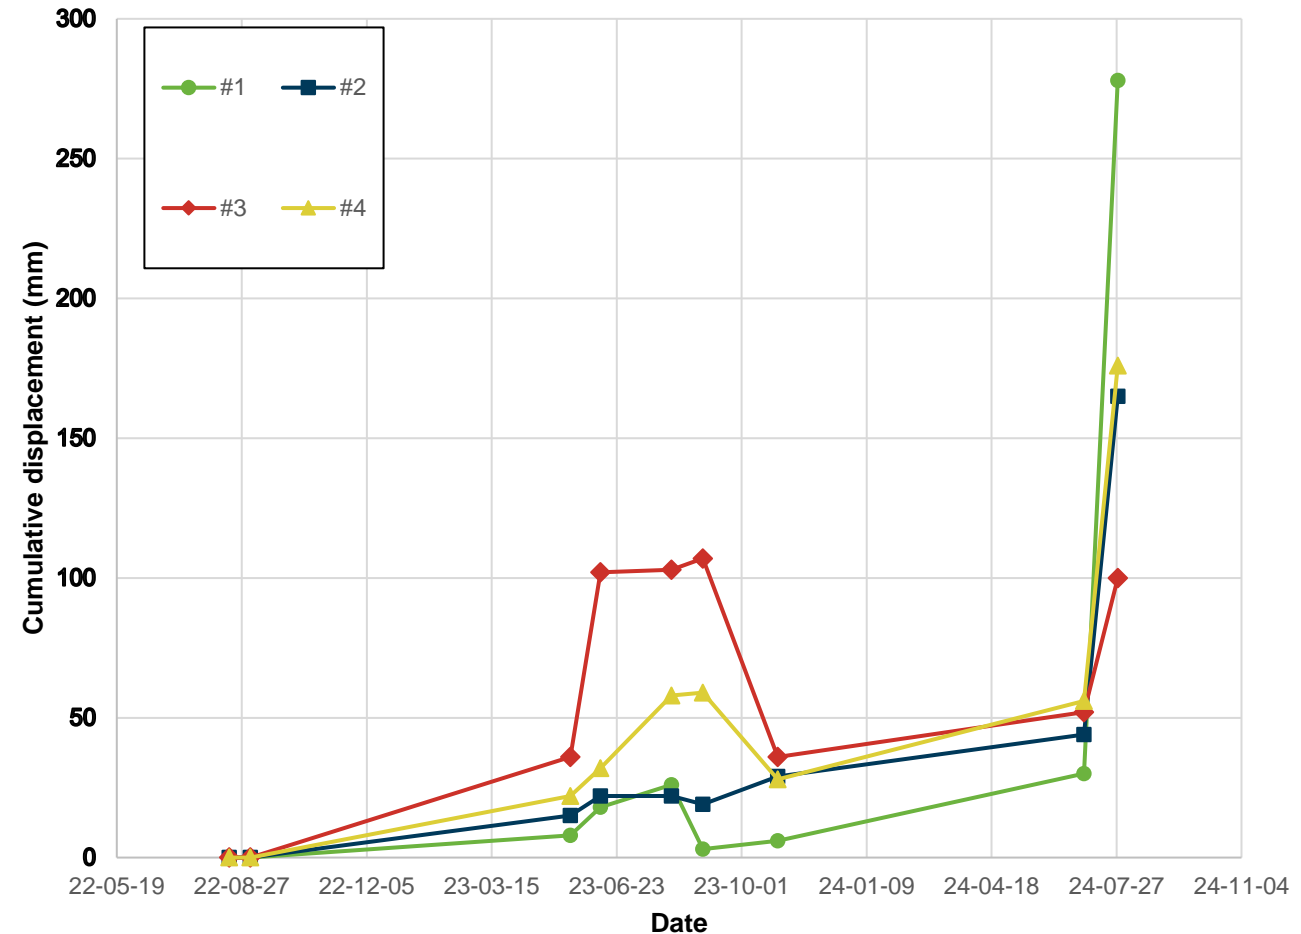
- The cause of the sudden increase in displacement has not been determined but is believed to be due to the increasing water elevation in the pit lake as well as the warmer summer temperatures. Together these factors would promote thawing of the dump, and the increasing water level would increase the pore water pressure in the submerged portion of the dump. During the annual inspection, additional readings were taken to confirm the readings.

- The observed deformation is within TARP Blue (Stable) status. However, such a sudden change in behaviour should trigger a review. The frequency of the visual inspections and survey pin readings should be increased (e.g., to weekly monitoring) while access is still required to the open pit.

- There is a need to better quantify the extents and total deformation. Recommend using drone photogrammetry to assess this on a semi-annual basis.

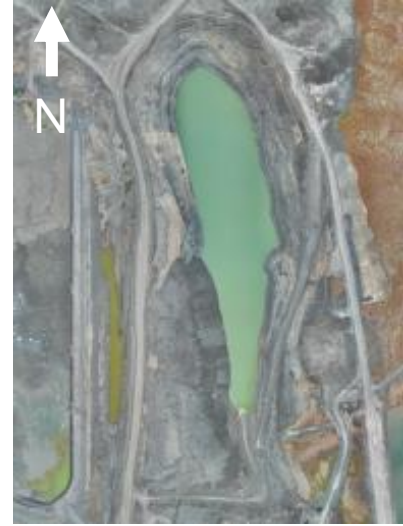
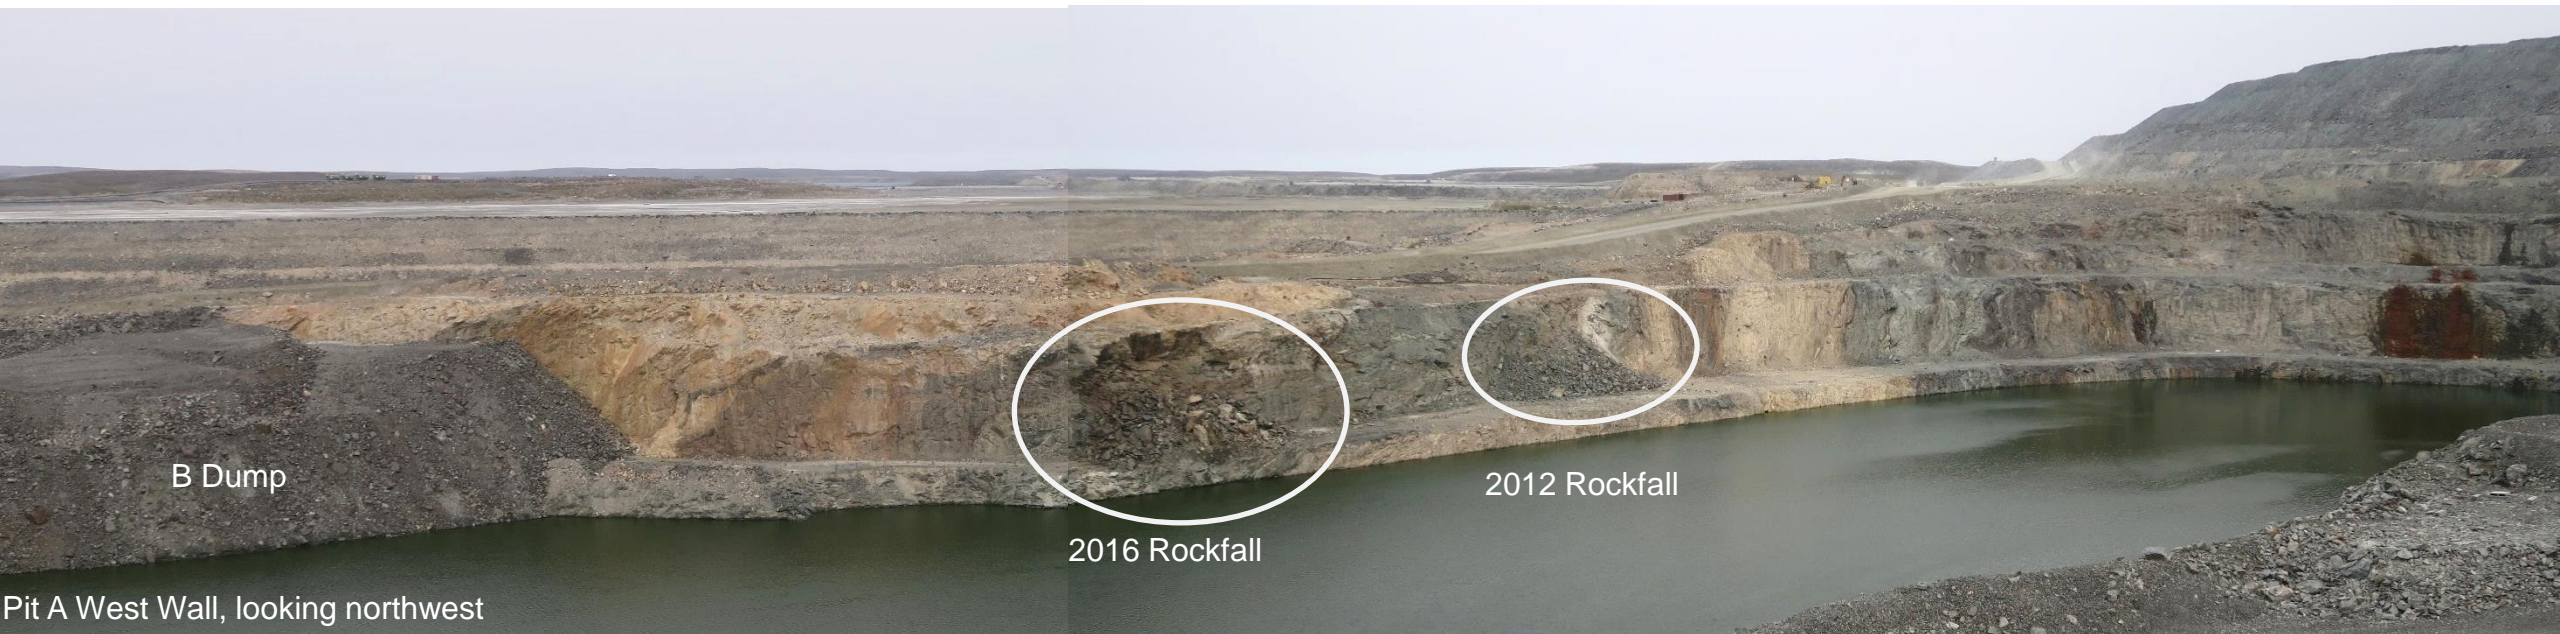
- Approximately one bench is exposed above the pit lake.
- No significant change was observed in the pre-existing bench-scale failures remaining above the pit lake since the 2022 inspection.
- Access to the East Ramp is restricted by berms at the top and bottom of the ramp (not shown in photo below).
- No particular geomechanical concerns were noted.

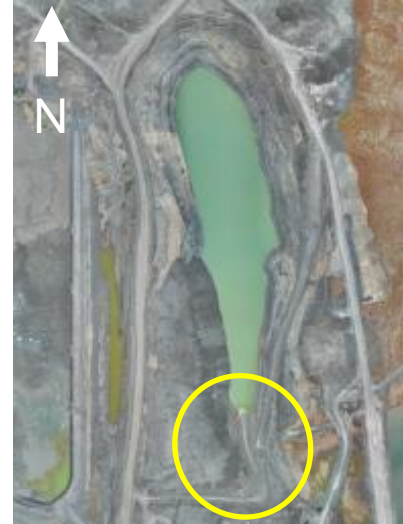
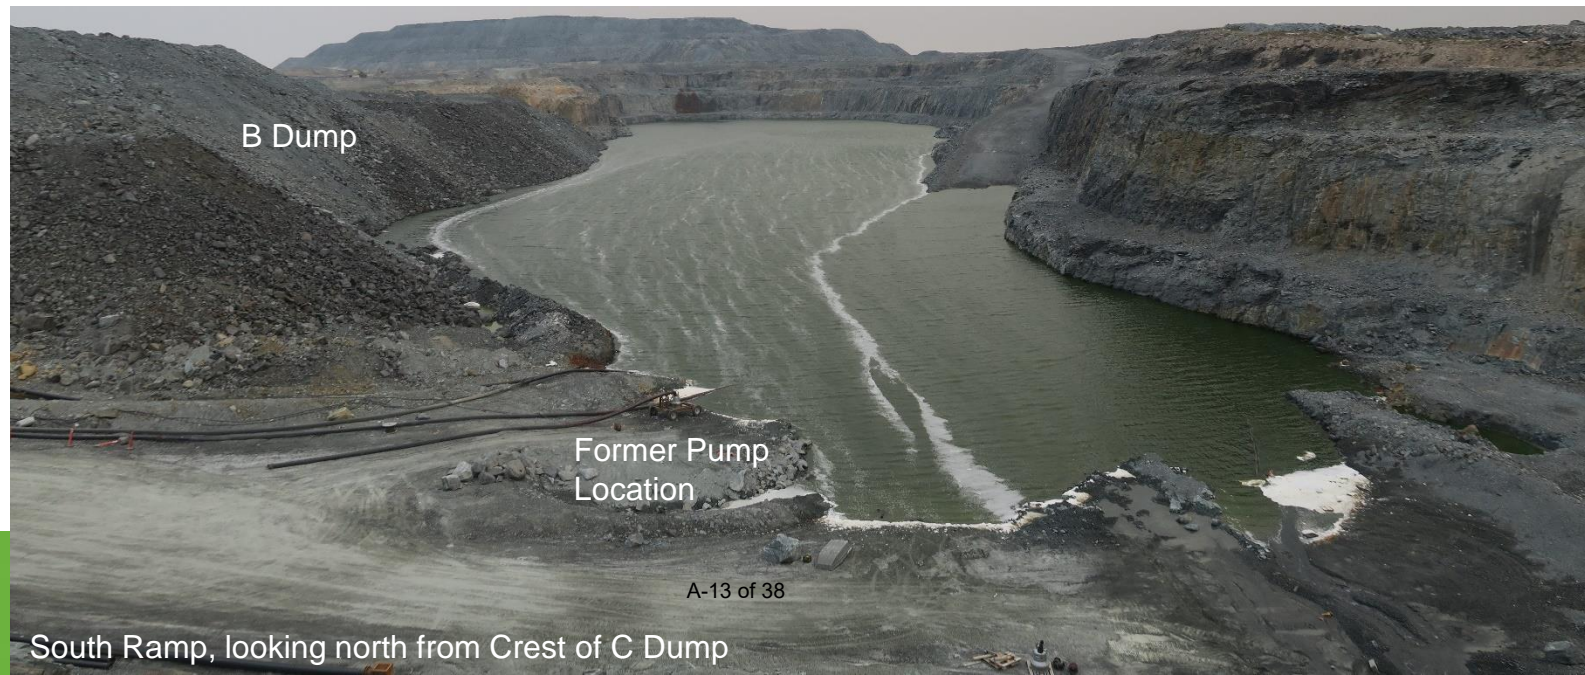
- The South Ramp is used to access the pit lake. Water management infrastructure is normally present along the ramp but had been partially removed at the time of the inspection so that it could be moved further up the ramp.
- Access to the ramp was unrestricted and unsigned at the time of the inspection. Warning signs and/or a removable barrier (e.g., pylons) should be installed at the top of the ramp.
- It is understood that the pump controls will be located up the ramp and around the corner from the pit lake. This will help mitigate the risk associated with a wave caused by a failure of the open pit slope or the dump.

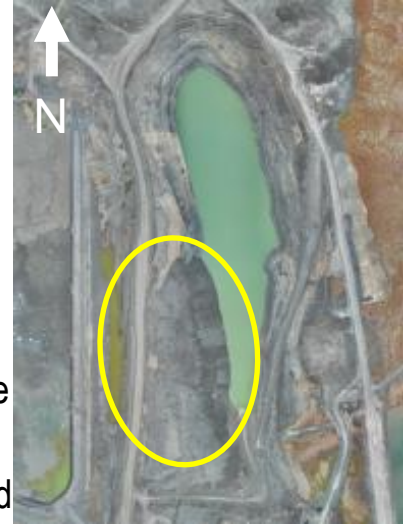
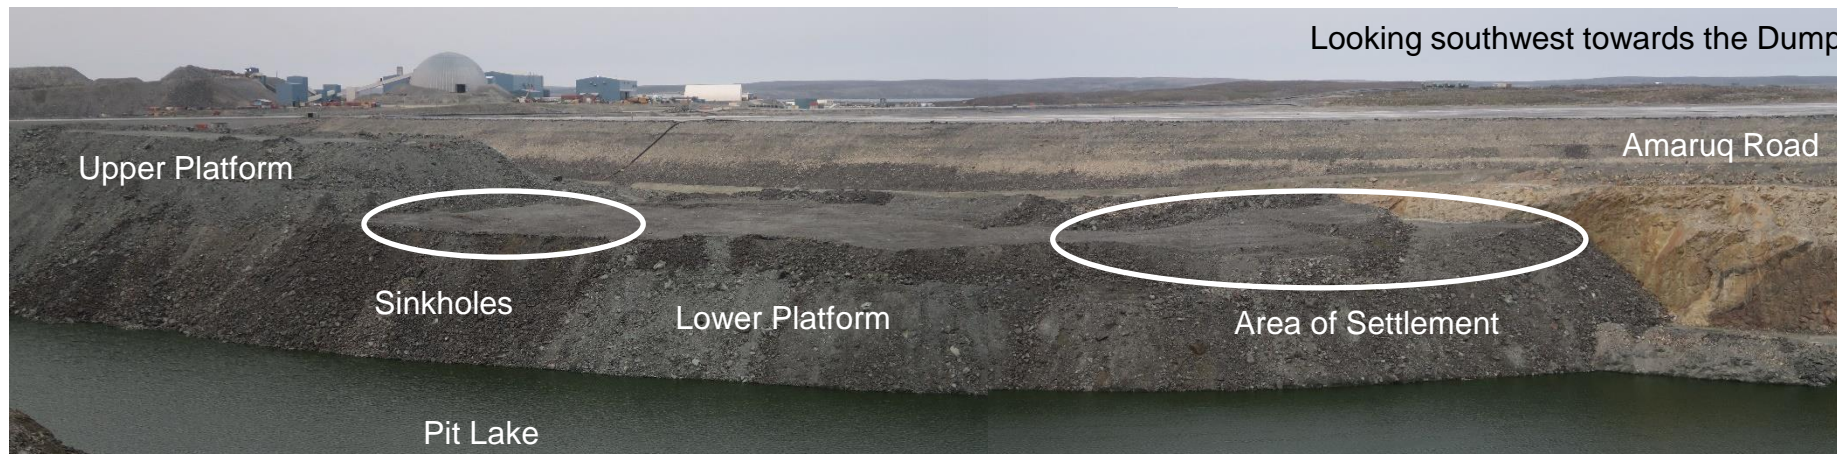
- The B Dump consists of an Upper and Lower Platform, both of which are inactive. Access to both platforms is prevented by berms.
- Failures of the dump slope are possible as the pit lake elevation rises but have not been observed to date. Such a failure could cause a large wave in the pit lake that poses a hazard to personnel conducting water sampling or managing the reclaim water lines.

- Tension cracks and subsidence continue to be observed on both platforms. The northern end of the Lower Platform has experienced the most subsidence. Sinkholes have also formed at the southern end of the Lower Platform. These are discussed on the following slides.

- An extensometer has been installed on the Lower Platform and this is described further on a following slide.
- The possibility of the settlement progressing back to the Amaruq Road was discussed in 2022 and concluded to be unlikely as the settlement and tension cracks appear to be limited to within the footprint of the pit. WSP was retained to complete a detailed assessment. The results are expected later this year and should be reviewed when they become available.

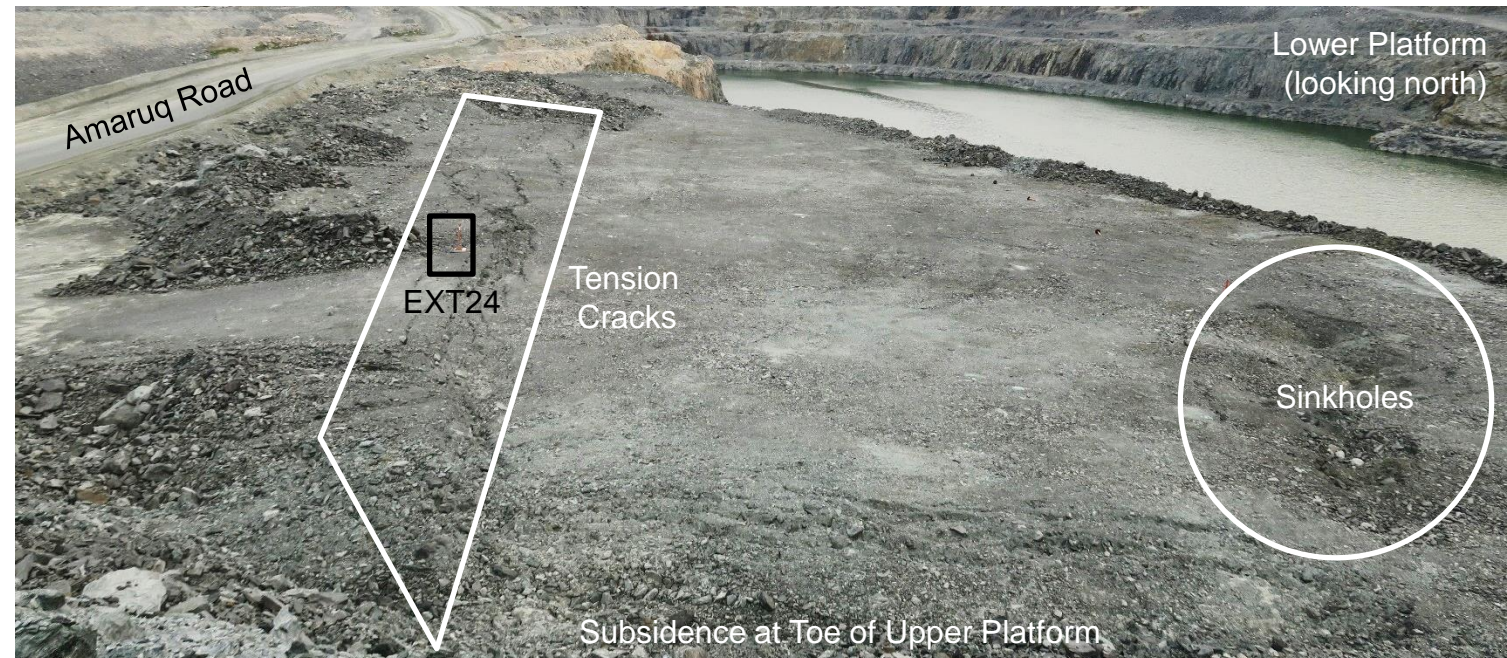
- Tension cracks are present along the western limit of the dump (outlined in white below). The cracks are believed to be located above the crest of the East Ramp of the open pit. The tension cracks and associated settlement have progressed since the 2023 inspection and several fresh cracks were noted.

- The interpretation of the tension cracks (i.e., whether they indicate deep-seated movement of the dump or simply differential settlement across the position of the bench/ramp below the dump) relies on their position relative to the underlying pit ramp. Recommend surveying the cracks and confirming their position relative to the geometry of the pit slope below the dump.

- An extensometer (EXT 24) was installed in 2022 and readings have been taken approximately monthly. The cumulative displacement has increased from approx. 260 to 350 mm over the last year and the displacement rate has been less than 1 mm/day. This is within TARP Blue (Stable) status.

- There has been limited change in the sinkholes and subsidence at the toe of the Upper Platform since the 2022 and 2023 inspections.
- Recommend continuing to monitor the settlement and tension cracks on the dump.

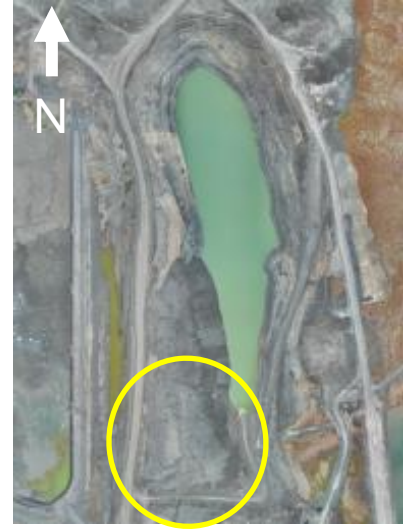
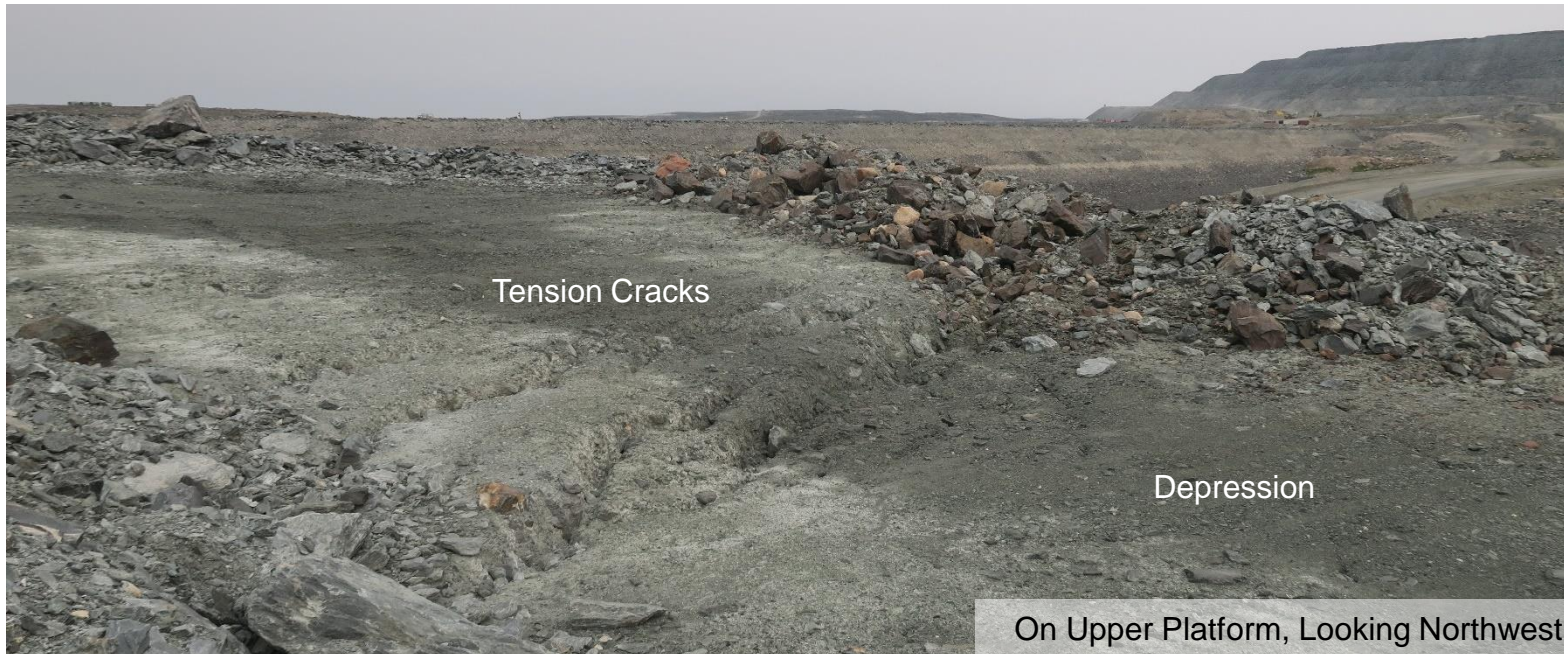
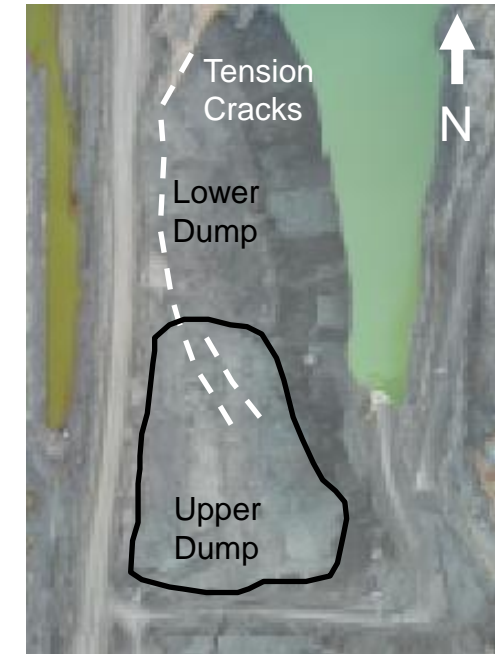
- The NW-SE tension cracks at the northern end of the Upper Platform have continued to develop since the 2023 inspection.
- The orientation of the cracks suggest that they are also linked to the geometry of the underlying pit slope. The position of the cracks should be surveyed and confirmed relative to the pit geometry.

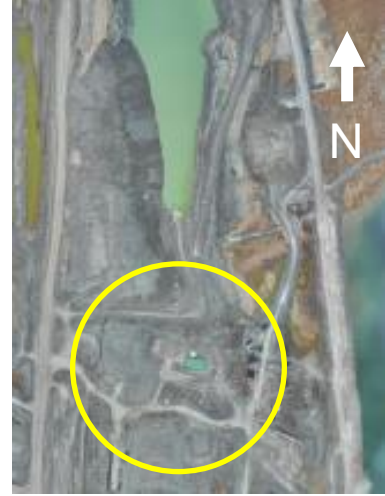
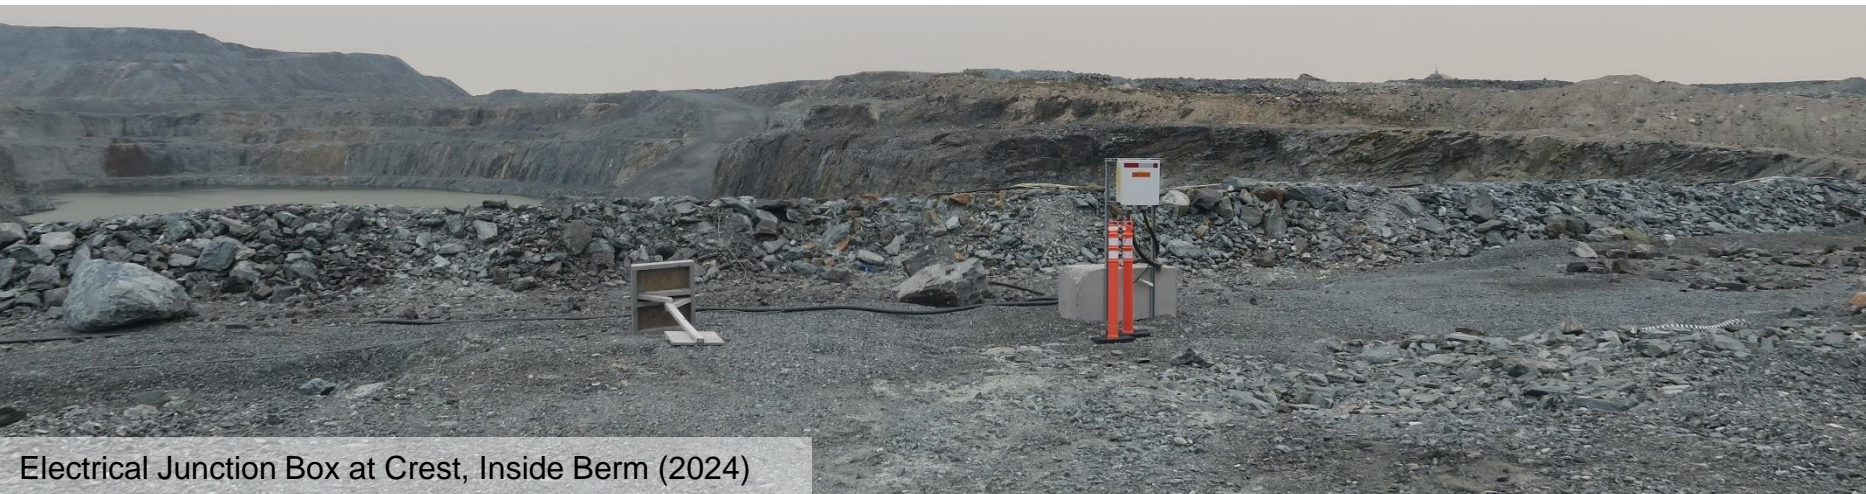
- Settlement of the dump is possible as the water elevation in Pit A and the water/tailings elevation in Pit E reach and surpass the base of the dump (approximately 5085 mRL). The current water elevations in Pit A (5103.6 mRL) and Pit E (5102 mRL) have risen above the base of the dump and it is believed that water is now flowing from Pit A to Pit E below the dump. However, no evidence of settlement or instability has been observed to date.

- As no evidence of instability has been observed, and settlement is likely to be gradual, the ongoing use of the dump as a laydown is considered acceptable.

Electrical Junction Box at Crest, Inside Berm (2024)

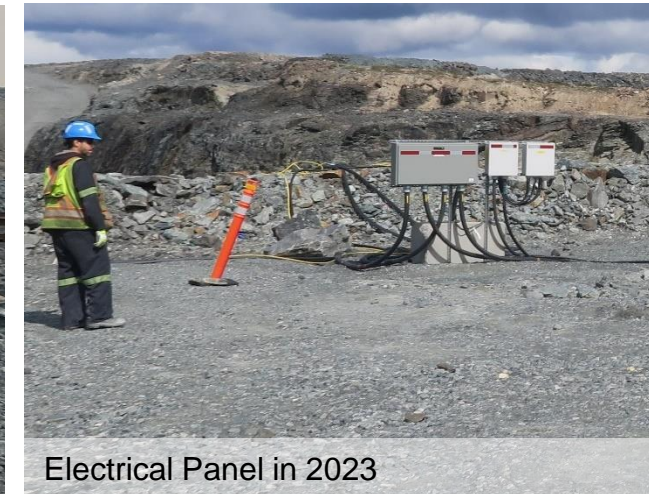
Electrical Panel in 2023

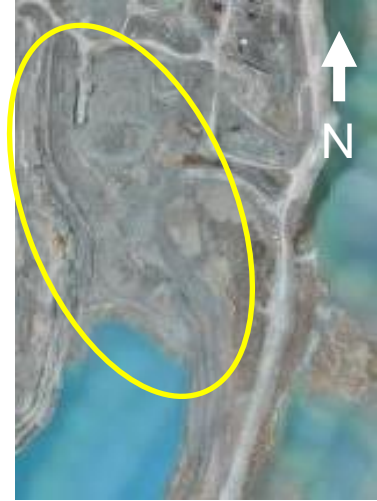
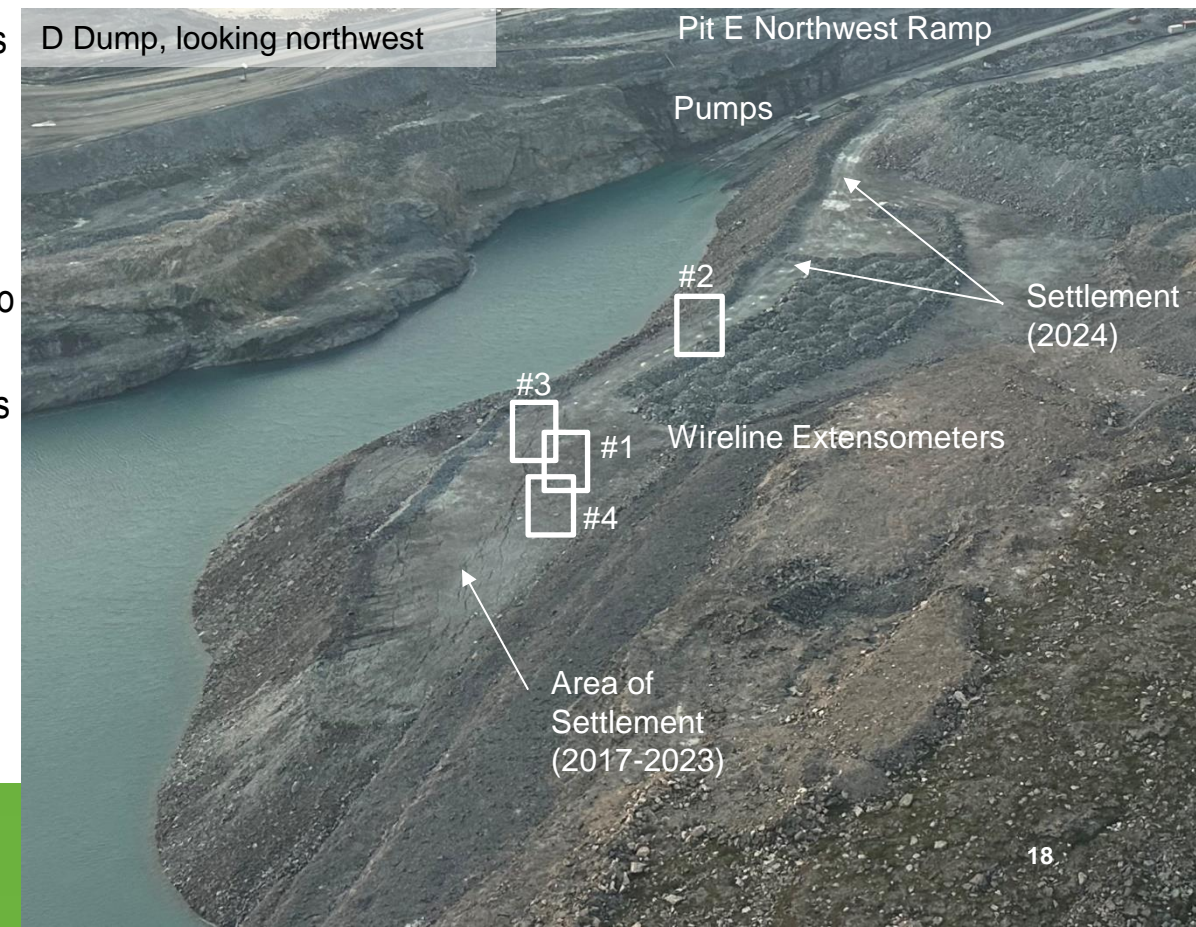
- The southwestern end of the dump started to settle in 2017 and is attributed to the deposition of water in the open pit. Tension cracks are visible in this area.

- The settlement and tension cracks have migrated progressively to the north as the elevation of the pit lake rises, and water migrates beneath the dump.

- The greatest change in the stability of the dump has been observed since the last annual inspection, with evidence of settlement progressing more than a hundred metres to the north.

- The four wirelines, extensometers installed at the crest of the dump continue to be monitored and are discussed on a following slide.
- The dewatering pumps for Pit E are located at the toe of the dump. The pumps have moved a significant distance up the ramp since the 2023 annual inspection. This has reduced the exposure of personnel to rockfall hazards along the ramp as well as any rockfall or instability of the D Dump.

- There is a regular presence of personnel at the pumps and infrequent access to the pit lake during the summer months for monthly water quality sampling.

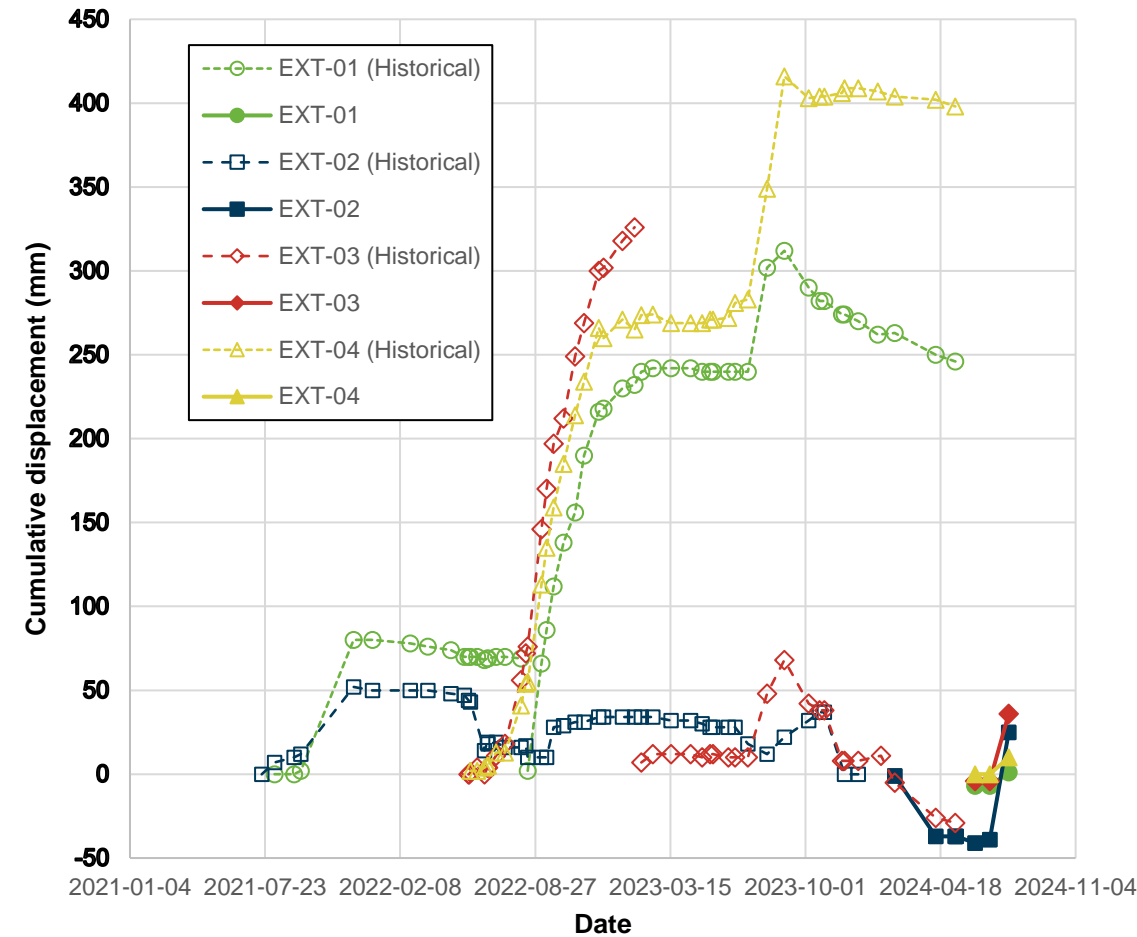
- The Geotechnical Group commit to monitoring the extensometers on a monthly basis.
- As the tensions cracks have progressed behind the extensometers, they have been repeatedly moved, resetting the data. The data are shown at right.

- A potential seasonal trend is observed in the data, with an increase in displacement over the summer months. The displacement rate varies between approximately 3 mm/day to less than 1 mm/day. This is within TARP Blue (Stable) status.

- The spatial extents of the settlement exceed what can be practically monitored with four extensometers and the need to repeatedly move the instruments limits the ability of the mine to assess long term trends. Recommend using drone photogrammetry to better understand the spatial distribution of the deformation. The use of the extensometers could be limited to areas with increased exposure (e.g., above the pumps on the Pit E Northwest Ramp).

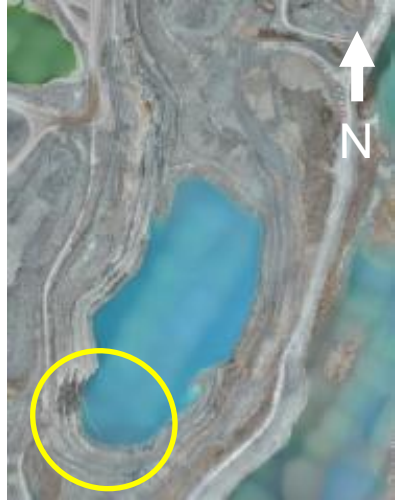
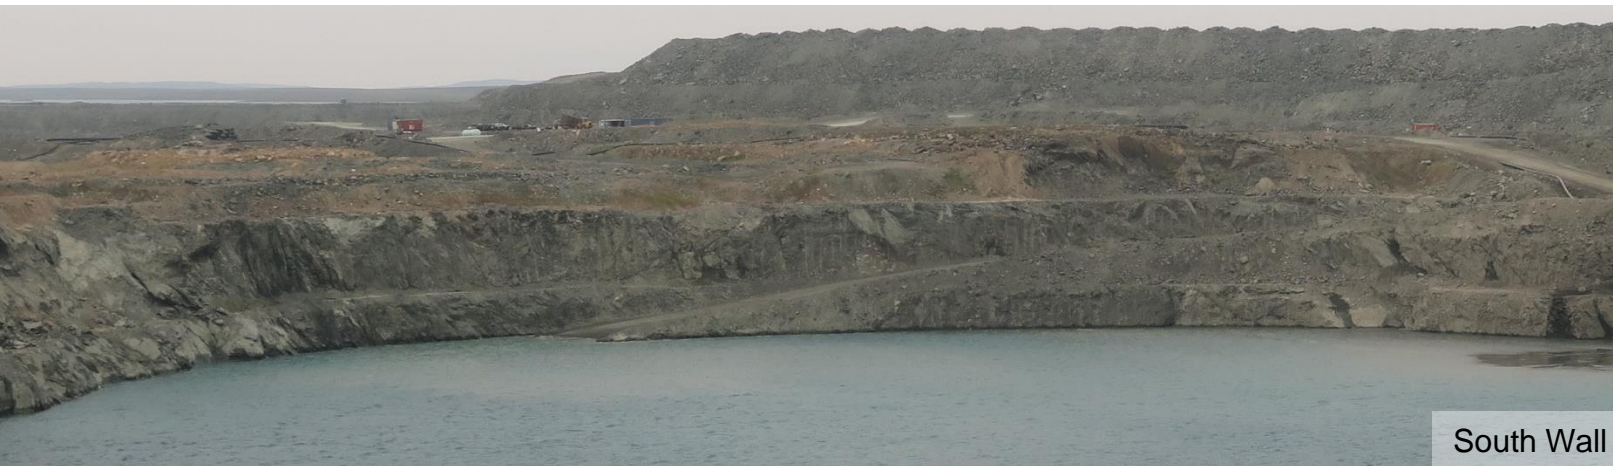
South Wall

- Approximately one and a half benches are exposed above the pit lake.
- The wall is performing well and no particular geomechanical concerns were noted.
- No significant change in the historical bench-scale instabilities along the south wall were observed.
- The ramp along the south wall was previously closed with a berm. At the time of the annual inspection, the berm had been partially removed and the ramp used to install a vibrating wire piezometer in the pit lake. The berm should be replaced.
- The vibrating wire piezometer cable run along the ramp (in yellow, below right) is located close to the pit wall. Rockfall is present on the ramp in this area. The cable should be relocated away from the pit wall (e.g., to the berm on the outside of the ramp).
- The ramp at the north end of the open pit is described on a following slide.

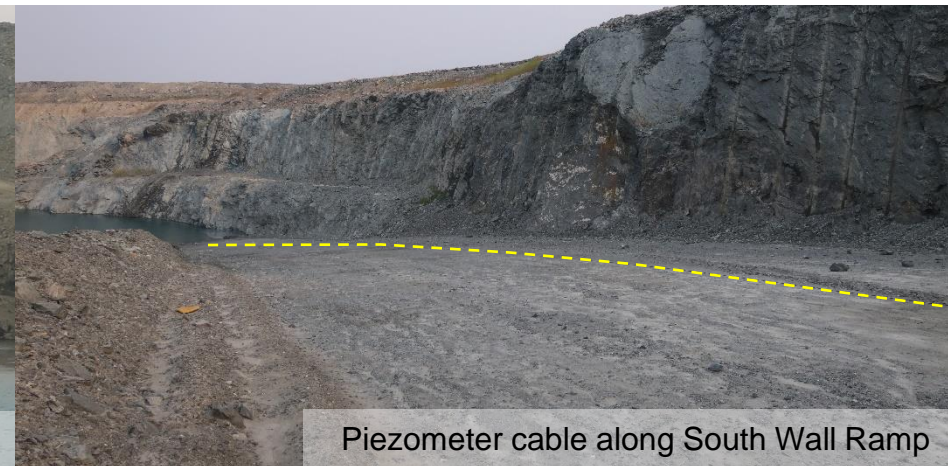
-	-	-	A vibrating wire piezometer has been installed at the base of the South Ramp. The cable for the piezometer runs along the ramp, within 5 m of the bench face. There are numerous active rockfall hazards along this ramp and a rockfall berm has not been established.	Re-locate the cable for the vibrating wire piezometer away from the wall. Alternatively, establish a rockfall berm along the inside of the ramp.	P3

Piezometer cable along South Wall Ramp

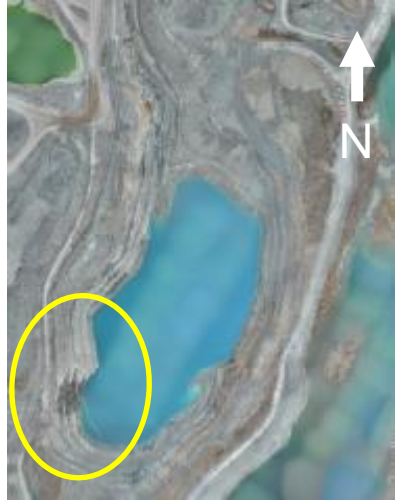
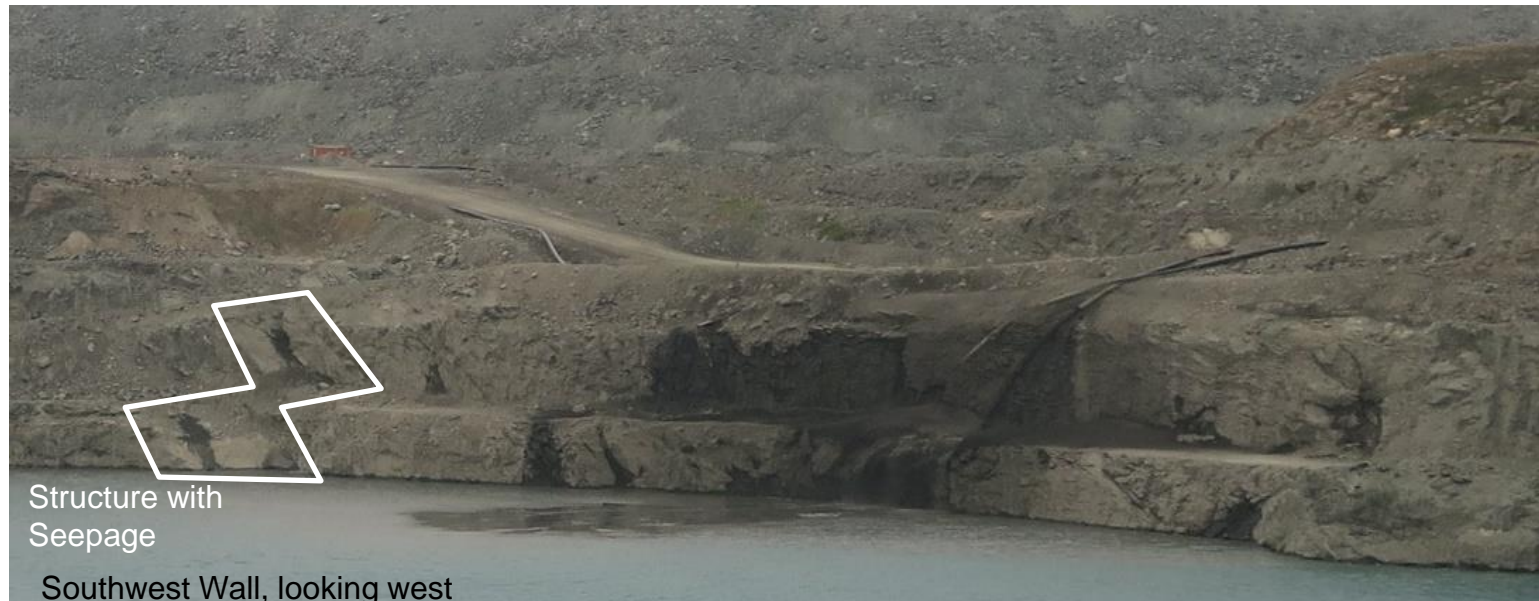
Southwest Wall, looking west

- Approximately one and a half benches in the Ultramafics are exposed above the pit lake. The wall is within talik.
- Tailings are discharged from a line at the crest of this wall. There have been concerns about the potential for erosion of the benches or slope instability due to water infiltration. Limited erosion (crest loss) of the bench directly below the discharge point has been observed, but no evidence of slope instability has been observed. The wall is performing well.
- Seepage continues to be observed from the prominent structure to the left of the tailings discharge point (outlined below). No evidence of deterioration or movement was observed.
- Recommend continuing the monthly visual inspections to monitor the area for bench degradation, erosion, tension cracks, seeps, etc.

Structure with
Seepage

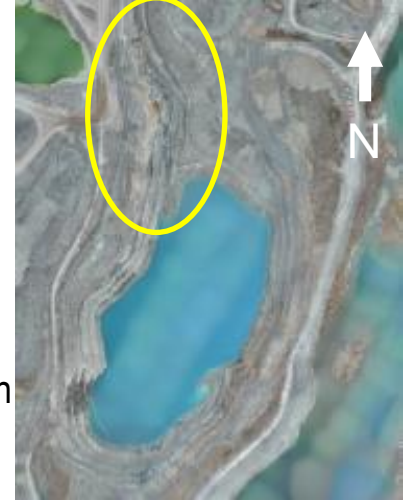
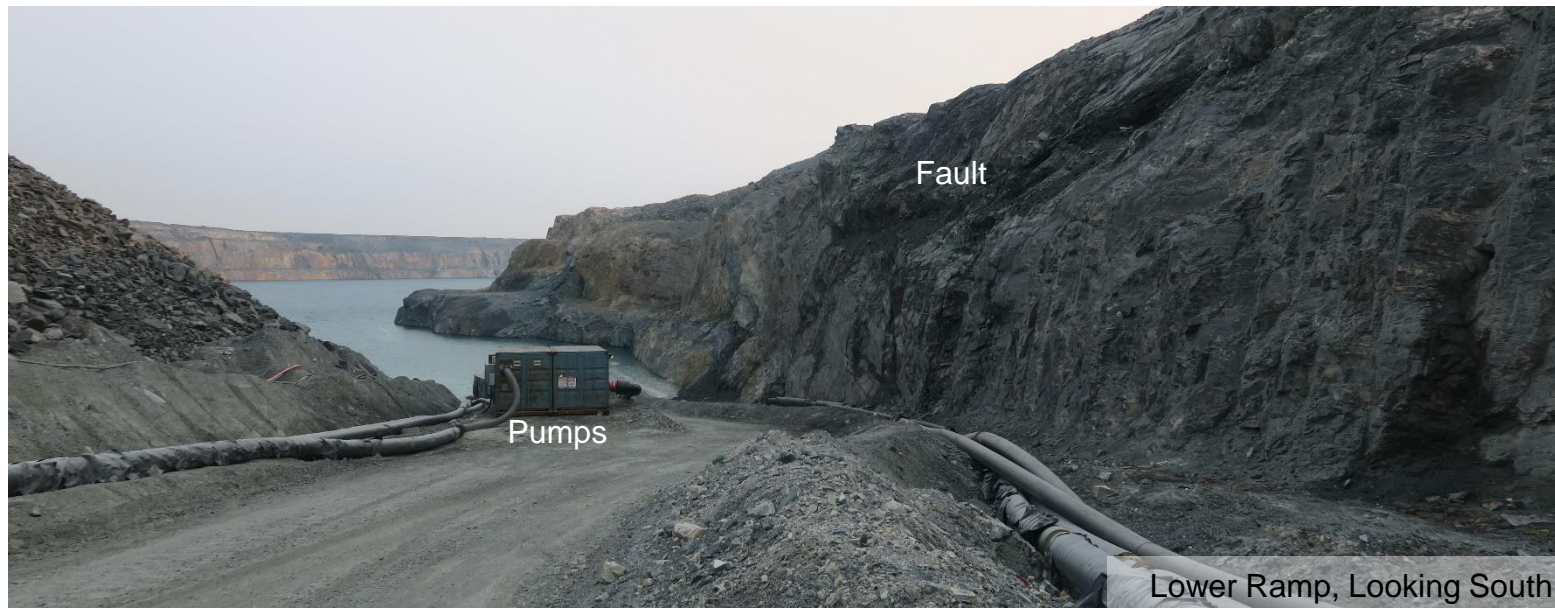
- The Northwest Ramp is used to access the pit lake and water management infrastructure is present along the ramp.
- Multiple rockfall hazards have been previously identified along this wall. With the rise of the pit lake, most of these hazards have been flooded and no longer pose a risk to personnel. However, a rockfall hazard remains on the Northwest Wall adjacent to the pumps, where a fault intersects the wall.
- The rockfall berm at the toe of the pit slope has been effective at managing rockfall. Over the last year, the berm was locally repositioned closer to the slope to create room for the pumps. The reconstructed berm is relatively short and may not be an effective rockfall barrier. Recommend increasing the height of the berm in this area to match the remainder of the berm.

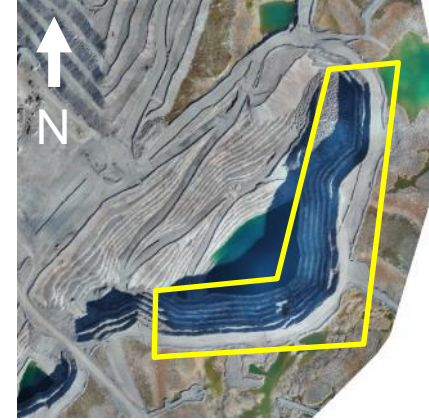
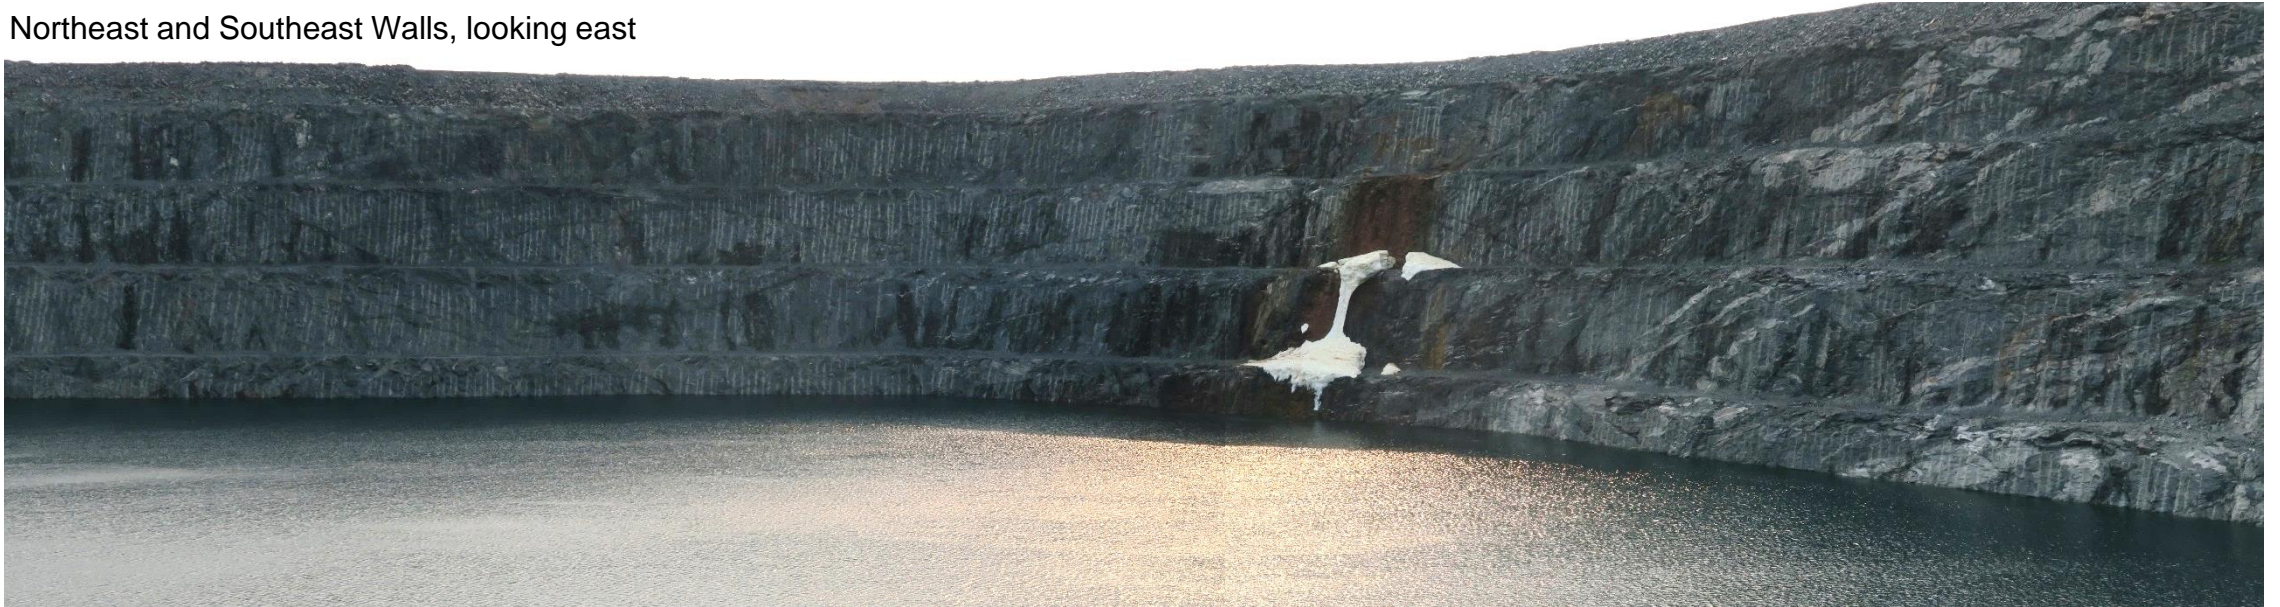
Northeast and Southeast Walls, looking east

- The walls are performing well. No particular geomechanical concerns were noted.
- The ice wall continues to form each winter on and below the talik zone in this wall. Limited seepage through the rock was observed at the time of the inspection.
- Access to / below the North Waste Rock Dump is not possible.
