Meadowbank 2024 Annual Open Pit Geomechanical Inspection

February 13, 2025

**RE: Meadowbank Complex - Meadowbank Site - 2024 Annual Open Pit
Geomechanical Inspection**

Meadowbank Complex - Meadowbank Site - 2024 Annual Open Pit Geomechanical Inspection

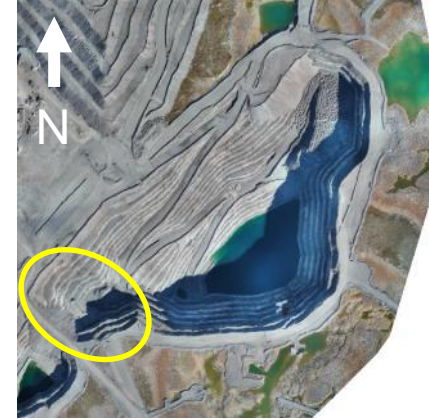
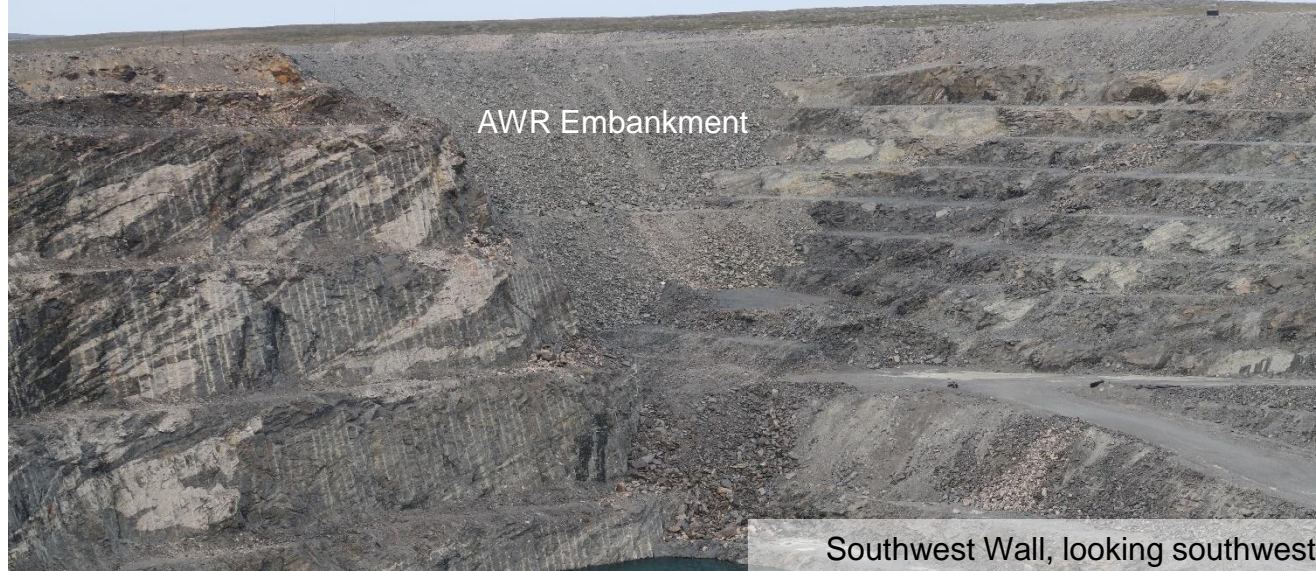
Southwest Wall, looking southwest

- The Amaruq AWR crosses a saddle between the Vault and Phaser pits on a rockfill embankment.
- During the winter of 2023, tension cracks were observed on the surface of the road, perpendicular to the axis of the road. The cracks have not been observed since and may have been due to frost heave within the upper road surface.
- No evidence of instability in the AWR embankment was observed during the inspection (e.g., no tension cracks on the road surface or bulging of the embankment toe).
- The stability of the Amaruq AWR embankment could be impacted if the water level in the Phaser Pit on the other side of the embankment increases and water ponds behind the embankment. This has not occurred. No seepage was observed at the time of the inspection. The presence of seepage should continue to be evaluated as part of the monthly inspections. Recommend noting the importance of this in the GCMP.

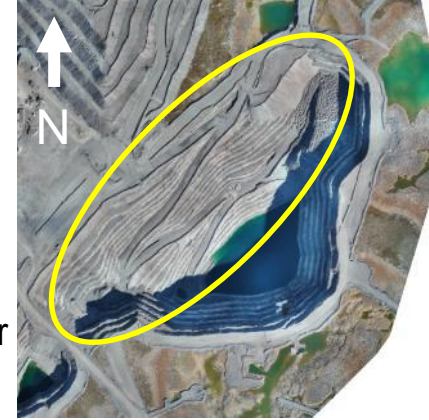
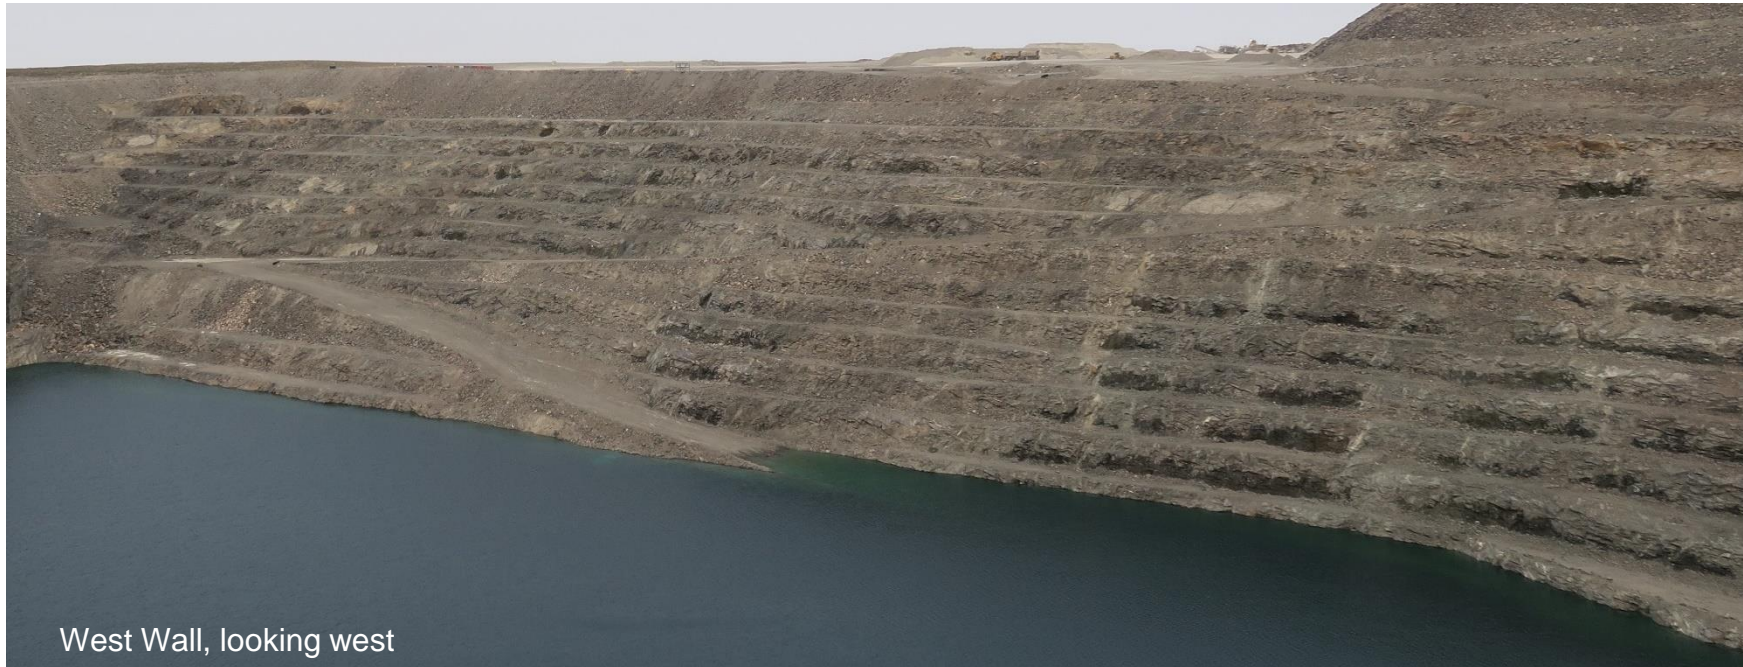
West Wall, looking west

- The West Wall is located along the footwall of the deposit. The wall was established with 7 m high single benches without pre-shear and commonly failed or were scaled back to the foliation. The ramp is located along this wall.
- At the time of the inspection, access to the ramp was restricted by a barricade.
- Rockfall hazards are present along the ramp. However, the ramp is sufficiently wide that personnel accessing the pit for water quality sampling are able to stay well away from the benches. A small rockfall (< 50 tonnes) was reported on the inside of the ramp in June 2024 and evidence of periodic rockfall was observed at the toe of the benches during the inspection.

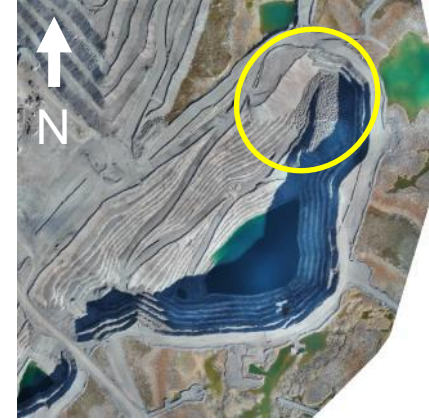
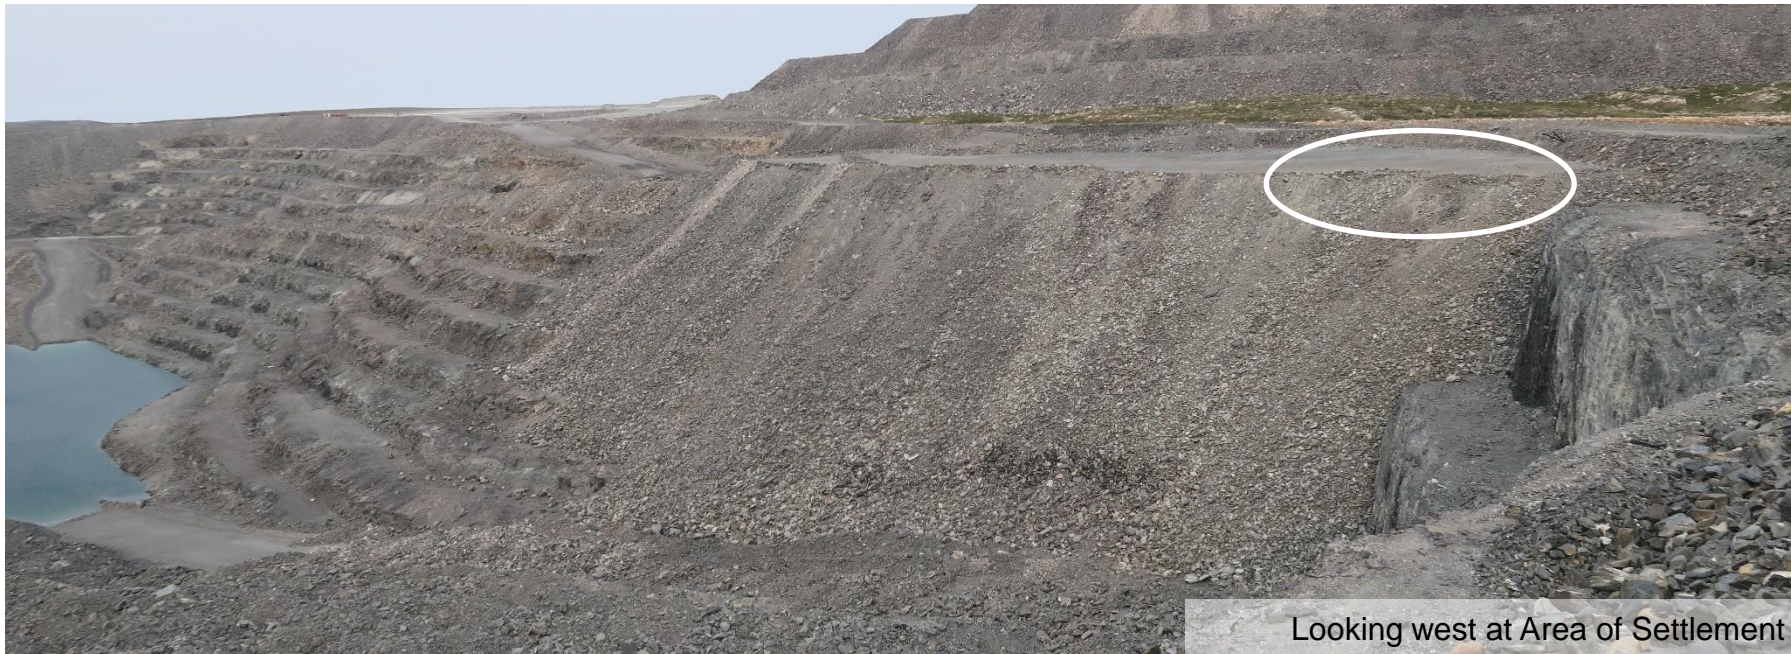
- A waste rock dump was constructed at the north end of the Vault Pit. The dump is inactive and consists of two platforms with elevations at approximately 5133 mRL and 5082 mRL.
- Settlement and tension cracks were observed at the crest of the upper platform at the north end of dump during the 2019 inspection. There appears to have been little change since that time. The affected area is relatively small and is not above the ramp.
- No other evidence of instability was observed during the inspection.
- Access to the dump is prevented with a berm.

Looking west at Area of Settlement

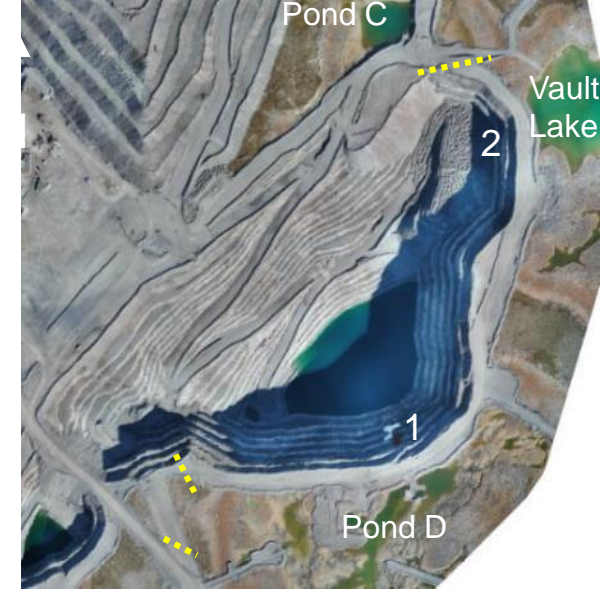
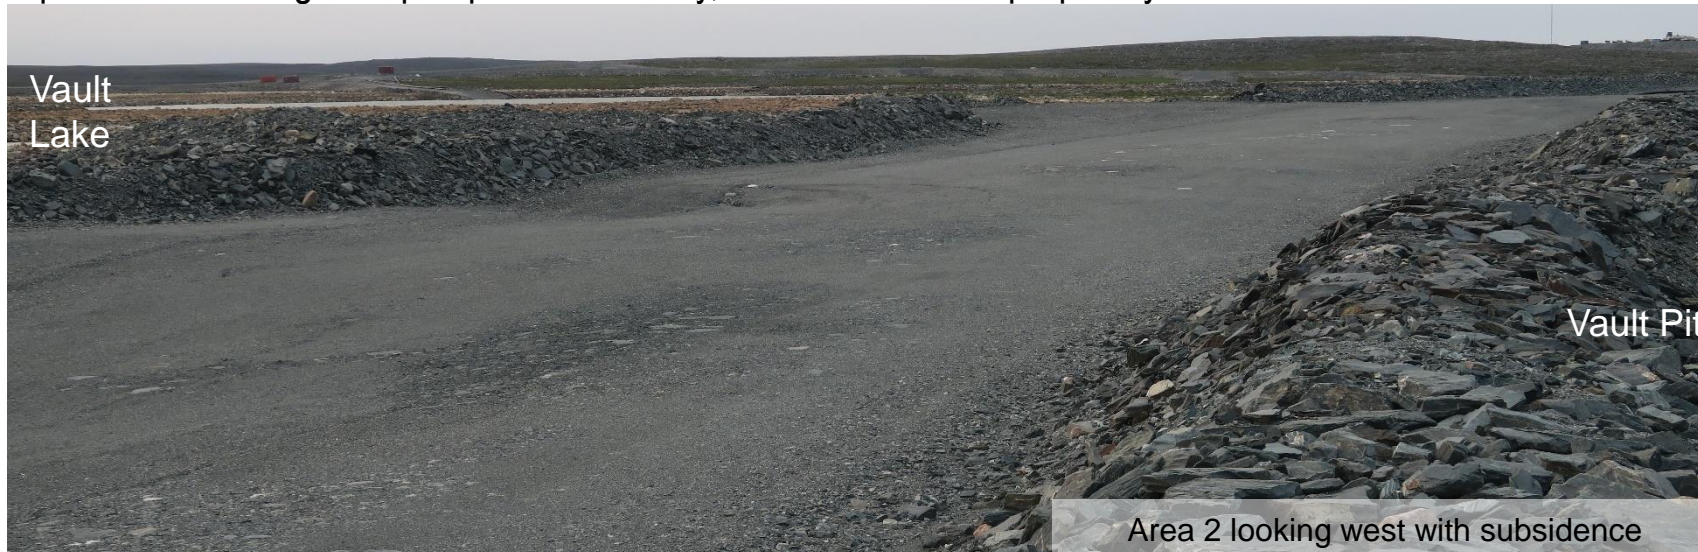
- A berm has been constructed at both ends of the Ring Road to prevent access (yellow dashed lines at right). Several geomechanical hazards have previously been identified along the road (numbered at right):
 1. Seepage from Pond D has flowed under the road and down the pit wall in 2019, 2021, and 2023. Seepage was not observed during this year's inspection.
 2. Subsidence of the road has occurred adjacent Vault Lake. The subsidence appears to have increased since the 2023 inspection. No seepage was observed below the road. The potential for a sudden inrush of water from Vault Lake into the open pit was previously identified as a hazard in the event of a breach or erosion of the Ring Road in this area. As a result, the area should continue be inspected prior to accessing the open pit. Alternatively, the road could be purposely breached in this area to eliminate the hazard.

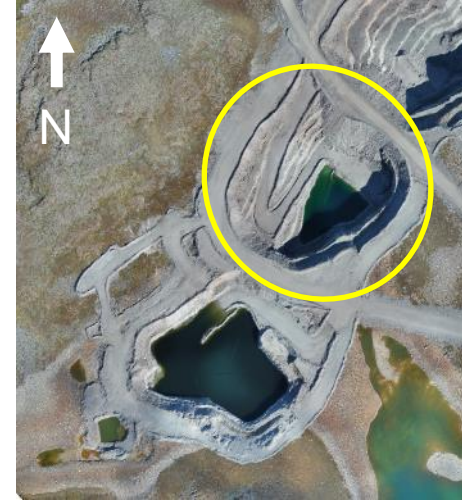
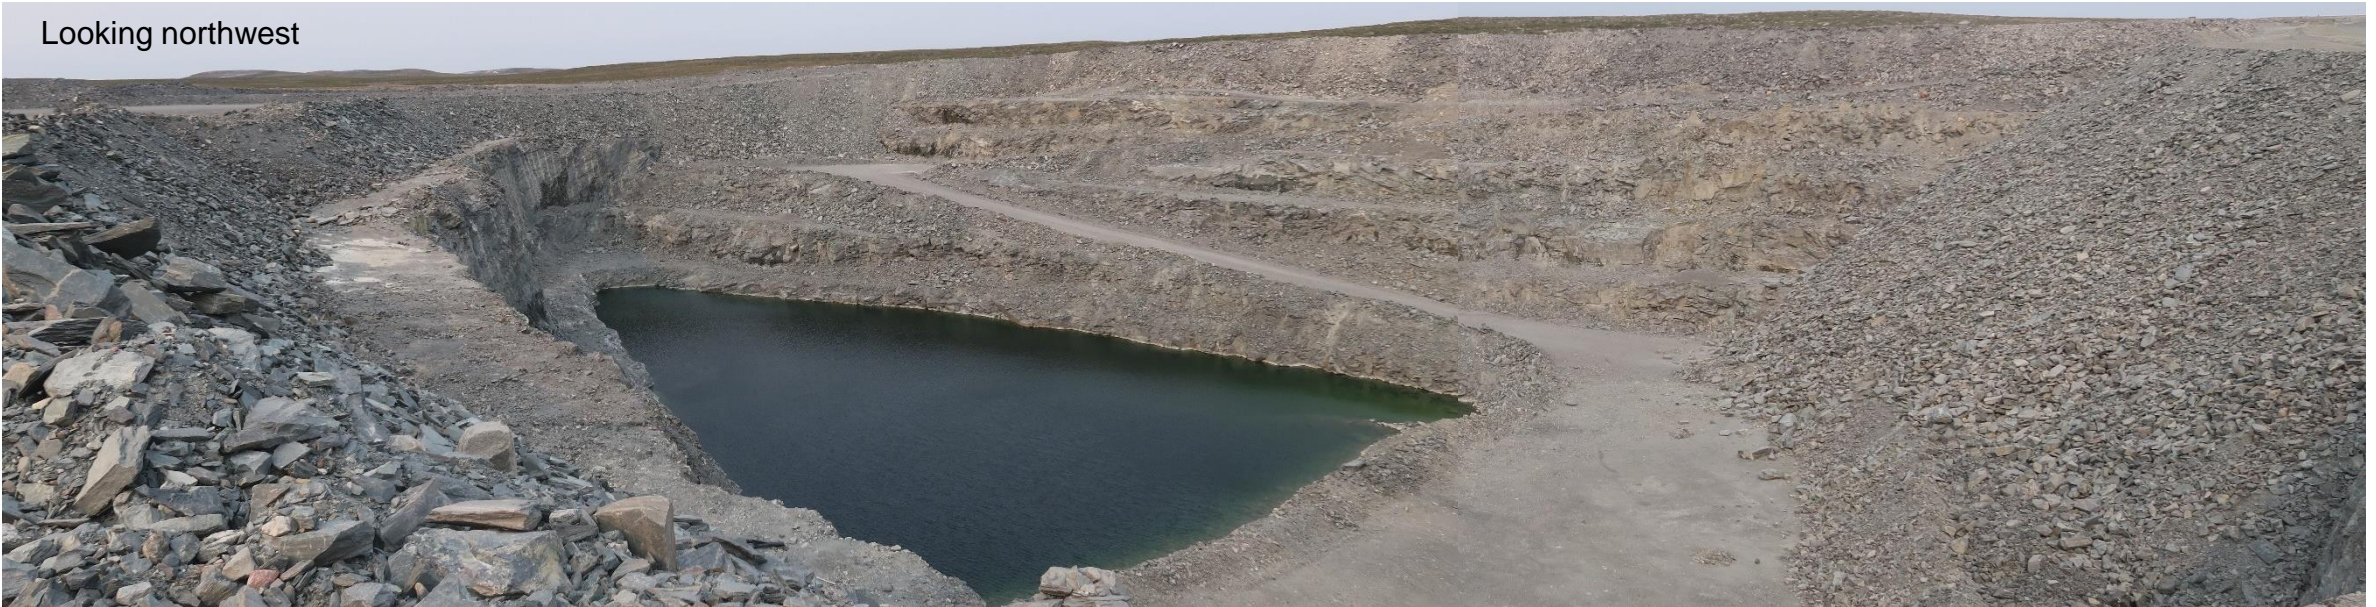
Looking northwest

- The open pit is partially flooded, limiting the current rock exposures to a single bench. No particular concerns were noted.
- Access to the open pit is prevented by a berm.
- No evidence of instability was observed in the Amaruq AWR embankment.
- The stability of the Amaruq AWR embankment could be adversely impacted if the water level in the Phaser pit increases and water ponds behind the embankment. A visual assessment of the water level in the open pit has been incorporated into the monthly inspections since the last inspection. The pit lake elevation does not appear to have significantly changed since the 2021 inspection.

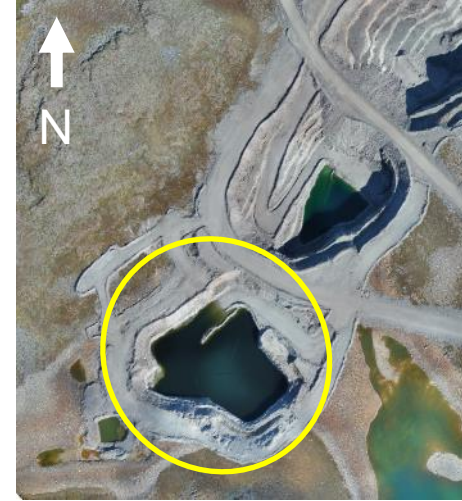
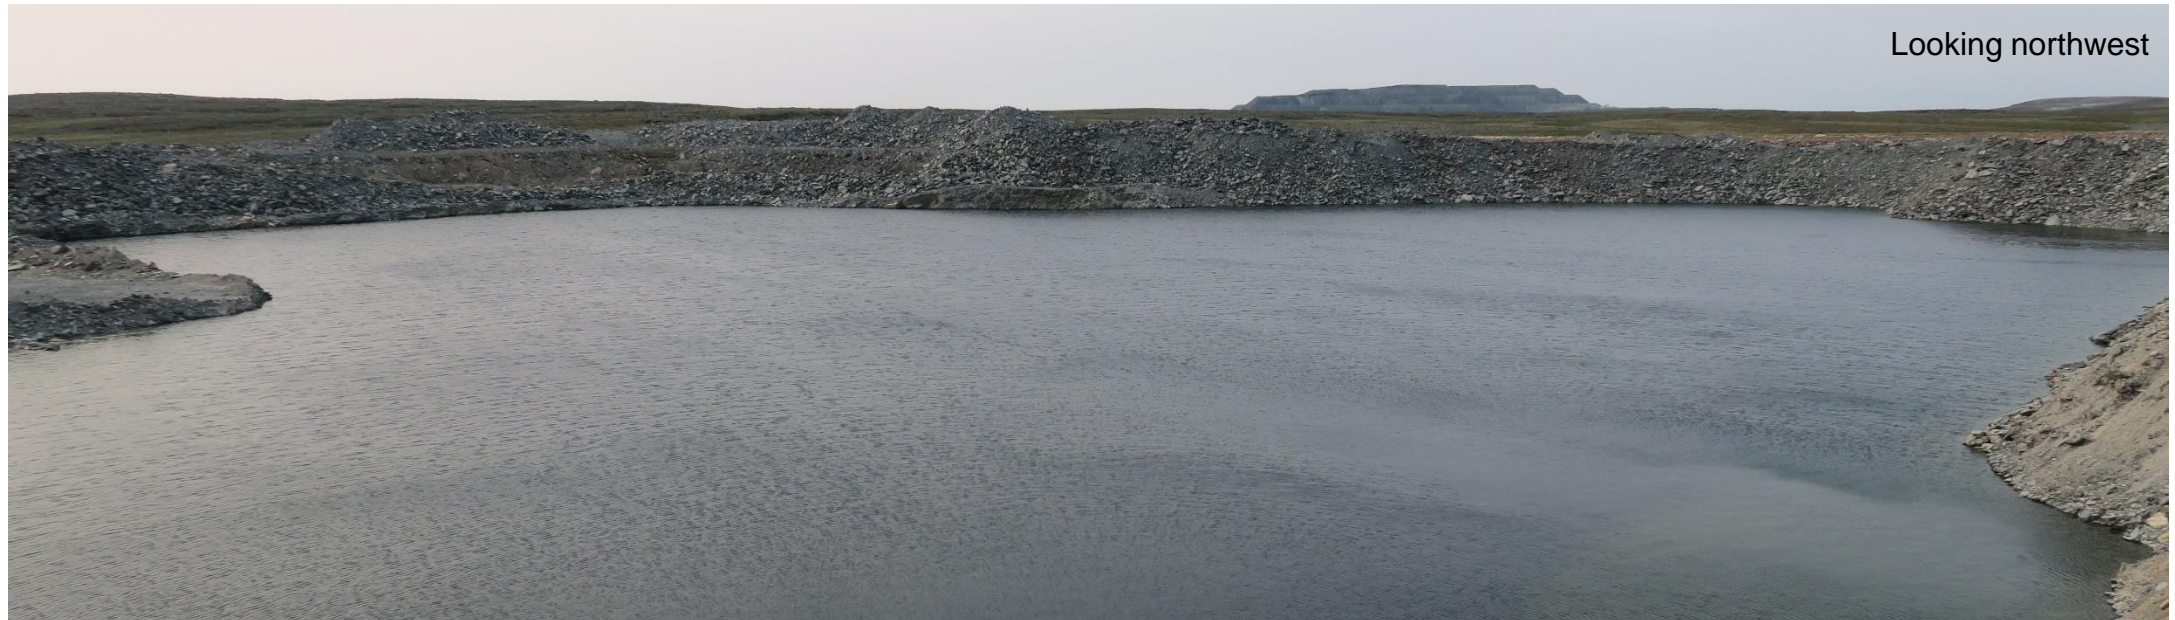
- The open pit is flooded, with no rock slopes visible.
- Access to the open pit is prevented by a berm. The berm is traversed when water quality sampling is required to be completed.
- No particular geomechanical concerns were noted.

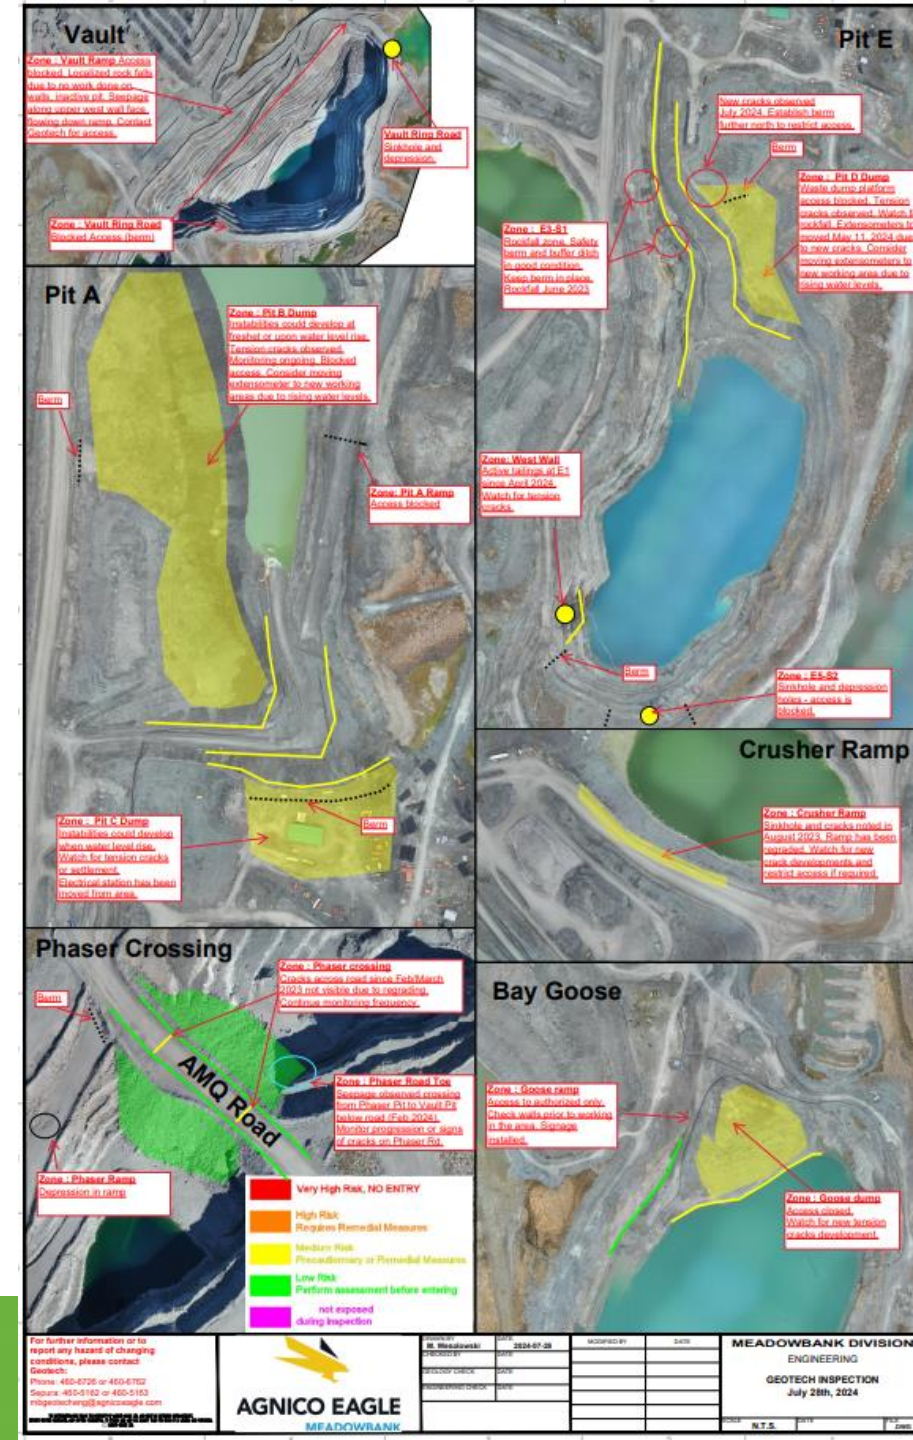
- The most recent hazard assessment map (July 28, 2024) was reviewed. A summary is shown at right and comments are provided below.
- All of the hazards identified during the annual inspection have been captured by the hazard assessment.
- The risk ratings assigned to the identified hazards are thought to be generally reasonable.
- The drone photos used for the hazard map are out of date and do not reflect the reduction in slope hazards / accessible areas as the pit lake elevations rise. The drone photos should be updated to reflect the current conditions.
