Whale Tail 2024 Annual Open Pit Geomechanical Inspection

February 3, 2025

RE: Meadowbank Complex - Amaruq Site - 2024 Annual Open Pit Geomechanical Inspection

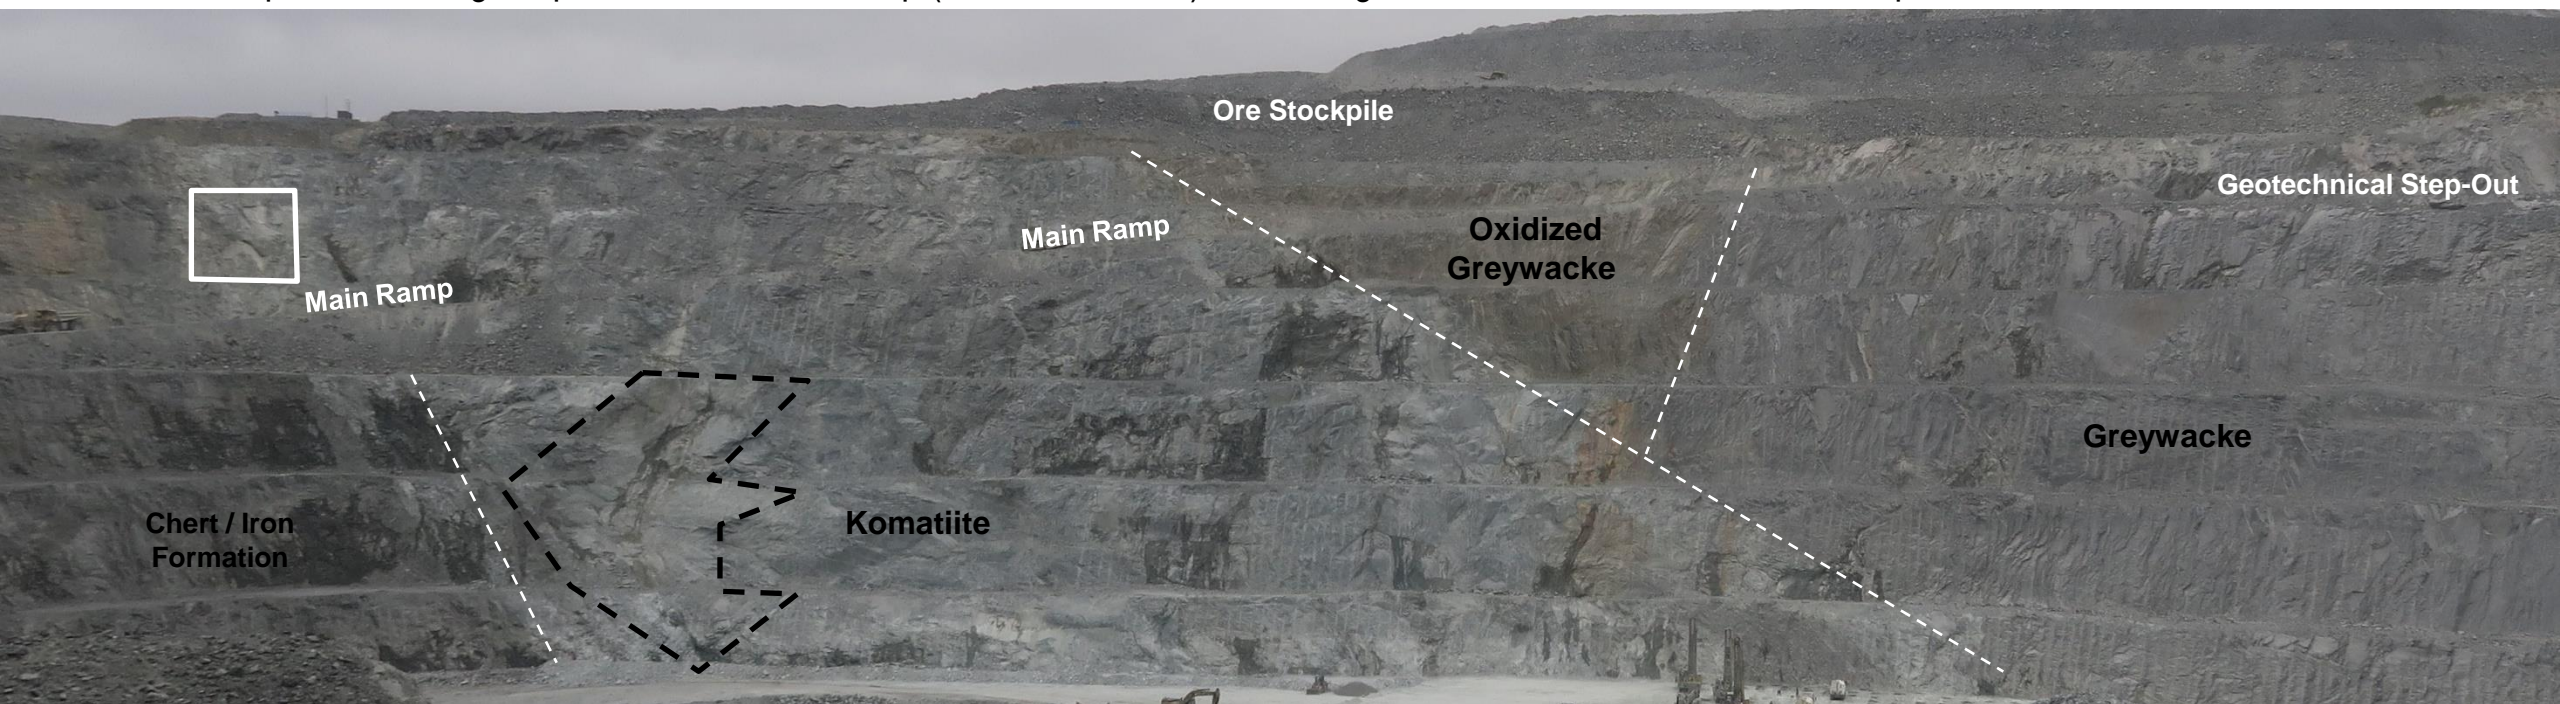
- Final wall in Design Sector A1/A1K.
- The benches in the Greywacke and Oxidized Greywacke are generally performing well.
- The benches in the Komatiite below the ramp have experienced significant backbreak in the northwest corner, as well as a sequence of bench-scale failures (outlined below in black). This is discussed further on the next slide. Elsewhere in the sector the Komatiite has performed well.
- A potential wedge is present above the ramp (white box below). The wedge is discussed further on a subsequent slide.

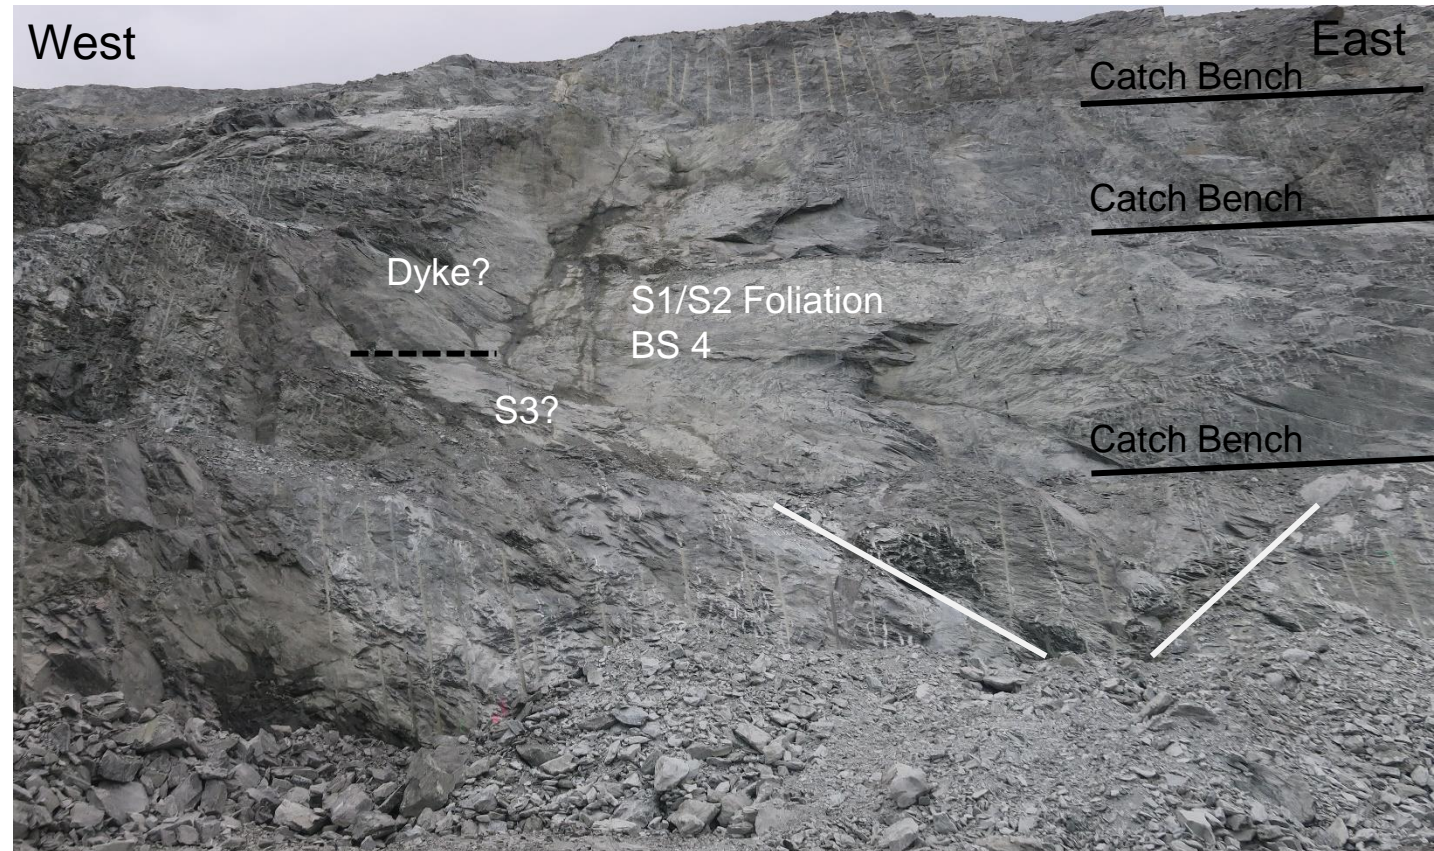
- The initial failure was forecast by the slope stability radar. The area was beamed off for the subsequent failures.
- Another potential wedge formed by the same structures is present on the current bench (outlined in white). The mine has attempted to scale down this wedge several times.

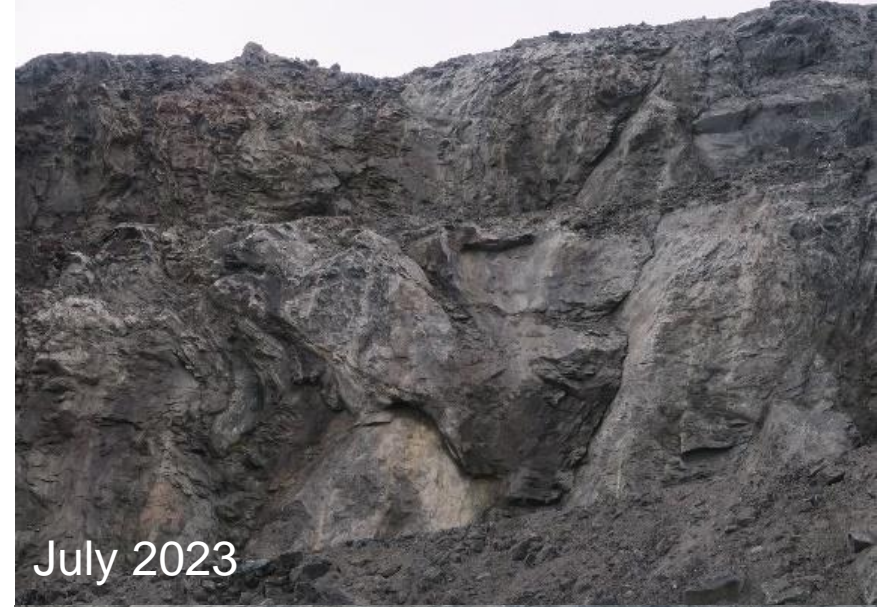
July 2023

- No significant changes in the condition of the wedge were observed between the 2023 and 2024 annual inspections.
- Continue to monitor this area closely, both from the ramp and the overlook above. If further deterioration is observed, further mitigation will be required (e.g., knocking down the wedge).

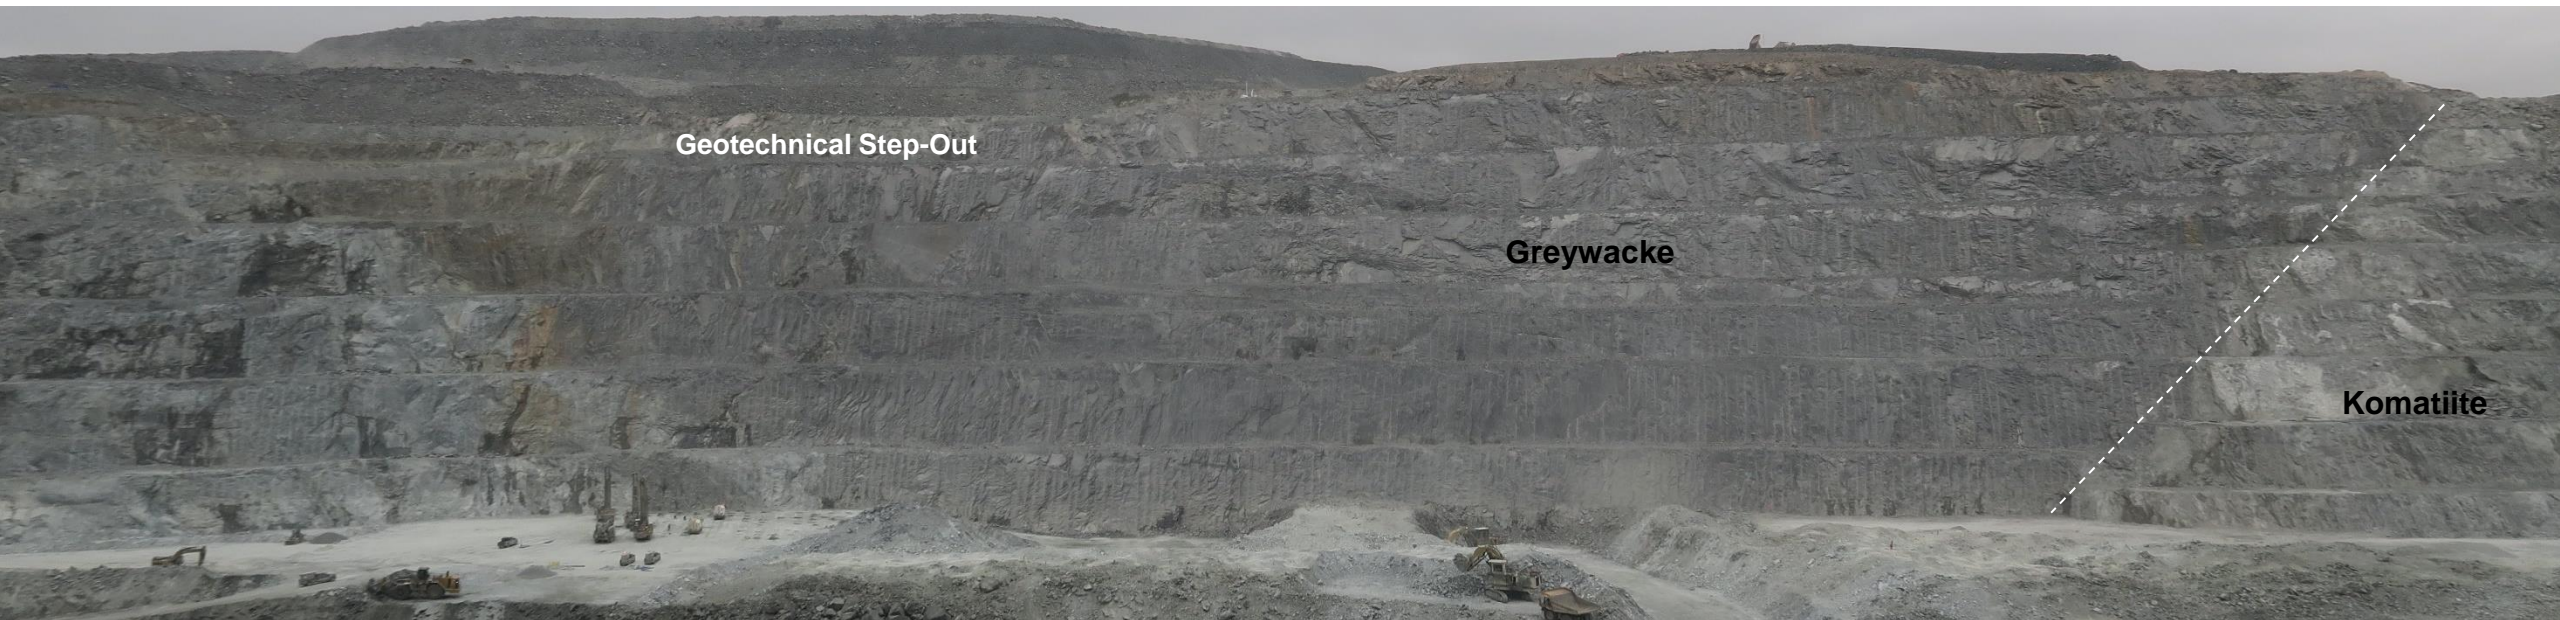
- Final wall in Design Sector B1.
- Approximately two benches have been mined on this wall since the last annual inspection.
- There have been no slope failures since the last annual inspection.
- The benches are performing better than expected, with the bench face often standing steeper than the foliation.

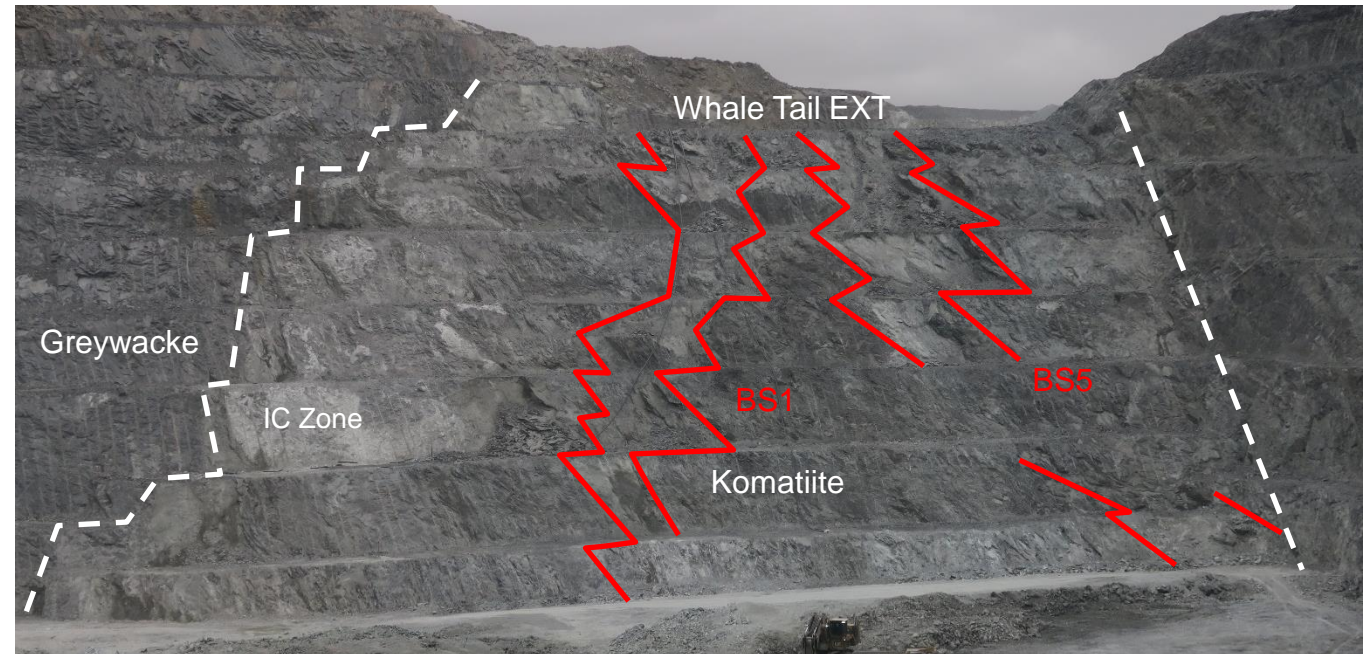
- Final wall in Design Sector D4K.
- This sector is within the Komatiite and has been characterized by a series of bench scale failures associated with the weak rock mass and the High-Strain / Brittle Structures (select structures are shown in red below). The slope design was revised in December 2021 and has been successful in managing the performance of the slope.

- The lower two benches have performed better than expected, with only small rockfalls along the High Strain Structures. This could be linked to better blasting, or a reduction in water on the slope due to the mining of the Whale Tail EXT.

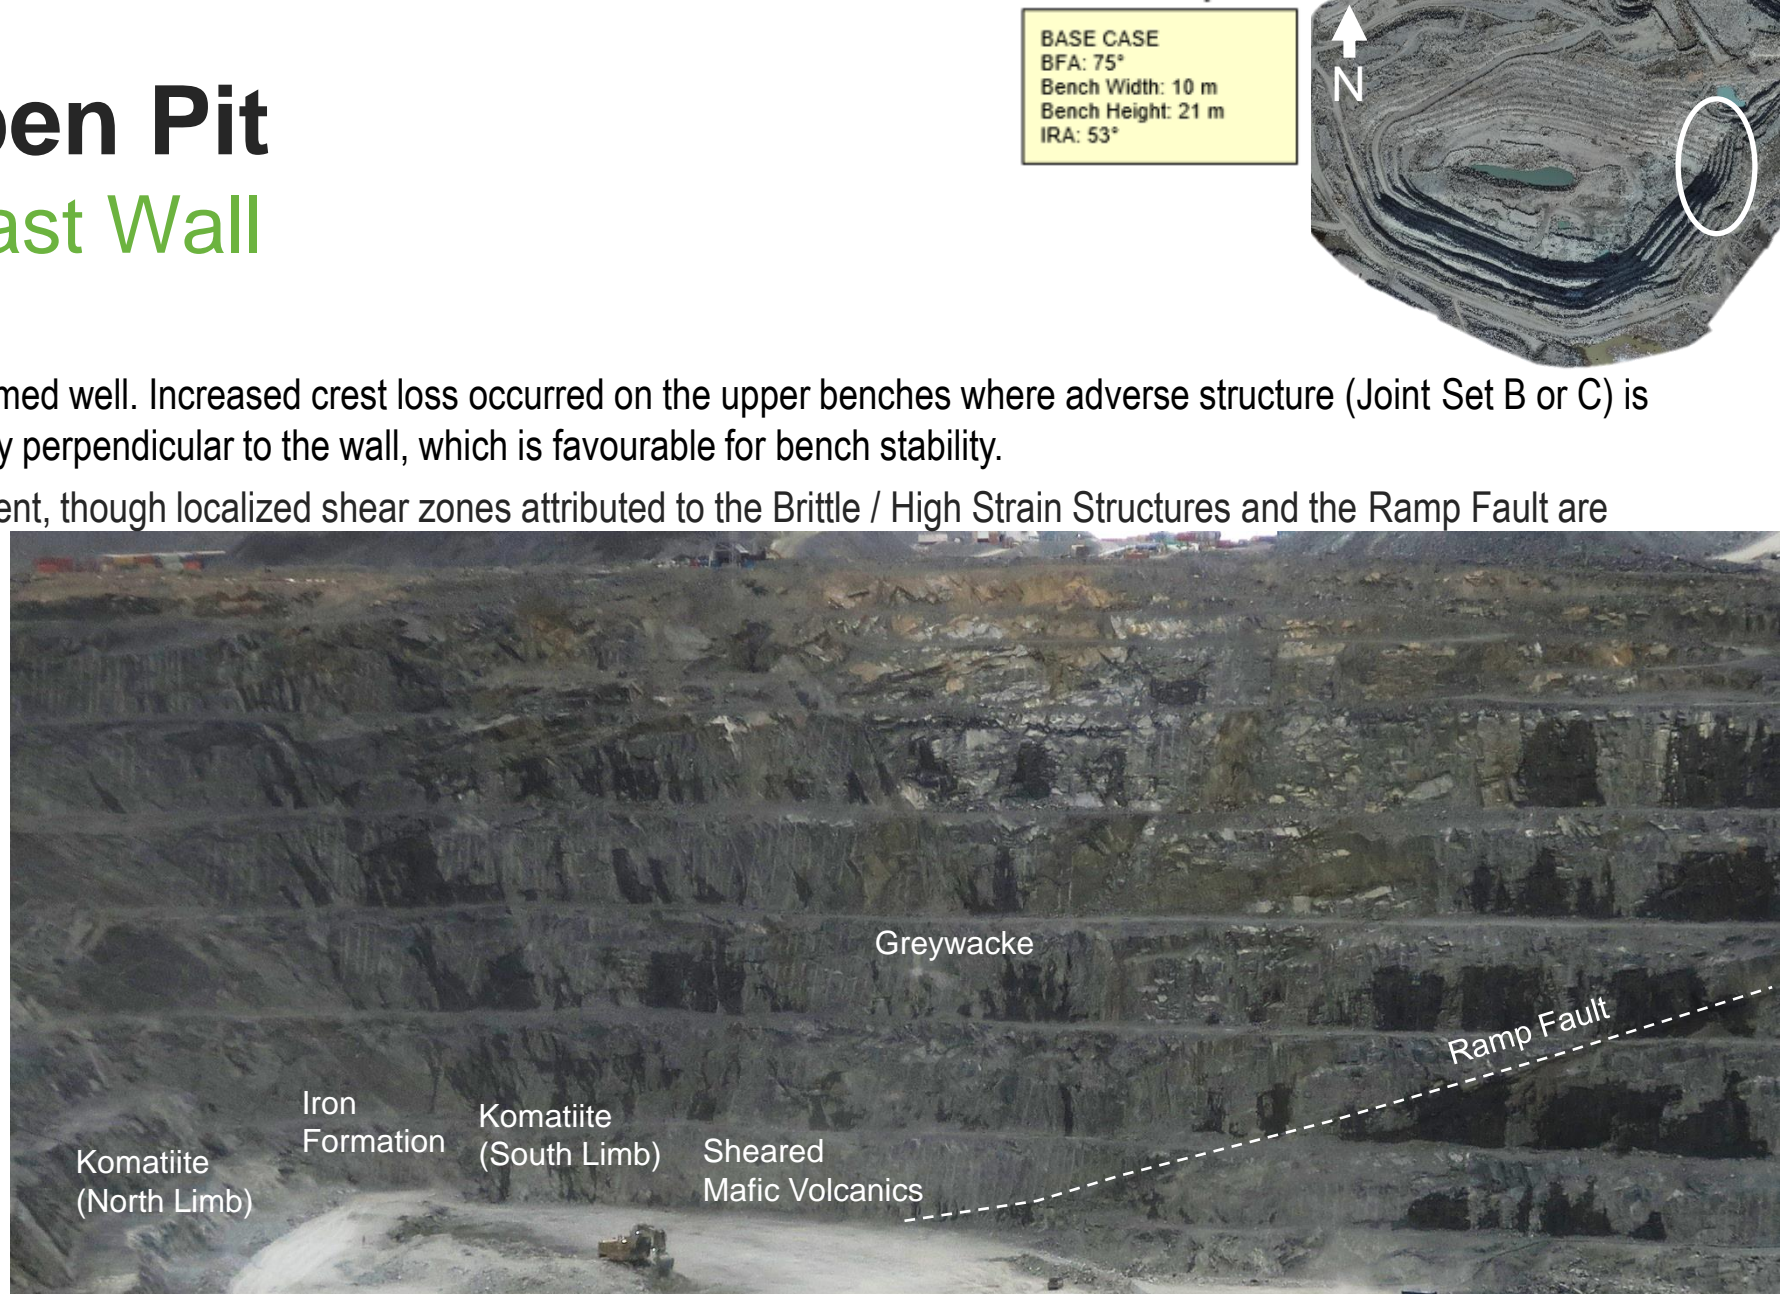
- Final wall in Design Sector E4.
- The benches have generally performed well. Increased crest loss occurred on the upper benches where adverse structure (Joint Set B or C) is present. The foliation strikes roughly perpendicular to the wall, which is favourable for bench stability.
- The rock mass is generally competent, though localized shear zones attributed to the Brittle / High Strain Structures and the Ramp Fault are observed within it.
- These structures represent a potential rockfall hazard, but this has not been an issue to date.
- There is an interval of intensely foliated/sheared Mafic Volcanics in the lower benches. This has not significantly impacted bench performance to date. However, the extents of this unit should be reviewed and the potential impact on subsequent benches assessed. It may be associated with Brittle / High Strain Structure #3.

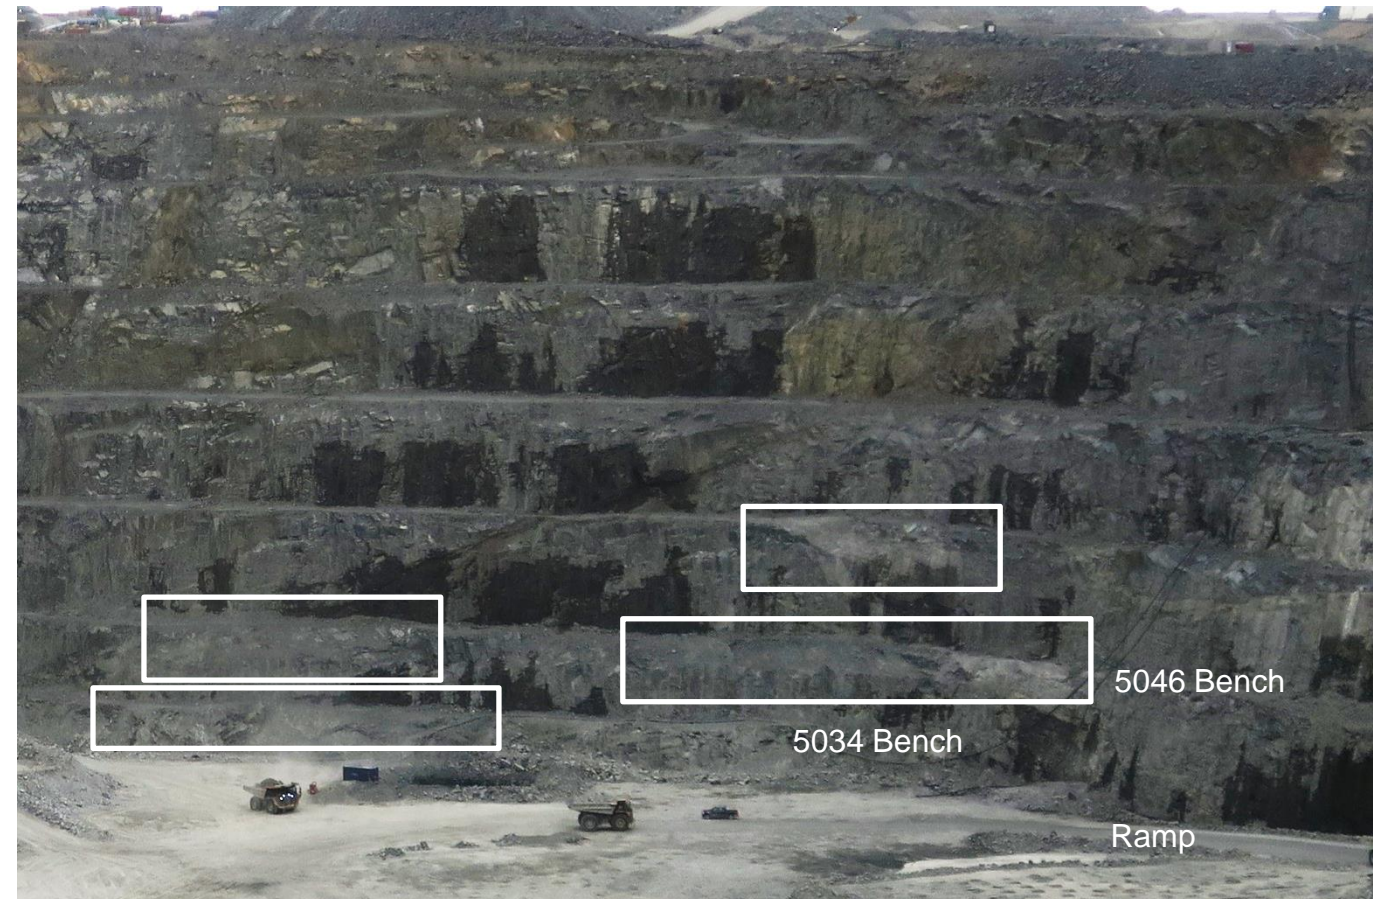
- Final wall in Design Sector F6
- The slope geometry recommendations for this sector were adjusted in late 2021. A catch bench width of 16 m, was thought to be achievable, with the expectation of backbreak in the order of 8 m along Joint Set C. The benches initially performed better than expected, with backbreak typically less than 4 m, and AEM reduced the design catch bench width to 13 m in March 2023.

- Different alternatives for managing the rockfall hazard were discussed during the visit. AEM is planning to install a Geobrugg rockfall barrier along the crest of the 5034 catch bench where the catch bench capacity has been lost. This is endorsed.

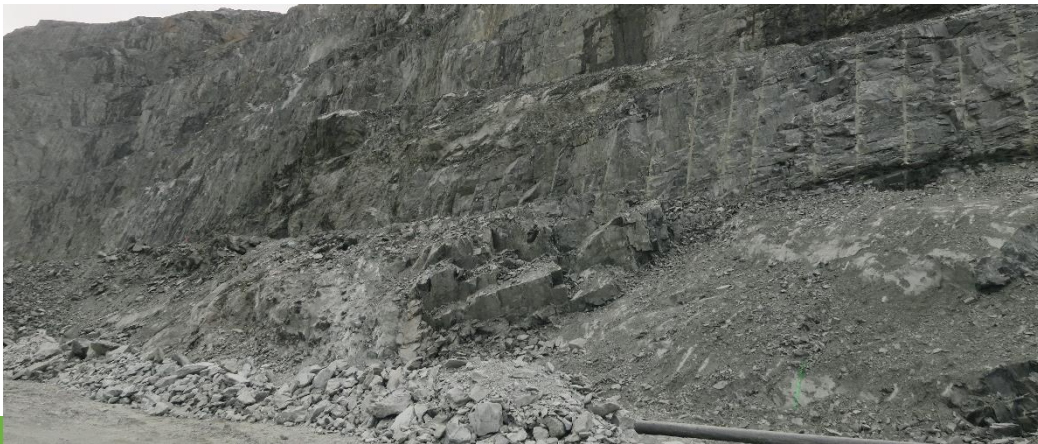
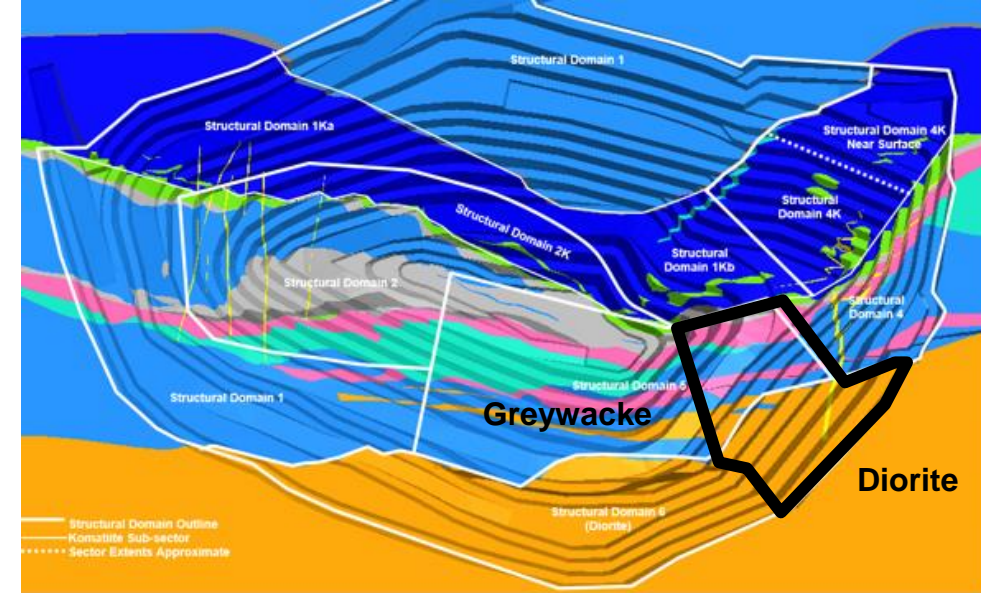
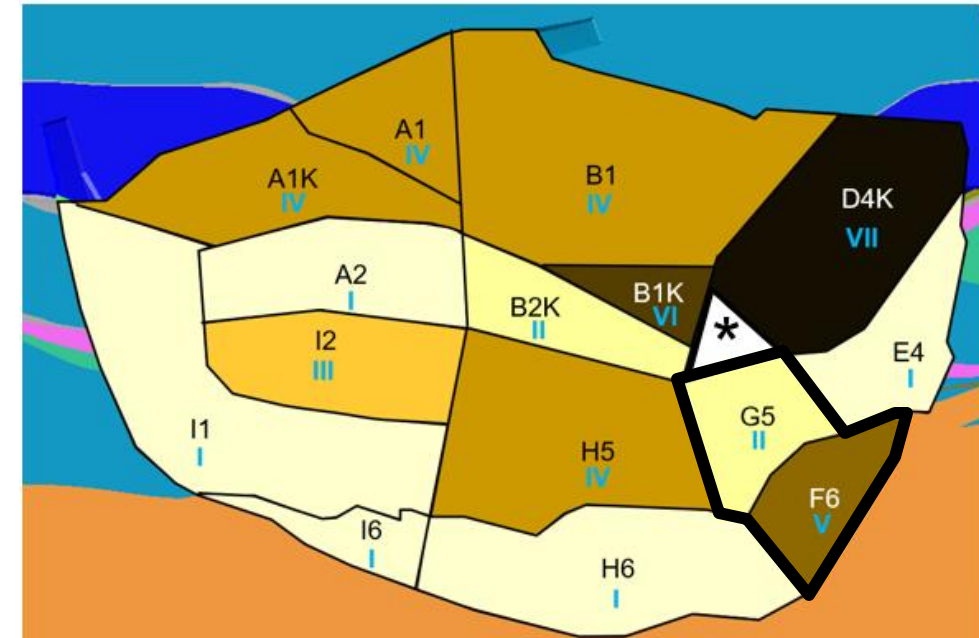
- Based on the observed catch bench performance, the design catch bench width in Design Sector F6 should be revisited.
- Crest loss on the next bench could reduce the usable width of the ramp. Consider installing vertical dowels along the outside of the ramp in this sector to reduce crest loss.
- Note that the wall is expected to transition out of the Diorite and into Greywacke and Komatiite just below the current elevation. At that point the slope geometry recommendations for Design Sector G5 will apply.
- The slope geometry recommendations for G5 incorporate a 10.5 m catch bench width based on the expectation that Joint Set C will no longer control the bench geometry.
- The change in rock mass structure needs to be validated in the field before the bench design is changed. It is possible that Design Sector F6 extends deeper than currently believed.

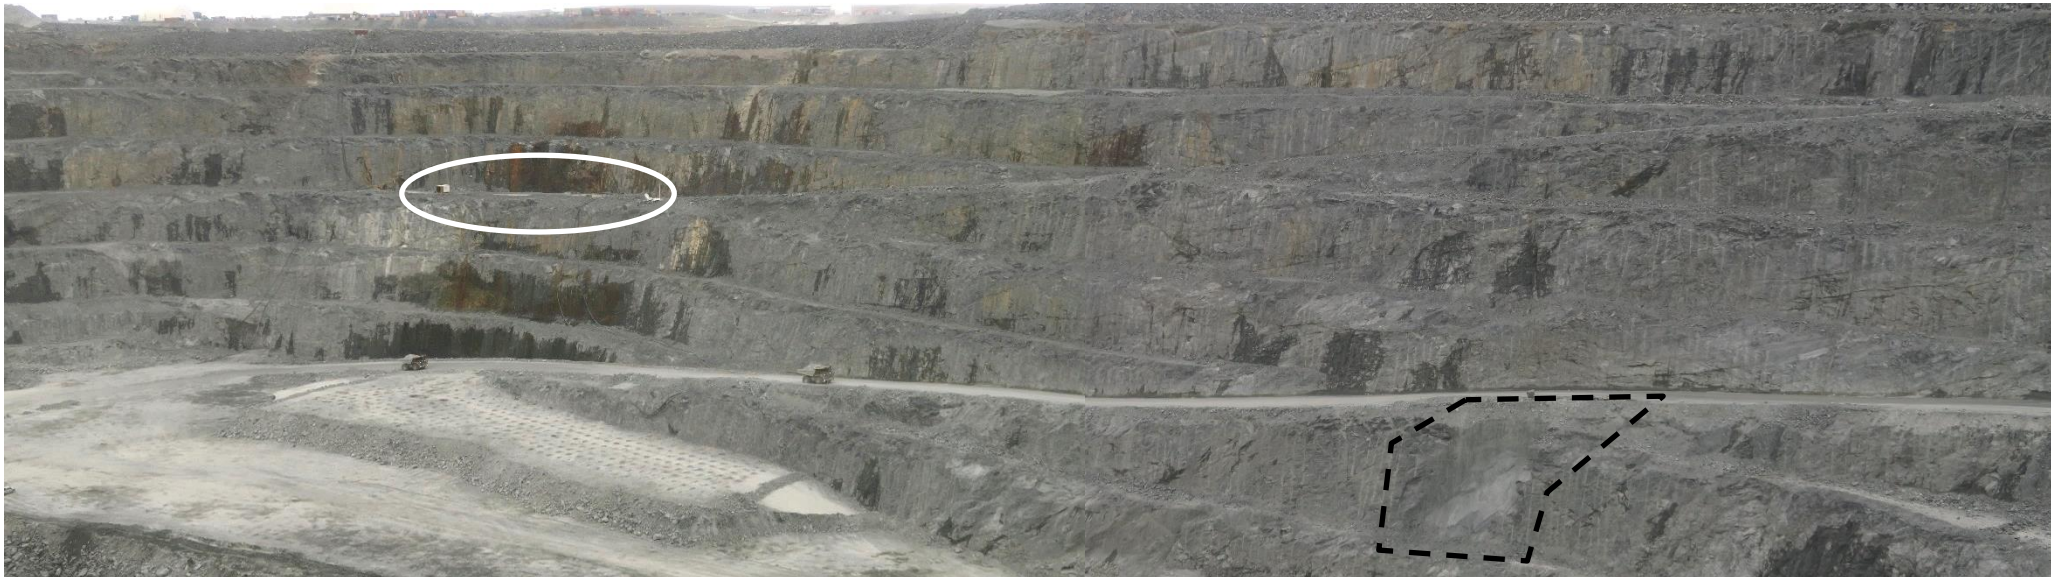
- Final wall in Design Sectors H6 (Diorite) and potentially H5 (predominantly Greywacke and Mafic Volcanics with intervals of Komatiite).
- The wall has reached an elevation where Structural Domain 5 is expected to be exposed in the wall. North dipping structures in this domain are expected to limit the achievable bench face angle. Periodic mapping is recommended to confirm the extents of this domain.

- A bench-scale failure occurred below the ramp in June 2024 (outlined in black below). The failure is discussed in detail on the next slide.

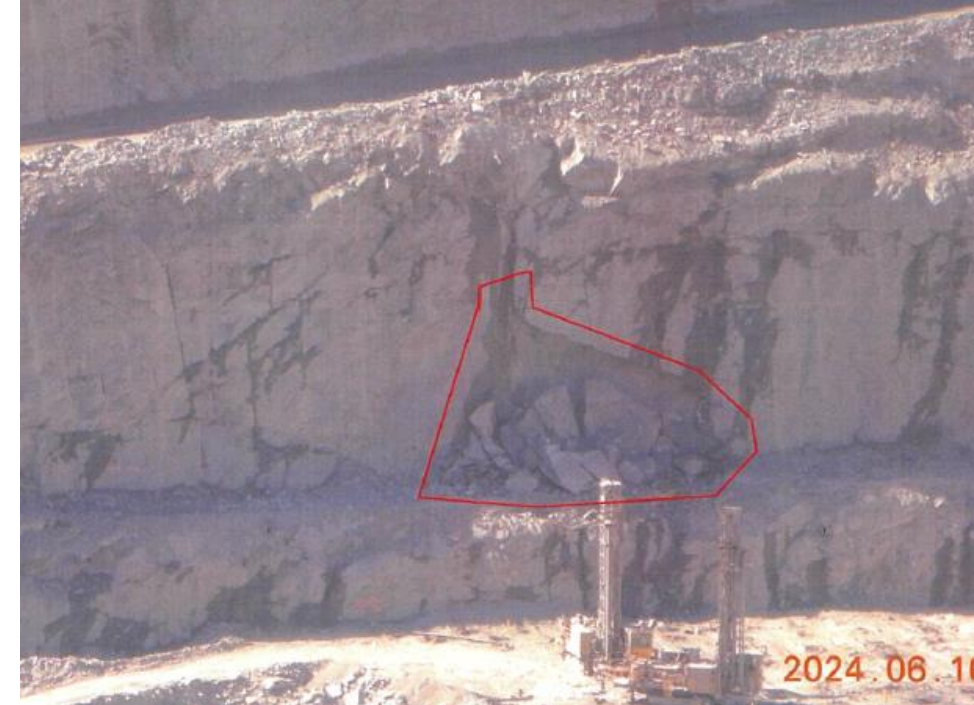
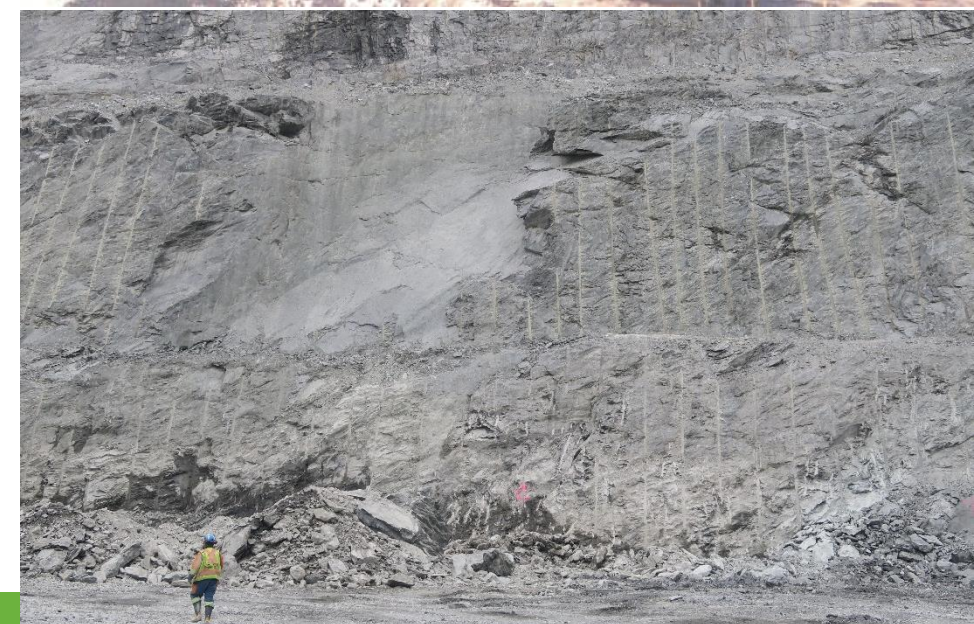
- During the inspection a number of topics related to this failure were discussed, including the potential causes of the failure, the possibility of reverting to two-lane traffic on the ramp, the possibility of future similar failures, and a long-term monitoring strategy.

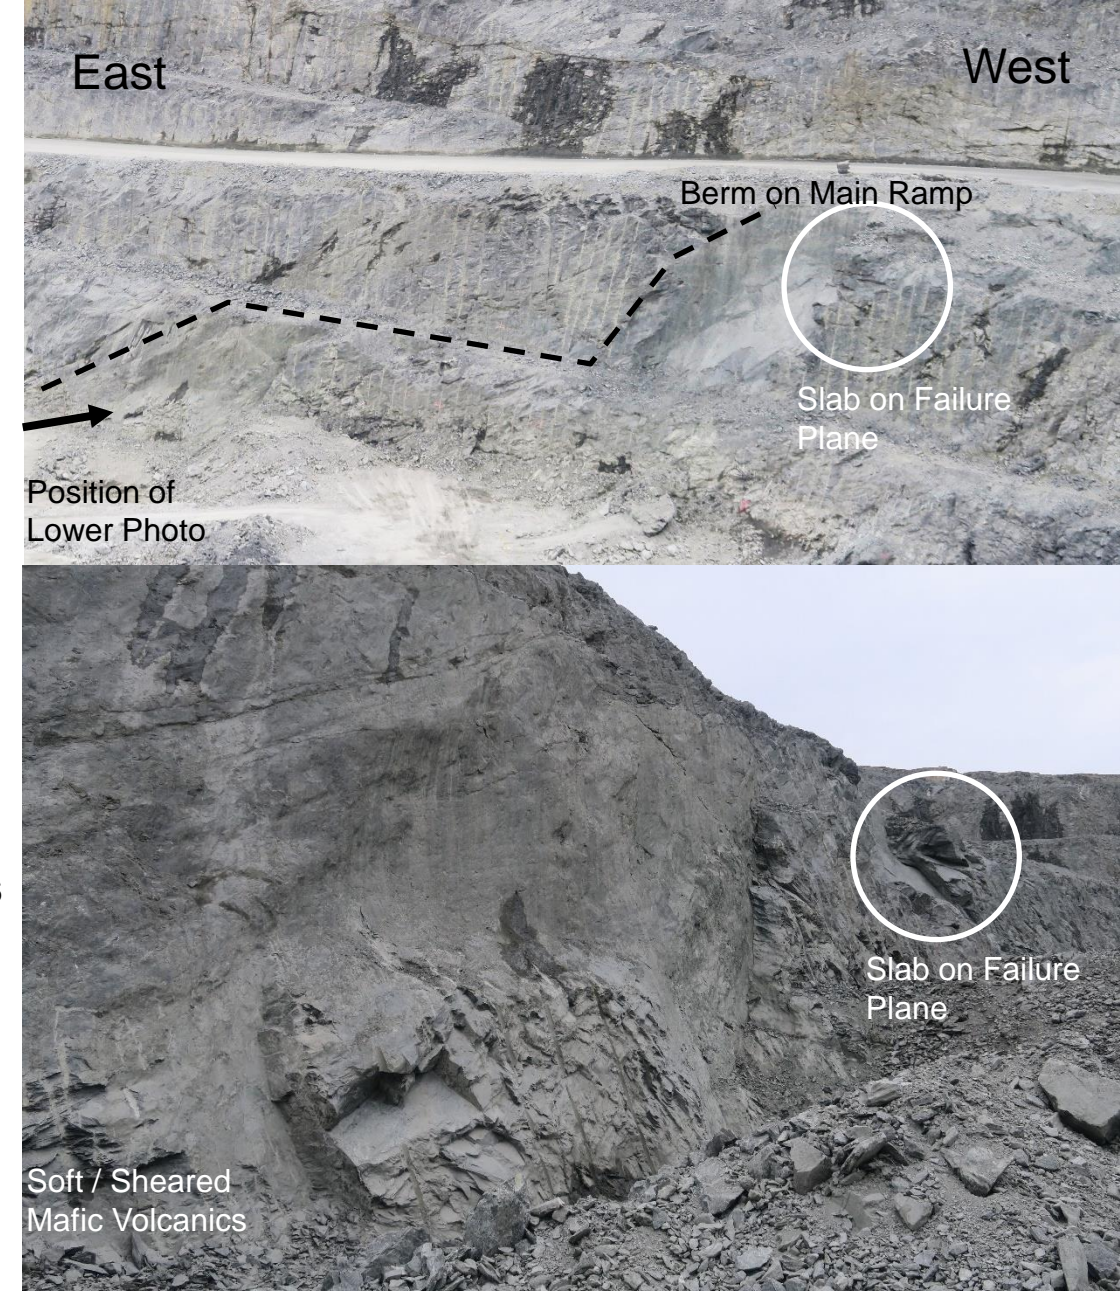
- A slab remains against the failure plane, despite efforts to scale it down, and it poses a hazard for personnel working below the failure area. Mining activities directly below the slab should continue to be limited to the day shift with a spotter. The area should continue to be closely monitored and inspected by Rock Mechanics after each blast.

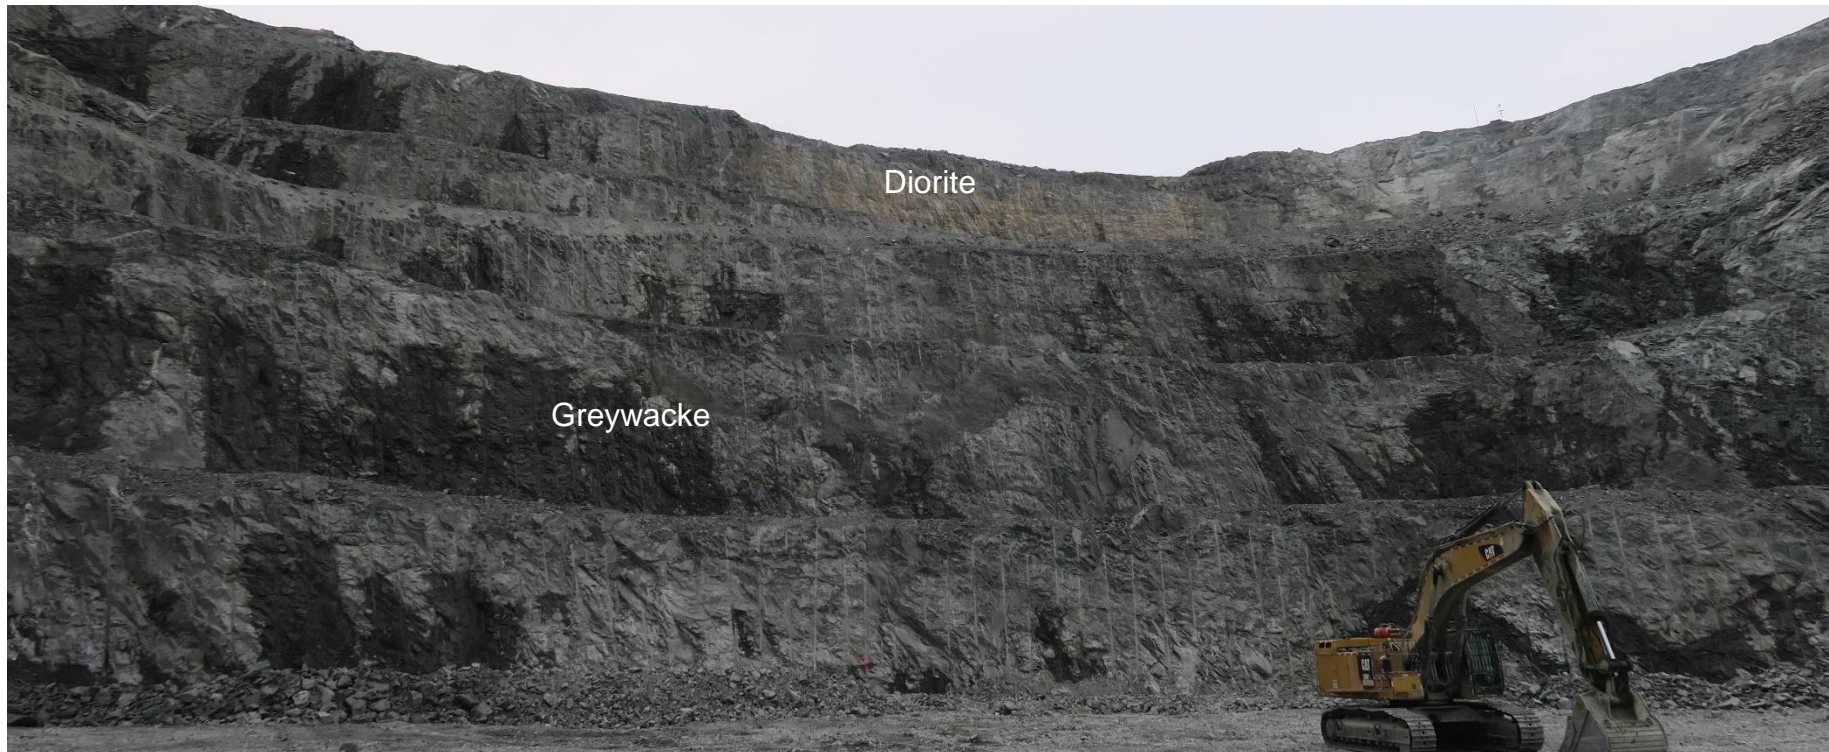
- Final wall in Design Sectors I6 (Diorite) and I1 (predominantly Greywacke).
- The wall is generally performing well. However, there continue to be challenges with drilling and blasting practices resulting in crest loss or hard toes on the benches.

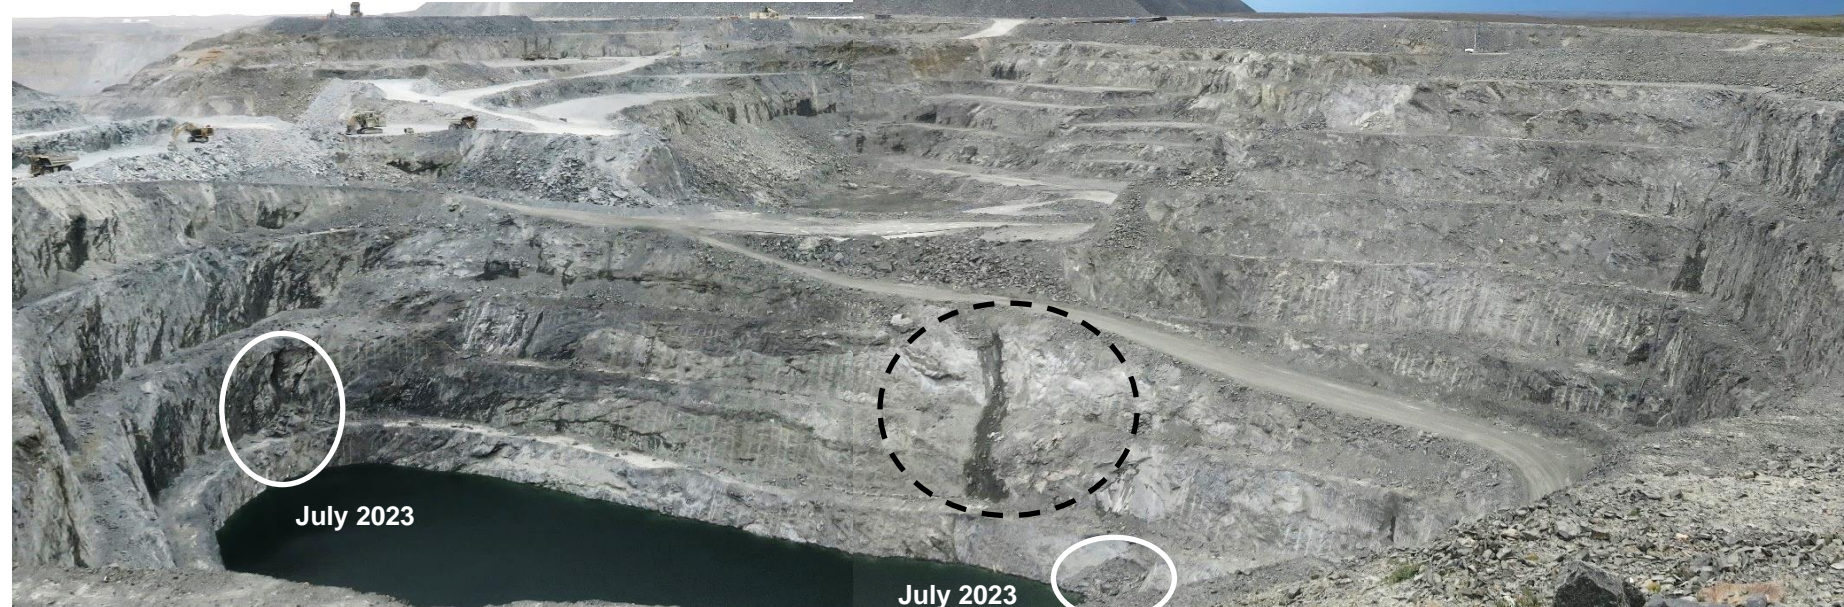
- The Northwest Wall is the footwall of the deposit and was established primarily within the Komatiite.
- Several bench scale failures and rockfalls have occurred over time on this wall, primarily associated with planar or wedge failures along the foliation. A progressive failure below the ramp (circled in black below) has impacted the ramp. Further failures are possible in this area.

- Access to the open pit continues to be prevented due to overspill from the blasting of the V2 open pit. It is understood that access will be re-established in the future for water management purposes. As part of this process, the ramp should be inspected by Rock Mechanics, a rockfall berm re-established along the inside of the ramp, and the hazard associated with the failures below the ramp reviewed.

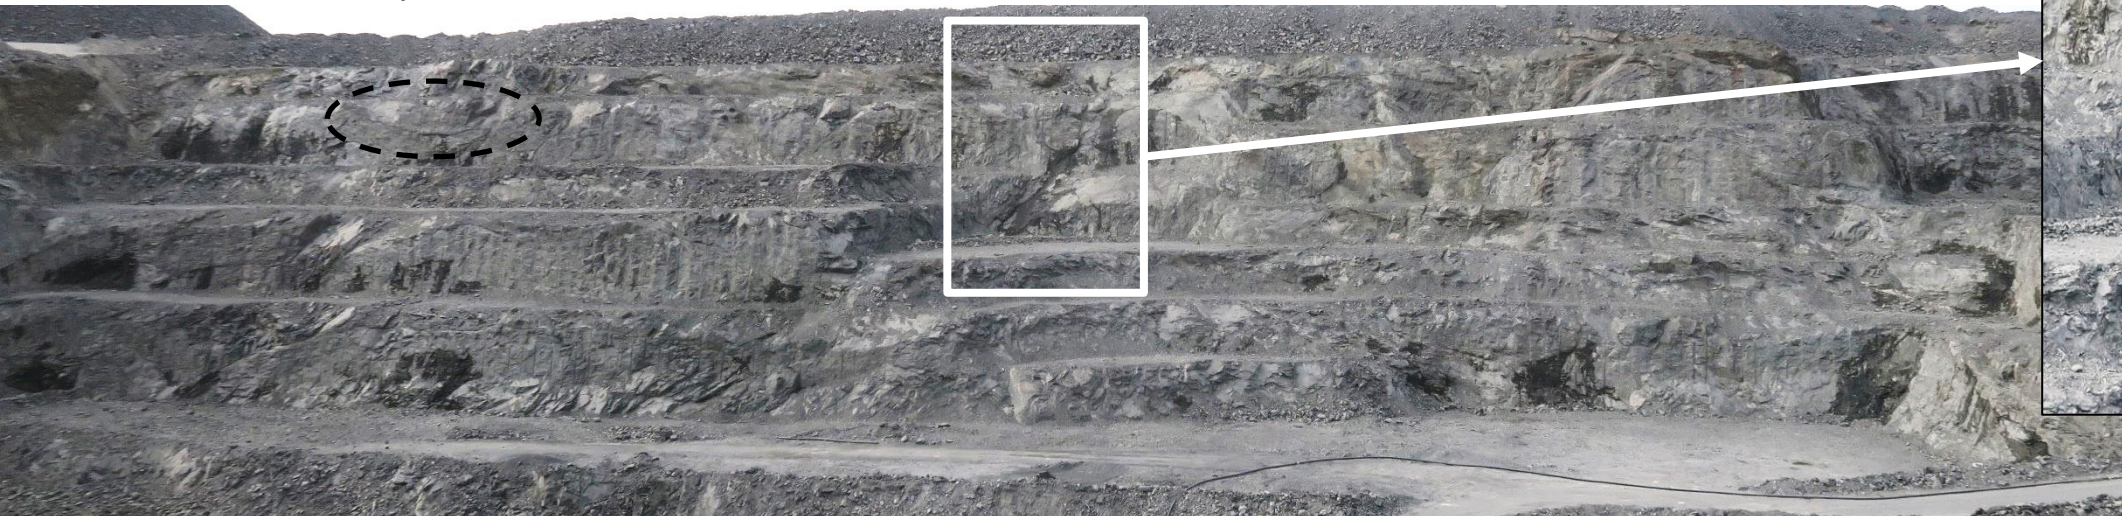
- Final wall established in the footwall of the deposit, primarily within the Mafic Volcanics.
- The observed slope behaviour is consistent with expectations. While crest loss occurs along the foliation, the bench face is typically held at a steeper angle than the dip of the foliation. However, crest loss has been greater than planned. This is discussed further later in this presentation.
- A prominent structure with graphite infill has resulted in a local loss of the catch benches across multiple benches (outlined in white below). This may be High-Strain/Brittle Structure 18.
- A possible wedge formed by an undulation in the foliation was previously identified near the western end of the wall within the Mafic Volcanics (circled in black). The condition of the wedge has not obviously changed since the last annual inspection.

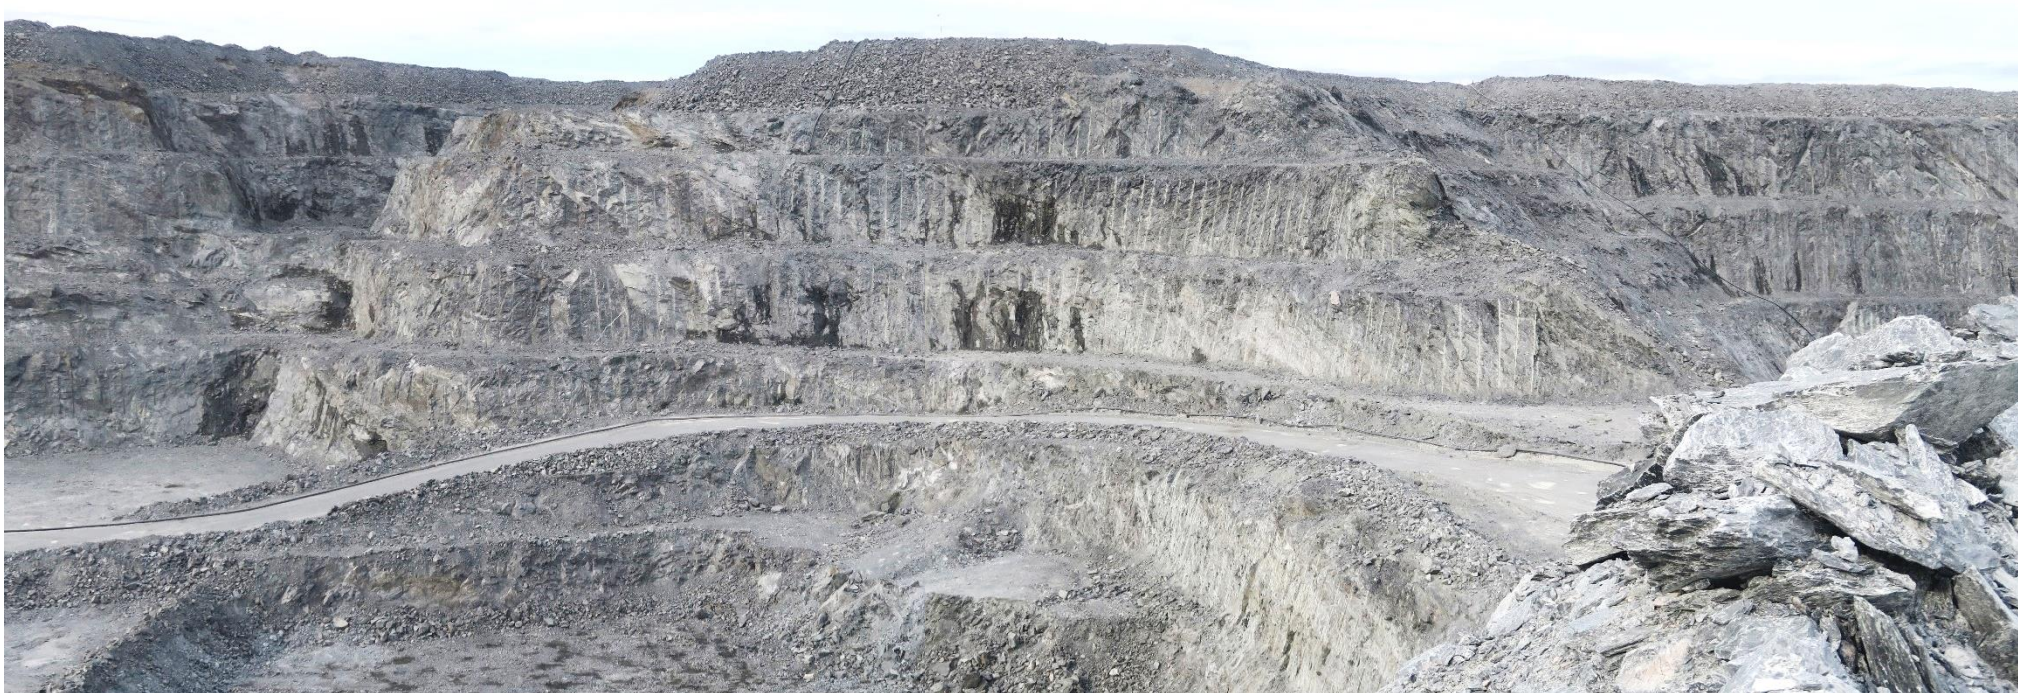
- The East Wall is performing well. However, the crest loss has been greater than planned. This is attributed to the previous Drill and Blast practices.
- The noses formed with the Turtlehead and with the IVR V1 open pit represent potential rockfall hazards and should continue to be a focus of the visual inspections.
- Note that the lowermost bench was recently established and has not yet been scaled.
