Whale Tail 2024 Annual Open Pit Geomechanical Inspection

February 3, 2025

RE: Meadowbank Complex - Amaruq Site - 2024 Annual Open Pit Geomechanical Inspection

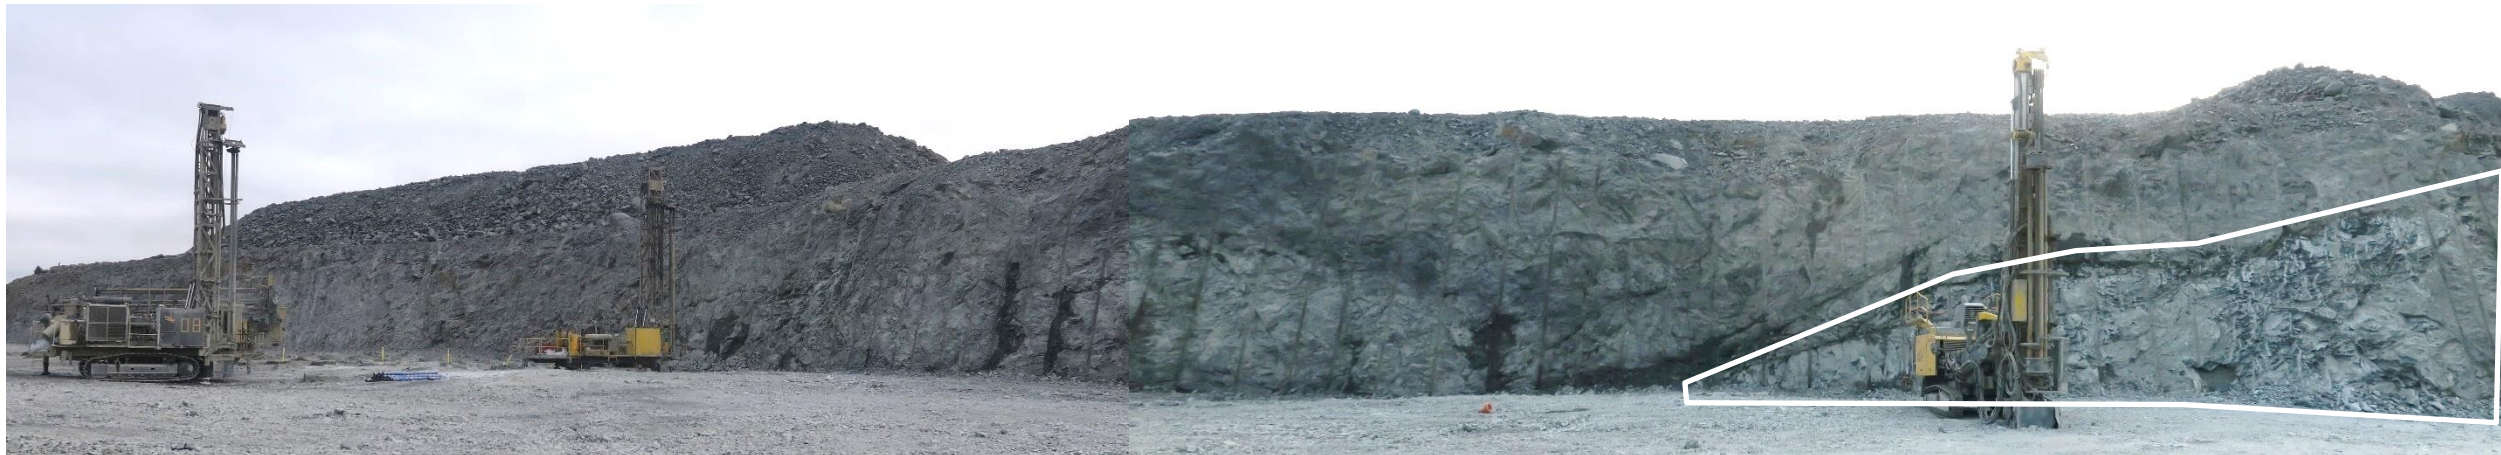
- The pushback of the west wall is in progress. Only a single bench was exposed at the time of the annual inspection.
- The rock mass structure is favourable in this sector and the bench has performed well.

- Previous drilling and blasting practices were adversely impacting the performance of the benches on the west and east walls, with hard toes, crest loss, and frozen rock on the face regularly observed. Drilling and blasting practices have been progressively improved in the first half of 2024. The push back bench appears to have benefited from this approach and half-barrels are regularly observed. The impact has not yet been quantified, but this is a positive development.

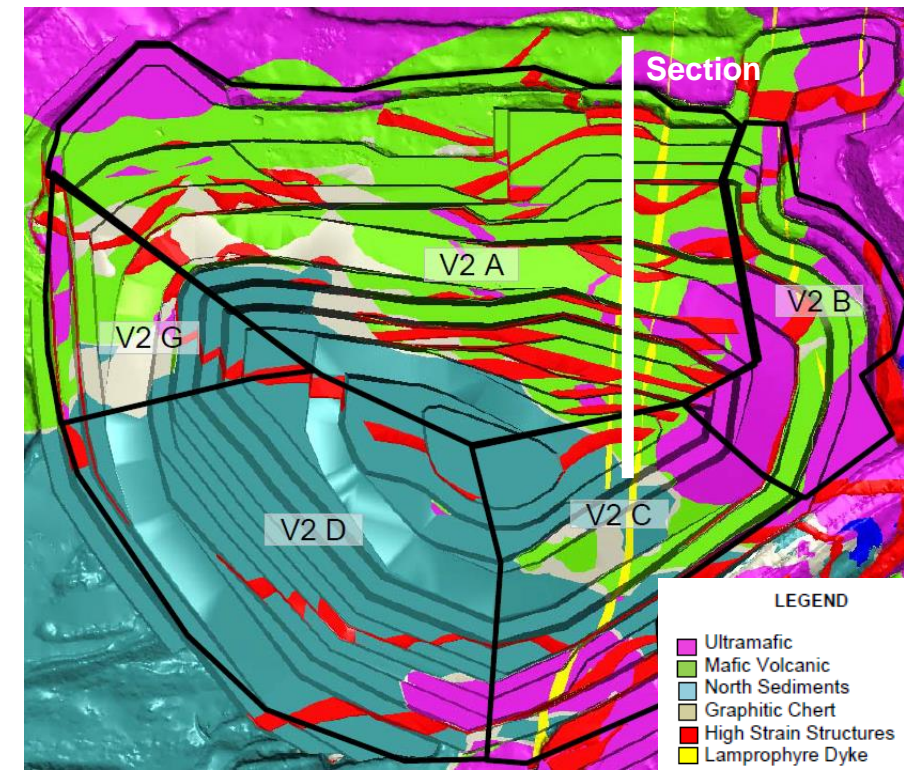
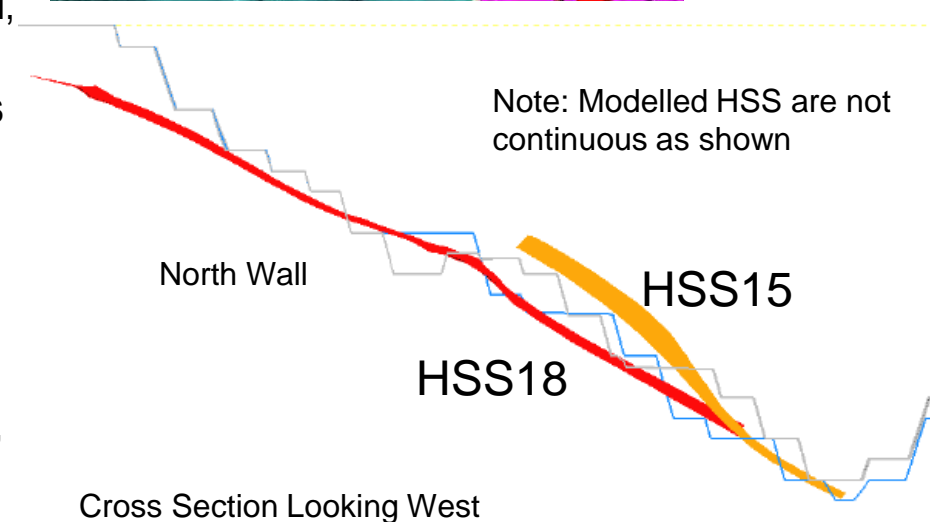
- As a result, there is a need for on-going geological and geomechanical mapping to confirm the lithology and rock mass structure exposed in the pit walls. If there are significant changes to the interpretation of the Komatiite or High-Strain / Brittle Structures, the potential impact on the open pit slope performance and design should be assessed.

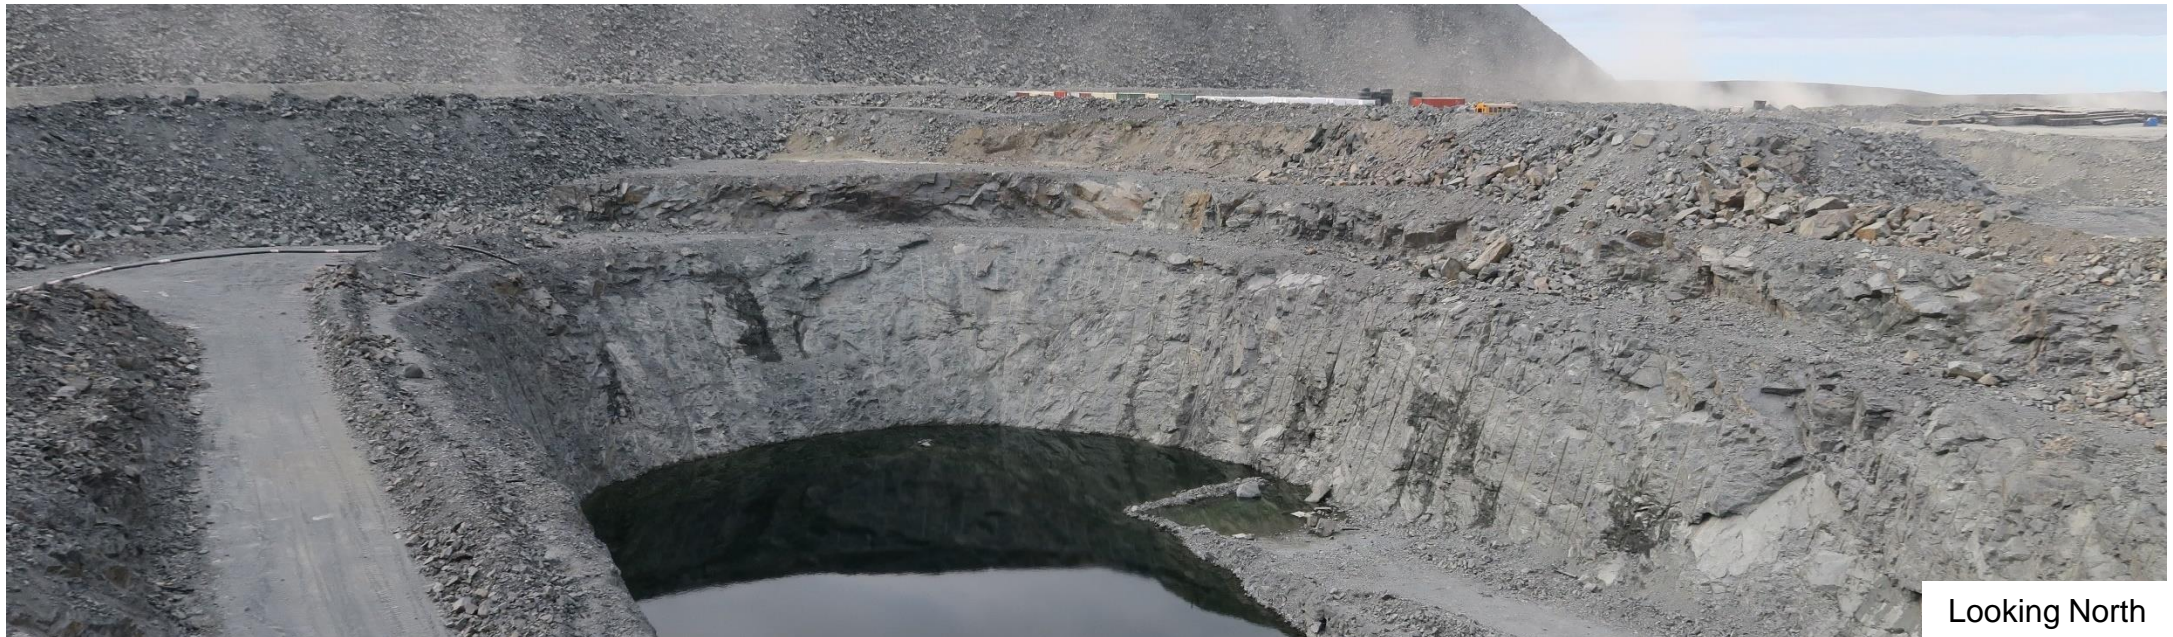
- Mining of the IVR West 2 pit is complete. A berm has been constructed on the ramp to prevent access to the open pit.
- It is understood that the pit is periodically used as a discharge point for water management but is never accessed. No dewatering infrastructure is present within the pit.
- Multiple rockfall hazards are present along the crest of the open pit above the ramp. If a decision is ever made to re-enter the pit, these hazards will need to be mitigated.

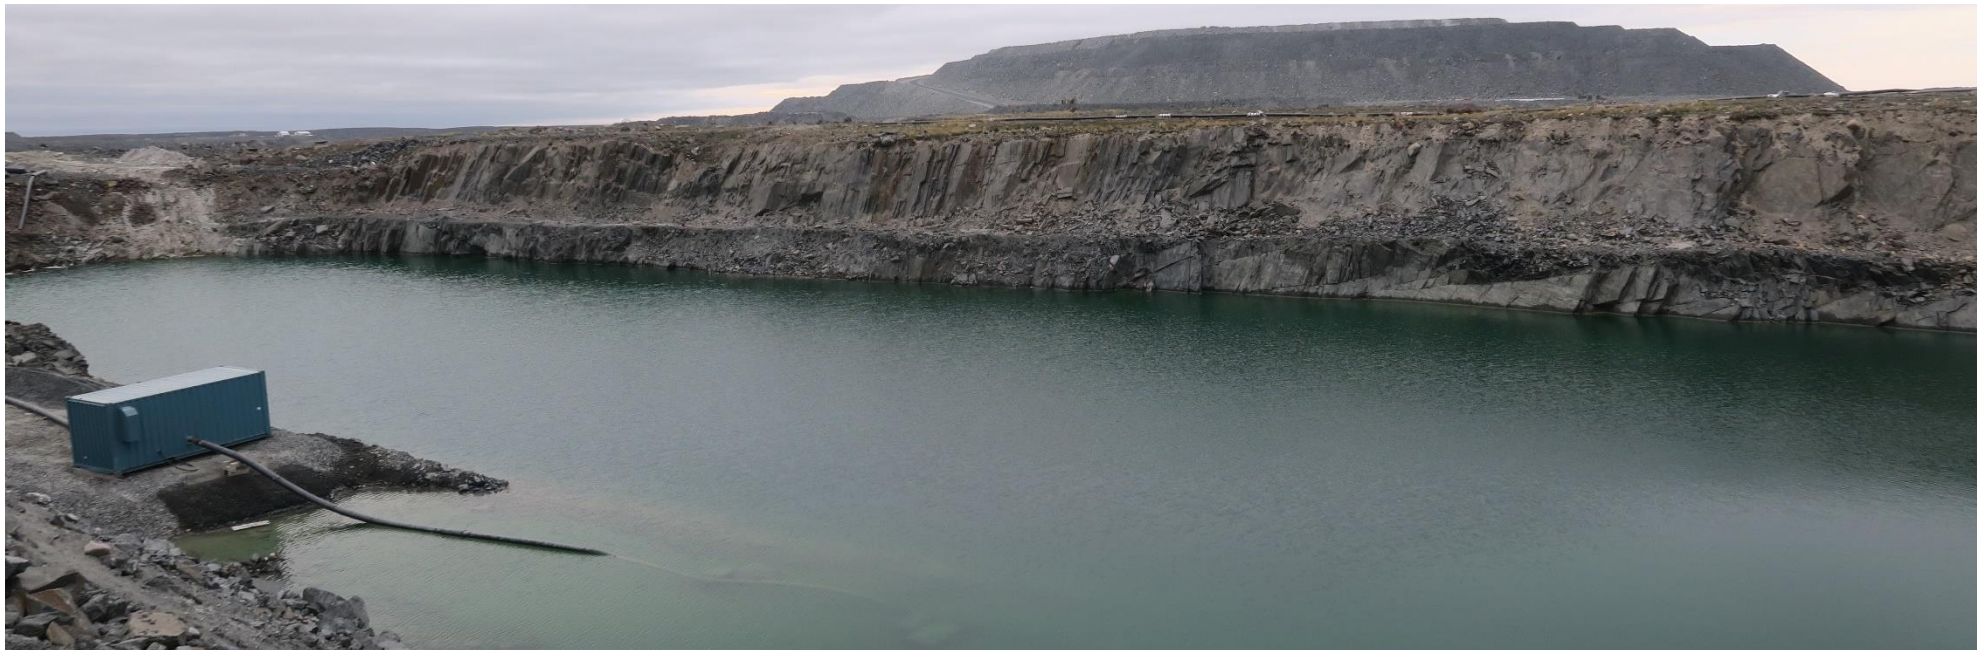
- Attenuation Pond 5 is a former quarry located to the east of the WHL open pit that is now used for water management. The pond was inspected on August 14, 2024.
- The pond is partially flooded, with one to two benches exposed above the pond water level. As a result, a detailed inspection could not be completed.
- No stability concerns were identified in the exposed slopes.
- Pumps were present at the time of the inspection.
