## **Spill 2025-092 - Reportable Spill at Doris Madrid Project (Hope Bay, NU) – 4 Feb 2025 – Drill Cuttings Water – Follow-up report**

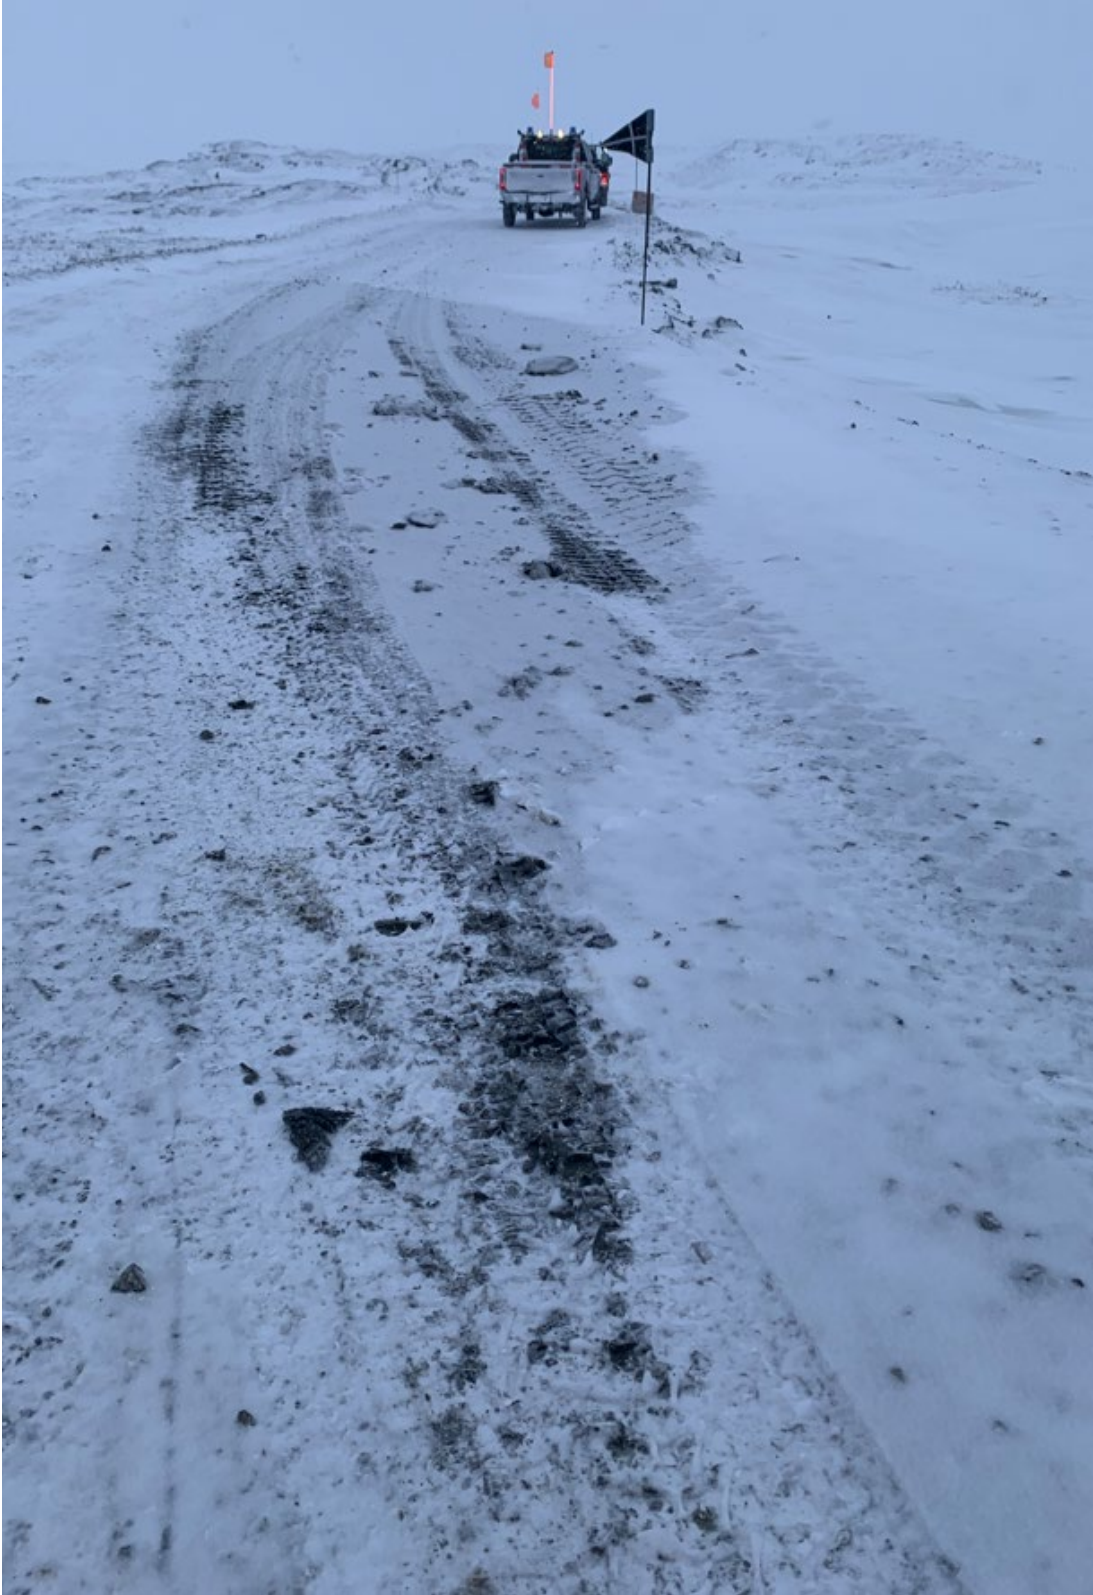
On February 4th at 11:35, while transporting drill cuttings from Drill #11 to the Madrid Waste Rock storage facility, approximately 300 liters of drill cuttings were spilled on the exploration track. Due to the frozen conditions, the spill was contained on the gravel track. Patch Lake, the nearest water body, is approximately 225 meters east of the spill area, and there is no indication that drill water migrated to the tundra. The coordinates of the spill are WGS 84, 68° 03' 21.41" N, 106° 35' 16.61" W.

The loader operator promptly notified the drilling supervisor, the Environment Department, and the Exploration Department. Upon arrival at the spill location, the team observed that the spill was frozen and contained on the surface of the gravel track.

Photo 1: Frozen spill on gravel track (South)

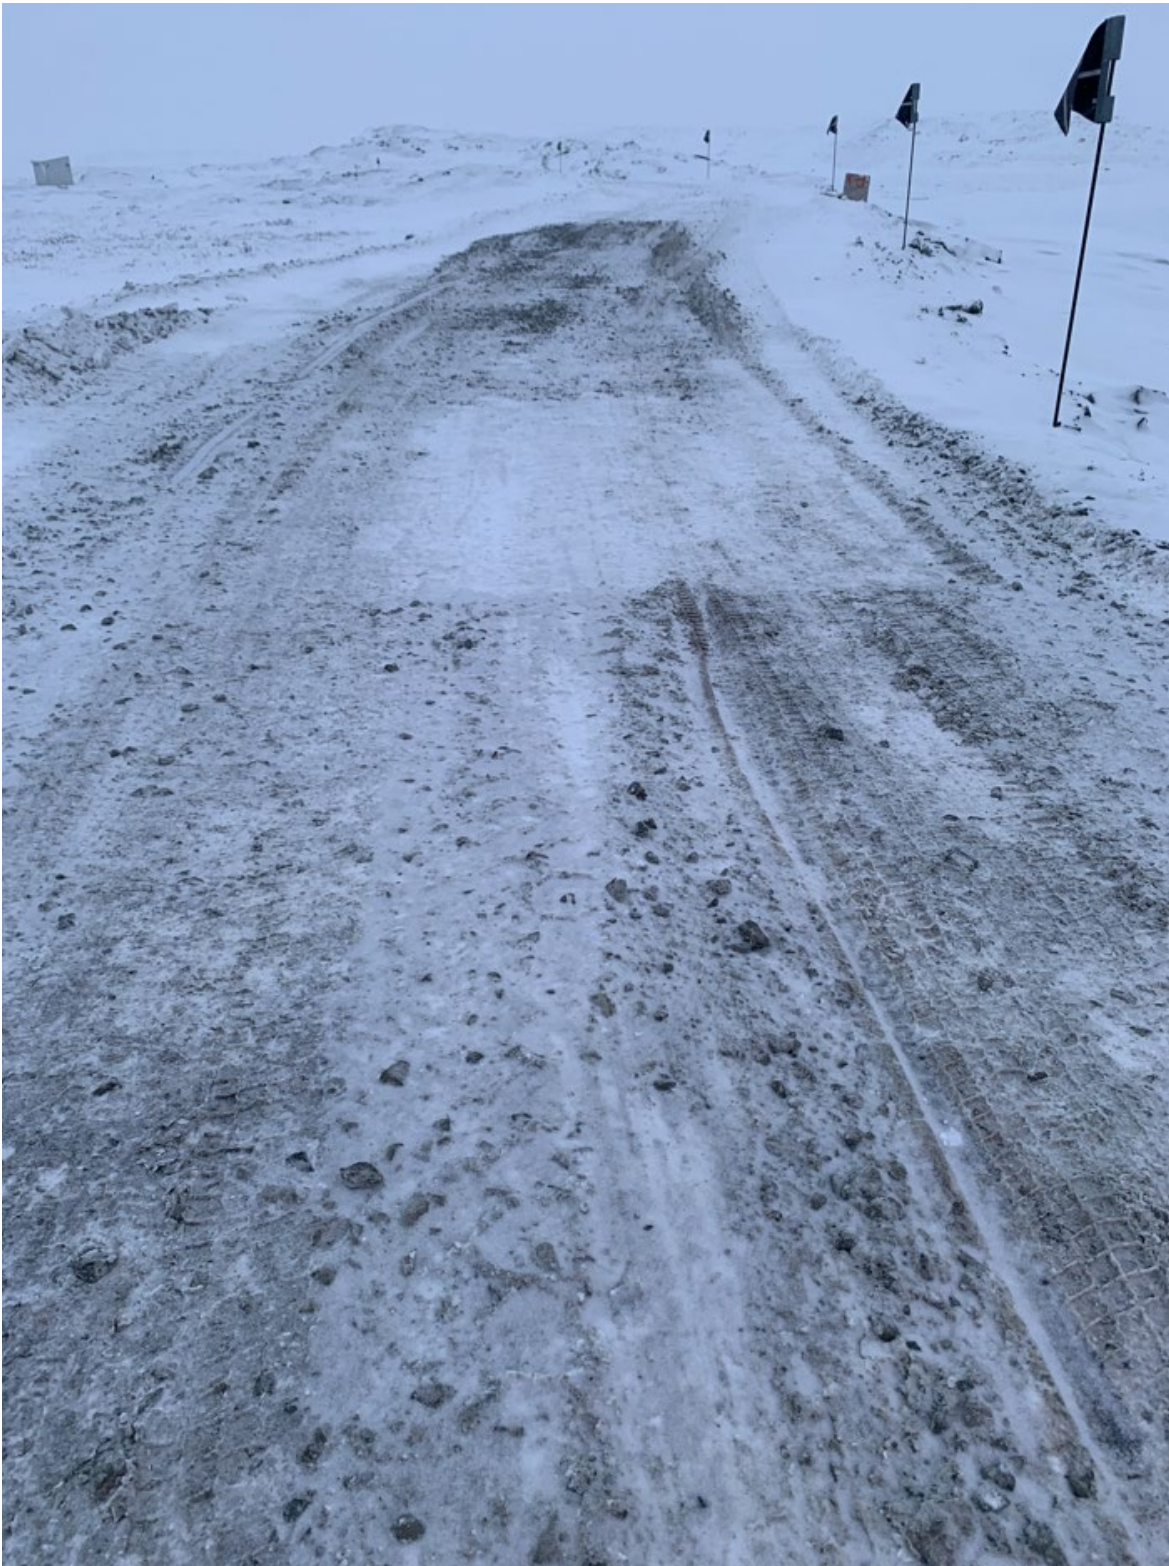
Photo 2: Final Cleanup (South)

The failed aluminum plate and the damaged tote were removed. The remaining two totes were secured to the cuttings rack and subsequently disposed of in the Madrid waste rock pile. A loader was utilized to scrape up the frozen material, which was also disposed of in the Madrid waste rock pile.
