Project: CAPR003759
March 25, 2026

Subject Hope Bay – 2025 Annual Geotechnical Inspection – Site-Wide

Agnico Eagle Mines contracted SRK Consulting (Canada) Inc. to conduct the 2025 Annual Geotechnical Inspection for the Hope Bay site in Nunavut. Hope Bay is a gold mine, located in Nunavut Territory 705 km northeast of Yellowknife, NWT and 153 km southwest of Cambridge Bay, NT. The mine is currently in care and maintenance.

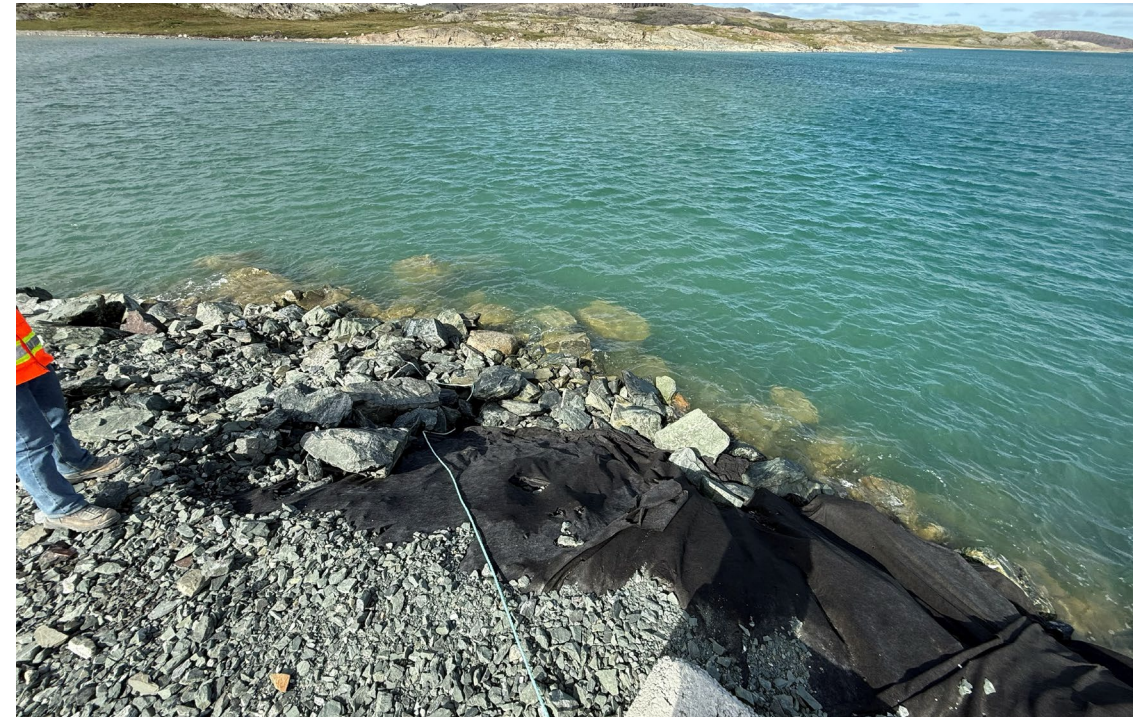
Photo 2: Exposed geotextile on the marine outfall berm

Marine Outfall Berm	<ul style="list-style-type: none"> ▪ Geotextile was exposed at many locations along the south side of the berm and the north corner. ▪ On the north corner of the berm, north of the outfall pipes, riprap is missing from the upper portion of the slope. It appears as though the riprap originally in this location has been relocated to the ocean floor beside the berm. ▪ Wave erosion resulted in minor undercutting at the end of the berm, near the outfall lines. 	<ul style="list-style-type: none"> ▪ Monitor area for progressive erosion and armoring loss. ▪ Replace the missing riprap. ▪ Blast matting could serve as temporary protection. 	<ul style="list-style-type: none"> ▪ 2023-AGI-43 (updated)
20 ML Tank Farm	<ul style="list-style-type: none"> ▪ The overall condition of the tank farm is good. ▪ There has been some rockfall from the highwall, with the largest pieces measuring approximately 30 cm. 	<ul style="list-style-type: none"> ▪ Continue to monitor the crushed rock overliner material and replace material with regular maintenance as required. Crushed rock overliner should be compacted when placed. 	<ul style="list-style-type: none"> ▪ 2022

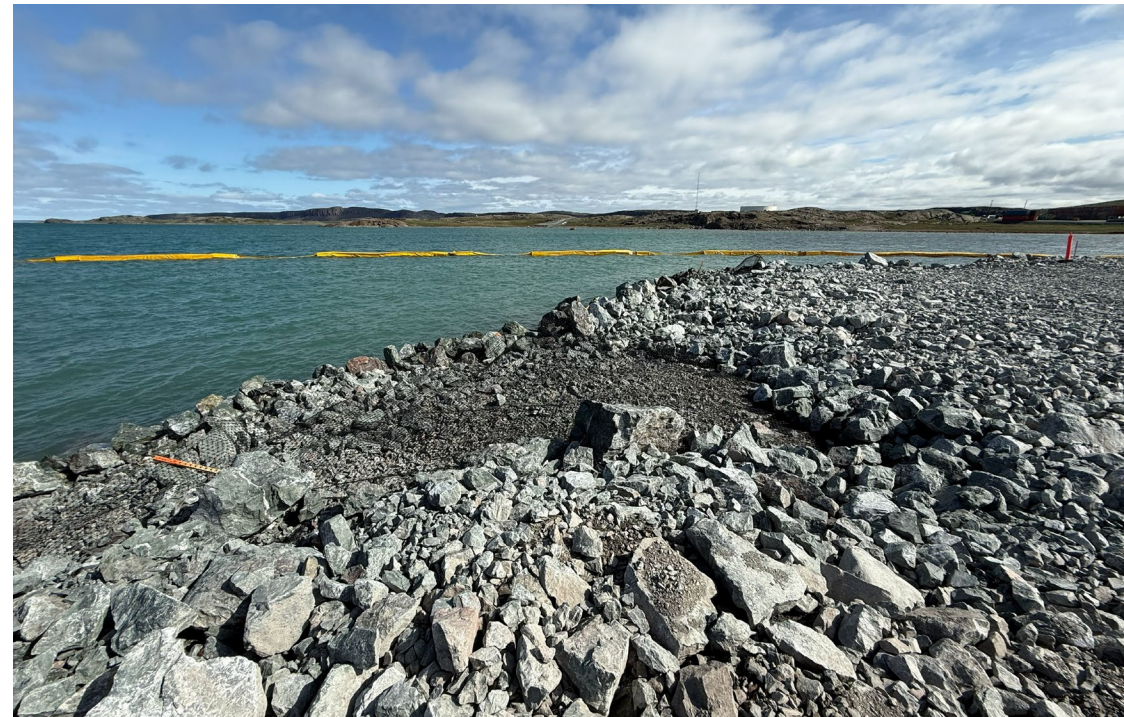
Photo 3: Roberts Bay Jetty, exposed geogrid for inspection (covered following inspection)

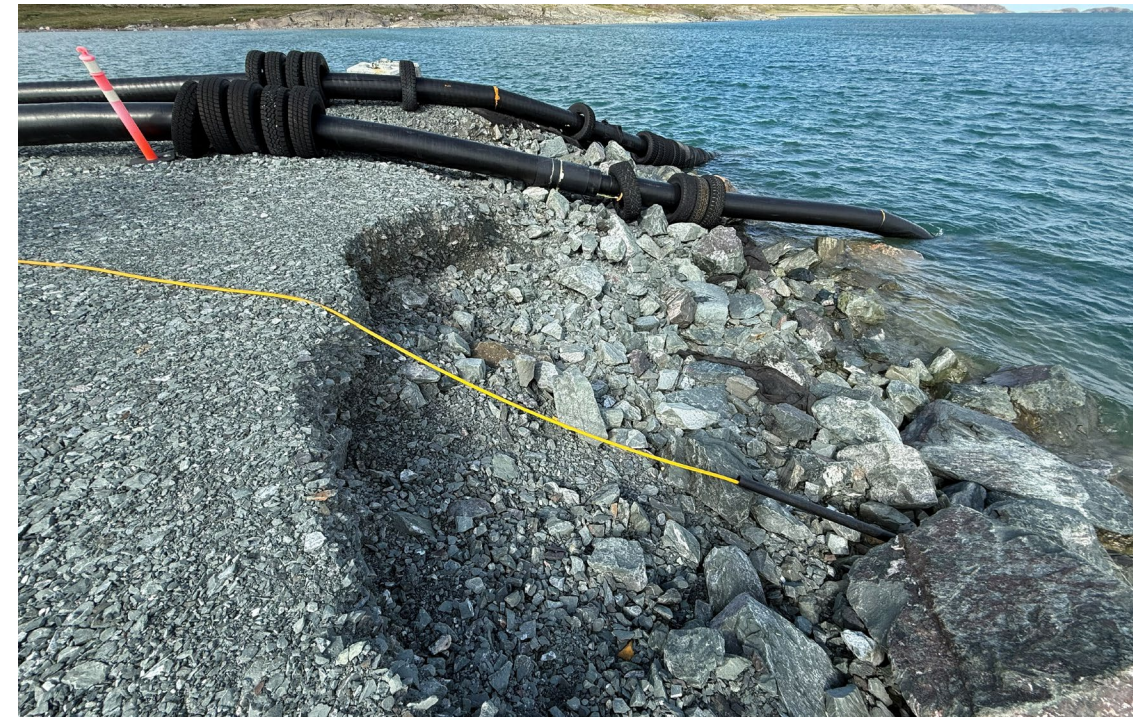
Photo 4: Short vertical face at end of marine outfall berm due to wave erosion

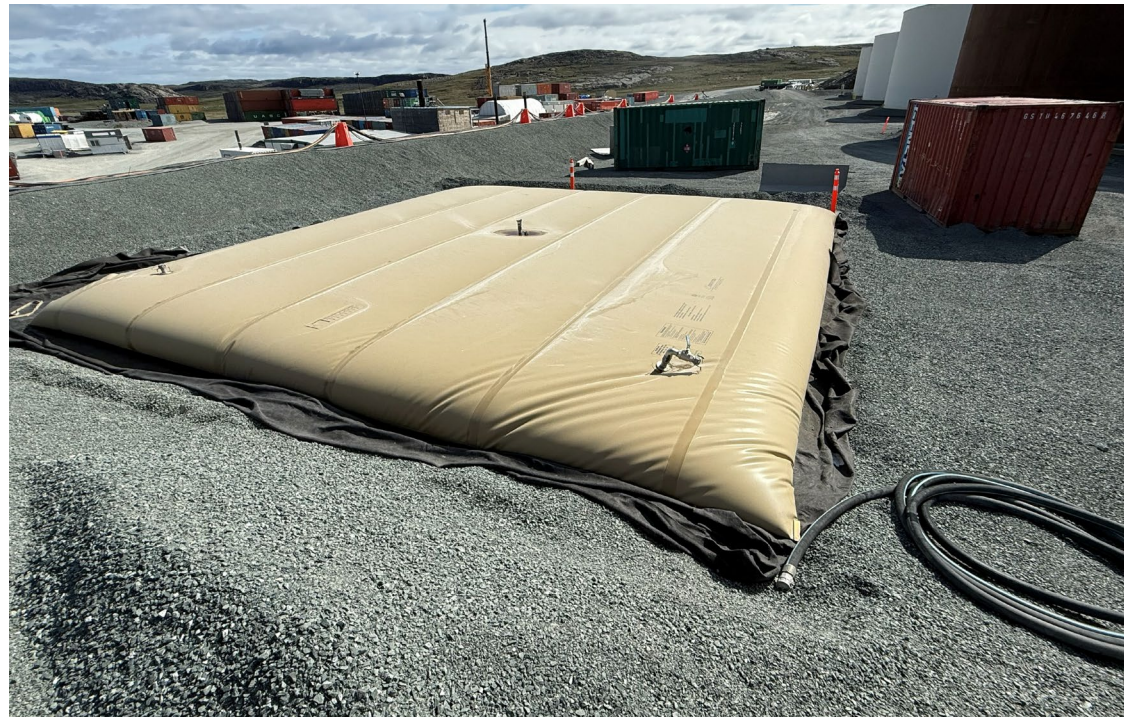
Photo 7: Multi-tank farm (20M liter) – Additional fuel bladder located within the tank farm

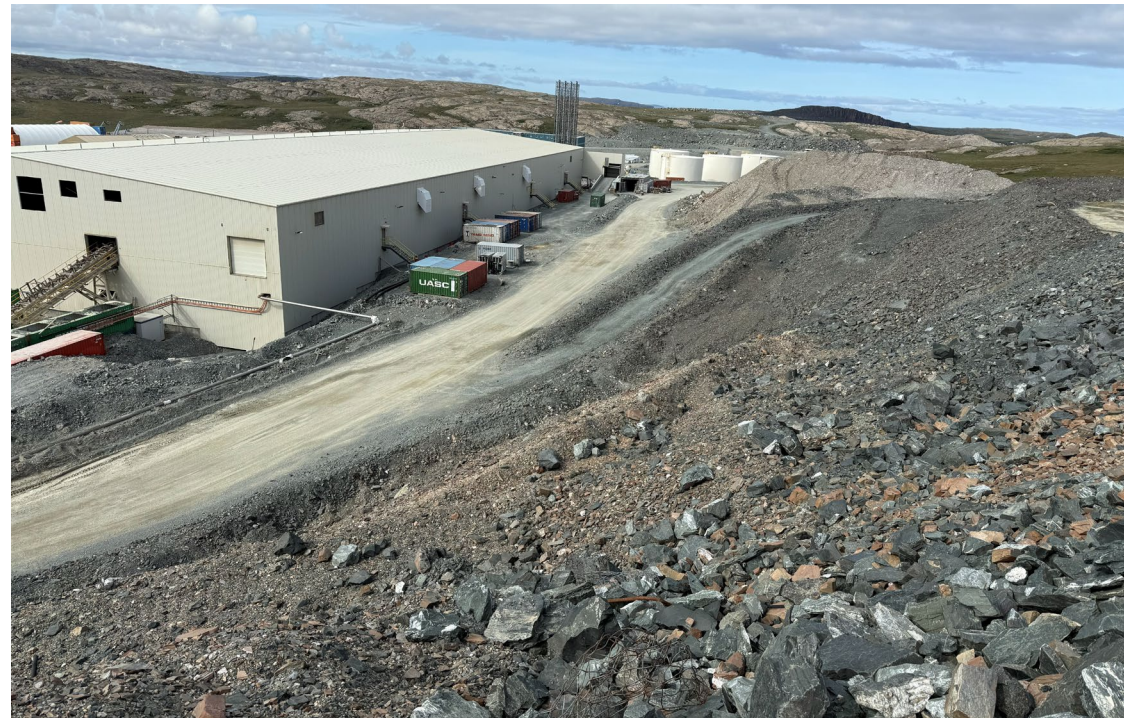
Photo 17: Pad T waste rock slope

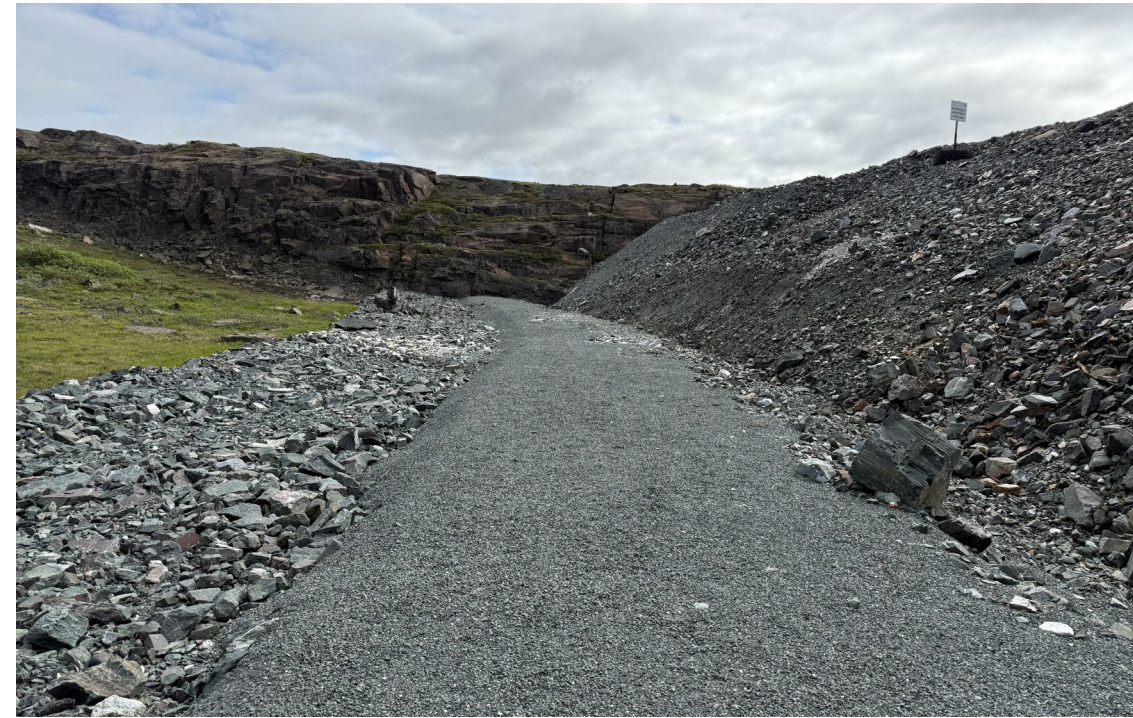
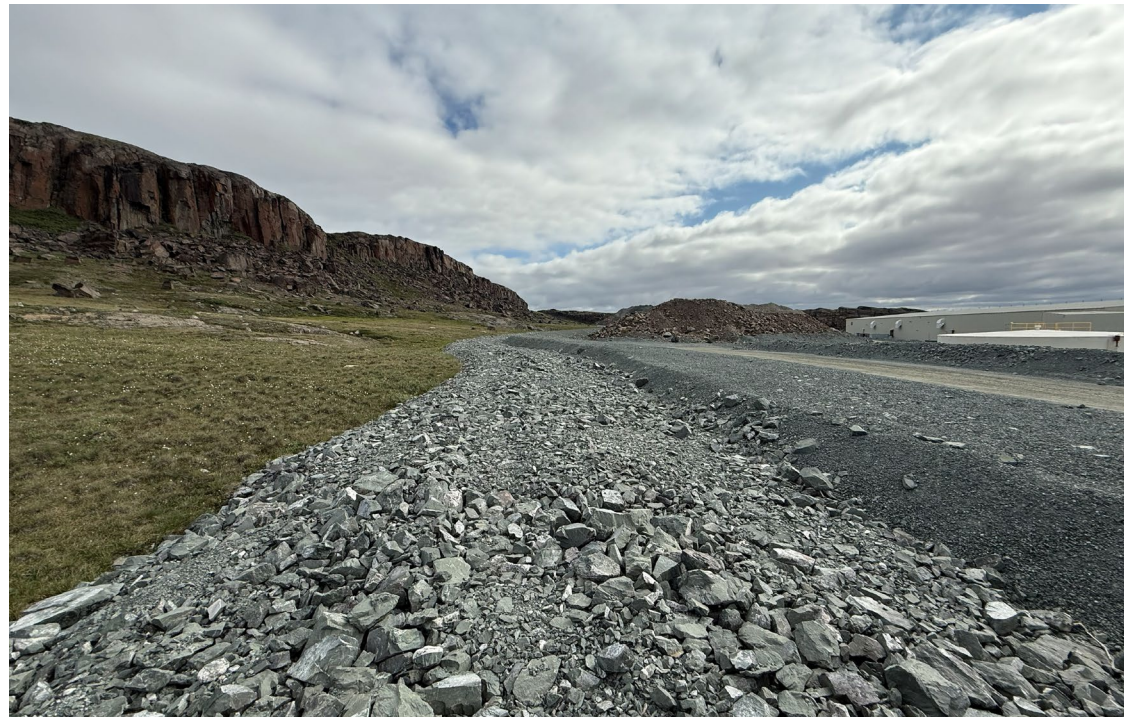
Photo 18: Doris Diversion Berm – upstream end, looking east

Photo 19: Doris Diversion Berm, looking east

Infrastructure	Observations	Recommendations and Comments	Recommendation ID
Doris Diversion Berm (North of Pad T and Camp Pads)	<ul style="list-style-type: none"> ■ Minor undercutting of the downstream side of berm was observed along the access road, due to snow clearing, and the geotextile protecting the diversion berm geomembrane is exposed in a few areas. ■ Tension cracking and thaw settlement of thermal protection layer toe on upstream side of the berm. ■ Minor differential settlement observed near upstream side of west diversion. 	<ul style="list-style-type: none"> ■ <i>Overall, the structure is in satisfactory condition.</i> 	<ul style="list-style-type: none"> ■ <i>N/A</i>
		<ul style="list-style-type: none"> ■ Cover exposed diversion berm geotextile. Consider reestablishing the design slope and/or establishing practices to limit further cutback of the downstream berm during snow clearing and grading. 	<ul style="list-style-type: none"> ■ 2023-AGI-23

<ul style="list-style-type: none"> ■ Consider methods to limit future migration of waste rock to the upstream side of the diversion berm. 	<ul style="list-style-type: none"> ■ 2023-AGI-24
Pad T Waste Rock Pile	<ul style="list-style-type: none"> ■ No significant changes have been made to the Pad T WRP in the past year, waste rock which noted to be displaced beyond the diversion berm was relocated to the south side of the berm. ■ No changes to past recommendations. 	<ul style="list-style-type: none"> ■ The stability of the pile should be reassessed following resumption of operations or if any significant changes occur before that time. ■ If material from Pad T is to be used for other works on site, the material should be sourced from the south pile crest, currently the steepest portion of the slope, in an effort to further reduce the height and slope of the pile and incrementally increase the factor of safety. 	<ul style="list-style-type: none"> ■ 2023-AGI-25

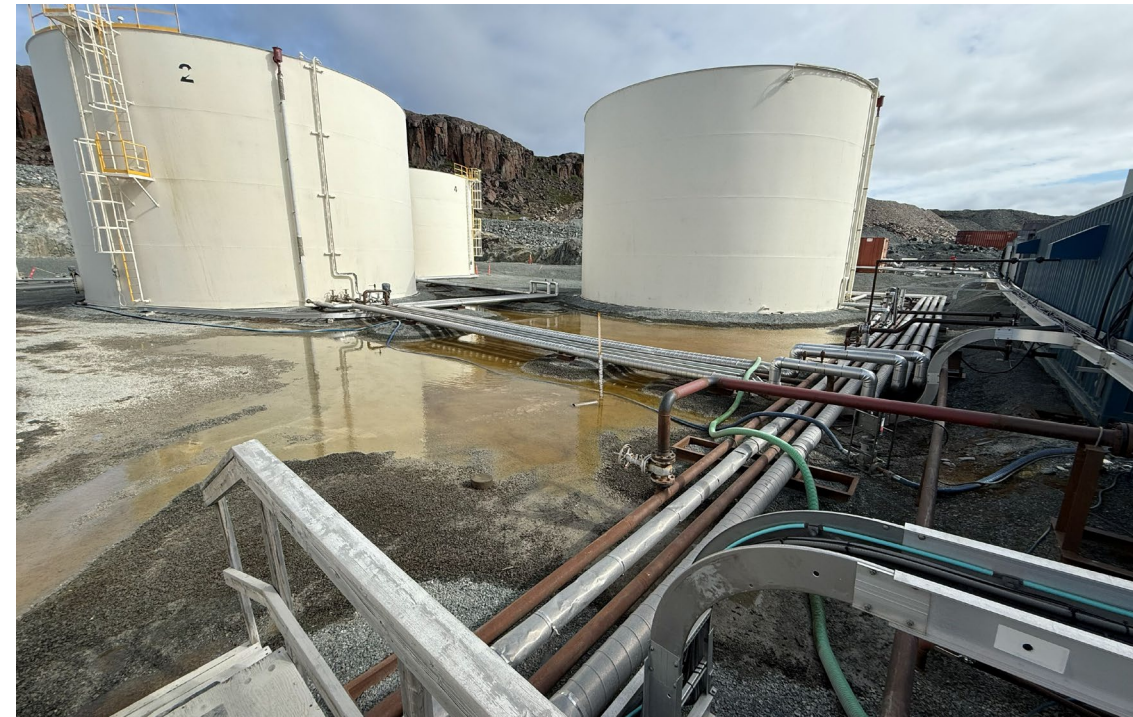
Photo 20: Doris tank farm water accumulation

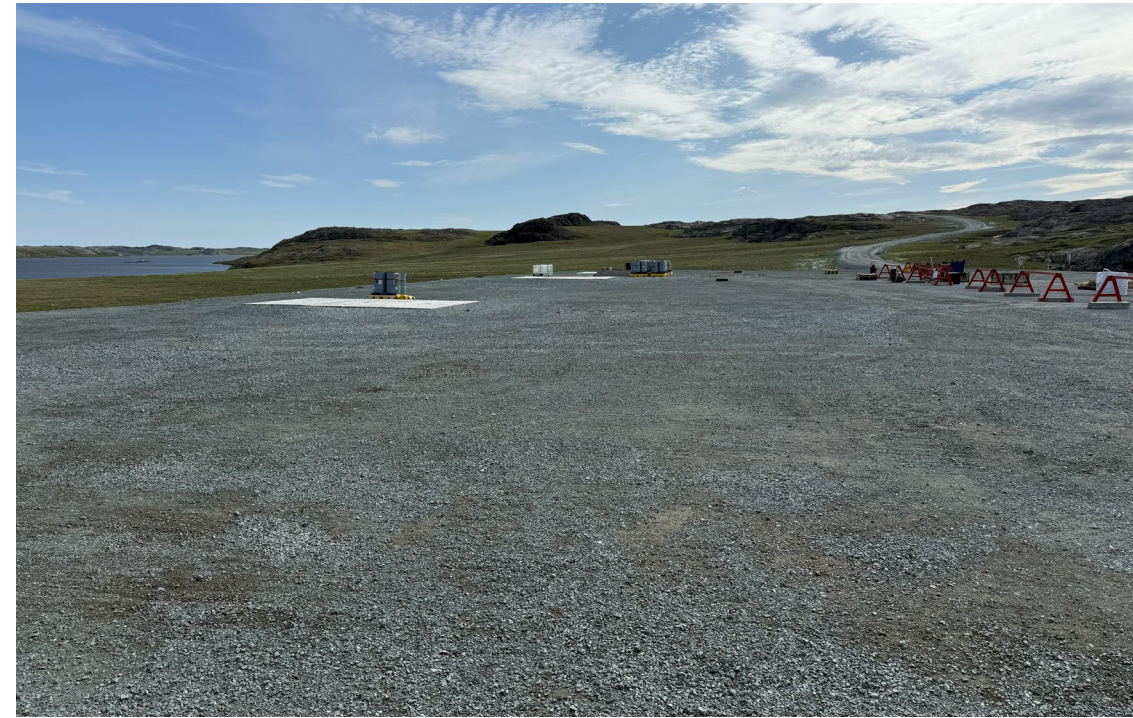
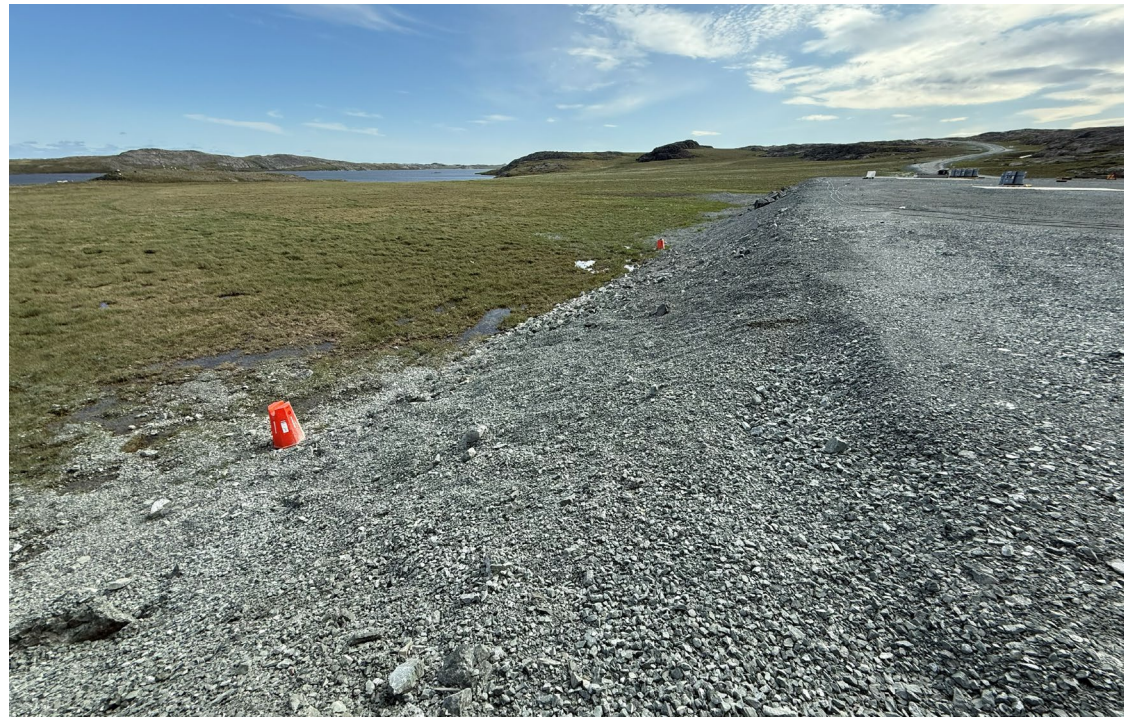
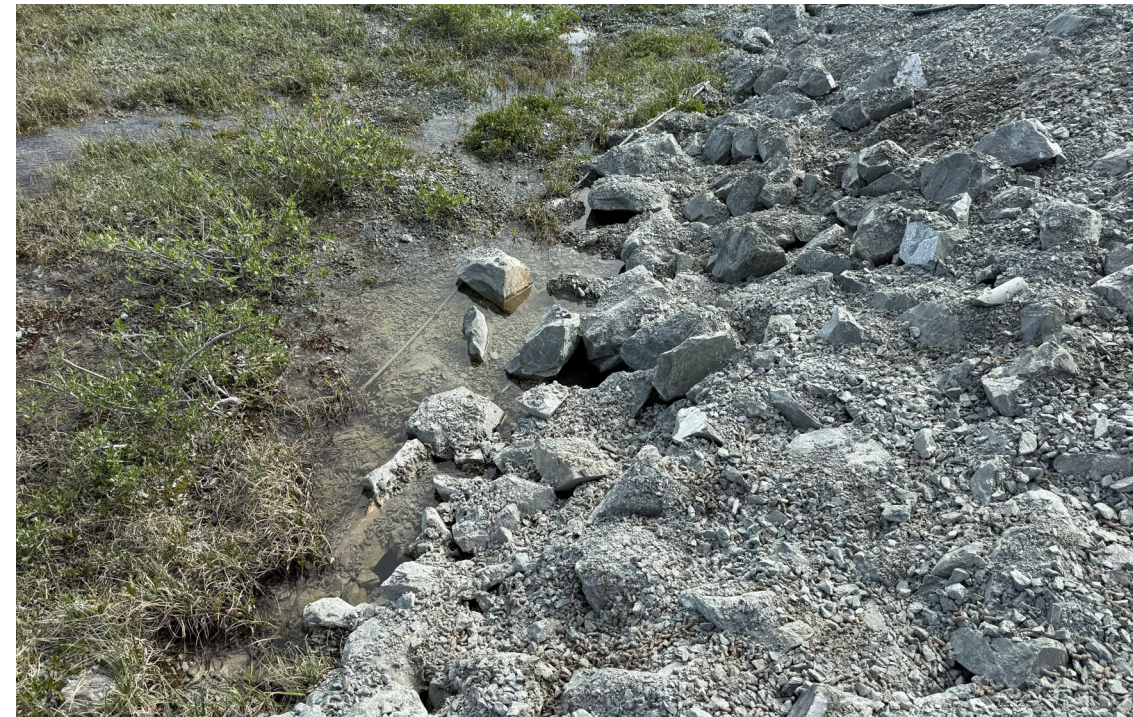
- A sinkhole observed in the helipad in 2023 was backfilled and water management practices upstream of the pad have been improved. No sinkholes or depressions have been observed in

2024 or 2025. It is recommended that a GPR campaign be carried out at the helipad when the next GPR survey is conducted at the airstrip.

Photo 22: Helicopter pad overview

Photo 23: Helicopter pad downstream slope

Photo 24: Helicopter Pad downstream flowing water emanating from toe

<ul style="list-style-type: none"> ■ When high frequency (500 Hz) GPR surveys on the airstrip are completed, consider completing a survey of the helipad. 	<ul style="list-style-type: none"> ■ 2024-AGI-10
Contact Water Pond	<ul style="list-style-type: none"> ■ As observed since 2017, the floor of the contact water pond is undulating due to active layer deepening. As a result small ponds form preventing complete drainage of the pond. 	<ul style="list-style-type: none"> ■ <i>The water retention elements of this pond are the underlying permafrost and HDPE liner which is tied into the permafrost. Therefore, to ensure the pond continues to retain water the permafrost tie-in must be maintained.</i> 	<ul style="list-style-type: none"> ■ N/A

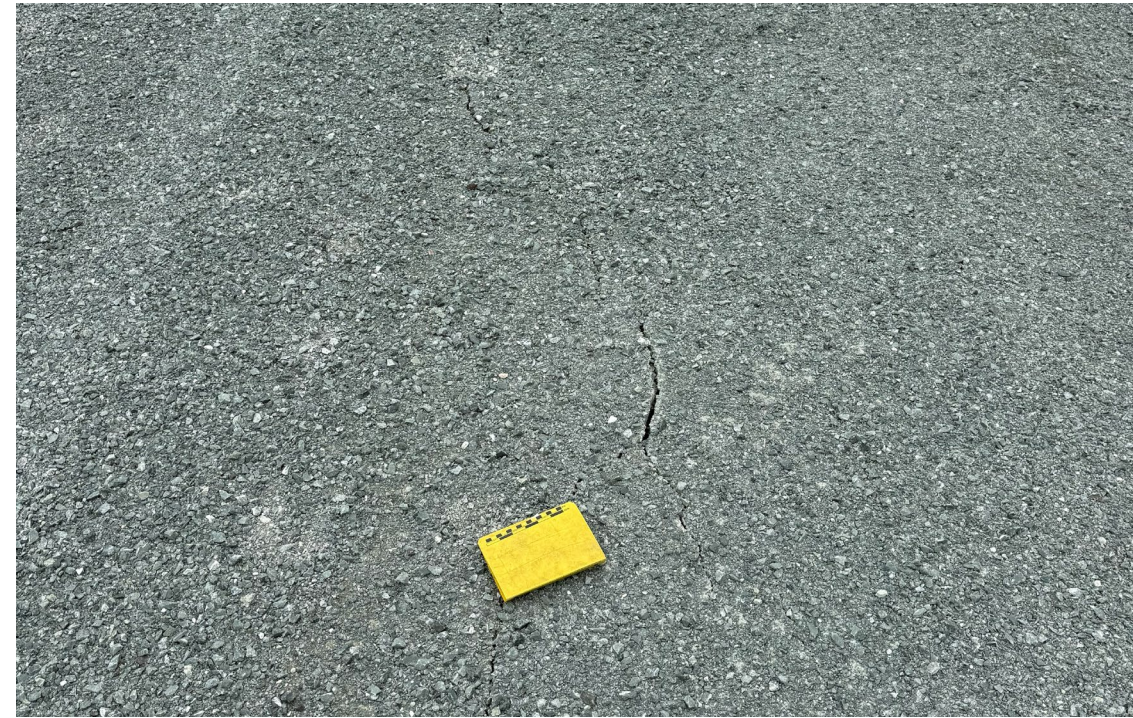
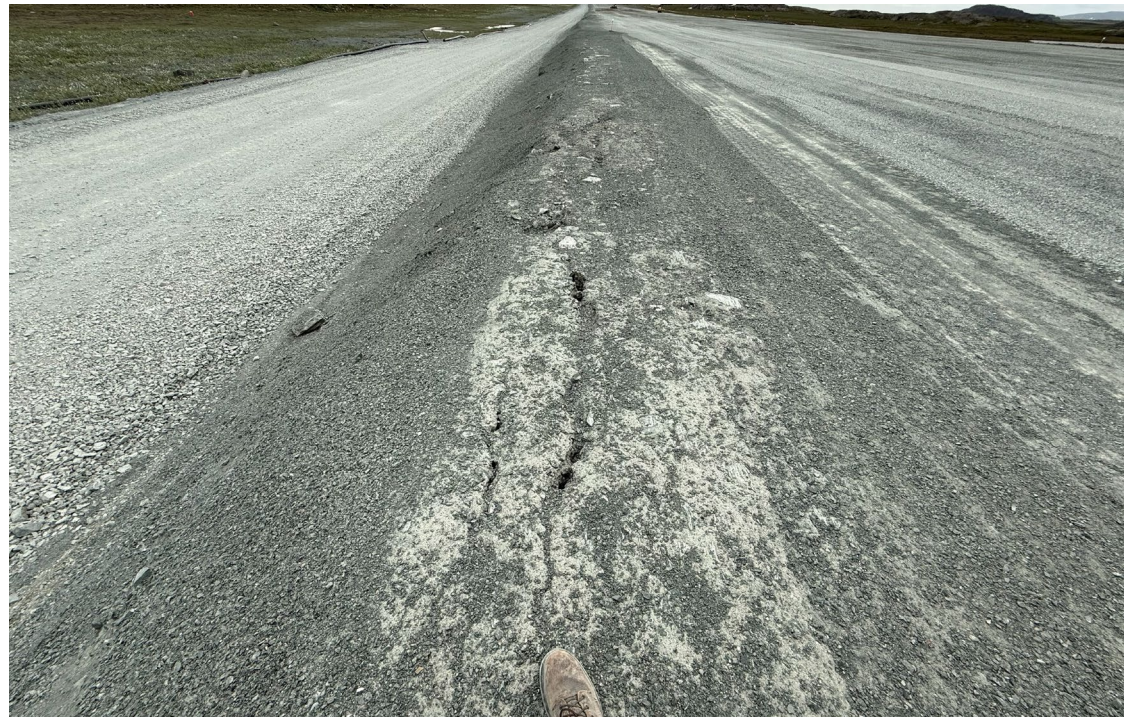
Photo 26: Airstrip shoulder tension cracking

Photo 27: Airstrip shoulder tension cracking at the edge

Airstrip and Aprons	<ul style="list-style-type: none"> ■ Airstrip has been undergoing increased grading maintenance which has greatly reduced visible tension cracking on the surfacing material (parallel or perpendicular to shoulders. ■ A second ground penetrating radar survey was completed to identify potential voids within the airstrip fill or foundation (which may progress to sinkhole formation). ■ The results of the ground penetrating radar survey indicate no clear presence of a large void. ■ Anomalies identified were not replicated with successive passes and as such only single point anomalies were identified along the location of the historic airstrip alignment, which is expected to be a more loose fill, and historic photos have indicated substantial tension crack voids along the shoulder prior to widening the airstrip. ■ A reading was collected at the SRK-22 GTC which is located west of the airstrip. 	<ul style="list-style-type: none"> ■ <i>Based on the visual inspection the airstrip appears to be in satisfactory condition; however, visual inspection cannot rule out the formation of sinkholes in the future. Additionally, the placement of crush material limited what could be seen over the surface of most of the airstrip.</i> ■ Conduct regular visual inspections prior to flights. ■ As noted in previous inspections, the cracking observed along the slopes of the airstrip is expected to be due to thaw settlement. Limiting disturbance to the permafrost on either side of the airstrip and taking steps to reduce the water flowing or ponding along the airstrip will likely reduce the required maintenance. Site can also consider strategic placement of additional fill material at the western toe of the airstrip in areas to limit permafrost degradation and move ponded water further from the toe of the airstrip. ■ Continue dewatering the upstream ponds early in freshet, limiting potential for thaw. ■ Site should continue to limit traffic near the crest and shoulders of the airstrip (particularly outside of the runway lights), especially during the summer and early fall when the active layer is deepest. ■ <i>Completed: The point reflectors identified by the GPR within the airstrip fill are at depths greater than 1.9 meters, these areas should be inspected and monitored regularly for signs of surface expression. In addition, they should be investigated further using GPR techniques available on site (500 MHz Noggin GPR used to conduct ice surveys for exploration).</i> ■ Monthly monitoring of the thermistor located near the airstrip (SRK-22) should be resumed as part of site wide GTC monitoring, for at least one year, to determine if there are any changes in the ground temperature regime in the area. 	<ul style="list-style-type: none"> ■ 2023-AGI-40 (updated) ■ 2024-AGI-15 ■ 2023-AGI-41

Infrastructure	Observations	Recommendations and Comments	Recommendation ID
		<ul style="list-style-type: none"> ▪ The design slope of the east side of the airstrip, along the access road, should be reestablished and markers should be placed during winter to prevent additional undercutting of the slope due to snow clearing. 	<ul style="list-style-type: none"> ▪ 2023-AGI-42
Doris Roads	<ul style="list-style-type: none"> ▪ Roads were generally observed to be in good condition. 	<ul style="list-style-type: none"> ▪ <i>Overall roads are in satisfactory condition, and nothing more than routine maintenance was noted.</i> 	<ul style="list-style-type: none"> ▪ N/A
Jetty	<ul style="list-style-type: none"> ▪ The jetty was expanded from a single berth to four berths to increase the potential offload rate during sea lift. The jetty construction was nearly complete during the inspection. ▪ Prior exposed geogrid on sea floor has now been buried. ▪ The new Jetty design has a much lower crest elevation to allow NEAS barge ramps to land. However, water is now able to exceed the crest during high tides, and may result in some additional maintenance following storms and prior to sealift. 	<ul style="list-style-type: none"> ▪ <i>Overall this structure is in satisfactory condition.</i> ▪ <i>Consider placing lock blocks as temporary wave breaks along the crest (offset in two meters) to limit maintenance requirements.</i> 	<ul style="list-style-type: none"> ▪ N/A

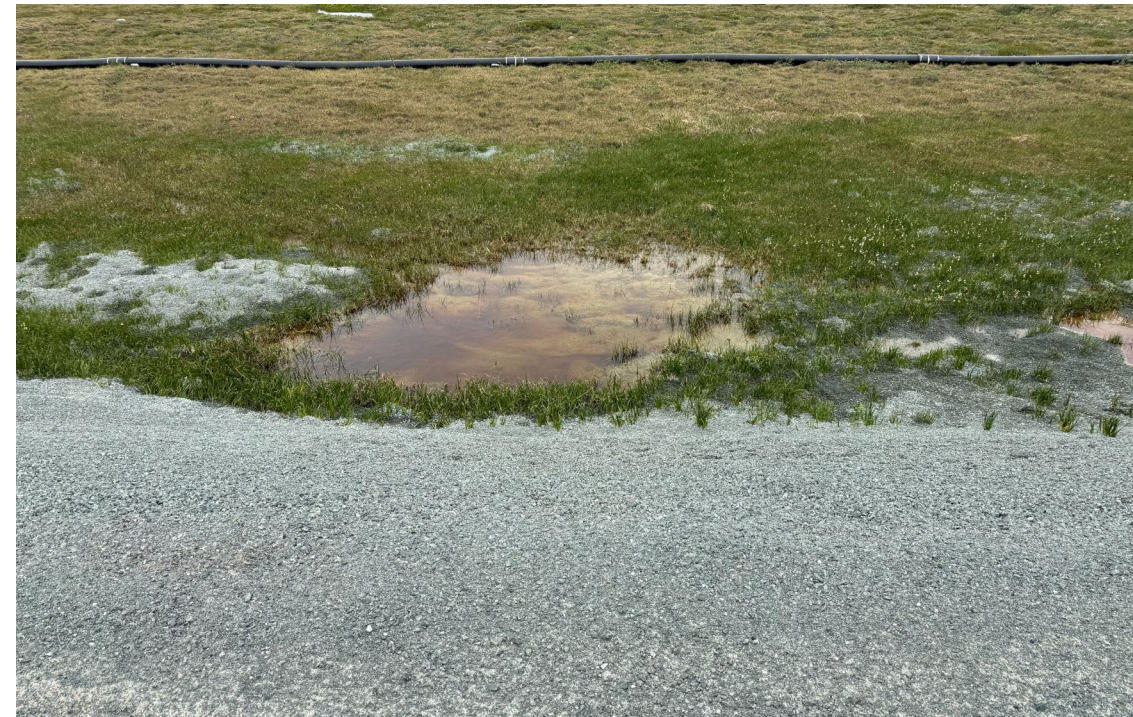
Photo 28: Water accumulation on the west side of the airstrip

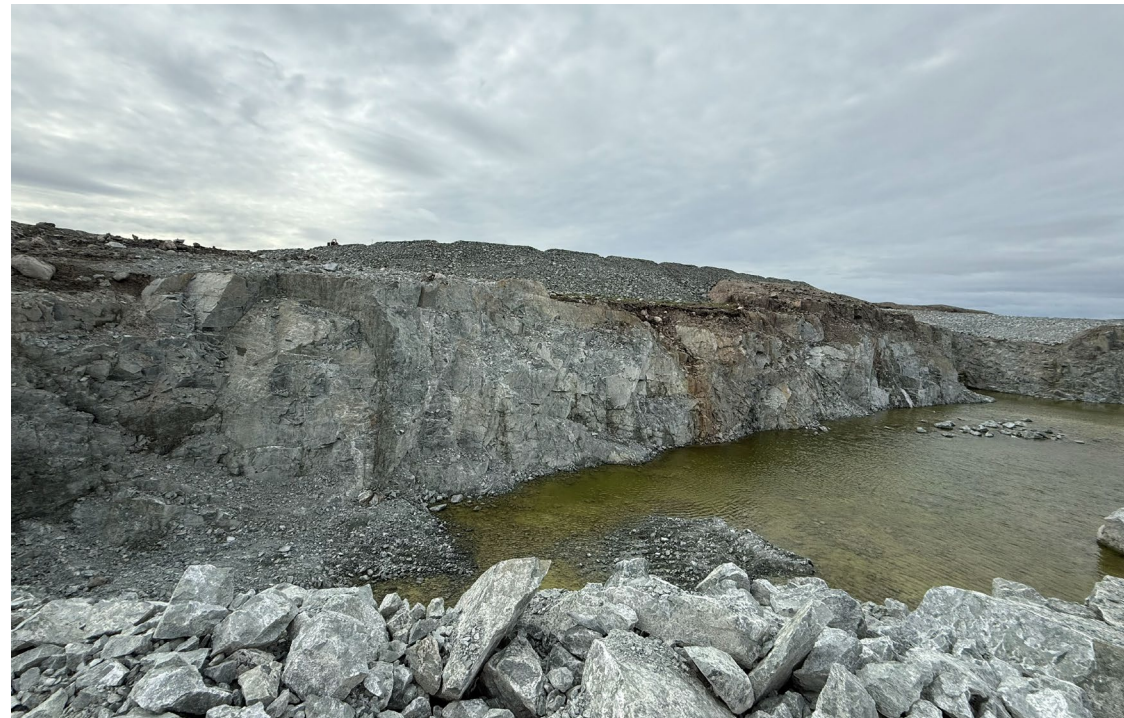
Photo 37: Madrid North Sump 1 west wall

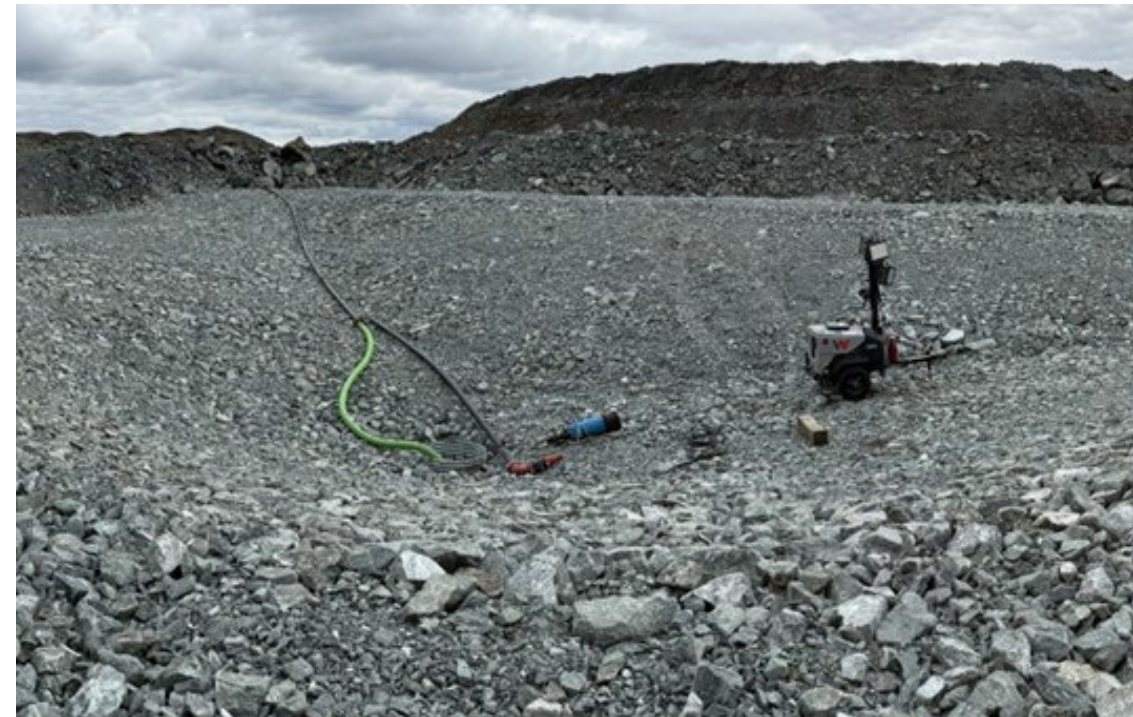
Photo 40: Sump 1B – north of Madrid Waste Rock Pile

Sump 1B	<ul style="list-style-type: none"> ■ Construction was completed in May 2025. ■ The structure appears to have performed well during the first freshet. ■ Dewatering pumps were active at the time of inspection. No evidence of seepage flow was noted downstream along the previous flow path. 	<ul style="list-style-type: none"> ■ Complete the GTC installation as per the design (Planned for 2026). ■ Establish an OMS manual for Sump 1B. 	■ 2025-AGI-05
Contact Water Pond	<ul style="list-style-type: none"> ■ Madrid CWP has been designed to be breached once construction of Sump 1 was complete. ■ Fly rock from Sump 1 blasting has perforated the liner. The CWP has a seep through a fracture in the bedrock so the water level has historically never increased more than 0.5 m, however the water level should be monitored to avoid water backing up and flooding the perforated liner, leading to excessive flow into Sump 1. ■ Up to 0.5 m of water was noted on the upstream side of the liner during the inspection. ■ Two survey monitoring events occurred in 2025 (July and September). ■ Where survey data is available, vertical and horizontal displacements for the downstream surface settlement points have increased. This is expected to be at least partially related to blast induced vibration from Sump 1 construction. Total displacements are within 0.35 m since 2019. (See Attachment 7). 	<ul style="list-style-type: none"> ■ Increase monitoring frequency of surficial settlement points (Monthly between May and November) to provide better resolution on the displacements observed. ■ Implement a plan for decommissioning of the CWP or repurposing as part of the waste rock piles. 	■ 2023-AGI-46 ■ 2025-AGI-06

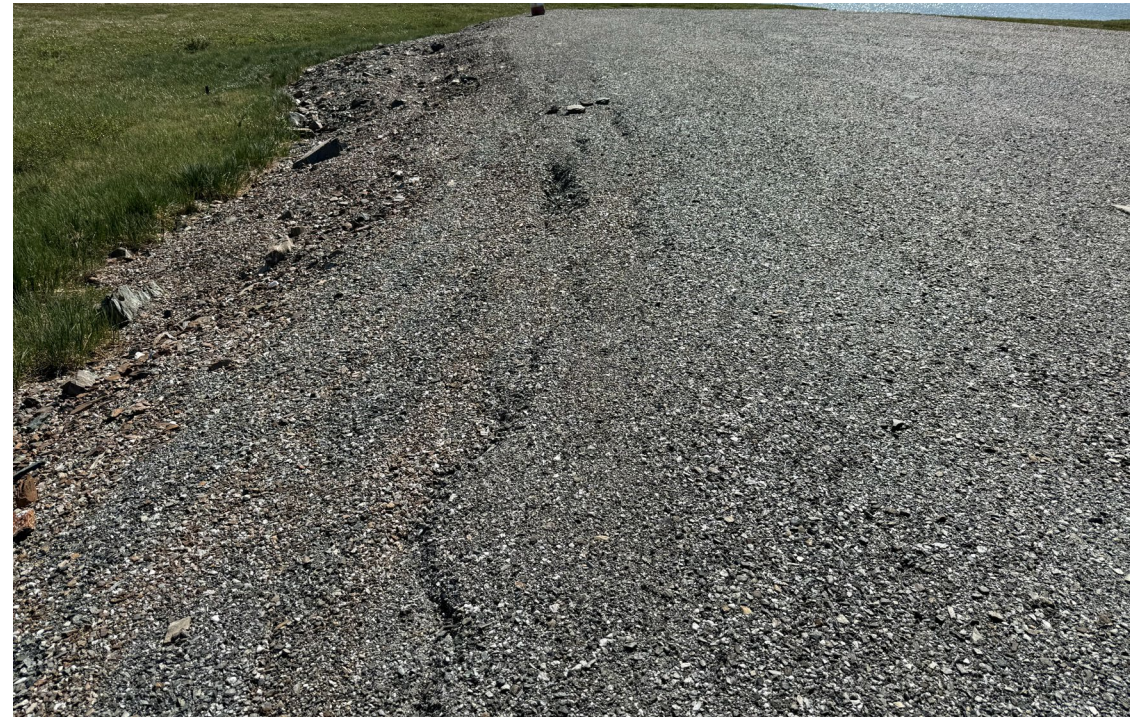
Photo 10: Tension cracking along shoulder of Boston Airstrip

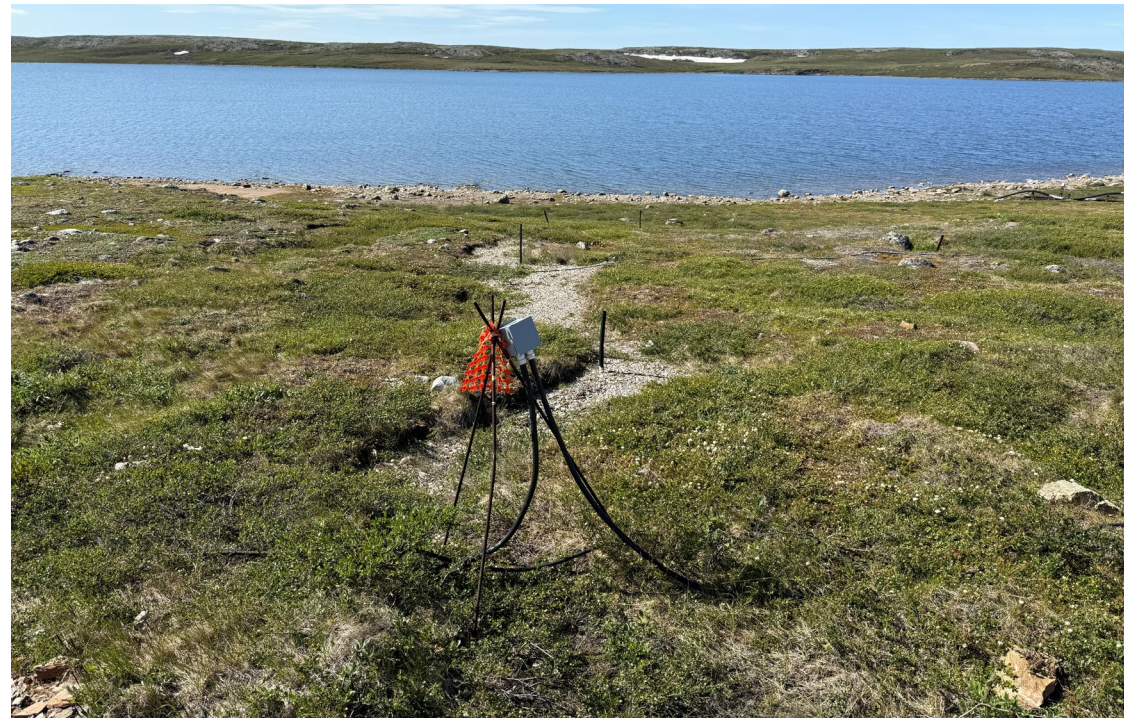
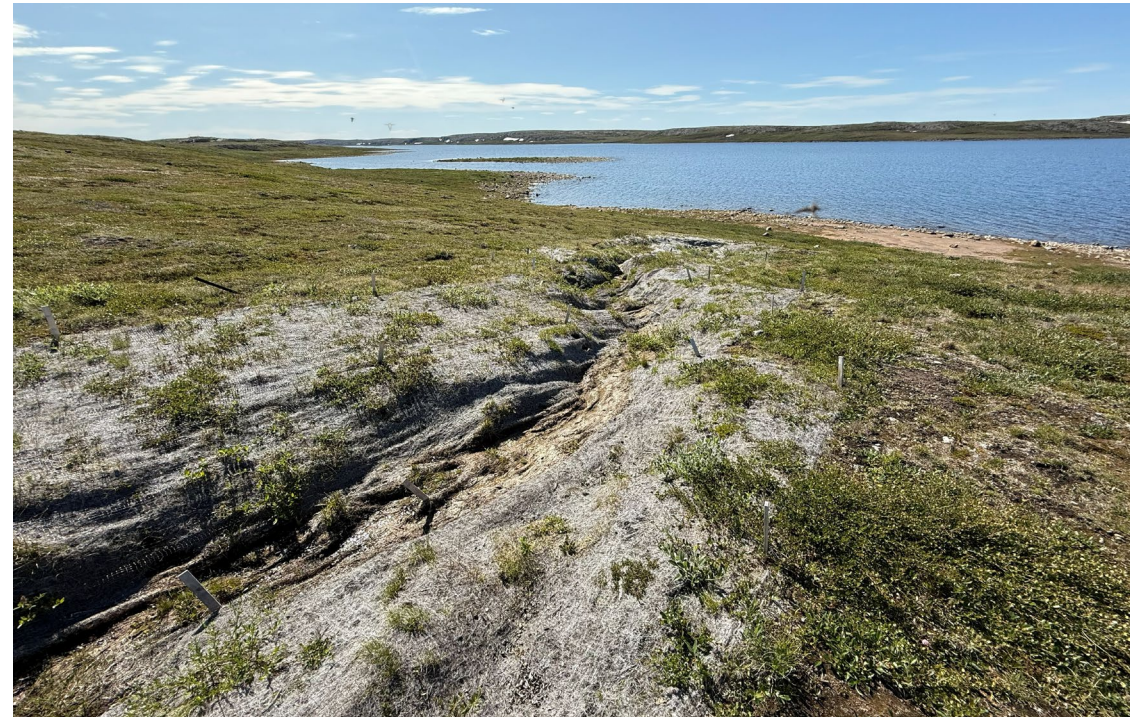
Photo 13: Thermal erosion gully west of Boston Camp

Photo 14: Thermal erosion gully west of Boston Camp

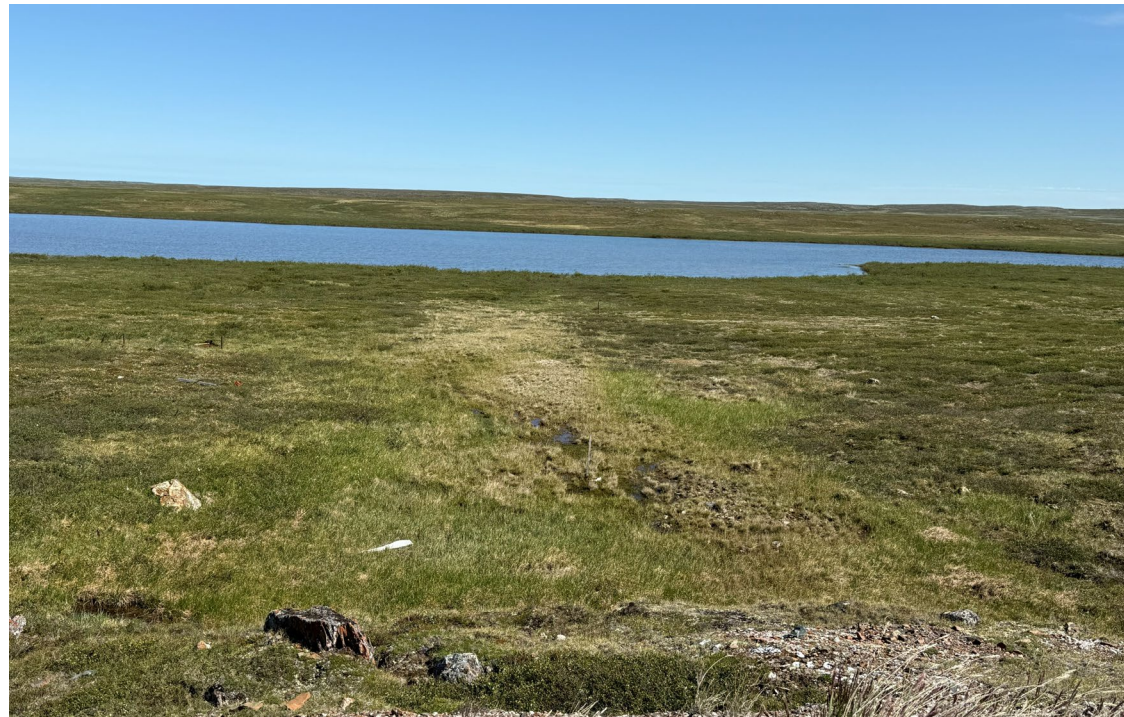
Photo 15: Water flow path downstream (southeast) of the historic lined area 2 (BOS-2)

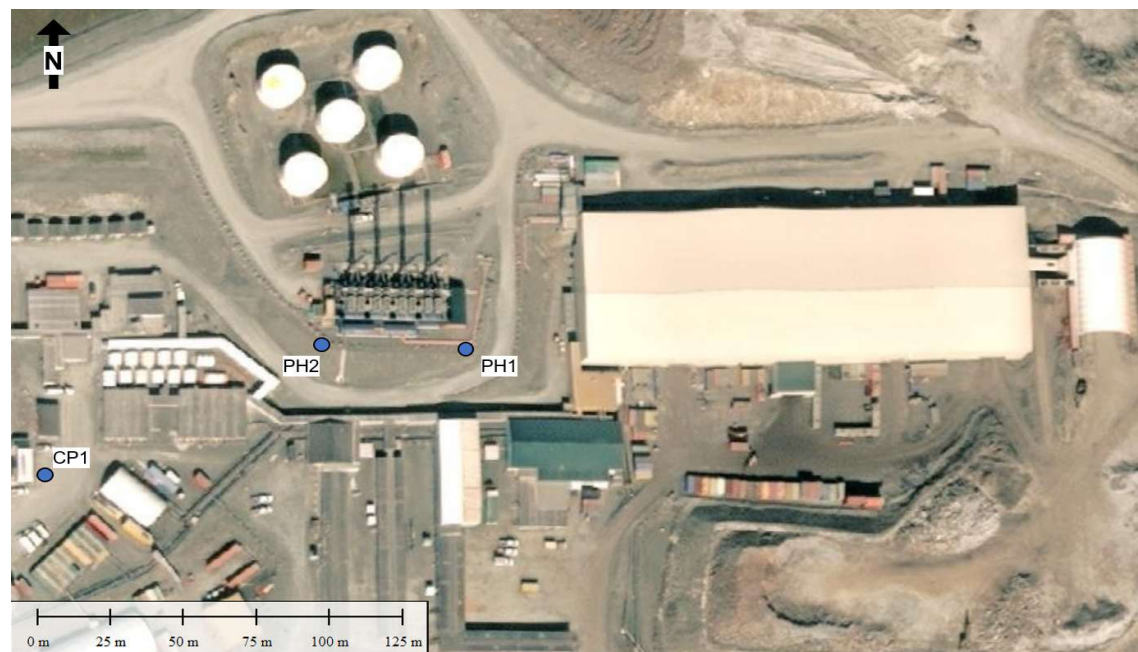
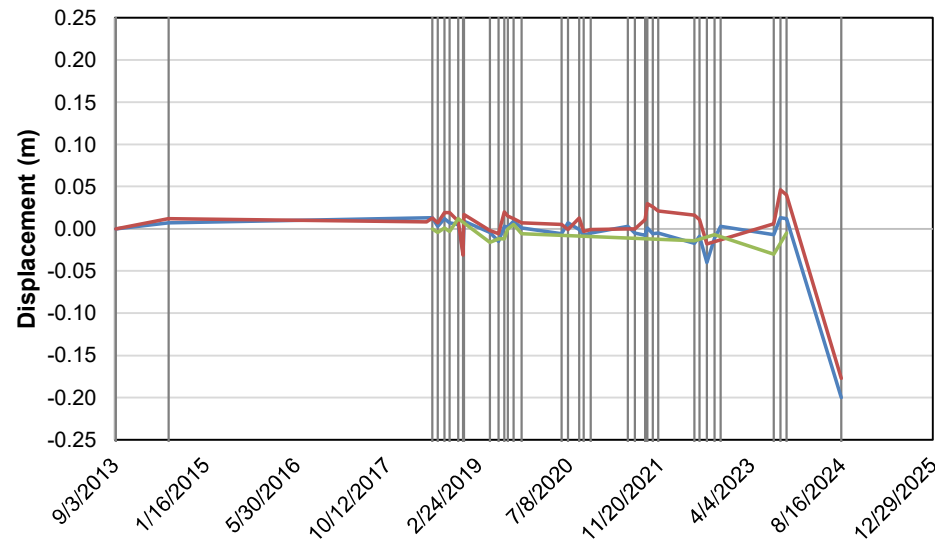
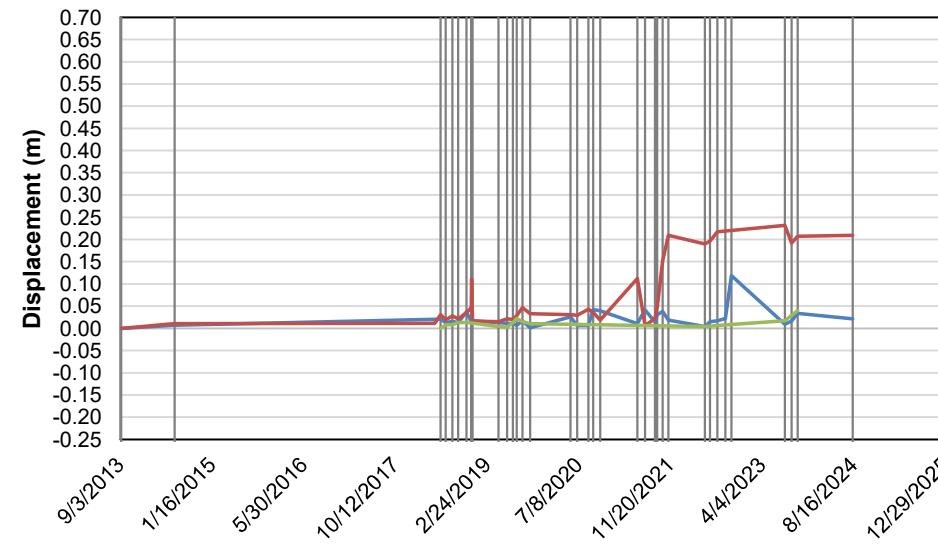
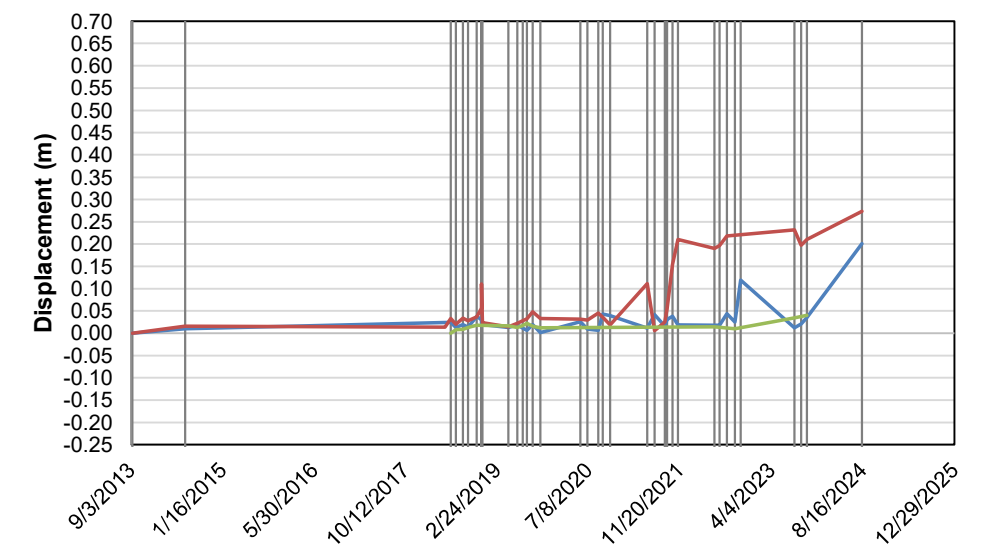
Job No: CAPR003759	  Hope Bay	Pad B		
		Survey Monitoring Points Displacement Timeseries		
		Date: December 2025	Approved: PDL	Figure: 1

1. CP1 corresponds to a control point (rock bolt in bed rock) that used as a check/secondary base point
2. PH2 is leaning at about 30 degrees to the west. This is assumed to have occurred in 2021, when the observed shift (primarily horizontal) occurred.

<ul style="list-style-type: none"> ■ Consider establishing a new survey pin to replace the displaced PH2 location, particularly if inconsistent readings or issues with GPS reception are noted in future. The new location must be near the southwest corner of the concrete powerplant pad near the crest of the slope where the placed pad fill is thickest. 	<ul style="list-style-type: none"> ■ 2023-AGI-28
		<p>Implement survey procedures with recorded control point check shots to provide survey error verification.</p>	<ul style="list-style-type: none"> ■ 2024-AGI-09
Helipad	<ul style="list-style-type: none"> ■ No further sinkholes or issues have been noted at the helipad in 2024 or 2025, and the proactive water management improvements appear to have been beneficial. ■ There was no ponded water on the upstream side of the helipad during the inspection, and minimal water in the sump, while a constant water flow is observed on the downstream side of the helipad. 	<ul style="list-style-type: none"> ■ Periodically inspect the area near the sinkhole, including under the nearby buildings, and pump the sump to reduce the water level in the pad. If water ponding is observed upstream of the helipad, consider pumping that water away to reduce the source of waterflow and thermal loading. ■ If additional settlement or sinkholes are observed, implement additional mitigation strategies such as ditching or pumping to decrease ponding water and infiltration into the rock fill at the upslope side of the pad. 	<ul style="list-style-type: none"> ■ 2023-AGI-30 (updated)
