Project: CAPR003759
March 25, 2026

Subject Hope Bay – 2025 Annual Geotechnical Inspection – Site-Wide

Agnico Eagle Mines contracted SRK Consulting (Canada) Inc. to conduct the 2025 Annual Geotechnical Inspection for the Hope Bay site in Nunavut. Hope Bay is a gold mine, located in Nunavut Territory 705 km northeast of Yellowknife, NWT and 153 km southwest of Cambridge Bay, NT. The mine is currently in care and maintenance.

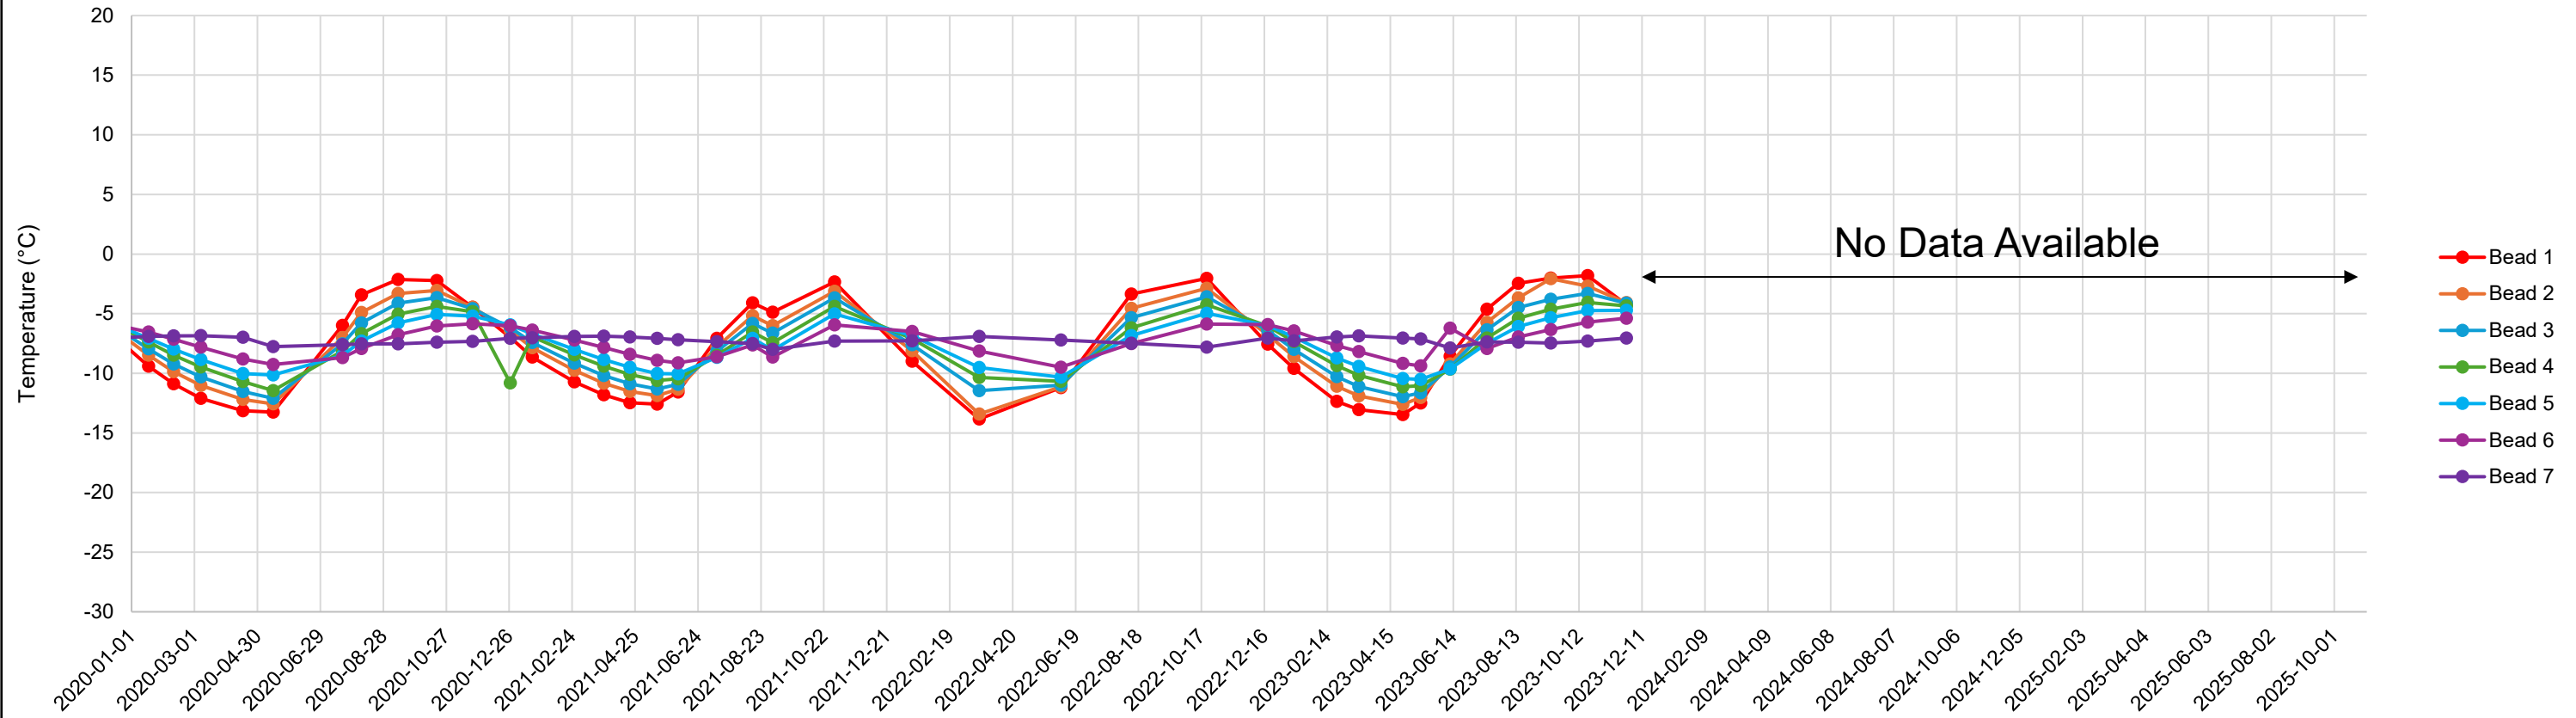
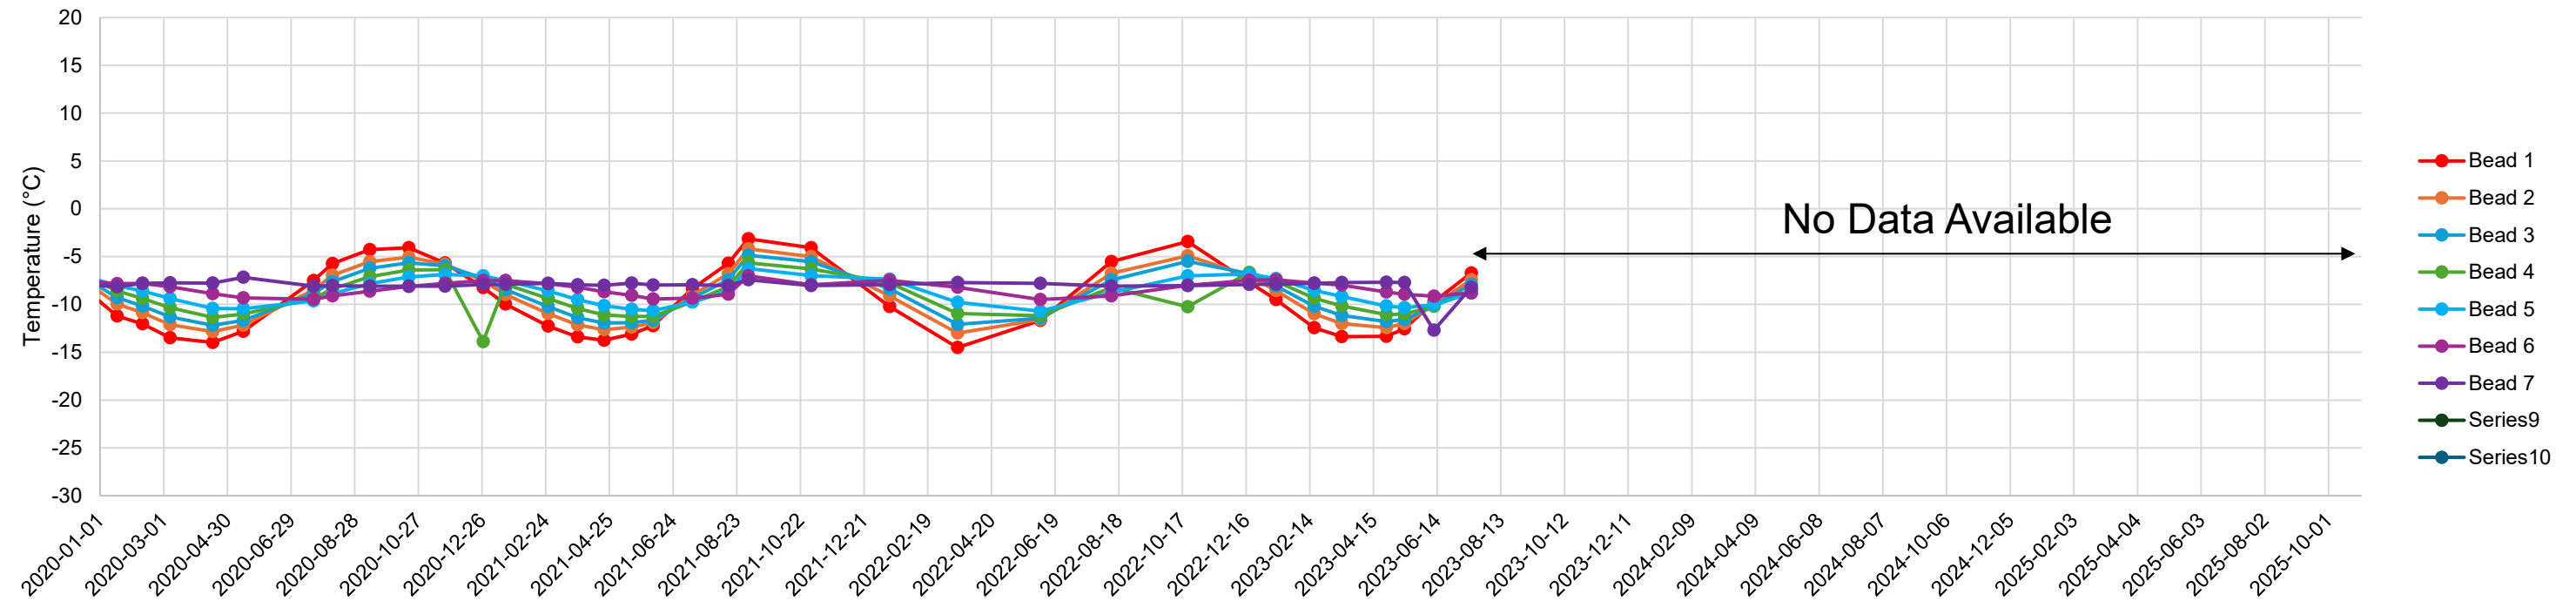
Job No: CAPR003759	  Hope Bay	Hope Bay Site-Wide – 2025 Annual Geotechnical Inspections		
		Doris Bridge Abutment Foundation Thermistors		
		Date: December 2025	Approved: AN/PDL	Figure: 3

- 1) Data is presented for the past five years, between January 2020 and December 2025. Data records began in 2011.
- 2) Cable SRK10-DCB2 (Doris Bridge East) was noted to be damaged after July 2023.
- 3) Cable SRK10-DCB1 has no data available since November 2023.

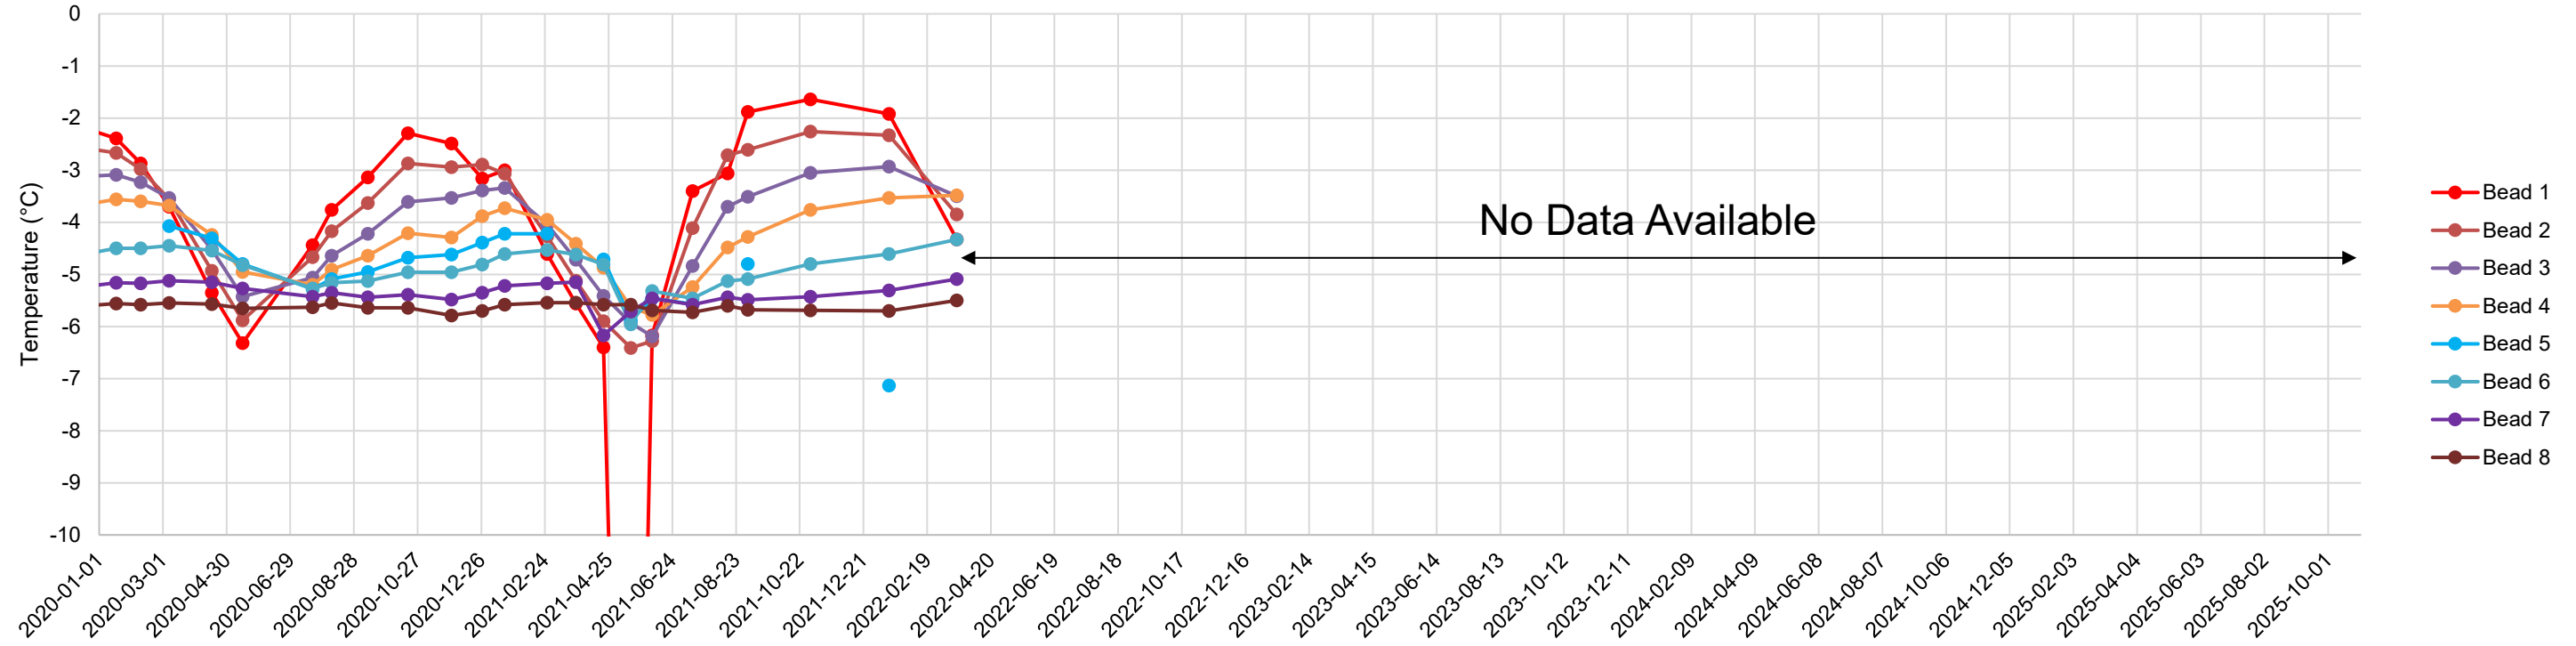
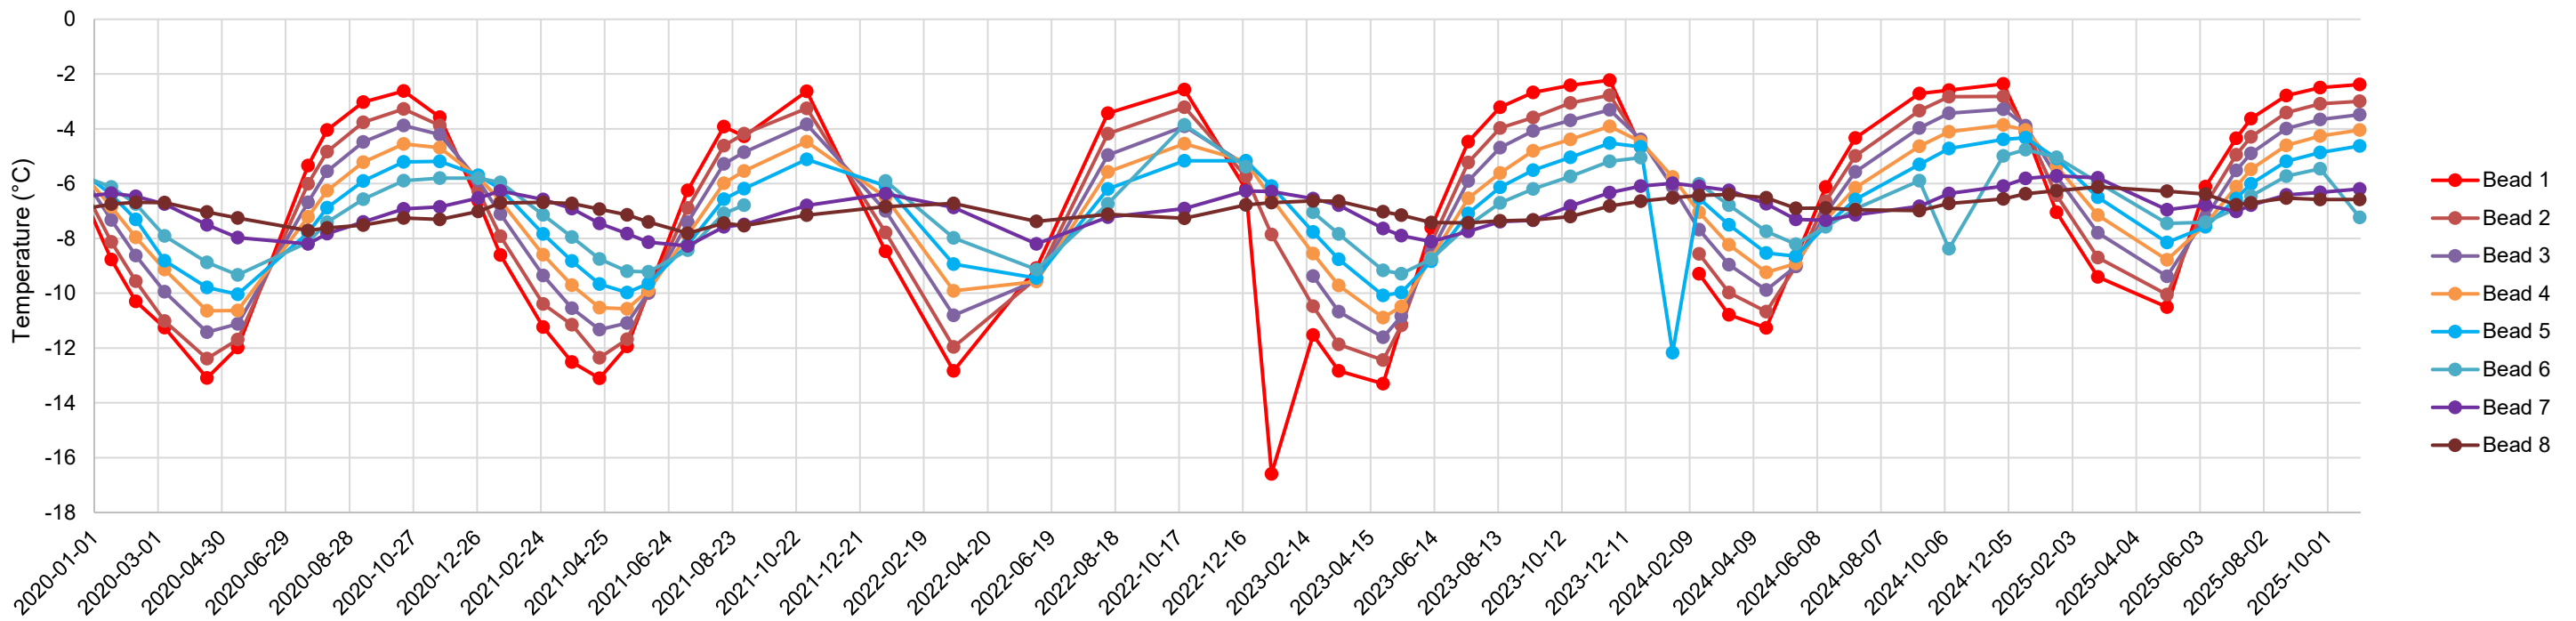
Hope Bay Site-Wide – 2025 Annual Geotechnical Inspections		
		Doris Contact Water Pond		
Job No: CAPR003759	Hope Bay	Date: December 2025	Approved: AN/PDL	Figure: 4

- The Doris Contact Water Pond GTCs monitoring data indicated the foundation and upstream toe remains frozen. The water-retaining element of the contact water pond is the HDPE liner tied into the underlying permafrost. For the pond to continue to retain water the permafrost tie-in must be maintained, ponding water near the toe of the berm can lead to thermal erosion and loss of containment. The low area of ponded water on the southwest corner of the pond, which is the current pumping point, should be shifted northward (offset approximately 5 meters from the berm toe). If grading in this area is undertaken, the water flowing along the north edge of the pond should also be directed towards the new pumping location. When practical to do so, the sumps or pumping low points should be maintained in a pumped down state.

- 1) Data is presented for the past five years, between January 2020 and December 2025. Data records began in 2012.
- 2) Cable SRK-12-GTC-DH01 was noted to be damaged after March 2022.
- 3) For cable SRK-12-GTC-DH01, data collected in May 2021 were resistance corrected (from 3,000 to 2,252 Ohms).
- 4) For cable SRK-12-GTC-DH02, data collected in May 2021, December 2022, March 2023 and July 2024 were resistance corrected (from 3,000 to 2,252 Ohms).
- 5) The May 3, 2025, data for SRK12-GTC-DH02 (Bead 1), was corrected from positive to negative.
