2025 Annual Geotechnical Inspection – Doris Tailings Impoundment Area

Hope Bay Mine, Nunavut, Canada
Agnico Eagle Mines Limited

SRK Consulting (Canada) Inc. ■ CAPR003759 ■ March 2026

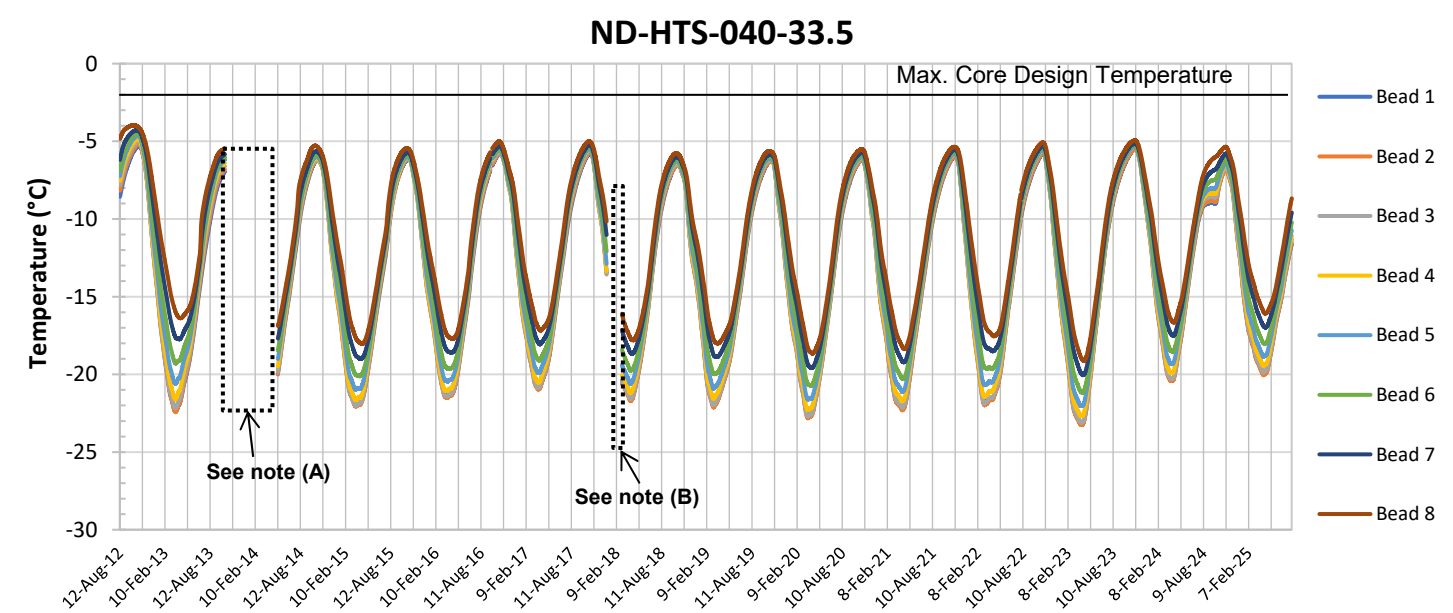
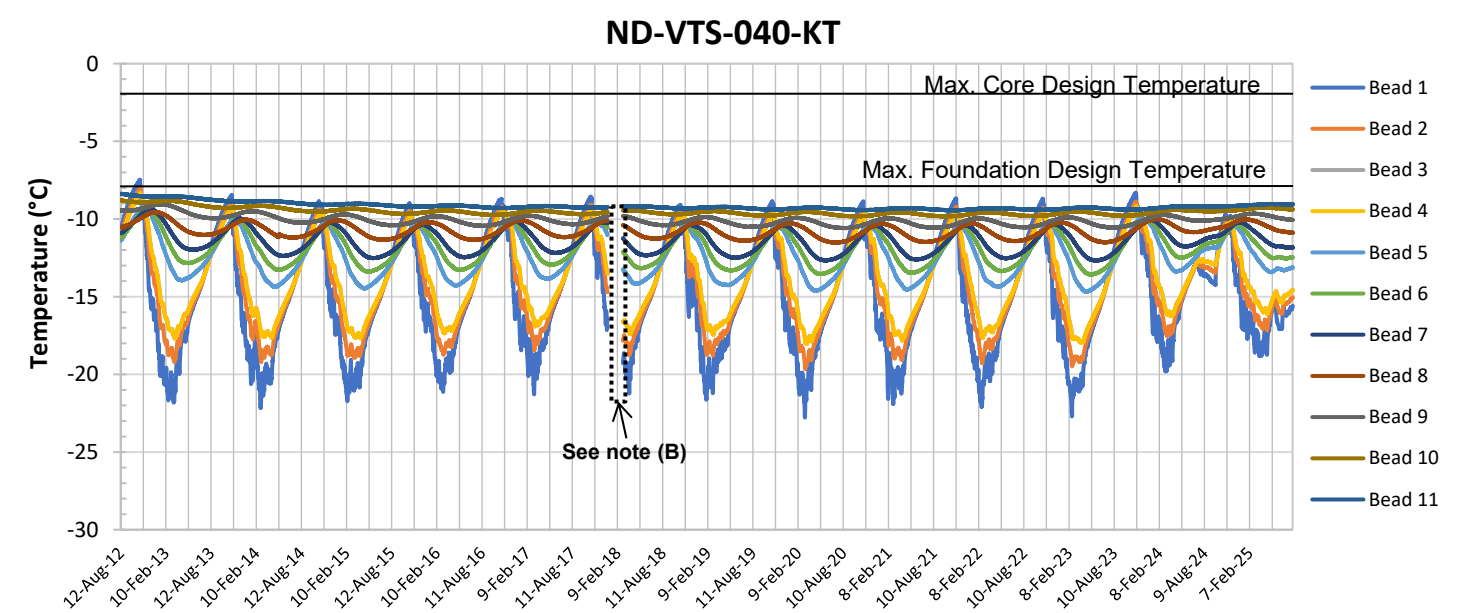
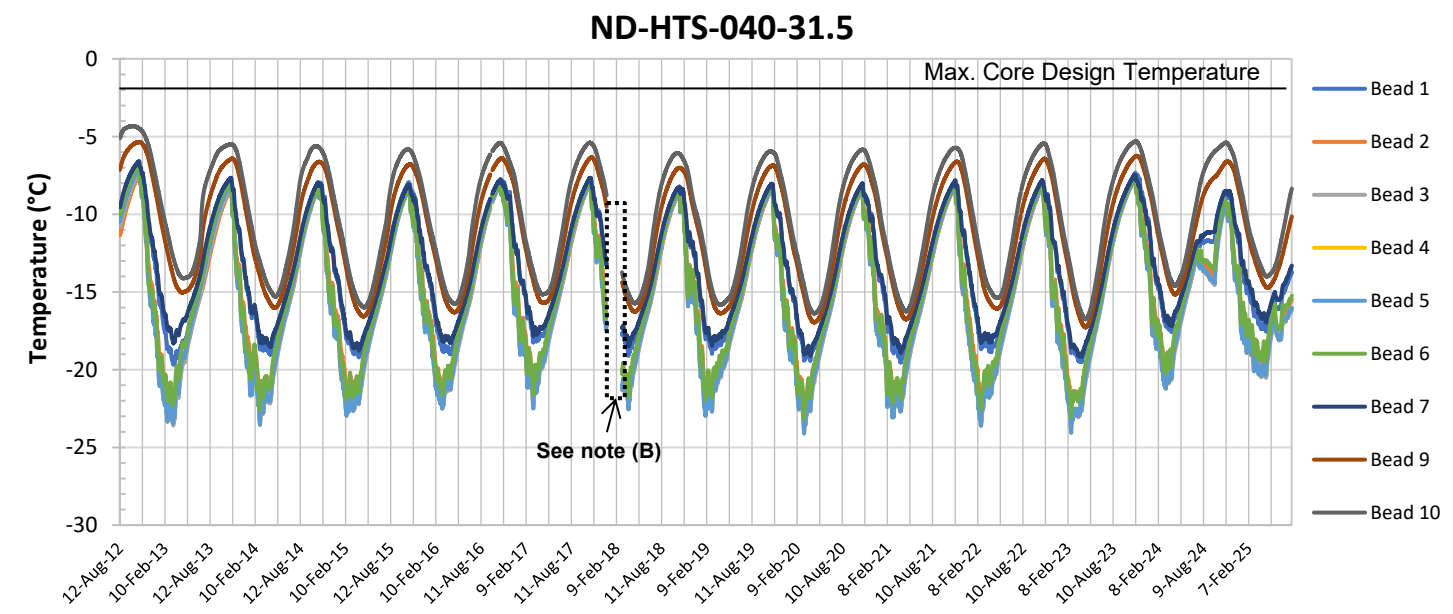
2025 TIA AGI		
		Station 0+40 Ground Temperature Cable Temperature Vs. Time		
Job No: CAPR003759	Hope Bay	Date: November 2025	Approved: PDL	Figure: A.1

- Notes:**
- Bead numbers increase from downstream to upstream (horizontal) and top to bottom (vertical).
 - (A) ND-HTS-040-33.5 data logger was disconnected from October 10, 2013, to May 12, 2014.
 - (B) Data logger was disconnected from January 1, 2018, to March 3, 2018, for recalibration.

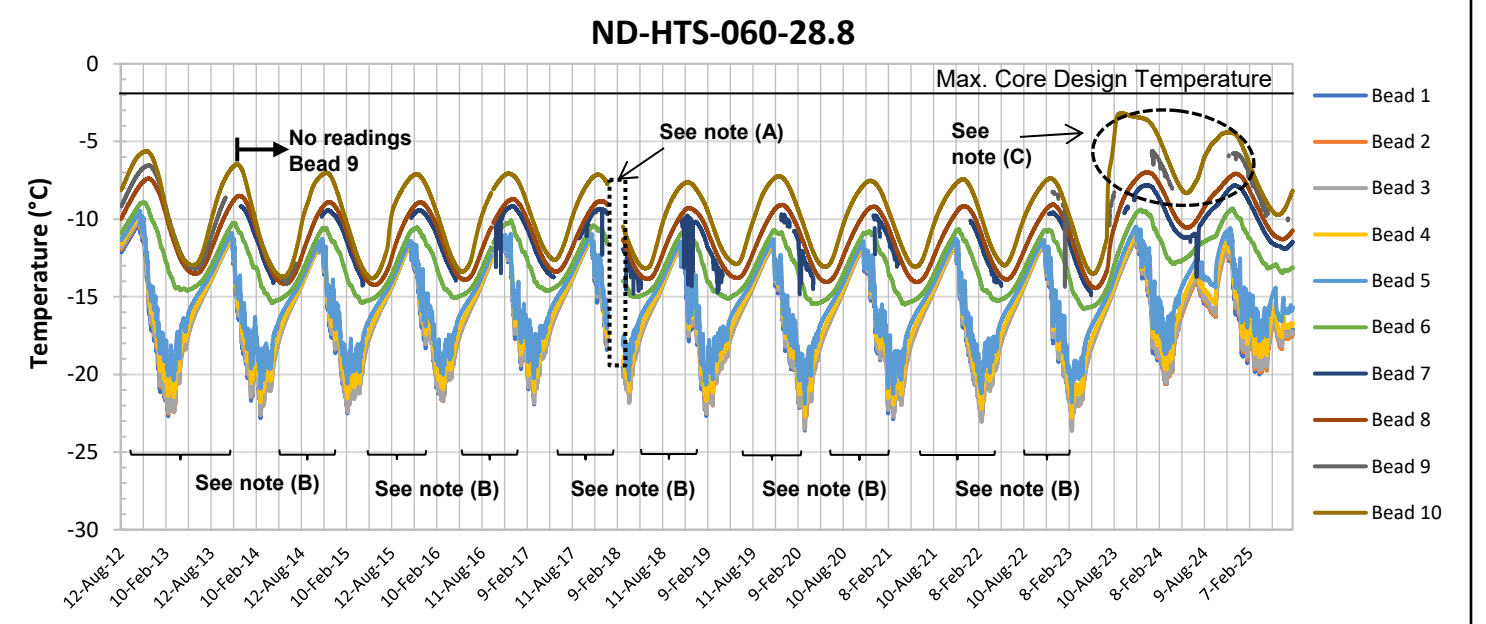
2025 TIA AGI		
		Station 0+60 Horizontal Temperature Cable Temperature Vs. Time		
Job No: CAPR003759	Hope Bay	Date: November 2025	Approved: PDL	Figure: A.3

- Notes:**
- Bead numbers increase from downstream to upstream (horizontal) and top to bottom (vertical).
 - (A) Data logger was disconnected from January 1, 2018, to March 3, 2018, for recalibration.
 - (B) Erroneous data were filtered out due to possible instrumentation error.
 - (C) Notable temperature increase at the upstream-most beads observed. This is expected to be related to historically high reclaim pond water levels in 2023-2024.

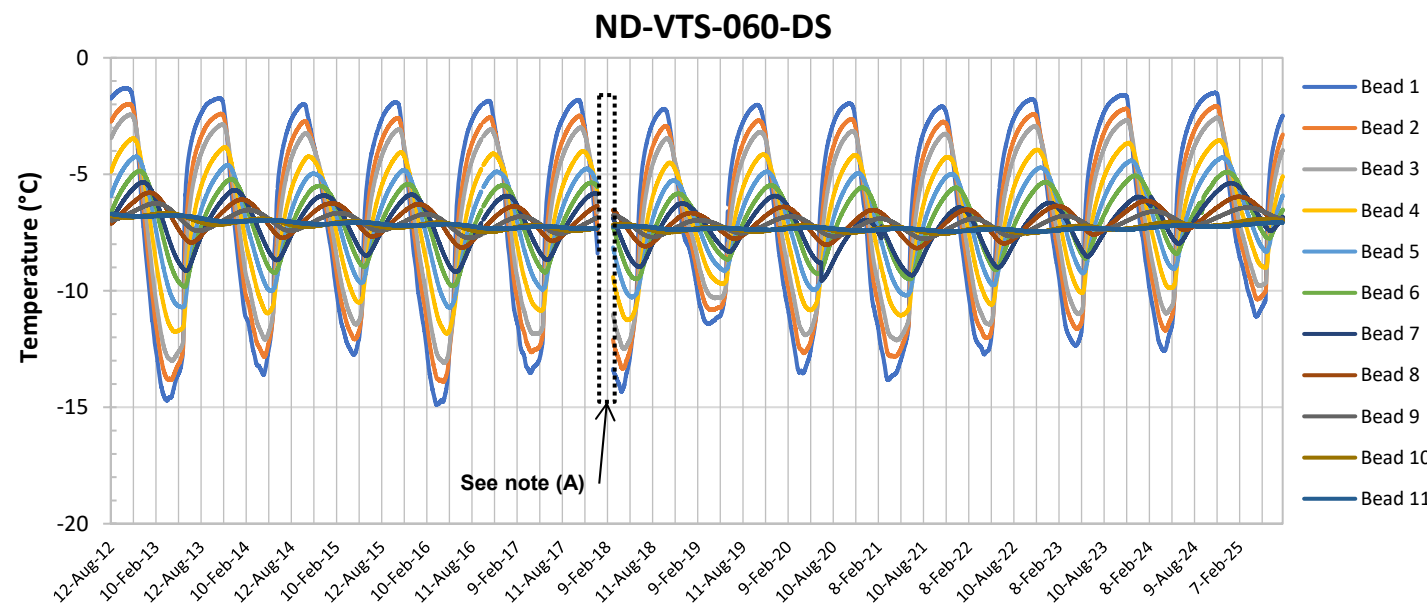
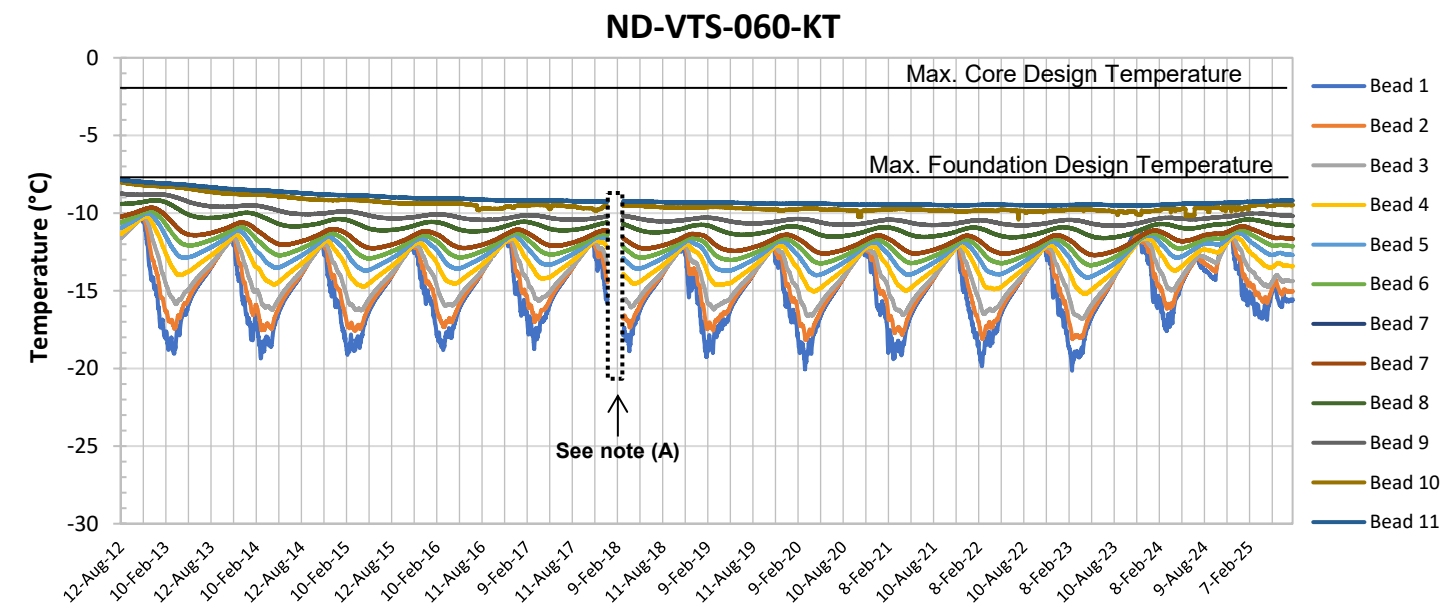
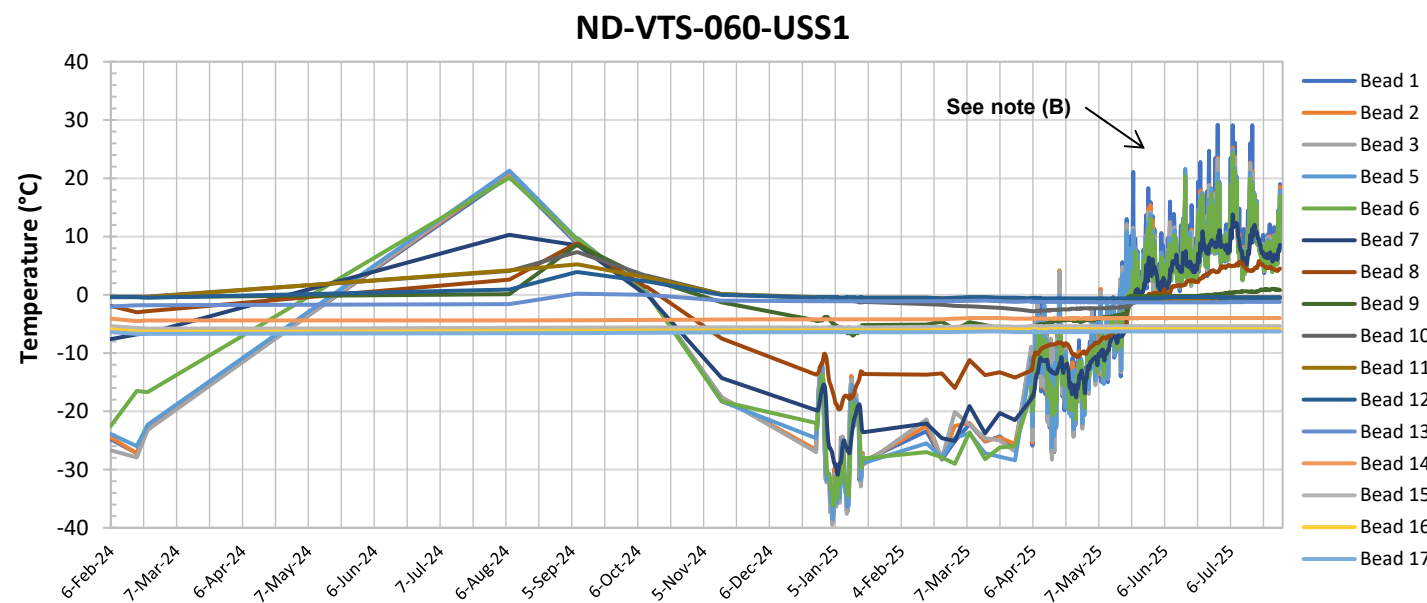
2025 TIA AGI		
		Station 0+60 Vertical Temperature Cable Temperature Vs. Time		
Job No: CAPR003759	Hope Bay	Date: November 2025	Approved: PDL	Figure: A.5

- Bead numbers increase from downstream to upstream (horizontal) and top to bottom (vertical).
- ND-VTS-060-US was damaged during construction.
- Recent ND-VTS-060-USS1 data were collected by both data logger and manual collection methods. Data gaps that fall within this reporting period can be attributed to infrequent manual collection of data.
- (A) Data logger was disconnected from January 1, 2018, to March 3, 2018, for recalibration.
- (B) Upper beads above surface and exposed to air temperatures.

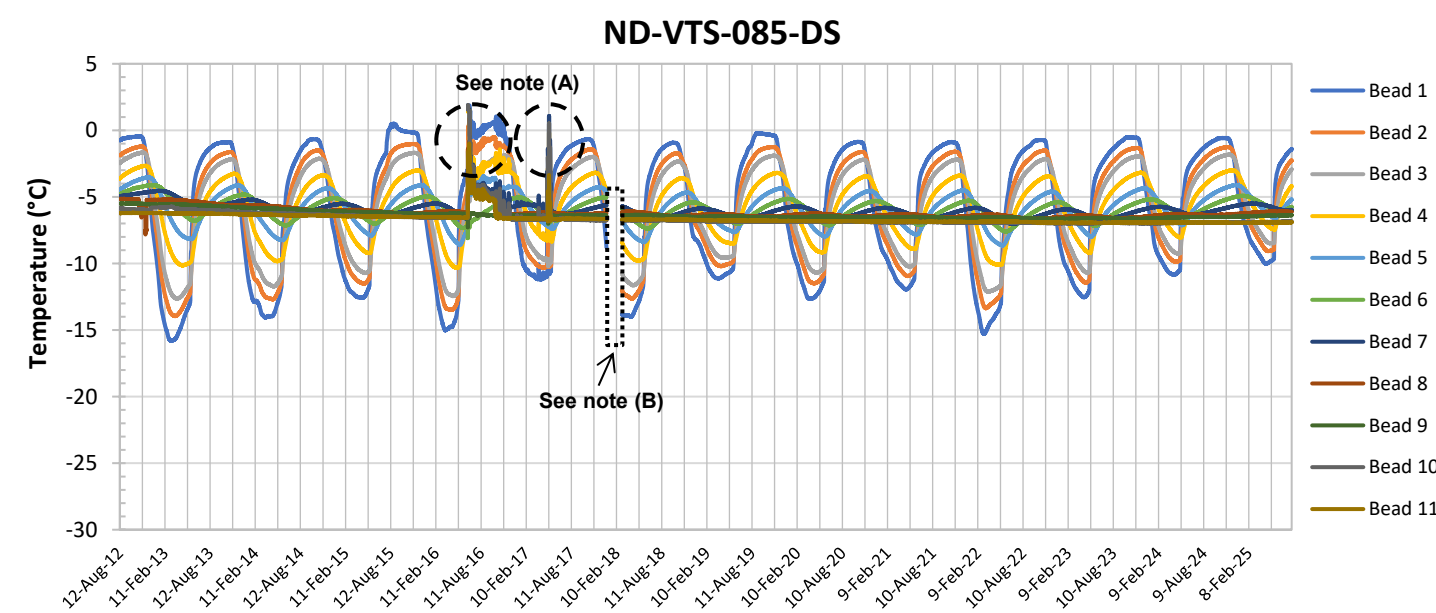
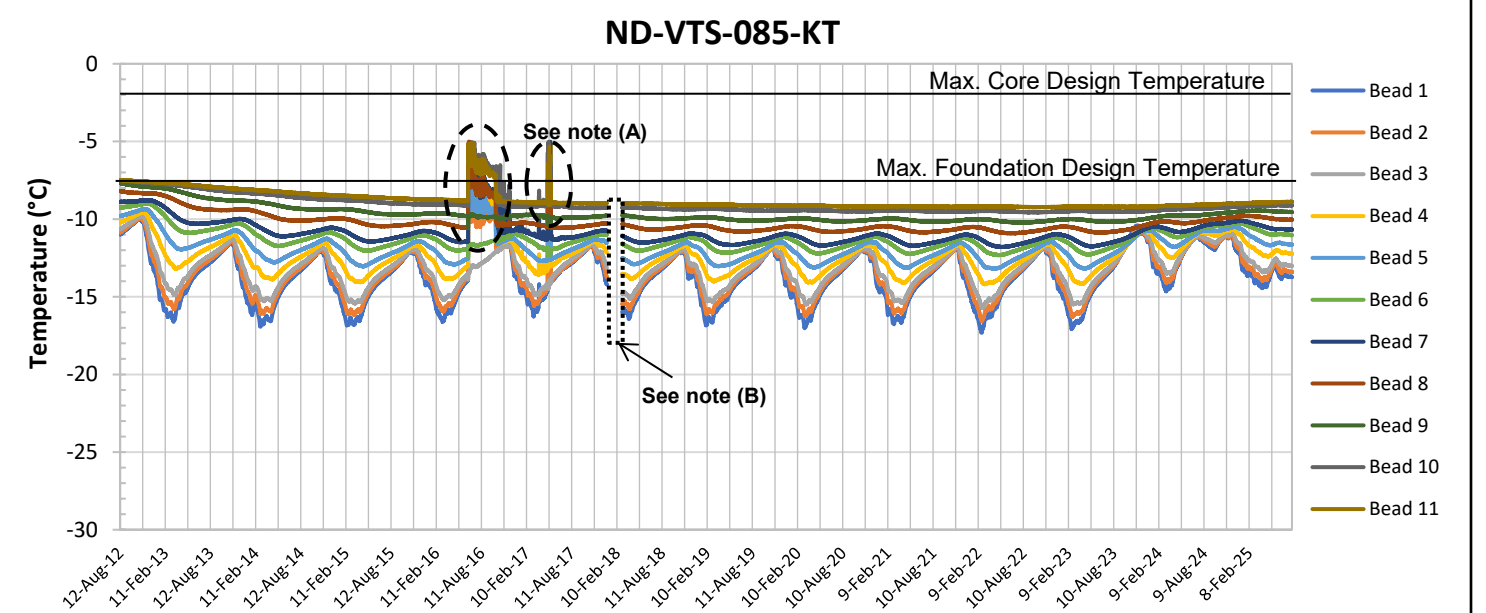
- Notes:**
- Bead numbers increase from downstream to upstream (horizontal) and top to bottom (vertical).
 - **(A)** Temperature in Bead 1, 2, 4, 5, 7, 8, 10, 11 spiked in the Spring of 2016 and 2017. Erratic readings in some elevations suggest a data logger issue.
 - **(B)** Data logger was disconnected from January 1, 2018, to March 3, 2018, for recalibration.

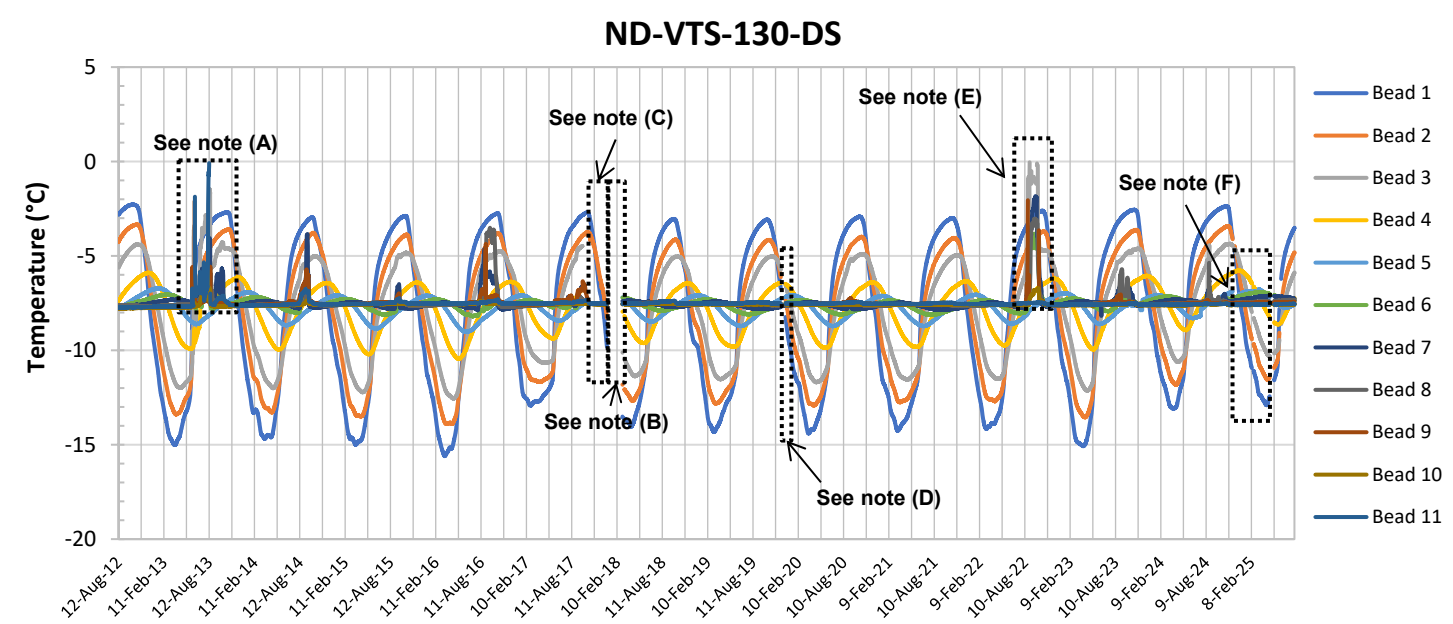
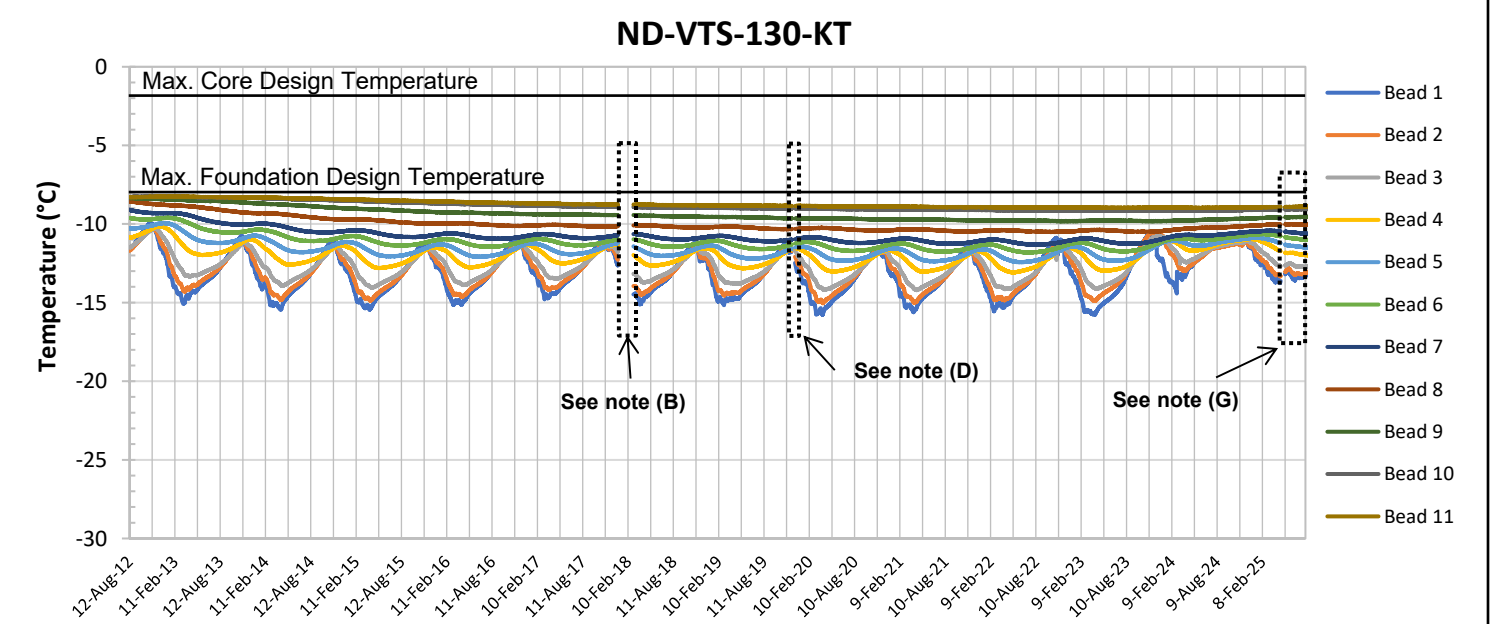
- Notes:**
- Bead numbers increase from downstream to upstream (horizontal) and top to bottom (vertical).
 - **(A)** Temperature spike is attributed to an instrumentation error rather than a change in the ground temperature.

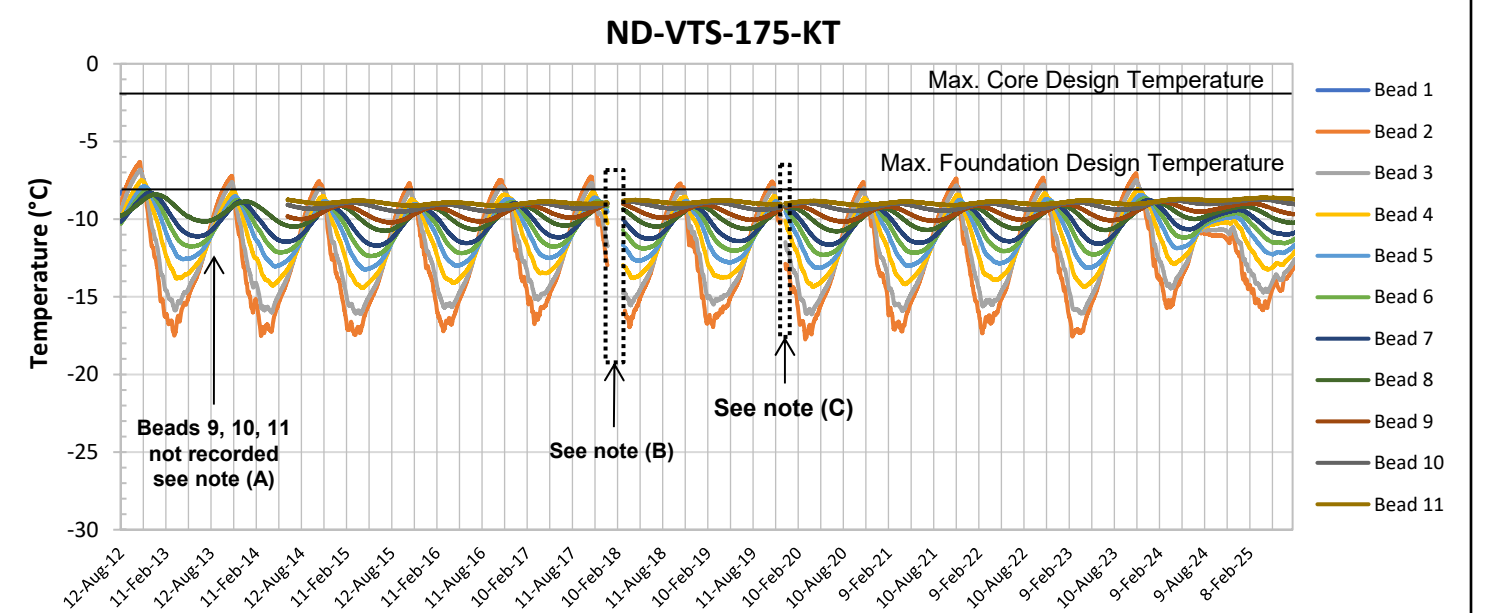
- Notes:**
- Bead numbers increase from downstream to upstream (horizontal) and top to bottom (vertical).
 - **(A)** Incorrectly connected to datalogger (as ND-HTS-175-KT) from August 9, 2012, to June 16, 2014; therefore, no readings for beads 9, 10, 11.
 - **(B)** Data logger was disconnected from January 1, 2018, to March 3, 2018, for recalibration.
 - **(C)** Data collection gaps between November 21, 2019, and December 20, 2019.
