APPENDIX 15 2025 REPORTABLE SPILLS

Re: Follow-up Report Spill #2025-007 – Release of 1,000 L of waste oil at the Meliadine Gold Project

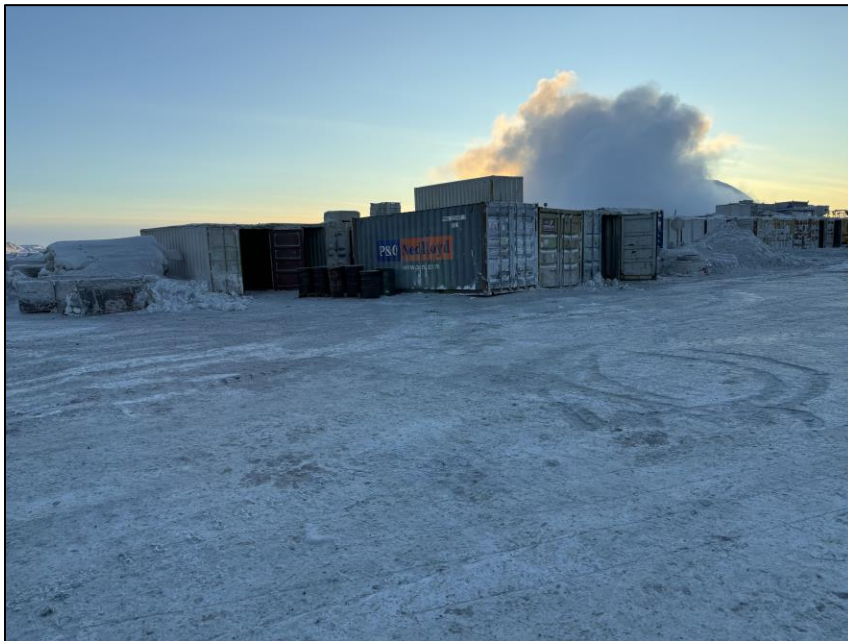
Photo 2: Used oil spill location post remediation.

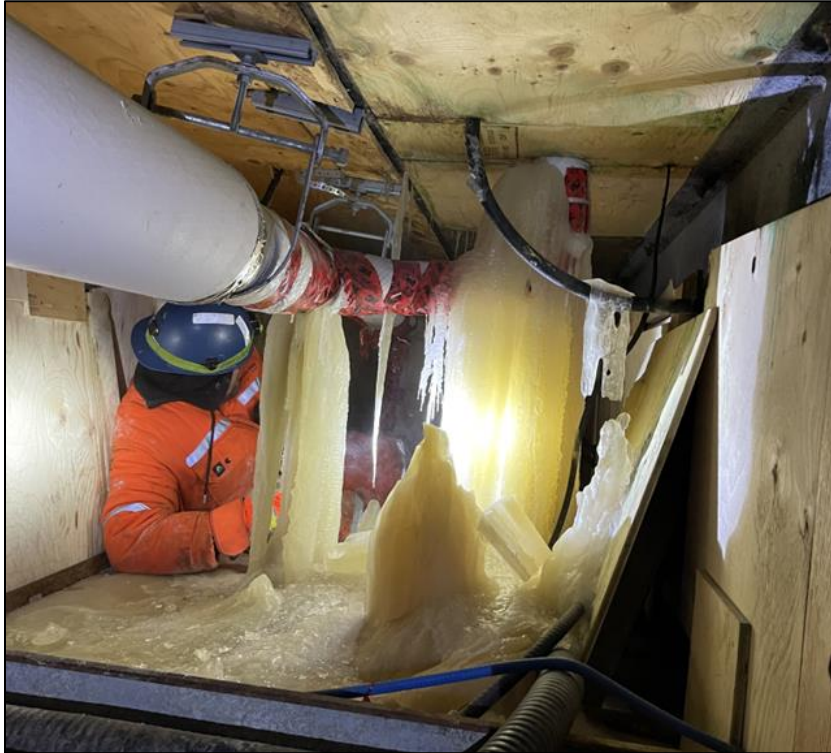
- The heat trace for this drain failed, and the light indicating a failure was located under the building, making it invisible for employees conducting inspections due to the snowpack.
- The lack of insulation did not protect the line from freezing and temperature fluctuations. Consequently, the temperature difference between the hot water flowing through this drain line and the outside temperature created thermal stress on the mechanical coupler of the line, resulting in its failure.

Photos 1: Greywater spill location, underneath the kitchen building.

- The entire line was inspected and repaired, and a new heat trace was installed. The emergency light is now located in the kitchen so employees can see it in case of a failure.
- A heat trace audit will be conducted by the Electrical team in 2025 to obtain an accurate count of working and obsolete heat traces.

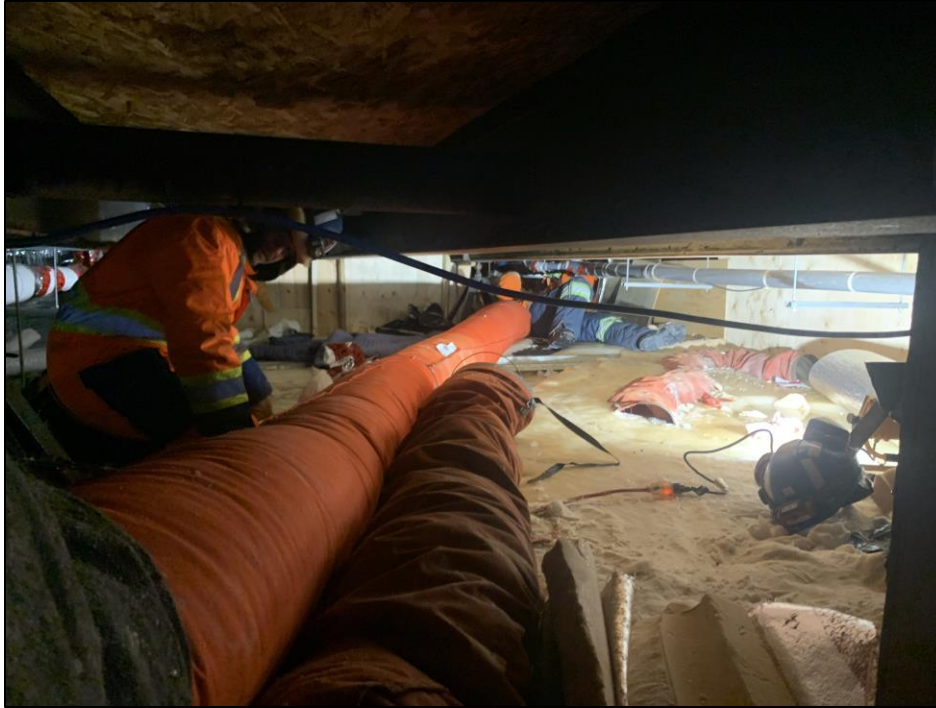
Photos 2: Greywater spill location, underneath the kitchen building.

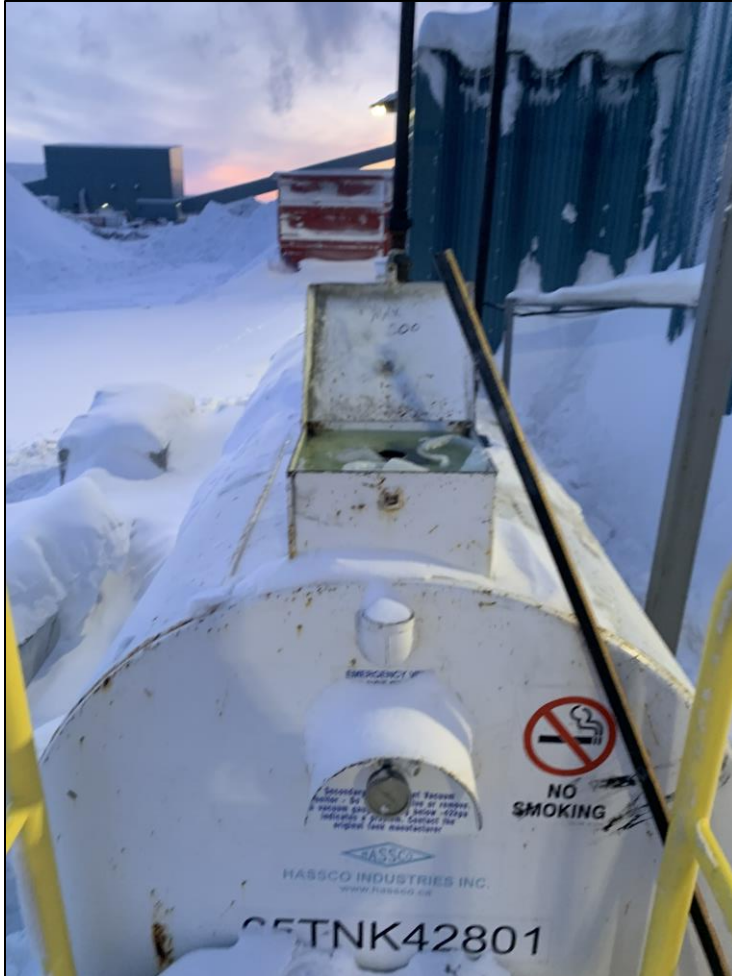
- The contractor responsible for the maintenance was inexperienced with this equipment, leading to the incorrect reassembly of the three-way valve on the return line. This error caused the fuel to flow towards the external tank instead of the internal tank.

Photo 1: Diesel spill location, at the incinerator laydown.

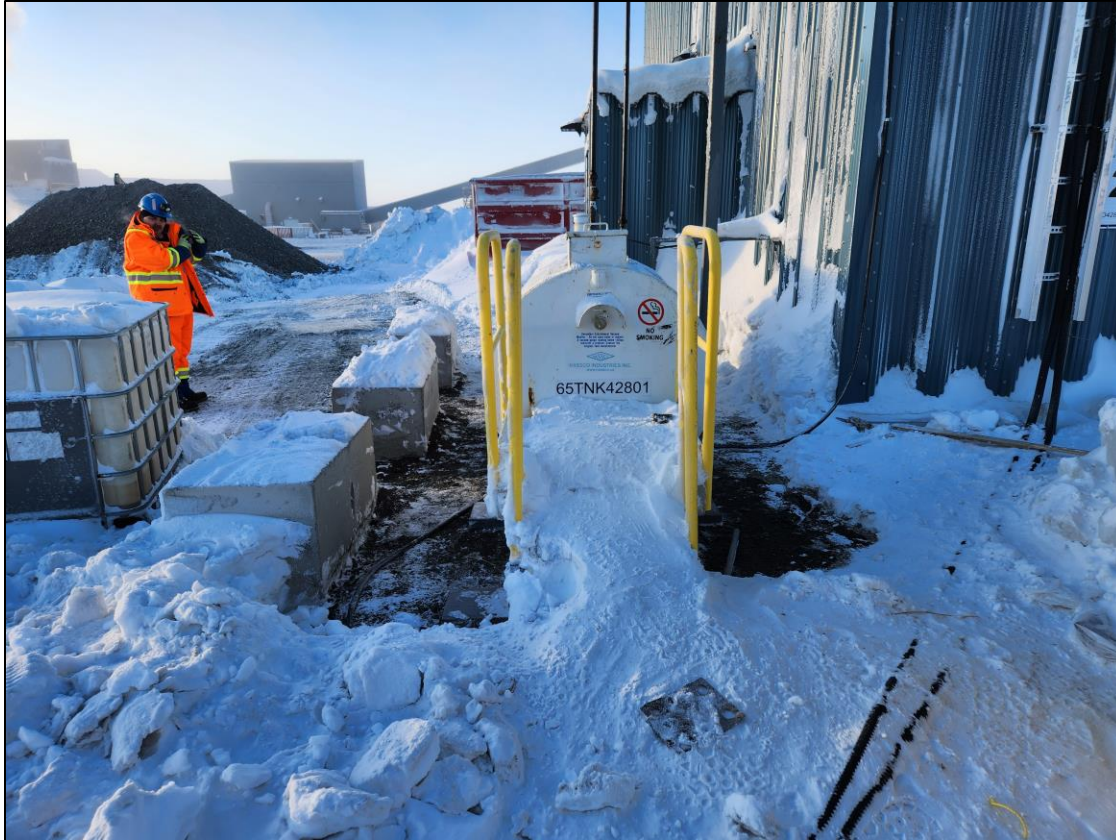
Photo 2: Diesel spill location post remediation.

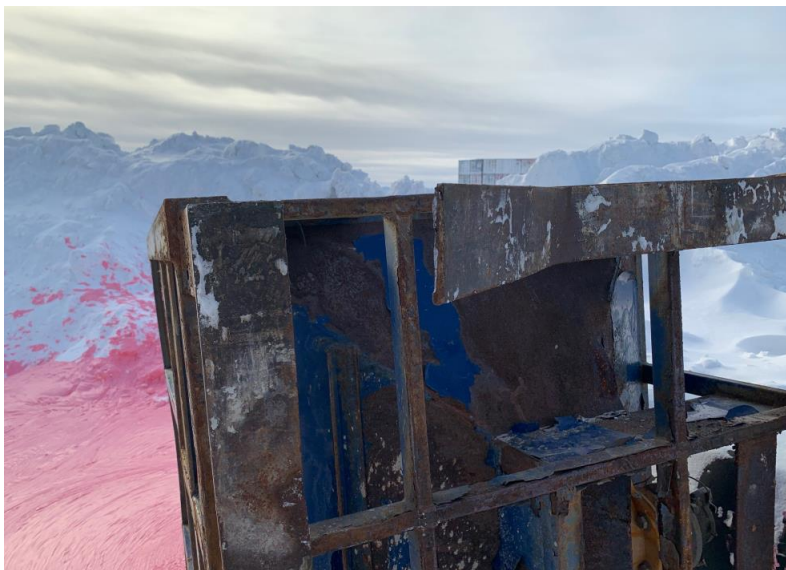
- The Dyno Nobel loader that is usually used for this task was having its engine replaced. As such, the loader being used was not the usual equipment for the task.
- The Dyno Nobel team called the Underground Construction department's loader operator to weigh the full bins and place them on the rack. The new operator was unfamiliar with this task, which led to repeated adjustments that ultimately caused the bin to tip over.
- As the emulsion bin was tipping, the base plate of the bin broke which allowed it to tip fully over.

Photo 2: Broken base plate on the bin.

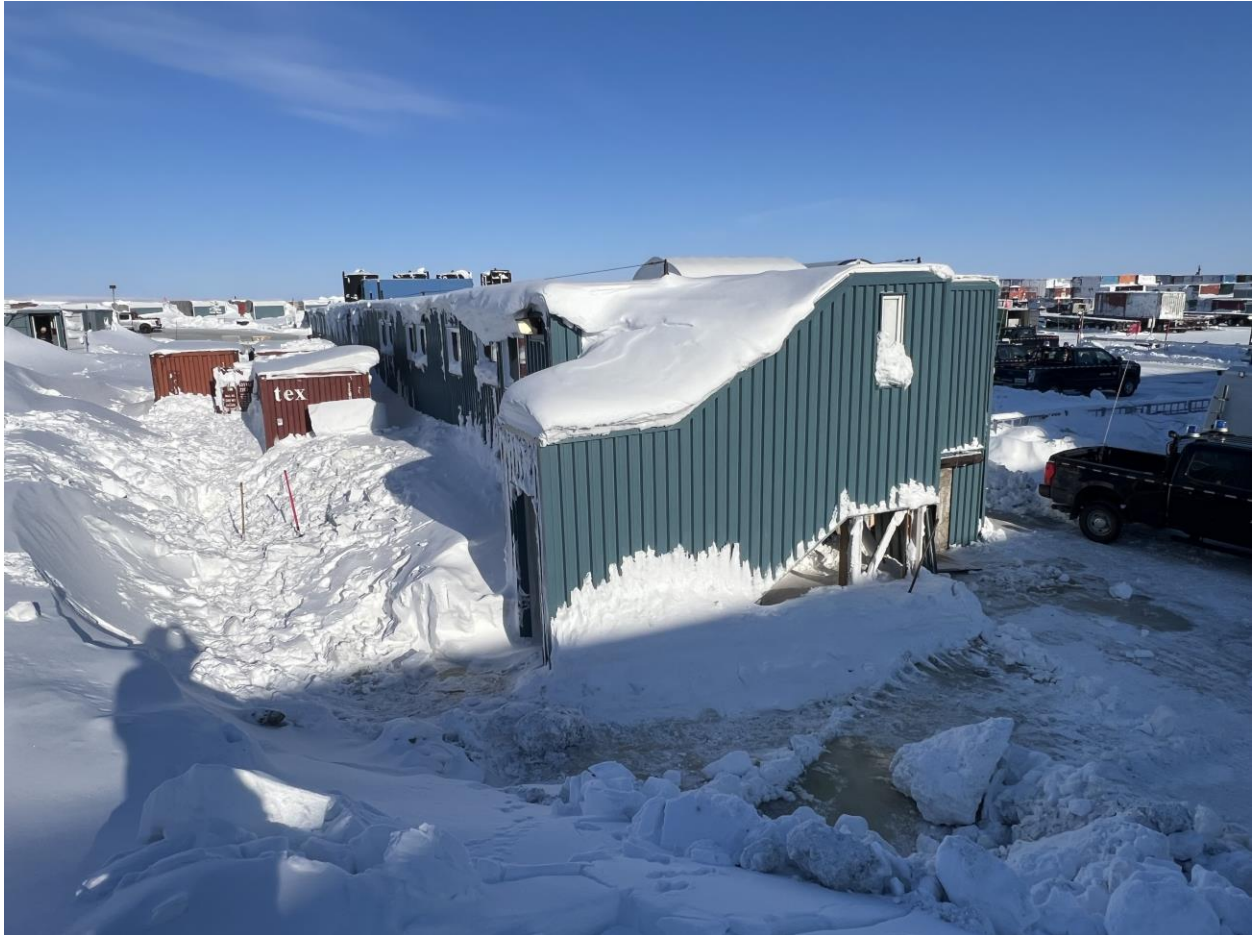
- The heat trace for the sewage line failed, and the light indicating a failure was located under the building, making it invisible for employees conducting inspections due to the snowpack.
- Due to the failed heat trace, the sewage line ruptured.

Photo 1: Sewage spill location

- The sewage line has been rerouted to a temporary holding tank.
- An investigation into how the sewage line that is running under the roadway was protected prior to coverage of material has been scheduled for after snowmelt.
- The heat trace will be repaired following snowmelt once the area is accessible.
- Repair and replace the section of pipe that is broken following snowmelt once the area is accessible.
- Ensure indicator light which signals the operational status of the heat trace is visible for inspection.

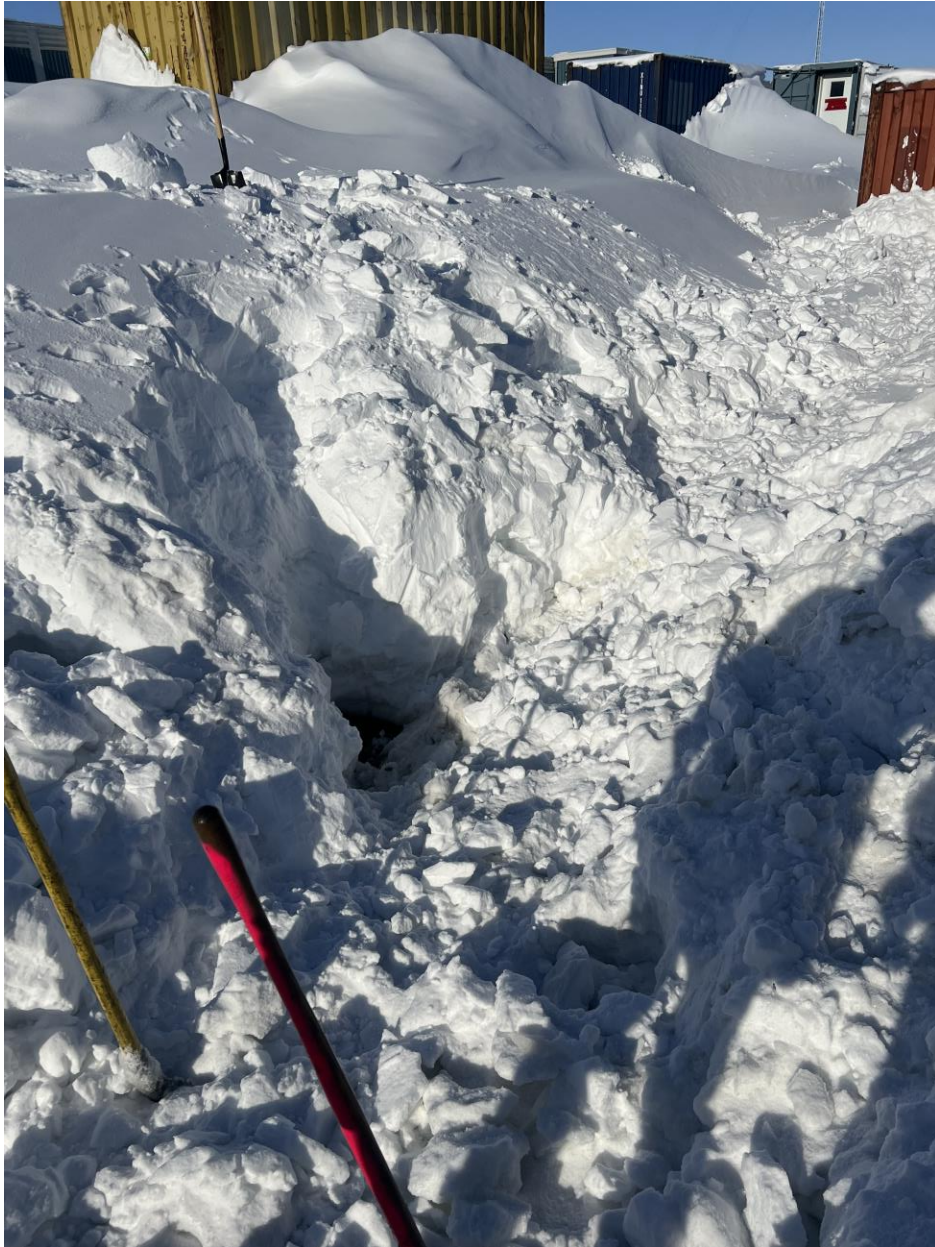
Photo 2: Sewage spill location

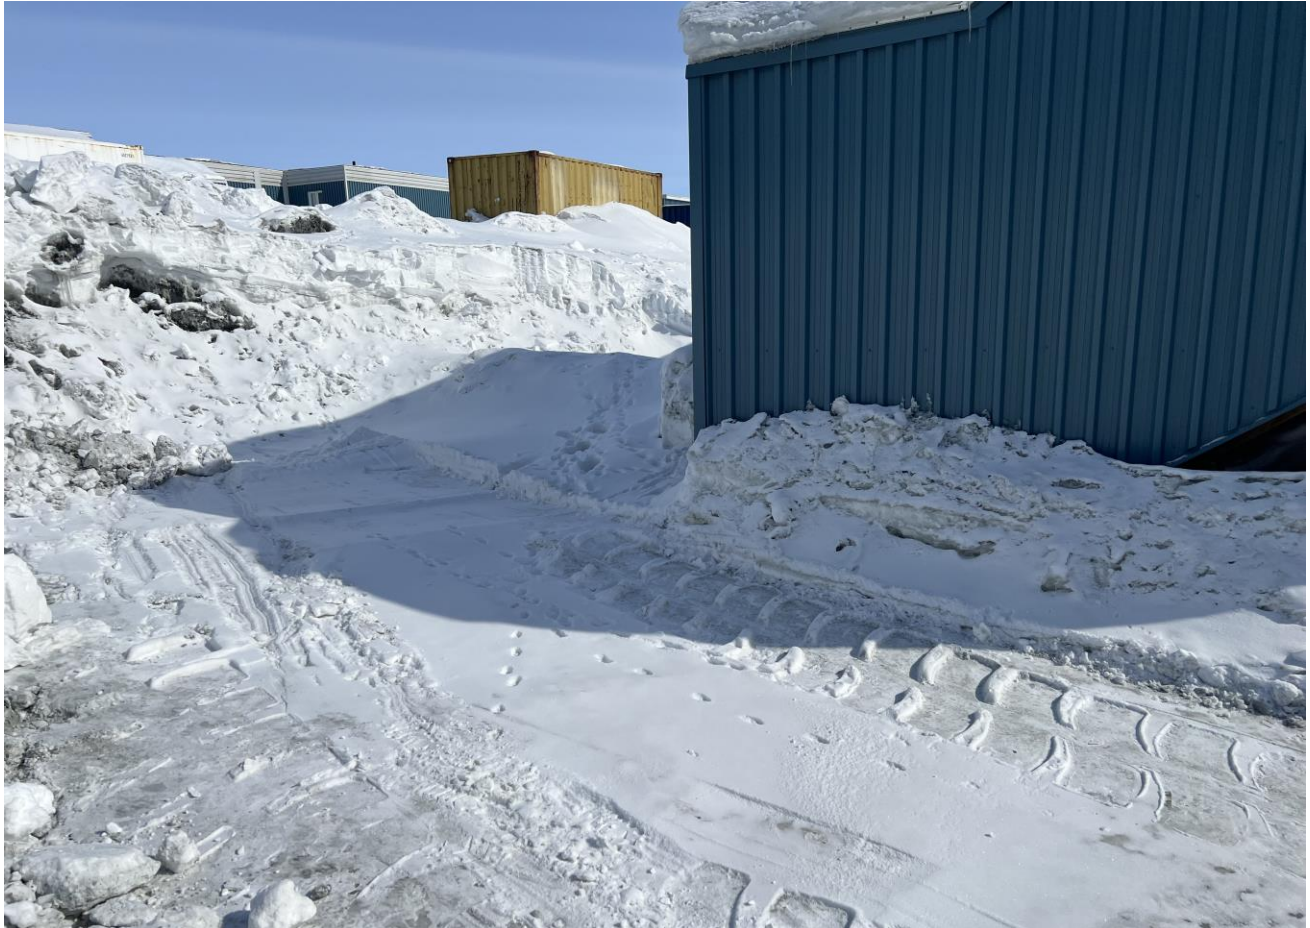
Photo 3: Sewage spill location post excavation of accessible contaminated material

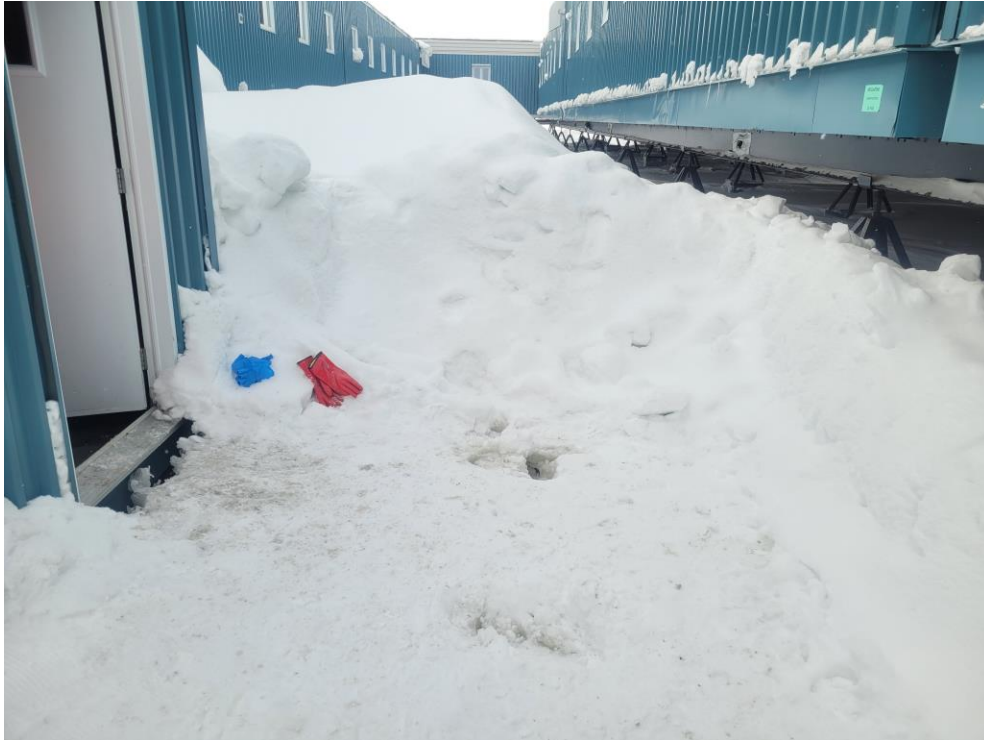
Photo 1: Spill location (spill covered in snow layer)

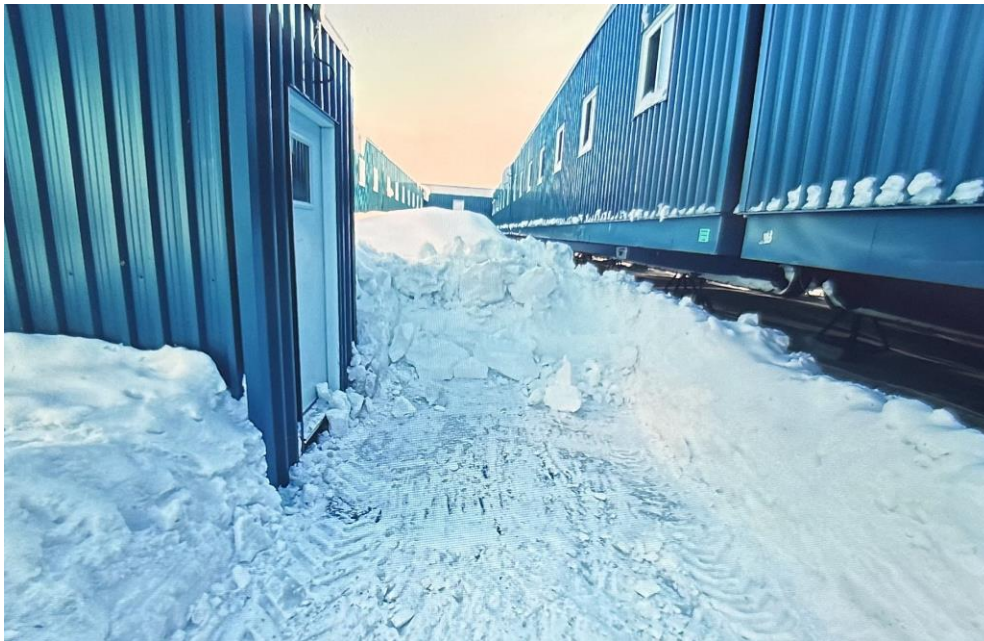
Photo 2: Spill remediation

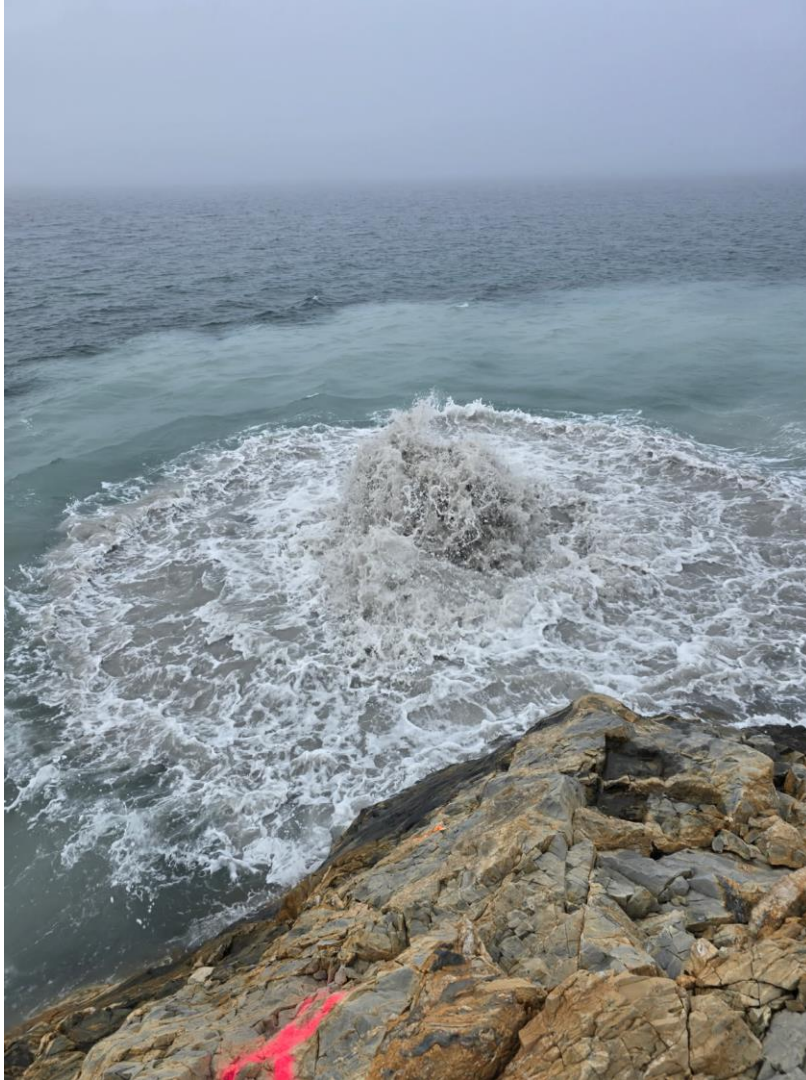
On August 20th, 2025, at approximately 2:30 PM, during the horizontal directional drilling (HDD) at Itivia Harbour a sediment plume was observed in Melvin Bay (Figure 1). As the drill penetrated the seabed, it exited the bedrock into an area of seabed debris. The compressed air used to stabilize the borehole escaped into the surrounding water, disturbing the fine sediments on the seabed. The release of energy caused particulates to become suspended in the water column, creating a plume that spread outward from the drilling site.

Photo 1: Location of sediment release in Melvin Bay.

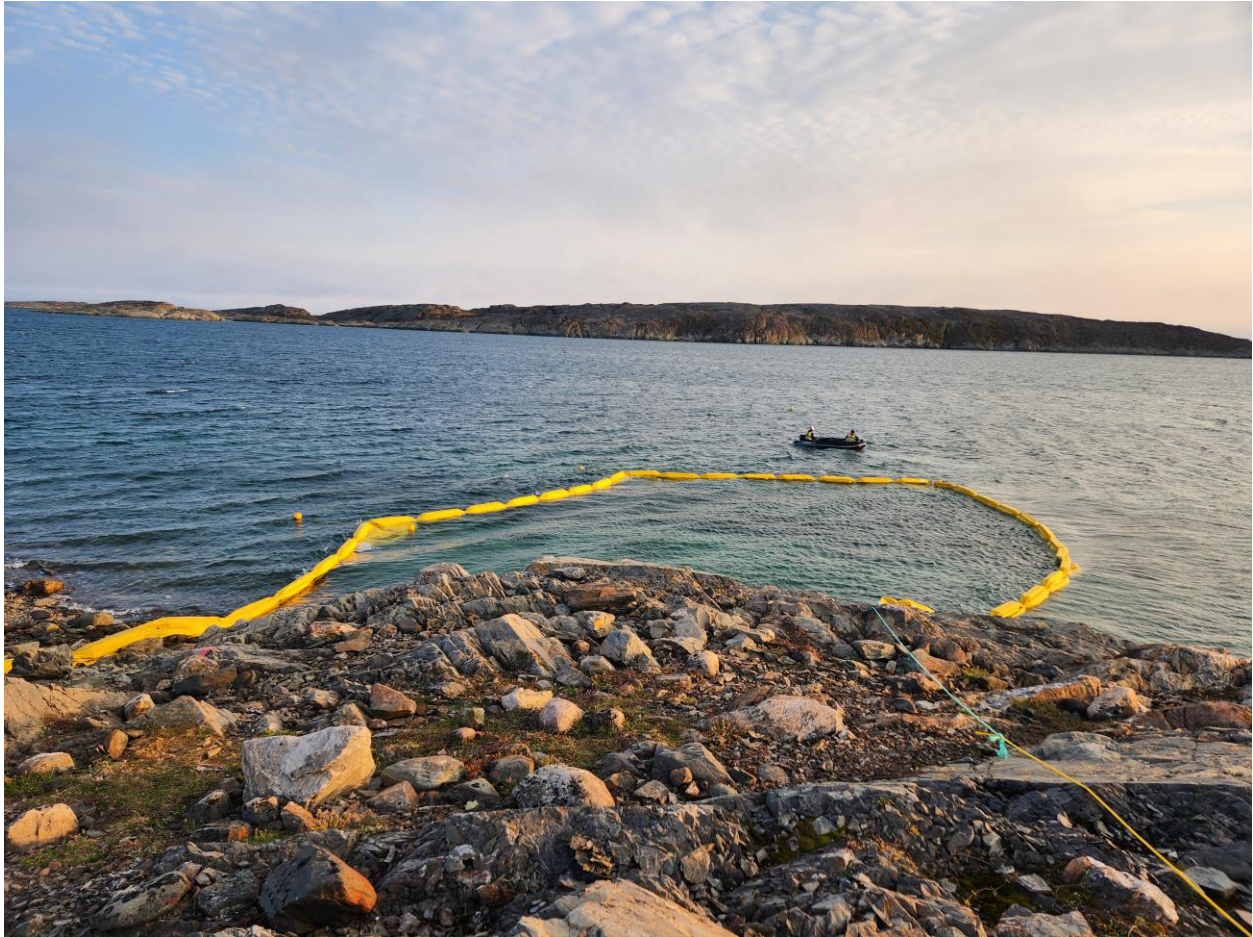
Photo 2: Turbidity curtains installed before resuming the drilling operation.

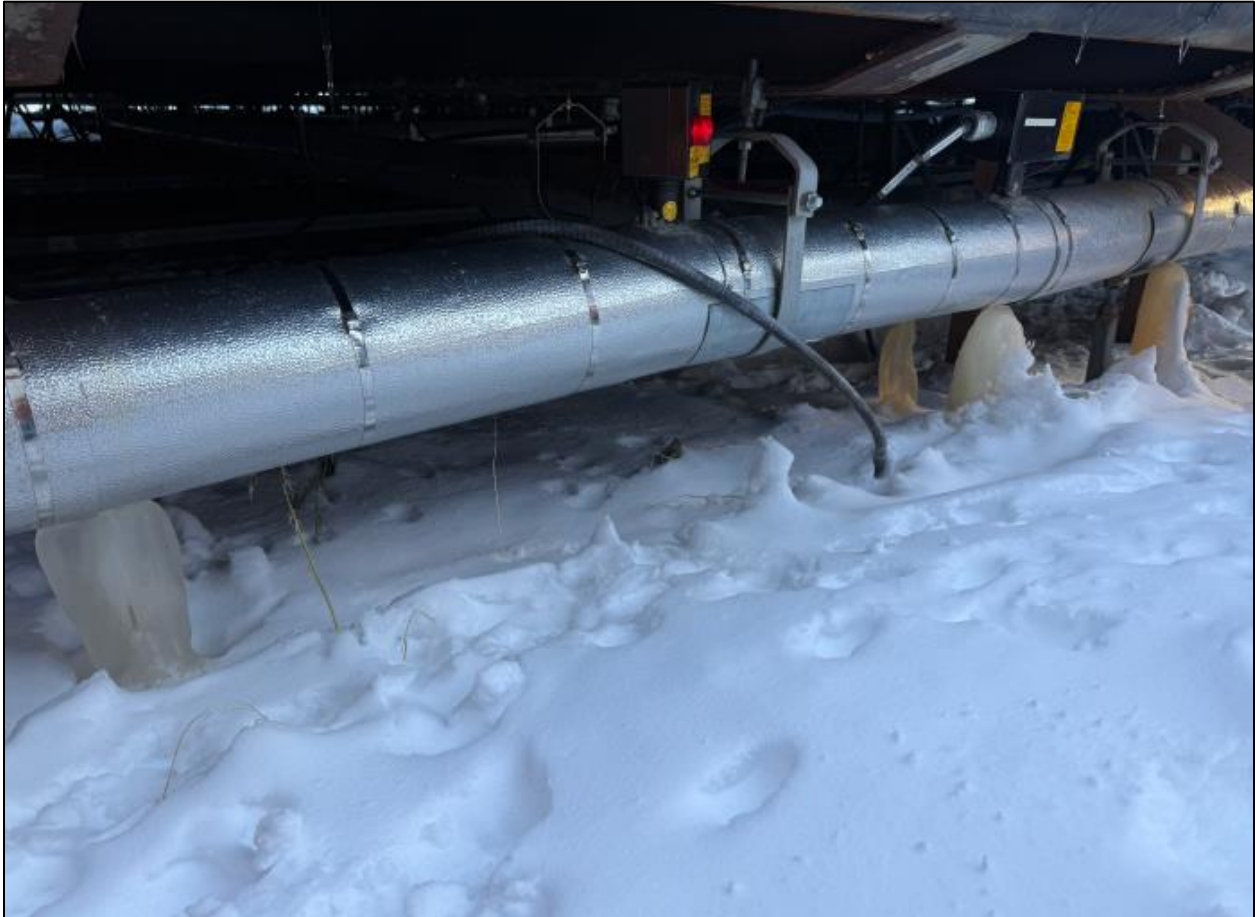
Photo 1: Spill location.

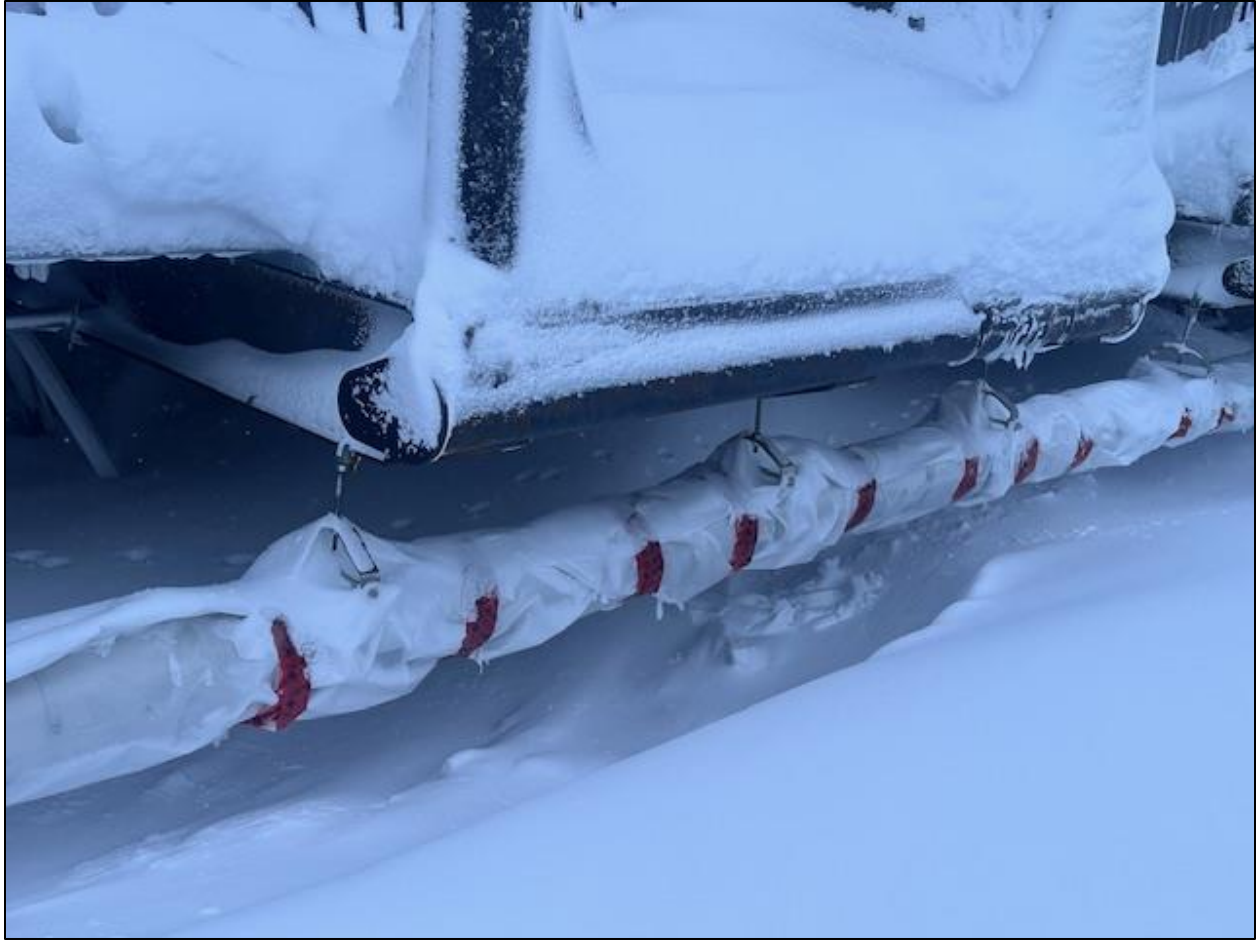
Photo 2: Spill location after remediation and tarp installation.

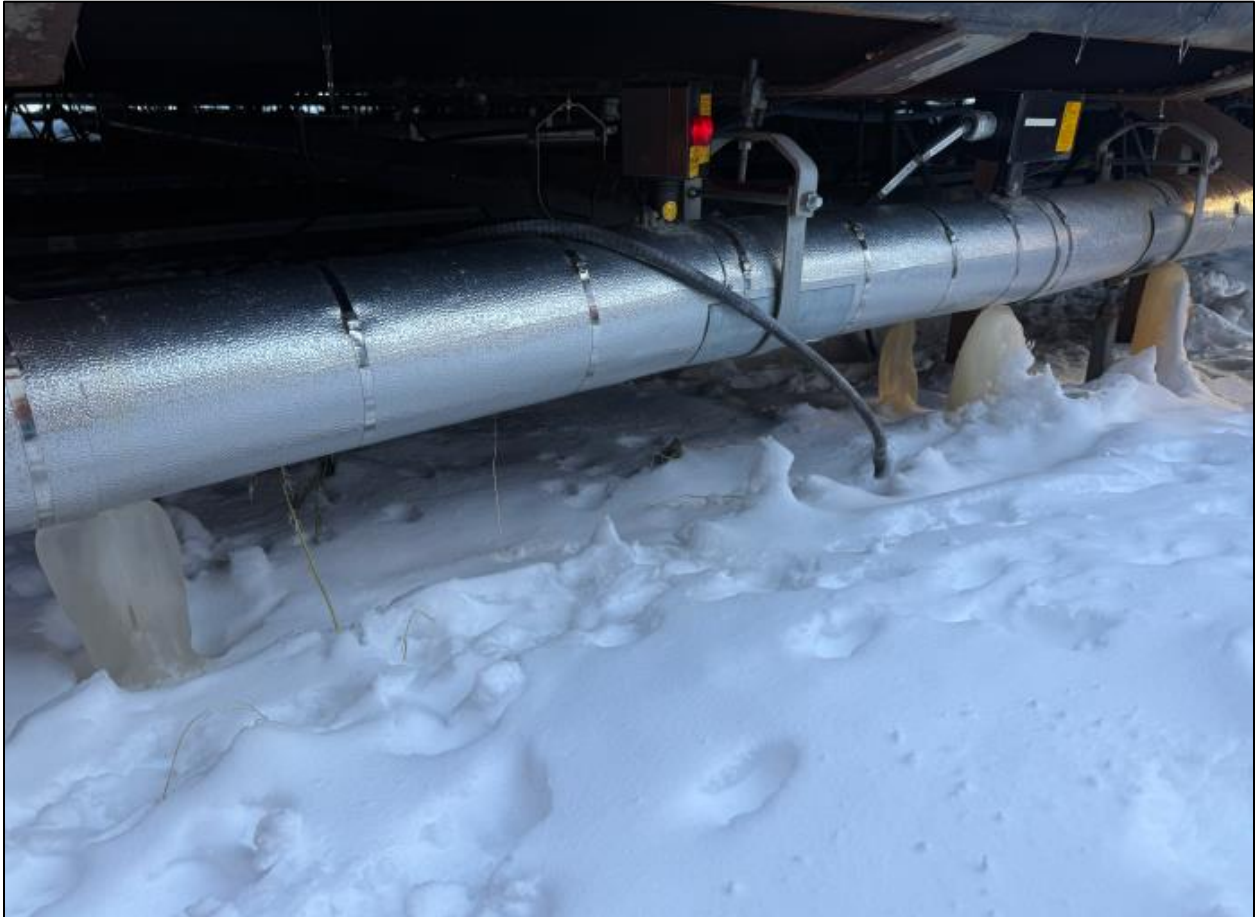
Photo 1: Spill location.

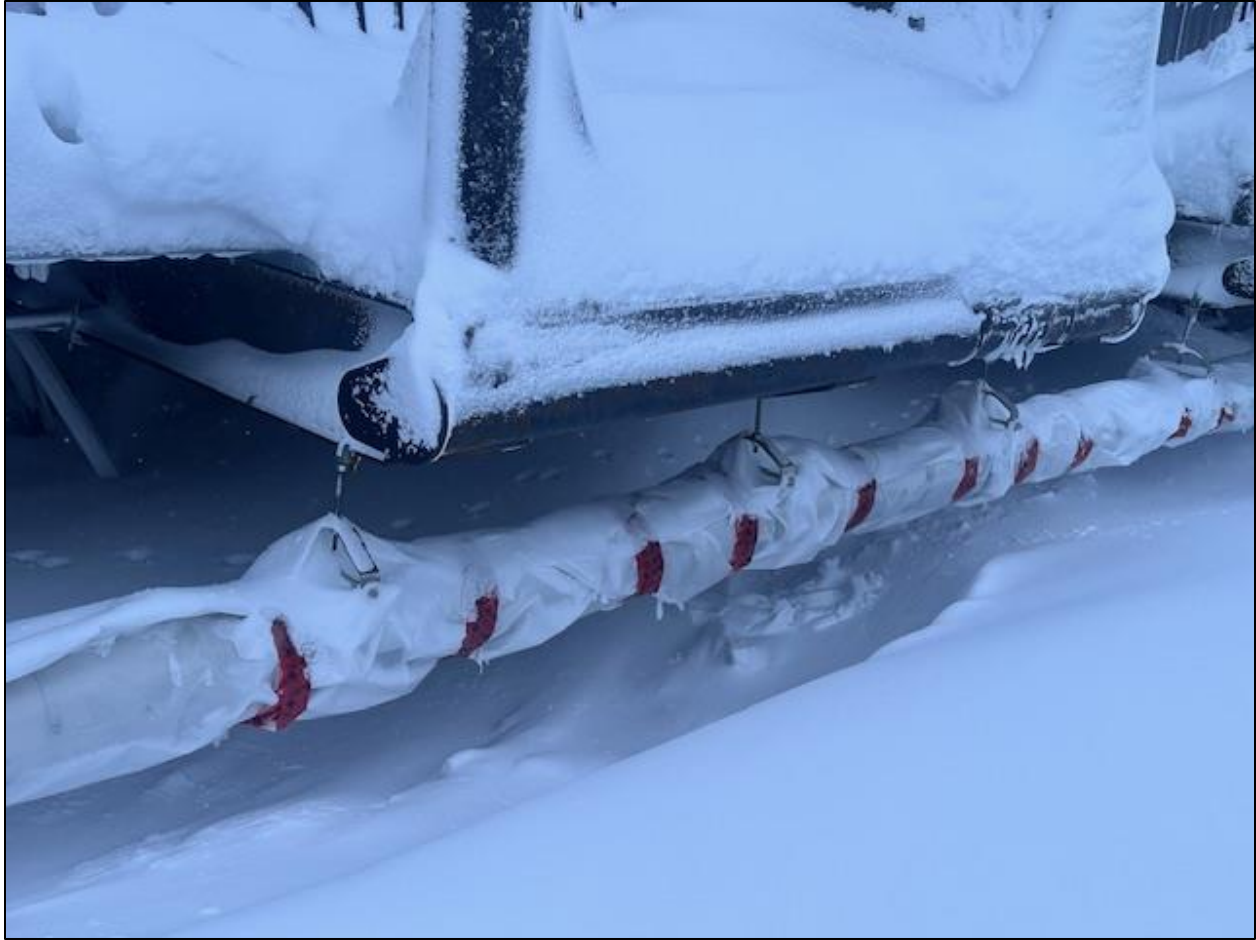
Photo 2: Spill location after remediation and tarp installation.

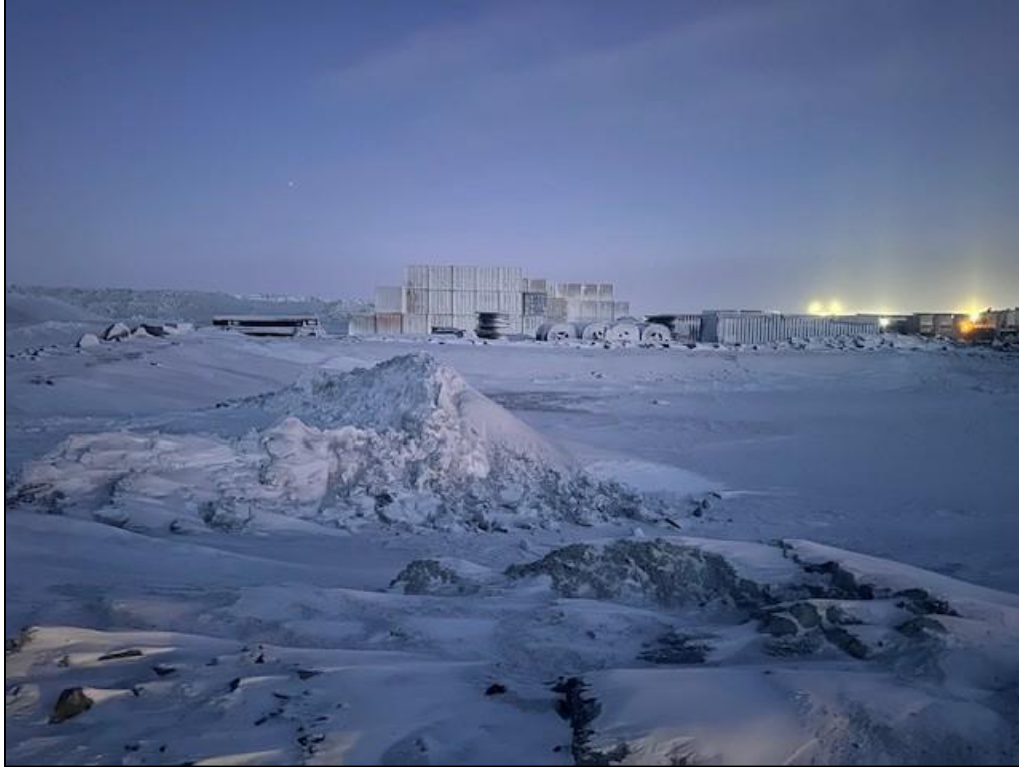
Photo 4: Material collected and placed at the contaminated Snow Cell
