Meadowbank 2020 Annual Pit Slope Performance Review

2020 ANNUAL PIT SLOPE Performance Review

Meadowbank Mine, Nunavut

ISSUED FOR USE 704-ENG.ROCK03163-01

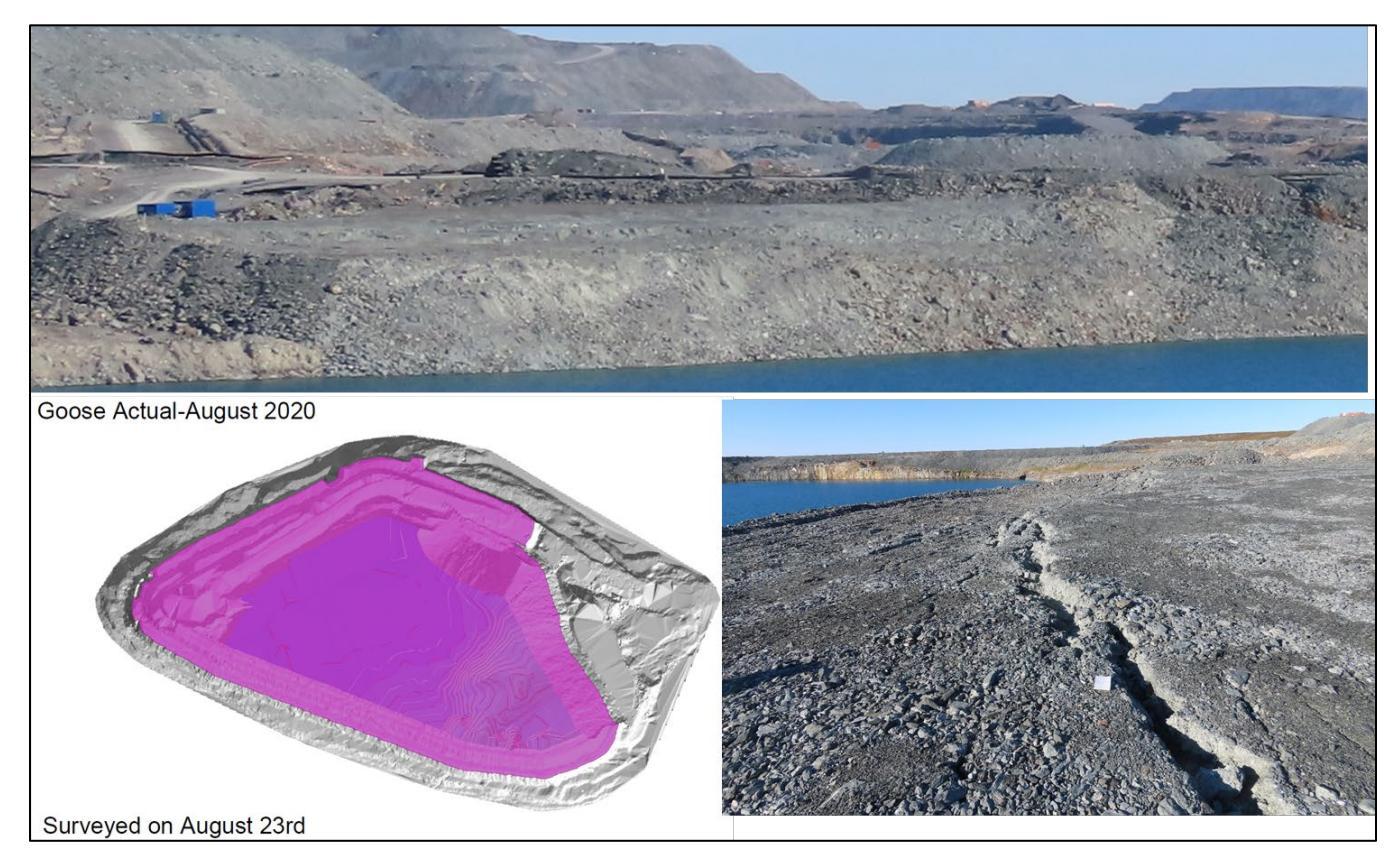
visible deformation can be seen is up to about 40 m. The performance of the Goose Pit Dump and platform is described in Section 6.5.1 of this report.

Photograph 4-15: Platform settlement and tension crack formation at the Goose Pit Dump (2020)

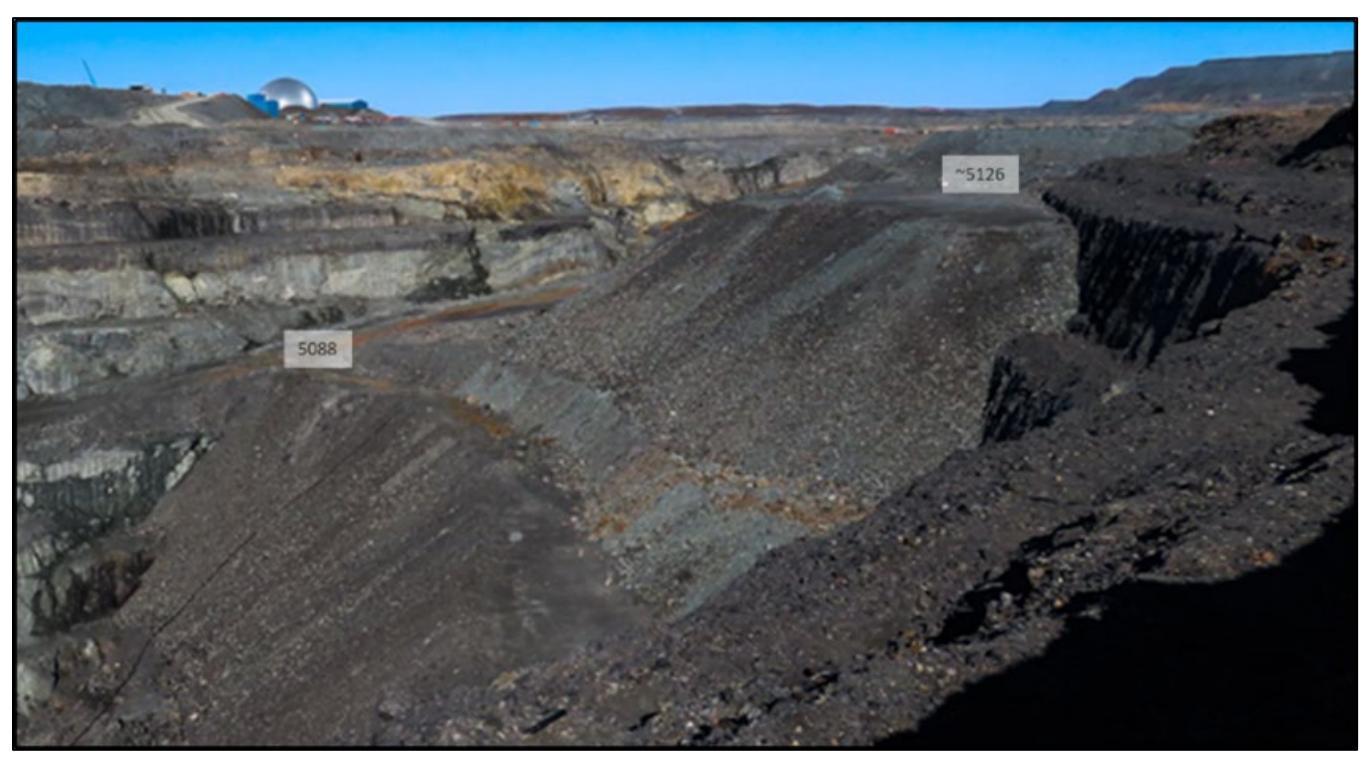
Areas of tension cracks that were observed on the Pit D Dump 5088 mRL and 5126 mRL platforms during the 2016 and 2017 inspections have not opened further. No additional tension cracks were observed suggesting that settlement of the platform crests in these areas has stopped. Photograph 4-17 shows the dump profile in 2020, and the 5088 mRL bench where tension cracks were previously noted.

Photograph 4-17: Pit D Dump profile and 5088 mRL platform (2020)

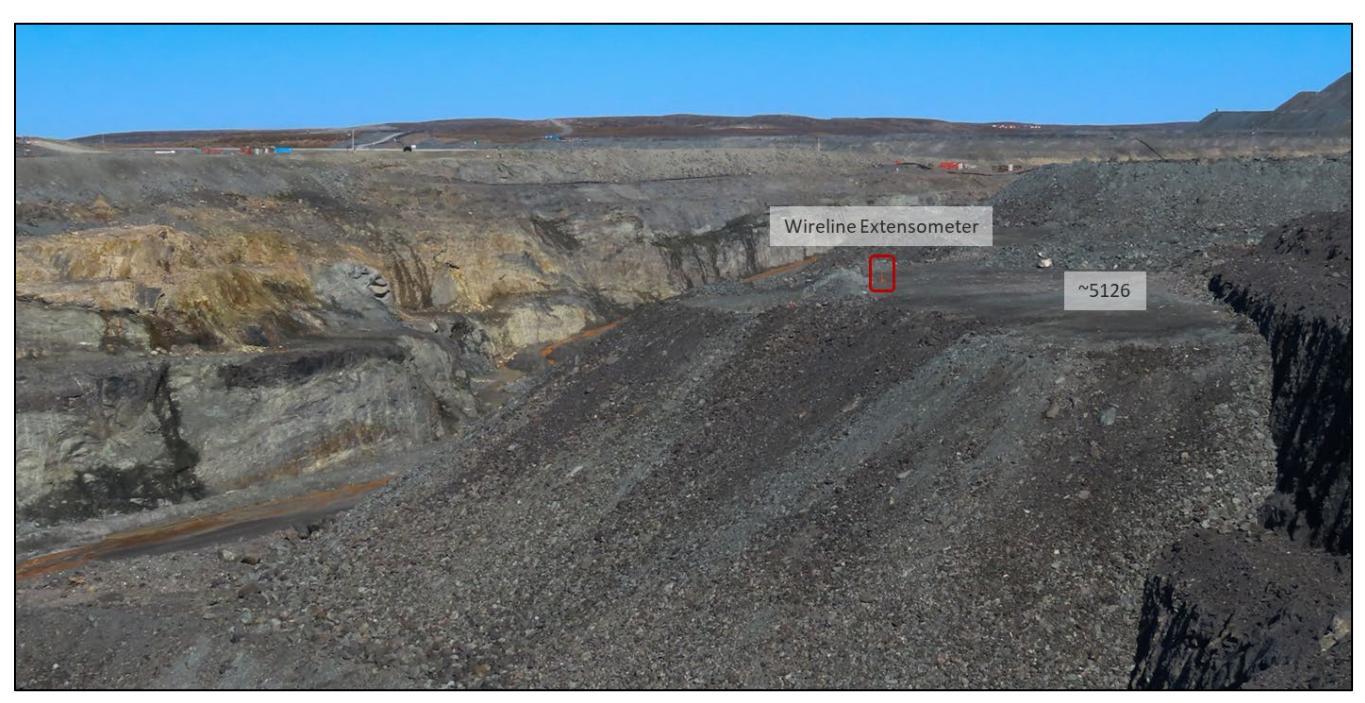
During the 2019 inspection an area of note is along the west crest of the 5126 mRL platform. This area is above the active haul road from Pit E which will continue to be maintained as access for tailings and water reclaim purposes. Several tension cracks were noted parallel to the crest of the dump above the road. The condition of the platform is shown in Photograph 4-19.

Photograph 4-19: Pit D Dump 5126 platform above haul road (2020)

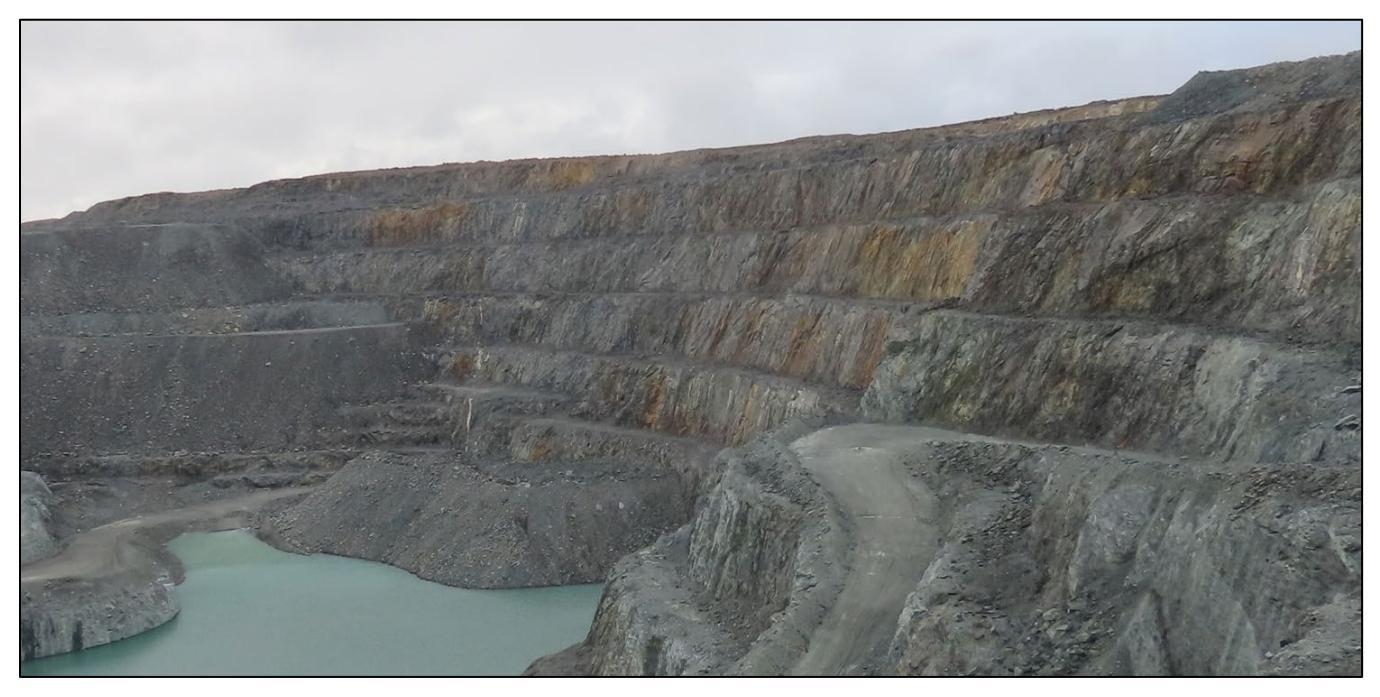
The main structural control for the east wall is the steeply west dipping stratigraphy and sub-parallel foliation which bench face angles either break to or are excavated to. The bench and overall wall performance continue to be satisfactory within the good quality intermediate volcanic rock. There has been no noticeable deterioration of the final benches or accumulation of material since mining of this wall was completed. The condition of the Pit E East Wall at the time of inspection is shown in Photograph 5-3.

Photograph 5-3: Pit E east wall performance (2020)

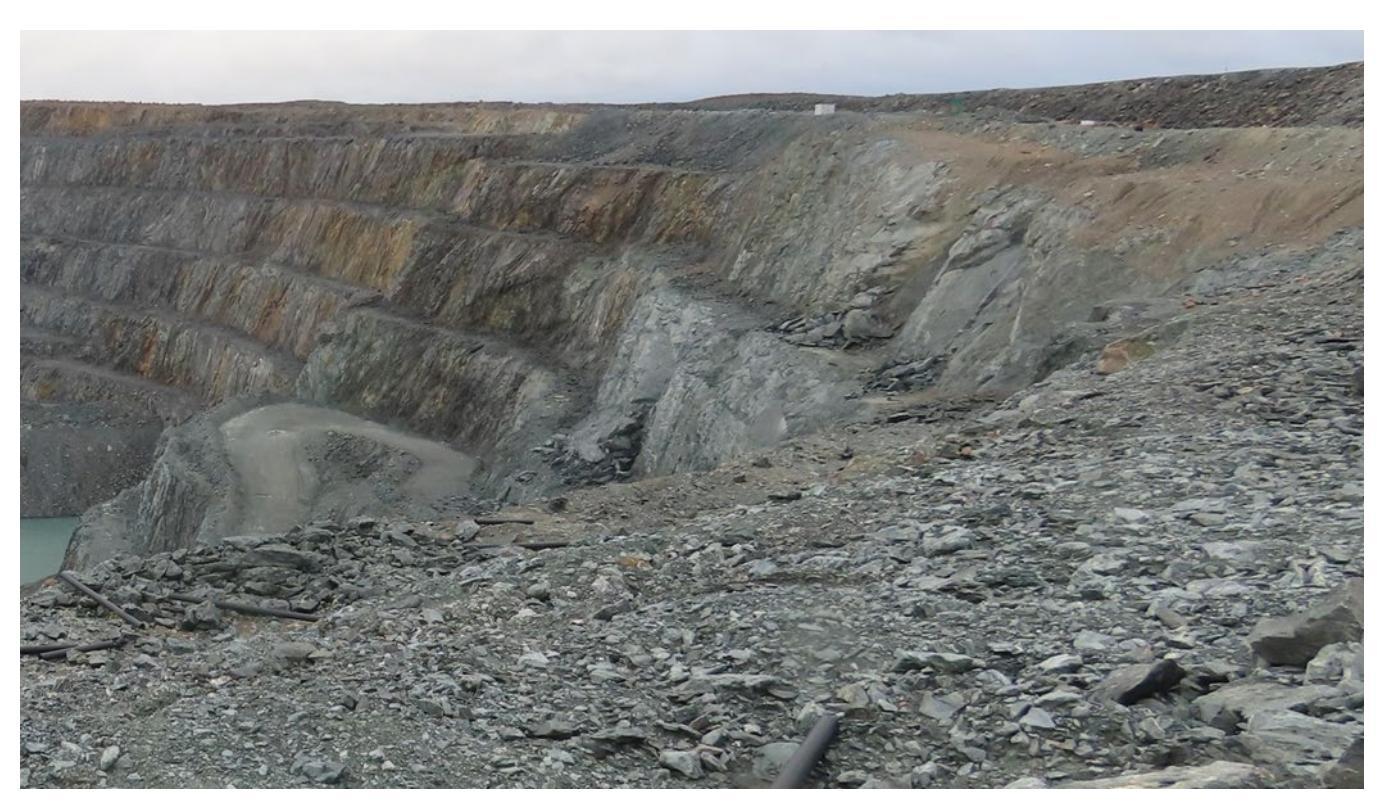
Photograph 5-5: Bench scale slab failure along foliation above South Ramp (2020)

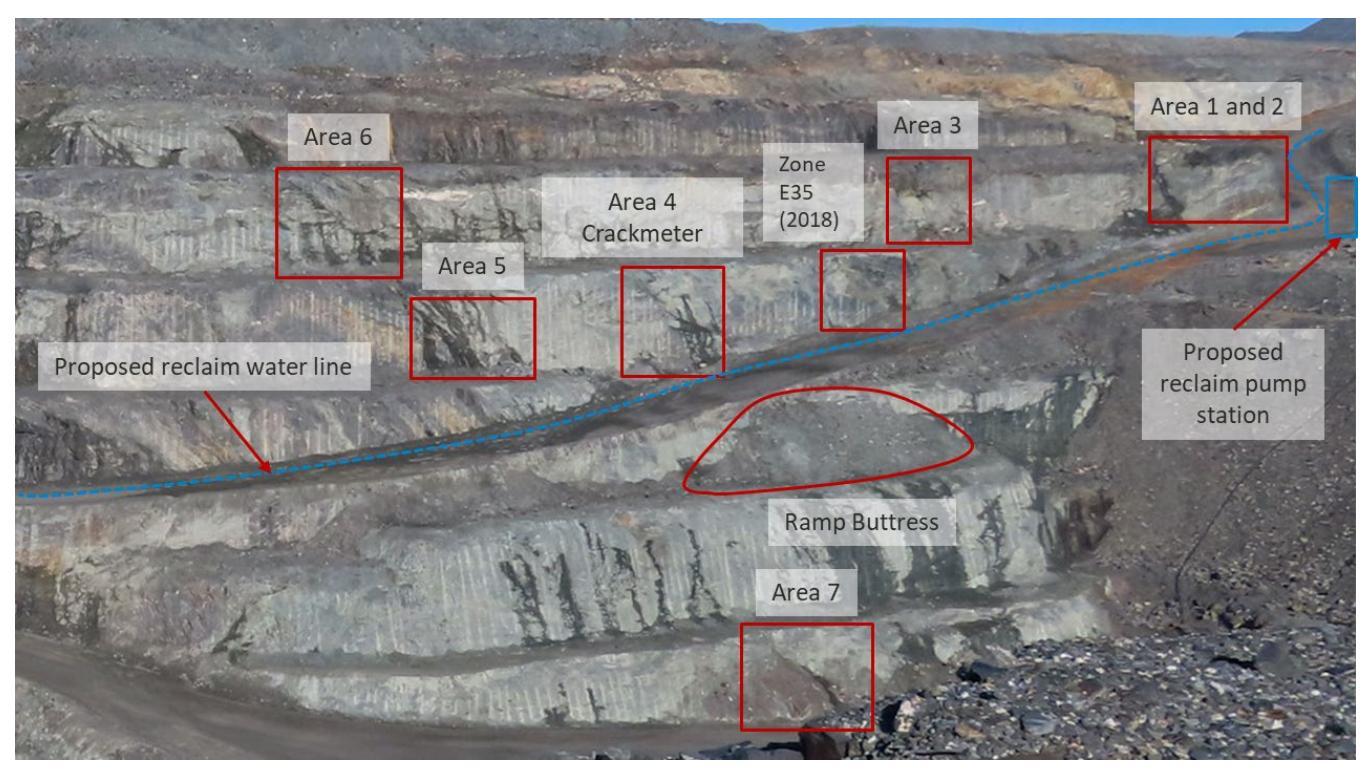
Nine key areas of geotechnical hazards identified during previous inspections continue to be monitored and are discussed below. The condition of the Pit E3 West Wall Ramp at the time of inspection is shown in Photograph 5-10 and Photograph 5-11.

Photograph 5-10: Pit E west wall ramp summary hazard identification (2020)

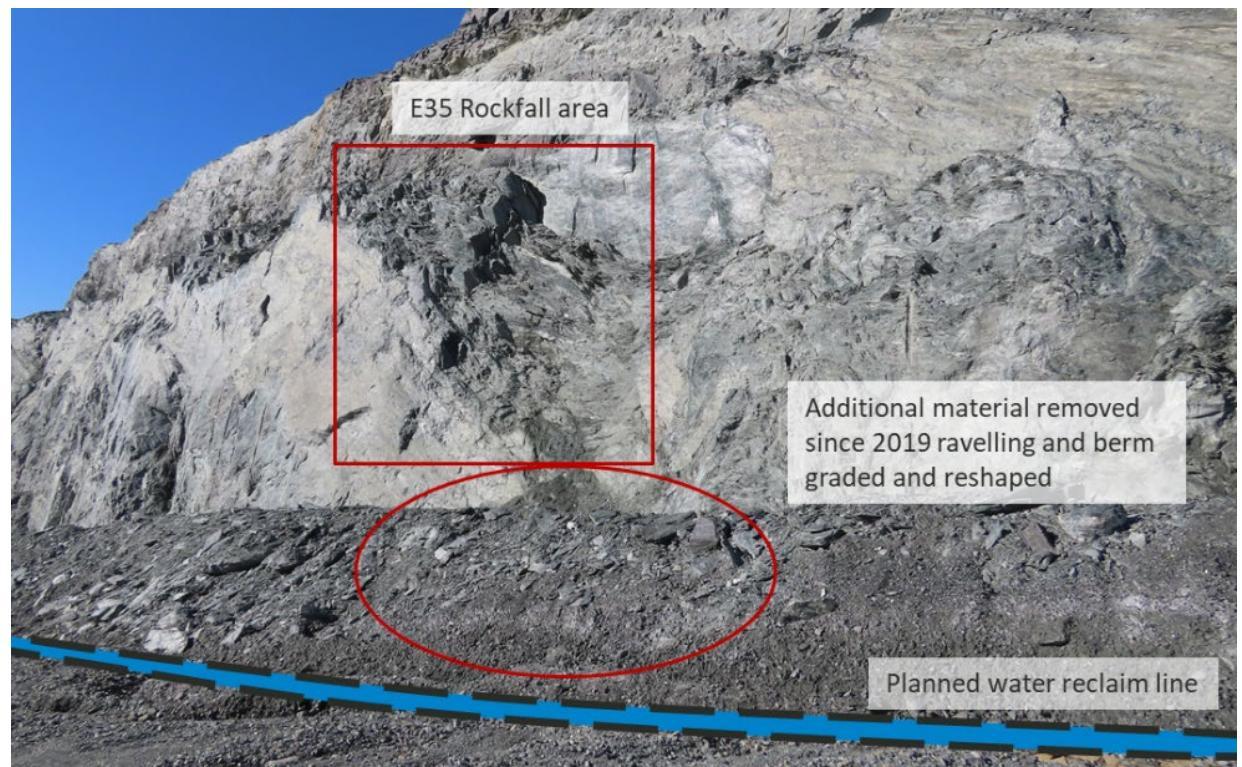
During the 2019 site visit additional material was noted to have failed in Zone E35, filling behind the berm. No additional material was noted to have accumulated during the 2020 site visit. The current condition of the Zone E35 rock fall is shown in Photograph 5-13.

Photograph 5-13: Zone E35 rockfall (2020)

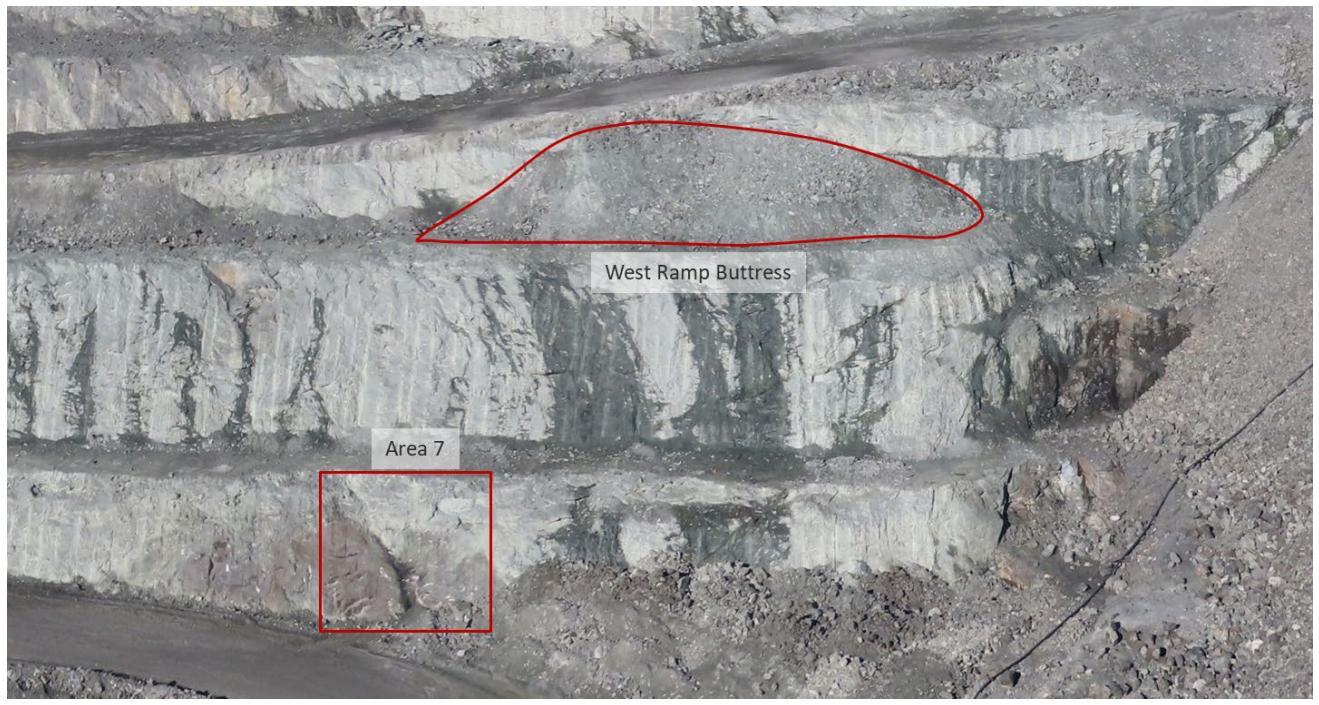
Photograph 5-15: Pit E Ramp Area 7 and West Ramp Buttress (2020)

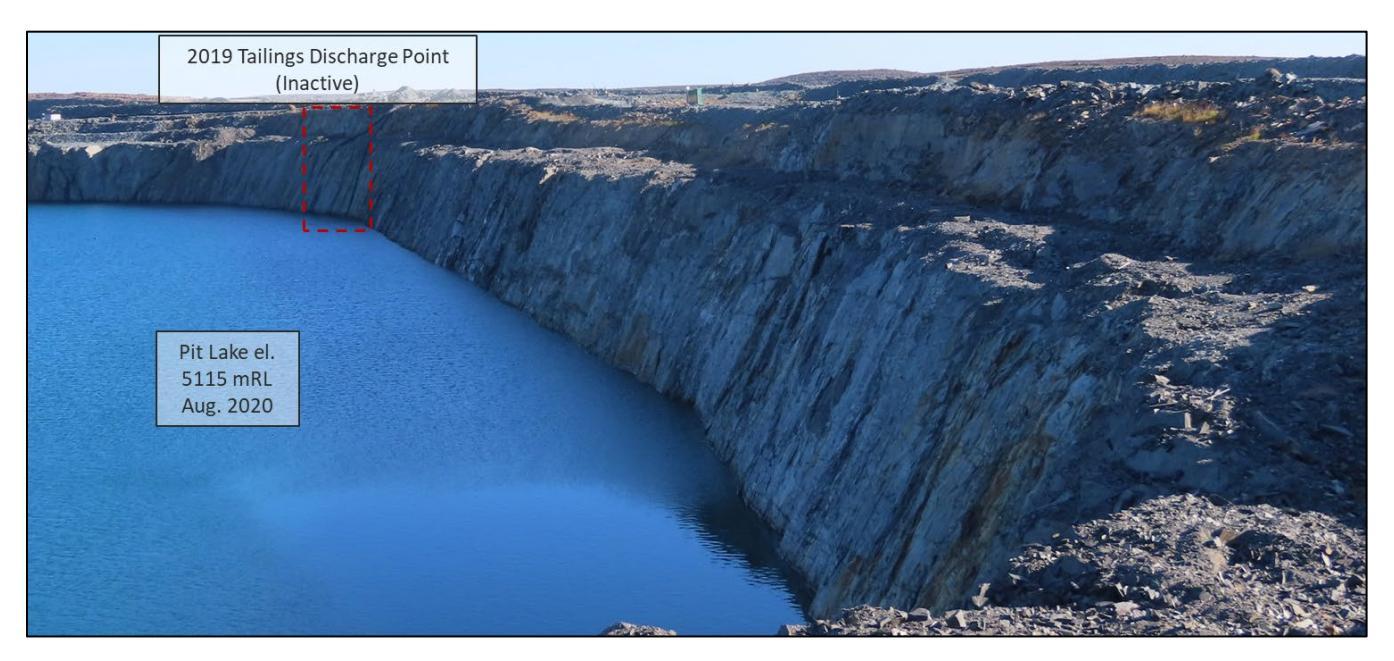
The wall continues to perform well and there are currently no geotechnical concerns. The Goose Pit East Wall at the time of inspection is shown in Photograph 6-1.

Photograph 6-1: Goose Pit east wall looking north (2020)

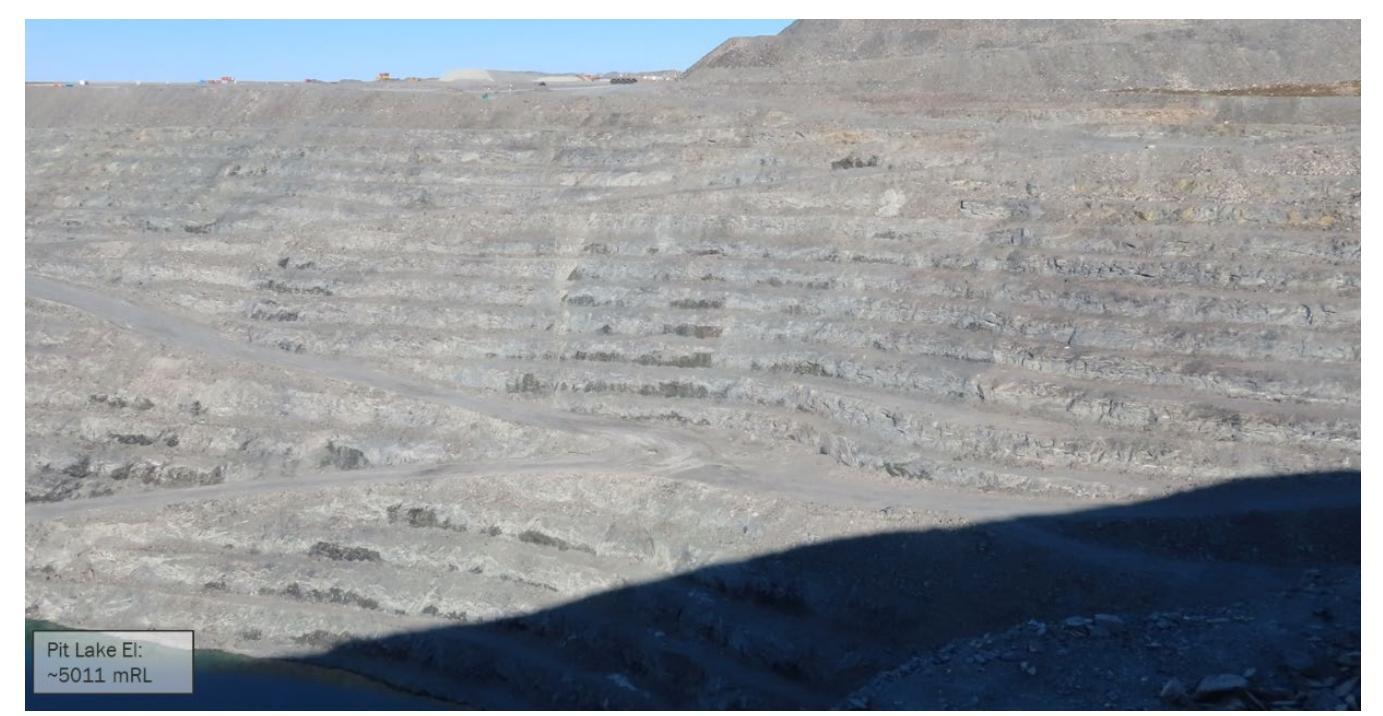
During the 2020 site visit, minor water seepage on the footwall (formerly called west wall seepage) continues to be noted in an area above the ramp which has been seeping at a very low rate since mining of the pit began (as shown in Photograph 7-1).

Photograph 7-1: Minor wall seepage noted on west footwall of Vault Pit (2020)

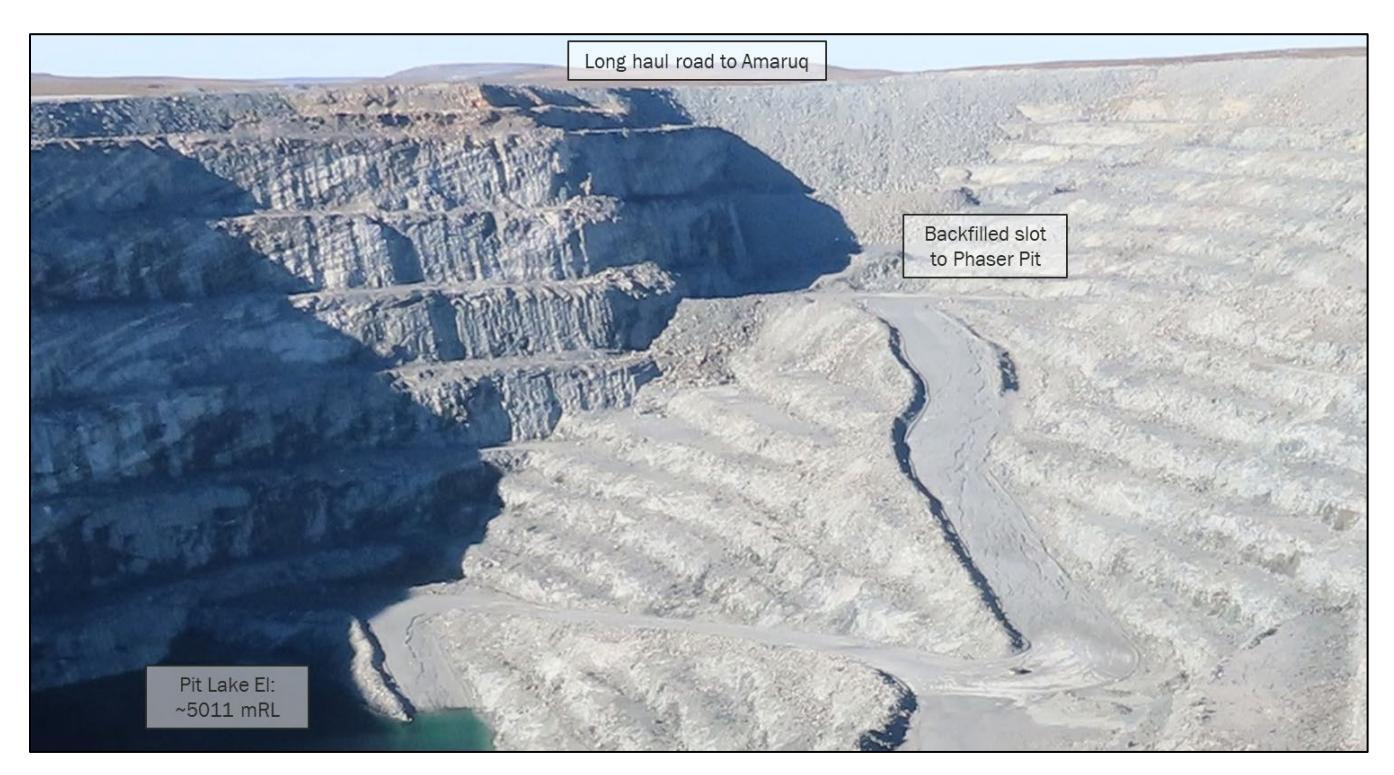
During the 2019 inspection, a significant inflow volume was noted to discharge from the backfilled slot separating Vault Pit from Phaser Pit. This was attributed to discharge from Phaser Pit. As previously discussed, the 2019 site inspection followed a period of heavy rain, which contributed to the observations of increased seepage and flows to the pit. During the 2020 inspection this area was noted to be dry. This is shown in Photograph 7-4.

Photograph 7-4: Inflow to Vault Pit from Phaser Pit (2020)

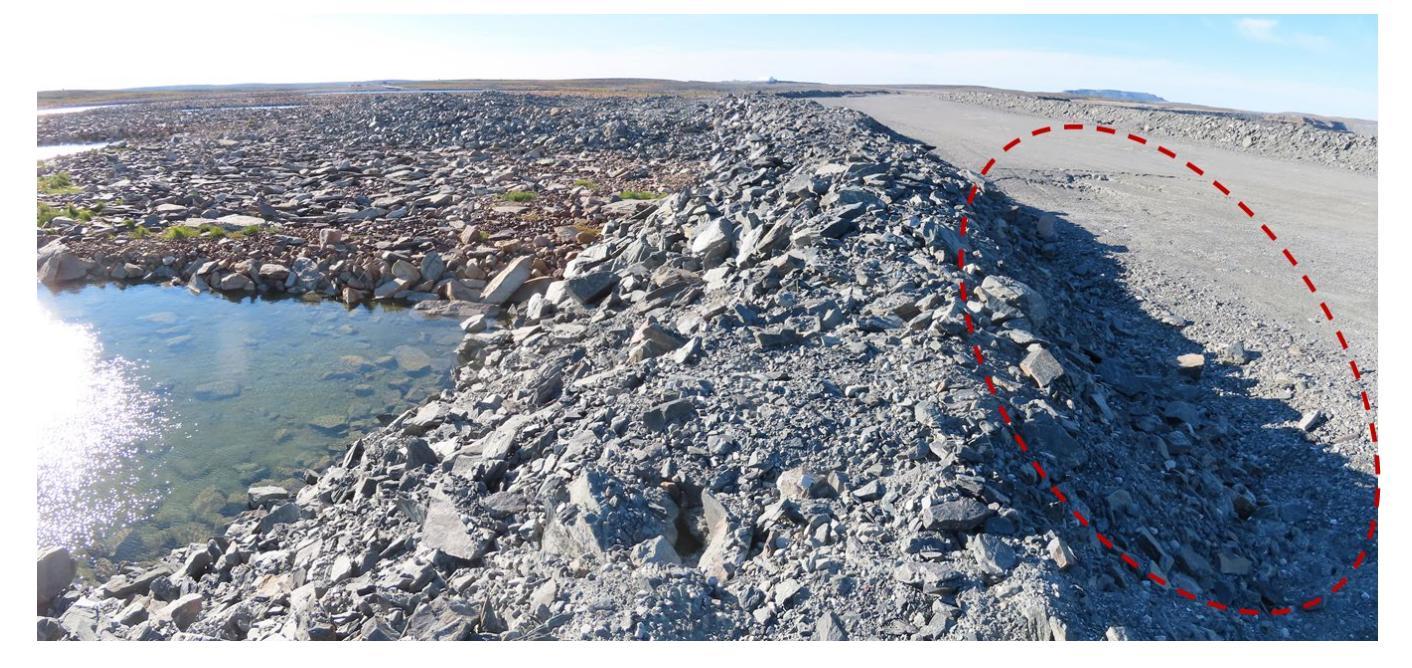
Photograph 7-6: Ring road at north end of pit showing area impacted by road surface settlement

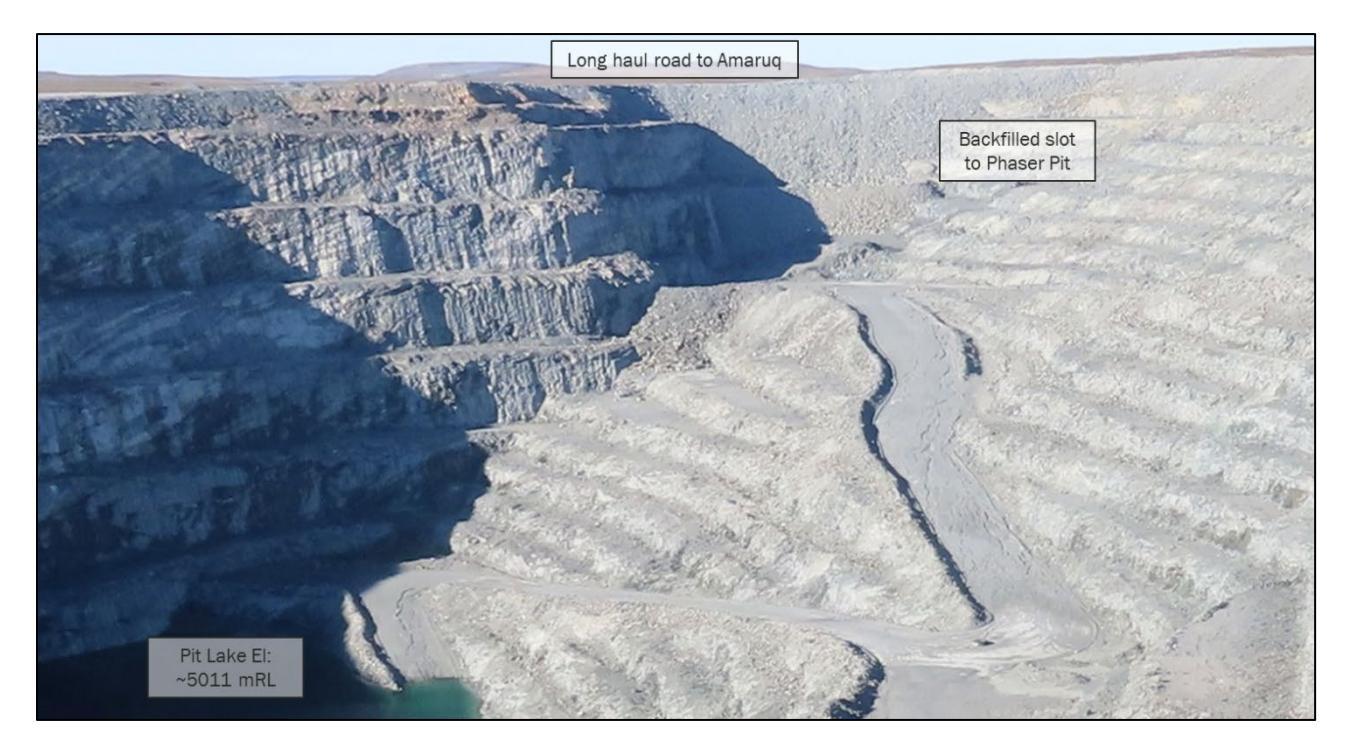
At the west end of the wall, the slot cut joining Vault Pit with Phaser Pit has been backfilled as part of the long-haul road extending north to the Amaruq Project area. Water that was noted to be flowing from the southwest corner of the pit towards the pit sump on the ramp at approximately elevation 5018 mRL in 2019 is no longer noted (as shown in Photograph 7-9).

Photograph 7-9: Vault Pit grid south wall and backfilled slot cut to Phaser Pit (2020)

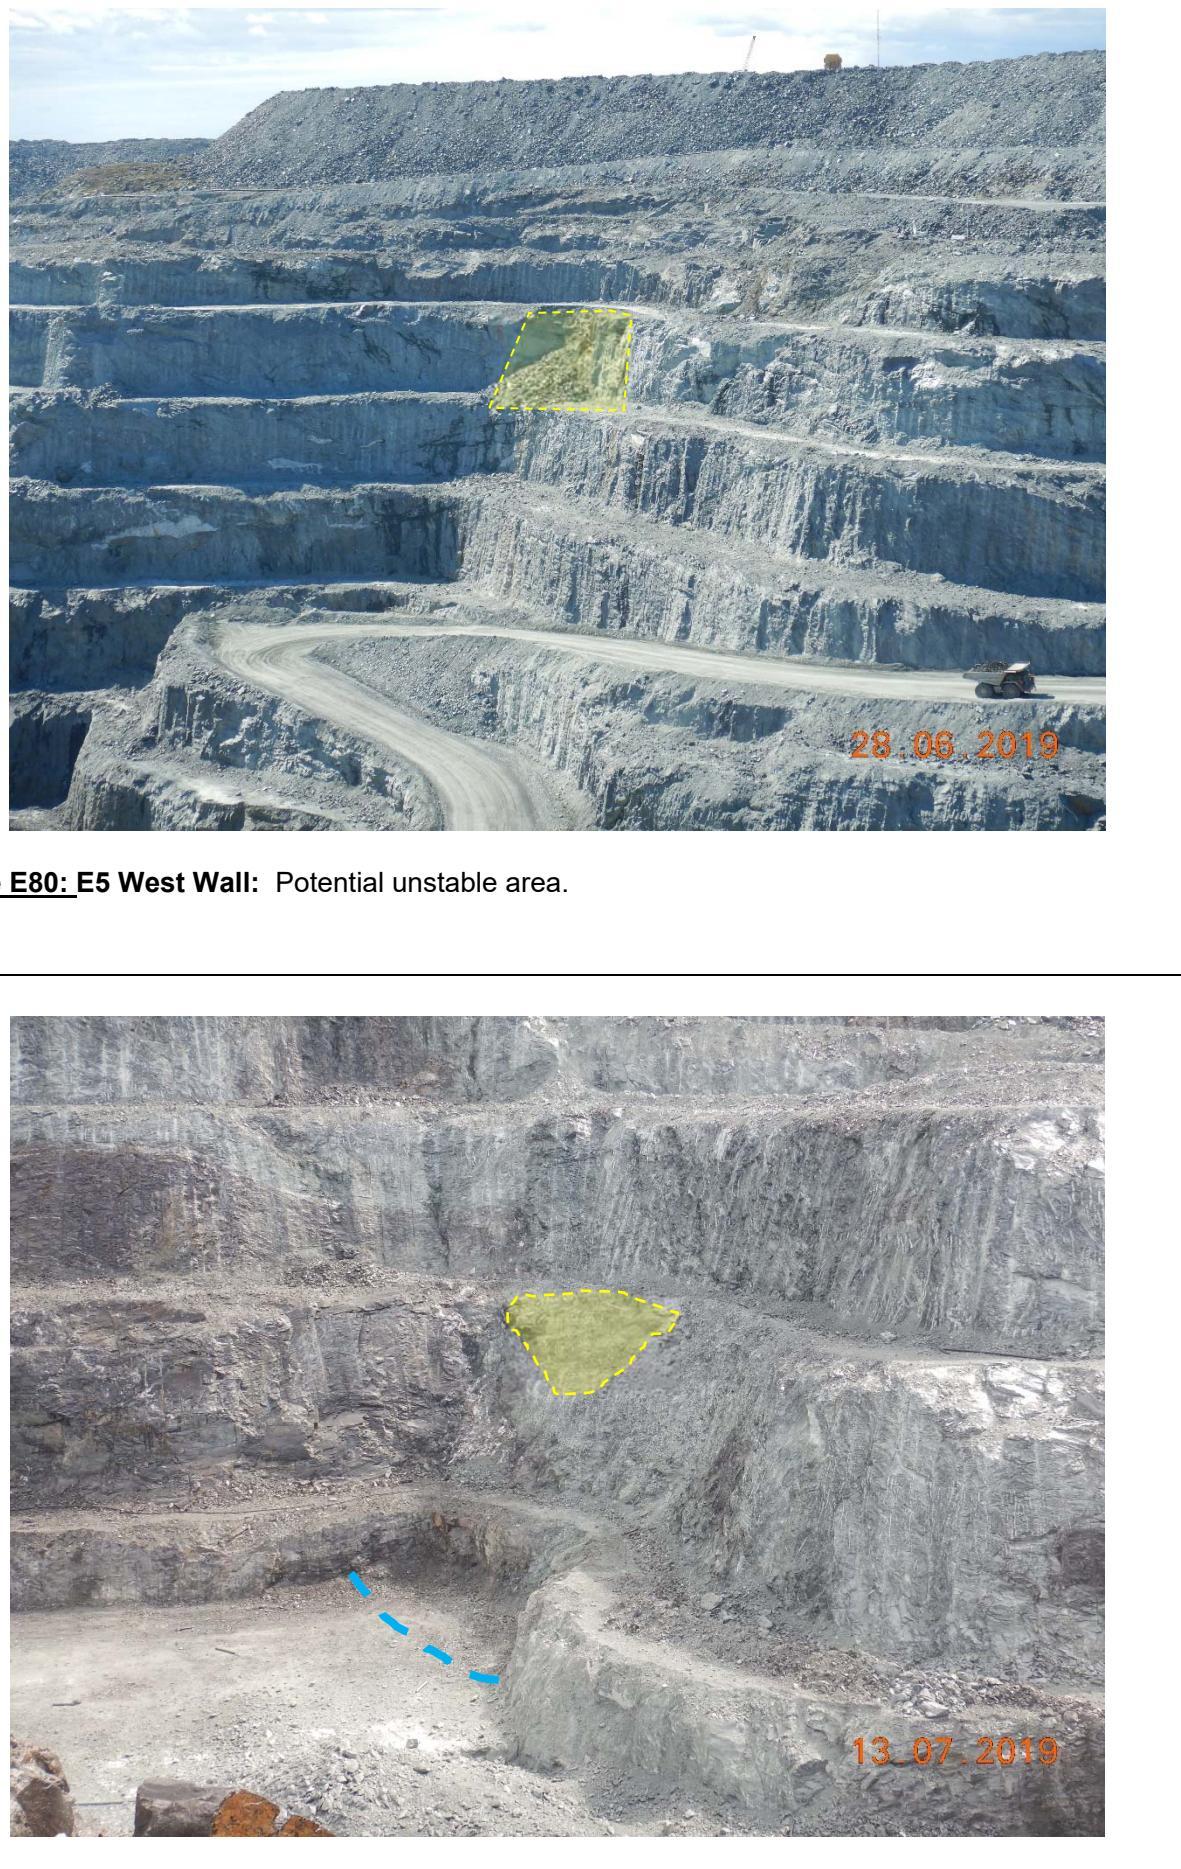
Zone E71: E5 South Wall: Potential wedge and cracks forming. Bumper in place.

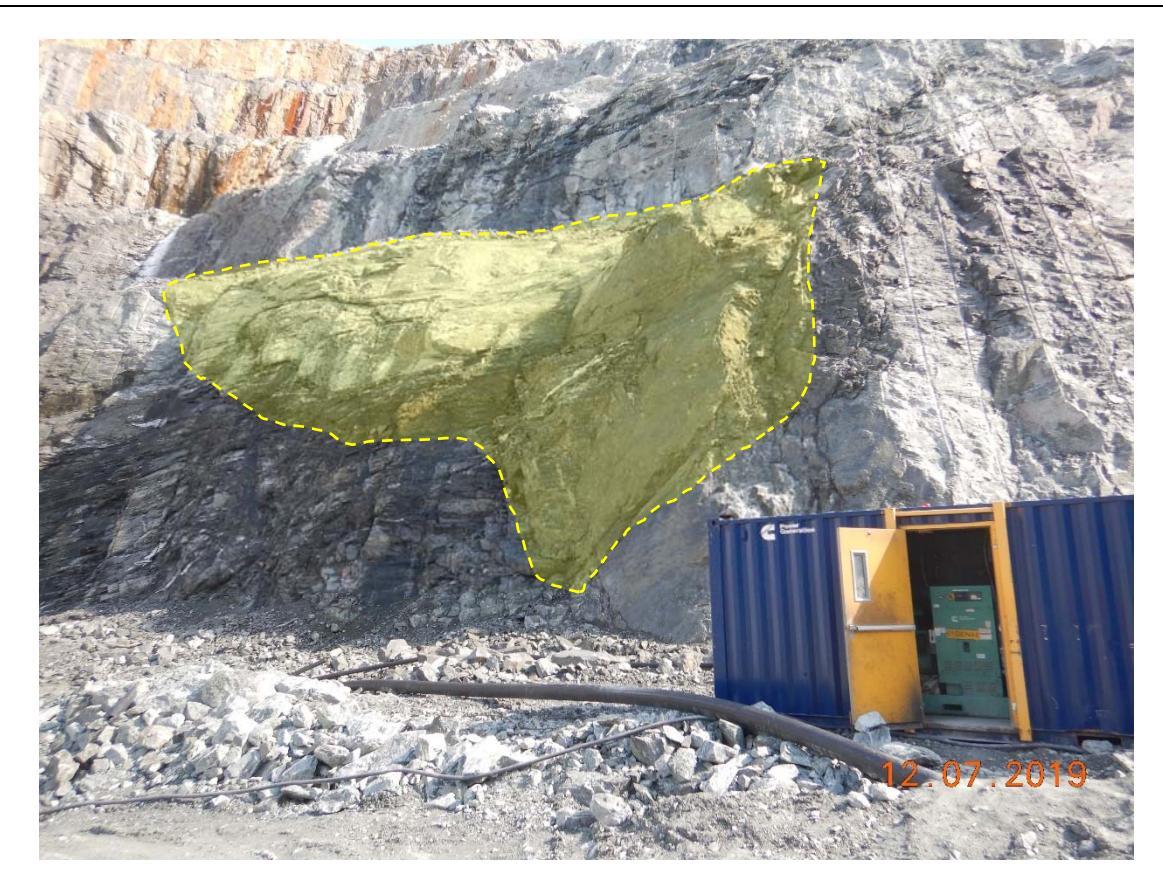
Zone E82: E5, East Wall: Potential unstable area.

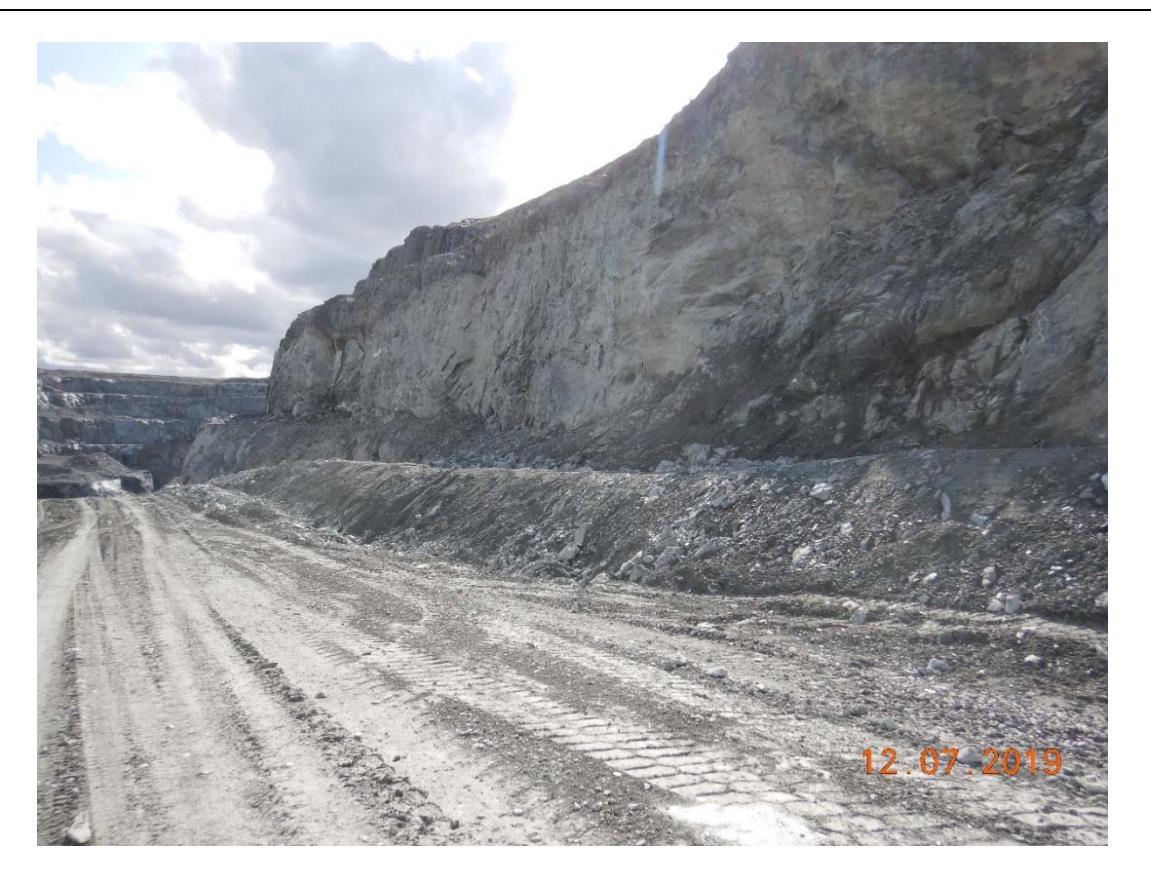
Zone E85: E5, 5004 Bench: Minor scaling prior to any work below these walls at 4990

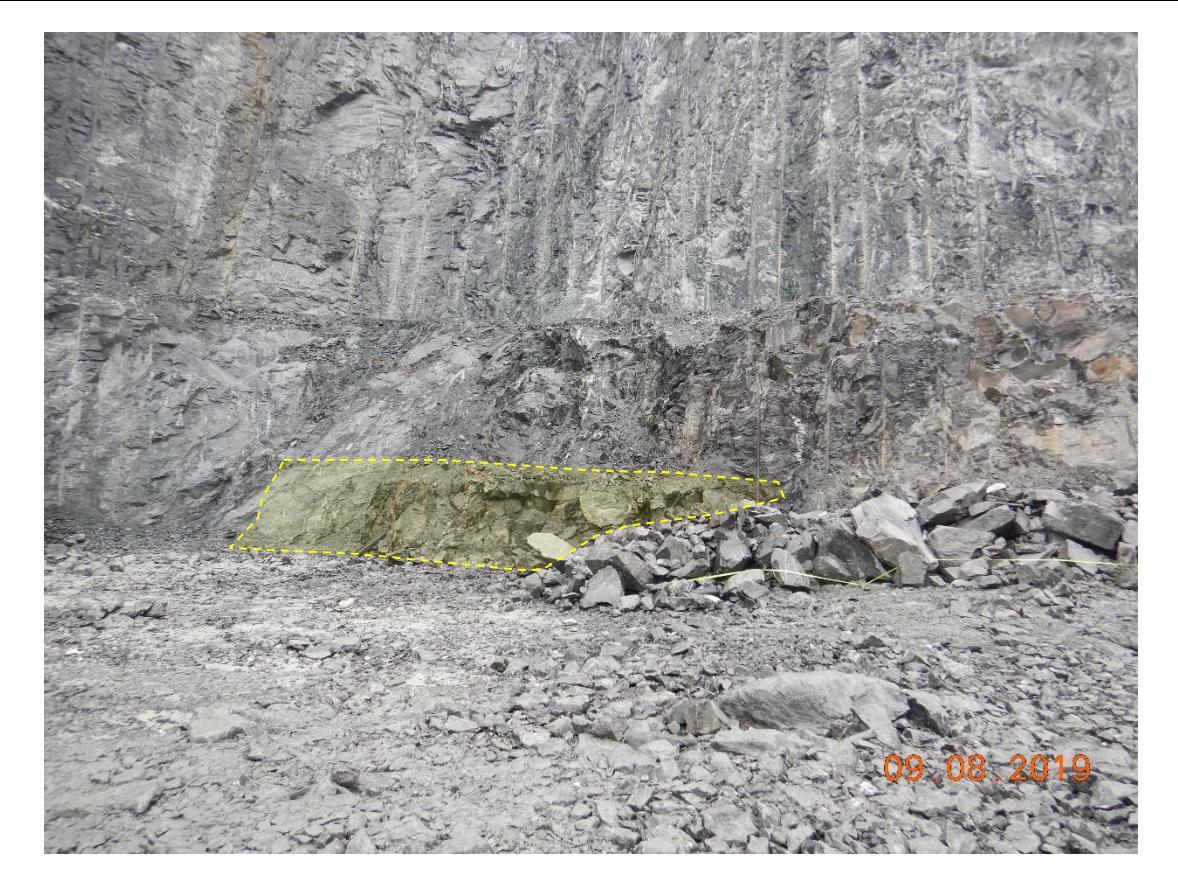
Zone E90: E5, North Wall: Scale the loose rocks on the final wall.

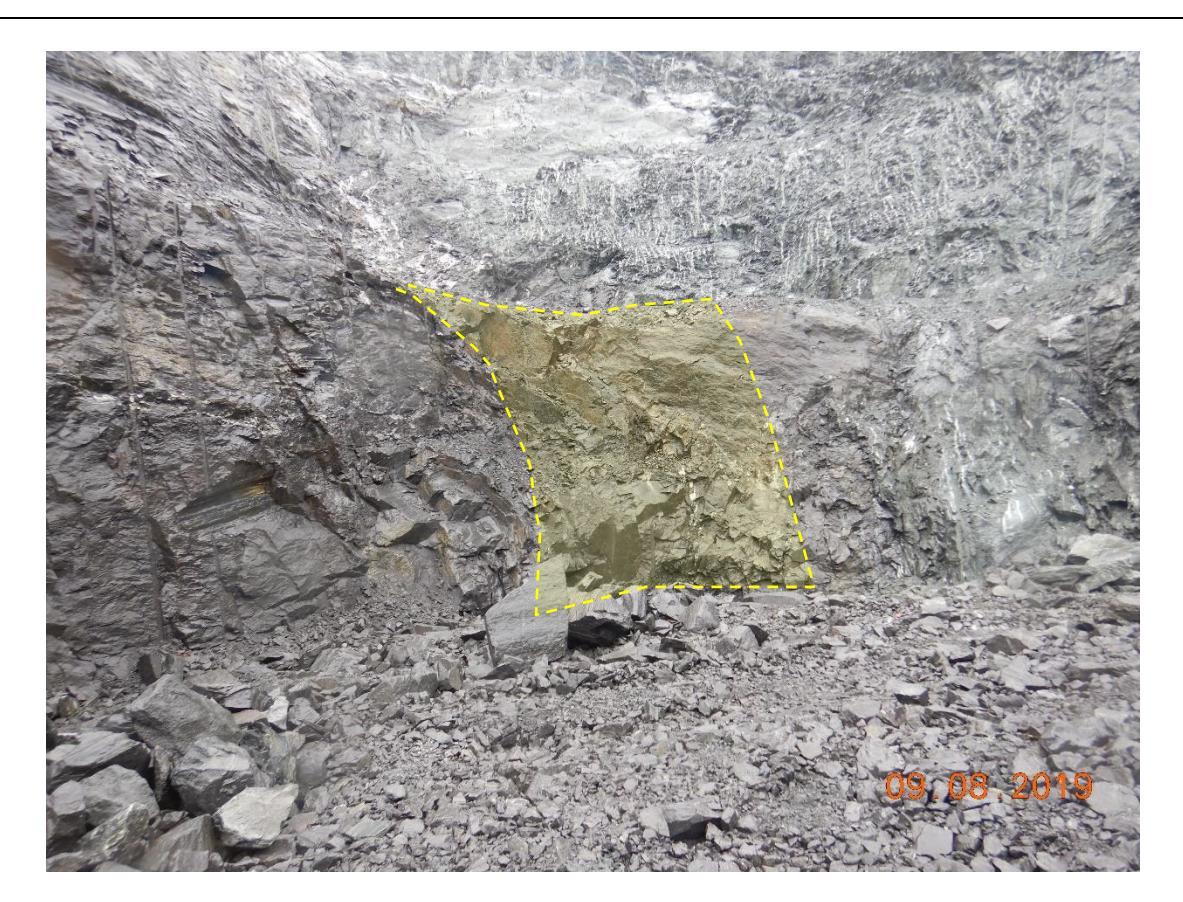
Zone E92: E5 South East Corner: Hammer the corner prior to drill next pattern.

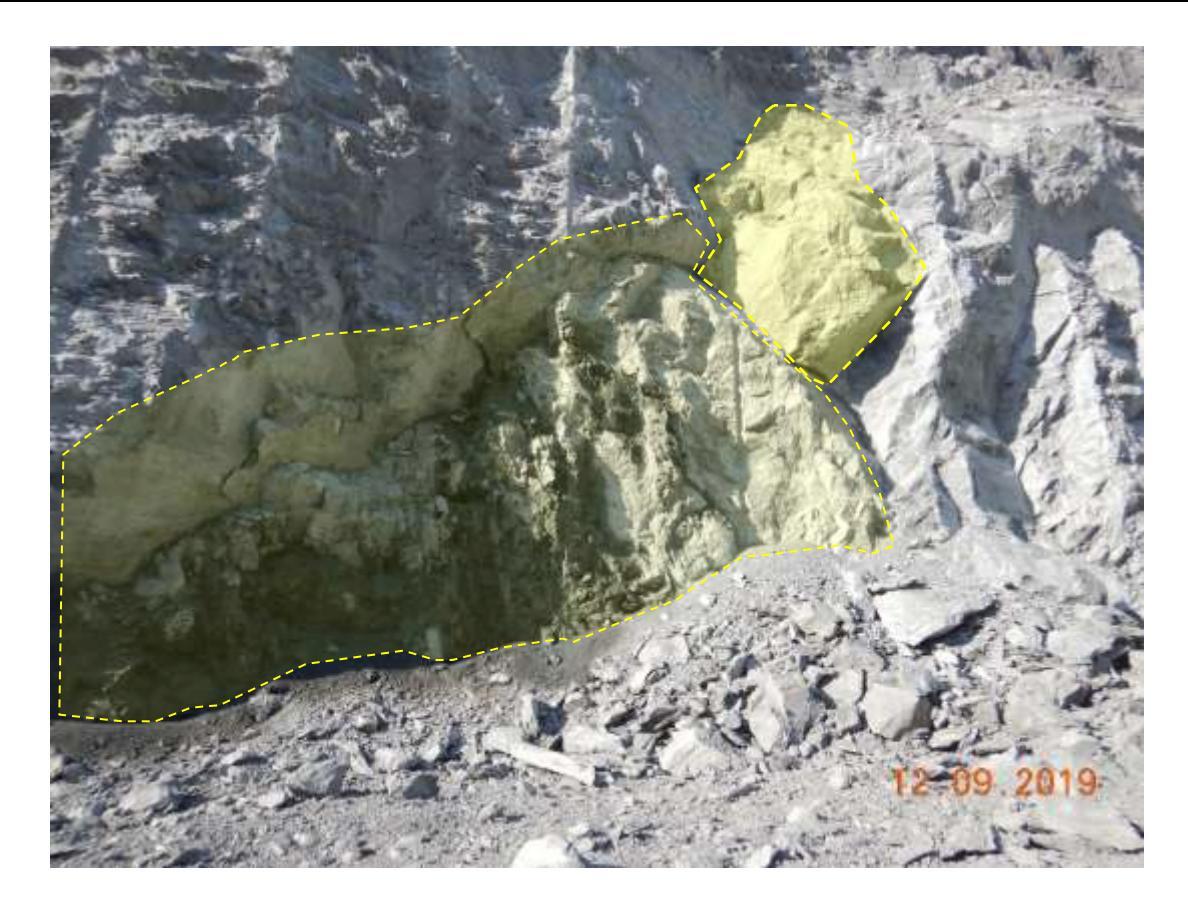
Zone E95: E5 West Wall: Presences of ravelling and undercut blocks. Berm is required.

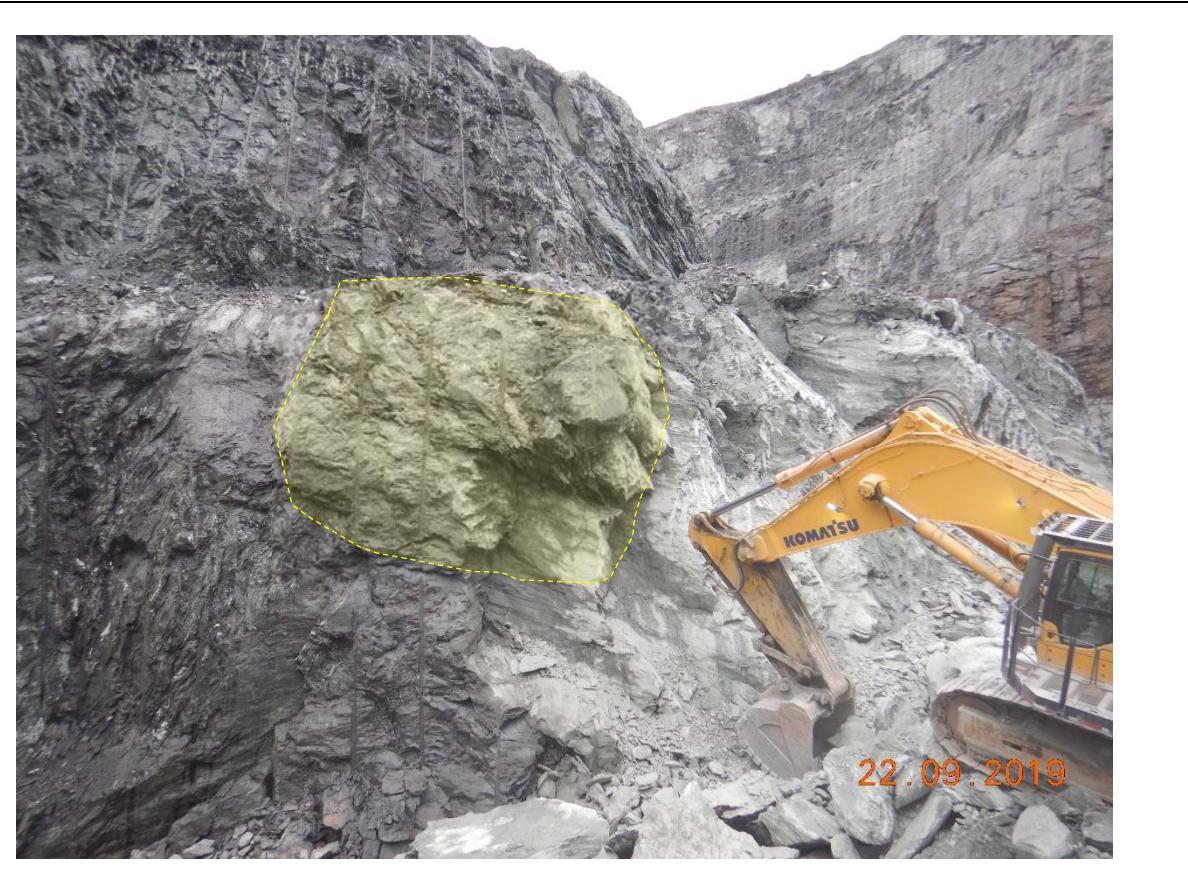
Zone E96: E5 South Corner: Hammer rest of overhanging blocks.
