Meadowbank 2020 Annual Pit Slope Performance Review

2020 ANNUAL PIT SLOPE Performance Review

Meadowbank Mine, Nunavut

ISSUED FOR USE 704-ENG.ROCK03163-01

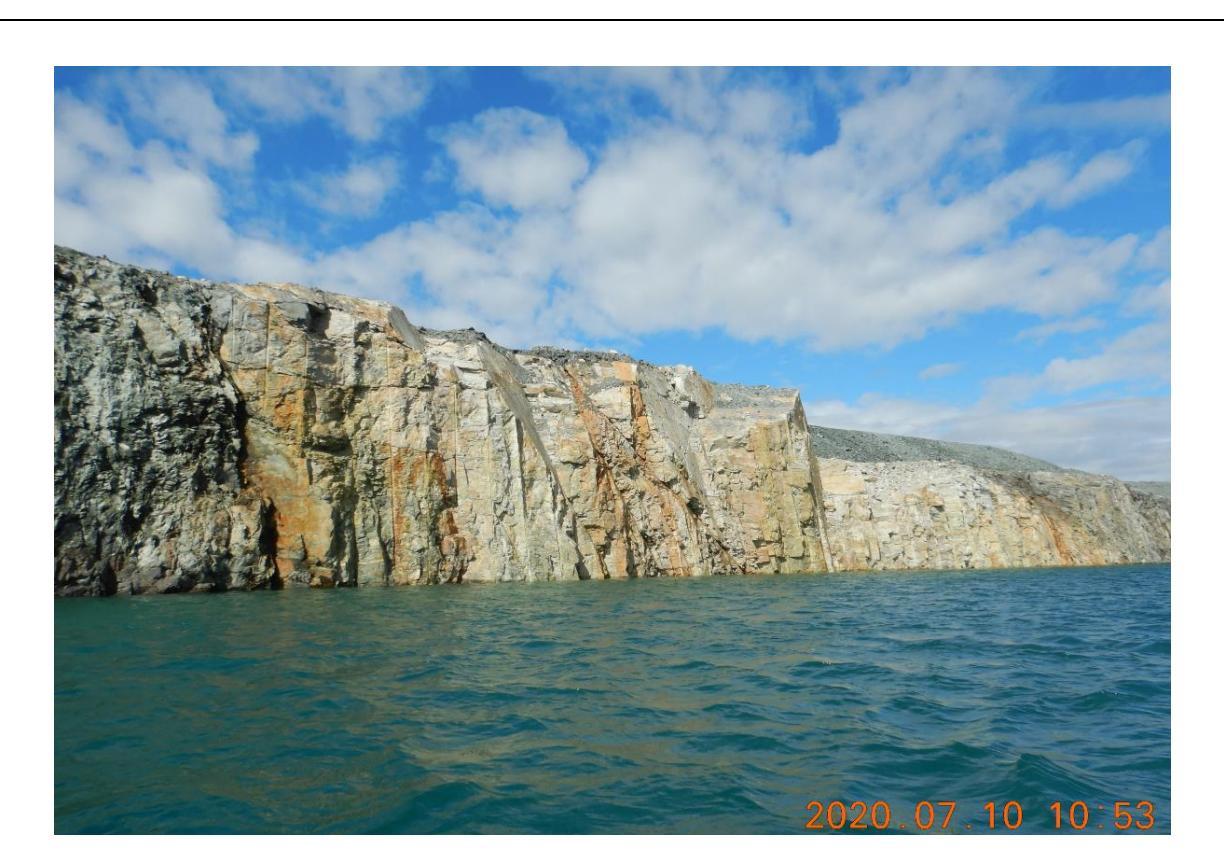
GOOSE PIT SW Wall: Wedges in Quartzite unit

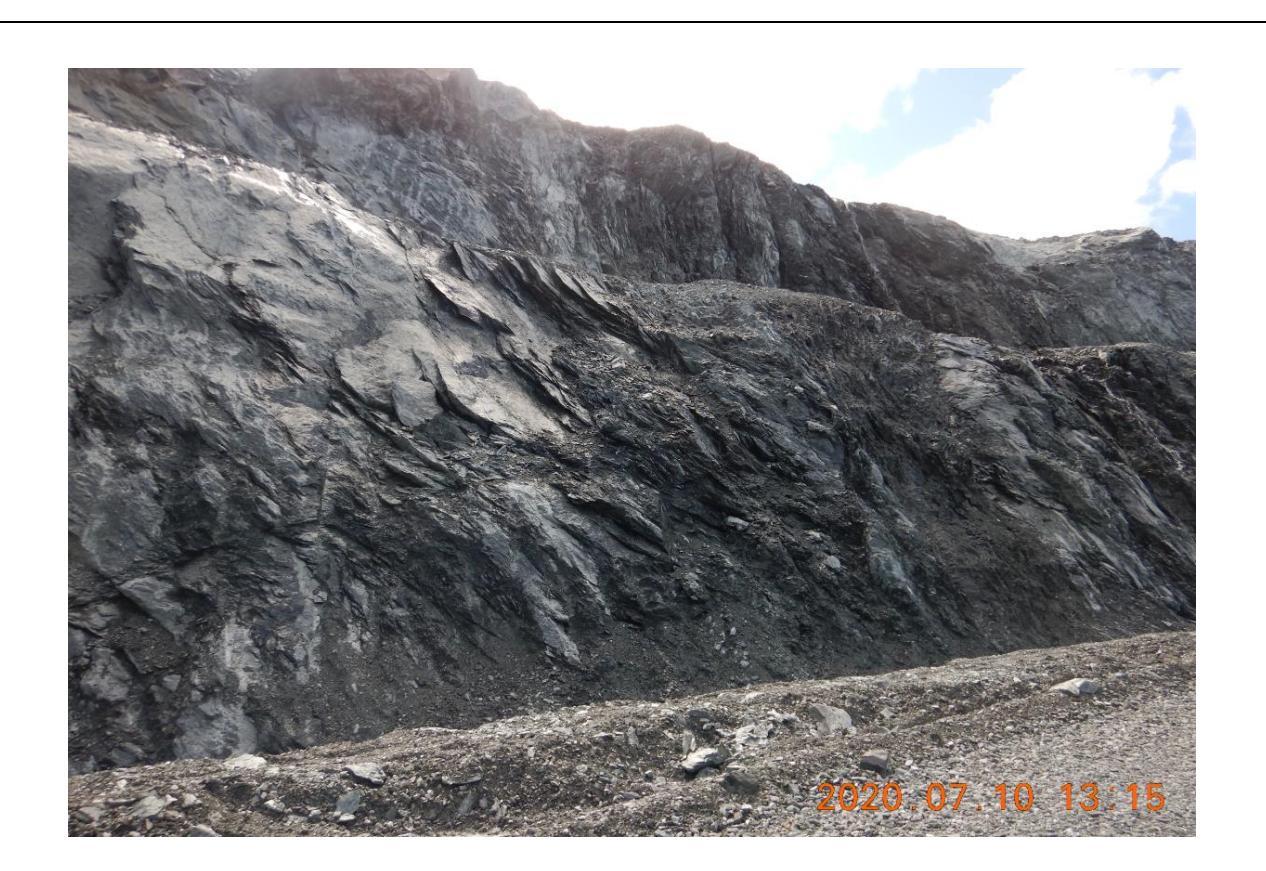
Pit E zone E5-S2: foliated unit, wet conditions

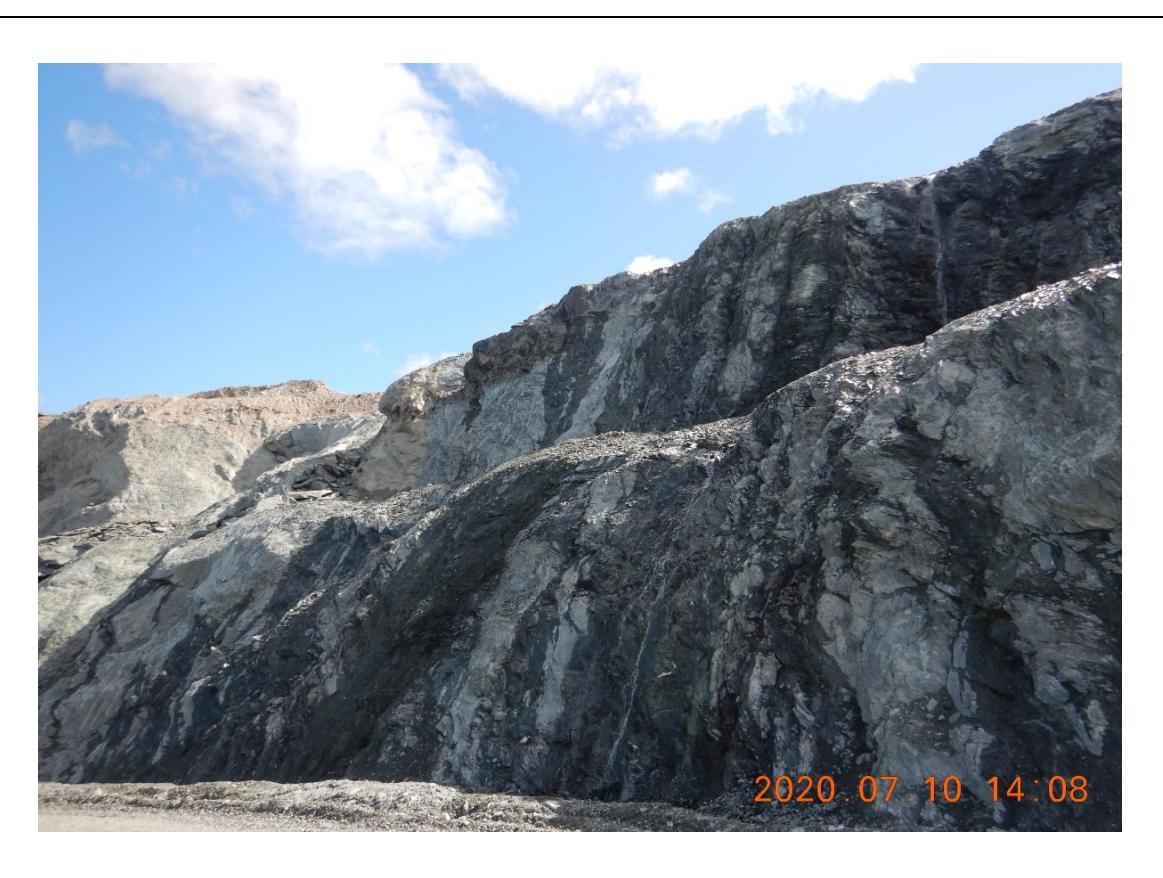
ZPit E zone E5-S3: Overhang on upper bench

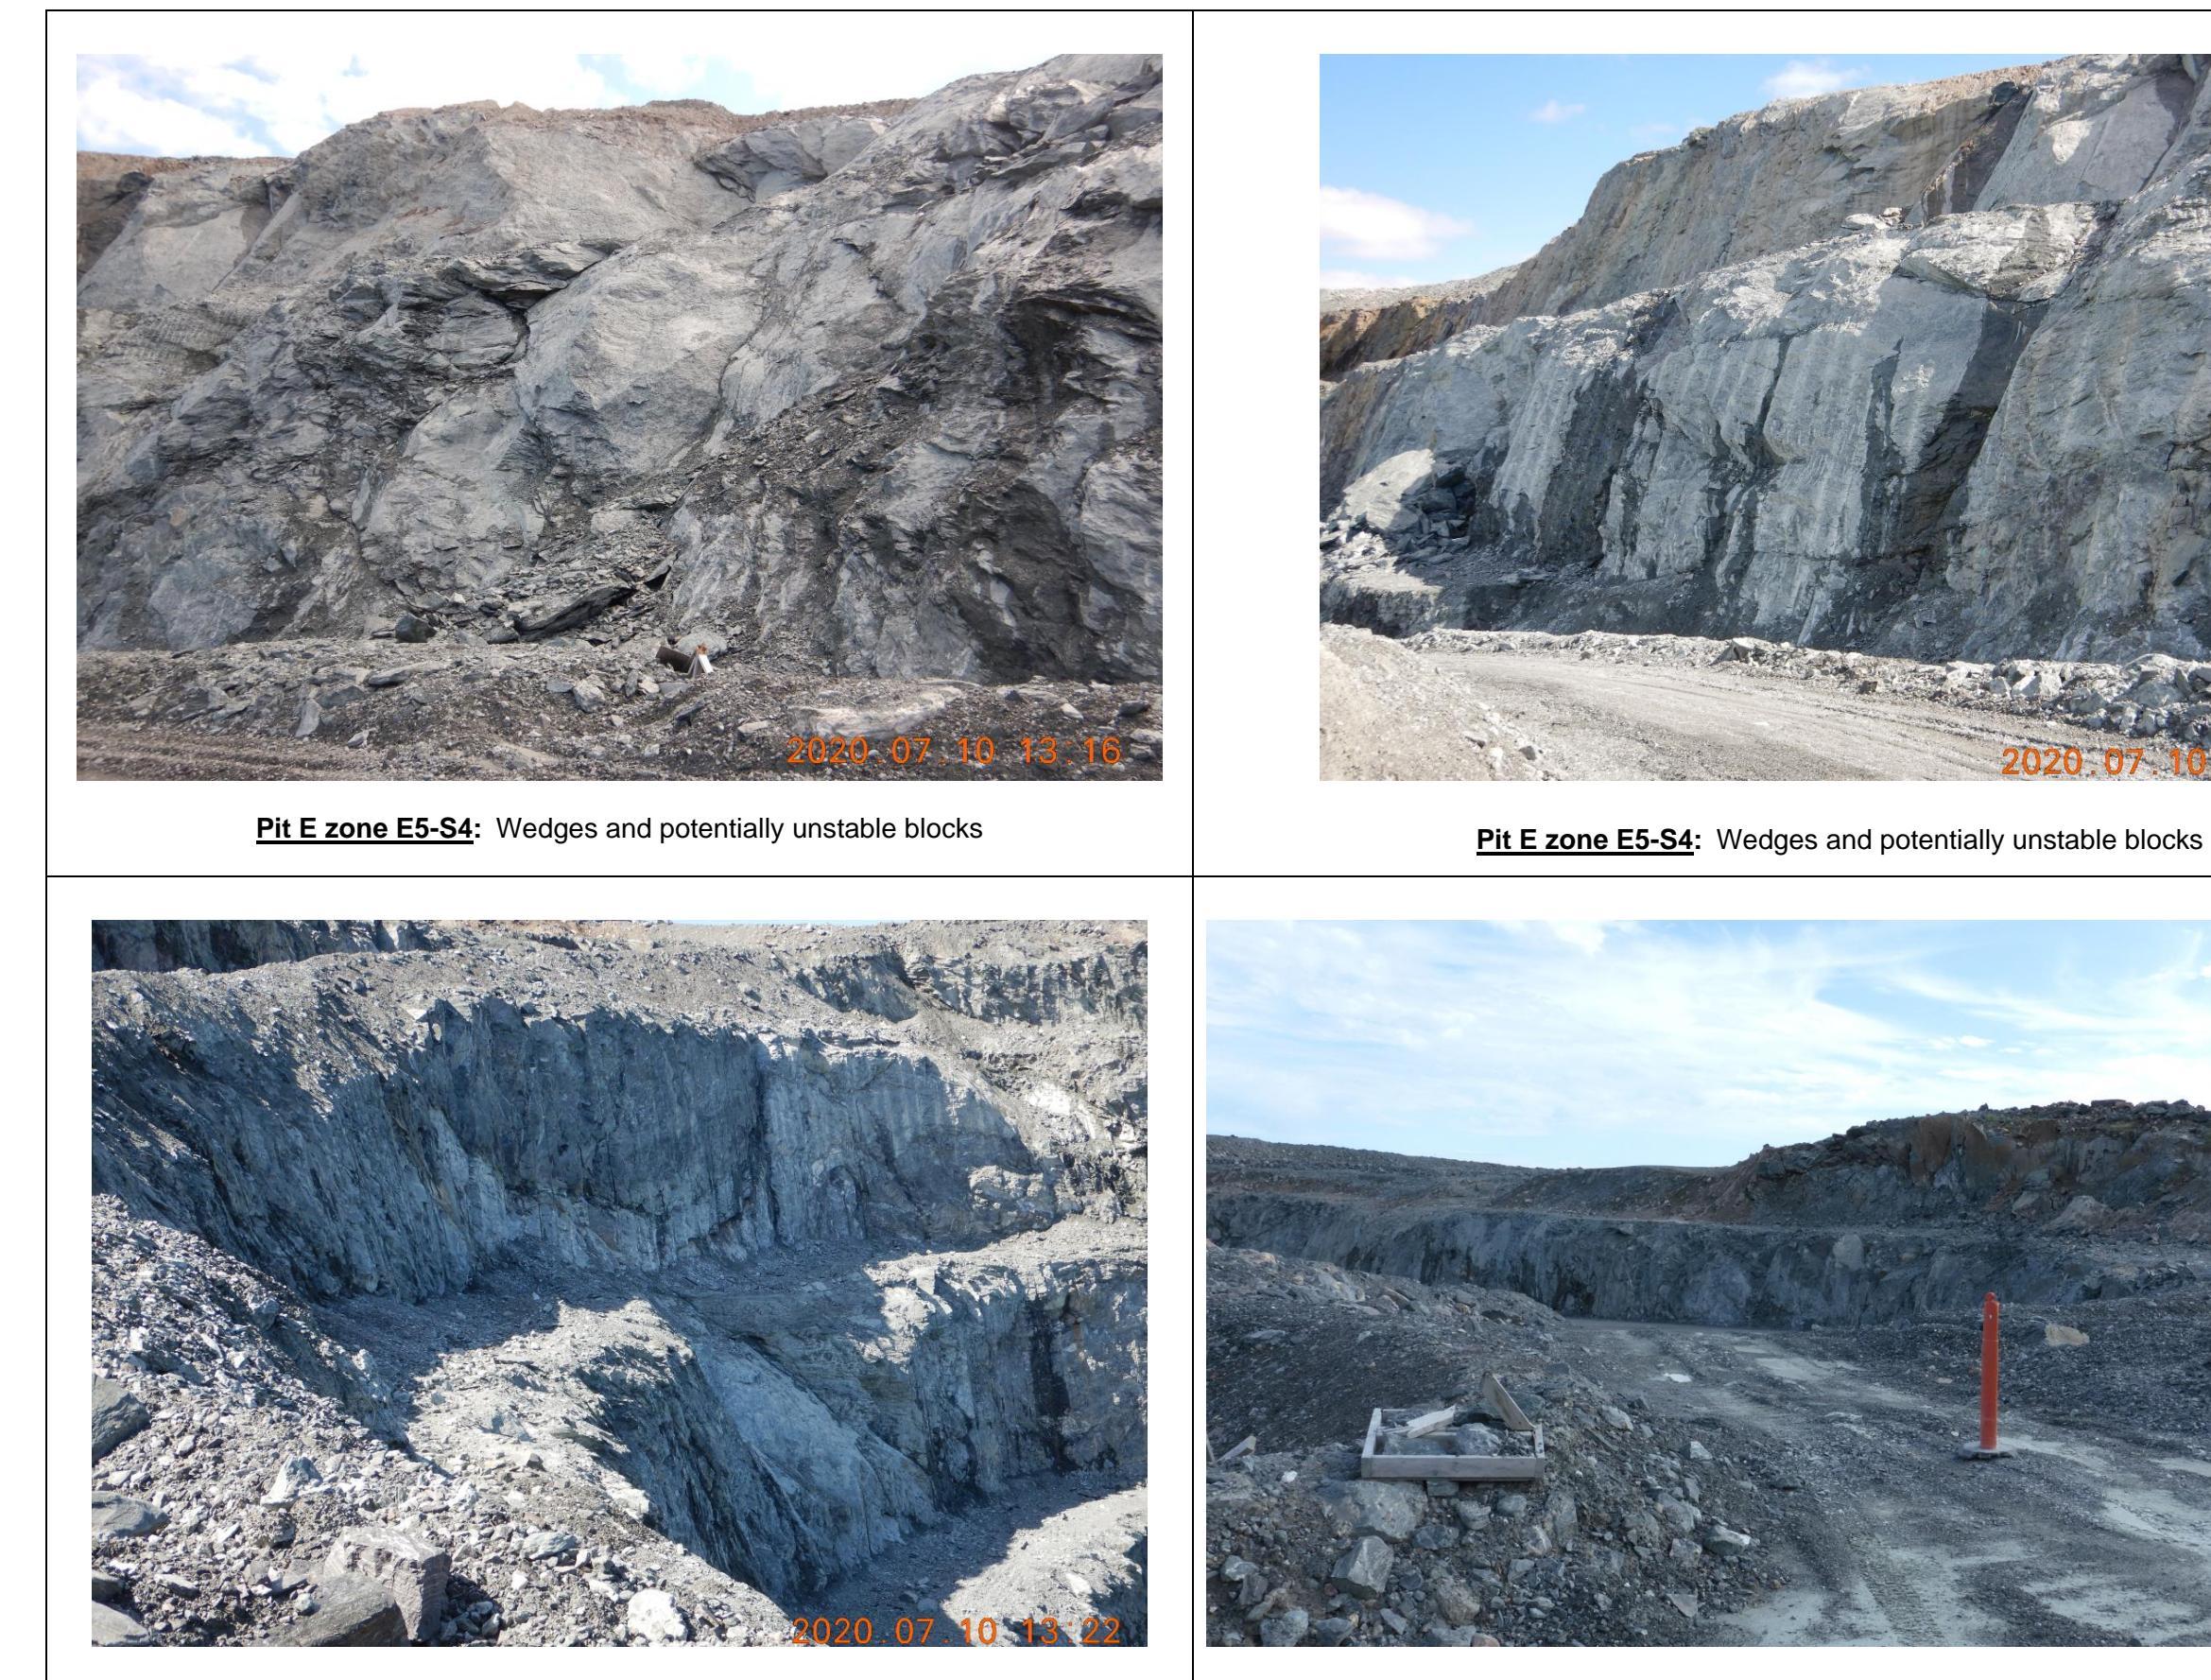
Pit E zone E5-S5: Potential large scale wedge failure below where the ramp is sitting
