Appendix 13

Meadowbank MDRB Report No.28

Report No 28 Meadowbank Dike Review Board (MDRB) Conference calls November 24th and 25th, 2020

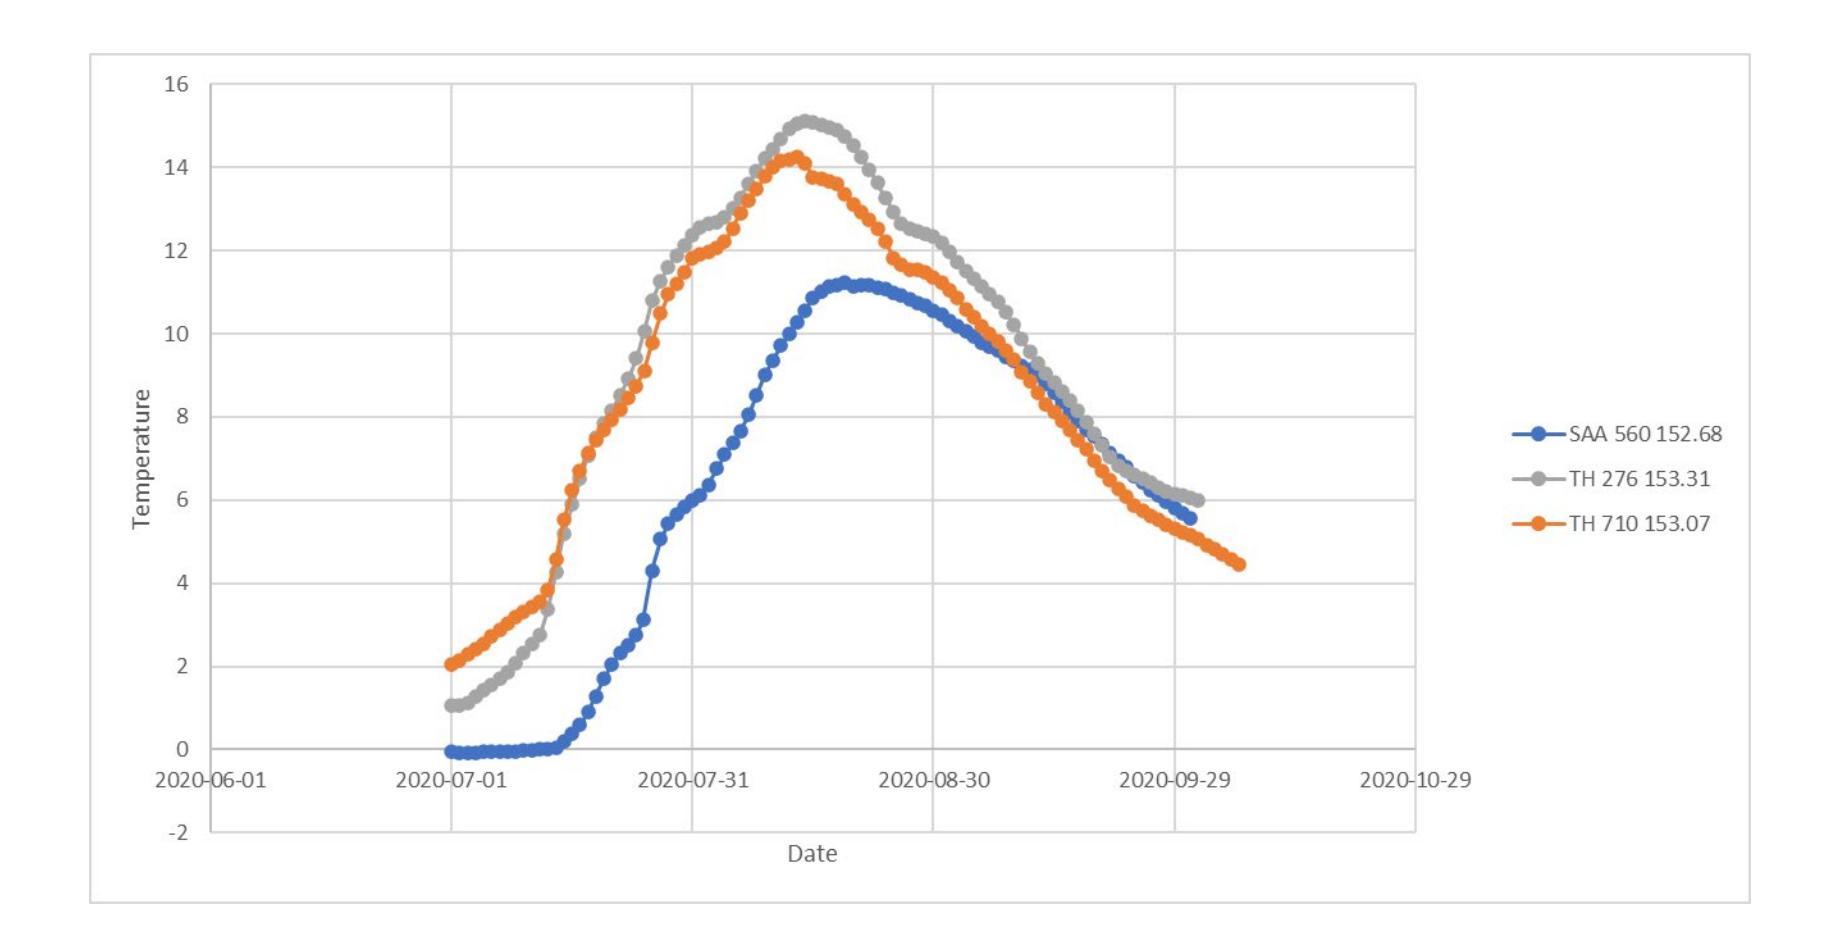
The interpretation of temperature readings could benefit from interrogation of the actual installation location in relation to features of the foundation topography, embankment zone, or cut-off as the case may be. Taken on face value, some temperature changes could be interpreted as indicating a defect in the cut-off wall permitting flow from the upstream to downstream. The temperature measurements taken at the location of the inclinometer INC-3 (SAA) at Stn. 0+560 are a case in point. The graph included in Attachment C compares the evolution of temperature at around elevation 153 m to readings taken in thermistor strings in the upstream embankment fill at Stns. 0+276 and 0+710. The instrument at 0+276 is taken as representing lake water temperature. There is a time lag for Stn. 0+560 and also a temperature differential. This indicates that significant seepage at that location is unlikely. Thermistors in the downstream embankment fill at 0+530 and 0+580 remain at around 0°C at a similar elevation and at the same time of year. The deformation recorded by SAA-560 (INC-3) is 20 mm over a height of 5 m, with a uniform profile and no sign of dislocation. Crushing or shearing of the cut-off is therefore also unlikely. Indeed, AEM has concluded that no significant seepage through the cut-off is occurring. Information relating the exact location of the instrument (Stn. and offset) compared to the cementbentonite column locations may be informative.

Graph illustrating a comparison of temperatures in Whale Tail Dike

AMQ Whale Tail Dike	MDRB #28	The interpretation of temperature readings could benefit from interrogation of the actual installation location in relation to features of the foundation topography, embankment zone or cutoff as the case may be. Take no face value, some temperature changes could be interpreted as indicating a defect in the cut off wall permitting flow from the upstream to downstream. The temperature measurements taken at the location of the inclinometer INC-3 (SAA) at Stn. 0+560 are a case in point. The graph included in Attachment C compares the evolution of temperature at around elevation 153 m to readings taken in thermistor strings in the upstream embankment fill at Stns. 0+276 and 0+710. The instrument at 0+276 is taken as representing lake water temperature. There is a time lag for Stn. 0+560 and a temperature differential. This indicates that significant seepage at that location is unlikely. Thermistors in the downstream embankment fill at 0+530 and 0+580 remain at around 0°C at a similar elevation and at the same time of year. The deformation recorded by SAA-560 (INC-3) is 20 mm over a height of 5 m, with a uniform profile and no sign of dislocation. Crushing or shearing of the cut-off is therefore also unlikely. Indeed, AEM has concluded that no significant seepage is occurring. Information relating the exact location of the instrument (Stn. and offset) compared to the cement-bentonite column locations may be informative.	This reasoning is systematically applied by the AEM team during routine review and interpretation of the instrumentation data. AEM will ensure that this information is also included in quarterly reports and MDRB communications. This method of comparing instrument location with data trends has allowed AEM to confirm that the thermal signature observed at 0+560 was not related to water ingress into the wall, given the time lag between thermal variations in the lake and this particular location in the wall.	Open	-

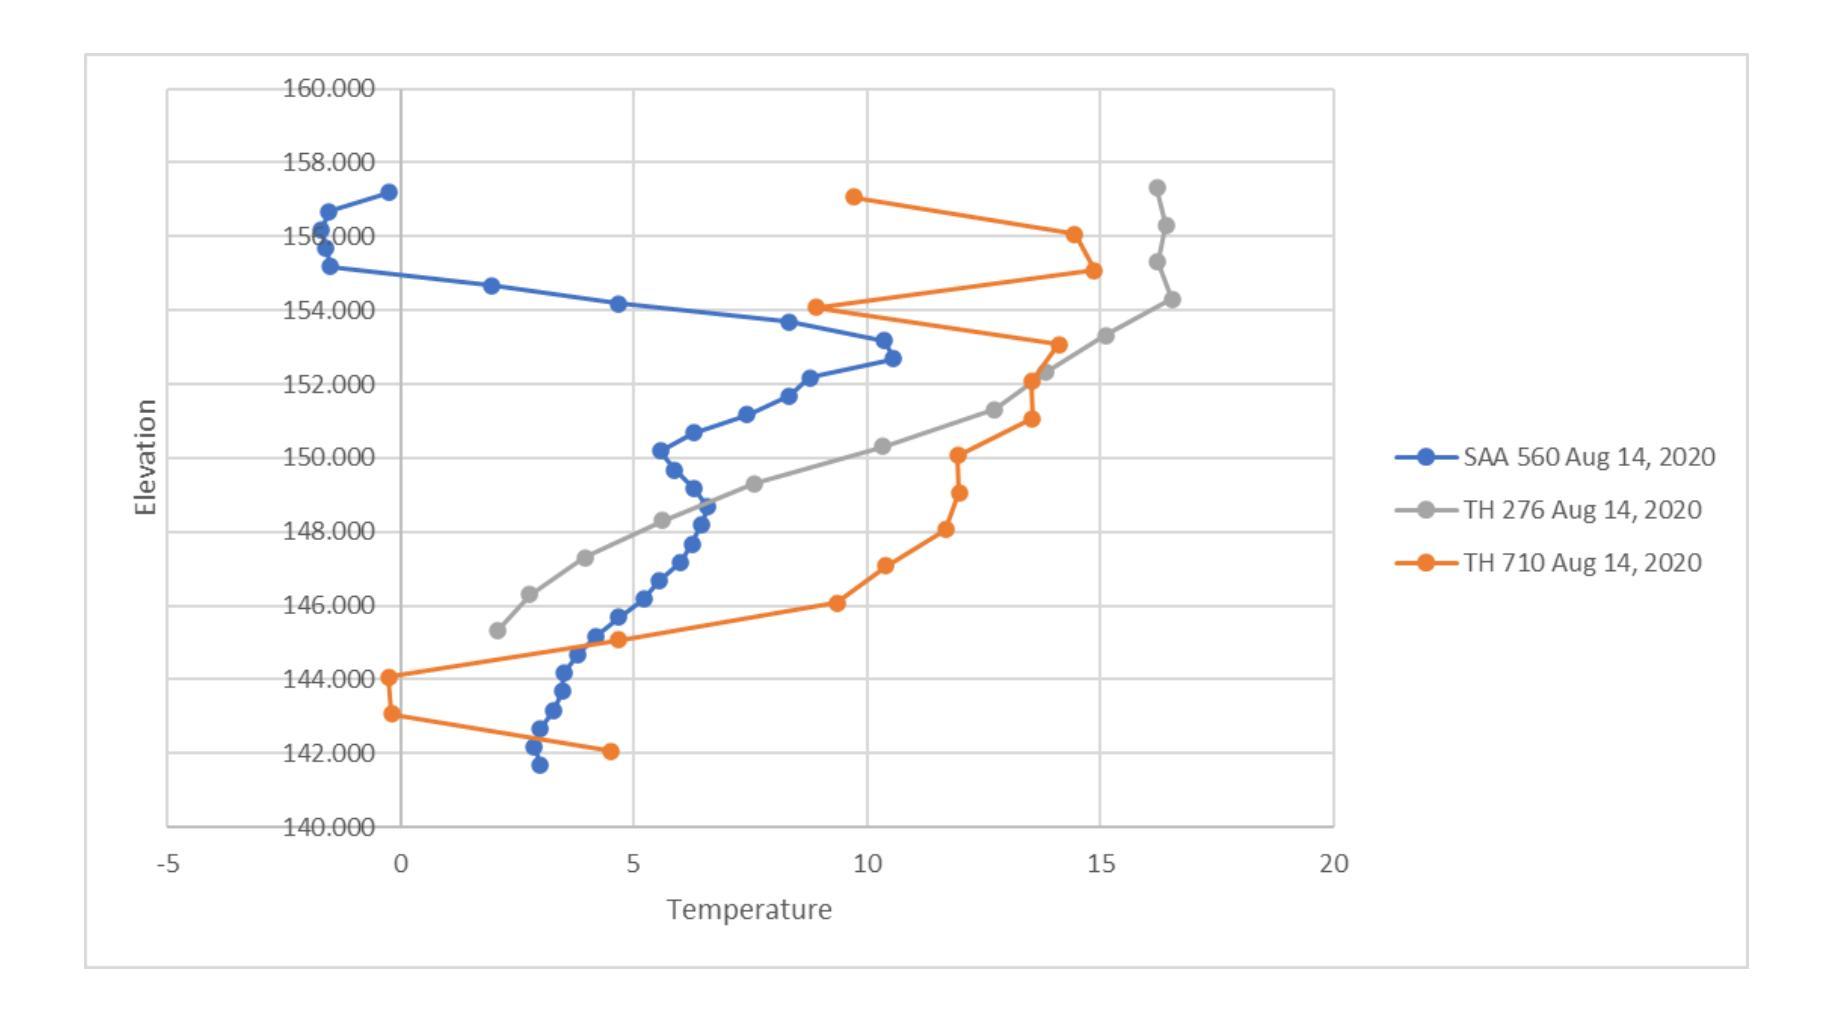
Instrument data indicates adequate control over seepage flow rates but, not surprisingly, an effect of the seepage on thermistor and piezometer readings is also apparent. The thermistor data points to a continuation of permafrost degradation on the abutments and in the eastern side of lakebed which is accompanied by deformation as manifested by cracking and inclinometer measurements. However, no increase of seepage flows has been noted.

Warming temperatures are noted at both abutments, leading the Board to reiterate a previous recommendation that backfill be placed in the depression on the upstream side and adjacent to the east abutment and to an elevation greater than the anticipated maximum lake level. This would increase the surface area exposed to cooling during the winter and reduce the penetration of warm lake water during the summer, thus enhancing freeze-back of the foundation. The possibility of further degradation of the permafrost in the abutments beyond or beneath the grout curtain cannot be totally excluded. The potential for a similar exercise at the west abutment should be evaluated also. Ideally, the material should be well graded medium to coarse sandy gravel that is placed in lifts and compacted. It should be built to an elevation about 0.5 m minimum above a reasonable maximum flood (say 50-100 yr. return period). Given that seepage flows are currently manageable, the Board understands that AEM is monitoring the behaviour and, if seepage quantities increase, this potential intervention may be re-evaluated.

Comparison of temperatures at El. 153 Whale Tail Dike

Comparison of vertical temperature profiles at three locations on the upstream side of Whale Tail dike

AMQ Whale Tail Dike	MDRB #28	Warming temperatures are noted at both abutments, leading the Board to reiterate a previous recommendation that backfill be placed in the depression on the upstream side and adjacent to the east abutment and to an elevation greater than the anticipated maximum lake level. This would increase the surface area exposed to cooling during the winter and reduce the penetration of warm lake water during the summer, thus enhancing freeze-back of the foundation. The possibility of further degradation of the permafrost in the abutments beyond or beneath the grout curtain cannot be totally excluded. The potential for a similar exercise at the west abutment should be evaluated also. Ideally, the material should be well graded medium to coarse sandy gravel that is placed in lifts and compacted. It should be built to an elevation about 0.5 m minimum above a reasonable maximum flood (say 50-100 yr. return period).	Backfilling in the vicinity of the East abutment would be logistically challening due to the presence of the diffusers and associated piping in this area. Backfilling of the abutments was previously identified as a possibe mitigation measure to reduce seepage through the dike but it was put on hold to be re-assessed after the completion of the remedial grouting campaign. Following this campaign, the current seepage rate is now stable and managable with the infrastructure present on site and it was decided to not pursue this mitigation technique. If the thermal degradation of the abutment would cause seepage rate to increase, the backfilling option would be considered again.
