Meadowbank and Whale Tail Bulk Fuel Storage Facility: Environmental Performance Monitoring Plan Version 6.1

Baker Lake Bulk Fuel Storage Facility: Environmental Performance Monitoring Plan

In Accordance with Water License 2AM-MEA1530

> Version 6.1 March 2022

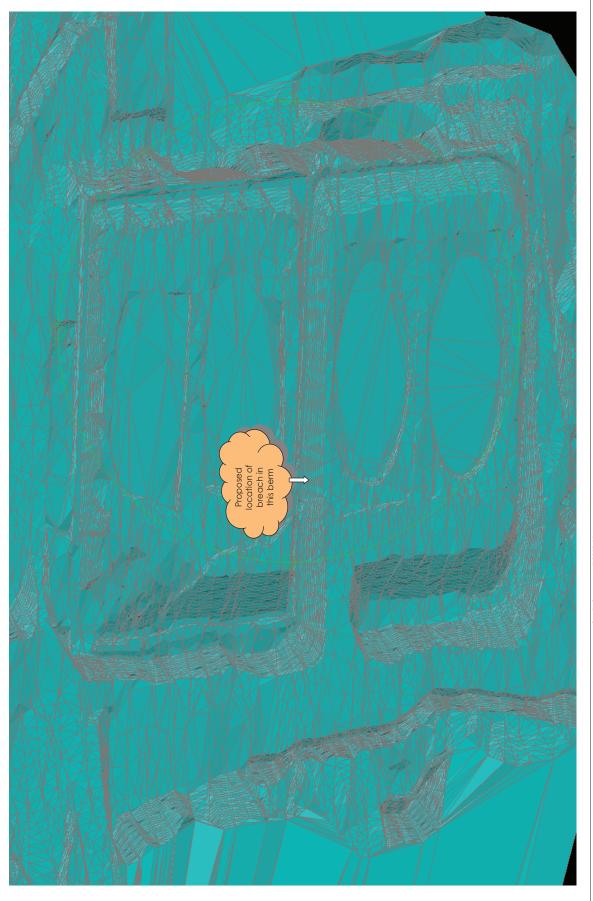
elevation	volume (m3)
water level as of November		
2008	31.70	-367.0

<u>Volume</u>
NET CONTAINMENT	11 219 m3 or 107%

A worst case scenario has been simulated, and consists in either a rupture of the first course of side plates in the tank shell, or a failure in the outlet piping, when either one of fuel tanks is 100% full.

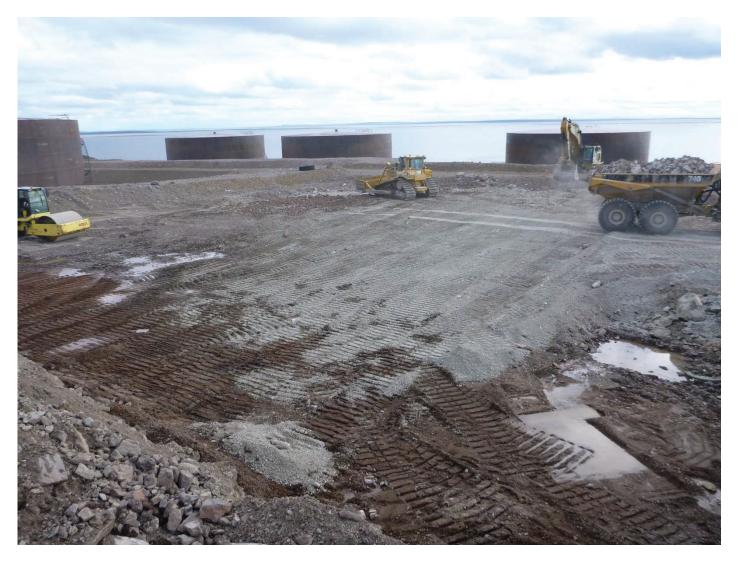
• Photo #1 – Overview of the infra. Some water accumulations caused by the thaw of the material in place. A small ditch will be make to try to drain this water during night.

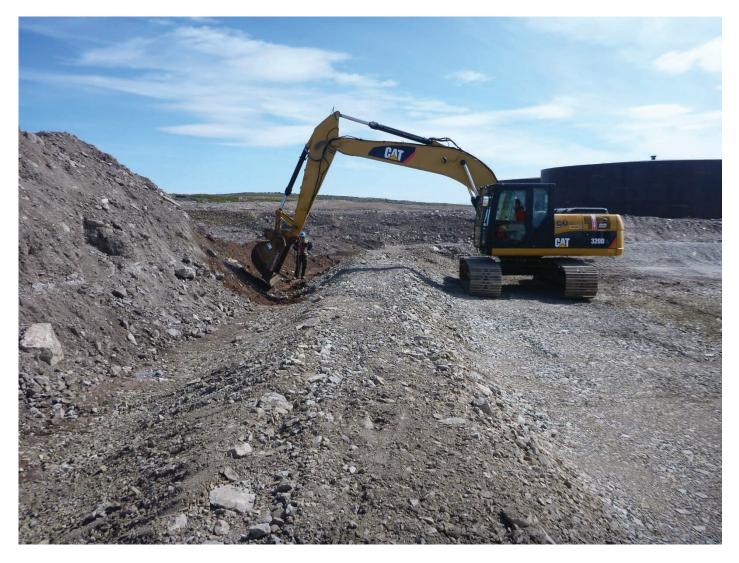
• Photo #1 – There is frost in the north ditch that prevent the excavation to the desired elevation.

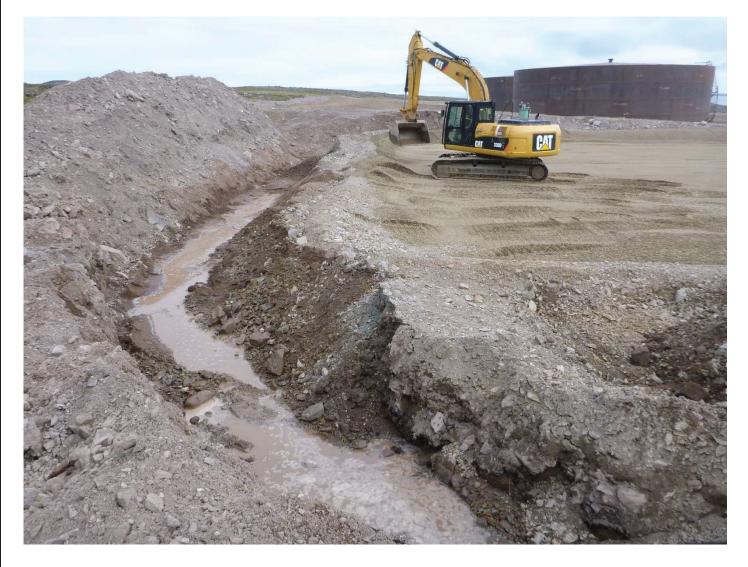
• Photo #1 – Excavation of the north ditch to the frost. There is a groundwater artery.

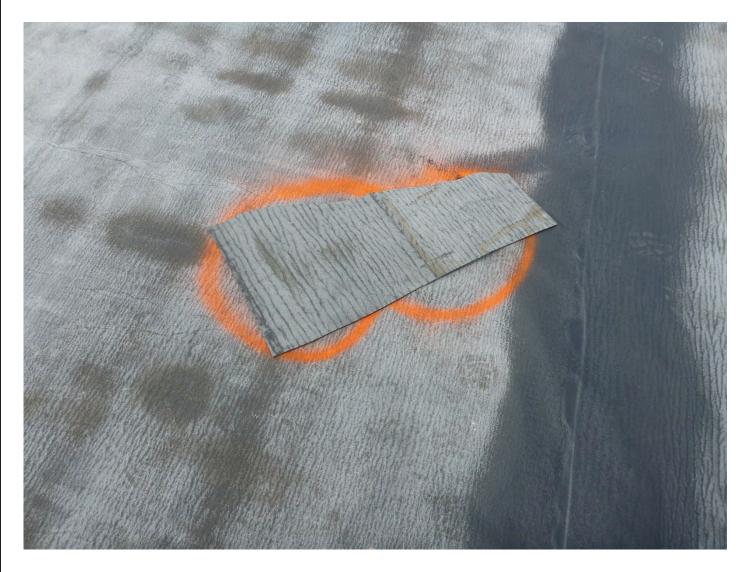
• Photo #3 – Inspection of the membrane. Small proeminent rocks (10mm and less) are detected at some place under the membrane. A second tickness of colétanche is added on these spots to make sure there will not be any punching.

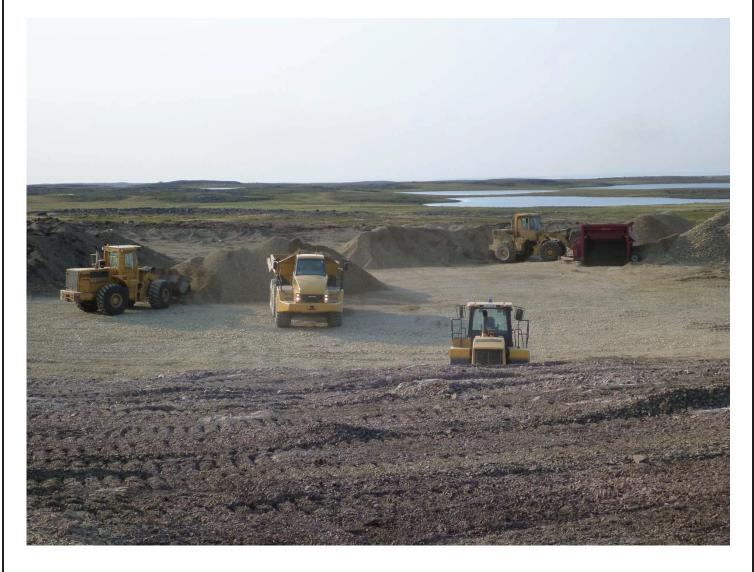
• Photo #1 – Sreening of the 0-20mm and loading of the trucks at the Nuna Pad (BLCS).

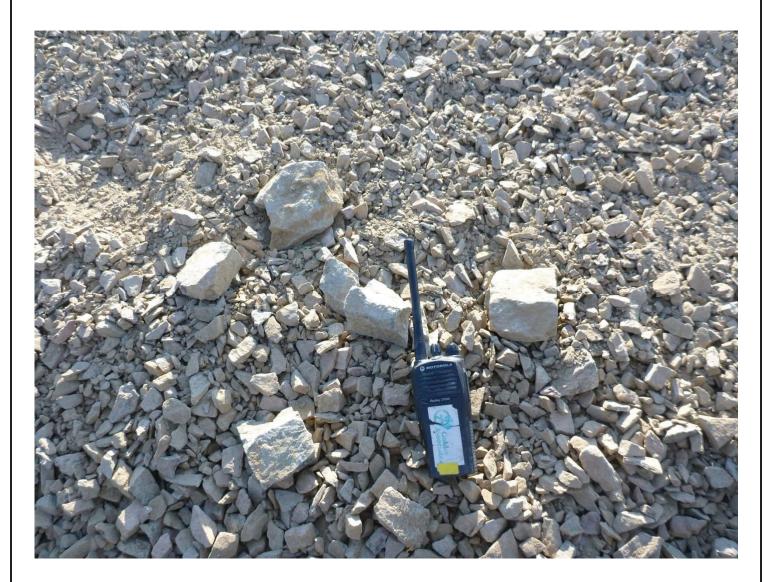
• Photo #1 – Lot of particules bigger than 20mm in the 0-20mm brought by BLCS. We advise BLCS to check the sreener. Indeed, there was a gap on the side of the sreen because of a missing inner bar. After the reparation of the screener, there is still presence of particules up to 100mm in the material from an unknow source. We remove them by hand on the field, but there is still a lot of rocks around 1 1/2" big.

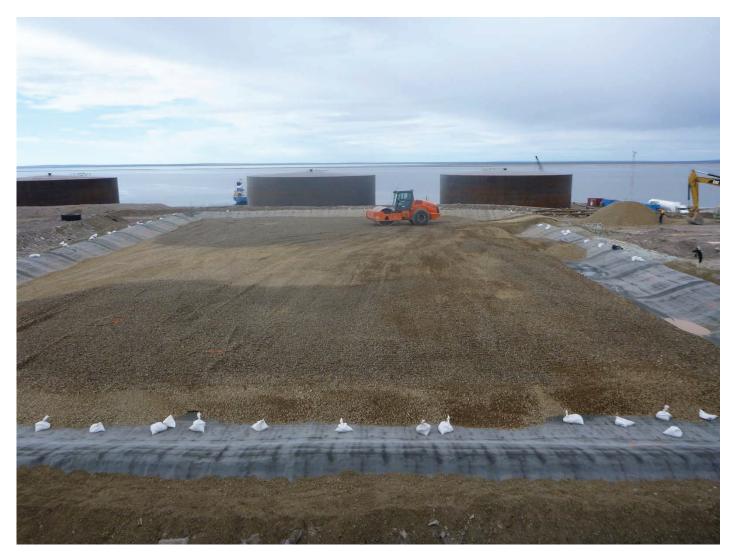
• Photo #1 – Moistening and compaction of the 0-20mm. Compaction: 2 static passes, 1 vibratory pass in each direction and 2 last static passes.

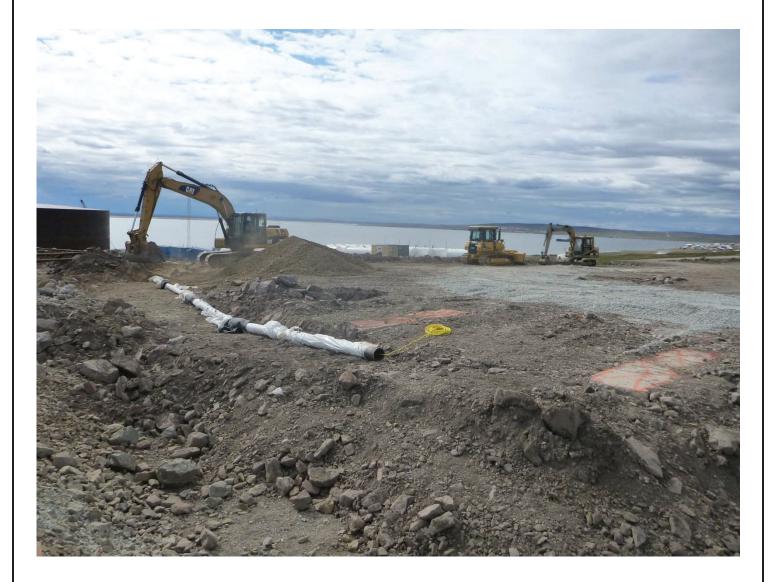
• Photo #2 – Installation of a steel pipe with a rope inside in prevision of passing the electric wire to the pump house.
