Whale Tail 2021 Thermal Report

WHALE TAIL PIT PROJECT

Thermal Monitoring Report 2021

Prepared by:
Agnico Eagle Mines Limited – Meadowbank Division

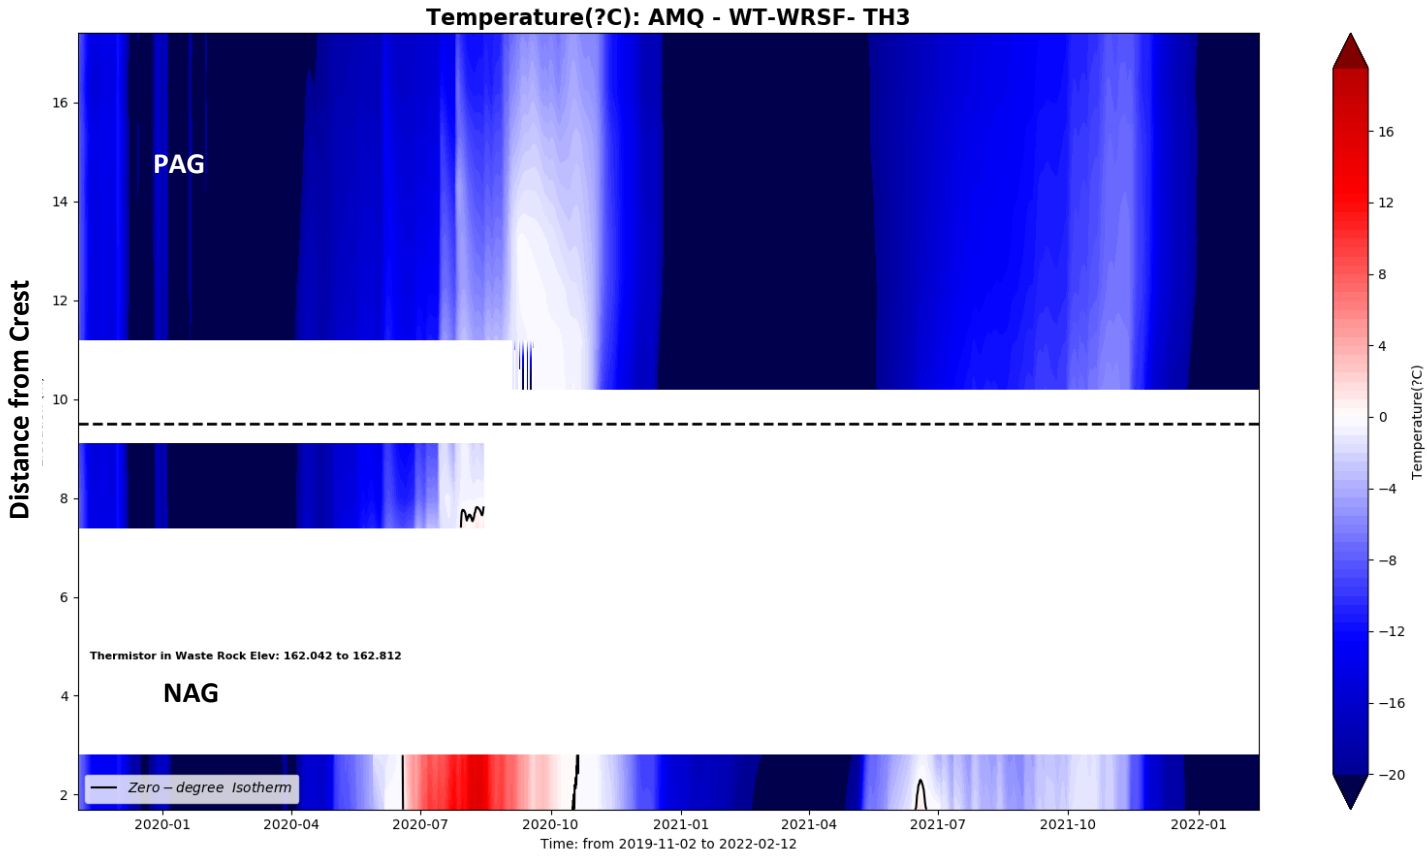
WT WRSF TH3

Thermistor in Waste Rock Elevation 162.042 to 162.812.

This instrument is installed horizontally and chart needs to be read accordingly
Beads 3 to 10 are not working

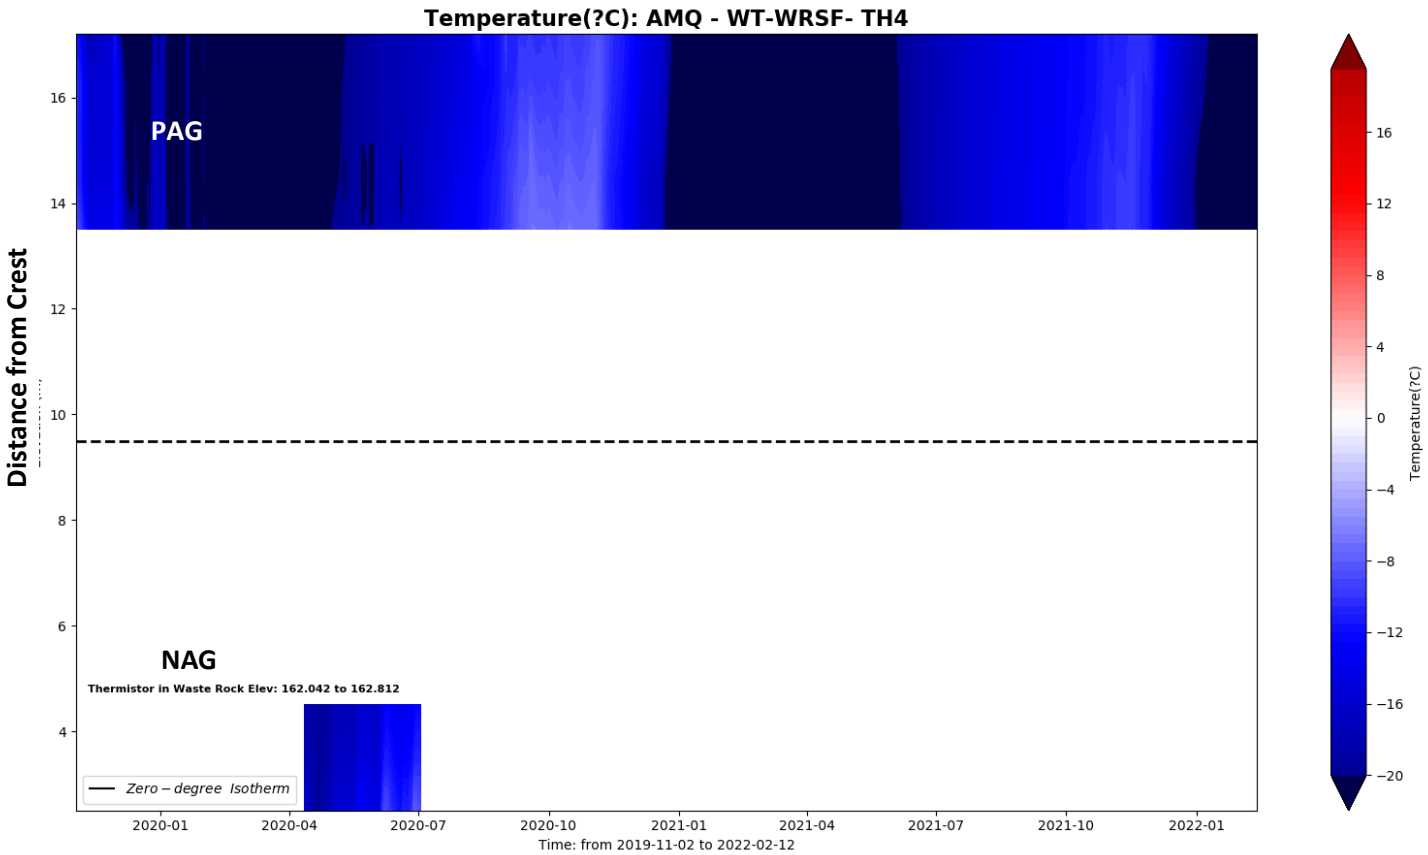
WT WRSF TH4

This instrument is installed horizontally and chart needs to be read accordingly

Beads 3 to 10 are not working

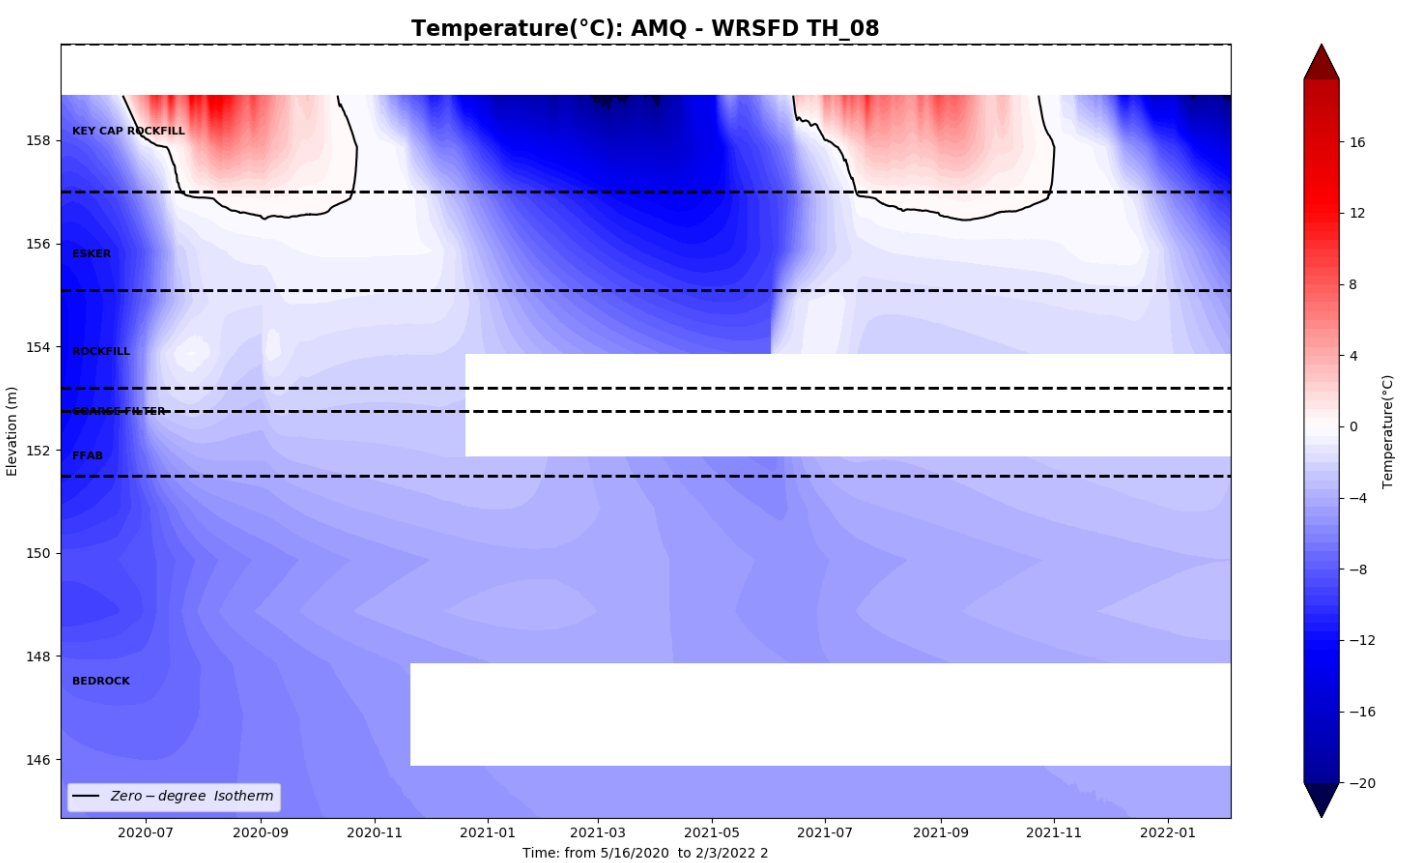
WRSFD TH08

Bead #1, #8 and #14 removed

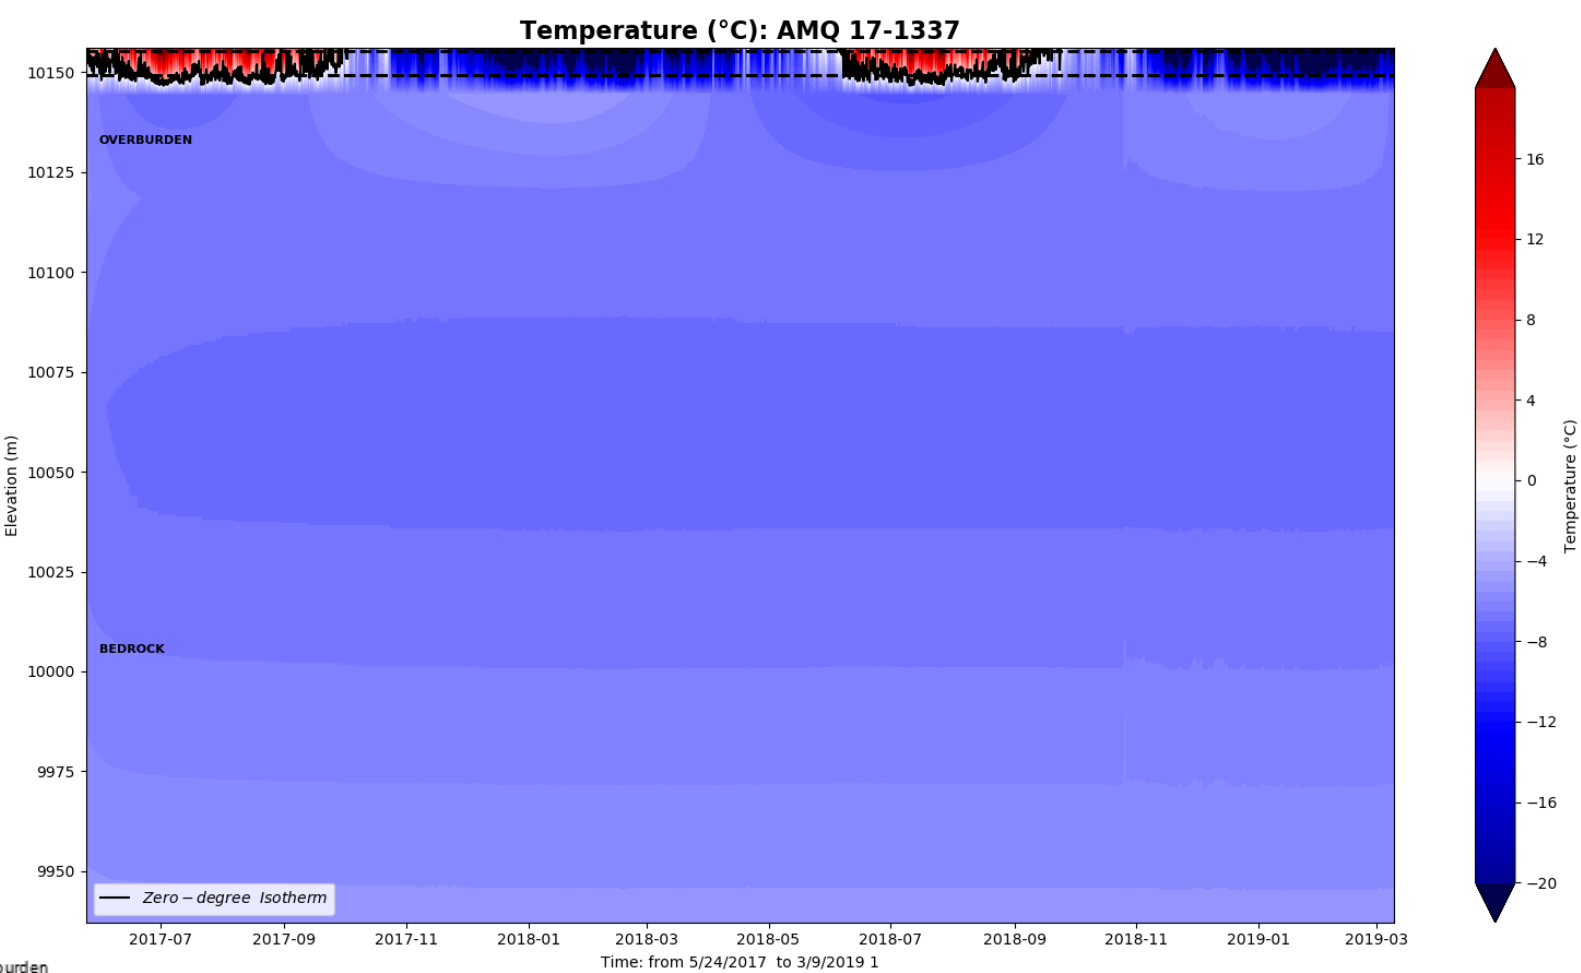
AMQ 17-1337

The previous thermistors installed in the IVR area are no longer functioning due to mining activity in the sector but were showing permafrost until they stopped working. A deep thermistor has been installed in 2020 in that area (IVR long TH) and shows permafrost conditions down to 500 m below ground surface, to El. 9600 m (mining datum).
