MEADOWBANK GOLD PROJECT
2019 Annual Report
61-000-100-REP-002

Agnico Eagle Mines Limited – Meadowbank Complex

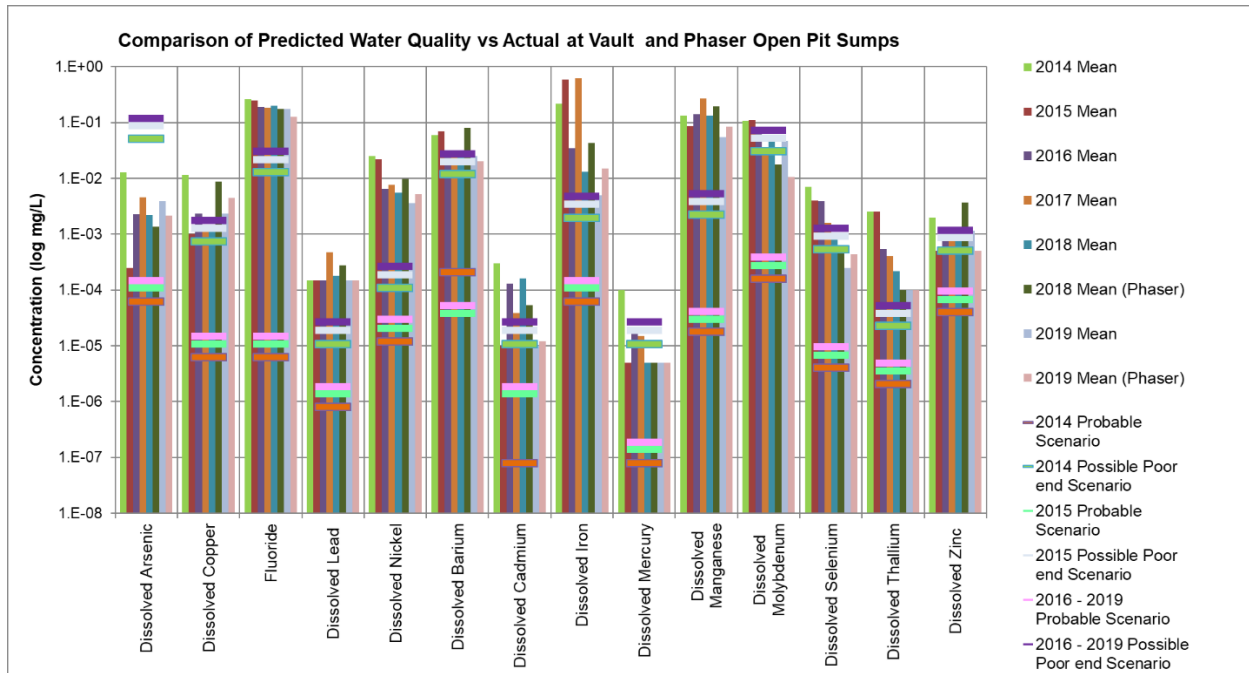
Figure 10 Meadowbank Mean Annual Water Quality - Vault and Phaser Open Pit Sumps

Based on this analysis, many of the predicted values for the Probable and Probable Poor End scenarios and Annual Average and 25% Centile Water Quality Forecast have differences greater than +/- 20% when compared to the measured values. There are several potential causes that could contribute to these differences:

- For Portage and Goose Pits, the measured water volumes were significantly less than what was originally predicted, specifically from 2012 to 2018. This reflects the fact that seepage, ground water and local runoff volumes were being managed and less water than what was originally predicted was reporting to the pit sumps. Consequently, there was less volume of water to attenuate any contaminant loads that may accumulate in the pit sump water body.

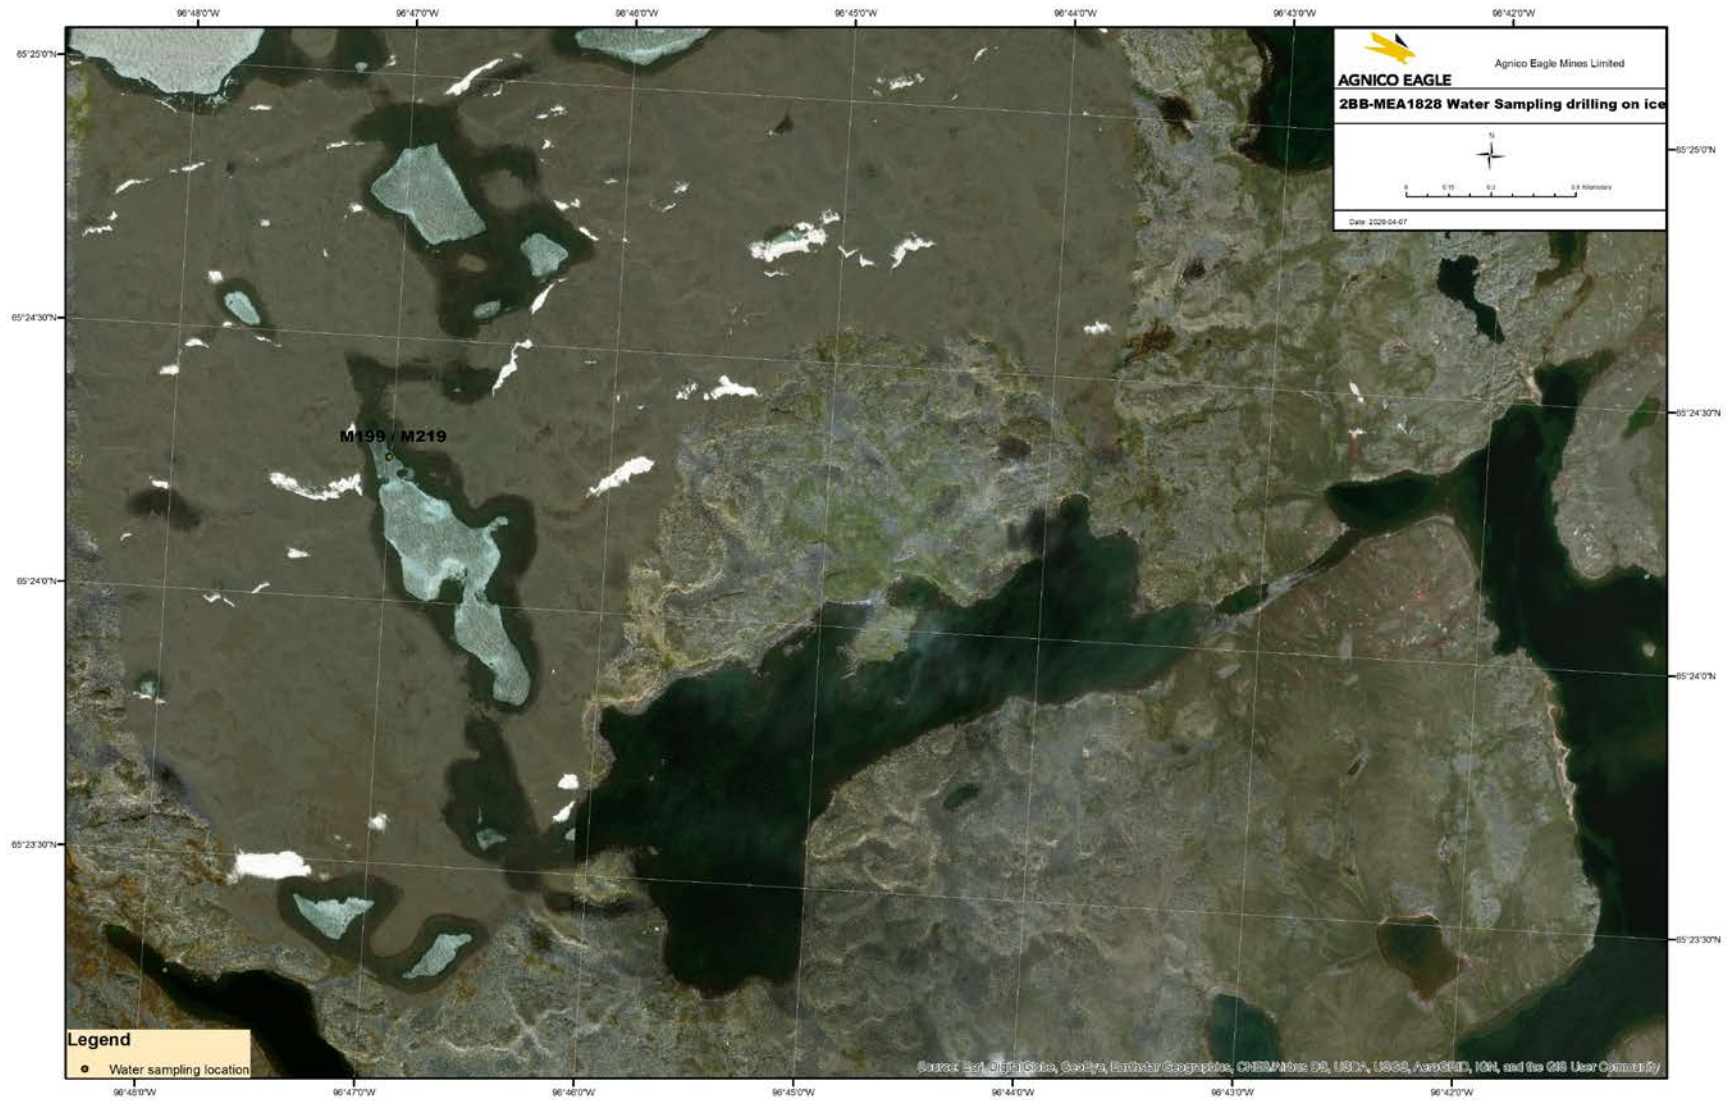
Figure 36 Whale Tail Drilling on ice Water Quality Monitoring

Table 11-1 and Figure 36 detailed the drill hole location for 2019 within the thirty-one meters of the High Water Mark. Both drilling were thought the ice.

Names	X	Y
M199	602927	7255353
M219	602927	7255353
