MEADOWBANK COMPLEX
2022 Annual Report
61-000-100-REP-005

Agnico Eagle Mines Limited – Meadowbank Complex

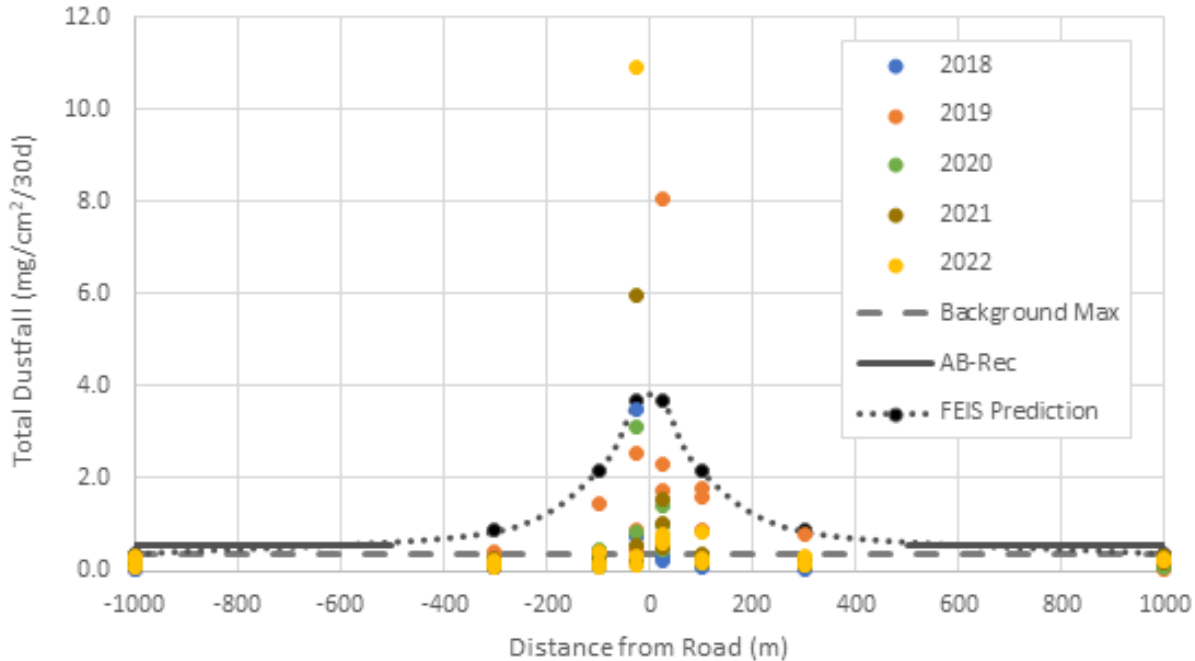
Figure 26. Total dustfall rates (mg/cm²/30d) for all samples collected in August along the Whale Tail Haul Road to date. 2018 and 2019 data was collected at ground level, while 2020+ samples were collected on stands. Negative distances represent the east (downwind) side of the road, and positive distances represent the west (upwind) side. FEIS Prediction values are from the FEIS Addendum Appendix 4C, Table 4-C-24 (Agnico Eagle, 2018b).
