### **Meadowbank 2018 Quarry 22 Report**

MEADOWBANK GOLD PROJECT

**2018 Quarry 22 Report**

Prepared by:  
Agnico Eagle Mines Limited – Meadowbank Division

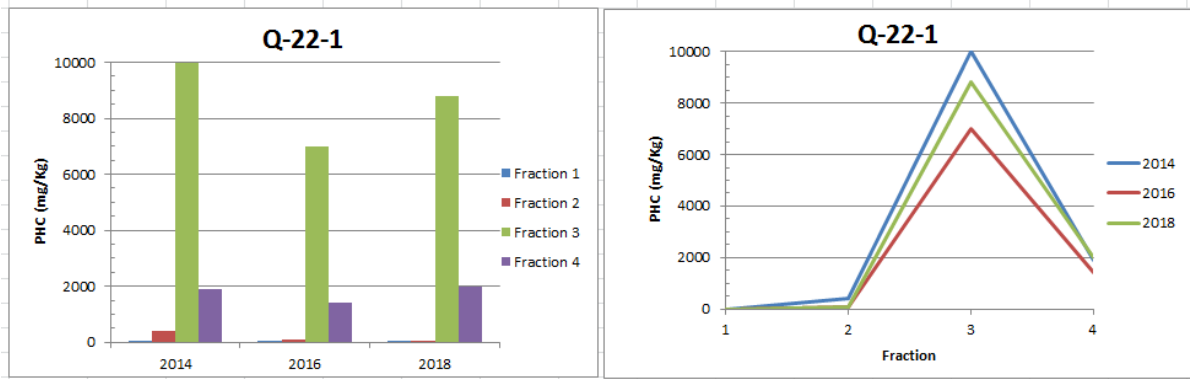
Figure 1 – Comparative results 2014, 2016 and 2018 – Section Q-22-1

When comparing results of 2018 with the sampling done in 2014 and 2016 (Table 2 and Figure 1-8), levels of contamination appear to be trending down. No more results are above CCME criteria for fraction 1, 2 and 4. Higher level is noted within fraction 3 in section Q-22-1 compared with 2016 which was the area that contained the bulk of historical contaminated material placed in the quarry.

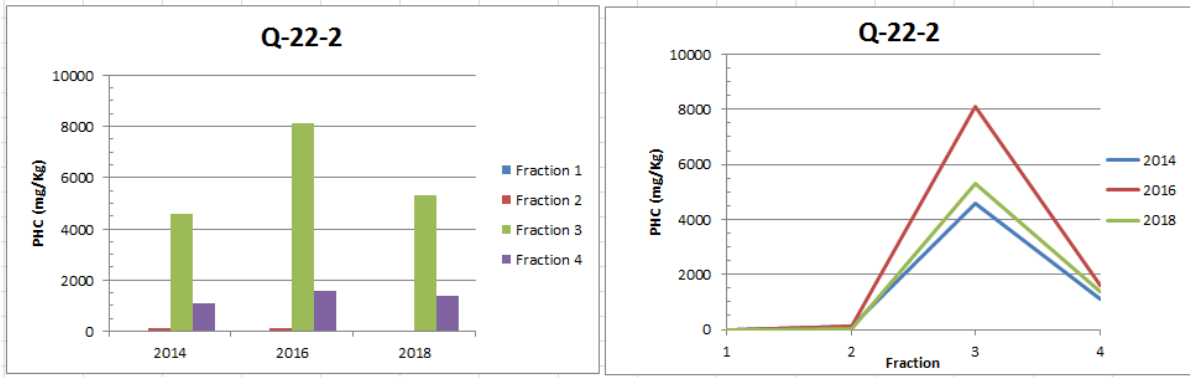
Figure 2 – Comparative results 2014, 2016 and 2018 – Section Q-22-2

An increased (compared to 2014) is noted within section Q-22-2 for fraction 3, but the result decrease in section Q-22-2 if the comparison is done with 2016 results.

These variations can be explained by the scarifying work done in 2015 and 2016 within the quarry that has spread material.

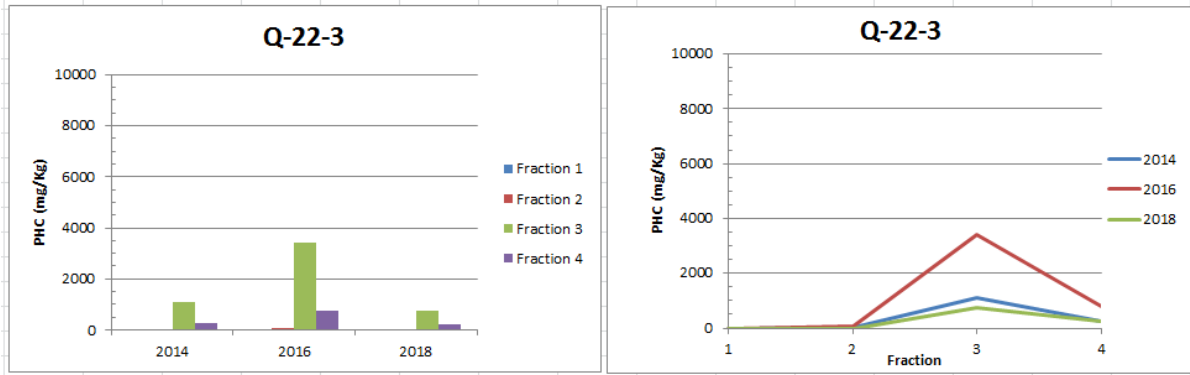
Figure 3 – Comparative results 2014, 2016 and 2018 – Section Q-22-3
