Whale Tail 2022 Thermal Monitoring Report

WHALE TAIL MINE

Thermal Monitoring Report 2022

In Accordance with
Project Certificate No. 008, T&C 14

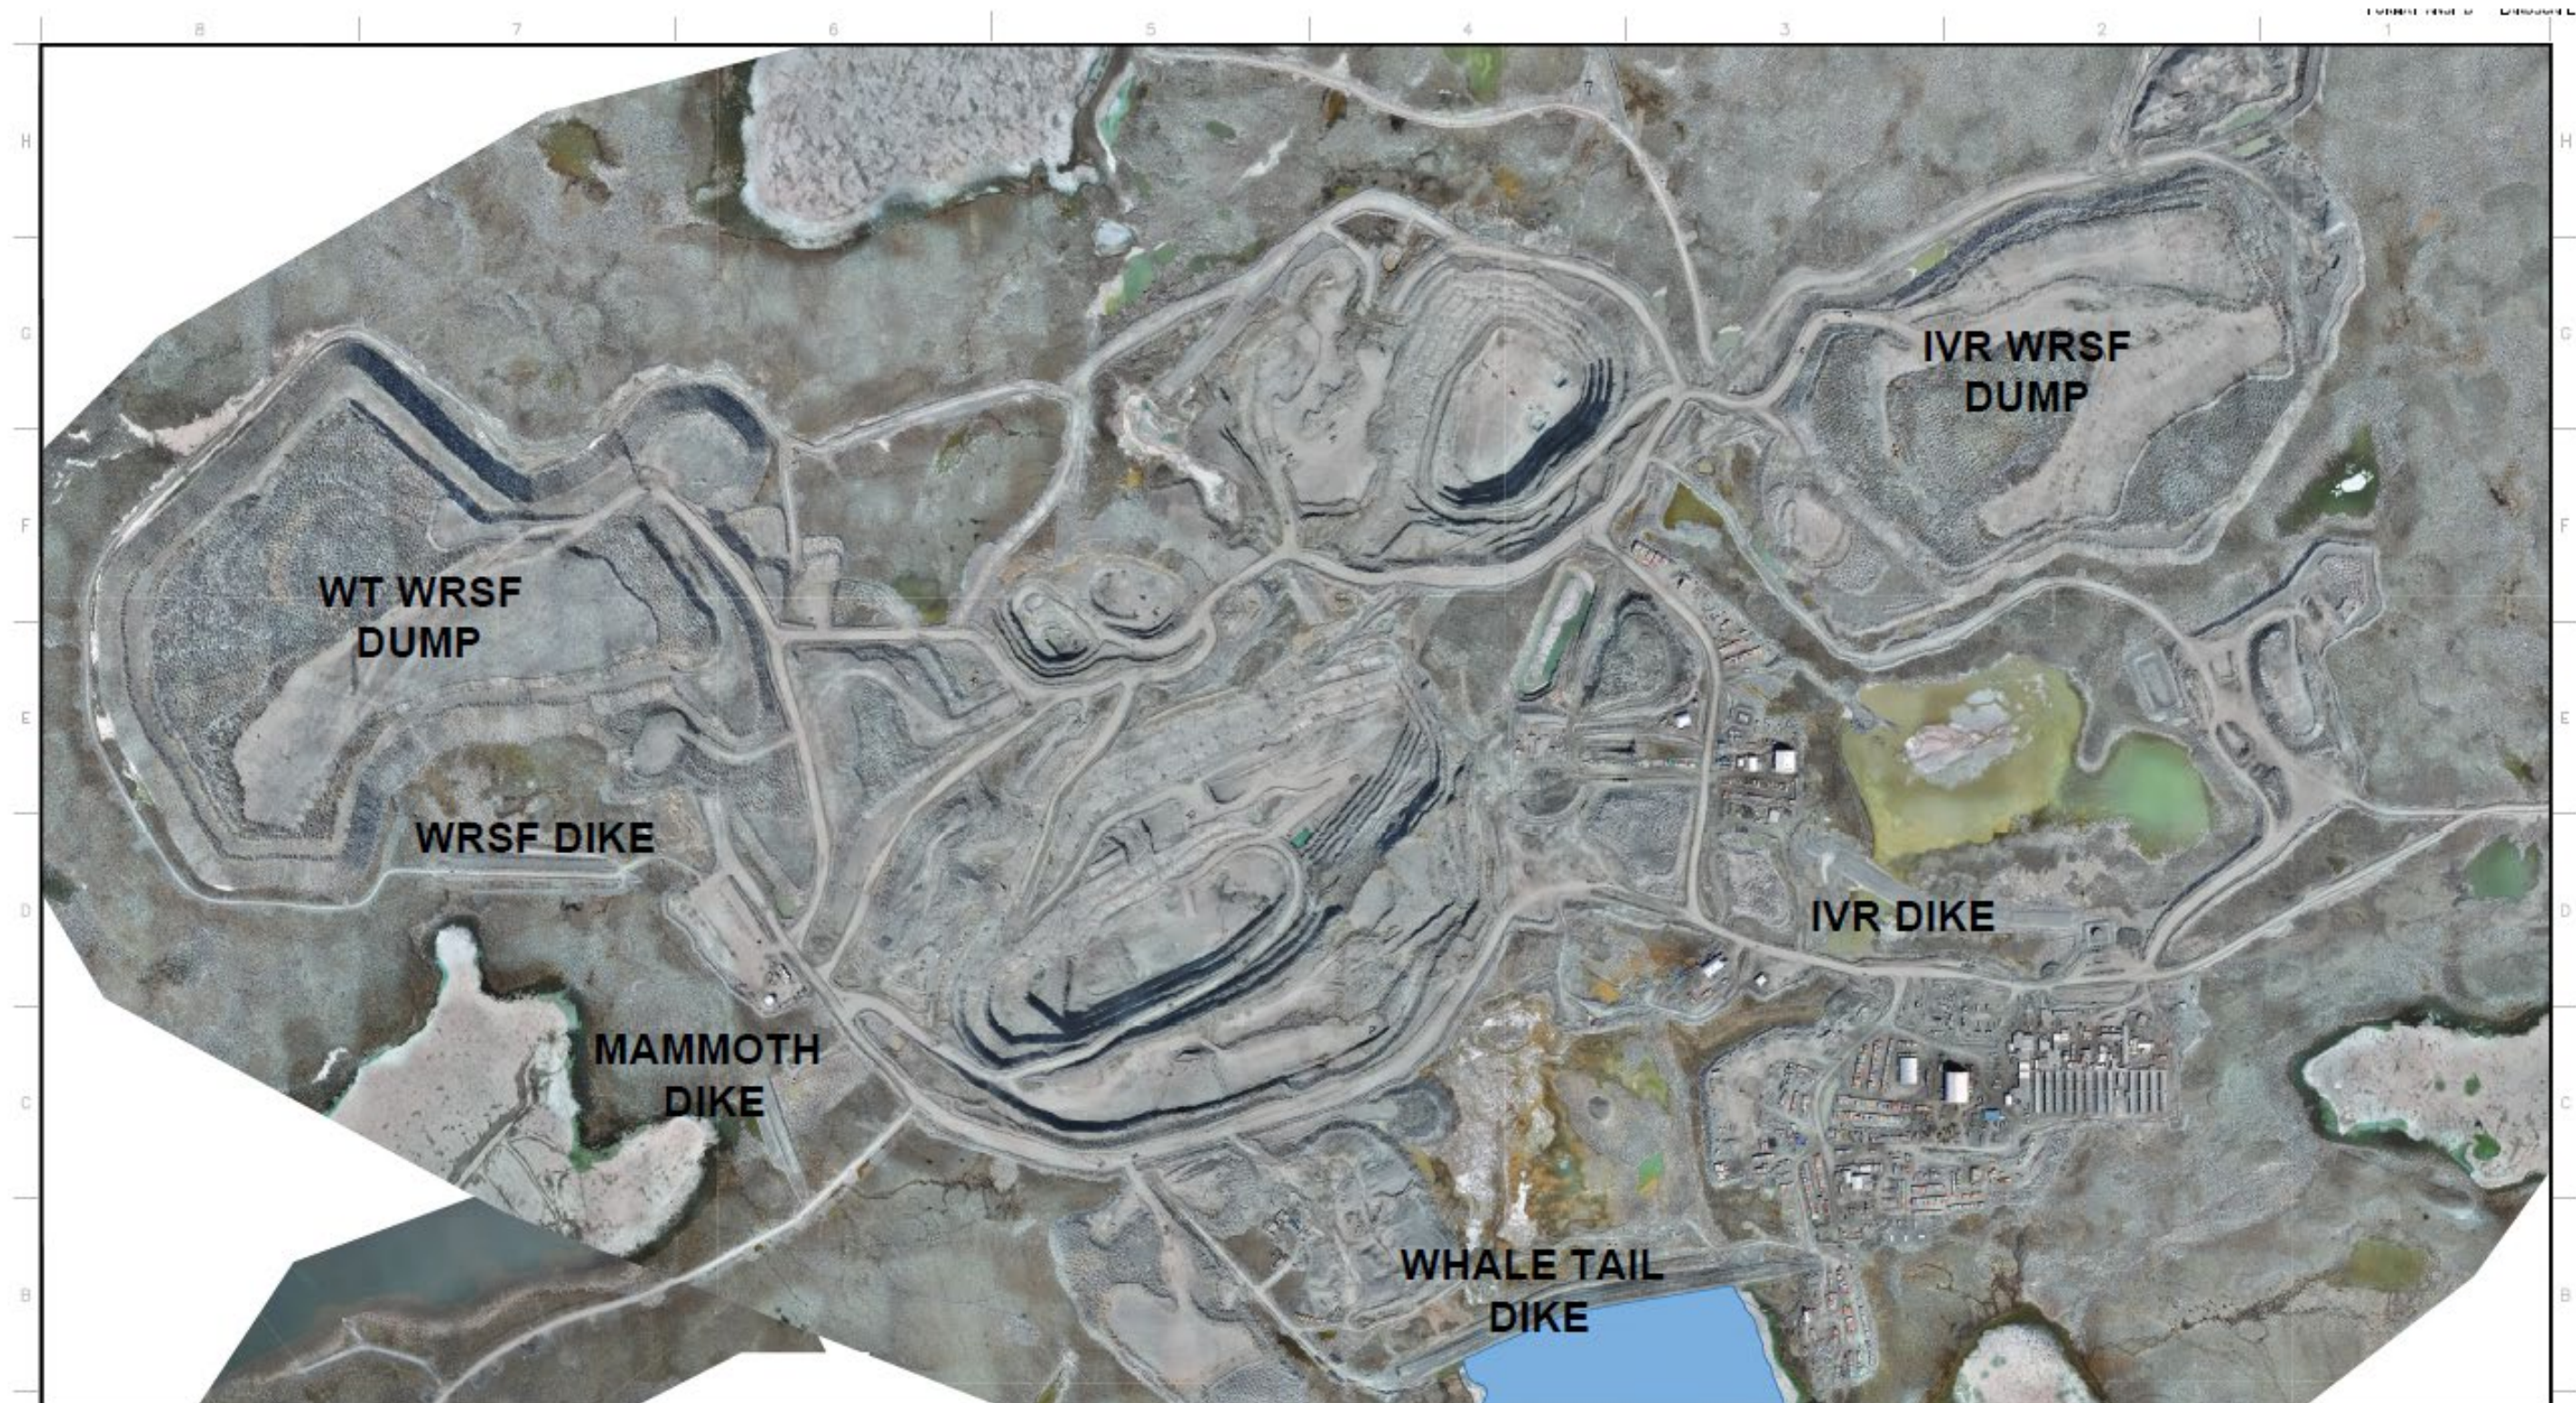
The location, installation summary, and status of all the thermistors installed within the Whale Tail Mine site are presented in the table in Appendix A. Figure 1 shows locations of active thermistors. Data are collected from the thermistors by data loggers every three hours or by using manual readout units.

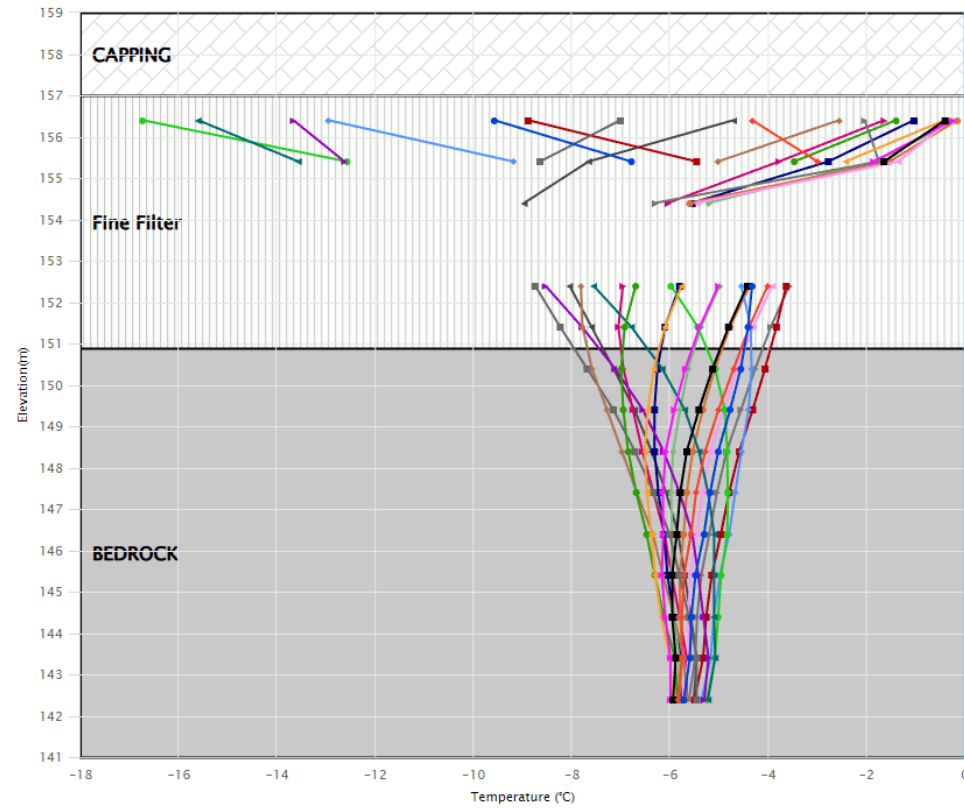
WTD-TH 0+110

Bead #4 and #16 damaged since datalogger connection

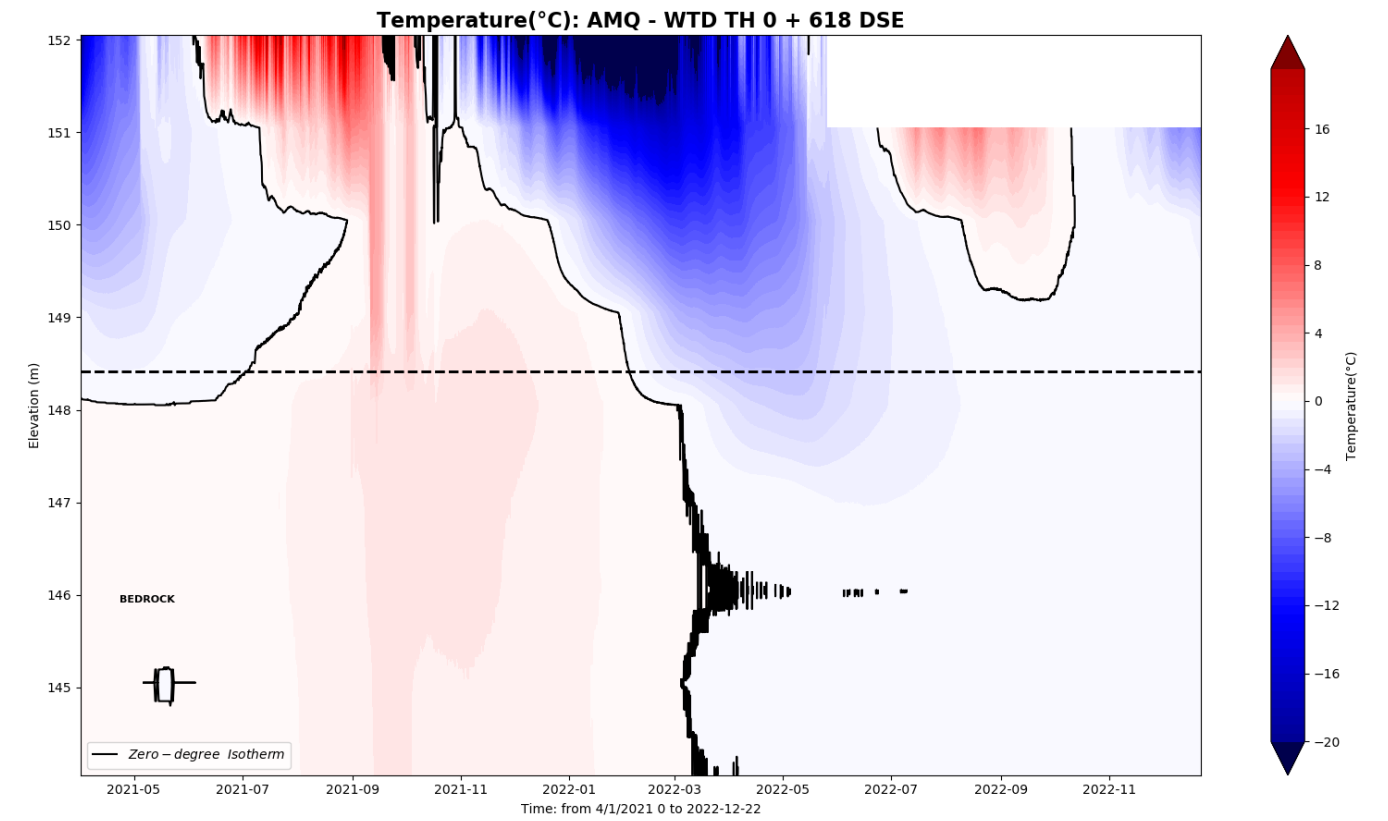
WTD-TH 0+618 DSE

Beads #10 to #16 are damaged.

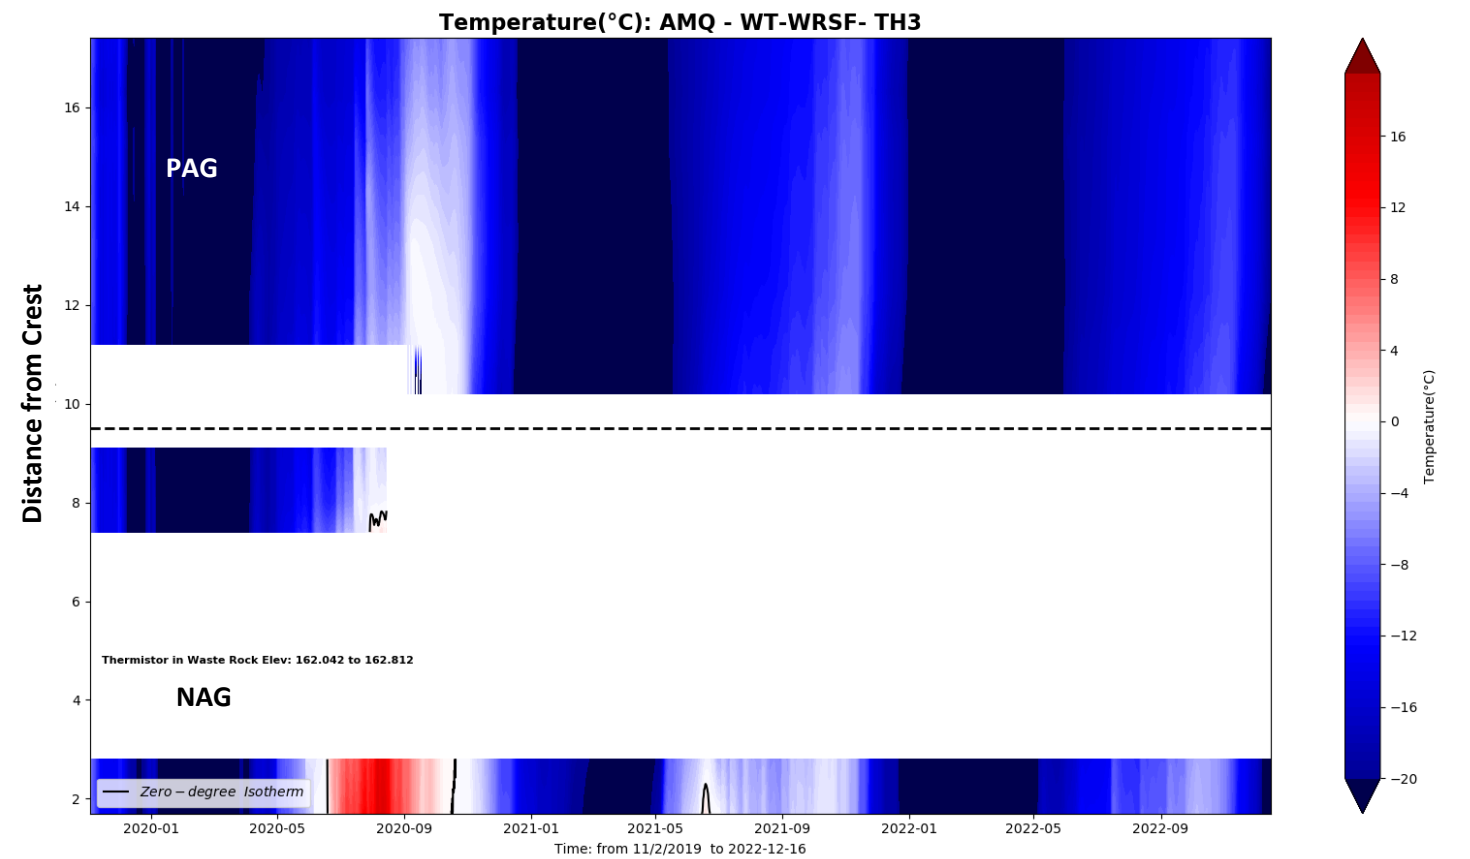
WT WRSF TH3

Thermistor in Waste Rock Elevation 162.042 to 162.812.

This instrument is installed horizontally and chart needs to be read accordingly

Beads 3 to 10 are not working

The instruments installed at mid-elevation in the PAG of the first bench are covered in waste rock and lots of beads have been lost especially in the NAG. The available data indicate that the active layer did not reach the PAG waste rock.

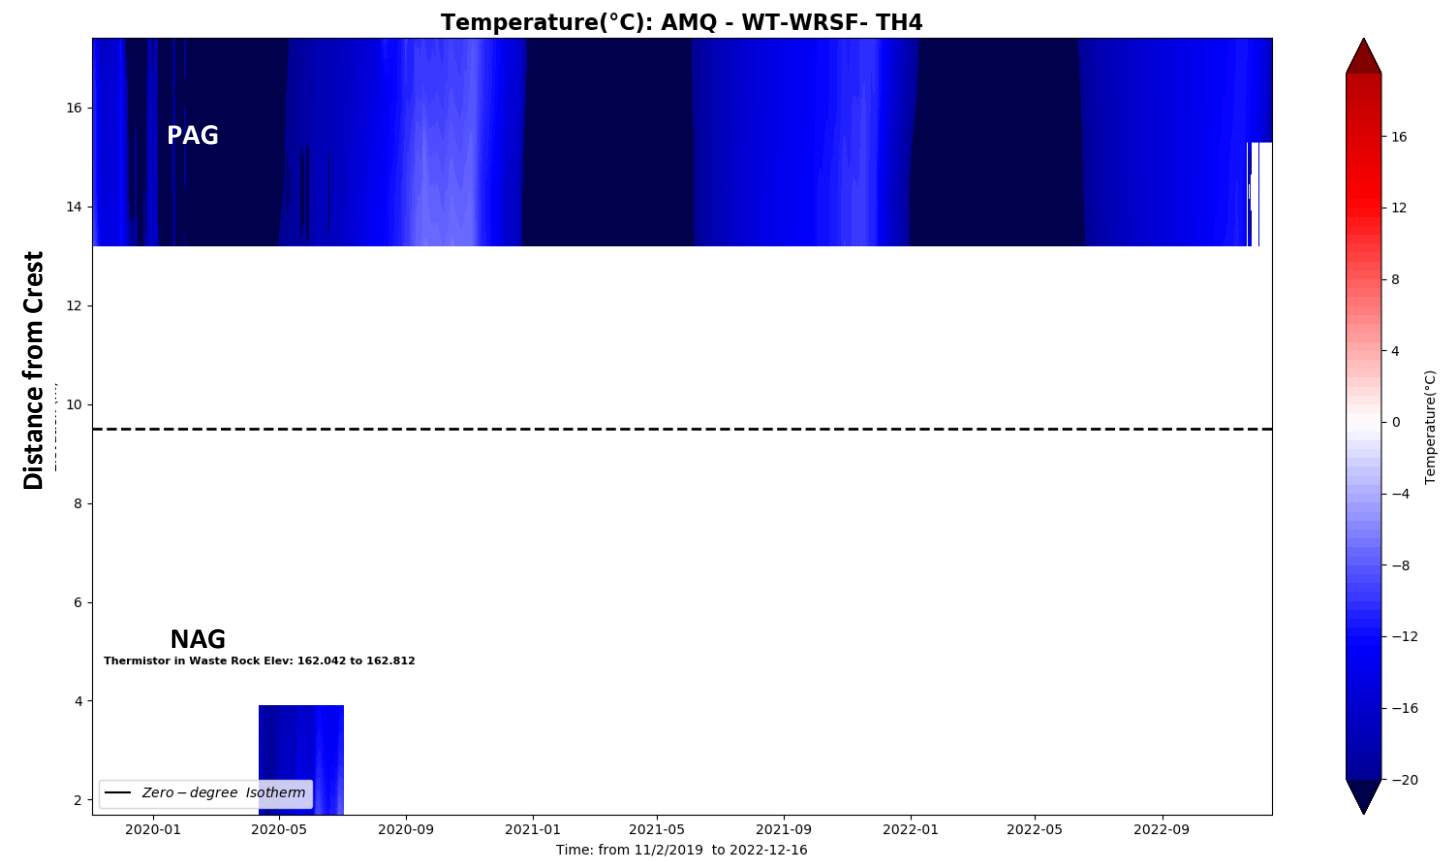
WT WRSF TH4

Horizontal Thermistor String

This instrument is installed horizontally and chart needs to be read accordingly

Beads 3 to 10 are not working
