Whale Tail technical memorandum on avoidance of serious harm to fish and fish habitat

Re: 2018 Report on the Implementation and Monitoring of Measures to Mitigate and Avoid Serious Harm to Fish – Whale Tail Pit Project

2018 Technical Memorandum on Avoidance of Serious Harm to Fish and Fish Habitat Agnico Eagle Mines Ltd. – Whale Tail Pit Project

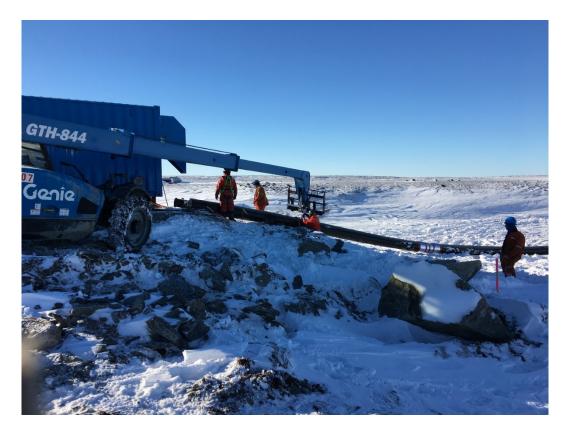
Picture 5 Telehandler pushing pipe with boom

To protect the lake and limit machinery circulation within 31 meters from the shore, Agnico Eagle Mine elected to install the intake pipe line on ice with a telehandler, instead of with a boat and a helicopter. Using that telehandler on the pump station gravel pad, the telescoping boom was used to push the pipeline on it pipe supports and on the ice. Once the fish screen was over the prescribe water depth, ice was cut from underneath the pipe line so that the line could sink, helped with ballast. Picture of this operation can be found in appendix C.

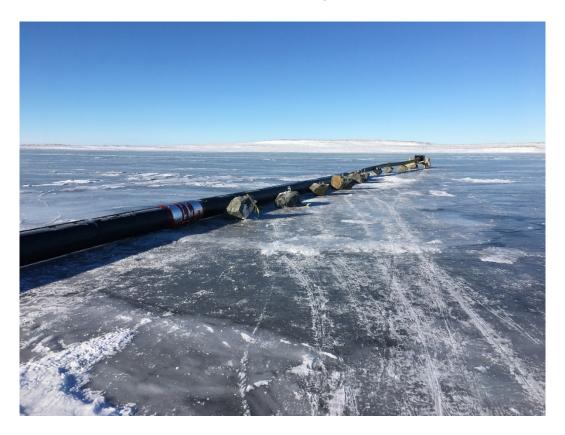
Picture 6 suction line with ballast on lake ice

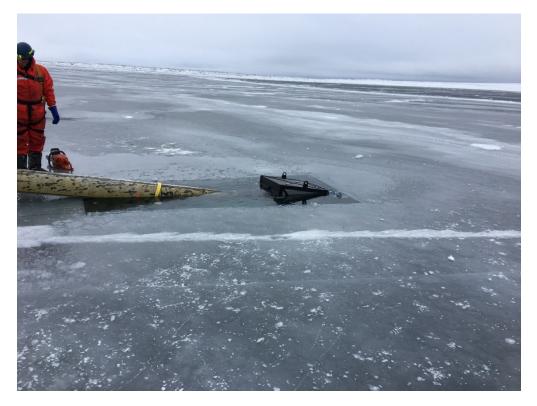
Picture 8 Suction line sinking

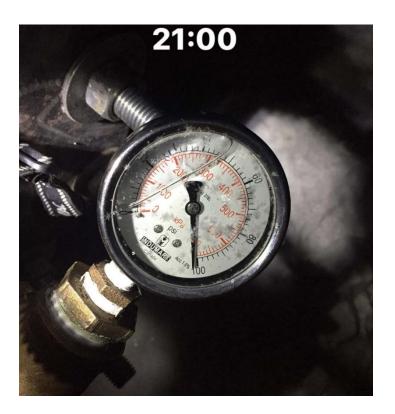
Picture 11 Pressure readout at 21:00

The results shown in table1 are within the acceptance limits for the pipeline. The pressure drop recorded on the 5 hours is less than 3% and confirms that no leaks are present on the line. This variation can be attributed in part to HDPE pipe expansion, in part to ambient temperature change during the test period and in part to the fact that closing the pipe line at the camp end was a butterfly valve, which are known to leak in such use.

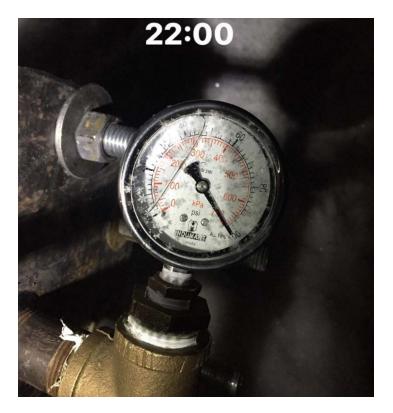
Picture 12 Pressure readout at 22:00

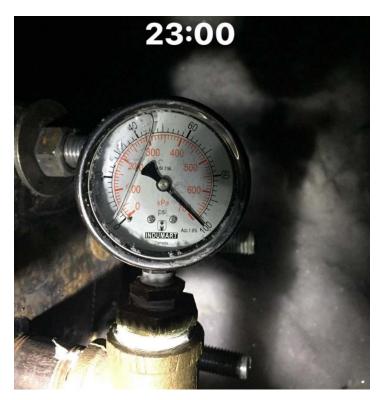
Picture 13 Pressure readout at 23:00

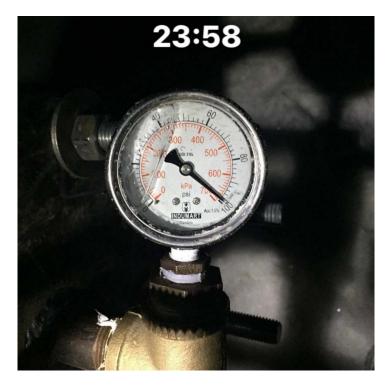
Picture 14 Pressure readout at 23:58

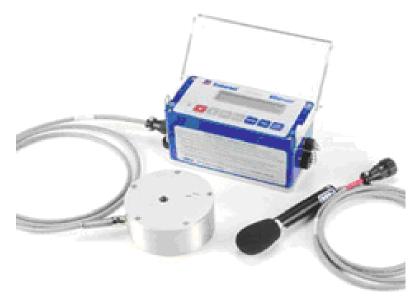
The Minimate Blaster has three main parts: a monitor, a standard transducer (geophone) and a microphone (figure 1). The monitor contains the battery and electronic components of the instrument. It also checks the two sensors to be sure that they work properly. The transducer measures ground vibration with a mechanism called a geophone.

Figure 1: Instantel Minimate Blaster Unit

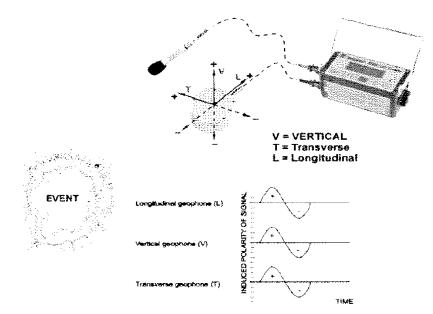
The transducer has three geophones that measure the ground vibrations in terms of particle velocity. They measure transverse, vertical and longitudinal ground vibrations (figure 2). Transverse ground vibrations agitate particles in a side to side motion. Vertical ground vibrations agitate particles in an up and down motion. Longitudinal ground vibrations agitate particles in a back and forth motion progressing outward from the event site (Instantel, 2016).

Figure 2: Sensor Orientation (Instantel, 2016)

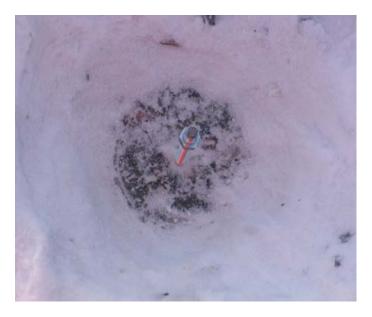
The transducer is installed on a hard surface, which in this case is rock. A 3/8 inch bolt is anchored in the rock (figure 3) and the transducer is tightened with a nut (figure 4). The arrow on the top of the standard transducer must be pointed in the direction of the event to ensure the geophone sensors, located inside the standard transducer, remains in their natural axis (Instantel, 2016). The trigger level of the instrument is set to 1 mm/s and the transducer will start recording an event automatically when the ground vibrations are greater than or equal to 1 mm/s. The recording time is 4 seconds, which is sufficient considering that the blast timing is rarely more than 2 seconds at Meadowbank. The instrument is protected with a box and the microphone is oriented in the direction of the blast.

Figure 3: 3/8 inch bolt anchored in the rock

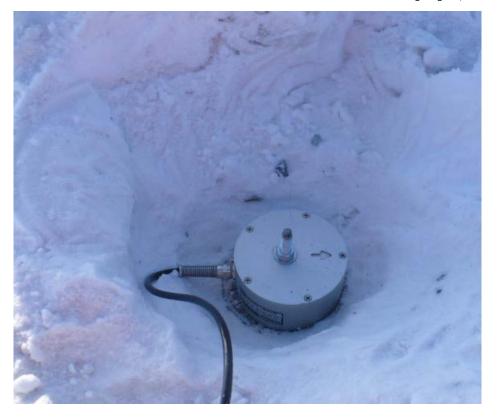
Figure 4: Transducer tightened with a nut

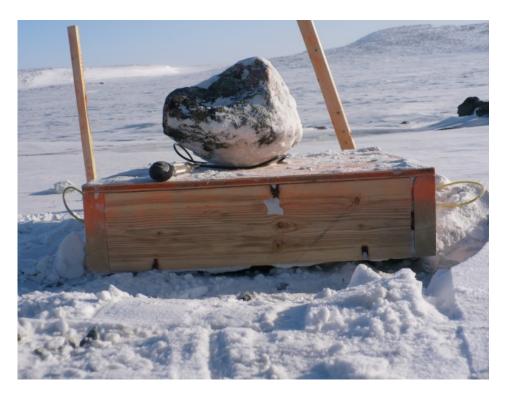
Figure 5: Final Set-up with the Microphone in the direction of the blast

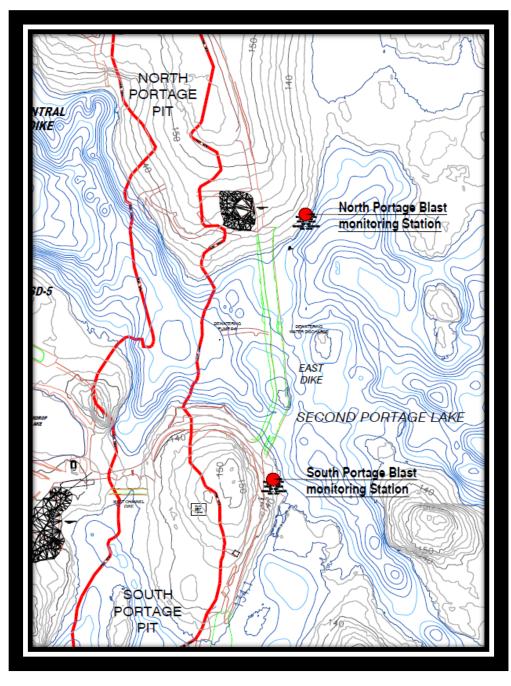
The blasts are monitored from three different locations. The locations were chosen to have the optimal distance between the blasts and the water (fish habitat). One station is located near the northern end of Portage pit and the other near the south end of Portage pit (figure 7). The third station is located at the complete northern of the Vault Pit (Figure 8).

Figure 7: Localizations of the two blast monitoring stations at Portage Pit

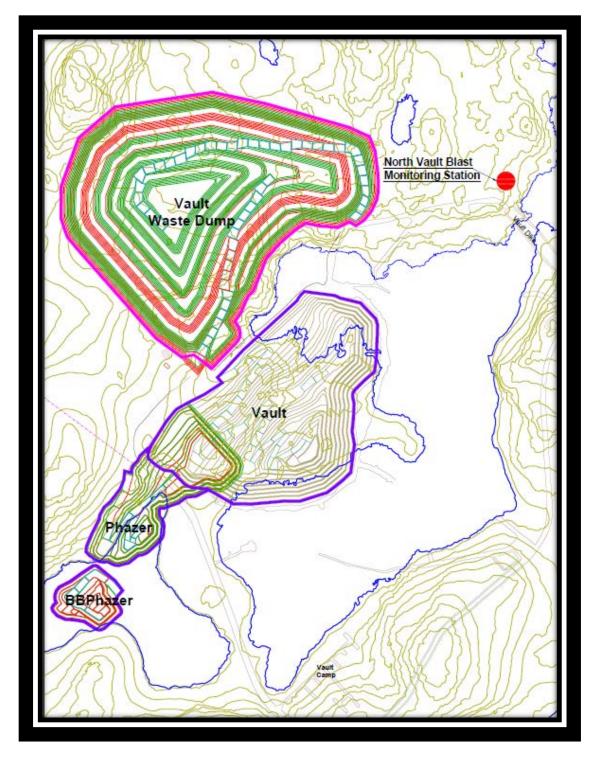
Figure 8: Localization of the blast monitoring station at Vault pit

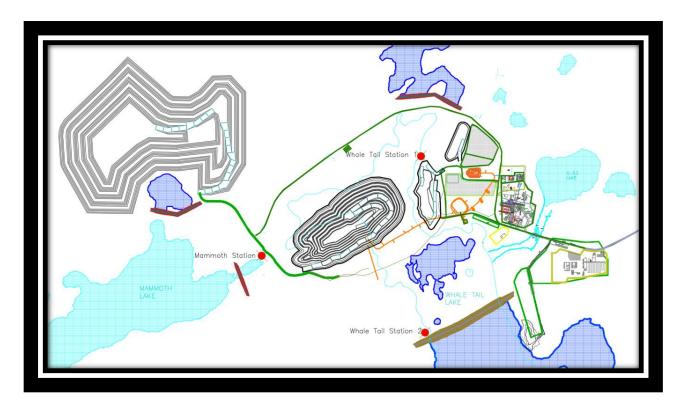
The blasts were monitored from Whale Tail Station 1 when mining in Quarry 1 and Ap-5. For Quarry 2 and Phase 1 of Whale Tail Pit; monitoring is done from Mammoth Station 1 only since the fish out of Whale Tail Lake has been completed. Depending on the location of the blast inside Whale Tail Pit, Whale Tail Station 2 will be used as well. Additionally, monitoring will be done on both Mammoth Dike and Whale Tail Dike which will provide redundancy and mitigation if ever the Instatel monitoring devices were to not record.

Figure 9: Localization of the blast monitoring stations at Amaruq

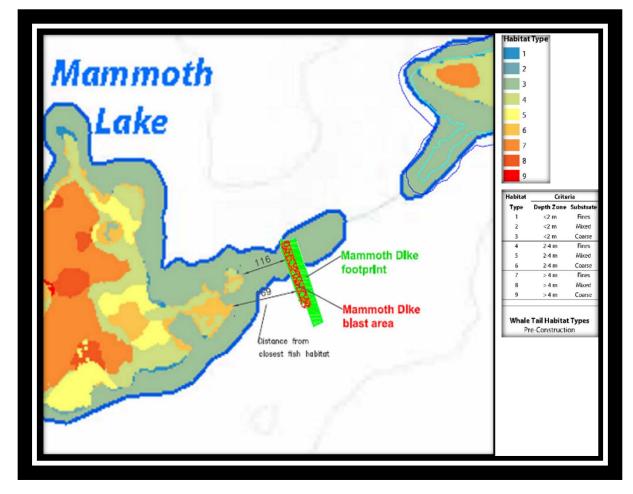
As demonstrated on Figure 10, the possible fish spawning areas are located West of Mammoth Dike while Mammoth Station is located East of the Dike. Therefore, it is safe to say, according to the formula for calculating PPV in Section 2, that if we record PPVs under the 13mm/s threshold, that the PPVs will be lower at the fish spawning areas.

Figure 10: Fish Habitat Types for Mammoth Lake
