### **Whale Tail 2022 Report on the Implementation of Measures to Avoid and Mitigate Serious Harm to Fish**

WHALE TAIL MINE

**2022 REPORT ON THE IMPLEMENTATION OF  
MEASURES TO AVOID AND MITIGATE SERIOUS  
HARM TO FISH**

DFO Fisheries Act Authorization 16-HCAA-00370

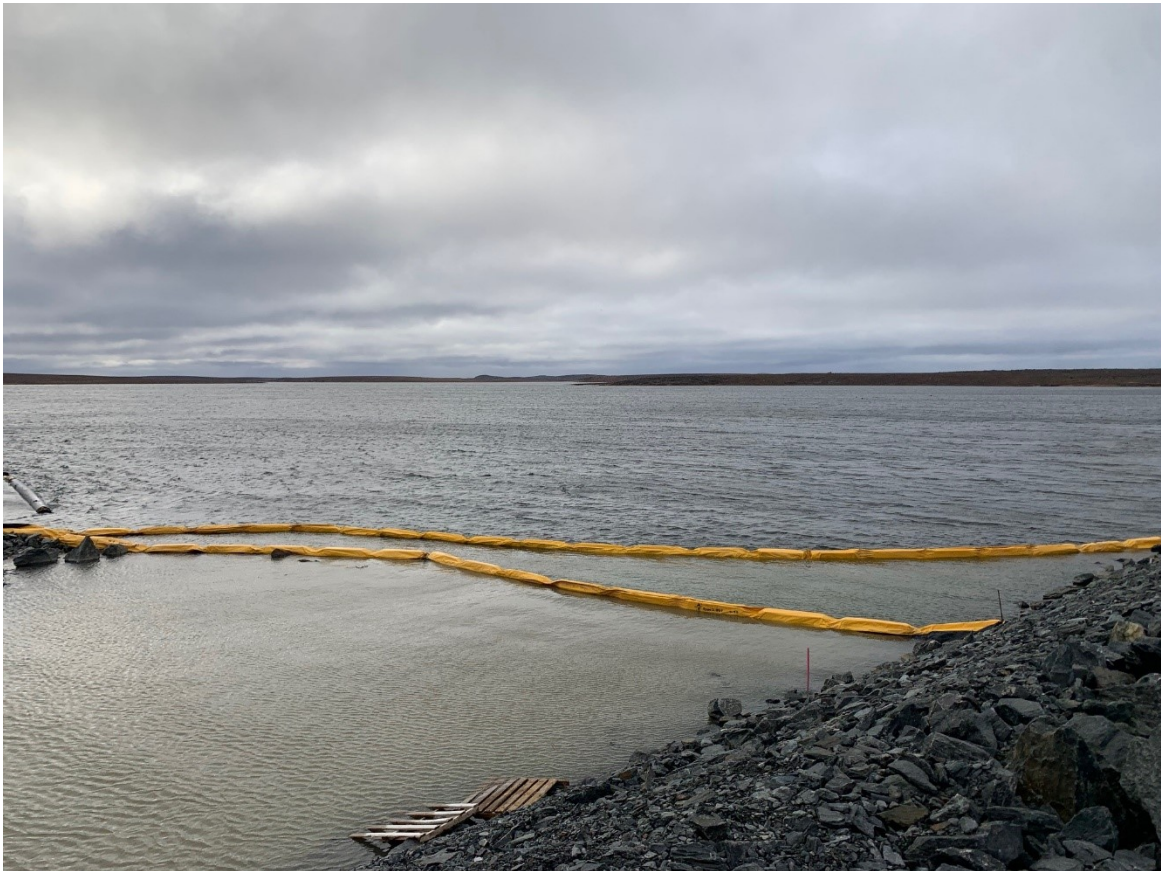
**Figure 3. Turbidity curtains deployed during in-water construction for the Whale Tail Dike East Abutment Thermal Berm (September, 2022).**

- *Monitoring Methods:* Water quality monitoring was conducted by surface grab samples outside of the turbidity curtains in Whale Tail Lake (Station ST-WT-DC-12), before, during and after the in-water remediation work. The Environment Department measured daily the temperature, pH, conductivity, turbidity, and dissolved oxygen. TSS analyses were performed daily by Agnico's onsite assay laboratory using standard methods. Accredited laboratory analysis for TSS, nutrients, major ions, and metals (full suite) was also conducted weekly during and after the in-water work (September 25 and October 2).

- *Results:* All results were less than available CCME guidelines and NWB Water License Part D, Item 7 criteria for TSS (50 mg/L for an individual sample, or 15 mg/L for the monthly mean), with a maximum recorded individual TSS value from the accredited laboratory of 2.0 mg/L.

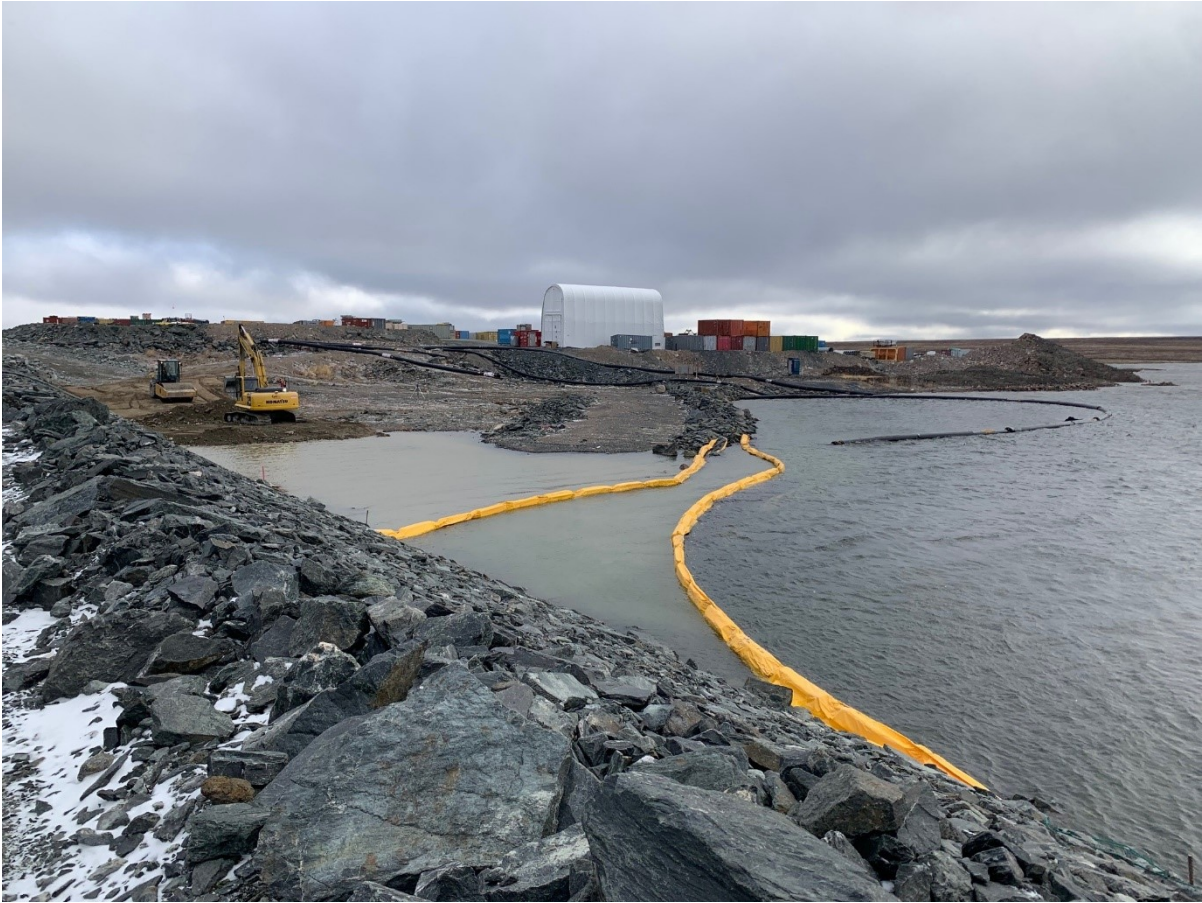
**Figure 4. In-water construction for the Whale Tail Dike East Abutment Thermal Berm (September, 2022) showing turbidity curtains.**
