### **Quarry 22 Report**

MEADOWBANK GOLD PROJECT

**2016 Quarry 22 Report**

Prepared by:  
Agnico Eagle Mines Limited – Meadowbank Division

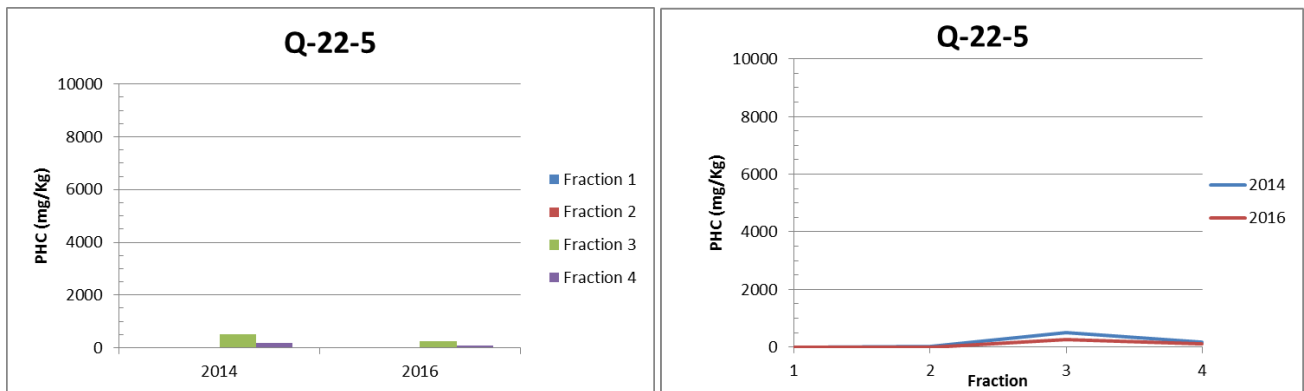
Figure 5 – Comparative results 2014-2016 – Section Q-22-5

When comparing results of 2016 with the sampling done in 2014 (Table 2 and Figure 1-8), levels of contamination appear to be trending down in general. No more results are above CCME criteria for fraction 1 and 2. Higher levels are noted within fraction 3 and in section Q-22-1 to Q-22-4, which were areas that contained the bulk of historical contaminated material placed in the quarry. An increase is noted within section Q-22-2 and Q-22-3 for fraction 3, but also associated with a decrease in section Q-22-1 and Q-22-4. These variations can be explained by the scarifying work done within the quarry that has spread material between the 2014 and 2016 sampling campaign. The general level of degradation is trending down.

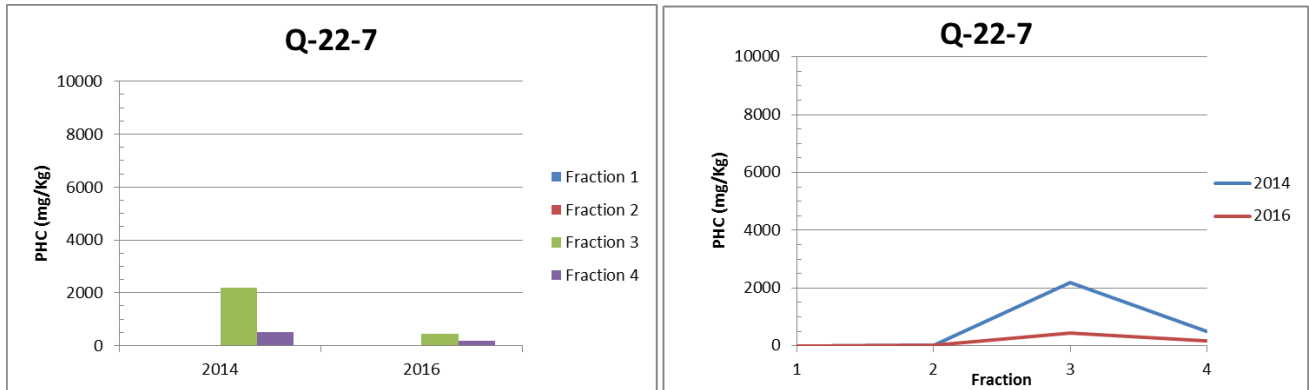
Figure 7 – Comparative results 2014-2016 – Section Q-22-7

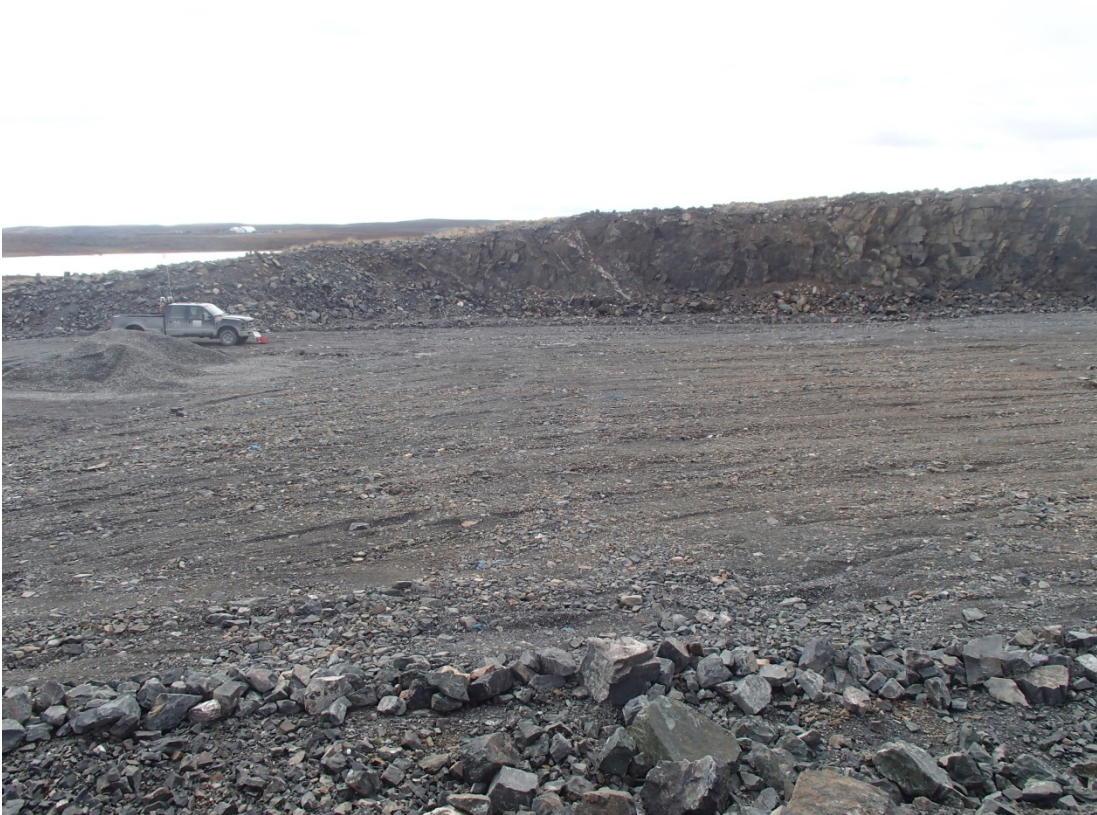
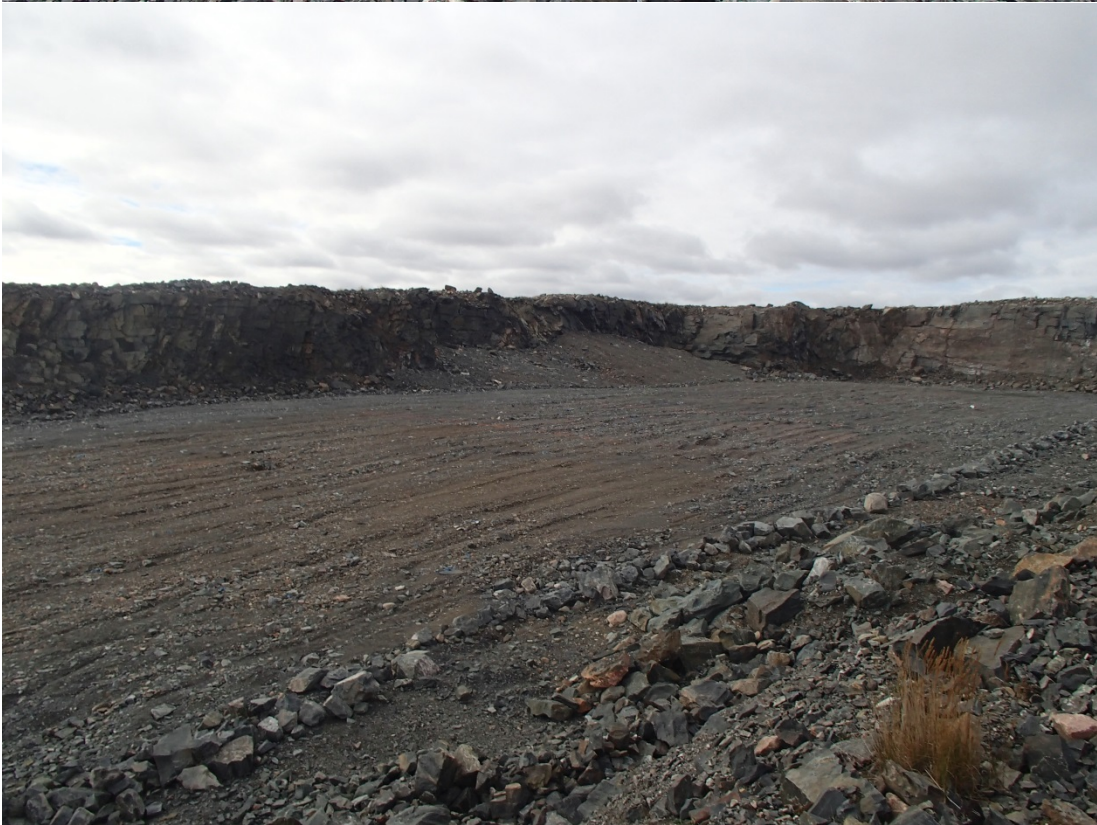
**Appendix A**  
**Photos after scarification**

Taking into consideration the results from 2014 and the 2015 work plan, Agnico Eagle continued in 2016 to scarify the surface of Quarry 22, as in previous years, with the back-end of a grader, allowing ground surface to be aerated thus increasing degradation of PHC.

The scarification work started mid-July and extended throughout warmer months, depending on equipment availability. On average it was done every second week from July to September (see photos, Appendix A).

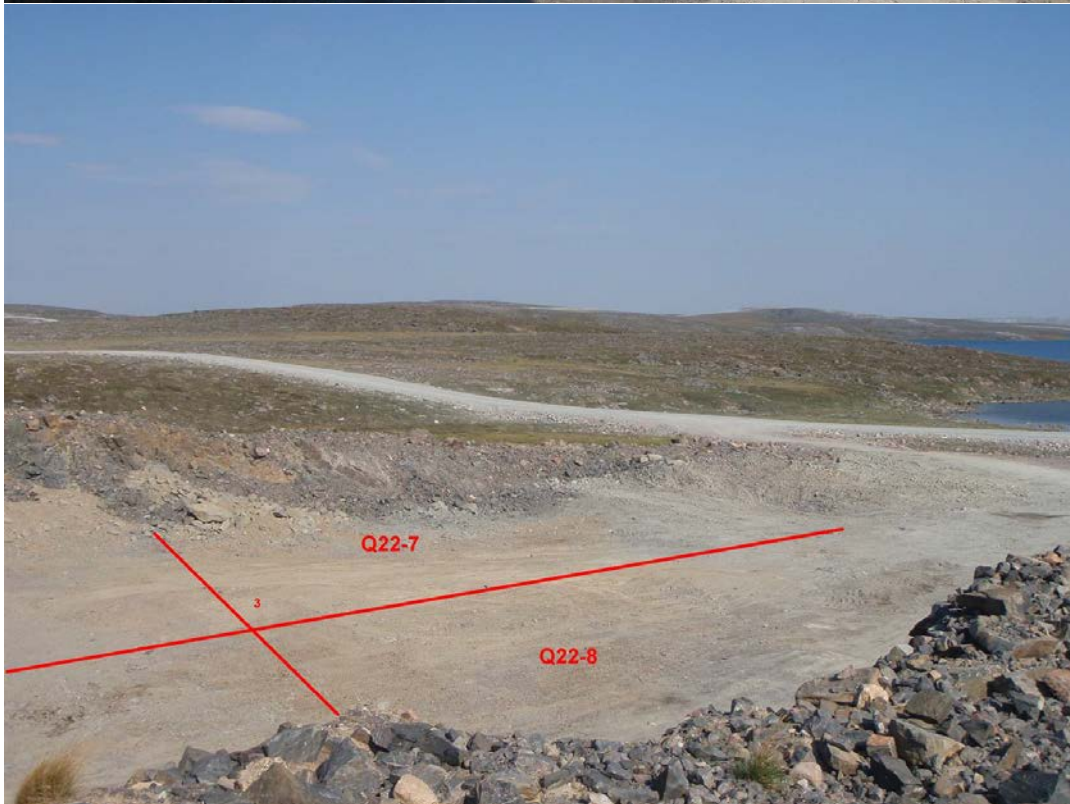
**Appendix B**  
**Area Delimitation Quarry 22**

As previously done in 2014, a grid was used to divide the quarry in portions representing areas where contaminated material had been stored (Appendix B). As such, areas from 0 to 1 represent a smaller sampling area in size as more contaminated material was stored in this area (towards back/walls). Size increased as areas move from 1 to 2 to 3. Portions from 3 and beyond represented the largest in area. The surface included any material that was used for sloping along the walls (see Section 2.1 above). This area sampling design was adopted to ensure that the soil characterization was well assessed; in particular, in the areas that received most of the contaminated material.
