Appendix J3

2017 Regulators Inspection Reports

WATER LICENCE INSPECTION FORM

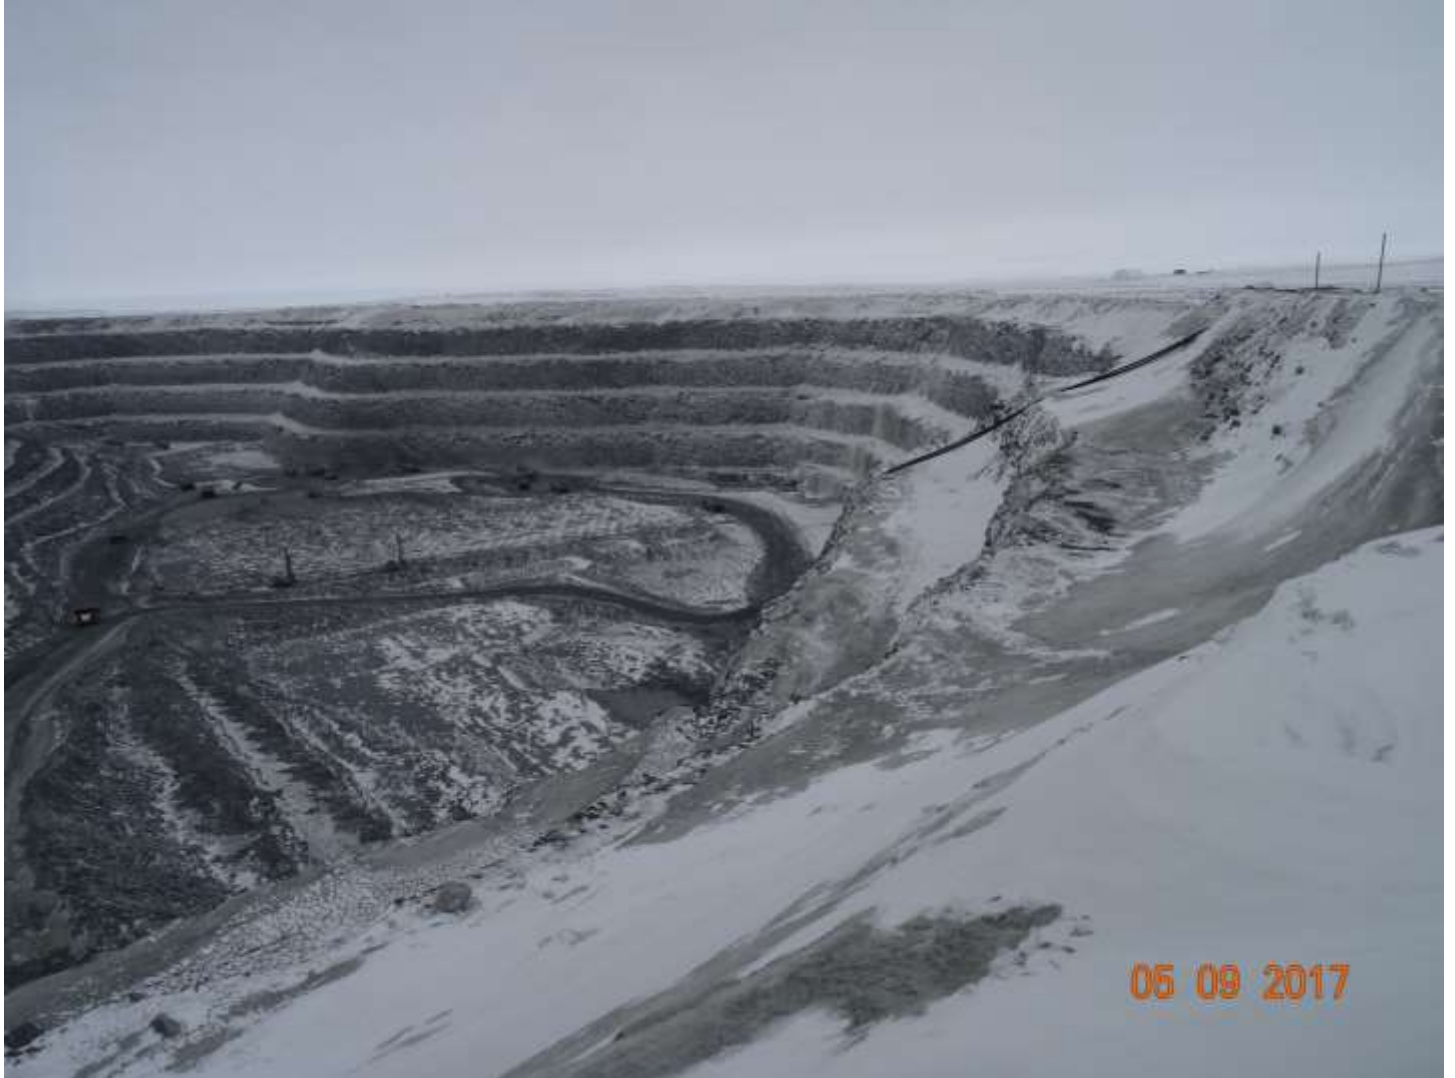
Photo 2

3. The inspector requests clarity on whether Phaser's diversion ditch will be constructed or if the plans have been altered.
4. Vault pit sump (ST-23) is pumped all winter into vault attenuation pond (photo 2).

Vault pit sump

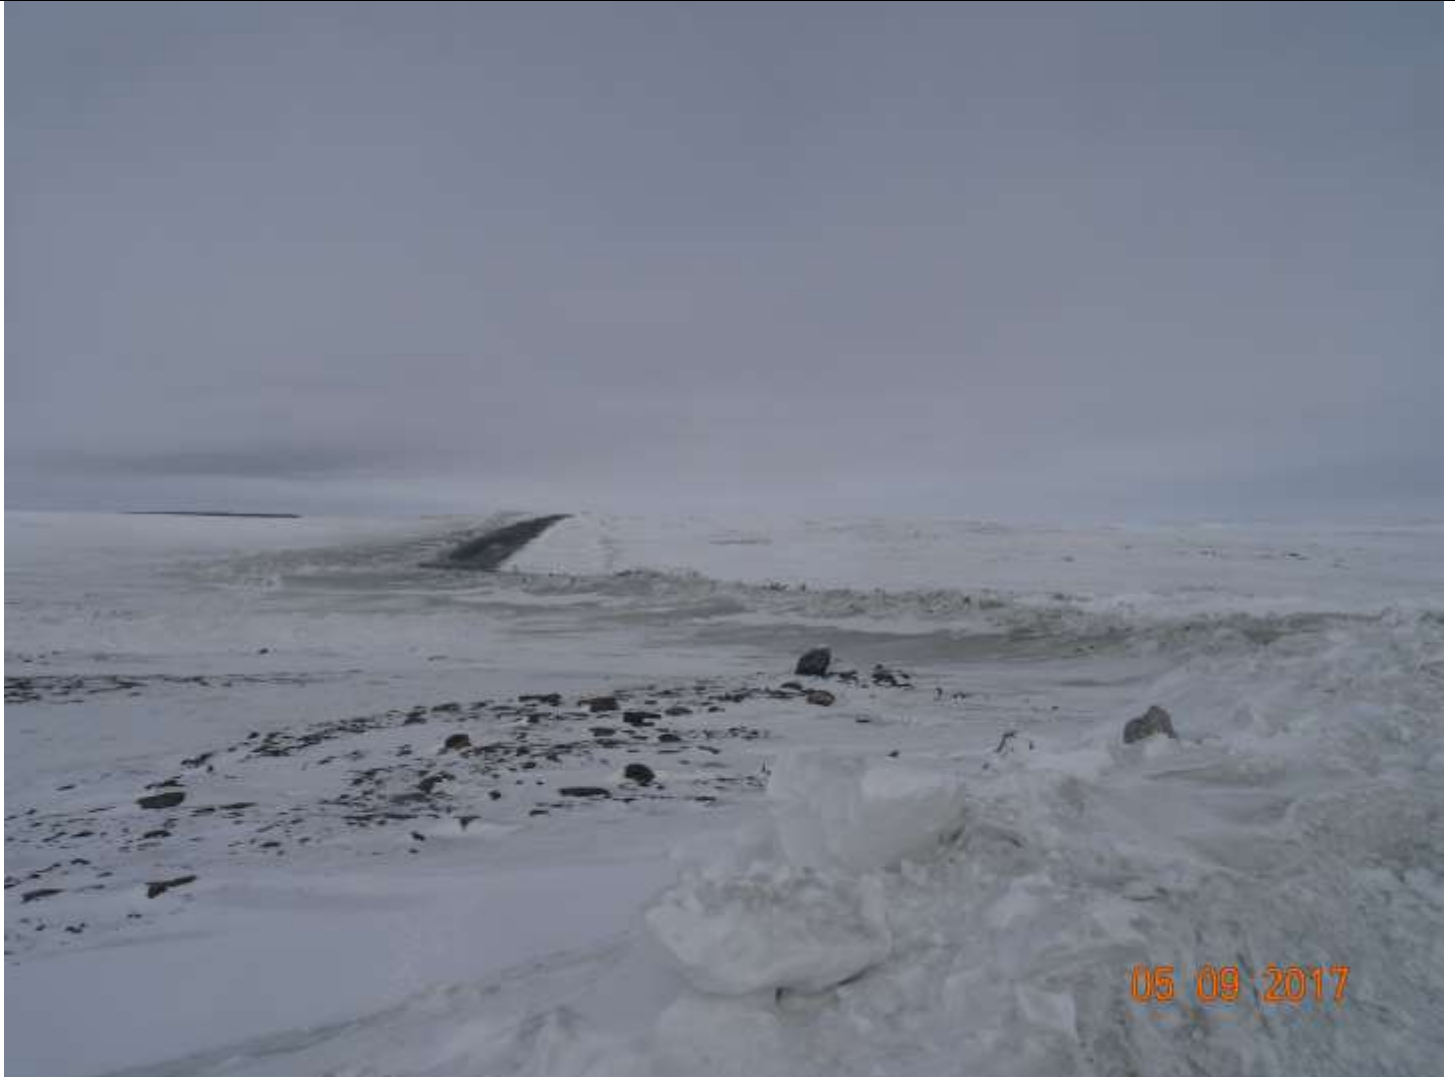
Photo 3

5. The culvert crossing at NP1-NP2 has a lot of sediment in the snow from road dust (photo 3) and snow moving. Piles of snow with road materials were observed along the water crossing (photo 4 and photo 5). Sediment mitigation measures continue to be taken in the form of curtains and freshet inspections.

Vault haul road

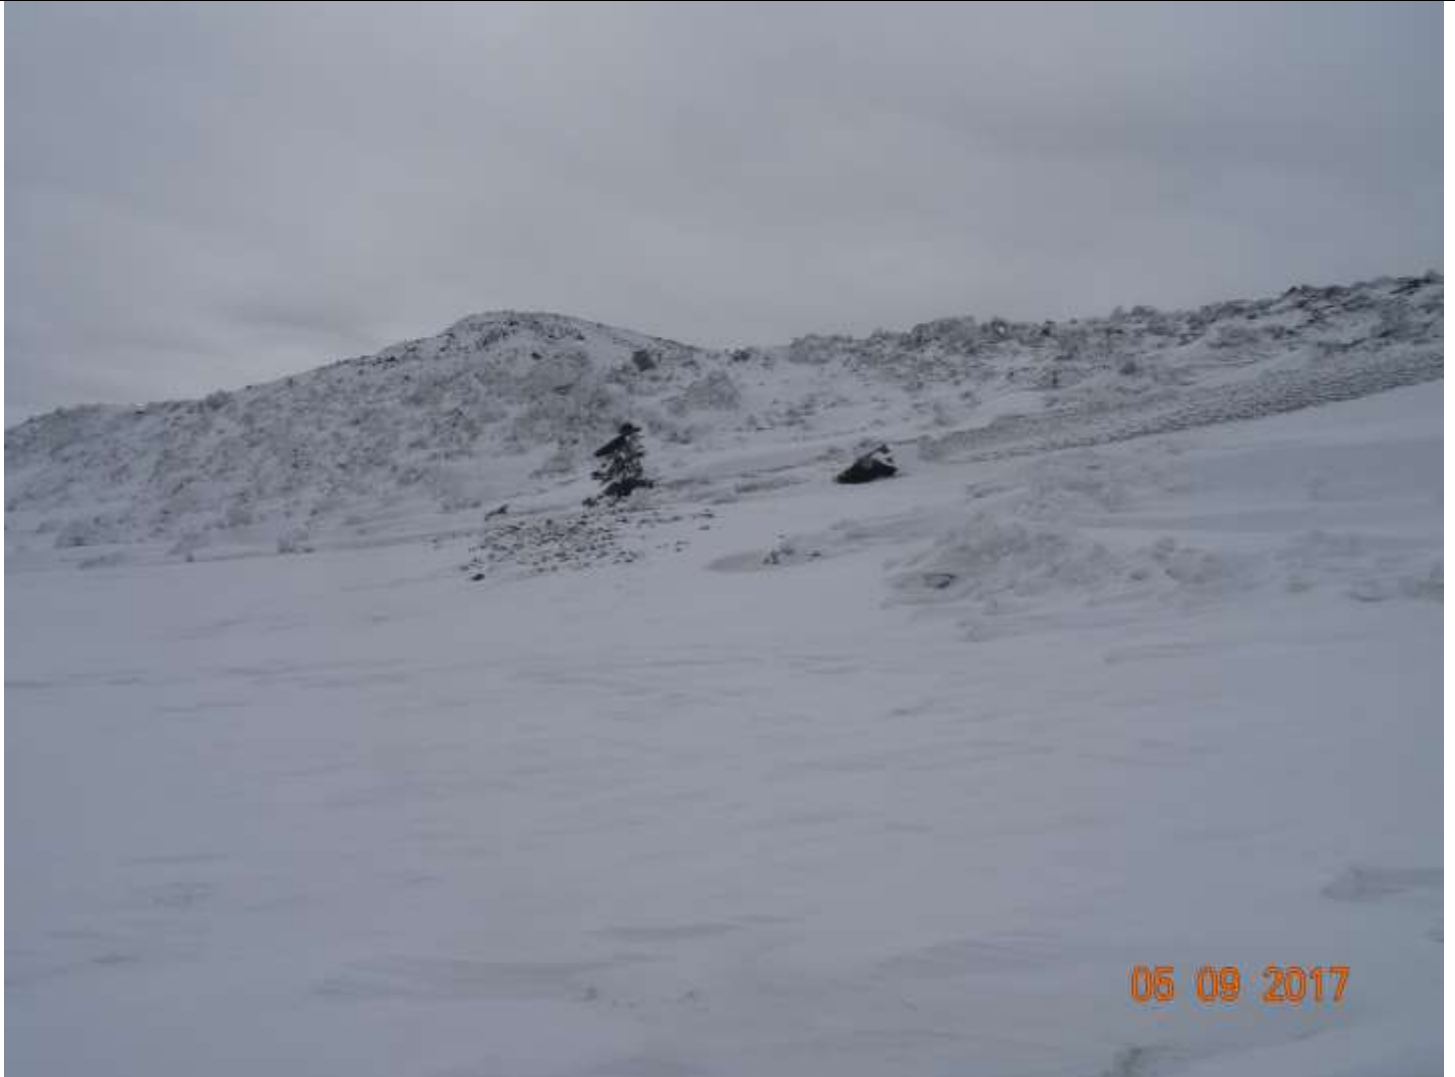
Photo 4

Vault haul Road, Sediment in snow

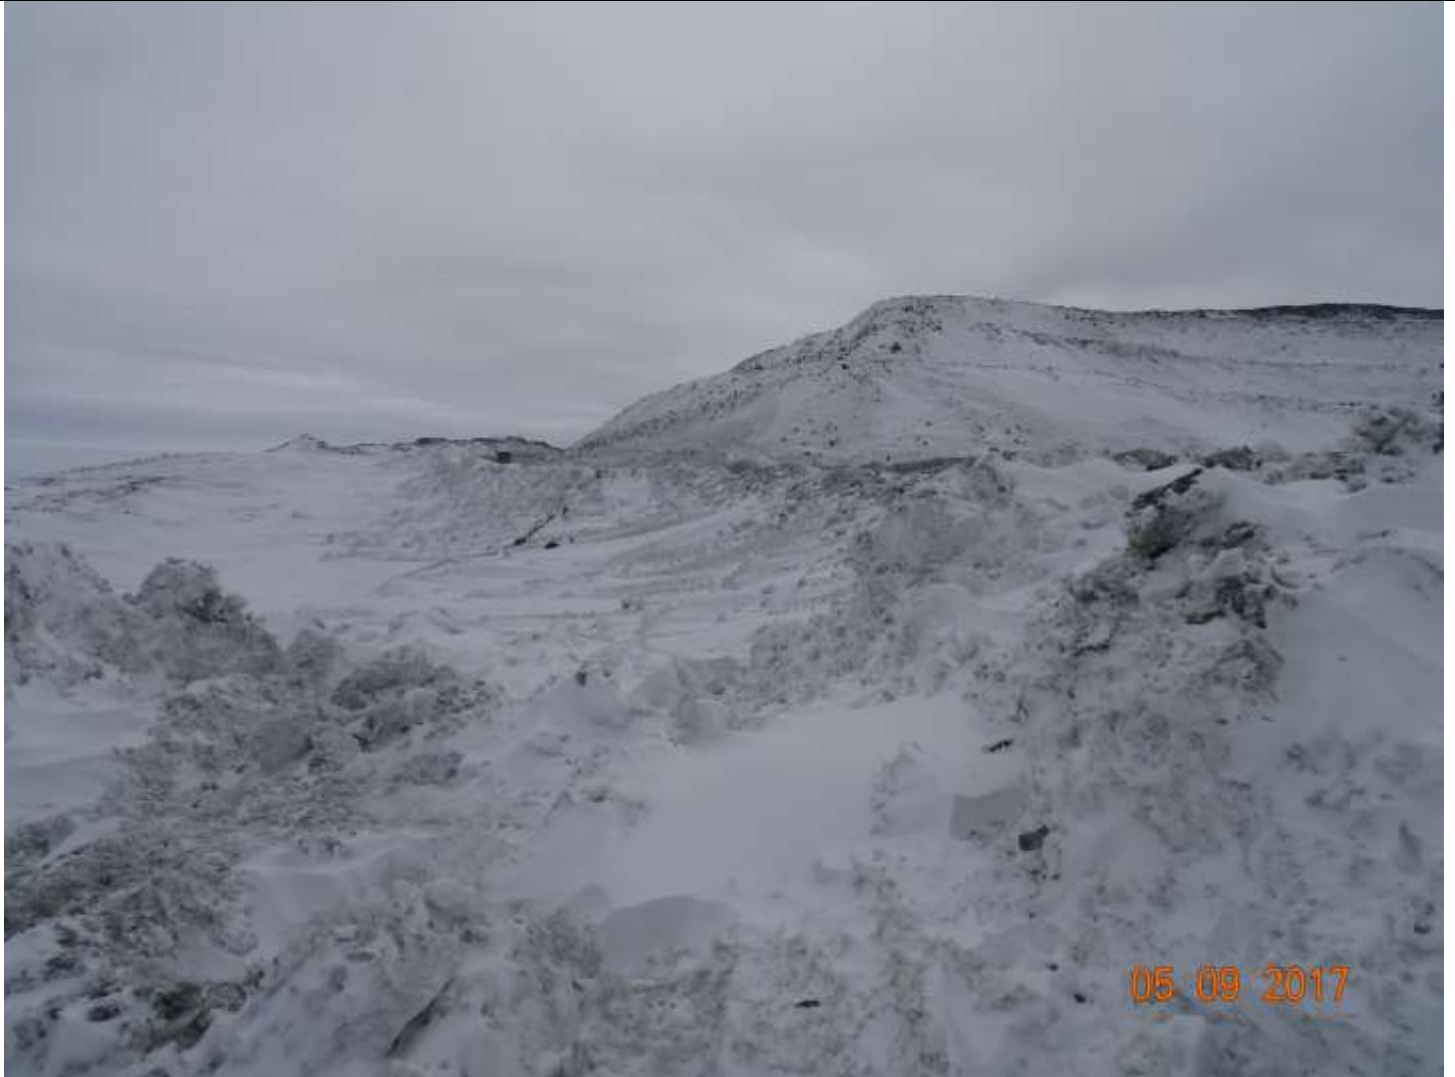
Photo 5

Vault Haul Road, Sediment on snow

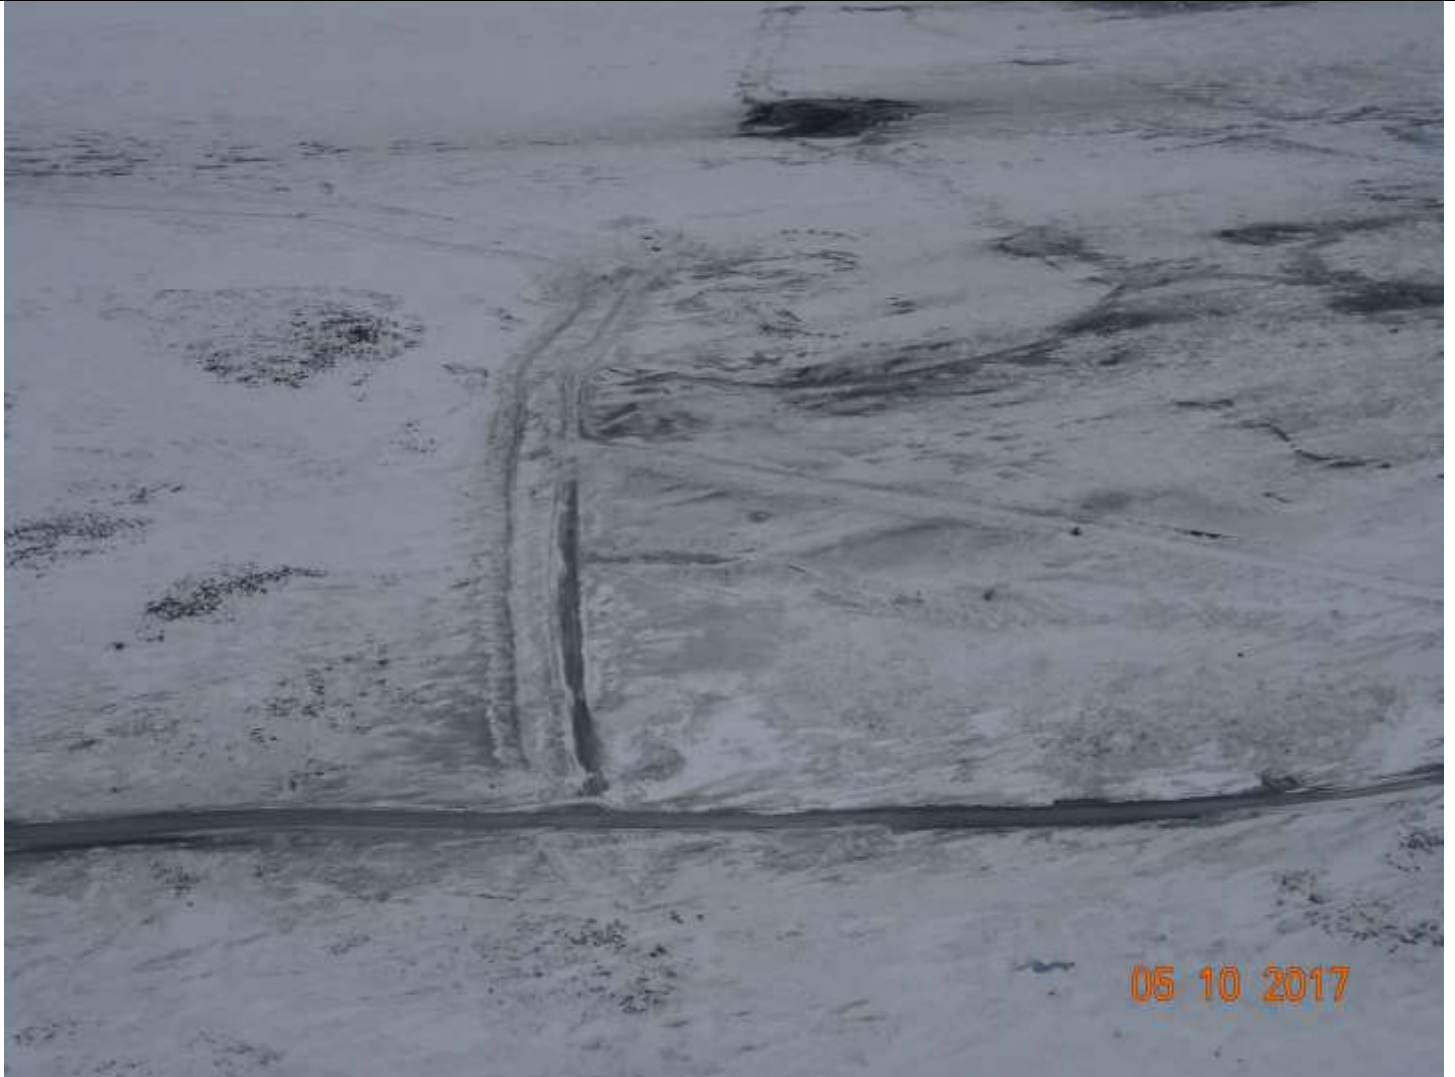
Photo 6

6. There was no observable flow at the time of inspection at NP1-NP2.
7. The snow has been removed from the non-contact water diversions ditches surrounds the tailings facility (photo 6).

Tailing facility non-contact water diversion ditch

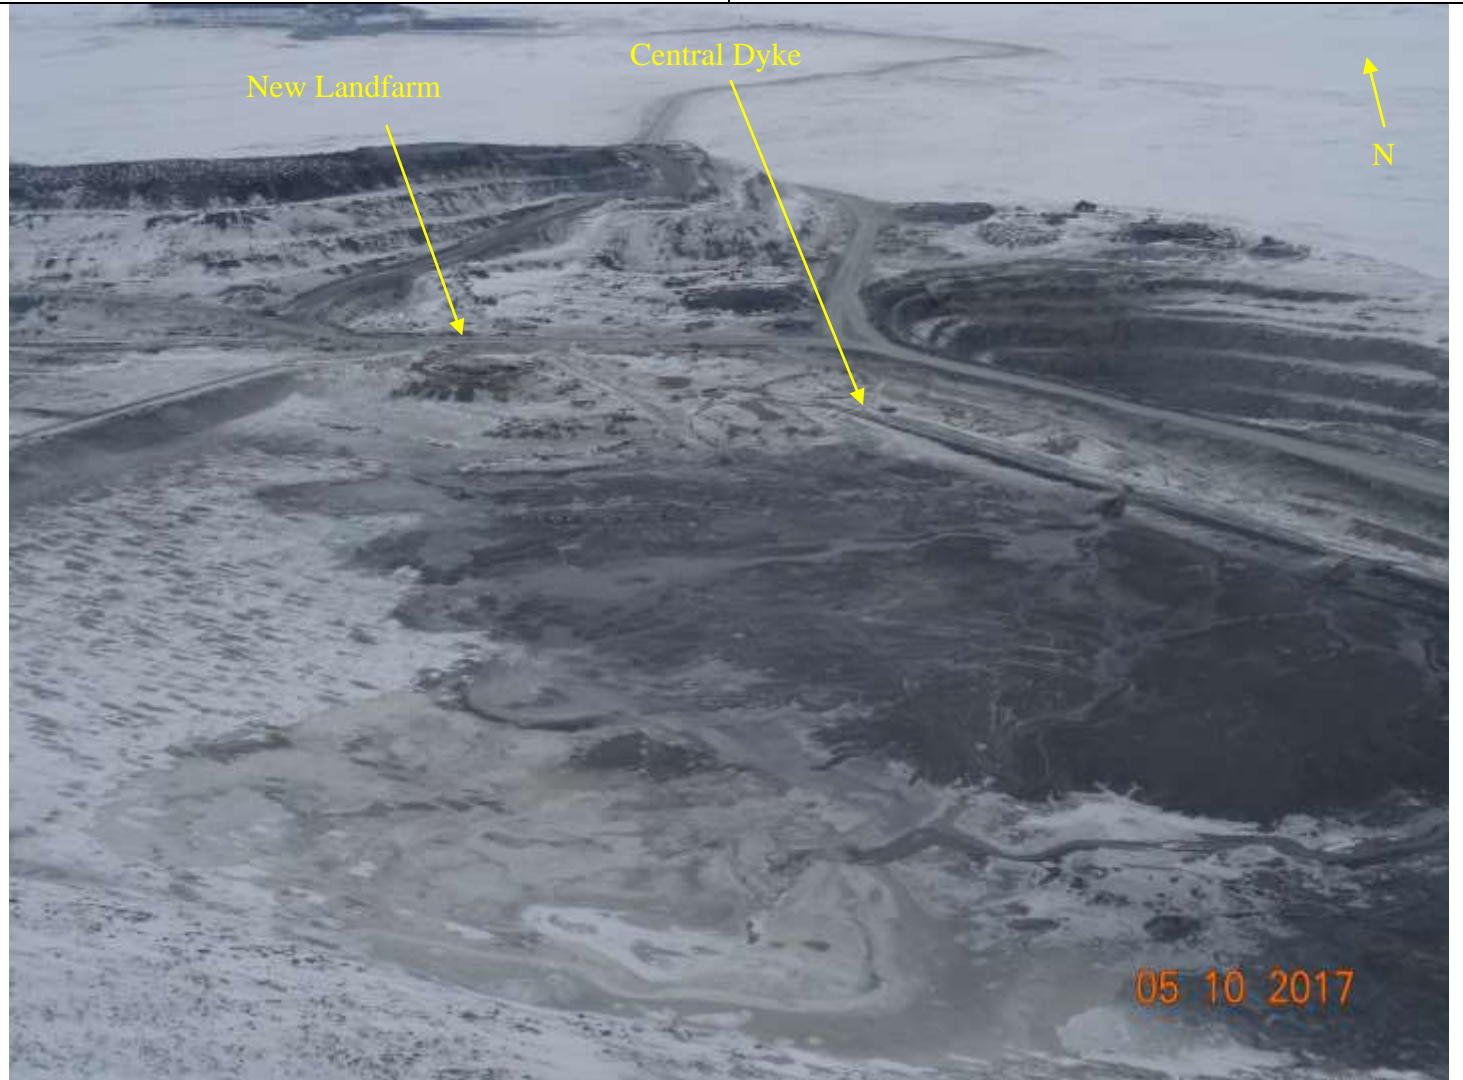
Photo 7

9. A new landfarm facility has been constructed at N65° 04' 21.1", W96° 00' 29.6" (photo 7).
10. The old landfarm was located in the North West corner of the South cell Tailings Facility ("STSF"). AEM anticipated the elevation of the STSF would be nearing the landfarm by 2017. The new landfarm was constructed in the fall of 2016. Further improvements need to be made before the term of the next inspection specifically regarding gradient and containment.

Landfarm

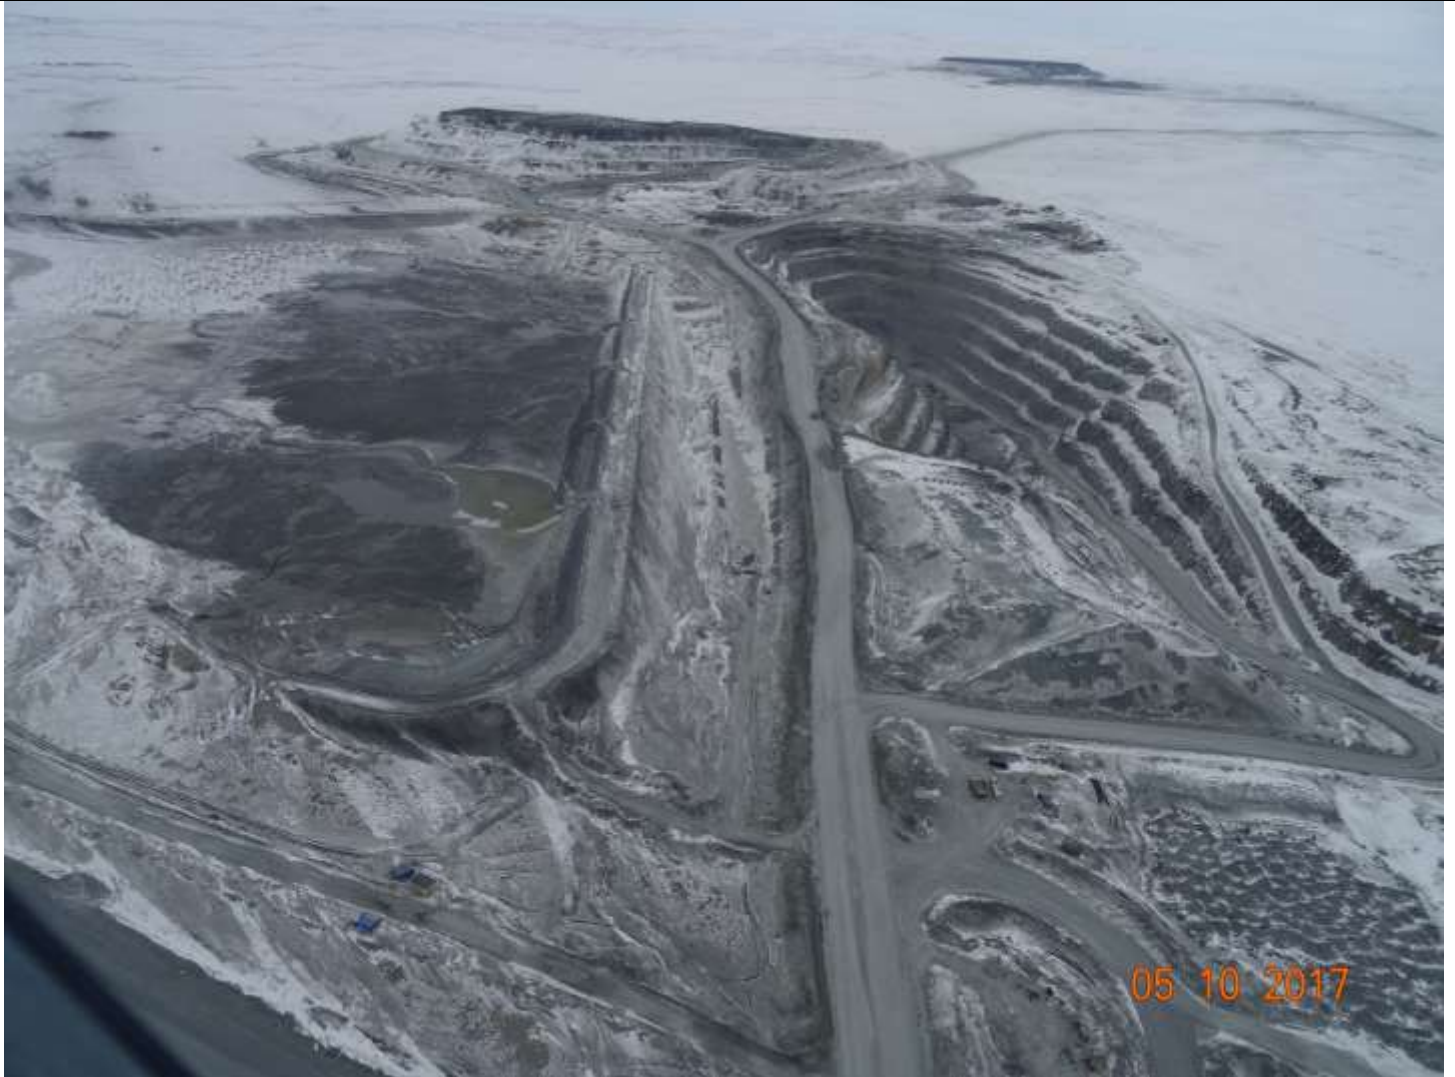
Photo 8

11. The central dyke seepage continues; it is estimated at approximately 1000m³ per day (photo 8).
12. The water found in the central dyke sump is light grey and turbid. AEM confirms the quality the same as the STSF. The sump remains open year around.

Central Dyke

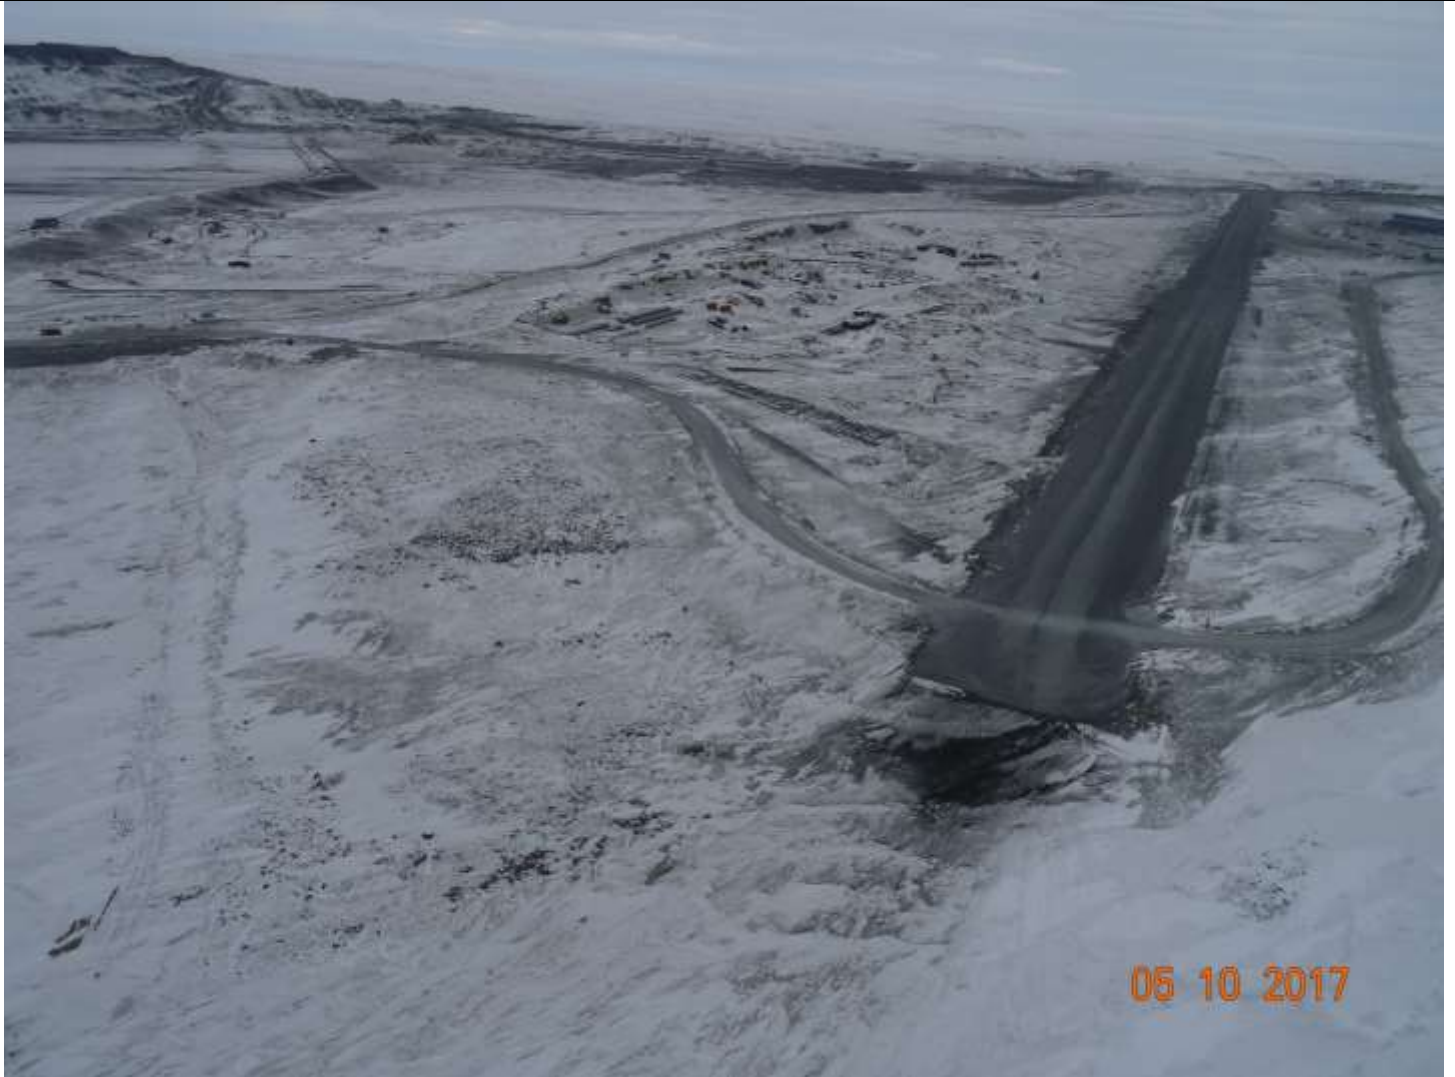
Photo 9

14. Sediment was observed at the end of the run way. The inspector was concerned with the closeness of the runway to the lake that there may be impacts (photo 9).

Sediment on North west extension of runway.

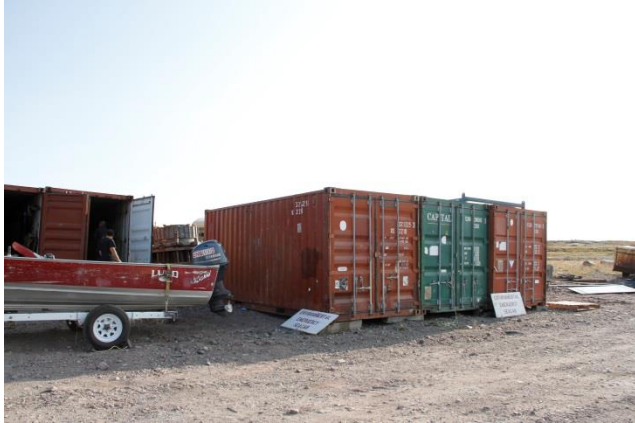
- a. The Monitoring Officer observed that the environmental emergency seacans containing booms, shovels, absorbent pads, and other miscellaneous spill response equipment were located at the Baker Lake laydown facility (see [Photo 1](#)). At the time of the site visit, a barge was at the Baker Lake dock facility and offloading equipment (see [Photo 2](#)) and [Photo 3](#)). The marshalling facility was very busy with the movement of supplies from the barge.

Photo 1: Environmental Emergency Seacan at the Baker Lake Marshalling Facility

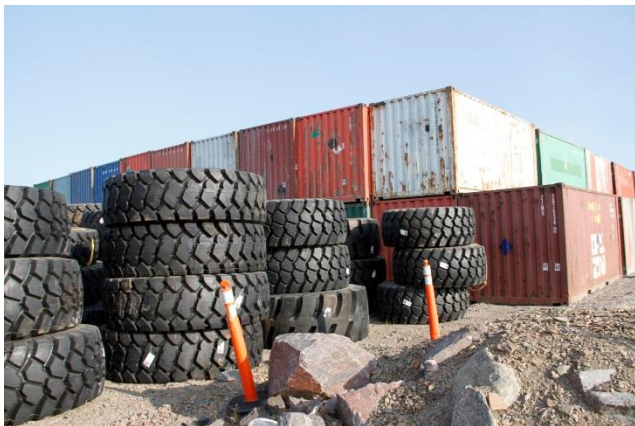
- b. It was further noted that the lower all-terrain vehicle (ATV) trail that goes through the Baker Lake bulk fuel storage facility/marshalling area was blocked by tires and seacans limiting access to the community members ability to travel to their cabins along the shoreline (see [Photo 4](#) and [Photo 5](#)).

Photo 4: Tires blocking lower ATV trail along the Baker Lake shoreline

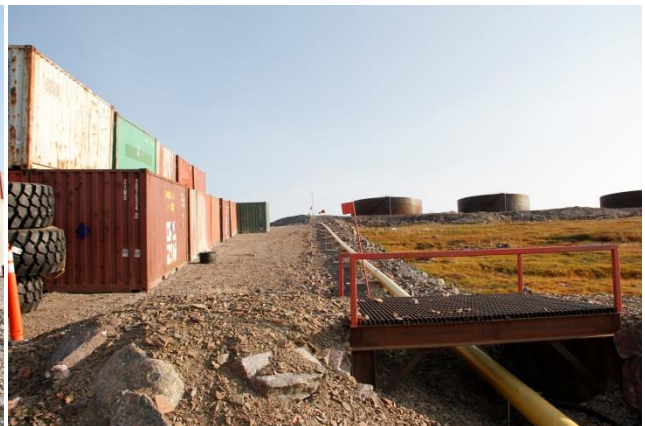
Photo 5: Little bridge to ensure access to ATV trail

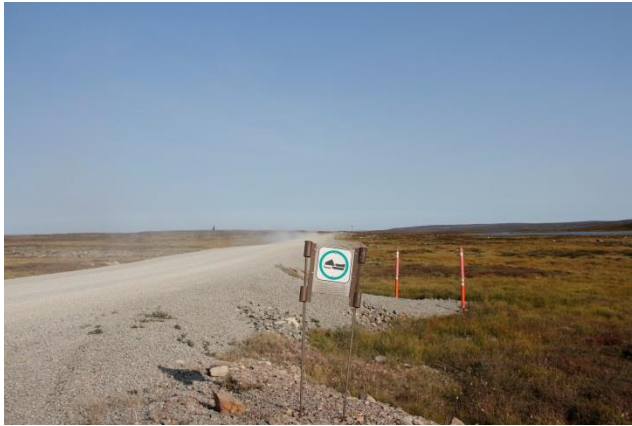
- e. Two snowmachine crossings are located along the AWAR, one near km 10 and the second near km 98 (previously near km 82). There were no signs of extreme slopes or rocks along the side of the AWAR (see [Photo 11](#) and [Photo 12](#)).

Photo 11: Snowmachine crossing near km 10

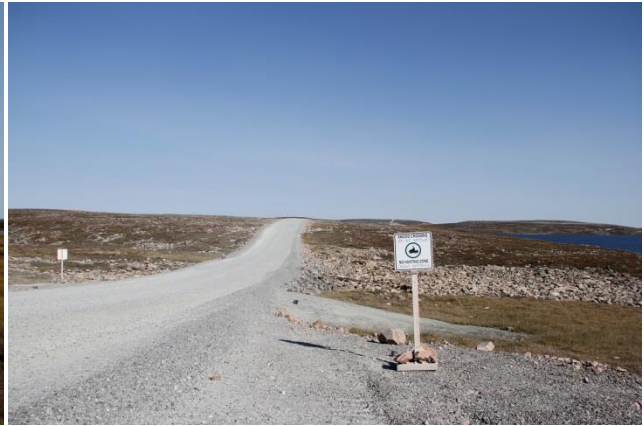
Photo 12: Snowmachine crossing near km 98

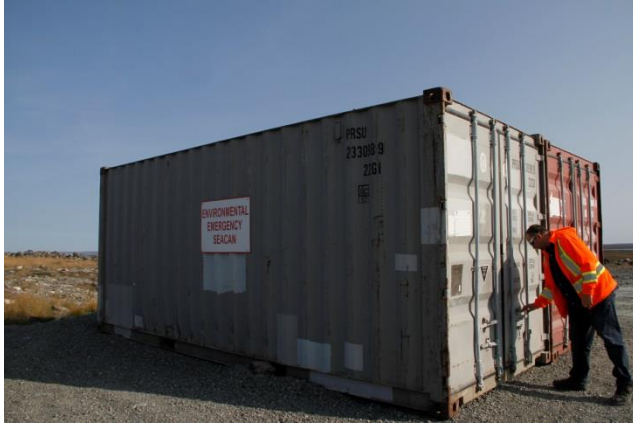
- f. Environmental emergency seacans were located at all bridge crossings (see [Photo 13](#) and [Photo 14](#)).

Photo 13: Environmental seacan near one of the bridges

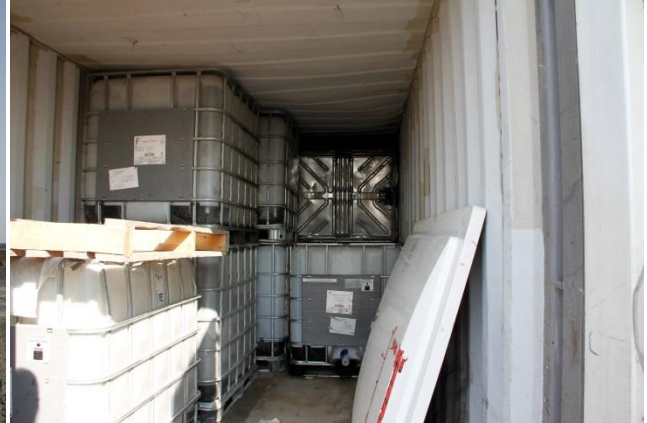
Photo 14: Contents of one of the environmental seacan

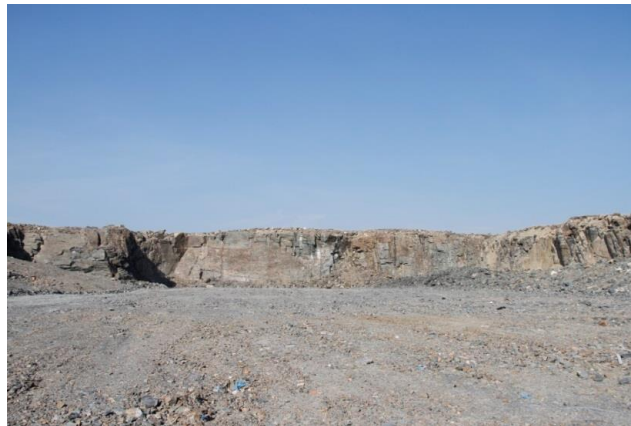
- g. Agnico Eagle indicated that remediation is ongoing at Quarry 22 following storage of contaminated hydrocarbon soil in previous years at this quarry site as the soil/gravel still tested positive for hydrocarbons (see [Photo 15](#)).

Photo 15: Quarry 22

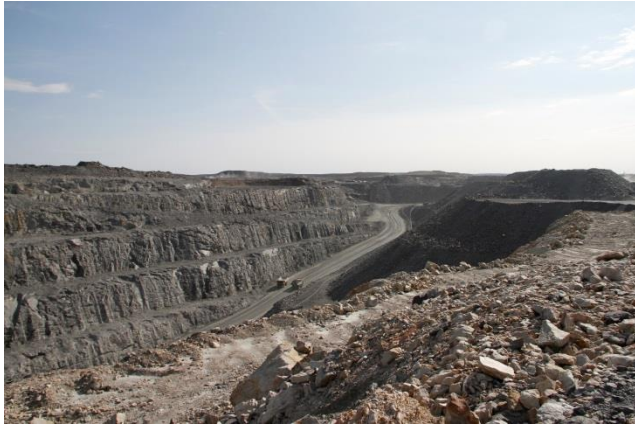
- h. While no blasting was conducted on the day of the site visit, active drilling was ongoing at Portage Pit (see [Photo 16](#) and [Photo 17](#)) and at Vault Pit. [Photo 18](#) through [Photo 21](#) shows the progress of Vault Pit. The Monitoring Officer was previously notified that mining at the Bay-Goose Pit had ended in early 2015 and the pit has been allowed to slowly fill in naturally with water (see [Photo 22](#) and [Photo 23](#)). During the site visit, the Monitoring Officer was informed that the pit will be filled with water during the fall.

Photo 16: View of Portage Pit

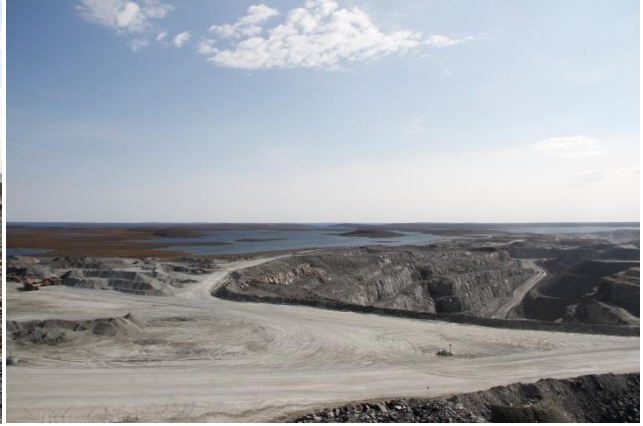
Photo 17: Portage Pit from viewpoint

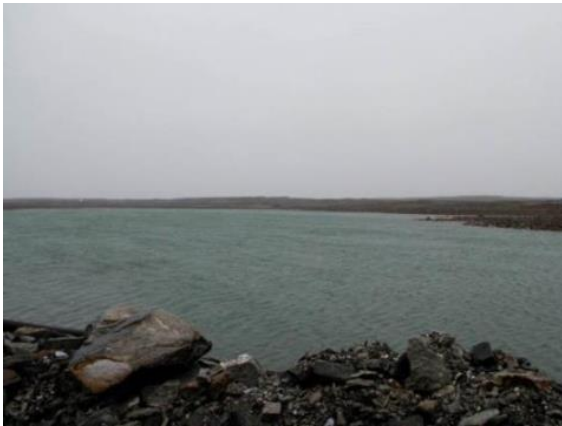
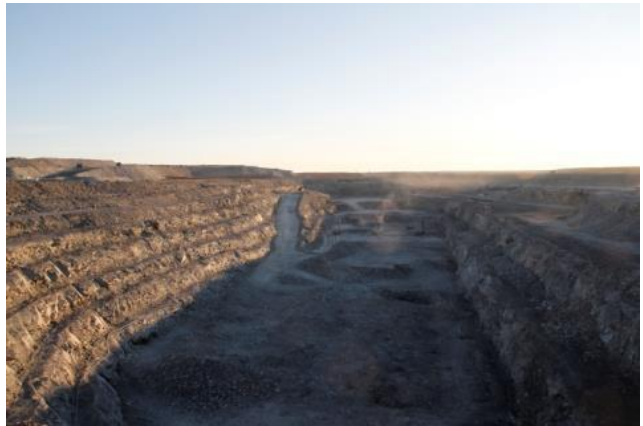
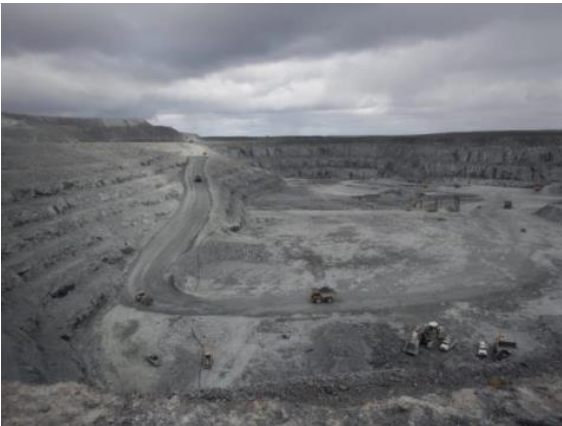
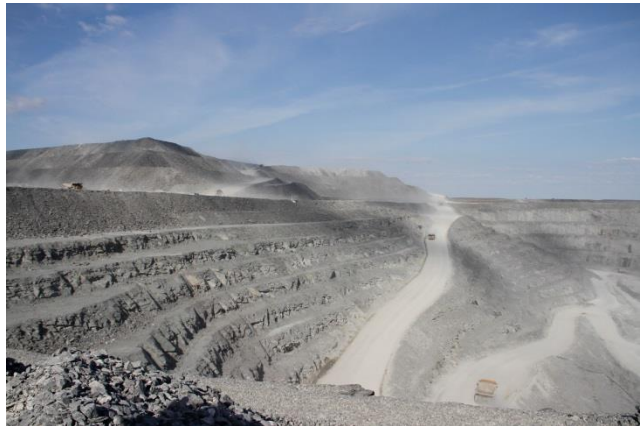
Photo 18: Vault Lake in 2013

Photo 19: Vault Pit in 2015

Photo 20: Vault Pit in 2016

Photo 21: Vault Pit in 2017

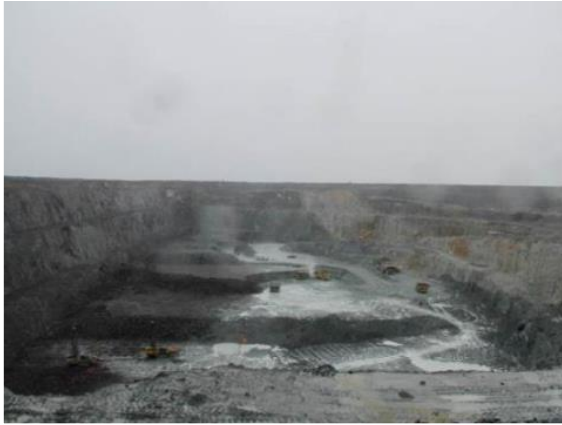
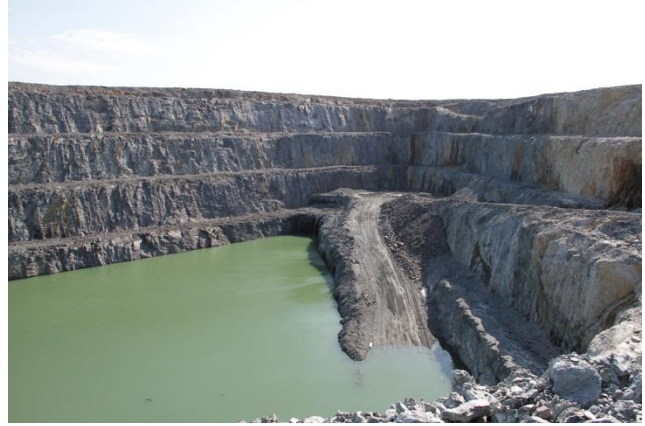
Photo 22: Mining of the Bay-Goose Pit in 2013

Photo 23: Bay-Goose Pit in 2017

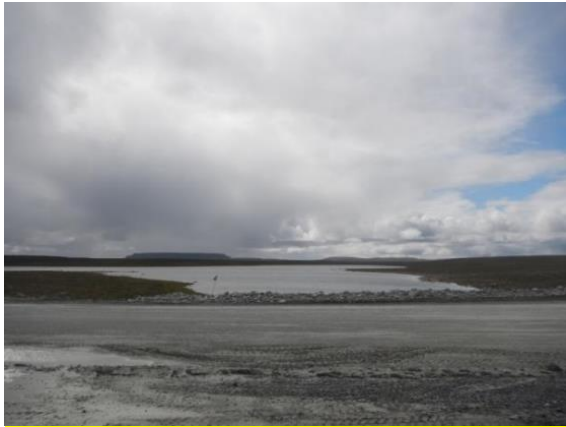
- i. The Monitoring Officer also observed that development has commenced at the recently approved areas for Phaser and BB Phaser pits that constitute part of the Vault Pit Expansion project. Phaser Lake was dewatered in late 2016 and during that site visit, it was observed that the overburden was removed (see [Photo 24](#) through [Photo 26](#)).

Photo 24: Area of proposed development of Phaser and BB Phaser pits in 2016

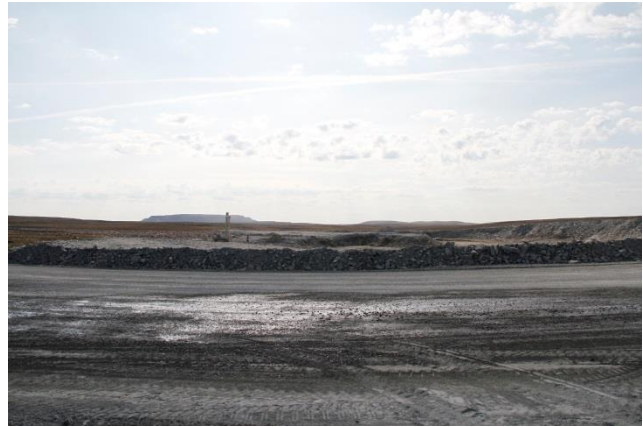
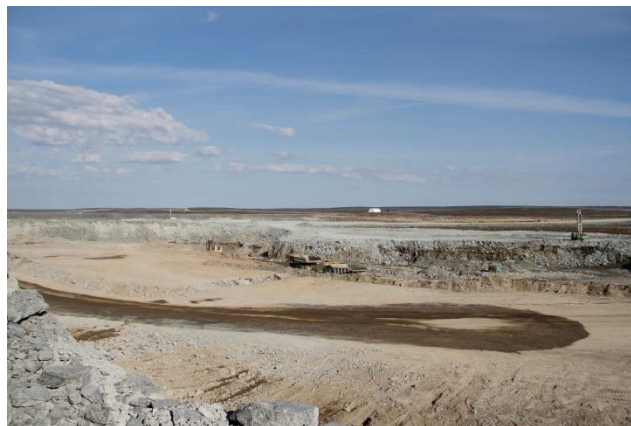
Photo 25: Phaser and BB Phaser in 2017 – south of Vault Pit

Photo 26: Phaser and BB Phaser in 2017 – looking east

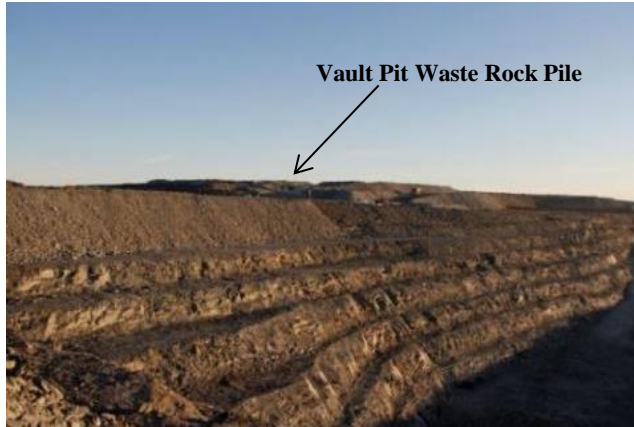
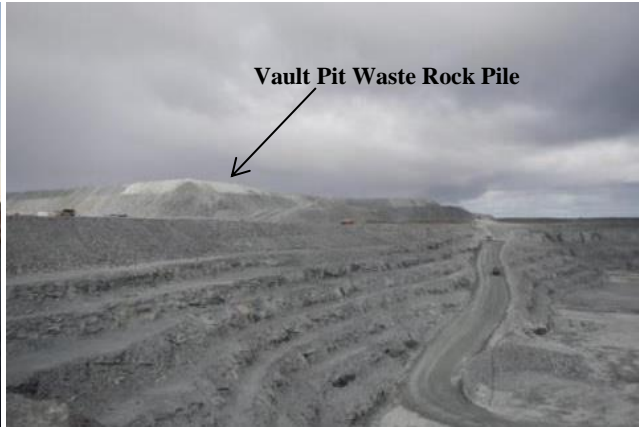
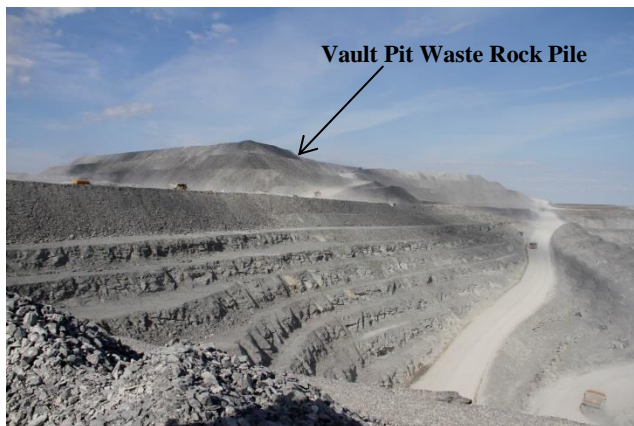
- j. Waste rock from Vault Pit was stored in the Vault waste rock storage facility (see [Photo 27](#) through [Photo 30](#)). Agnico Eagle staff stated that waste rock from the Vault Pit has been tested to be non-potentially acid forming (NPAG rock). The NPAG rock is stored in the Vault marginal stockpile for re-use on-site.

Photo 27: Vault Pit waste rock storage facility in 2015

Photo 28: Vault Pit waste rock storage facility in 2016

Photo 29: Vault Pit waste rock storage facility in 2017

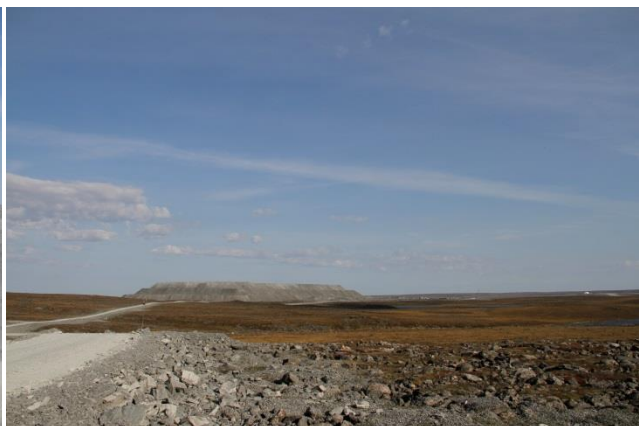
Photo 30: Vault Pit waste rock storage facility in 2017 from Amaruq single-lane road

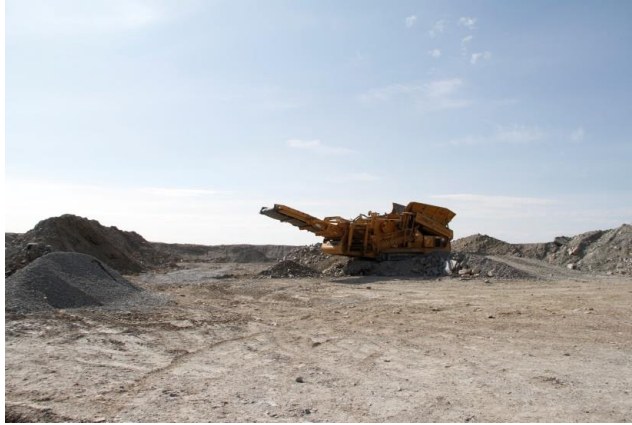
- k. Agnico Eagle started a new landfarm site to treat all contaminated hydrocarbon soil on site, while the old landfarm, which is located next to the South Cell, will be flooded as the tailings deposition continues. Mr. Allard noted that the remediation program, which commenced in 2013 was still ongoing and appears to be successful. The remediation program at the Meadowbank site uses on-site nutrients (sewage sludge) to initiate biodegradation of all contaminated hydrocarbon soil on site (see [Photo 31](#)).

Photo 31: New contaminated soil remediation site (landfarm)

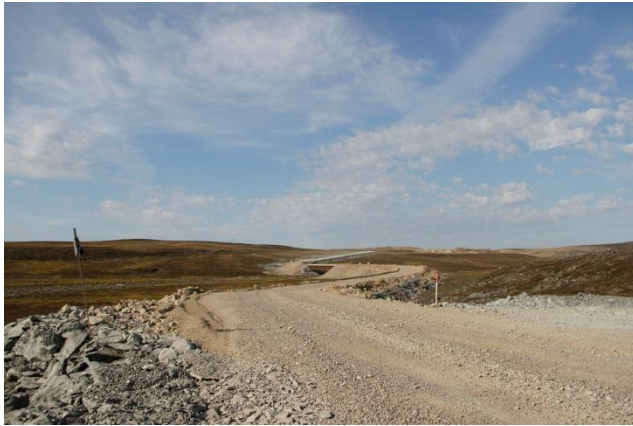
Photo 32: Bridge #2 along the Amaruq single-lane road

1. The NIRB staff were driven along the newly constructed Amaruq road to bridge #2. Mr. Allard indicated that the road was complete but that the final layer of gravel needed to be placed (see [Photo 32](#) and [Photo 33](#)).

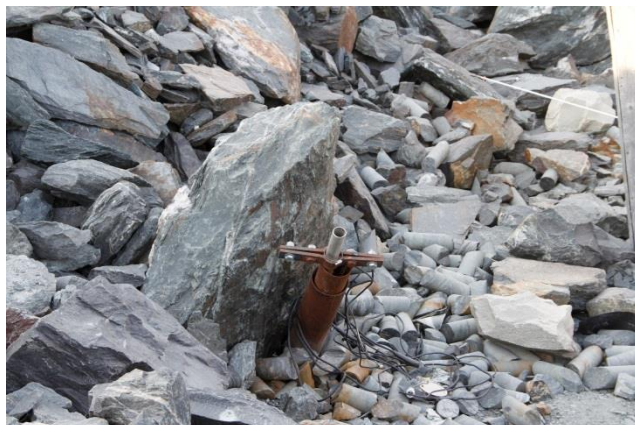
attempting a different technique to ensure the groundwater wells stay open and do not freeze or are damaged. This technique involves the installment of a seacan on top of the groundwater wells and ensuring a heat trace could be installed down the well. A consultant from SNC Lavalin has audited the revised groundwater monitoring protocols and at the time of the site visit was to come again in September to conduct a final audit.

Photo 34: Groundwater monitoring well MW-08-03

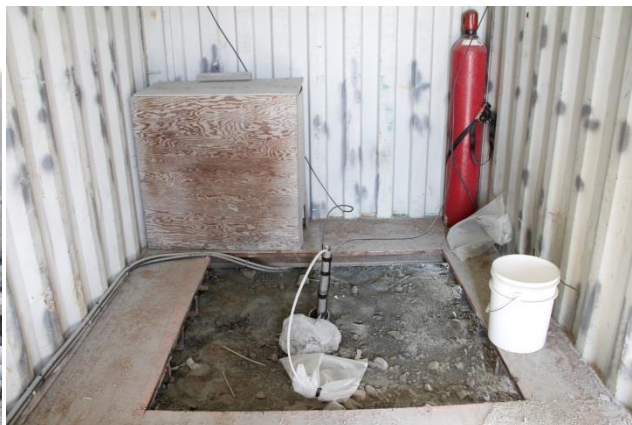
Photo 35: Groundwater monitoring well MW-16-01

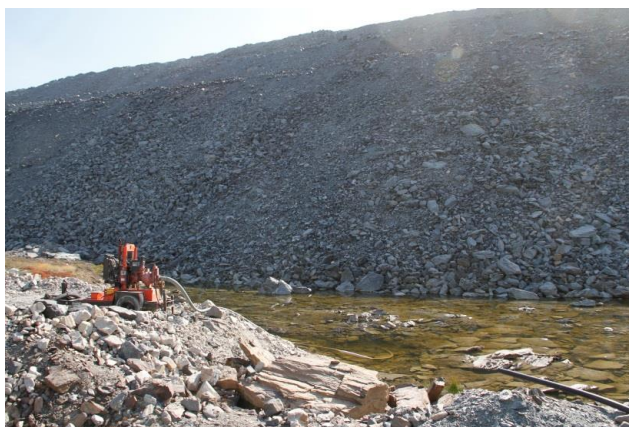
In 2013, Agnico Eagle noted seepage from the Portage waste rock storage facility with potentially acid generating rock (which has a high sulphur content, heavy metals, and other contaminants) at a location near the south shore of a fish bearing lake (referred to as North Pole 2 or NP-2 lake) (see [Photo 36](#)). Agnico Eagle staff stated monitoring of the seepage is ongoing during the open water season and that accumulated water is pumped directly back to the North Cell tailings storage facility. Mr. Allard noted that no seepage have been observed since the North Cell was raised during the summer. This may potentially have occurred as the tailings storage facility was built on an old riverbed system.

Photo 36: Seepage from the Portage waste rock storage facility

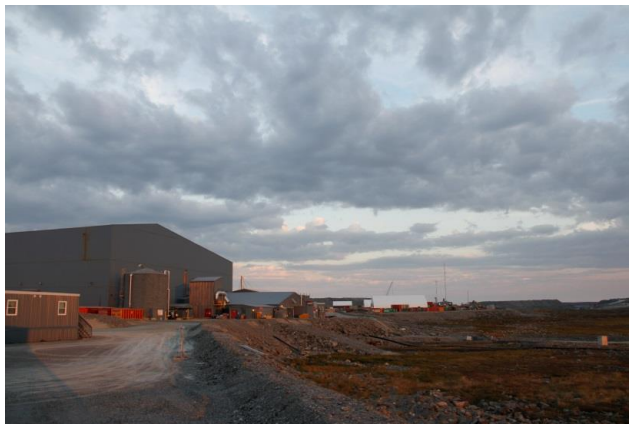
Photo 37: Assay Laboratory

In 2013, Agnico Eagle discovered water seeping through the road in front of the Assay laboratory towards Third Portage Lake where cyanide destruction in tailings occurred (see [Photo 37](#)). Following investigation, Agnico Eagle determined that the seepage was coming from the

process plant, specifically leakage from containment structures through test results of the seepage water that indicated levels of cyanide, iron, and copper.

In April 2014, a trench was constructed to intercept any potential water seepage during freshet and pumped back to the mill (see [Photo 38](#)). Mr. Allard stated during the site visit that following repairs and sealing of the containment structures within the mill, seepage had diminished, the volumes of water pumped had decreased and no levels of cyanide, iron, and copper were detected within the tested water. However, to be safe, water from the trench continues to be pumped back for use at the mill.

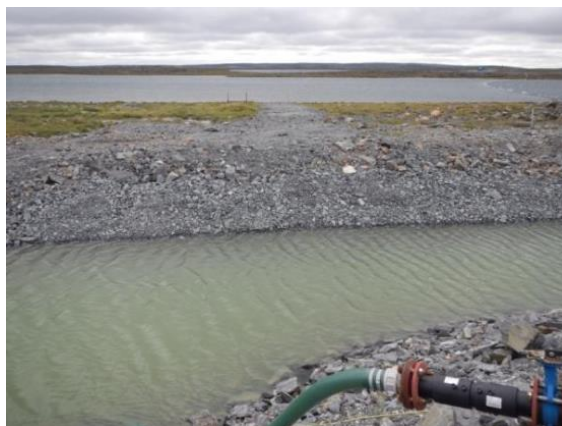
Photo 38: Trench below Assay Laboratory to prevent water from entering lake
