Appendix J3

2017 Regulators Inspection Reports

WATER LICENCE INSPECTION FORM

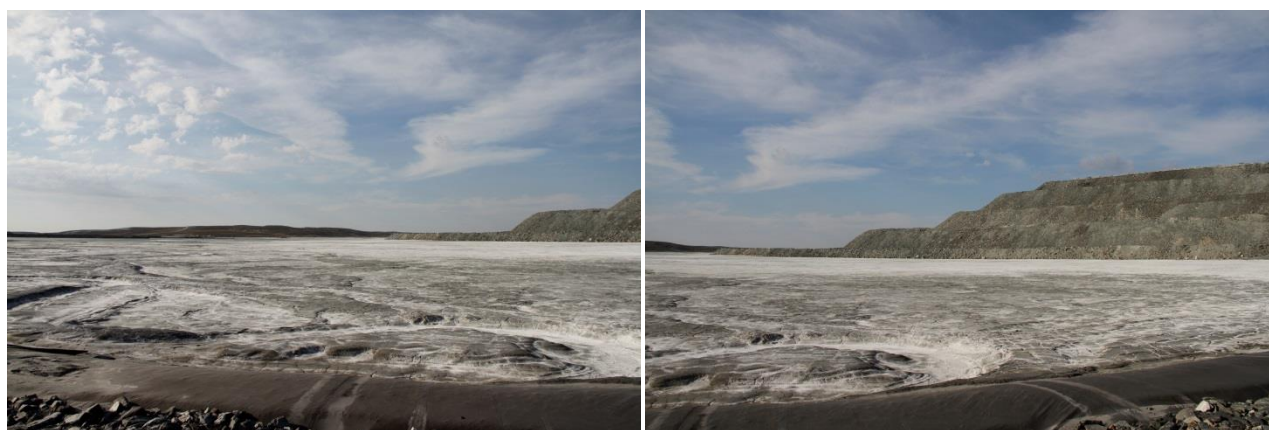
When viewing the North Cell of the tailings storage facility, the Monitoring Officer observed the thermistors, installed in 2012 to measure freezeback, and did not observe any apparent rips in the exposed lining of Saddle Dams 1 and 2 or at the Stormwater Dike (see [Photo 40](#)).

Photo 40: Tailings Storage Facility (North Cell)

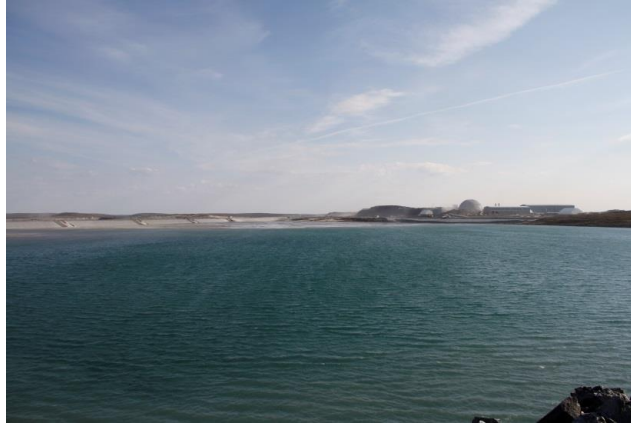
Photo 41: Tailings Storage Facility (South Cell)

Tailings have been deposited into the South Cell of the tailings facility (see [Photo 41](#)) since 2016. The construction of the different phases of the Central Dike and Saddle Dams were ongoing during the site visit (see [Photo 42](#)).

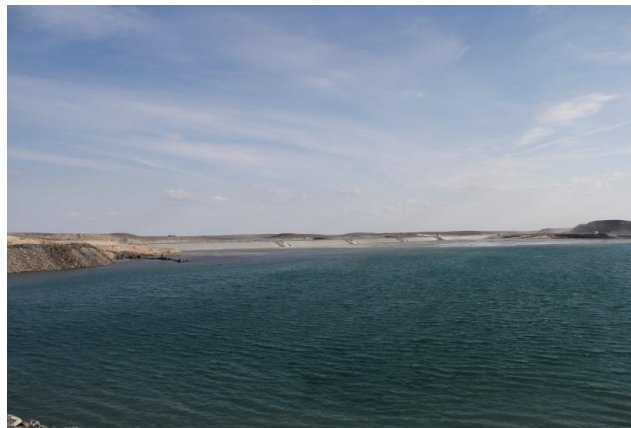
Photo 42: Raising the height of Saddle Dam

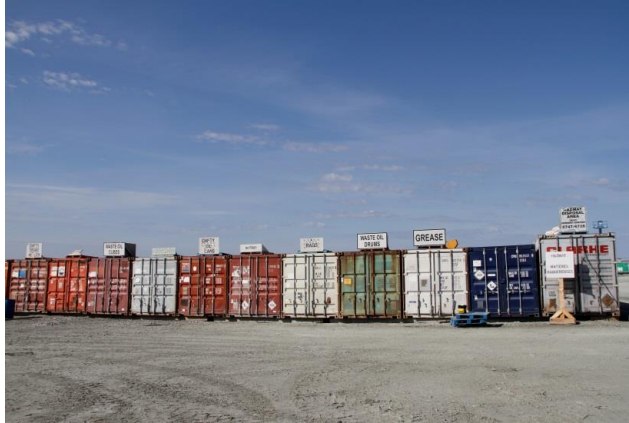
As per previous NIRB site visits, the Monitoring Officer noted during the 2017 site visit that Agnico Eagle continues to segregate and store all domestic, hazardous, and combustible wastes in marked seacans prior to these materials being incinerated or shipped to the appropriate and approved off-site disposal facilities (see [Photo 43](#)).

Photo 43: Seacans used for waste segregation and storage area

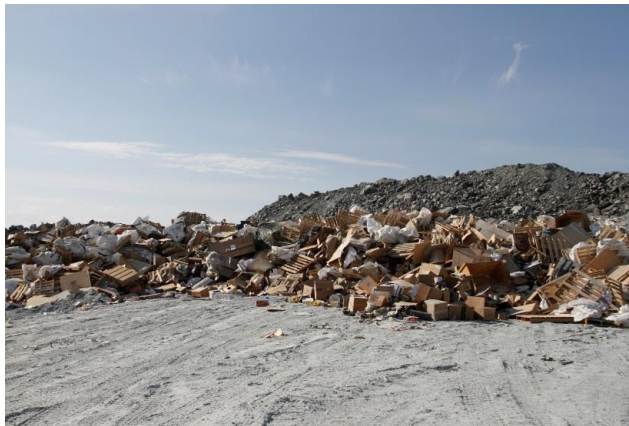
Photo 44: Landfill at Meadowbank mine site in 2016

In 2014, Agnico Eagle started a pallet recycling program where pallets not needed at site are transported in seacans to the high school in Baker Lake for use as building materials in the woodshop. In 2017, Agnico Eagle noted that it continued to supply the high school with pallets for their woodshop program. Any additional wood that was not used by the school was then donated to community members for personal use (see [Photo 44](#) of the Meadowbank landfill).

Agnico Eagle stated that the landfill is frequently inspected by employees to ward off any wildlife that may be present.

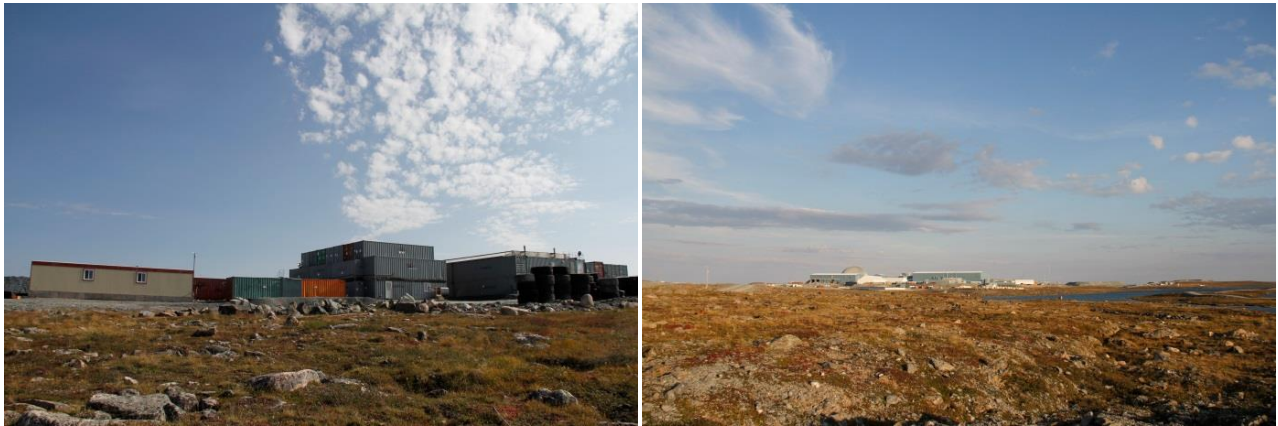
During the 2017 visit to the Meadowbank site, the Monitoring Officer observed that all areas were kept in a clean state, with no obvious spills. There was no evidence of wind-blown material viewed around the Meadowbank site and at the ancillary facilities in Baker Lake (see [Photo 46](#)).

Photo 46: Meadowbank Mine Site

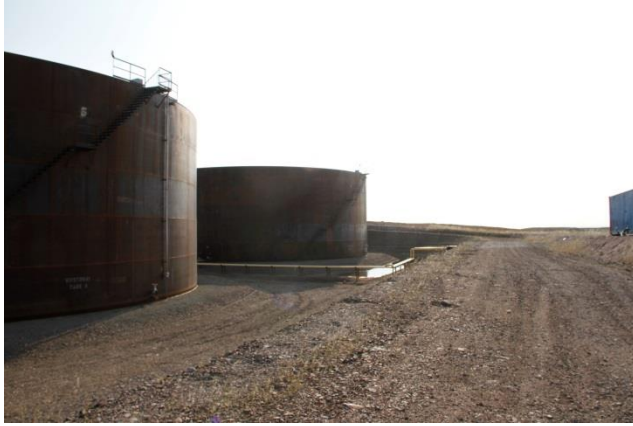
During the 2017 site visit, the Monitoring Officer noted that fuel and hazardous materials associated with Agnico Eagle’s Meadowbank project appeared to be stored in a safe and environmentally protective manner (see [Photo 47](#) to [Photo 49](#)). Any observed water in the containment berms had no visible sheen on the water or discernable hydrocarbon odours at either the Baker Lake or the Meadowbank site fuel facilities (see [Photo 48](#)).

Photo 47: Baker Lake Fuel Tank Farm Facility

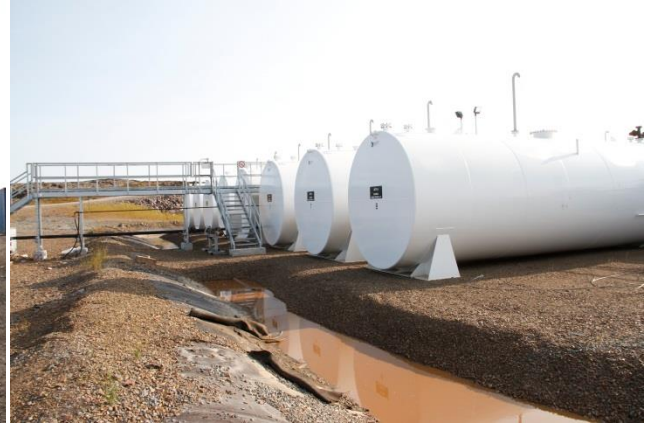
Photo 48: Baker Lake Aviation Fuel Tank Farm

Mr. Allard noted that a sheen has been observed at the aviation fuel tanks and to be on the safe side all water that collects within the bermed area is pumped to tailings facility. Overflow occurred during the summer when one (1) of the aviation fuel tanks was overfilled and the fuel expanded due to heat and therefore approximately 50 litres leaked from above of the tank (see [Photo 48](#)).

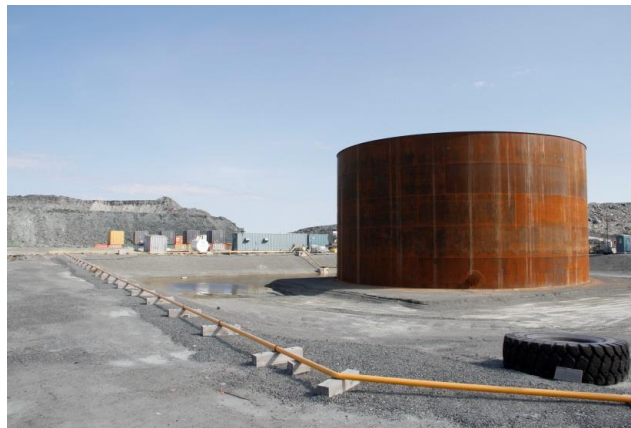
Photo 49: Meadowbank Fuel Tank Farm Facility

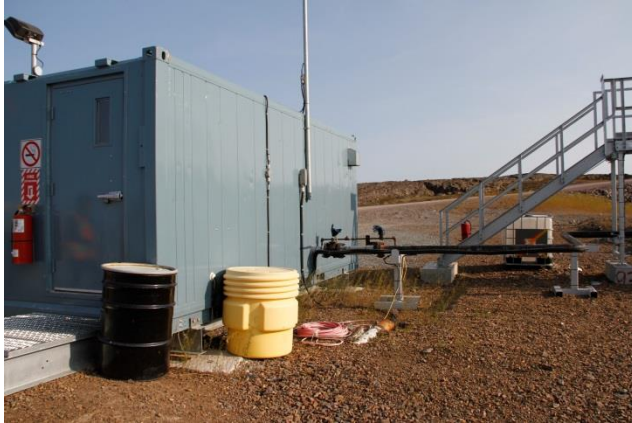
During the 2014 site visit, the Monitoring Officer noted that spill pads or drip pans were not in use during refuelling of vehicles by the Meadowbank site employees. During the 2015 site visit, Mr. Pratt stated that drip pans are being used during refuelling, and spill containers were also located nearby any refuelling locations. These drip pans and spill containers were observed to be in place near the refuelling locations at the Baker Lake facility (see [Photo 50](#)). In 2017, additional safety procedures were added by installing vent overflows, which are used to ensure that any overfilled fuel would overflow into the overflow tanks (see [Photo 51](#)).

Photo 50: Refuelling station at the Baker Lake Fuel Tank Farm with Spill Containers in place

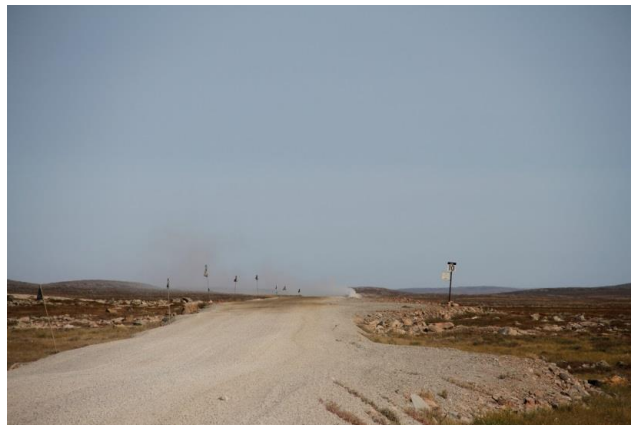
Road signs required as per Condition 32(c) were posted in both English and Inuktitut at the gatehouse (see [Photo 54](#)), at each major bridge crossing on the side of the environmental emergency sea-cans, and at 10 kilometre intervals along the AWAR.

Photo 54: Signs posted along the AWAR

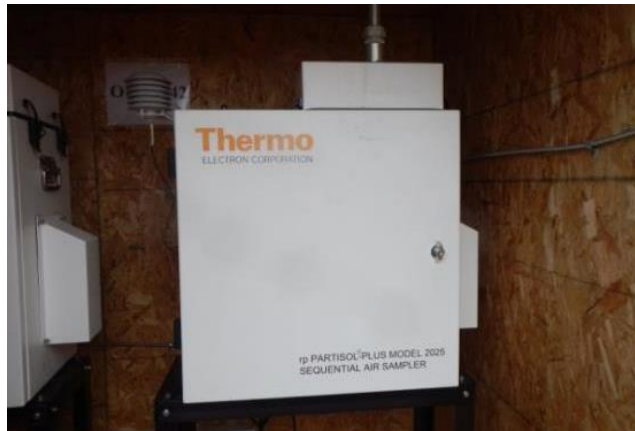
Photo 55: Air and partisol monitoring station near the emulsion station

The NIRB staff viewed the air and partisol monitoring stations at the northern corner of South Camp Island (see [Photo 55](#)). Agnico Eagle staff stated that both dustfall and partisol monitoring occurs year round (see [Photo 56](#)).

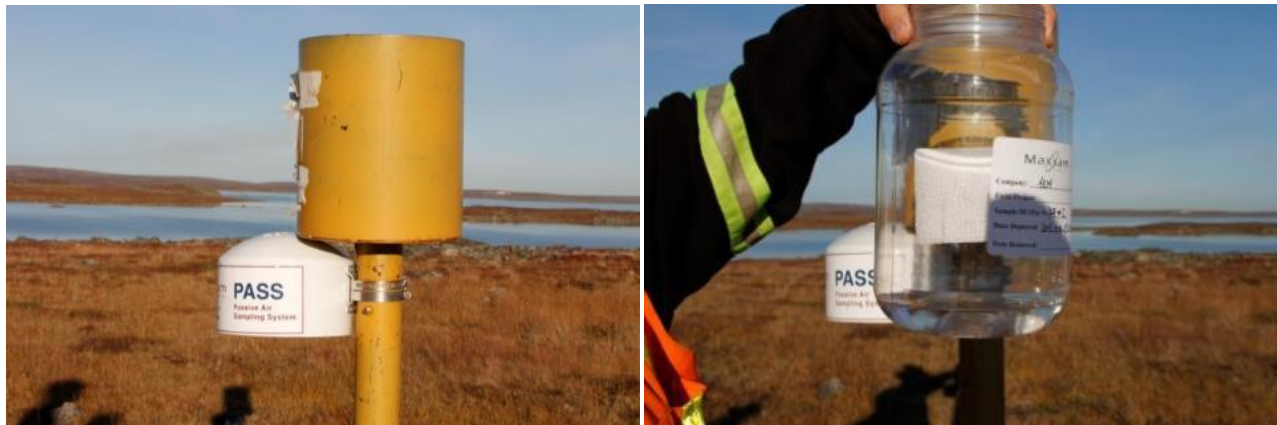
Photo 56: Dustfall sampling station at the mine site (2015)

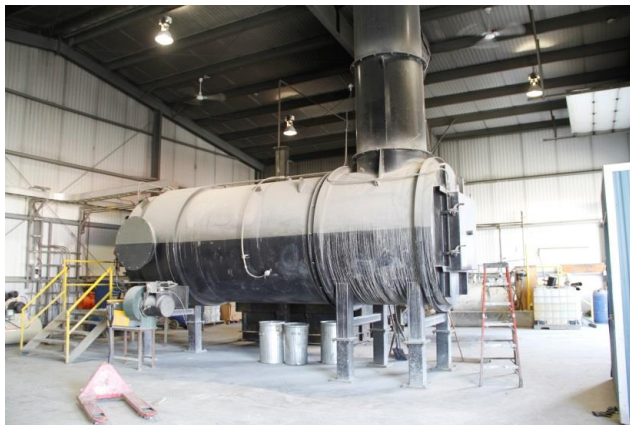
The Meadowbank site dual chamber forced air incinerator remains in service for the combustion of all non-hazardous, combustible materials at the site (see [Photo 57](#)). During the site visit, Agnico Eagle noted ongoing education is required to ensure that wastes such as metal cans are not incinerated. As noted under Condition 25, ongoing education is required with site staff to ensure wastes are segregated appropriately.

Photo 57: Incinerator at Meadowbank mine

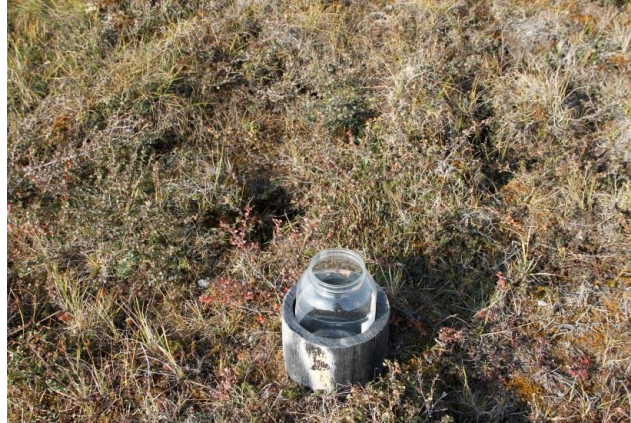
As in previous years, Agnico Eagle staff noted that dust sampling stations were placed along the AWAR at various distances from both the east and west sides the road in two (2) duplicate transects (see [Photo 58](#)) to monitor dust deposition distance from the road. Dust canisters are placed 25, 50, 100, 150, 300, and 1000 metres away from the AWAR.

Photo 58: Dust Sampling Station

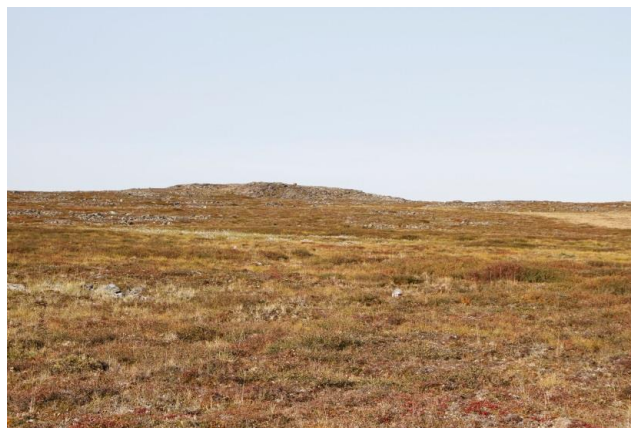
Mr. Allard also noted that Agnico Eagle continues to apply TETRA flakes (calcium chloride) along three (3) critical areas on a two (2) km section of the AWAR as agreed upon with the local Hunters and Trappers Organization (see [Photo 59](#)). Along each of the three (3) sites, Agnico Eagle continues to conduct additional dust sampling.

Photo 59: Dust canister located on the tundra

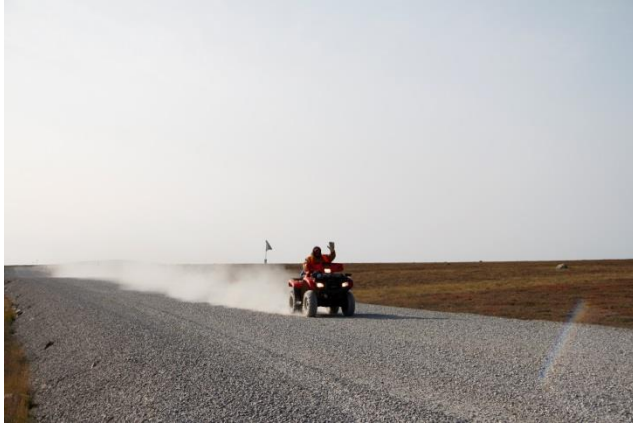
Agnico Eagle staff also indicated that calcium chloride flakes are applied to the areas around the Meadowbank camp site and from the Baker Lake dock facility to the gatehouse. In addition, water is used as the dust suppressant on the mine access roads around the Meadowbank site and within the pits. However, during the site visit, NIRB staff noted that the use of water as a dust suppressant within the pits and along the haul roads did not appear to be effective (see [Photo 60](#) and [Photo 62](#)).

Photo 60: Dust created by vehicles along the AWAR

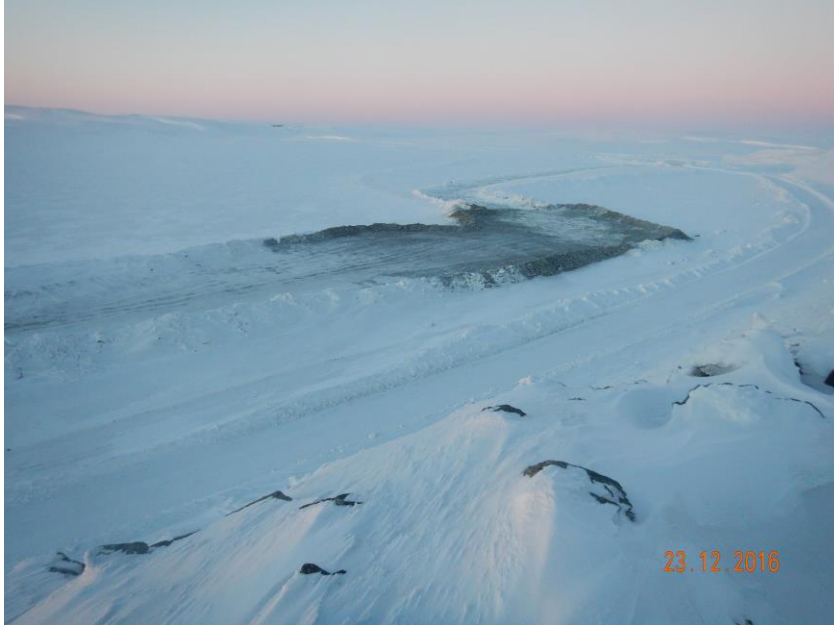
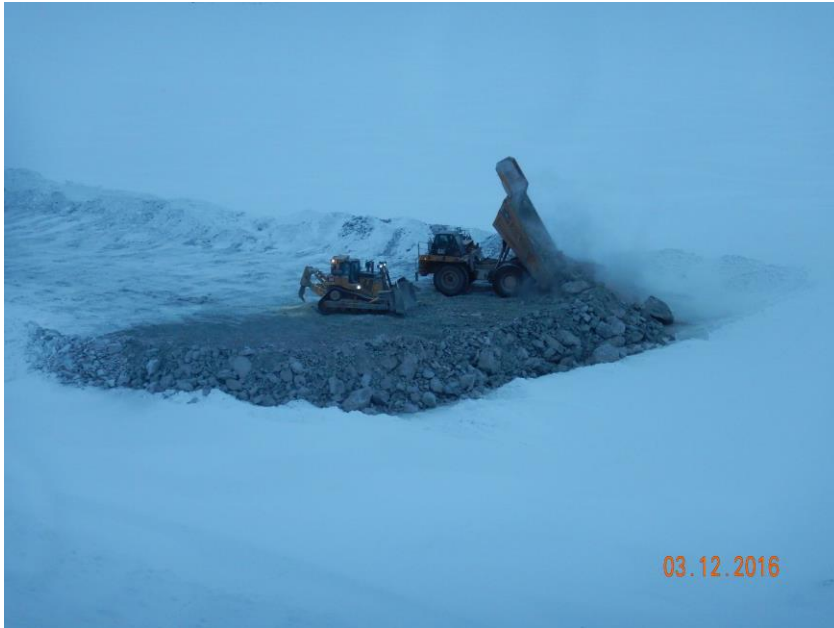
Photos 1: 2016 TSF Cover Construction

closure is planned to continue on the North Cell in winter 2017. As the tailings deposition is completed in the North Cell, additional areas of the tailings can be covered with NPAG material.

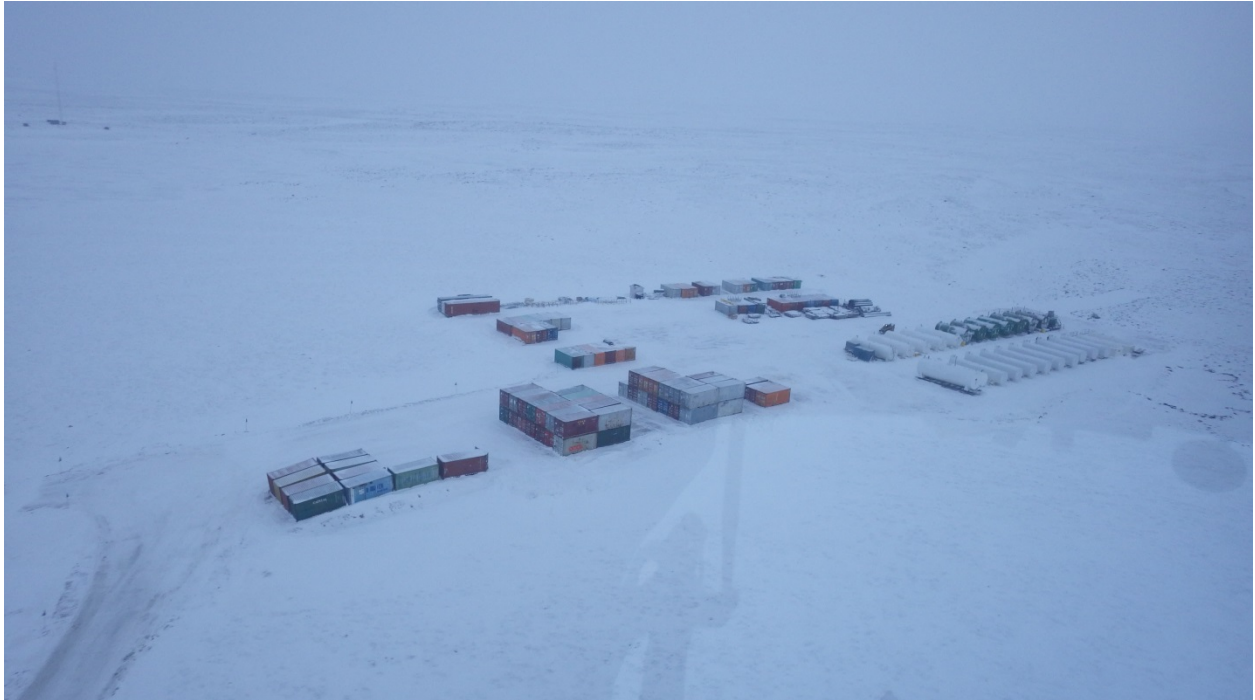
Agnico Eagle Mines Limited's Exploration division has 2 fuel storage locations related to the NIRB decision #11EN010. One is located at the Meadowbank exploration camp and contains two 75,000 liter double walled tanks that are used to store diesel and jet fuel. The main fuel storage is located at the Amaruq exploration camp and has a capacity of 1,800,000 liters of diesel and jet fuel.

Amaruq fuel farm and sea cans storage, October 2016

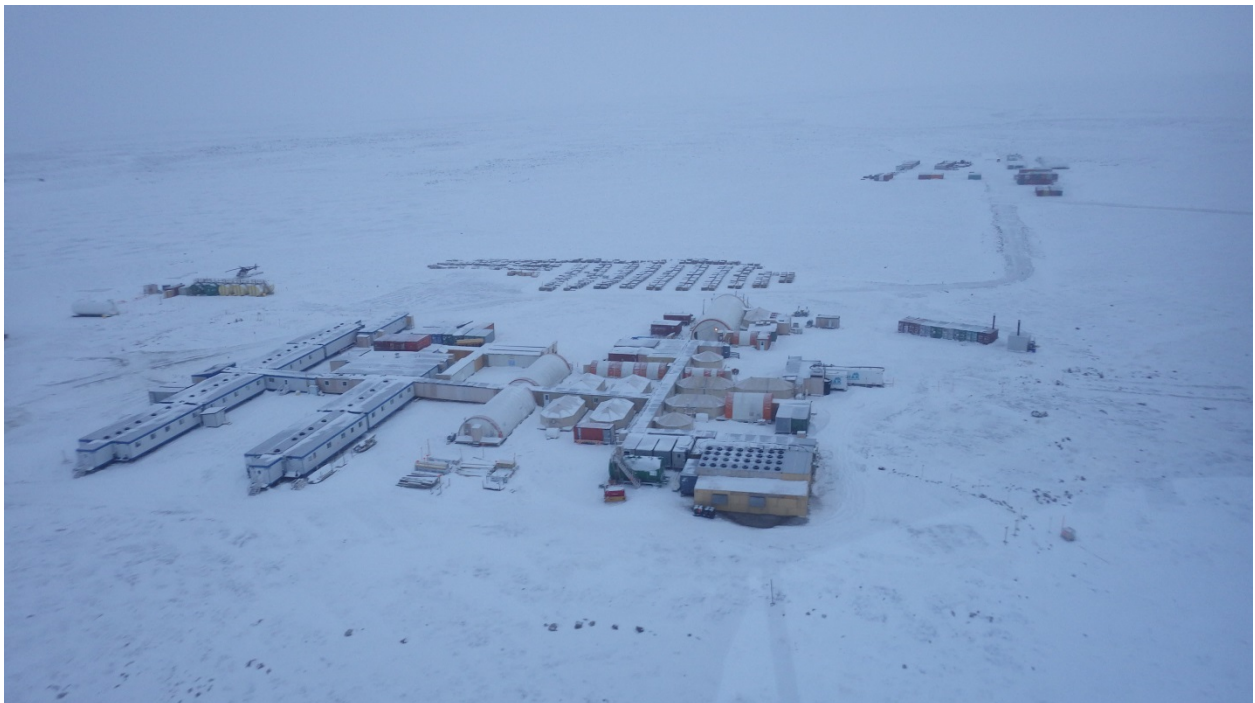
Amaruq camp, October 2016
