Appendix E: 2023 Windy Camp Reclamation Summary

Windy Camp Reclamation – 2023 Update

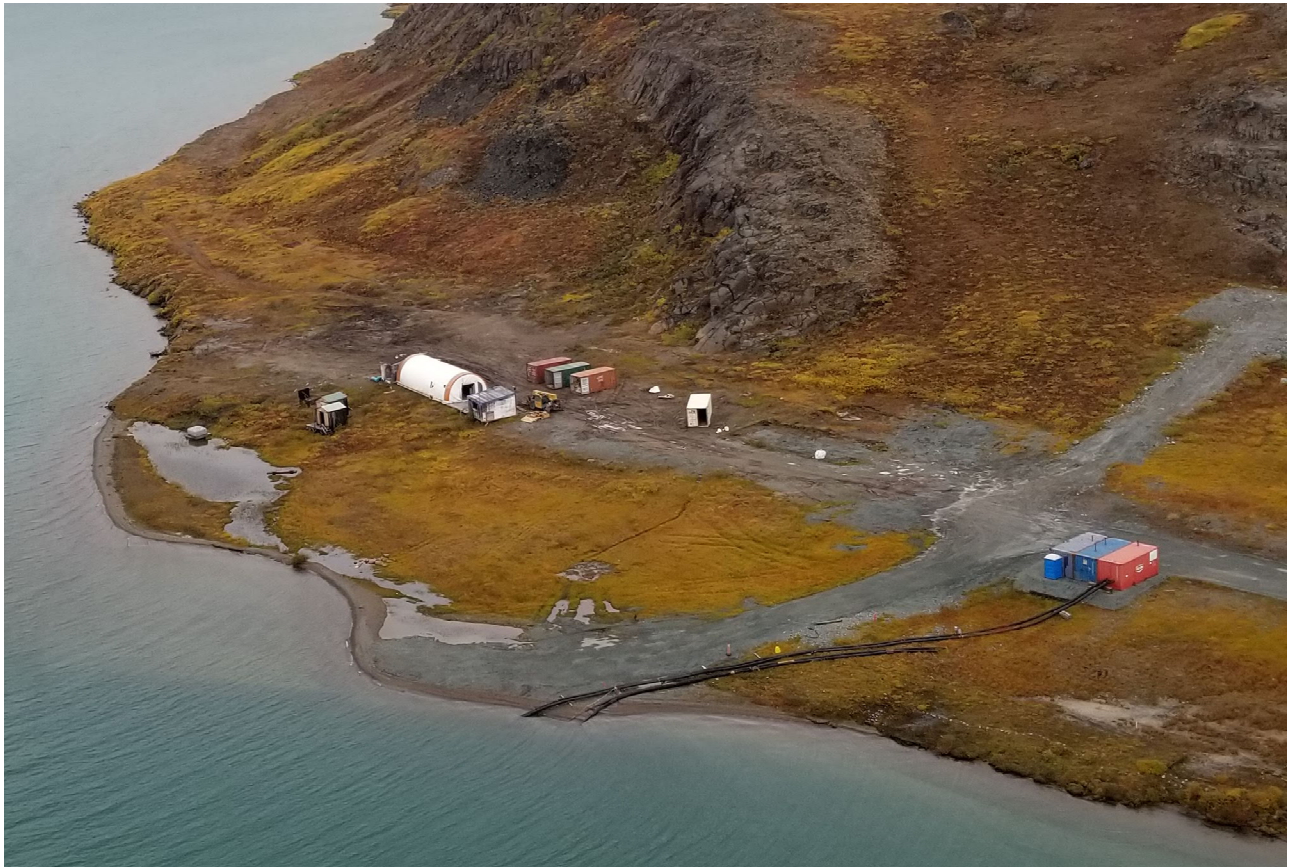
Figure 1 Windy Camp Site Prior to 2023 Reclamation

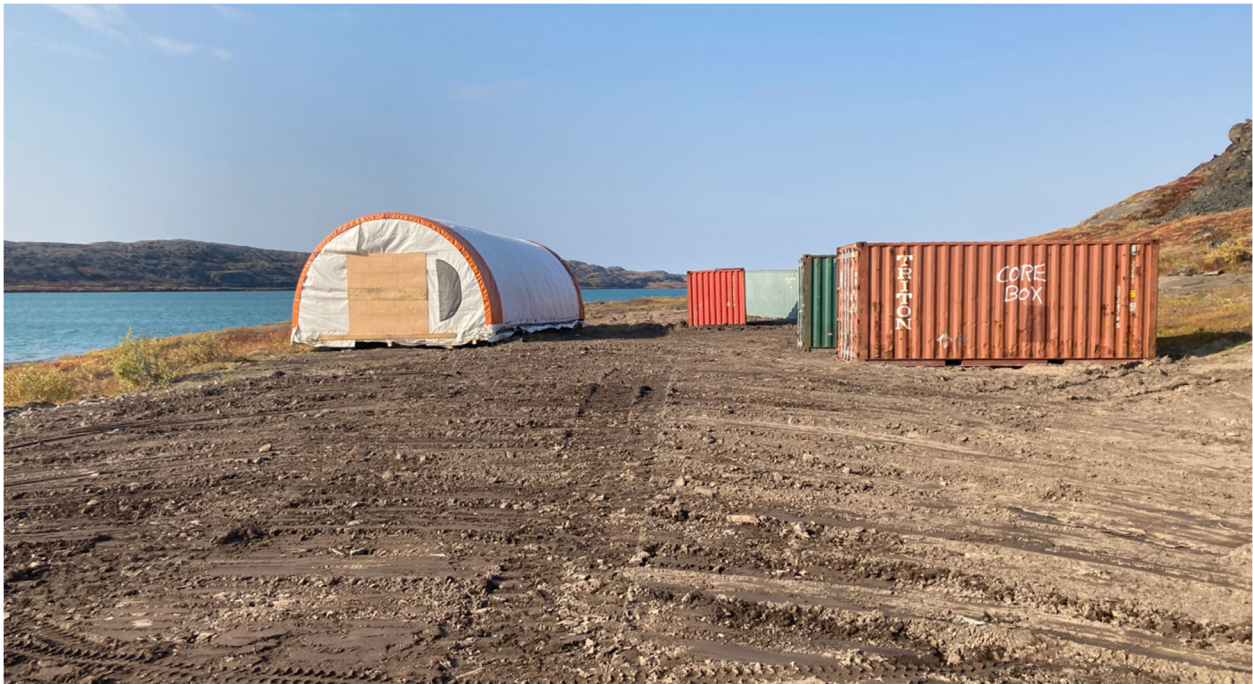
Figure 2 Windy Camp After Cleanup Showing Weatherheaven Tent and Sea Containers

In total, five sea containers were filled with debris from clean-up of the remaining infrastructure at the camp, for a total weight of 35.6 tonnes. The sea containers were then transported to the Roberts Bay laydown area. The Weatherhaven shell was partially removed, and the structure remains to be dismantled which is scheduled for the summer of 2024.

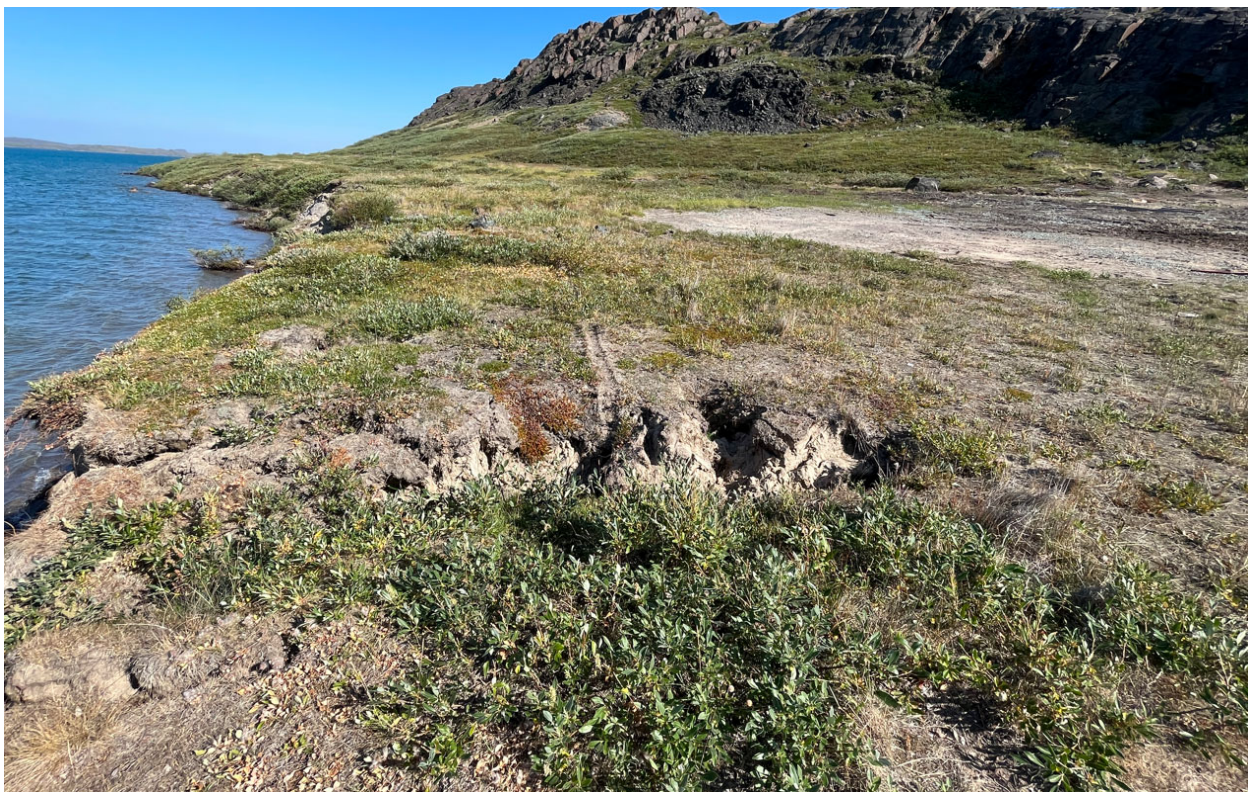
Figure 3 Erosion Gully South of Windy Camp

Affected areas of erosion gullies along the shore to the north and south of Windy Camp were filled in and erosion blankets were placed to prevent further damage to the shoreline.

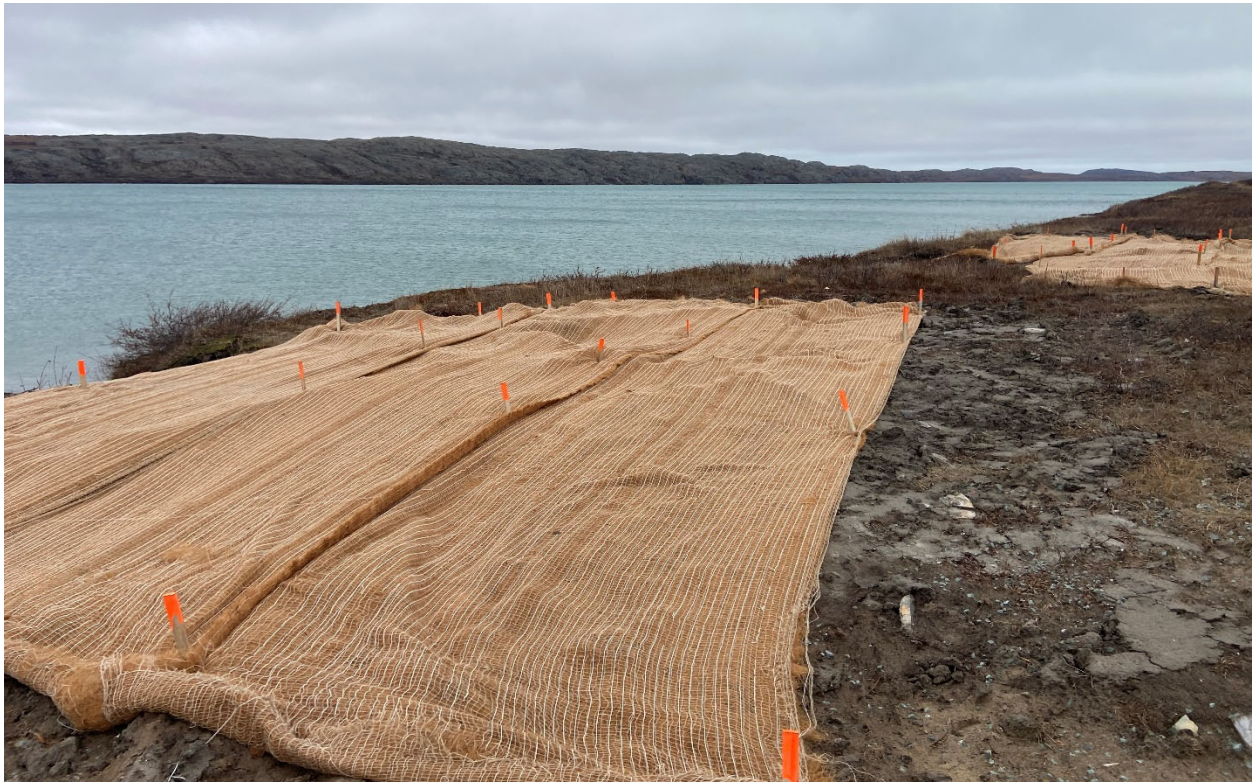
Figure 4 Erosion Blankets Along the Shoreline

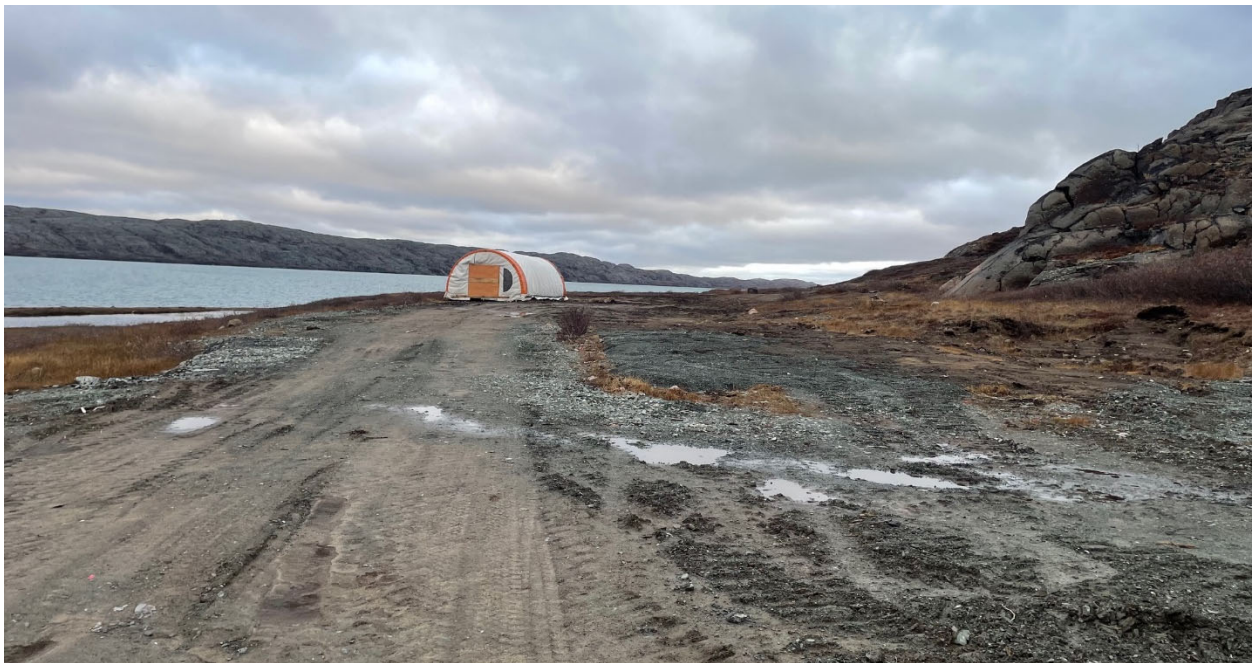
Figure 5 Windy Camp Site Current Status

Looking ahead, Agnico Eagle plans to update the site assessment to confirm soil conditions from previous activities at the camp. The site assessment will help indicate whether further rehabilitation is required (e.g., soil excavation) or if the reclamation activities are complete.
