**Habitat Compensation Monitoring Plan**

In Accordance with Fisheries Act Authorizations NU-03-0190, NU-03-0191.3,  
NU-03-0191.4, NU-08-0013, and NU-14-1046

Prepared by:  
Agnico-Eagle Mines Limited – Meadowbank Division

Version 4  
February 2017

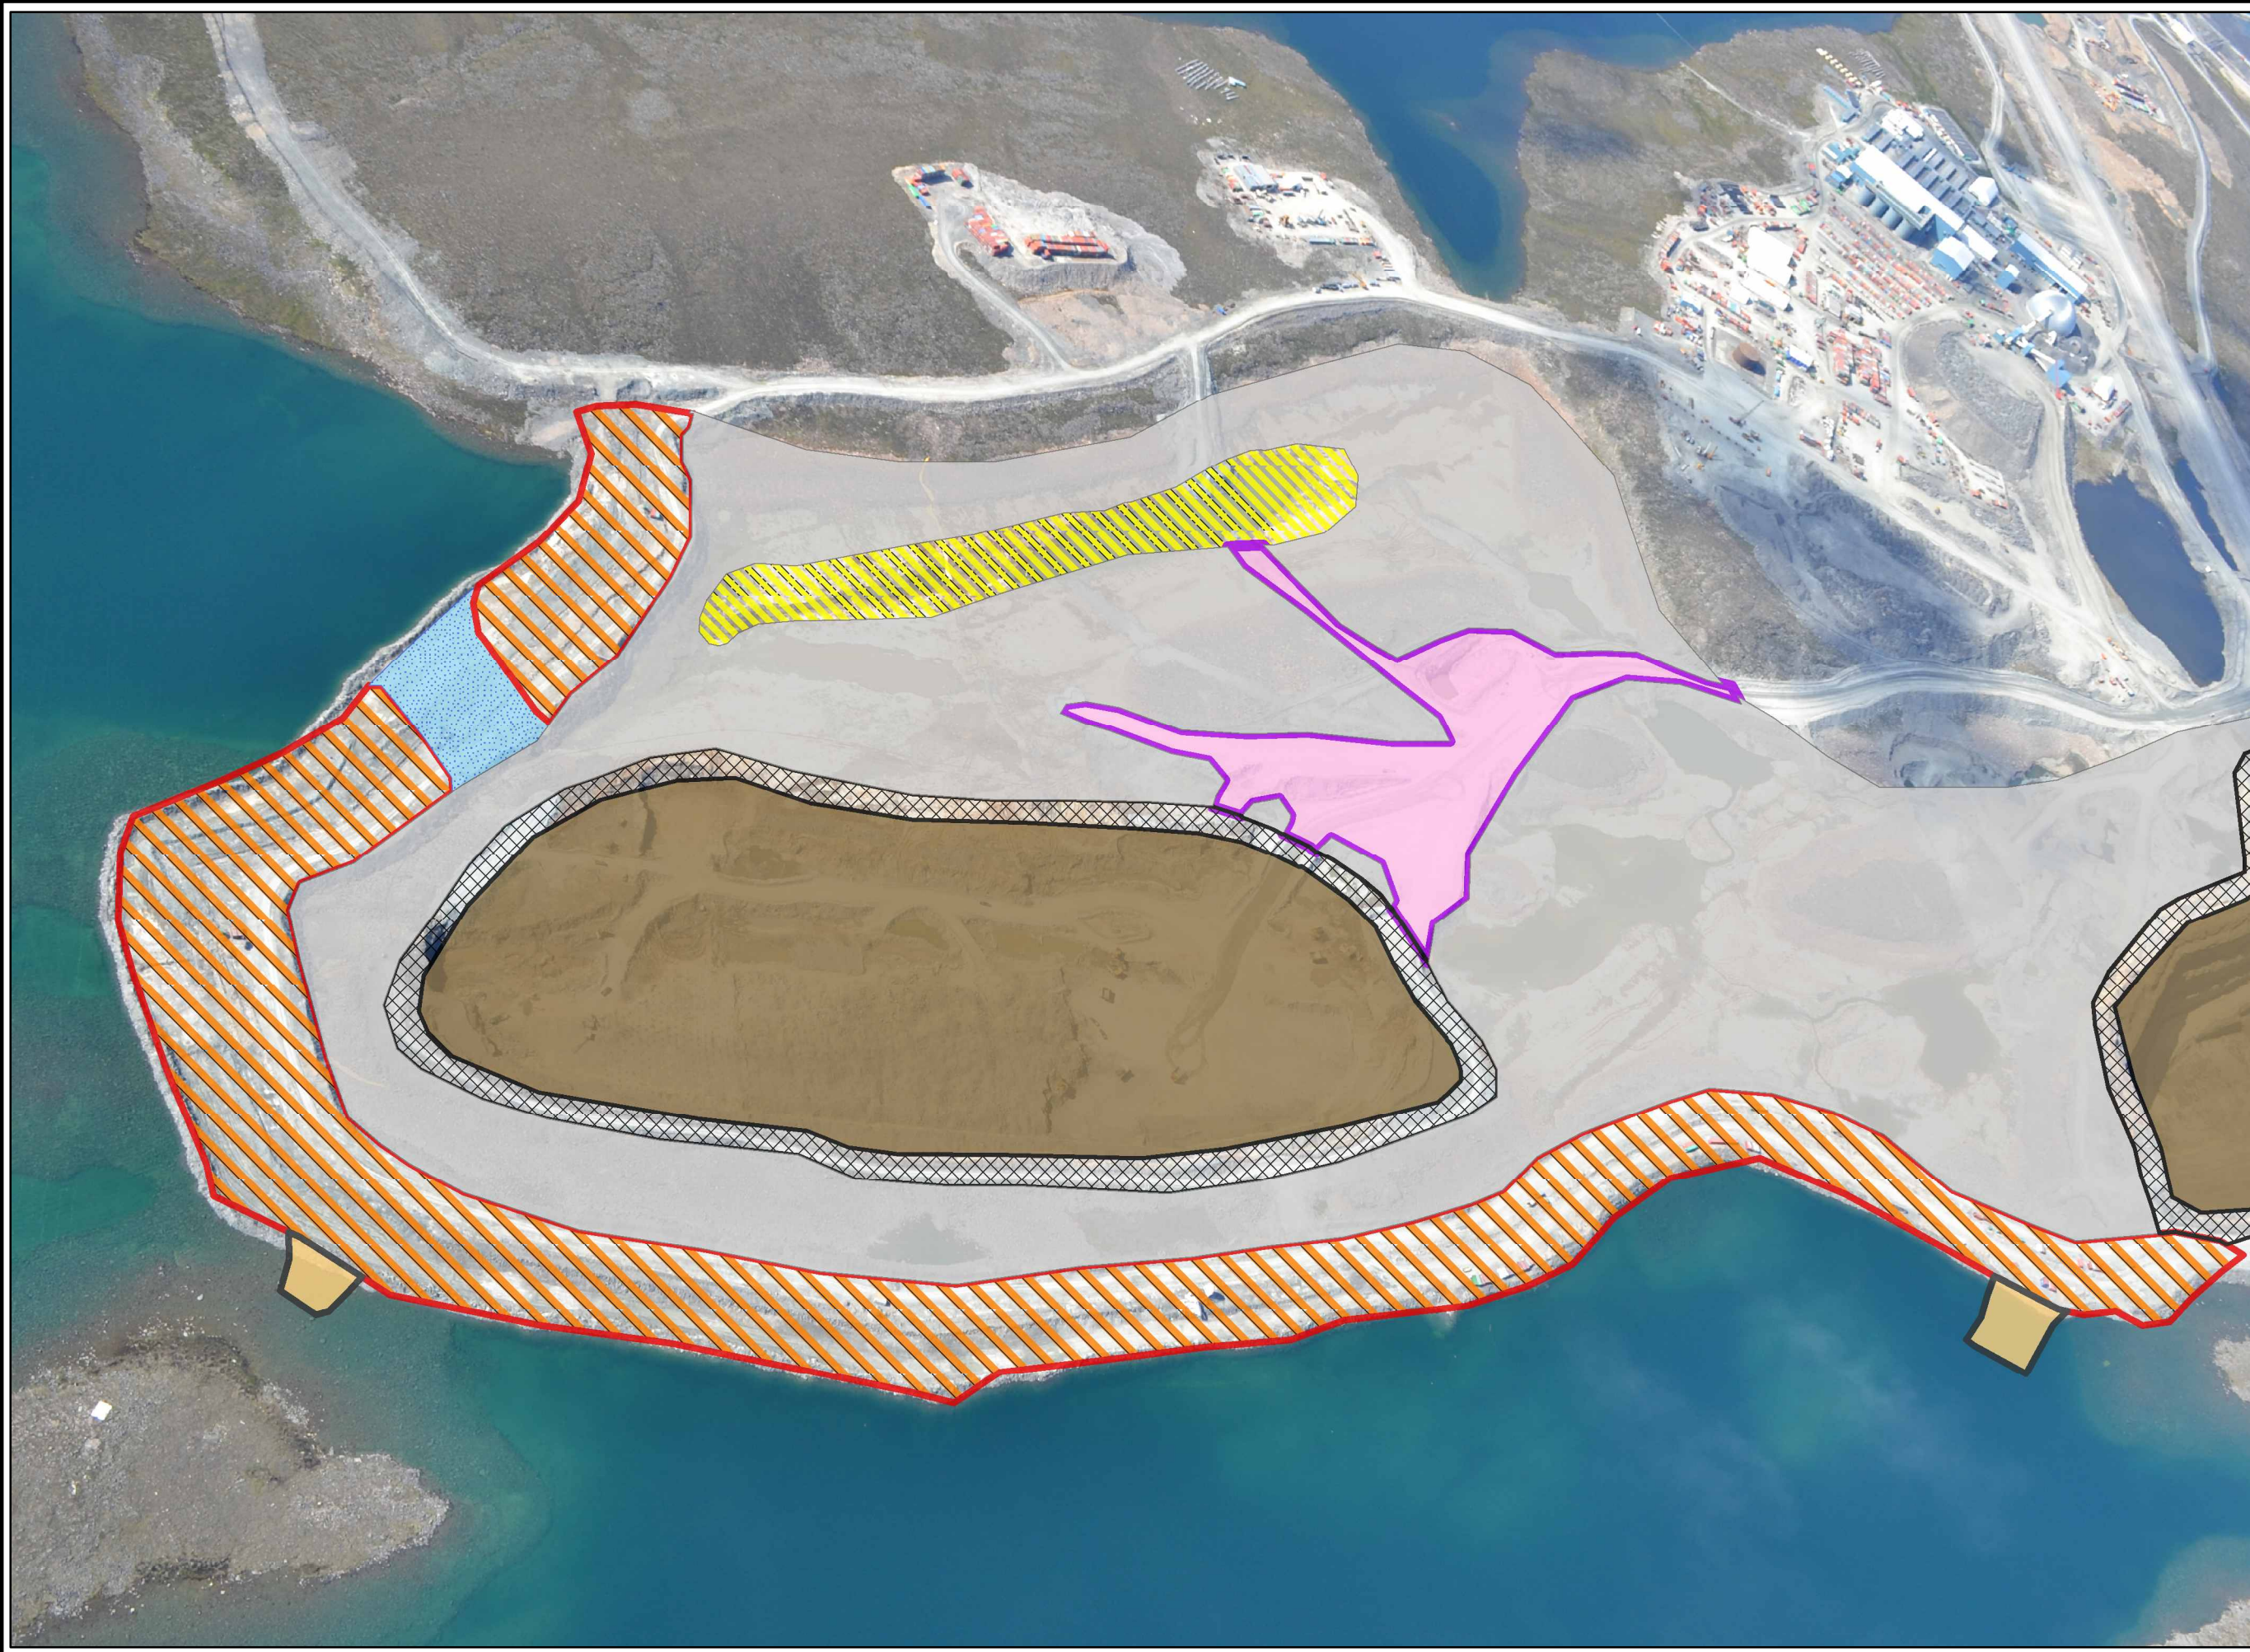
FIGURE:  
**1**

### Bay Goose Basin Conceptual Drawings

### POST-CLOSURE FEATURES

Prior to re-flooding, a number of habitat improvement measures will be implemented to increase the productive capacity of this area (Figure 1). Construction of a boulder garden feature along the west side of the soft-sediment Bay-Goose Basin will increase habitat suitability in this area. This feature will consist of at least 2.97 ha of heterogeneous, coarse substrate habitat in the <4 m depth zone, just west of the Goose Island Pit. Further, construction of mine-related features (pit caps, roads and dikes) from coarse rock material throughout the basin will create shoals and reefs after re-flooding. In addition, approximately 30% of the area of Portage Pit will be backfilled to a depth of 4-10 m during the construction phase, reducing the amount of ultra-deep water areas, and increasing habitat suitability in this area.

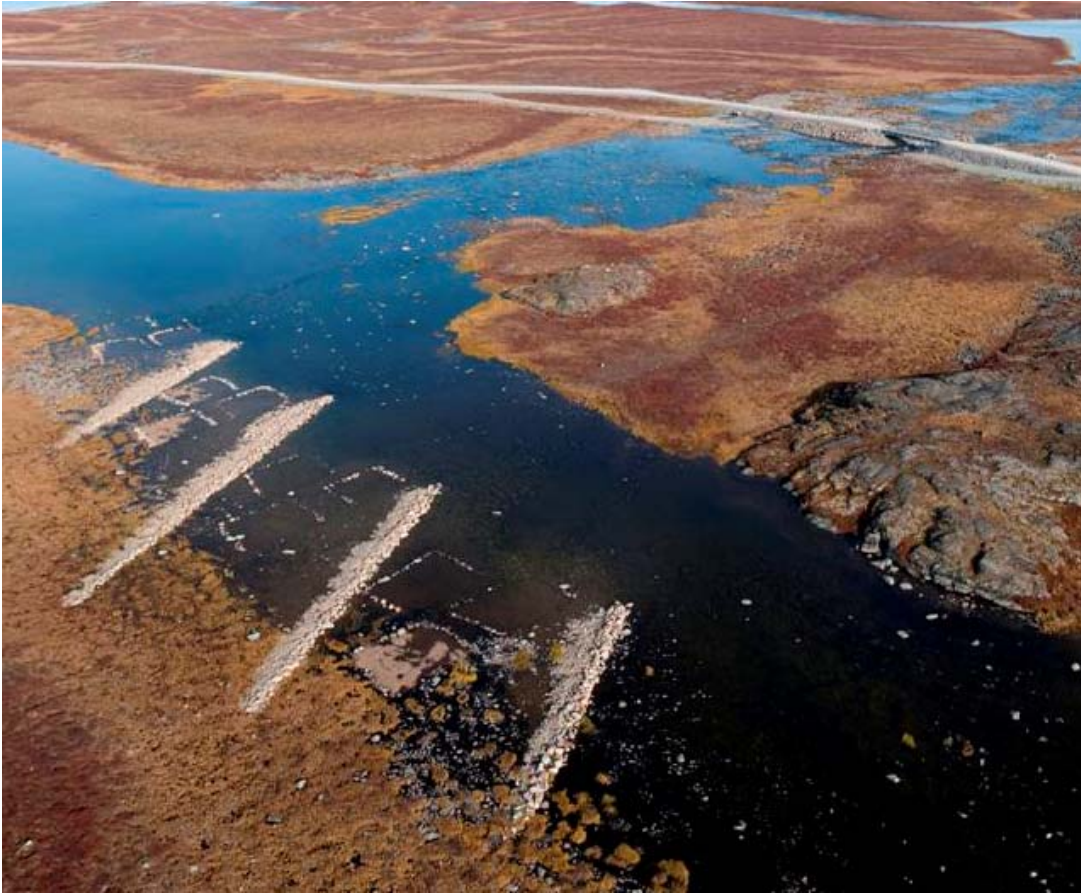
*Figure 4- Aerial Photo of R02 Habitat Compensation Feature- Taken in September 2009*

As part of the habitat compensation plan for construction of the roadway between Baker Lake and the mine site, a spawning pad was constructed in 2009 near bridge crossing R02 (Figure 4). This habitat compensation project was constructed according to design specifications that met biological criteria aimed at enhancing Arctic grayling productivity in this stream system. The construction focused on creating high value spawning and nursing habitat to compensate for the loss of the low and medium value habitat affected by bridge abutment construction at the four crossings. An overview of the Meadowbank area post-closure, incorporating all compensation features, is shown in aerial photo below.
