Meadowbank 2023 Habitat Compensation Monitoring Report

**2023 HABITAT COMPENSATION MONITORING
REPORT**

DFO Fisheries Authorizations NU-0190, NU-03-0191.3, NU-03-0191.4 and
14-HCAA-01046

Prepared by:
Agnico Eagle Mines Limited – Meadowbank Complex

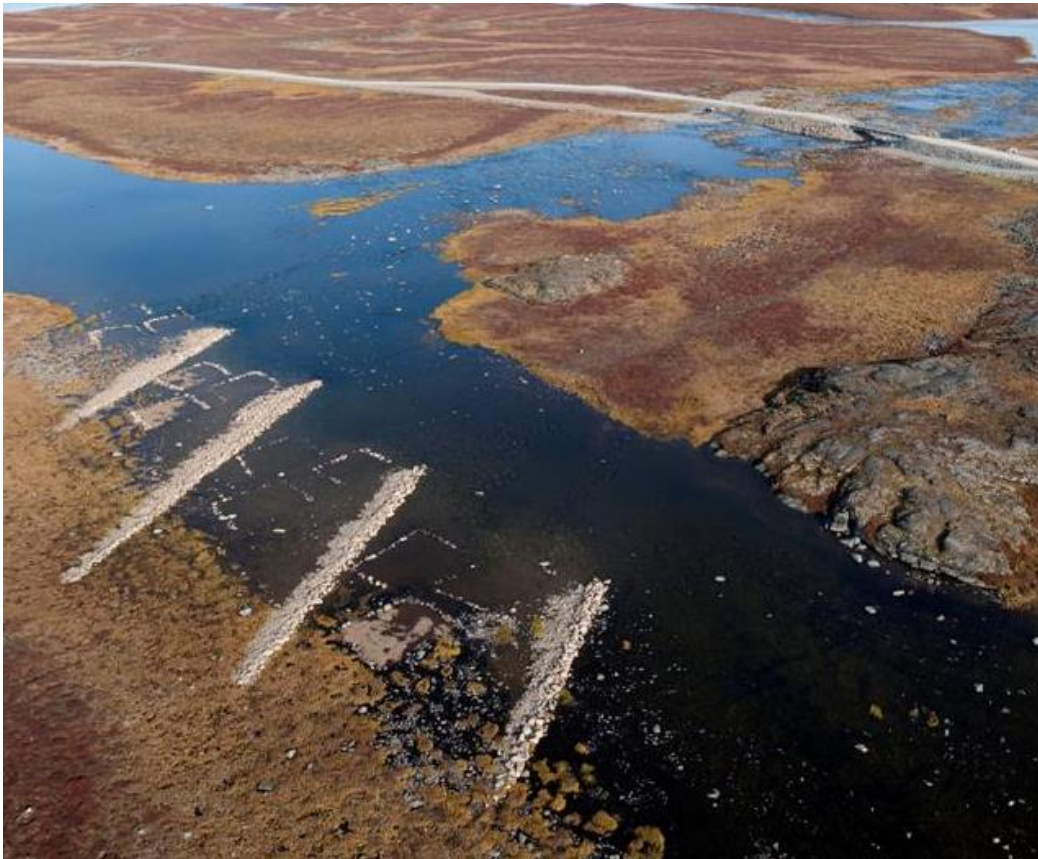
In 2009, a habitat compensation project consisting of four gravel spawning pads was constructed at crossing R02 according to design specifications that met biological criteria aimed at enhancing Arctic grayling (*Thymallus arcticus*) productivity (Figure 1). The construction focused on creating high value spawning and nursery habitat to compensate for the loss of the low and medium value habitat affected by bridge abutment construction at the four crossings.

Figure 1. Arctic Grayling spawning pads constructed at Meadowbank all weather road crossing R02.

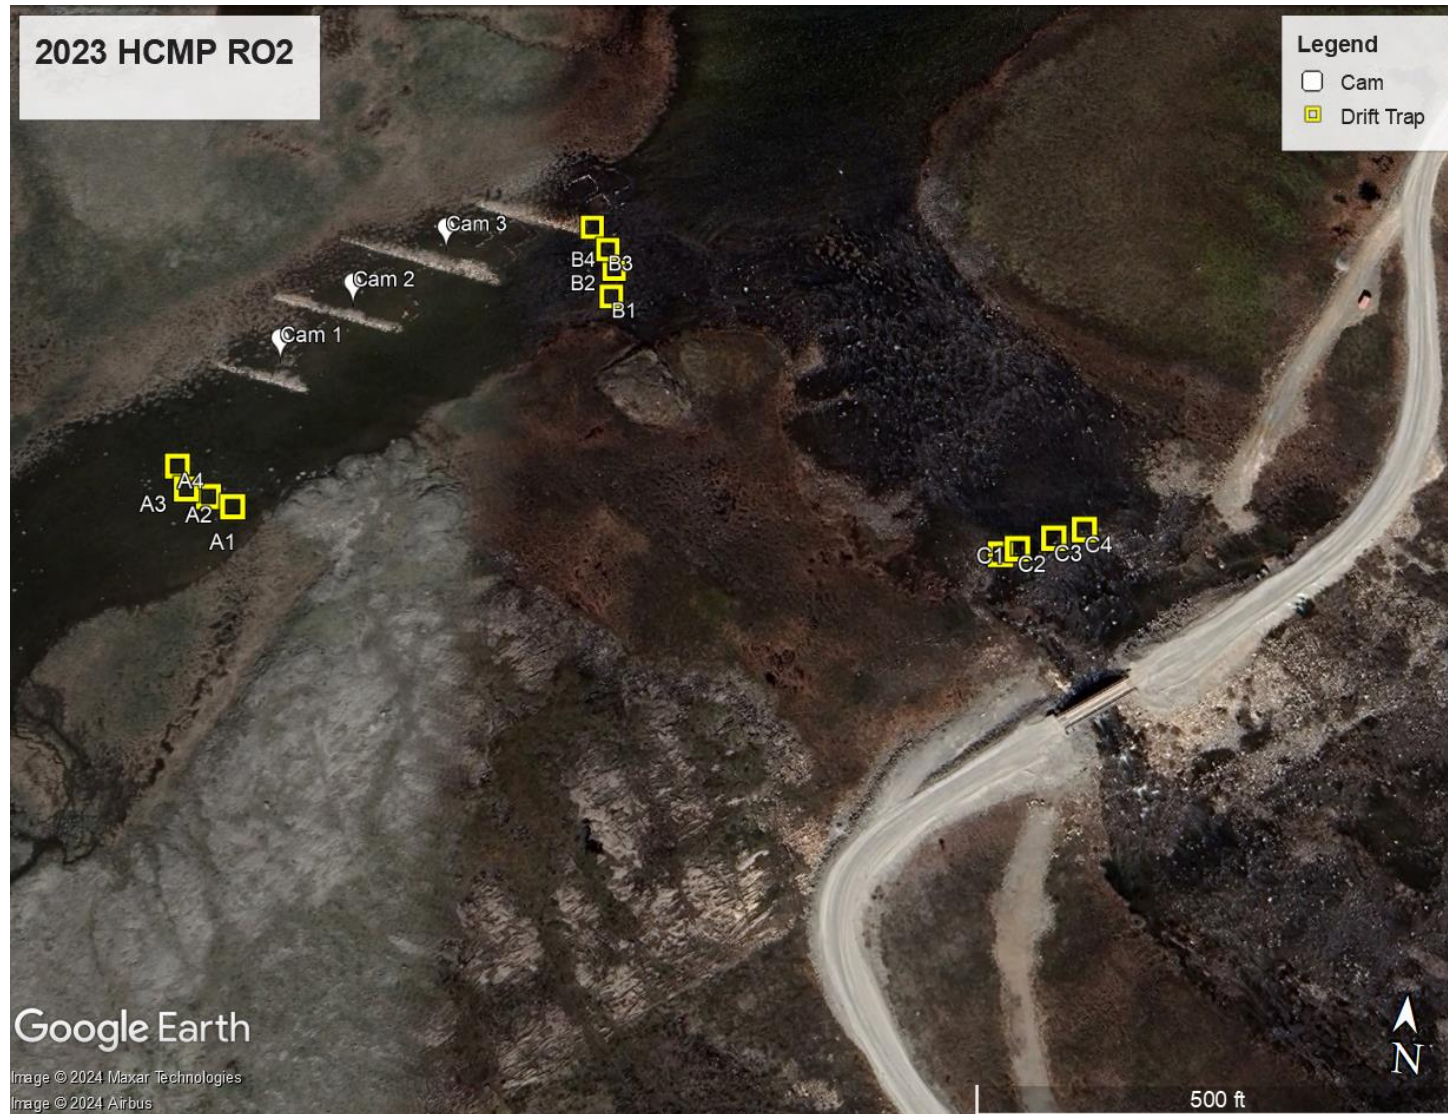
To demonstrate ongoing reproduction within the R02 reach, drift trap monitoring for Arctic grayling larvae proceeded in a manner similar to previous years. In total, 12 larval drift traps (DT) were set at R02 from June 17 through July 7, 2023 (UTM coordinates provided in Table 1; locations shown in Figure 2). Four traps (DT A1 to A4) were upstream of the R02 habitat compensation area. Four traps (DT B1 – B4) were immediately downstream of the R02 habitat compensation, and four traps (DT C1 – C4) were set further downstream, slightly upstream of the bridge in locations identical to previous monitoring events. Five of the larval drift traps consisted of a square sided metal cone with a rigid frame (~47 x 30 cm) that funnelled into a 0.5 mm nitex mesh bag. Attached at the back of the nitex bag was a Nalgene®-type container where the drift was collected. Seven traps consisted of a ~60cm x 30 cm square frame which has a 0.5 mm nitex mesh bag, attached to a hard plastic container where the drift was collected. The frames were submerged at least halfway under water (as water levels permitted) and secured by poles on each side. Drift traps were initially checked every three days, but since no larvae were captured after six days, they were then left unchecked for each of two seven-day periods prior to removal on July 7.

As in previous years, underwater video cameras were set between two sets of the spawning pad berms, facing the shore. The cameras were mounted on a ½” x 12” L shaped piece of rebar which was welded to a 4” x 12” steel “C” beam. The “C” beam acted as a base for the camera mount. A rope with a buoy at one end was attached to the rebar and lowered into the water. The buoy was used as a locator once the camera was deployed under water. Cameras were set for approximately 20 min or 1.5 h on July 17 between (4 recordings total), and 3h43m of footage were recorded.

Figure 2. Locations of cameras (Cam) and larval drift traps in 2023 at the R02 habitat compensation feature.

Of the four videos recorded (all on June 17), fish were only observed on one recording (camera 1; see Figure 2). Throughout the 1h29m recording, 48 observations of fish on screen were noted, and in any one case between one and six fish were seen. In 21 observations, the fish were identified as lake trout, and in one observation, the fish was identified as an Arctic grayling. In previous years, very few observations have been made through underwater imagery (e.g. three observations in 6h of footage in 2021, all Arctic grayling or unidentified).

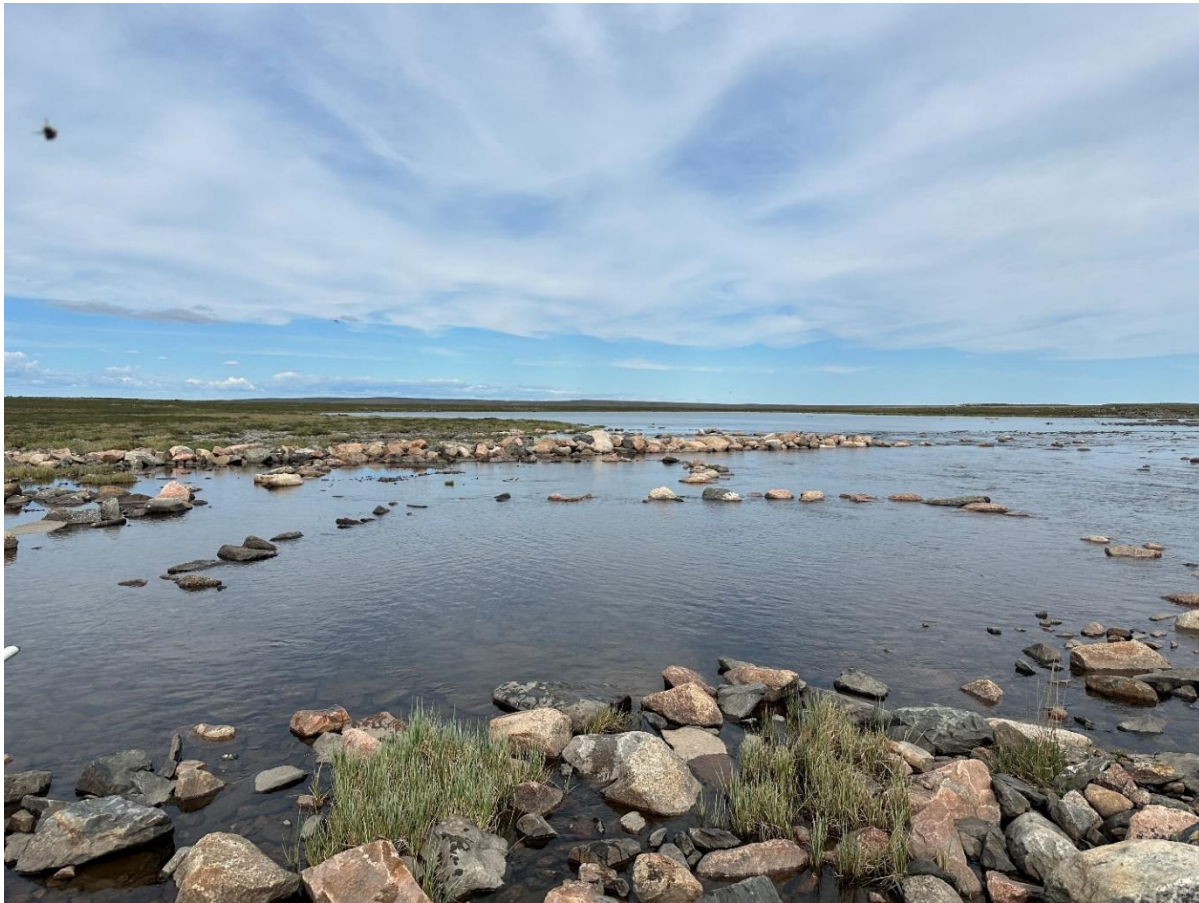
Visual observations in 2023 indicated limited movement of the spawning berm material. The baffle berms appear to be functioning as intended to reduce water flow rates and depths, and the cobble U-berms constructed to retain the spawning material (gravel/cobble mix) remain generally intact. Substrate surveys of the spawning pads themselves (area within the U-berms), indicated that in most pads, gravel substrate has eroded in some areas compared to the 90% design criteria (Table 2). However, gravel and small cobble combined continue to form on average 90% of substrate with survey plots. Across all plots, average substrate types consisted nominally of: 1% sand/silt/clay, 33% small gravel, 45% large gravel, 12% small cobble, 7% large cobble, and 2% boulder.

Figure 3. Spawning pad 2 area showing the outline of one of the three U-berms (June 30, 2023).

Stability of the feature was visually confirmed in 2023, with some shifting of spawning bed gravel material since construction in 2009, as anticipated. However, on average, 90% of spawning bed material consists of gravel and small cobble.
